BE INSPECTED LLC

TREC REI 7-6

1708 Morse St Houston, TX 77019

PROPERTY INSPECTION REPORT FORM

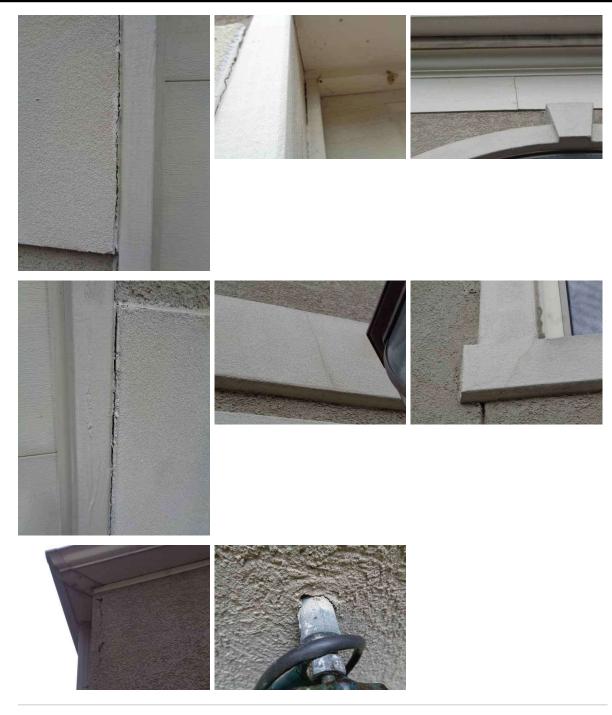
2: Damaged Siding Recommendation

Damaged stucco was observed around the home. Most notably at the right side.

Recommendation: Contact a stucco repair contractor
