## PROPERTY INSPECTION REPORT

10102 TRIBECA TRAIL, MISSOURI CITY, TX 77459

HAO WANG

4/7/2022

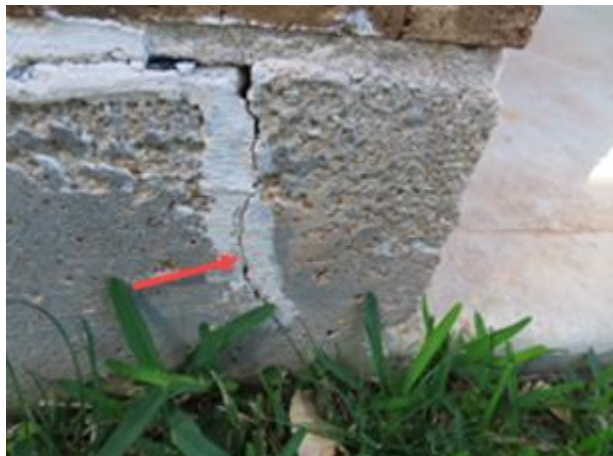
Small crack was visible on some foundation corner

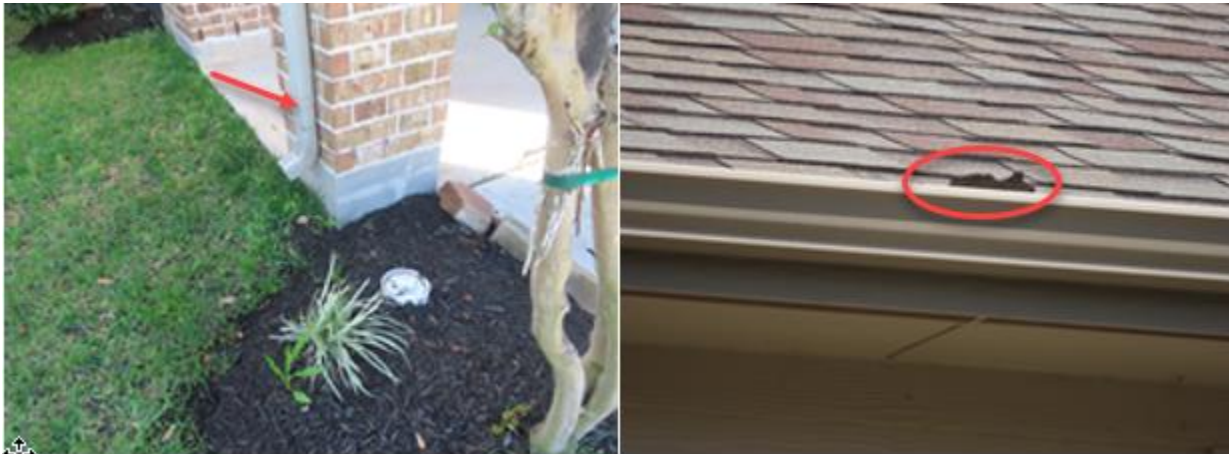
Some downspouts drain water too close to the foundation. It is better to move rain at least 3' away from the house.

Some trash needs to be cleaned at back gutter

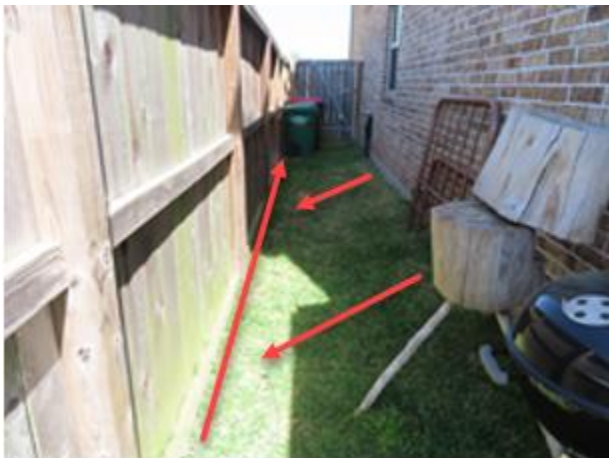
Yard drainage and grading were inadequate at both sides. Yard grading should be drained away from the foundation by 6 inches within first 10 feet.

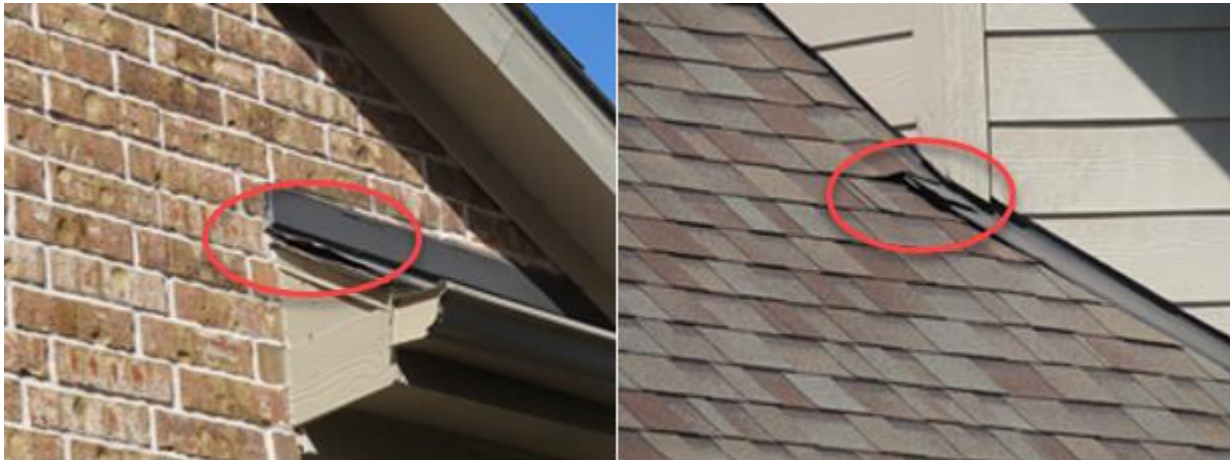
Some shingles and flashings need to be properly secured down to reduce chance of future damage at left side and above back patio

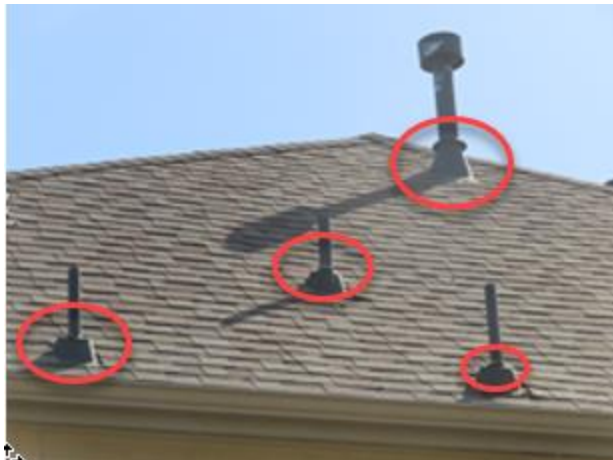
Some paint was missing at vent pipe on roof, suggest seal all vent pipe and roof jack on roof

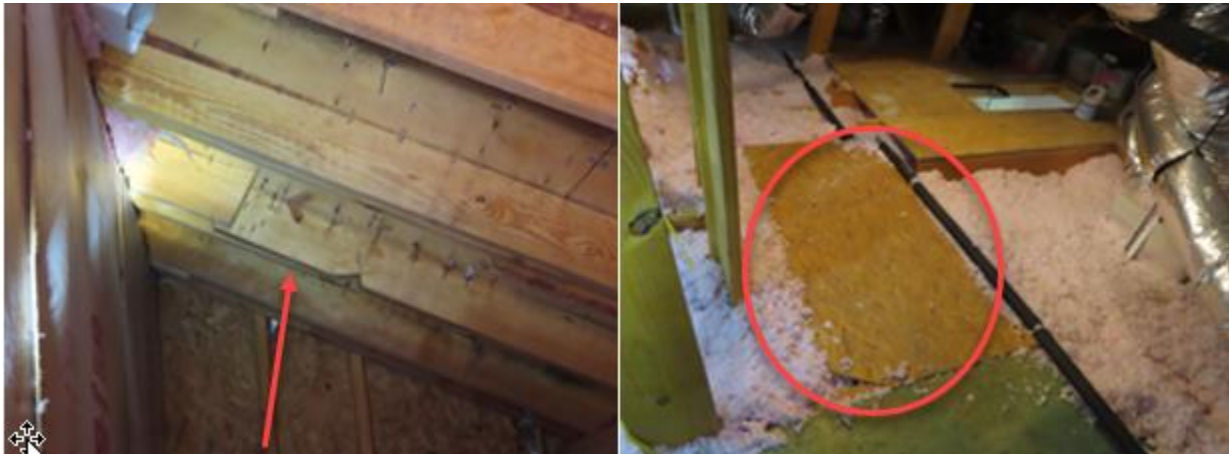
Support needs at one overlapped rafter in left back walk-in attic on second floor

Soft walking board needs to be strengthened in ceiling attic

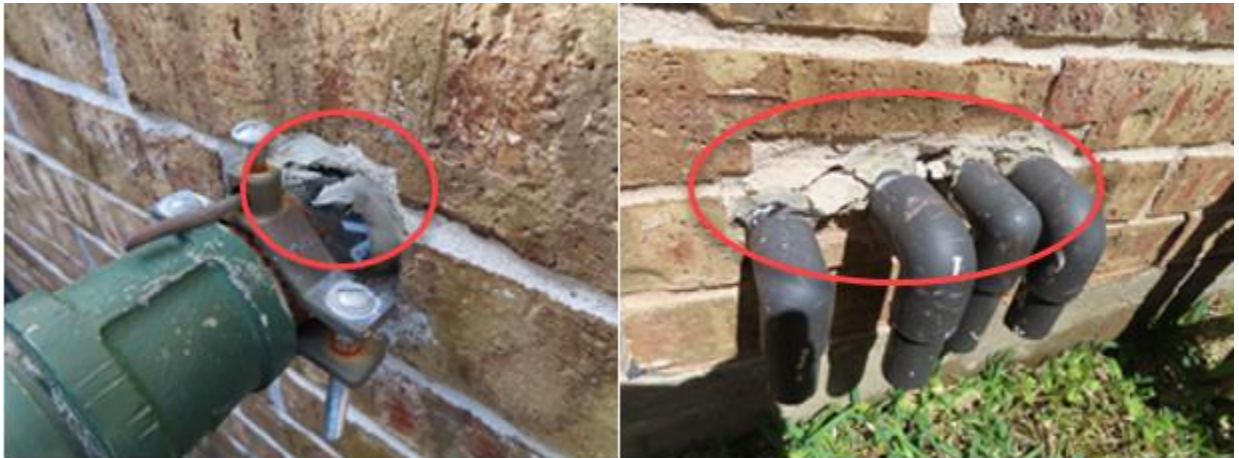
All penetrations through brick should be sealed to prevent water infiltration

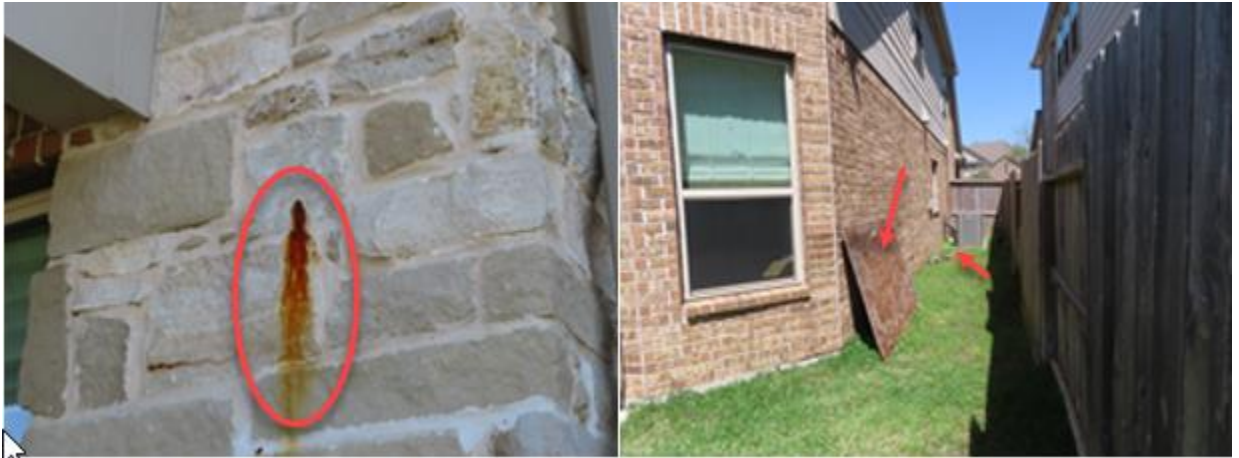
Rust stain was visible on stone wall

Wood board needs to be removed away from exterior wall on left side

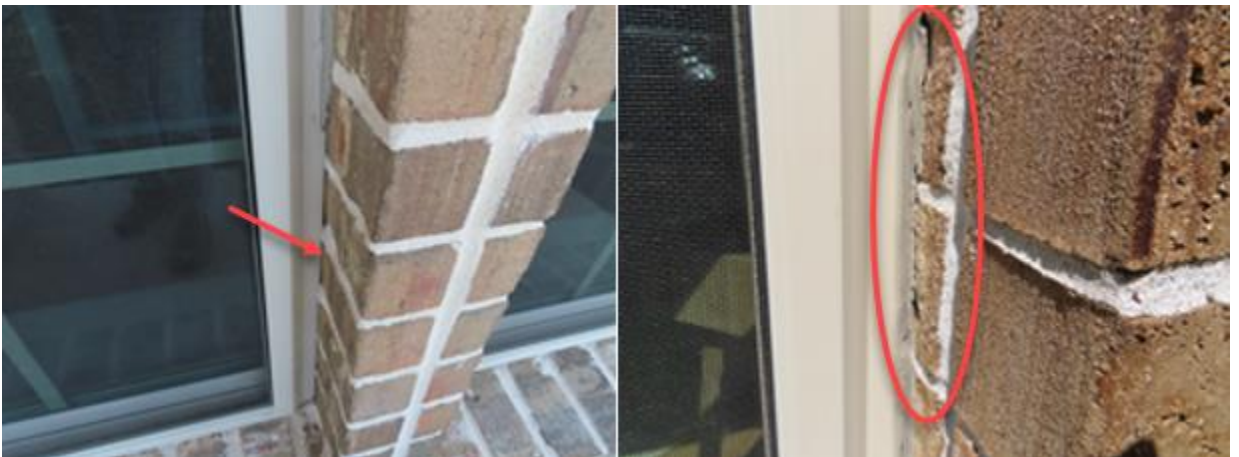
Some caulking was missing on front window jamb

Some caulking was separated at back window jamb and sill

Caulking needs to be repaired

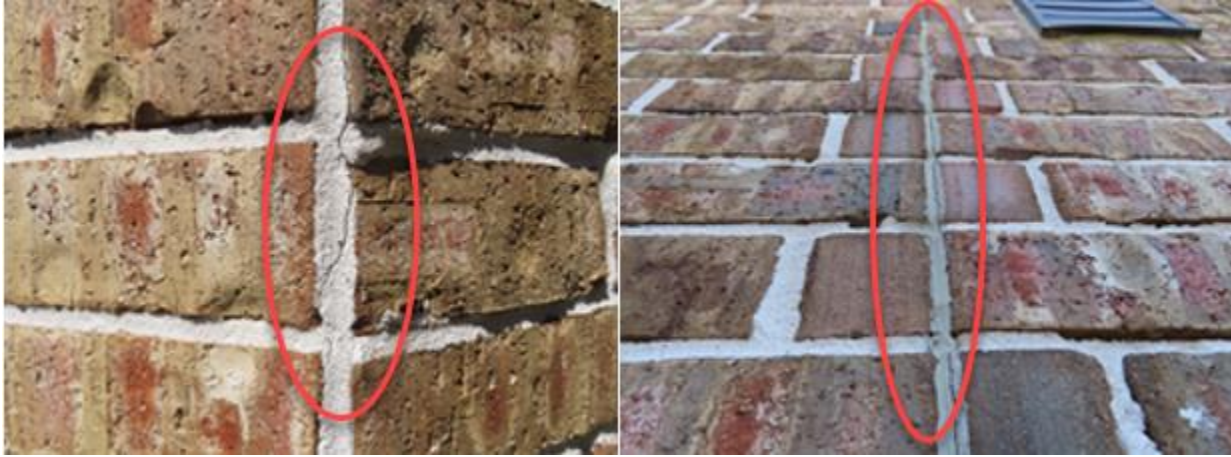
Some mortar was separated at front wall and back wall

Caulking in need of repair at right joint

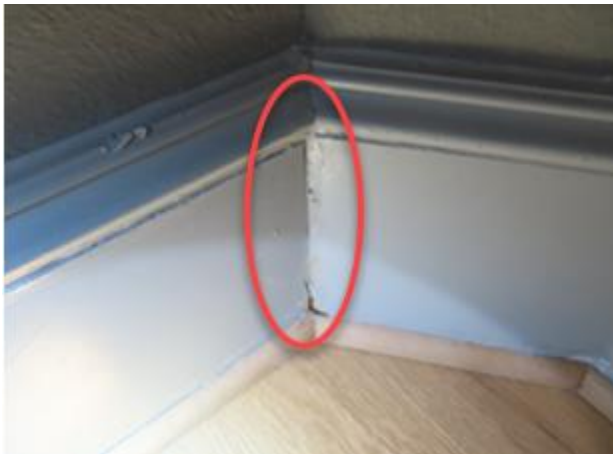
Hole on base board needs to be sealed near toilet in half bath

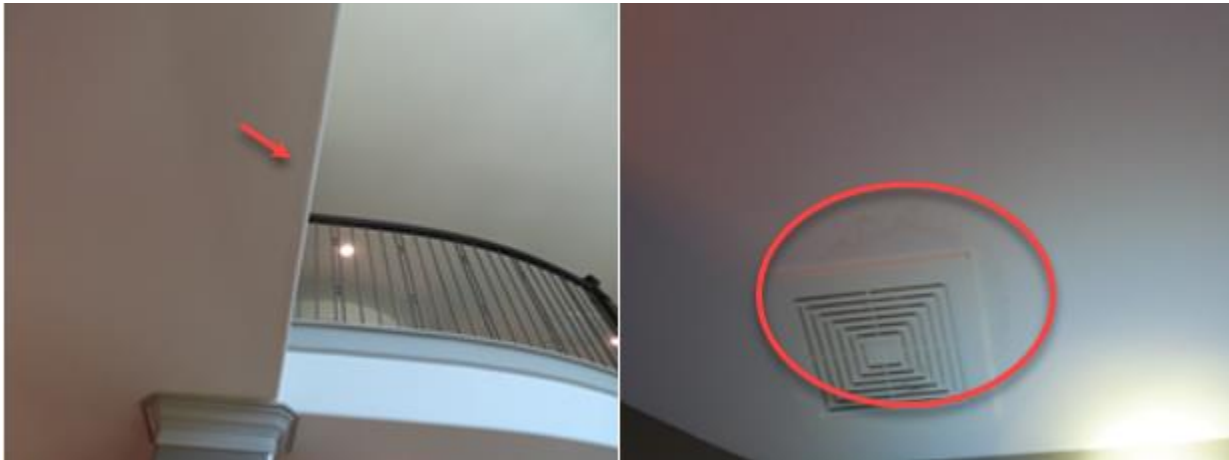
Hairline crack was visible on ceiling between kitchen posts

Some stain was visible on ceiling at half bath

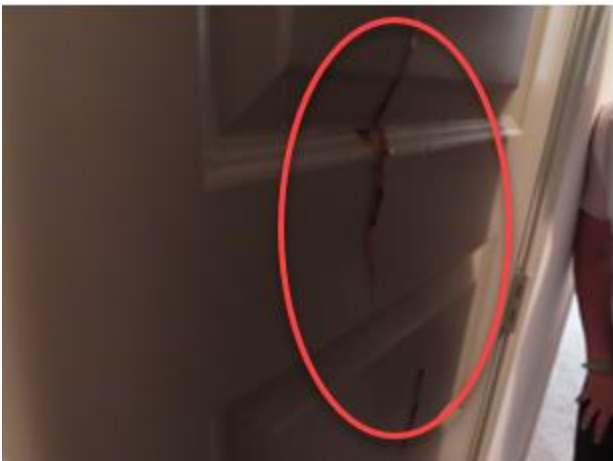
Damaged door panel needs to be replaced at right front bedroom closet on second floor

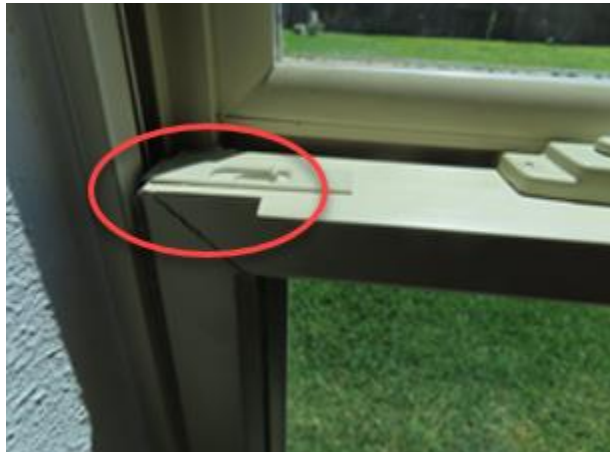
Tilt latch needs to be repaired at one back window in master bedroom

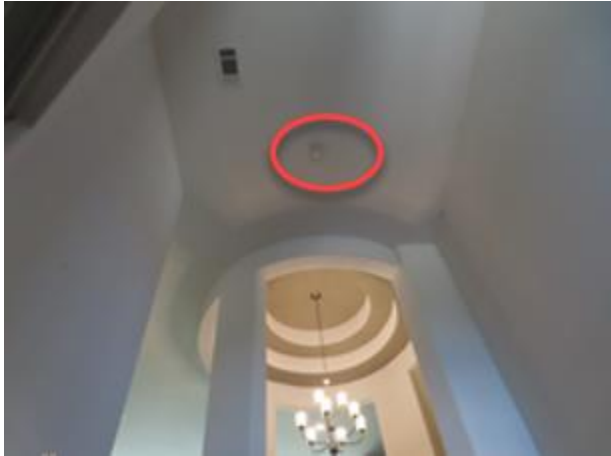
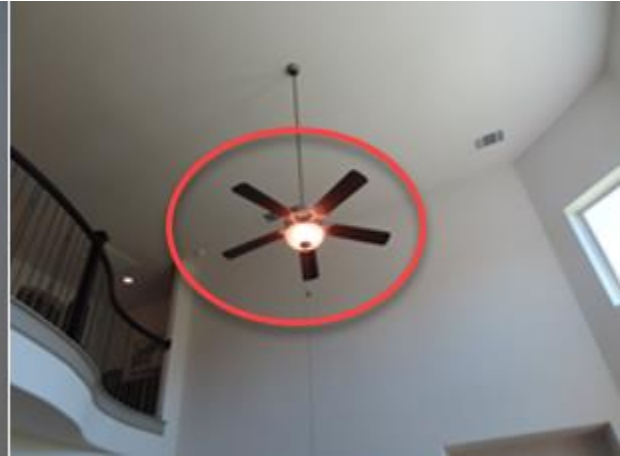
Some light bulbs/fixture did not function at foyer

Ceiling fan vibrates in family room

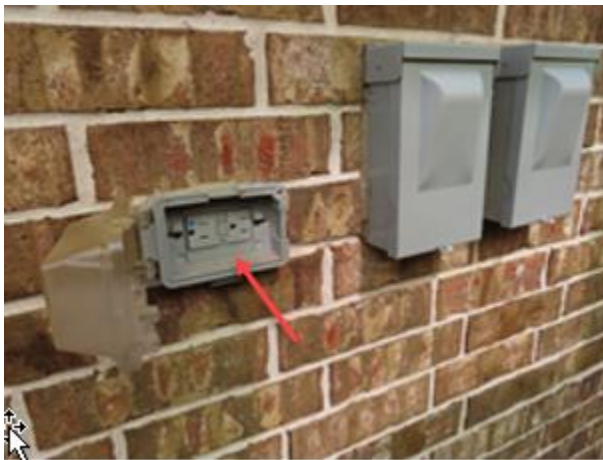
GFCI outlet malfunction at AC unit and needs to be replaced

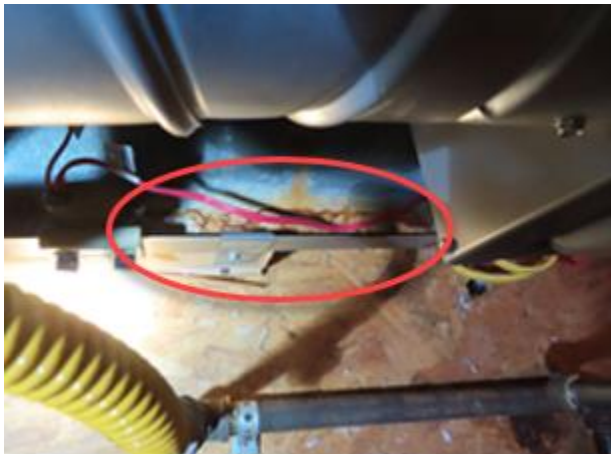
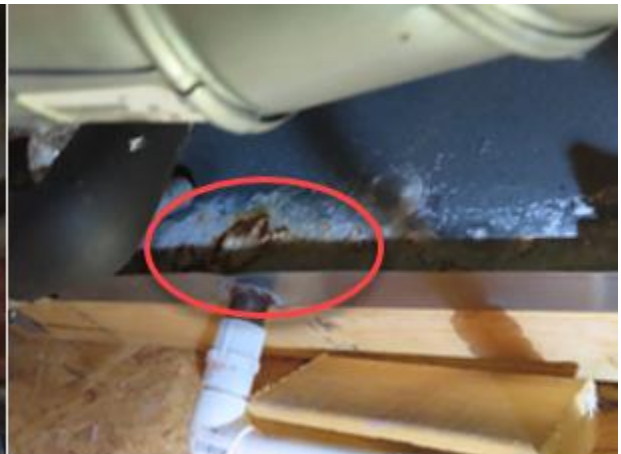
Little rust was observed in the evaporator coil overflow pan

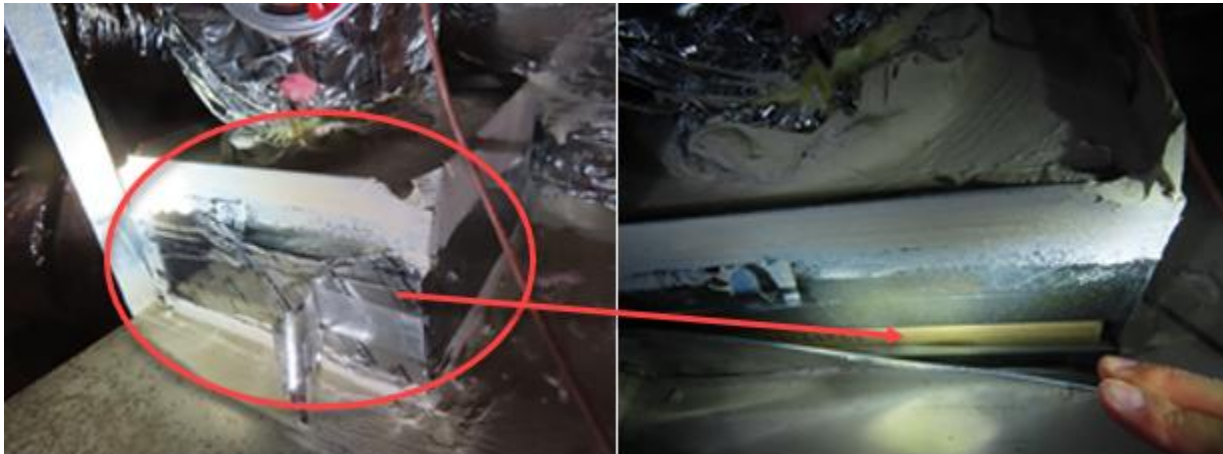
Filter ( size: 12x12) was dirty and needs to be replaced every few months on furnace 1

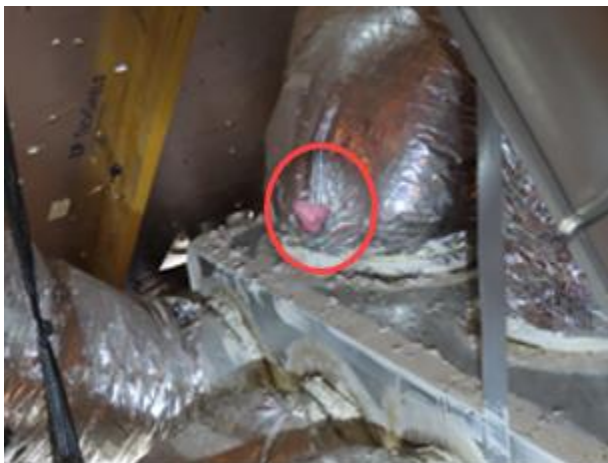
Damaged wrap was visible on some ducts

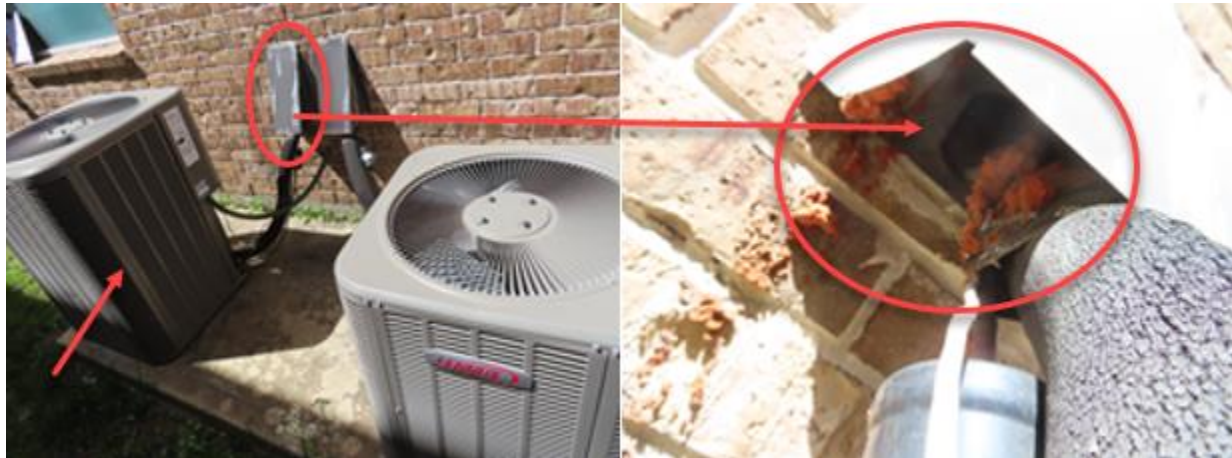
Back AC unit vibrates excessively when running, suggest evaluated/fixed by HVAC licensed contractor

Gap needs to be sealed under back FREON line cover at exterior wall

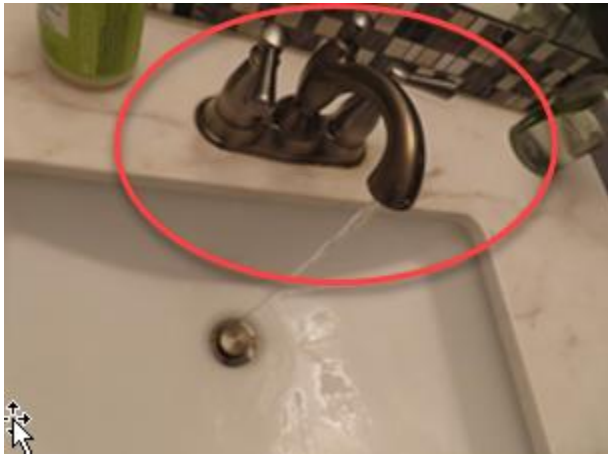
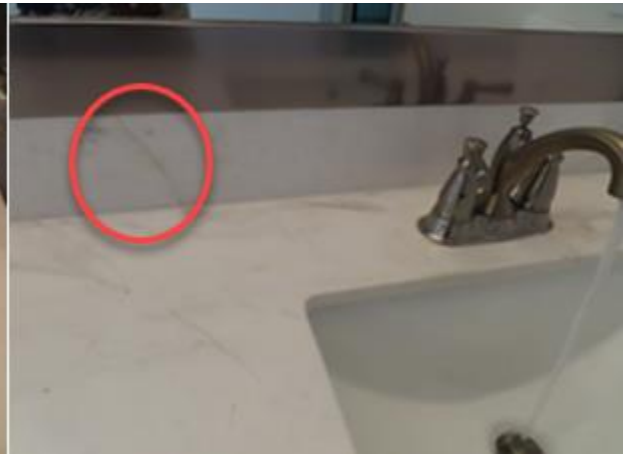
Lower water pressure at sink in right bath on second floor

Cracked back splash was visible at master vanity

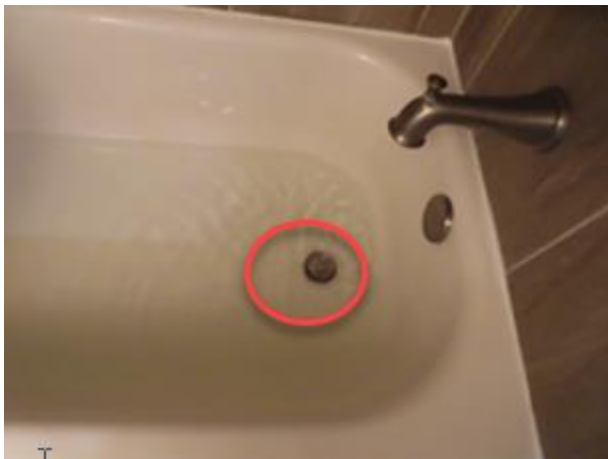
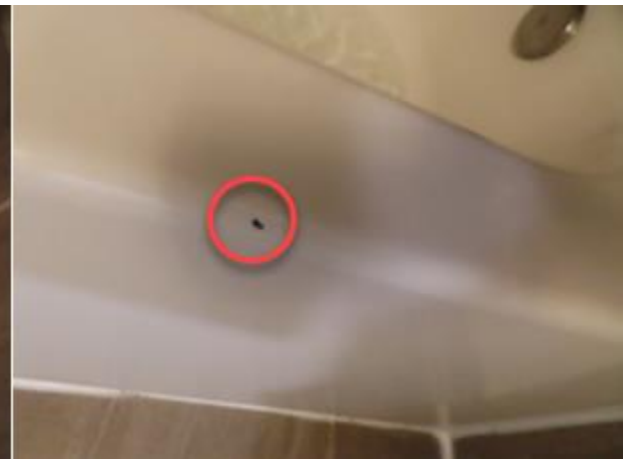
Tub drains slowly at right bath on second floor

Damaged finish at tub in right bath on second floor

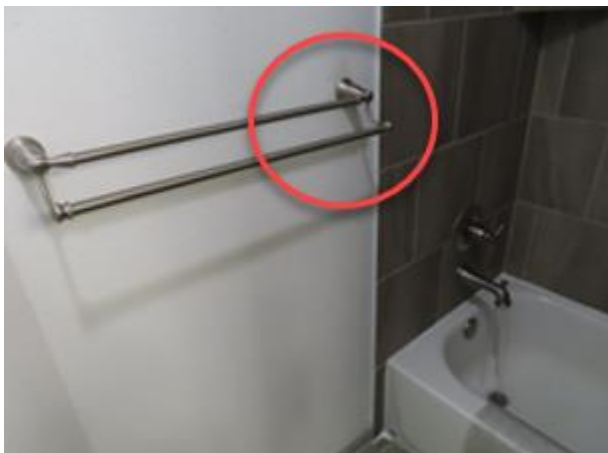
Loose towel bar needs to be fixed at left front bath on second floor

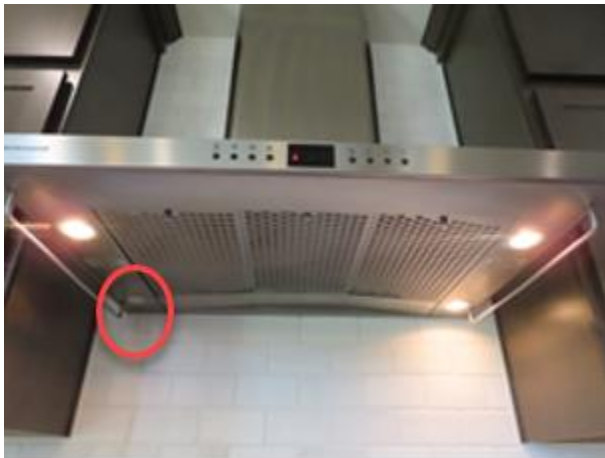
One light malfunction

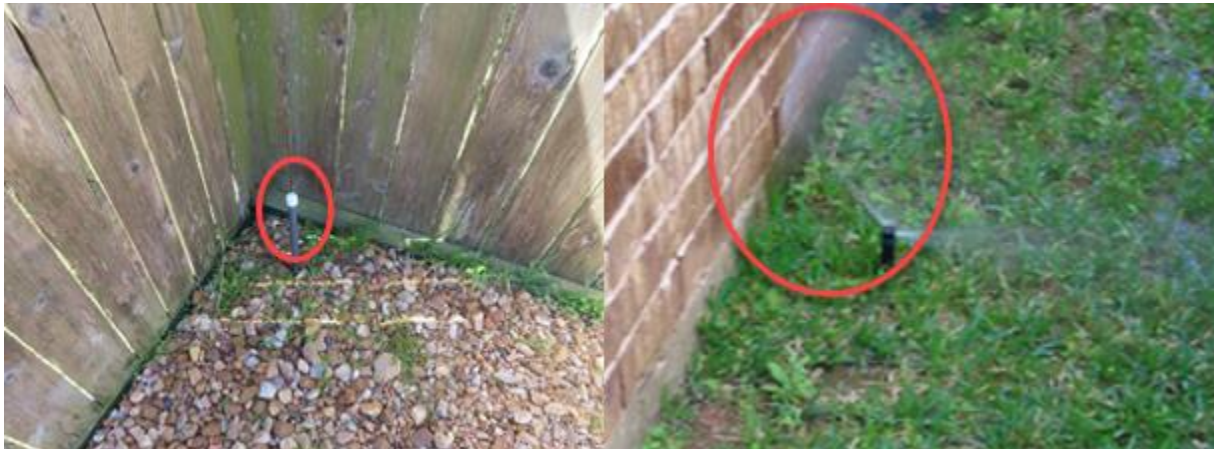
Some sprinkler head was capped at back yard

Some sprinkler heads need to be adjusted to spray away exterior wall at station 3
