Lone Star Stucco, LLC

Moisture Assessment Report

1316 Peden Street, Unit B

Houston, TX 77006

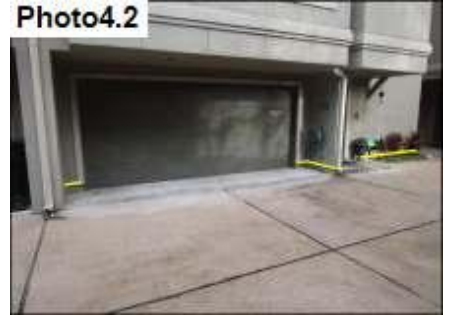
Photo4.2

Proper Grade Termination with Plaster Stop / Positive Detail

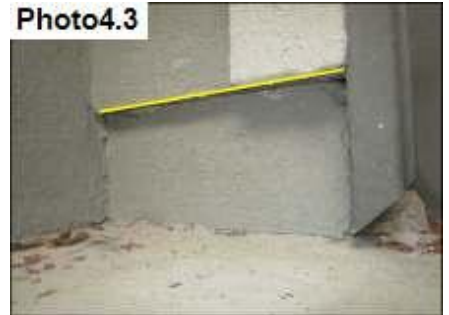
Photo4.3

Proper Grade Termination with Plaster Stop / Positive Detail

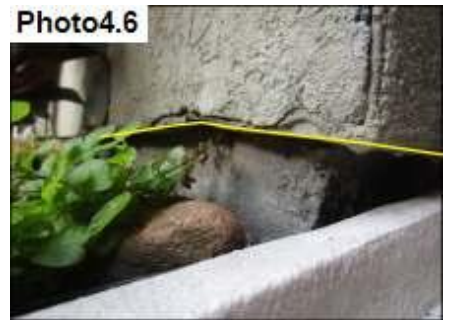
Photo4.6

Proper Grade Termination with Plaster Stop / Positive Detail

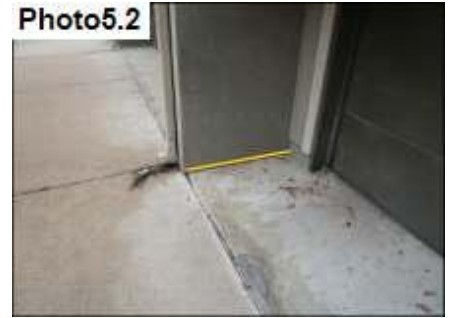
- The wall noted is in contact with flatwork. The inspector suggests to have a qualified waterproofing contractor further assess and apply a "kant" bead to all base terminations in an effort to prevent moisture intrusion. Please refer to photos #5.2 and #5.3 for more detail.

Stucco In Contact with Grade/ Apply a Kant Bead

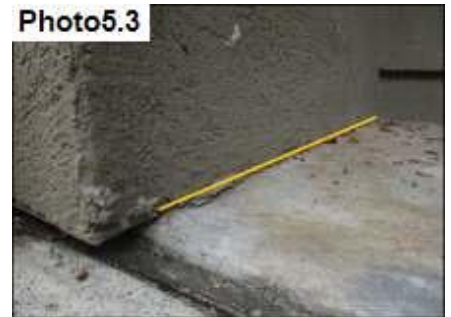
Stucco In Contact with Grade/ Apply a Kant Bead **Repaired**

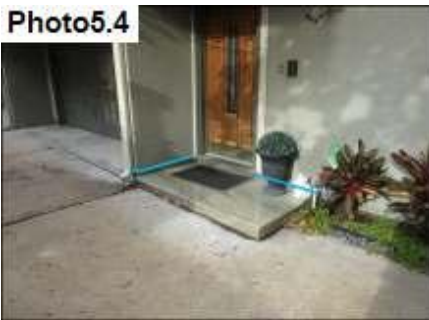
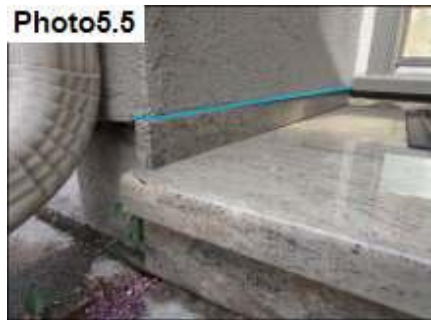
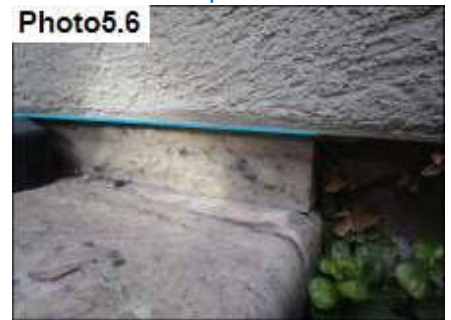
- Although the stucco terminates to the tile accent at these locations, no substrate damage is noted. The inspector recommends no modification at this time. Please refer to photos #5.4, #5.5 and #5.6 for more detail.

Stucco In Contact with Tile / No Modification **Repaired**

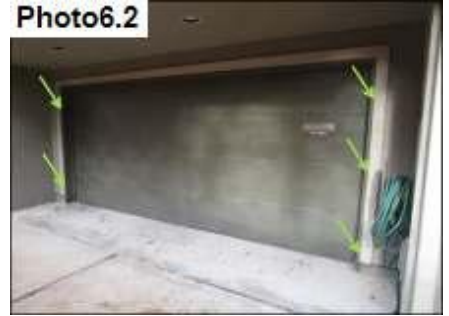
Photo6.2

- The door trim and miter sealants are aged or separated at these locations. The inspector suggests to have a qualified waterproofing contractor seal these areas with a low modulus sealant in an effort to prevent moisture intrusion. These types of sealants are of high quality and compatible with stucco and other termination points. Please refer to photos #6.2, #6.3, #6.4, #6.5 and #6.6 for more detail.

Door Sealants / Seal

All areas caulked - sealed.

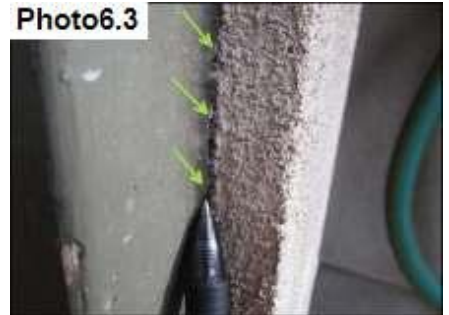
Photo6.3

Door Sealants / Seal

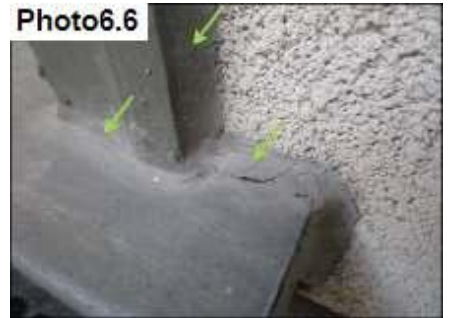
Photo6.6

Door Sealants / Seal

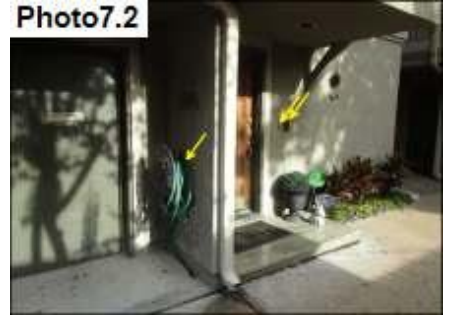
Photo7.2

- The penetration sealants are missing in these locations. The inspector suggests to have a qualified waterproofing contractor seal these areas with a low modulus sealant in an effort to prevent moisture intrusion. These types of sealants are of high quality and compatible with stucco and other termination points. Please refer to photos #7.2, #7.3, #7.4, #7.5 and #7.6 for more detail.

Penetration Sealants / Seal

[All Penetrations Caulked/Sealed](#)

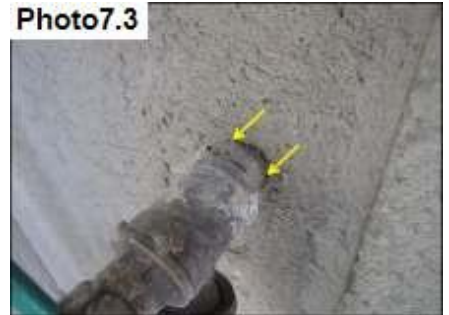
Photo7.3

Penetration Sealants / Seal

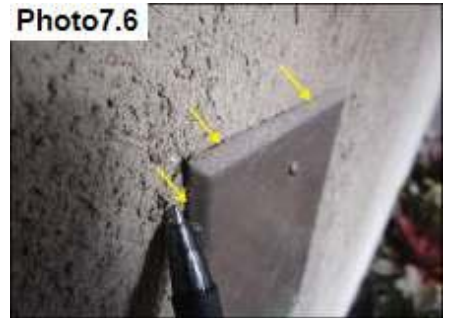
Photo7.6

Penetration Sealants / Seal

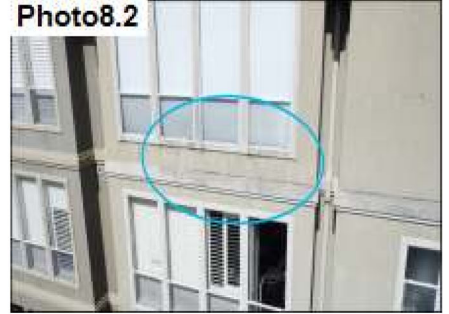
Photo8.2

- Run-off stains are noted at this area. The inspector suggests to have a qualified waterproofing contractor clean as needed. Please refer to photos #8.2, #8.3, #8.4 and #8.5 for more detail.

Run-off Stains / Clean (Aesthetic)

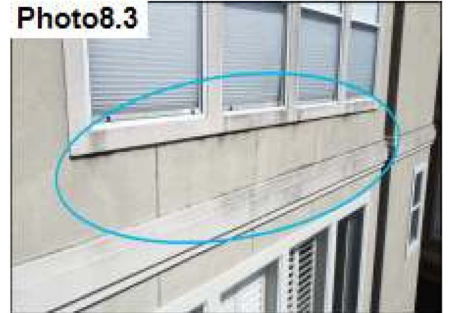
Photo8.3

Run-off Stains / Clean (Aesthetic)

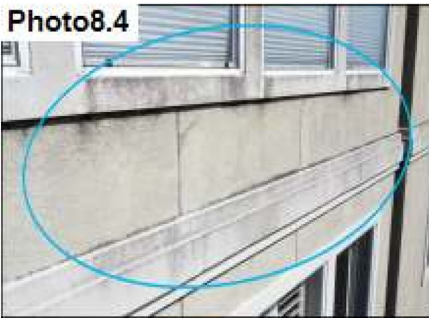
Photo8.4

Run-off Stains / Clean (Aesthetic)

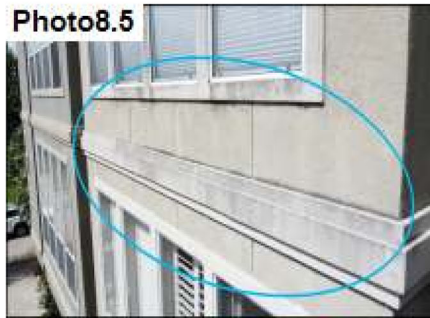
Photo8.5

Run-off Stains / Clean (Aesthetic)

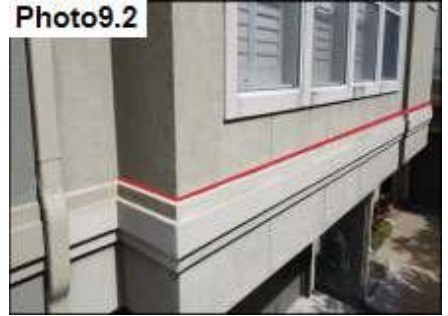
Photo9.2

- Foam accent/stucco termination sealants are aged at these locations. The inspector suggests to have a qualified waterproofing contractor further assess and seal these areas with a low modulus sealant in an effort to prevent moisture intrusion. These types of sealants are of high quality and compatible with stucco and other termination points. Please refer to photos #9.2, #9.3, #9.4, #9.5 and #9.6 for more detail.

Foam Accent & Stucco Termination / Seal

Foam Accent & Stucco Termination Sealed

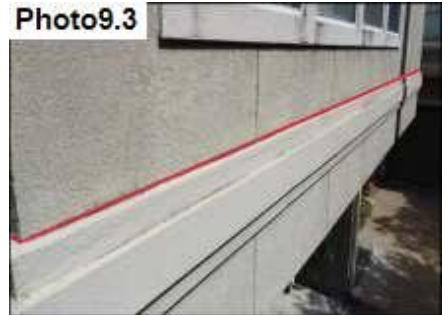
Photo9.3

Foam Accent & Stucco Termination / Seal

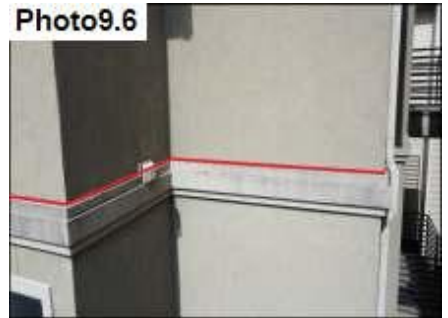
Photo9.6

Foam Accent & Stucco Termination / Seal

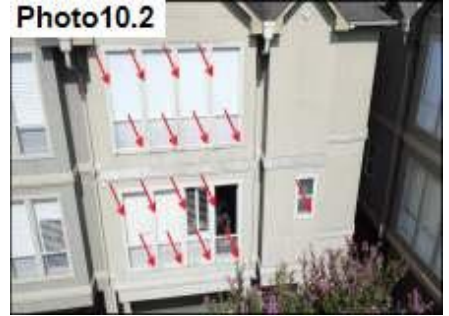
Photo10.2

- The window sealants are aged or separated. The inspector suggests to have a qualified waterproofing contractor further assess and seal these areas with a low modulus sealant in an effort to prevent moisture intrusion. These types of sealants are of high quality and compatible with stucco and other termination points. Please refer to photos #10.2, #10.3, #10.4, #10.5 and #10.6 for more detail.

Window Sealants / Seal

All Windows were caulked/sealed

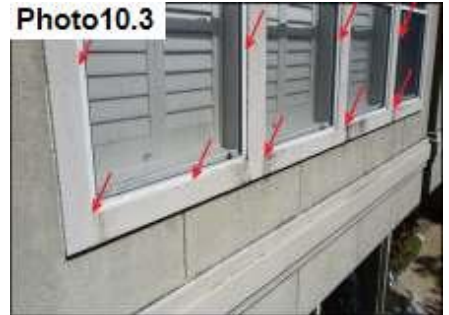
Photo10.3

Window Sealants / Seal

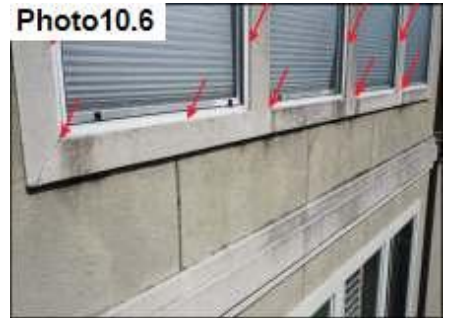
Photo10.6

Window Sealants / Seal

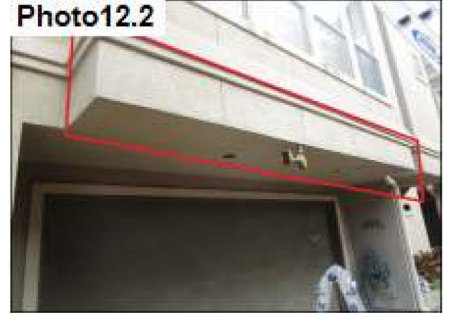
Photo12.2

- Confirmed substrate and potential frame damage is noted at the bottom of the bumpout wall below the bank of windows. The inspector recommends having a qualified waterproofing contractor further assess the extent of damage, repair as needed and install a proper relief in an effort to prevent moisture intrusion. Please refer to photos #12.2, #12.3, #12.4 and #12.5 for more detail.

Substrate Damage / Assess, Repair & Install Relief

All damaged areas were repaired/replaced and a relief was installed.

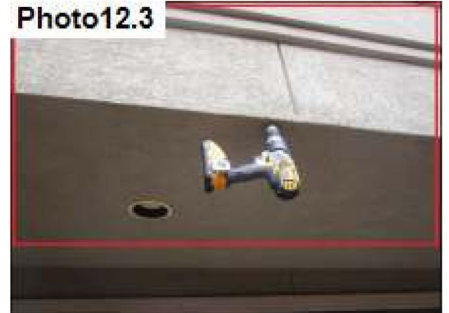
Photo12.3

Substrate Damage / Assess, Repair & Install Relief

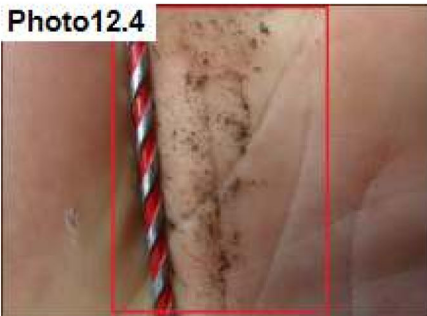
Photo12.4

Substrate Damage / Assess, Repair & Install Relief

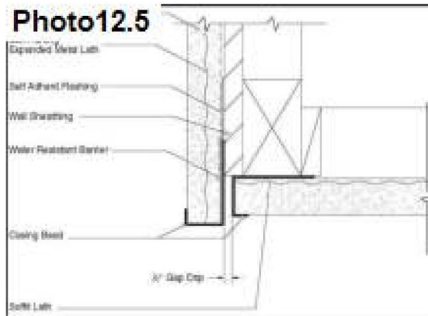
Photo12.5

Relief / Proper Detail

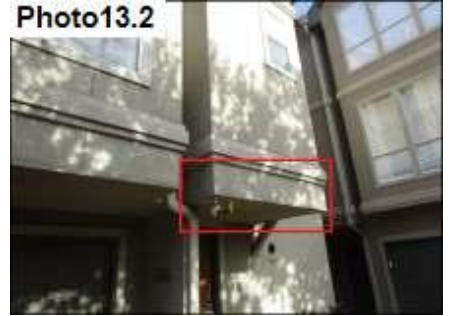
Photo13.2

- Confirmed substrate and potential frame damage is noted at the bottom of the bumpout wall below the window. The inspector recommends having a qualified waterproofing contractor further assess the extent of damage, repair as needed and install a proper relief in an effort to prevent moisture intrusion. Please refer to photos #13.2, #13.3, #13.4, #13.5 and #13.6 for more detail.

Substrate Damage / Assess, Repair & Install Relief

All damaged areas were repaired/replaced and a relief was installed.

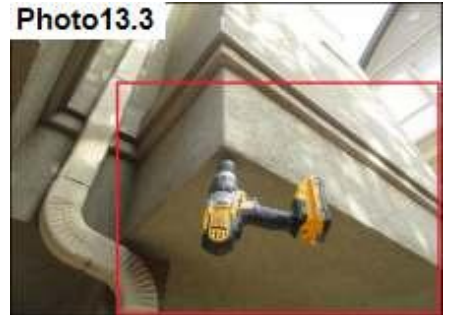
Photo13.3

Substrate Damage / Assess, Repair & Install Relief

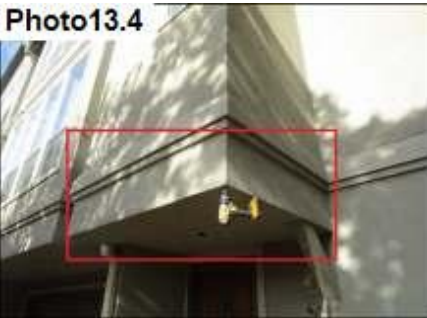
Photo13.4

Substrate Damage / Assess, Repair & Install Relief

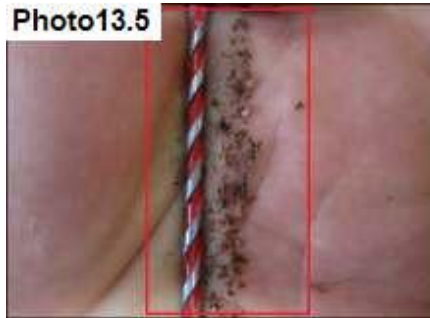
Photo13.5

Substrate Damage / Assess, Repair & Install Relief

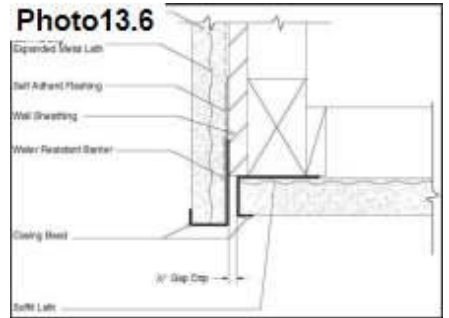
Photo13.6

Relief / Proper Detail

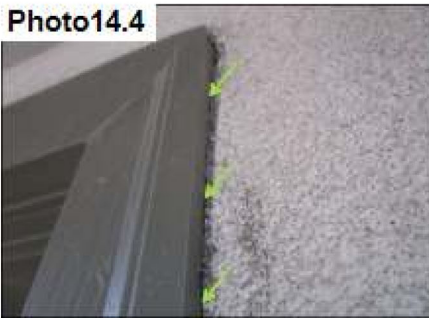
Photo14.4

- The door trim and miter sealants are aged, separated or missing at these locations. The inspector suggests to have a qualified waterproofing contractor seal these areas with a low modulus sealant in an effort to prevent moisture intrusion. These types of sealants are of high quality and compatible with stucco and other termination points. Please refer to photos #14.2, #14.3 and #14.4 for more detail.

Door Sealants / Seal

All door trim and miters were sealed.

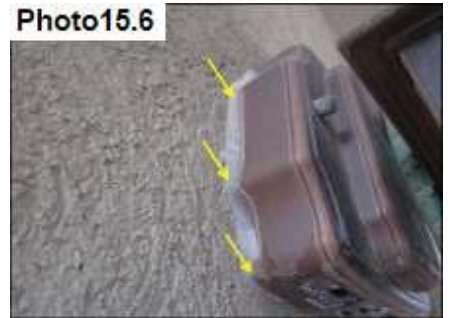
Photo15.6

- The penetration sealants are aged, separated or missing in these locations. The inspector suggests to have a qualified waterproofing contractor seal these areas with a low modulus sealant in an effort to prevent moisture intrusion. These types of sealants are of high quality and compatible with stucco and other termination points. Please refer to photos #15.2, #15.3, #15.4, #15.5 and #15.6 for more detail.

Penetration Sealants / Seal

All Penetrations were sealed.

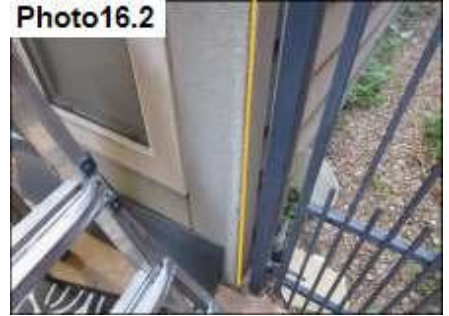
Photo16.2

- Trim/stucco termination sealants are aged or separated at this location. The inspector suggests to have a qualified waterproofing contractor further assess and seal this area with a low modulus sealant in an effort to prevent moisture intrusion. These types of sealants are of high quality and compatible with stucco and other termination points. Please refer to photos #16.2, #16.3, #16.4, #16.5 and #16.6 for more detail.

Trim & Stucco Termination / Seal

[All stucco terminations were sealed](#)

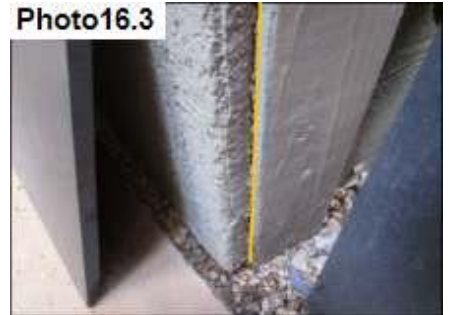
Photo16.3

Trim & Stucco Termination / Seal

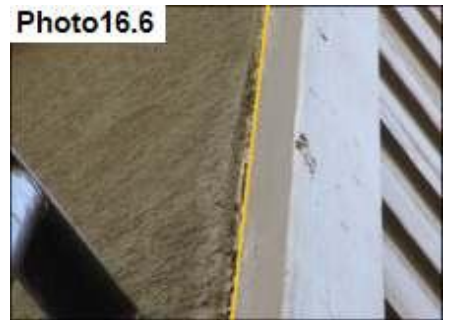
Photo16.6

Trim & Stucco Termination / Seal

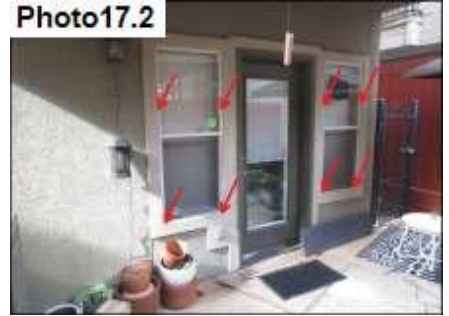
Photo17.2

- The window sealants are aged, thin, separated or missing. The inspector suggests to have a qualified waterproofing contractor further assess and seal these areas with a low modulus sealant in an effort to prevent moisture intrusion. These types of sealants are of high quality and compatible with stucco and other termination points. Please refer to photos #17.2, #17.3, #17.4, #17.5 and #17.6 for more detail.

Window Sealants / Seal

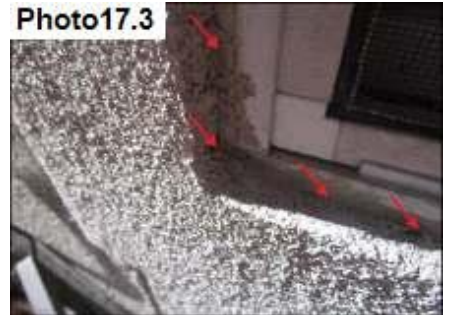
Photo17.3

Window Sealants / Seal

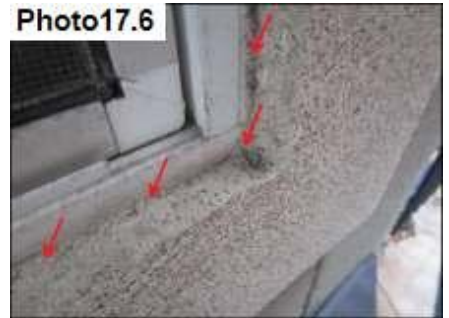
Photo17.6

Window Sealants / Seal

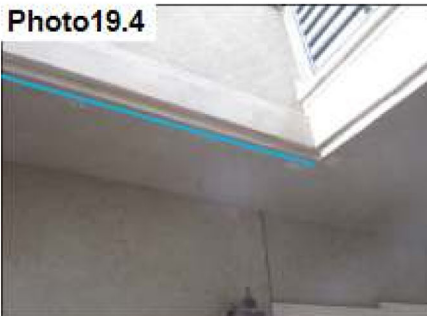
Photo19.4

- Although the bottom of the wall noted does not have a proper relief, this was a proper detail at the time of construction. Upon invasive testing at this location, the substrate was semi-firm with elevated moisture readings. The inspector recommends a qualified waterproofing contractor assess this area. No damage was noted at this time, however, it is recommended to maintain all sealants above. Please refer to photos #19.2, #19.3 and #19.4 for more detail.

No Relief / No Modification but Maintain Sealants Above

[A relief was added.](#)

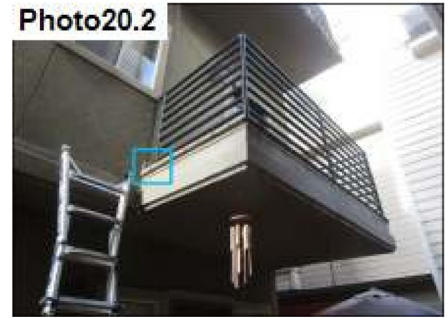
- The second floor balcony flashing sealants are aged or separated at this location. The inspector suggests to have a qualified waterproofing contractor further assess and seal this area with a low modulus sealant in an effort to prevent moisture intrusion. These types of sealants are of high quality and compatible with stucco and other termination points. Please refer to photos #20.2, #20.3, #20.4 and #20.5 for more detail.

Balcony Flashing / Seal

All Balcony flashing was sealed.

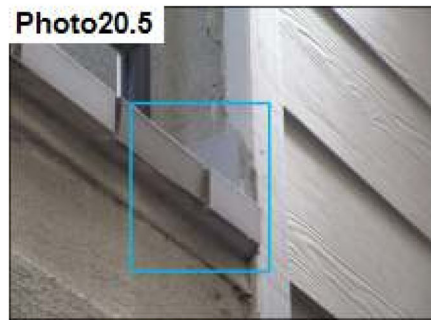
Balcony Flashing / Seal

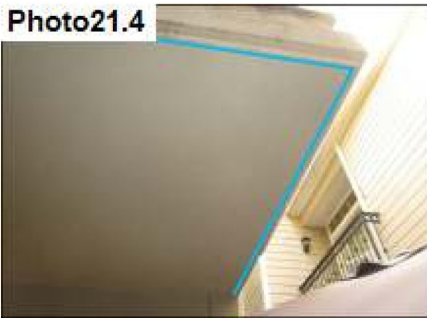
Photo21.4

- Although the bottom of the second floor balcony does not have a proper relief, this was a proper detail at the time of construction. Upon invasive testing at this location, the substrate was semi-firm with elevated moisture readings. The inspector recommends a qualified waterproofing contractor assess this area. No damage was noted at this time, however, it is recommended to maintain all sealants above. Please refer to photos #21.2, #21.3 and #21.4 for more detail.

No Relief / No Modification but Maintain Sealants Above

Reliefs were added.

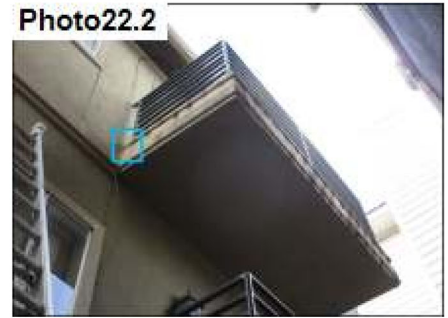
- The third floor balcony flashing sealants are aged or separated at this location. The inspector suggests to have a qualified waterproofing contractor further assess and seal this area with a low modulus sealant in an effort to prevent moisture intrusion. These types of sealants are of high quality and compatible with stucco and other termination points. Please refer to photos #22.2, #22.3, #22.4 and #22.5 for more detail.

Balcony Flashing / Seal

Balcony Flashing was sealed.

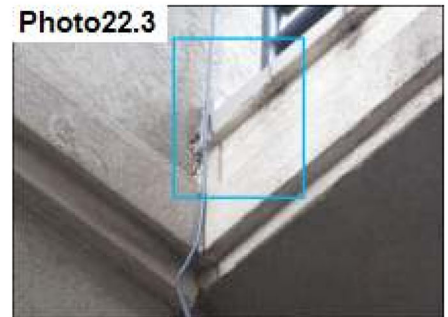
Balcony Flashing / Seal

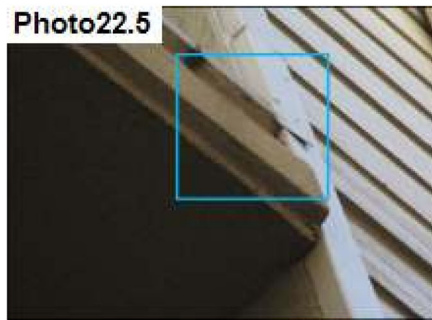
Balcony Flashing / Seal

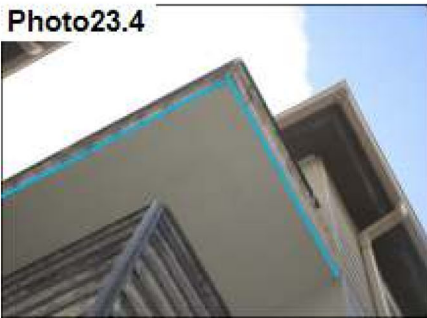
Photo23.4

- Although the bottom of the third floor balcony does not have a proper relief, this was a proper detail at the time of construction. Upon invasive testing at this location, the substrate was firm with acceptable moisture readings. The inspector recommends no modification at this point in time but recommends to maintain all sealants above this location to prevent potential moisture intrusion. Please refer to photos #23.2, #23.3 and #23.4 for more detail.

No Relief / No Modification
