Inspection Report

Property Address:
8011 Serenity Ct
Houston TX 77025

Houspecx Inspection Service

PROPERTY INSPECTION REPORT FORM

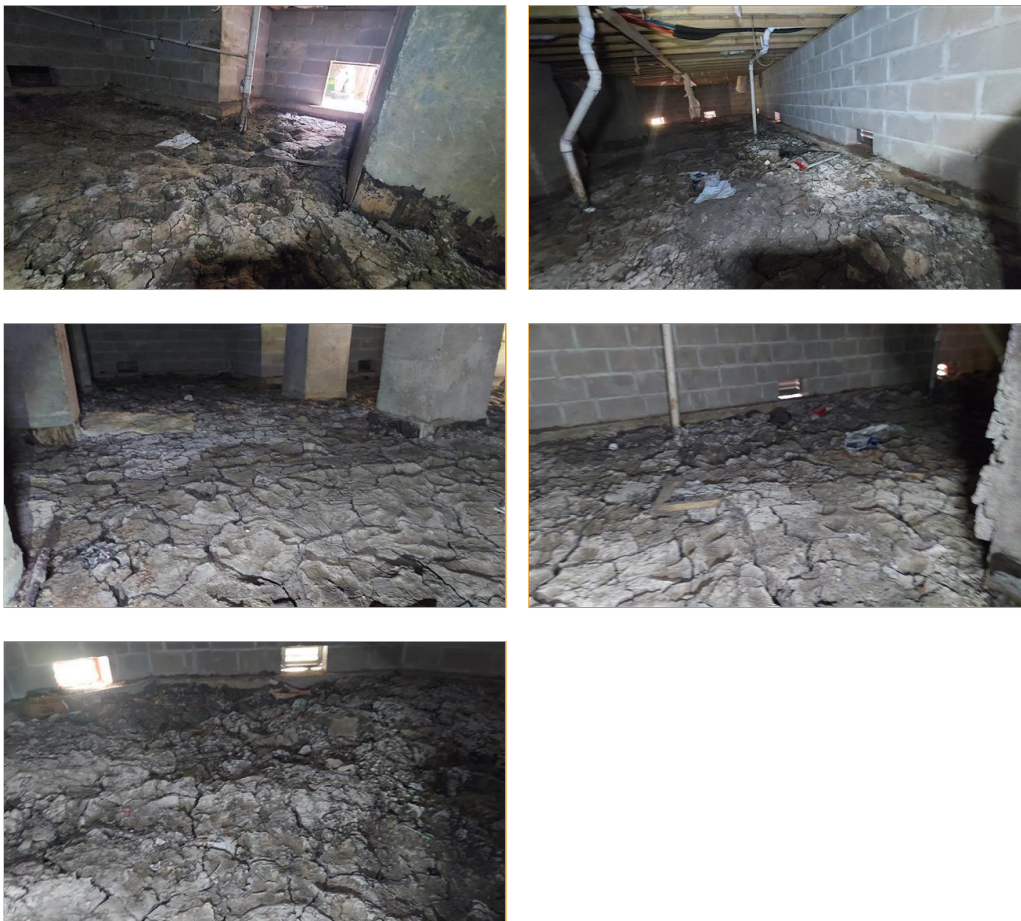
No soil cover No soil cover was installed at the time of the inspection. Soil covers help reduce humidity levels in crawlspaces by limiting moisture evaporation into the air from soil. Reducing humidity levels can help reduce the chances for mold growth.

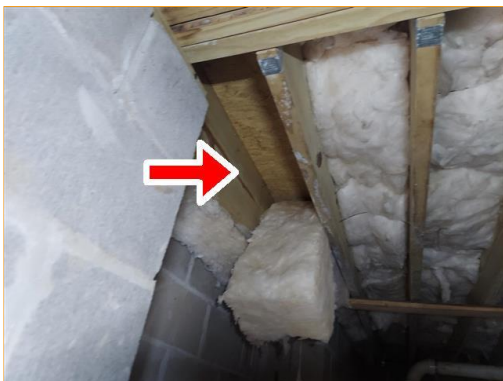
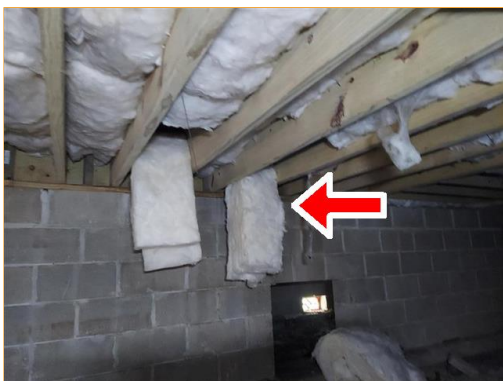
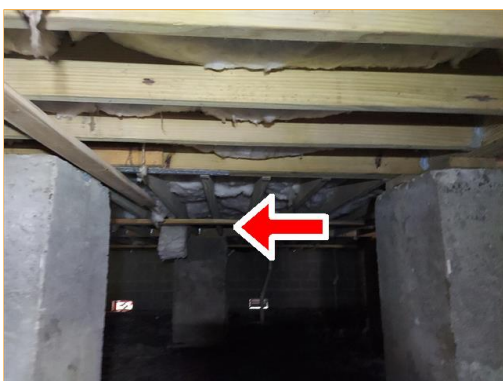
(5) Loose or missing insulation noted at the underside of the main floor during the inspection; repair performed by a qualified contractor is recommended.

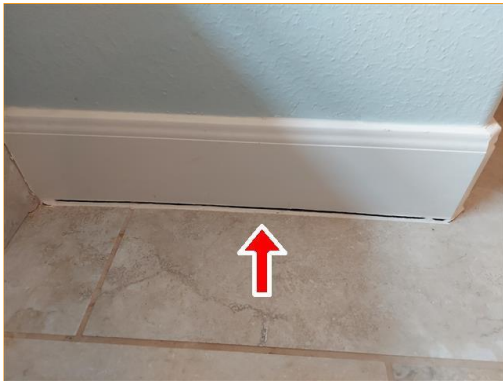
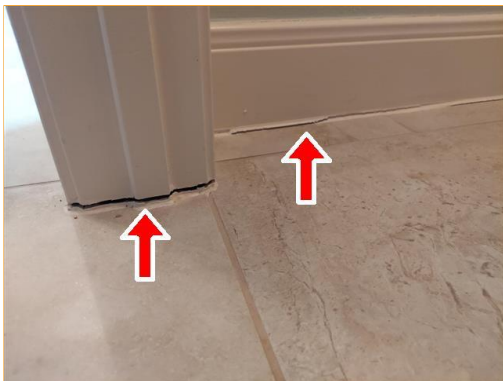
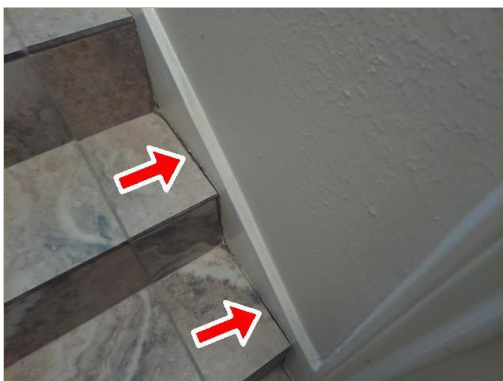
(6) The window, wall, floor, ceiling cracks, or separations that occur greater than normal were observed which were indications of movement, settlement, or other defects; further evaluation is recommended. [\(Right-click to view the detail\)\(CHN\)](#)

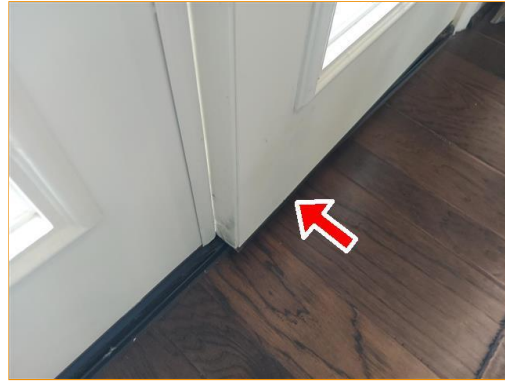
(7) One or more interior or/and exterior doors were observed to be binding, out-of-square, or non-latching observed during the inspection; further evaluation is recommended and repair is recommended. ([Right-click to view the detail](#))(CHN)

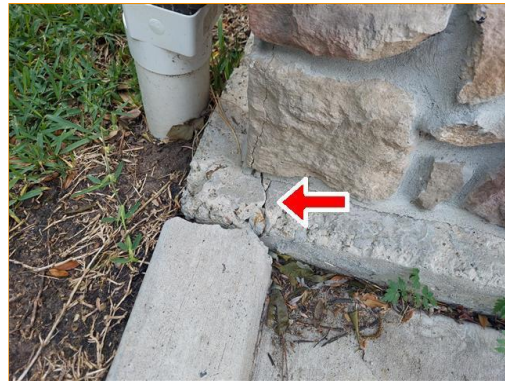
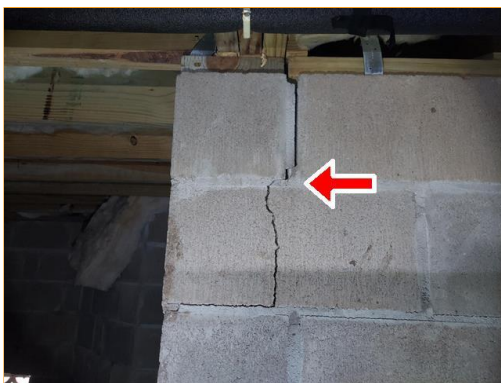
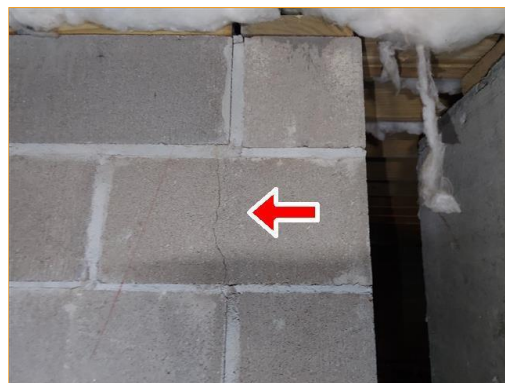
(8) Stepped cracking

Concrete Masonry Unit (CMU) foundation walls had minor stepped cracking visible in mortar joints. Cracking should be monitored in the future and patched to avoid freeze damage and the cause of cracking should be determined and corrected. Consider consulting with a qualified foundation repair contractor or structural engineer before the expiration of your Inspection Objection Deadline to discuss options and costs.

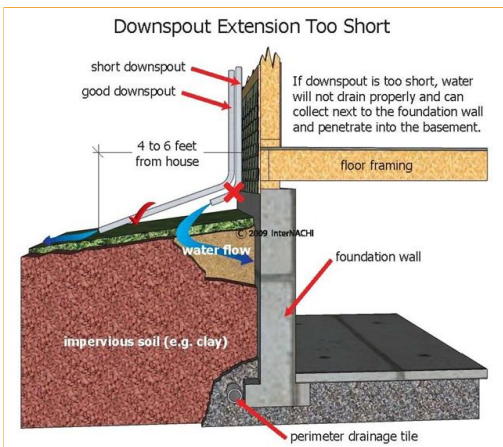
Downspouts Extensions

(2) One or more downspouts lacked extensions or splash blocks which are recommended to move runoff water away from the foundation and to prevent erosion and to help protect the home structure and occupants. ([CHN](#))

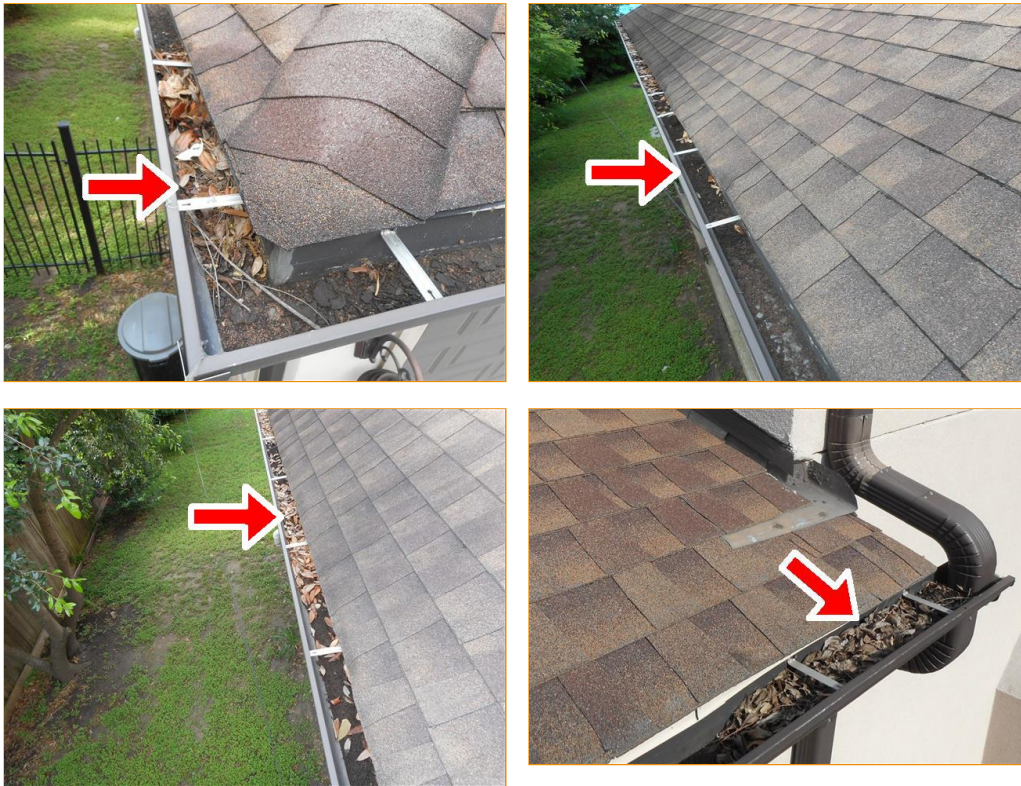
(3) The gutters and downspouts contained leaves and other debris. Cleaning gutters and downspouts is recommended to allow for proper drainage.

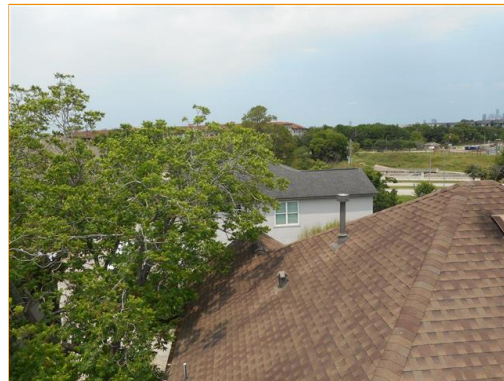
(4) Large tree limbs were growing overhang the roof covering and may lead to damage to the roof covering or restrict the roof drainage; Consider having these limbs trimmed away by a qualified arborist. [\(CHN\)](#)

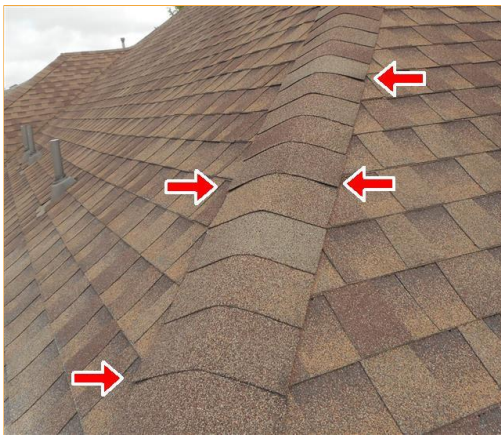
(6) Loose shingles were observed at the ridge cap during the inspection due to malfunctioning adhesion of the back strip on the shingles; this may lead to roof leakage; repair is recommended.

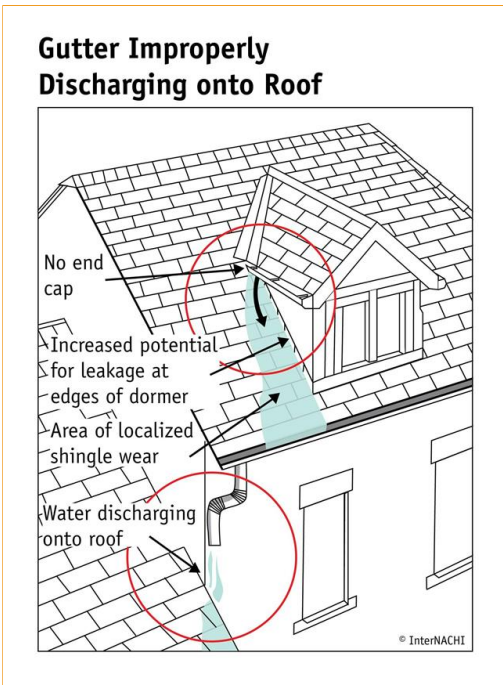
(8) The gutters or downspouts were found to discharge rain water directly onto roof shingles. The secondary roof rain gutter lacks a downspout; lack of a downspout at secondary roof rain gutters may allow localized deterioration and premature wear of the roof covering materials; the condition should be evaluated and corrected as needed by a qualified roofing contractor. [\(CHN\)](#)

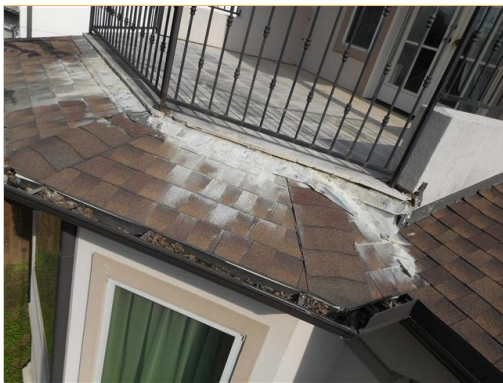
(9) Dirty roof covering was noted in some areas during the inspection; professional cleaning is recommended.

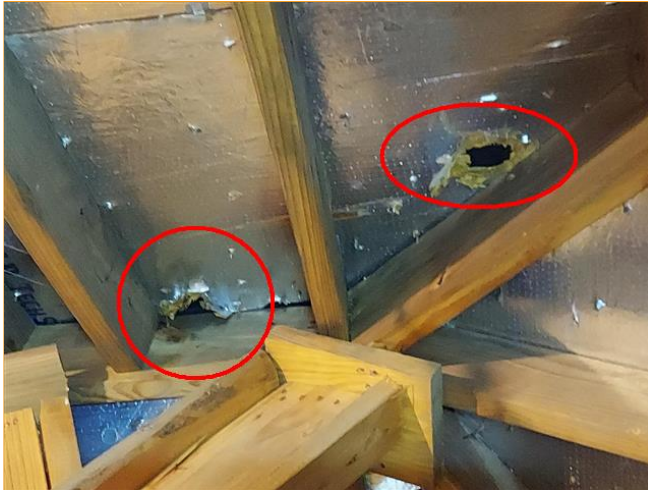
(3) ***Damaged roof sheathing with underlayment exposed was noted from the attic.***

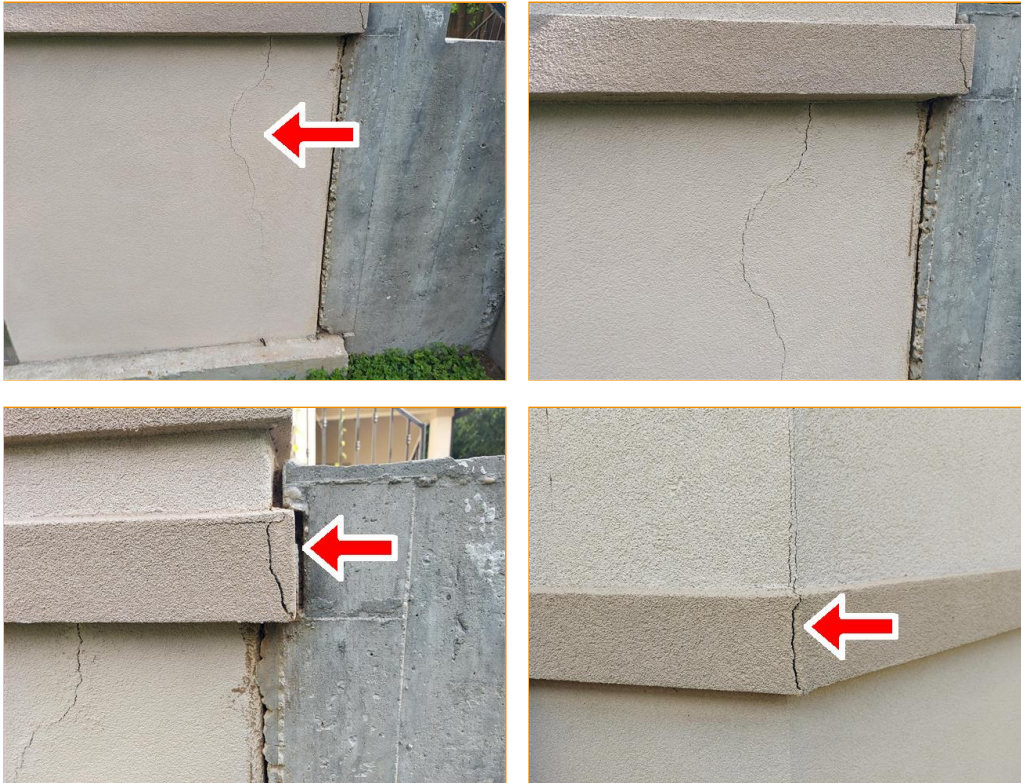
(5) Cracking was noted in the stucco covering the exterior walls of the home at the time of the inspection. This cracking appeared to be consistent with that caused by structure movement; the result of elevated moisture levels in the soil at the home foundation; cracks should be filled with an appropriate material to prevent freeze damage and monitored in the future for continued activity; Damage from heaving is likely to continue as long as moisture levels in the soil near the foundation are elevated.

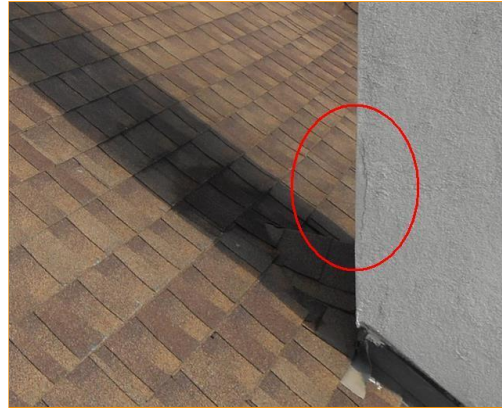
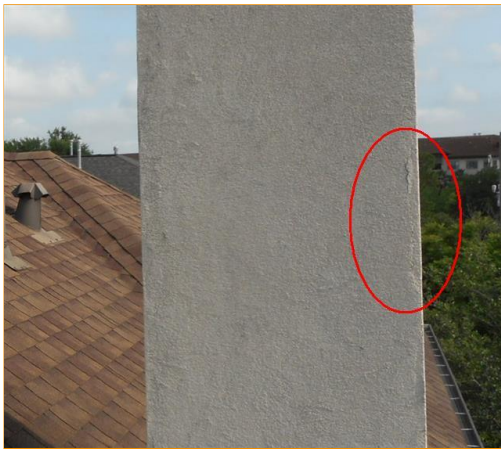
(6) **Mortar was observed to be damaged, separated or missing in one or more areas.** Missing, separated or damaged exterior masonry mortar may allow moisture penetration and should be repaired (repointing).

Mortar improvements are recommended for the exterior masonry veneer.

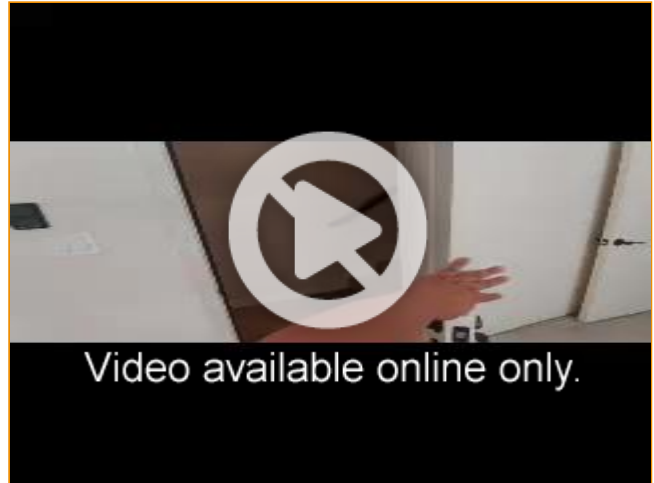
(2) One or more exterior doors in this home were binding on the jamb and were difficult to close. The condition should be repaired to ensure properly latched.

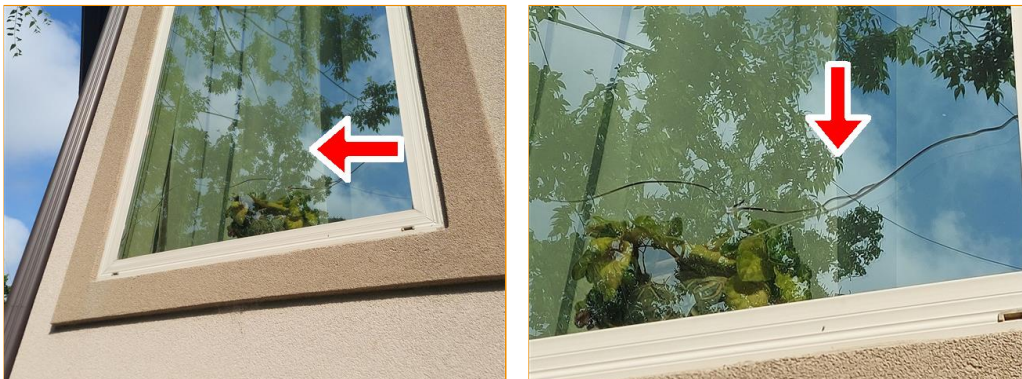
(3) Cracked window glass panes were found in this home, necessitating replacement by a window specialist.

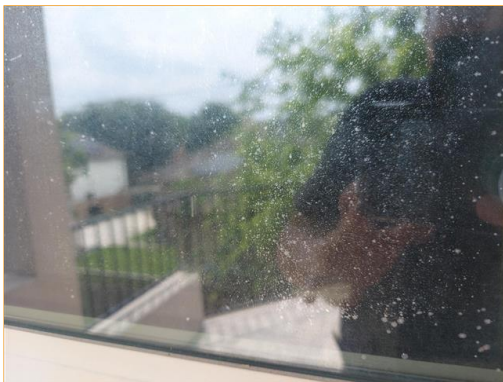
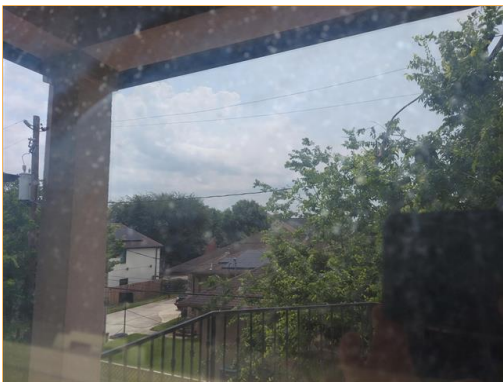
(4) Stains visible on the glass at a double-pane glass window indicated that the desiccant strip designed to absorb moisture from the space between the panes has become saturated and will no longer prevent

condensation from forming; The severity of the staining indicated that the window is damaged beyond repair; You should consult with a qualified contractor to discuss options and costs for replacement, which will be expensive.

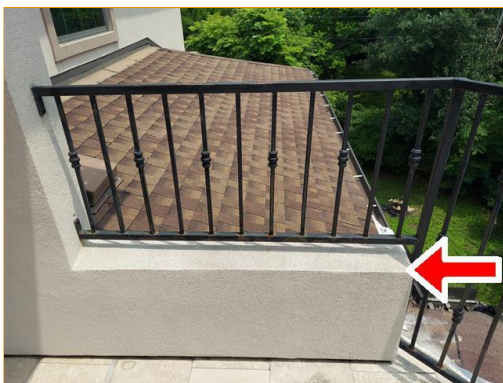
(3) Climbable parapet under the guardrail in the balcony may create safety hazard; further evaluation by a qualified contractor and correction as needed.

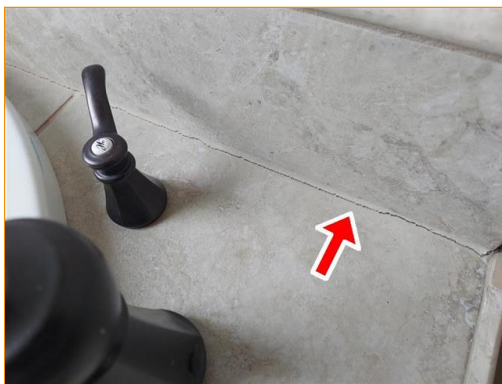
(3) Grout lines in the tile wall of this bathroom needed maintenance at the time of the inspection.

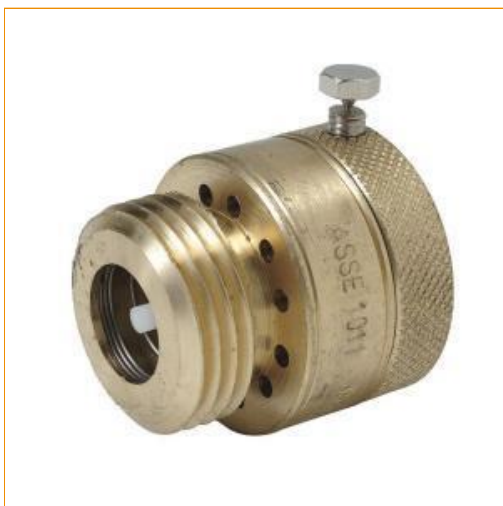
One or more of the exterior water hose bibs (faucets) were not equipped with a backflow and/or anti-siphon (vacuum breaker) device; An anti-siphon device prevents unsanitary water from being pulled back through a garden hose and/or lawn sprinklers and contaminating the household water system; Correction is recommended and performed by a qualified plumber. [\(CHN\)](#)

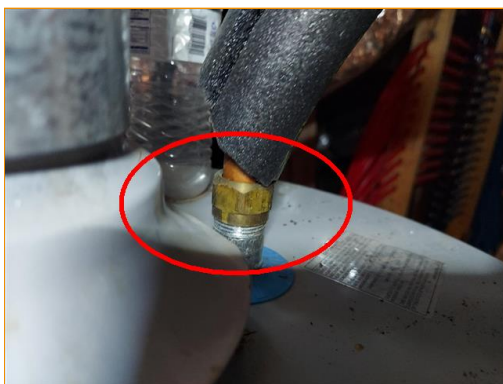
Water pipes connected to the water heater had dissimilar metals in contact with each other during the inspection. This condition can cause galvanic corrosion. The Inspector recommends the installation of a dielectric union by a qualified plumbing contractor to help prevent future erosion, deterioration, or leakage made possible by this condition. [\(CHN\)](#)

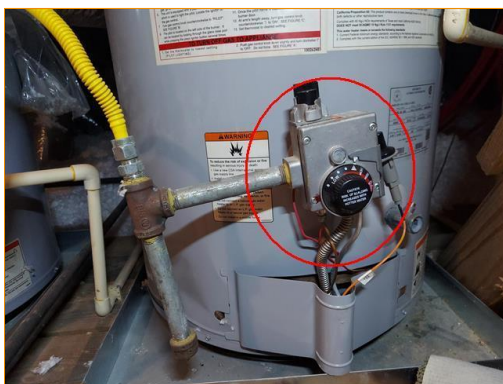
(7) The gas valve of the water heater was not properly installed onto the water tank; the condition may create leakage when overheating; further evaluation performed by a qualified contractor.

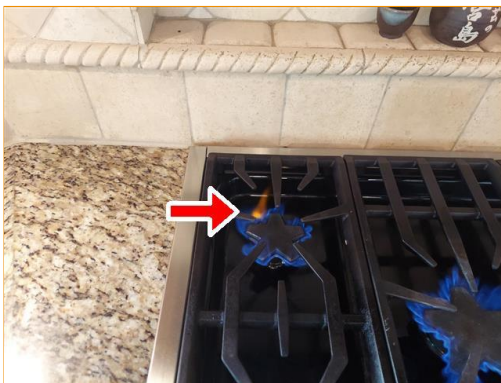
(2) Improper burner flame color observed; fluctuates between orange, yellow, and red with wavering. The color indicates carbon soot particles from incomplete methane combustion—servicing required by qualified technicians.
