Legacy Inspection Service

PROPERTY INSPECTION REPORT FORM

02/02/2024

808 Llano, Port Neches, TX 77651

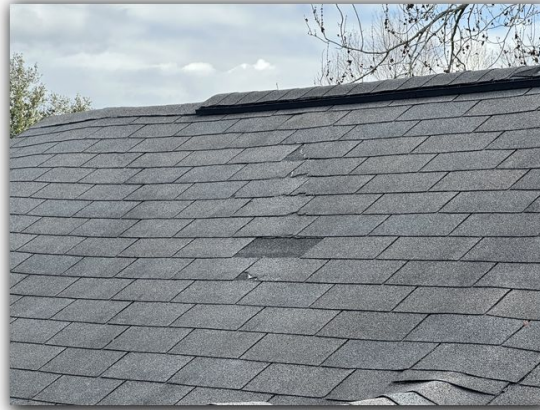
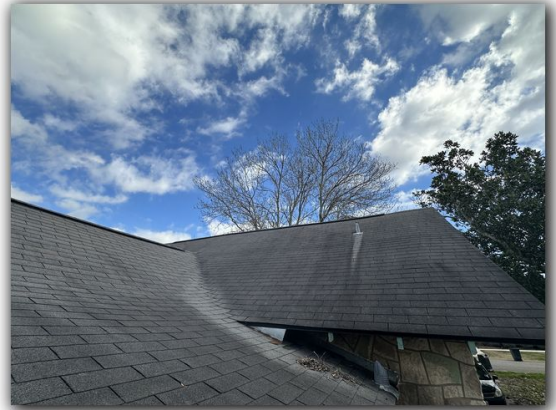
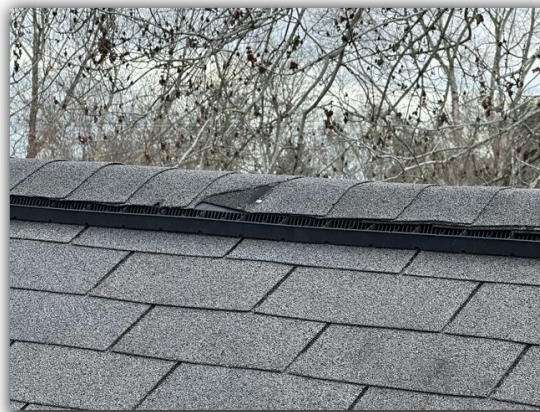
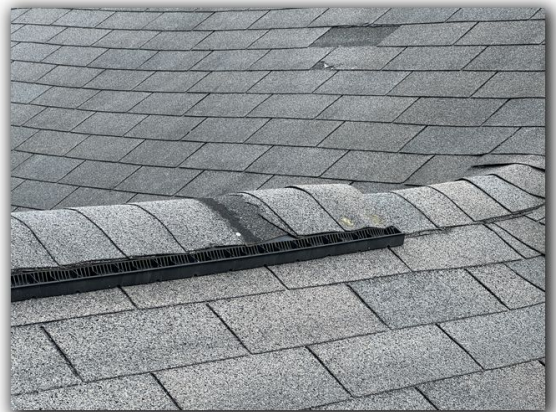
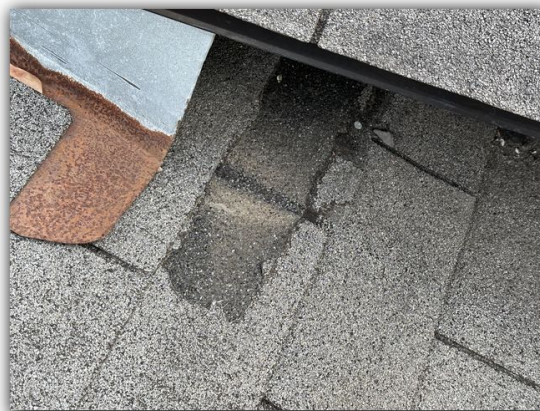
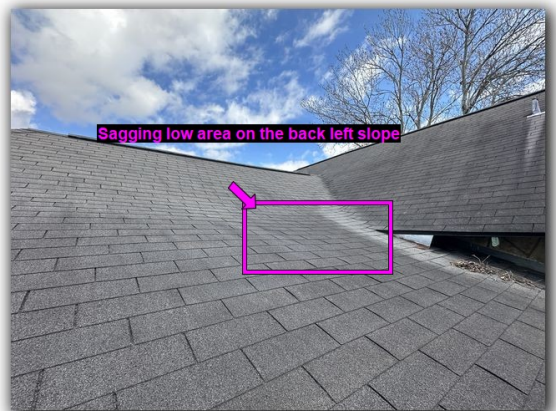
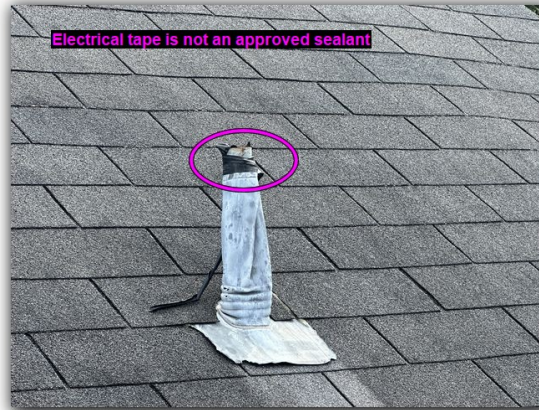
- Damaged, or missing shingles were observed on the back slope and at the ridge caps. Repair is recommended.
- Roof decking deflection and / or sagging was observed on the back left slope.
- The plumbing vents are not properly sealed at the top edge and could allow water to enter the attic and structure.

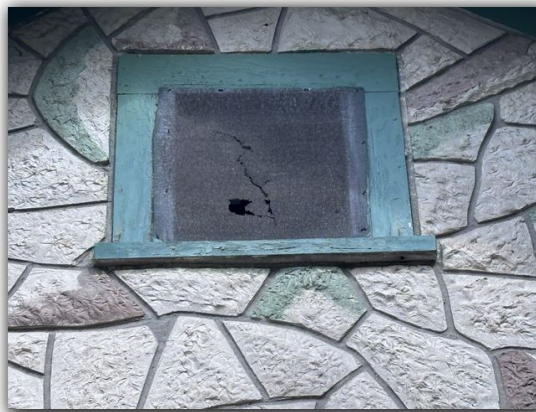
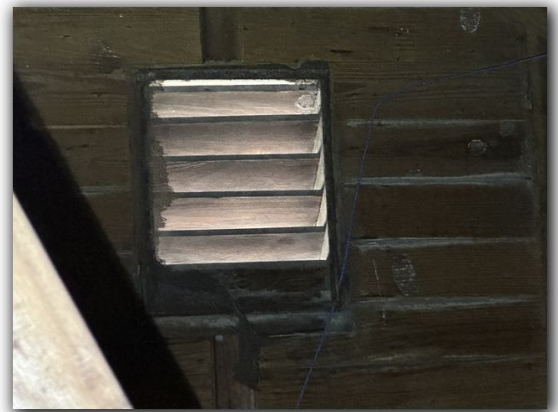
- The left gable vent screen is damaged and needs to be replaced.

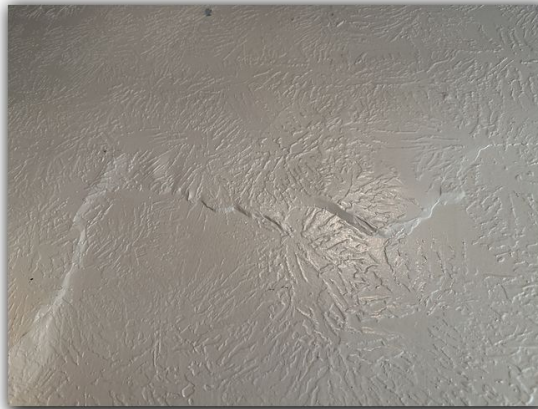
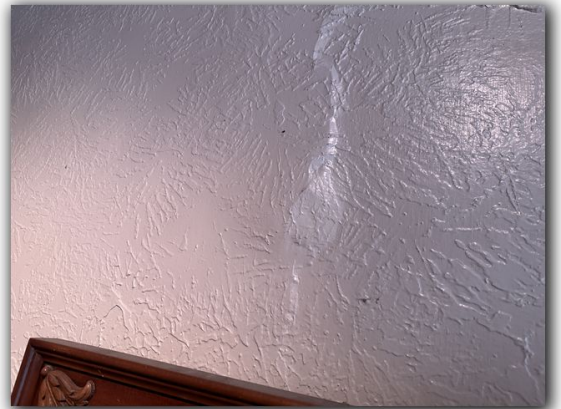
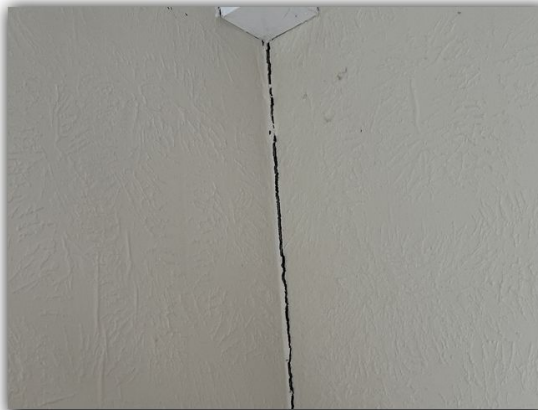
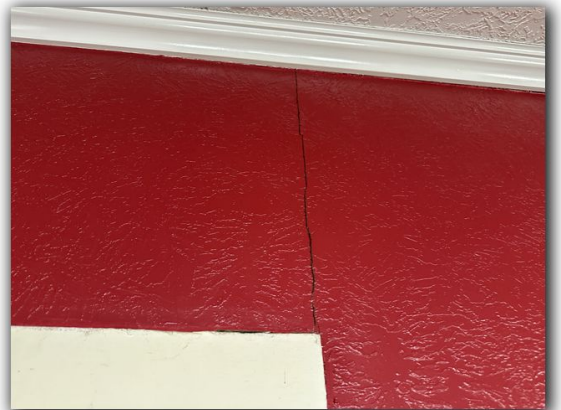
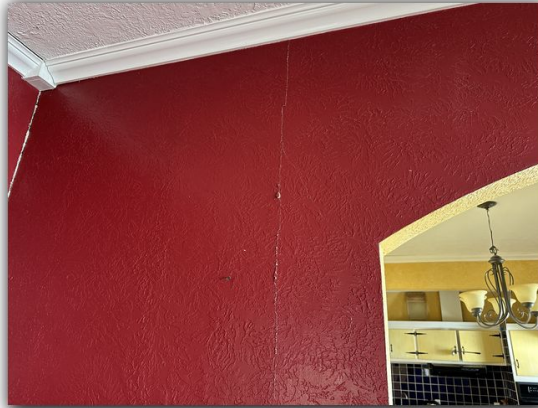
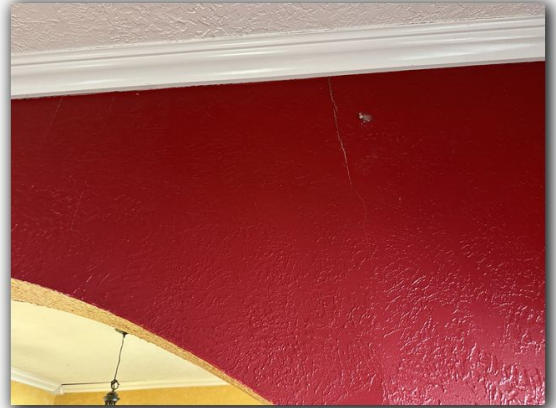
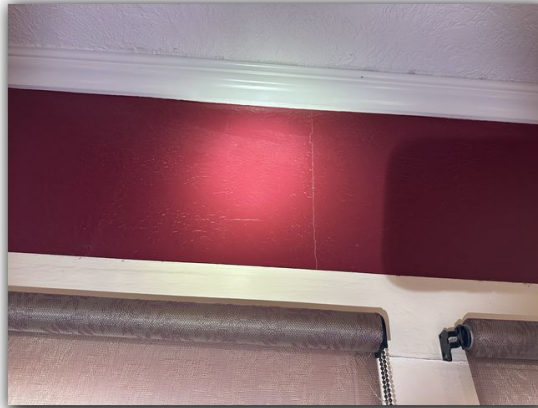
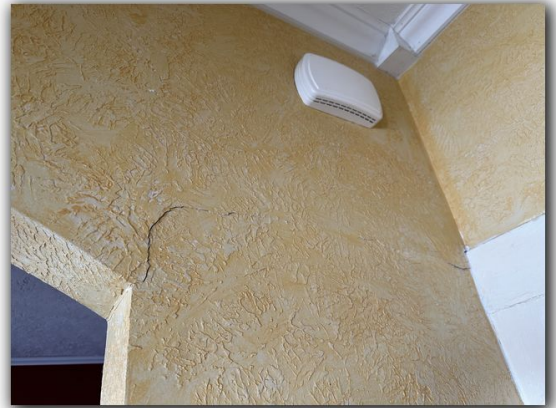
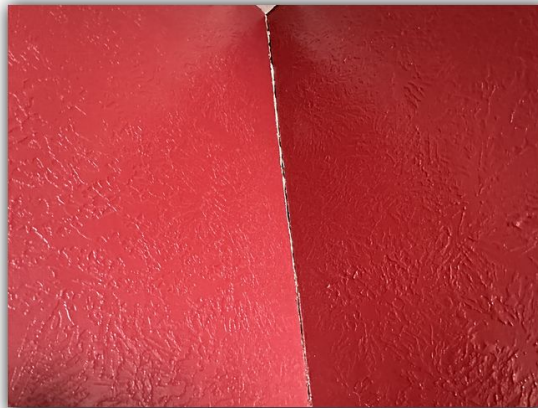
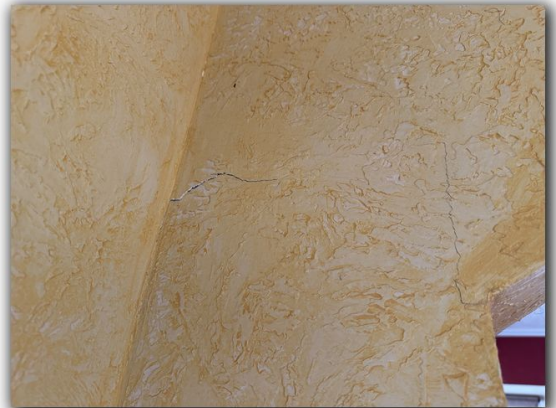
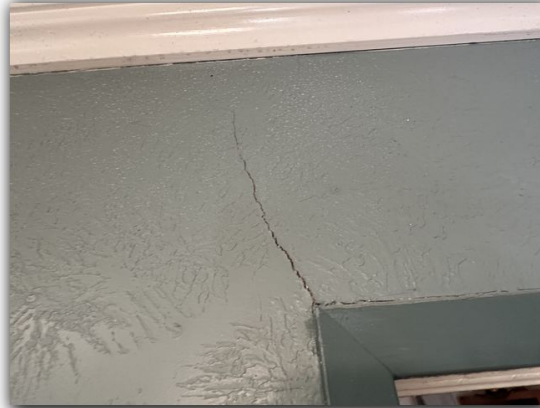
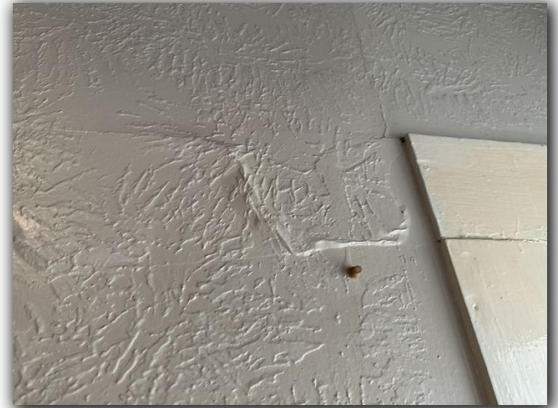
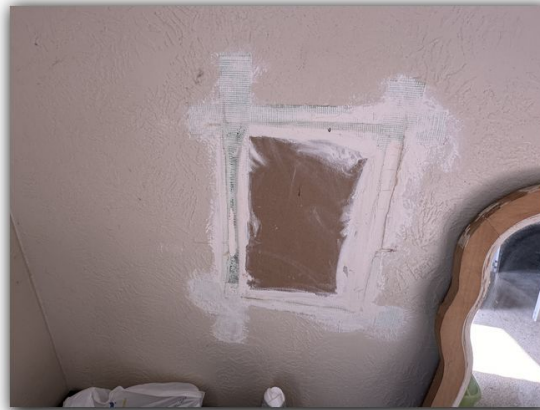
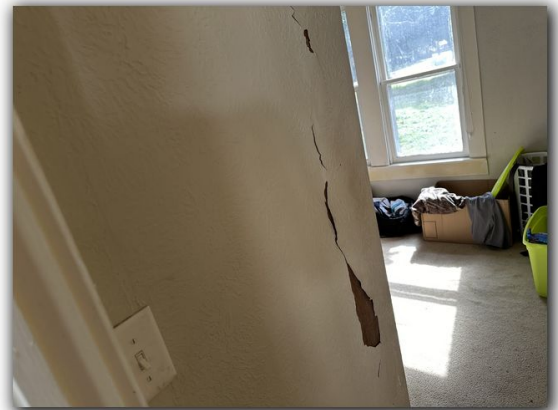
- Stress cracks were observed throughout the home.
- Water damage was observed on the wall and window trim in the back left bedroom adjacent to the bath.

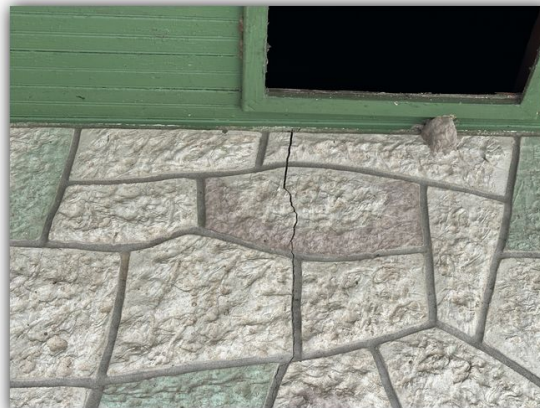
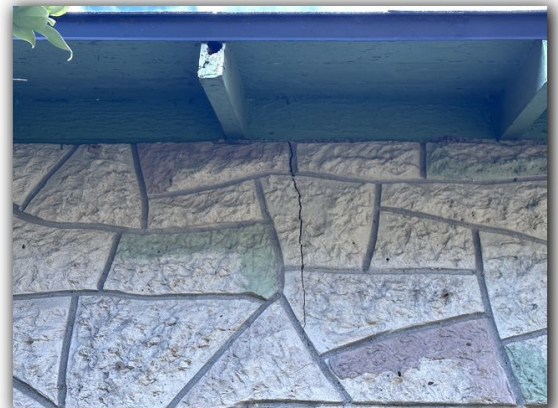
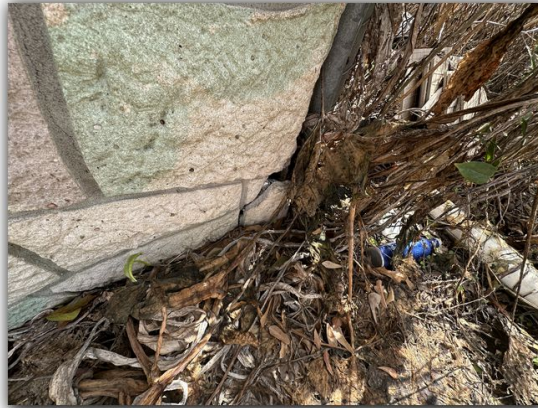
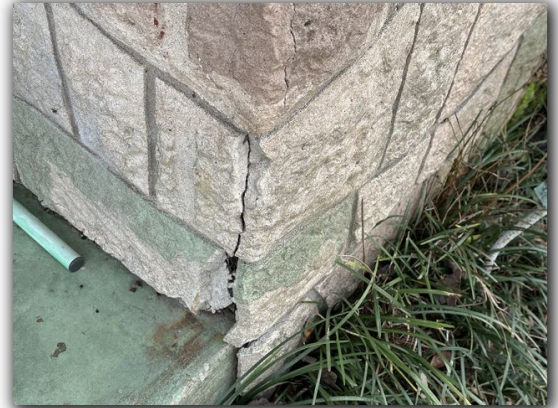
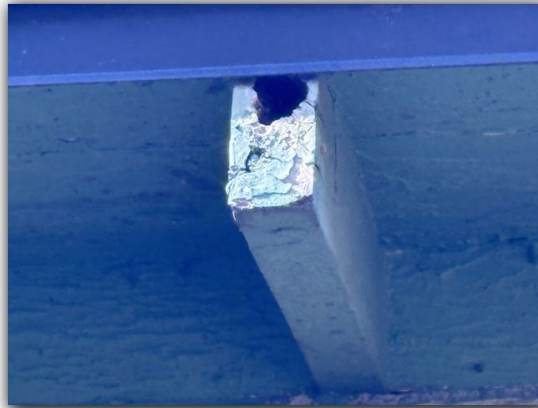
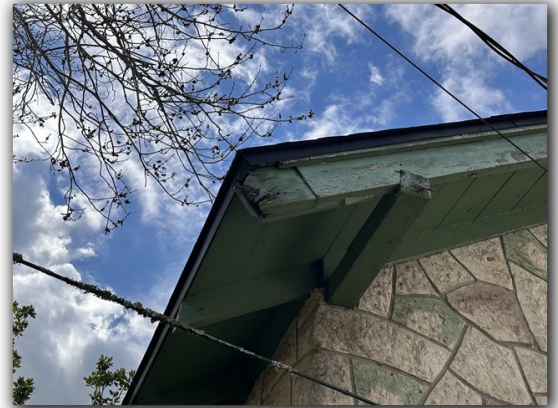
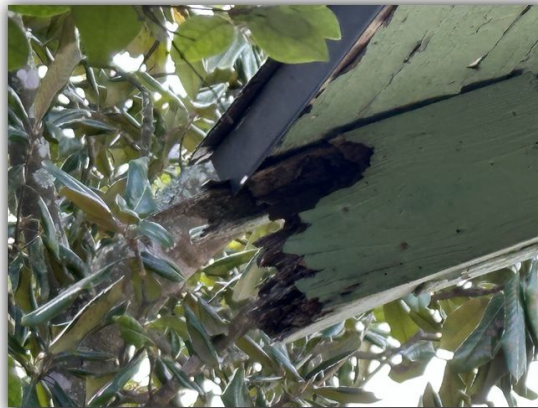
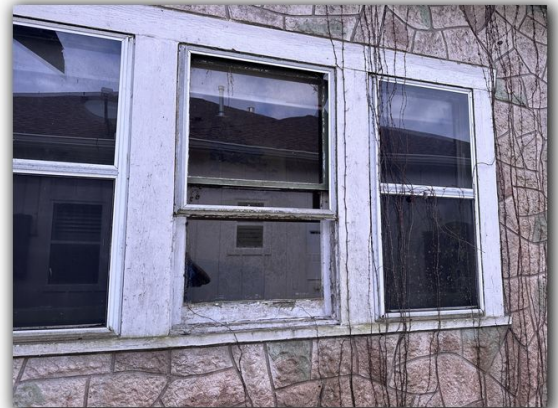
The stone veneer has stress cracks on the exterior. Once the home is leveled and stabilized, some repair will be needed.

Exposed rafter tails show signs of water damaged and or rot.

Vines are growing on the stone veneer. Removal is recommended.

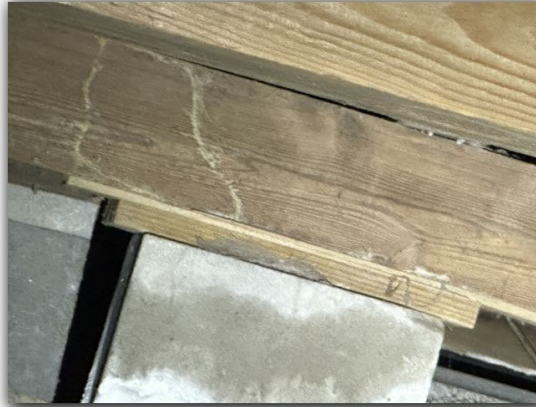
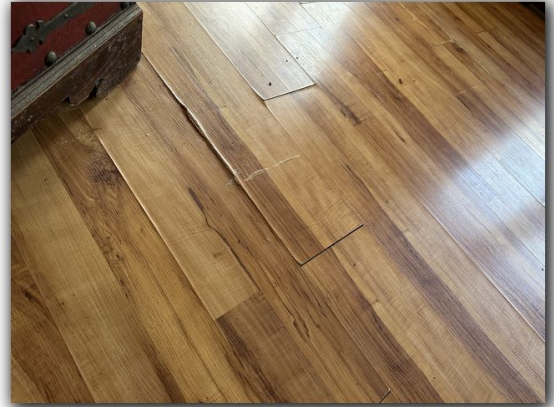
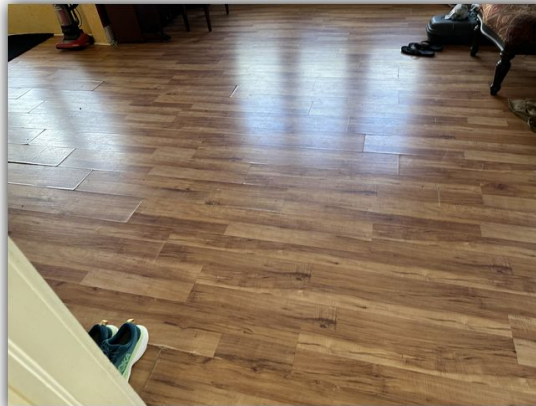
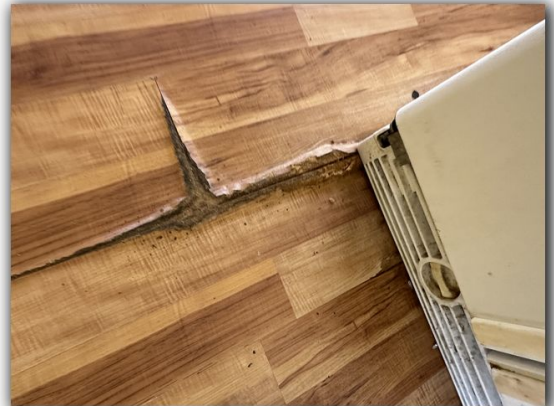
- Ceiling stress cracks were observed in the home
- The subfloor is soft throughout the home. Repair is recommended ASAP.
- Some evidence of pest intrusion was observed in the crawl space. This was not a Pest inspection.
- Laminate flooring is moisture damaged through the home. Replacement is recommended.

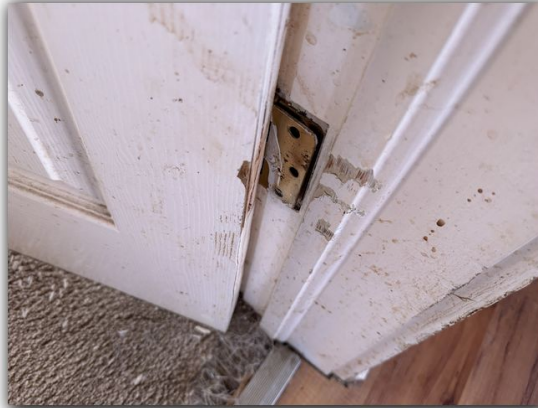
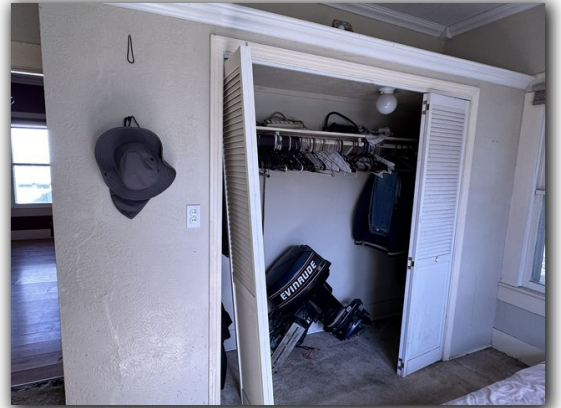
- Some doors are damaged and drag the floor. Most doors are out of square.

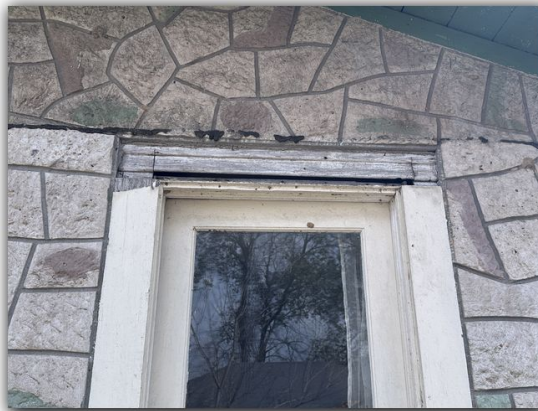
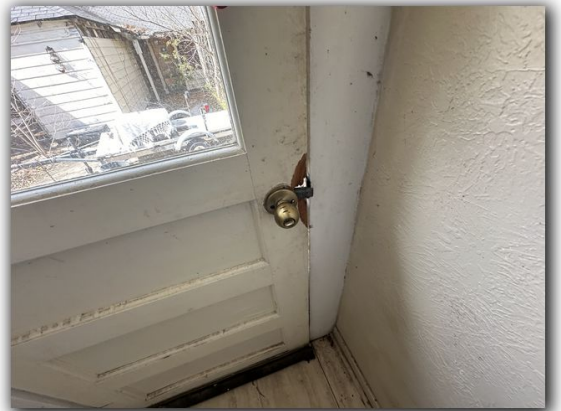
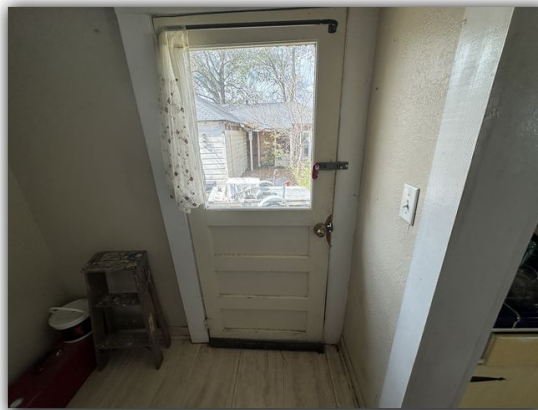
- The back door jamb and door is damaged and only partially closes. The glass is not safety glass. Replacement is recommended.
- Wood door trim is missing in the back and is an area for unwanted water entry.

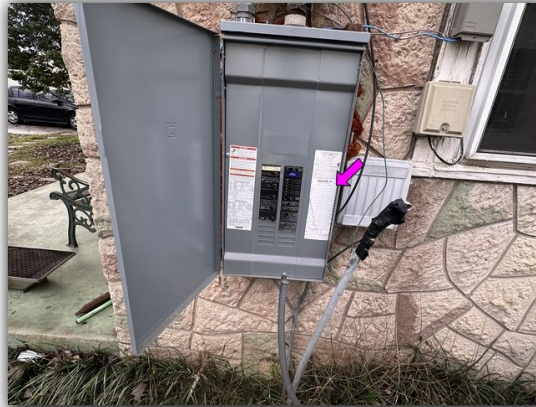
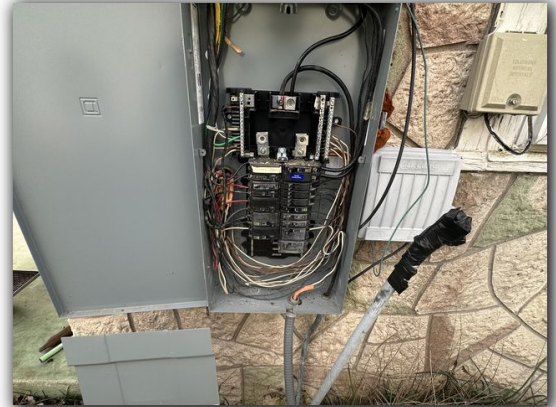
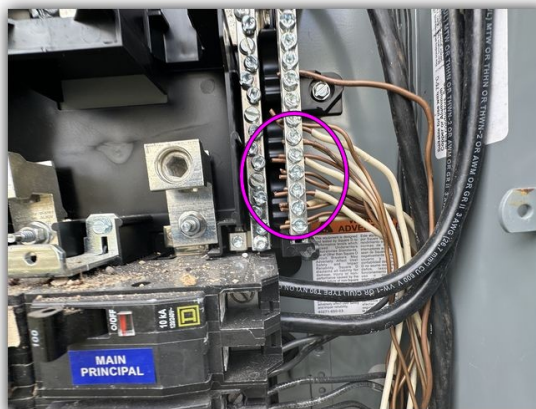
Panel is not labeled completely. All circuits and circuit modifications shall be legibly identified as to their clear, evident, and specific purpose or use. The identification shall include sufficient detail to allow each circuit to be distinguished from all others.

Doubled lugged neutrals were observed at the bus bar. Separate neutral (White) conductors so only one white neutral wire is under a lug (Screw)

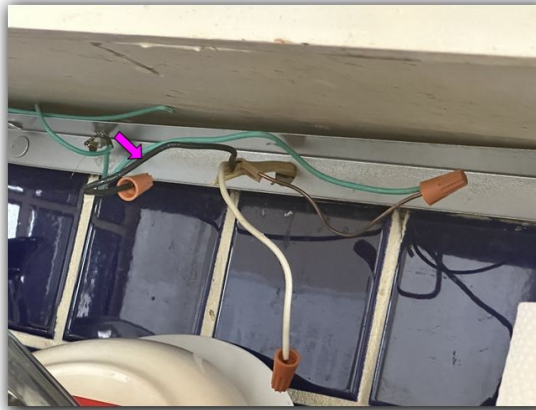
The wire under the kitchen upper cabinet is hot when the switch is in the up position. I showed Bart how to keep it in the off position.

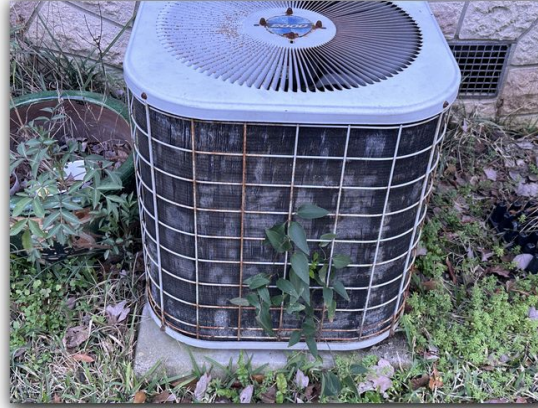
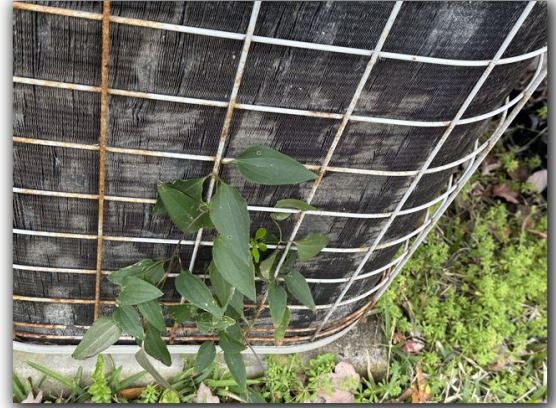
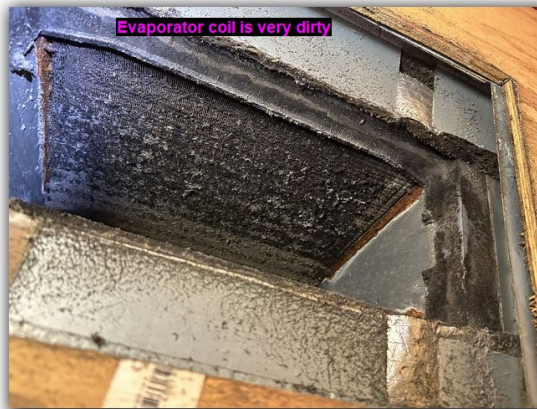
- Temperature differential is not within range of 15-20 degrees Fahrenheit. Service and evaluation by a licensed HVAC contractor is recommended
- Condenser unit coil fins damaged and dirty. The evaporator coil inside is dirty too. Cleaning is recommended.

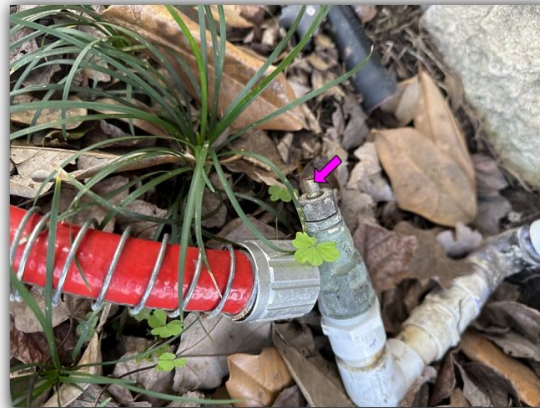
Exterior hose bibs do not have back-flow prevention and the handle is missing at the front hose bib.

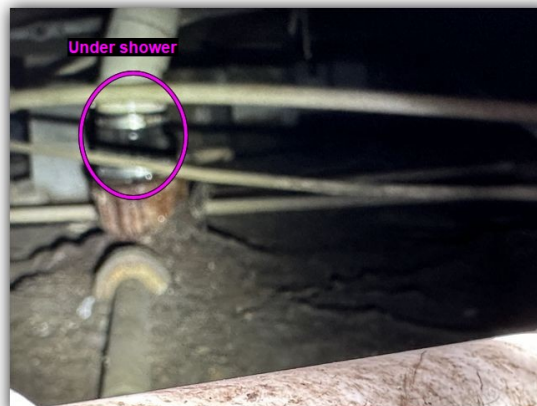
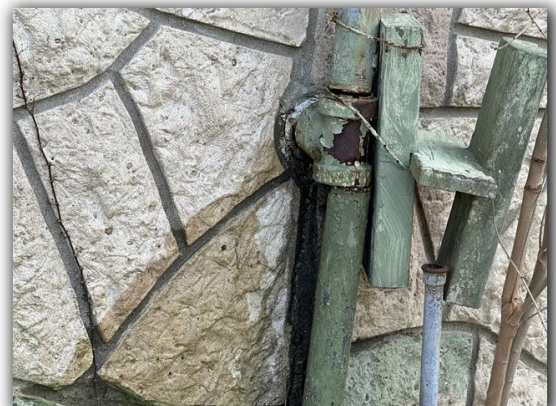
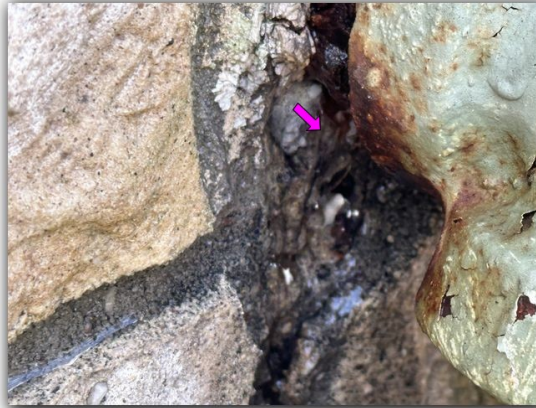
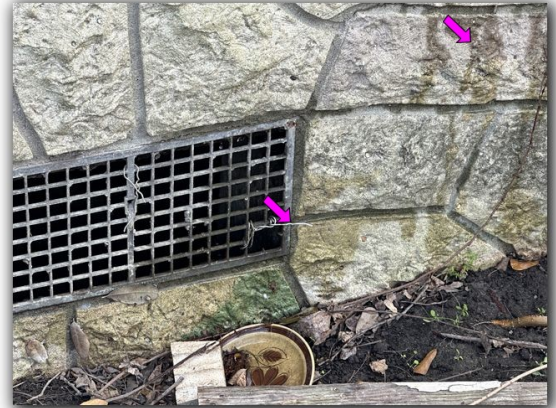
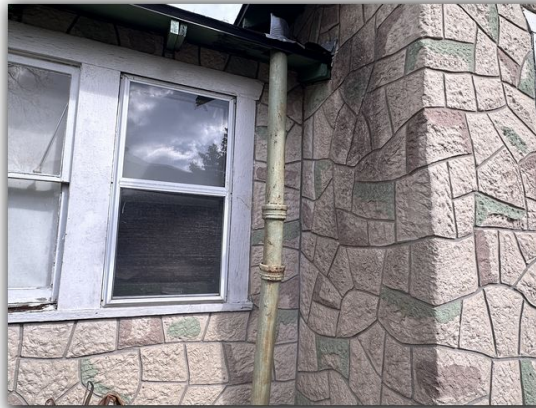
- The drain line is leaking in the back of the house and under the bath shower. Repair is recommended.
- The sewer vent on the left side of the home is in need of repair or replacement.

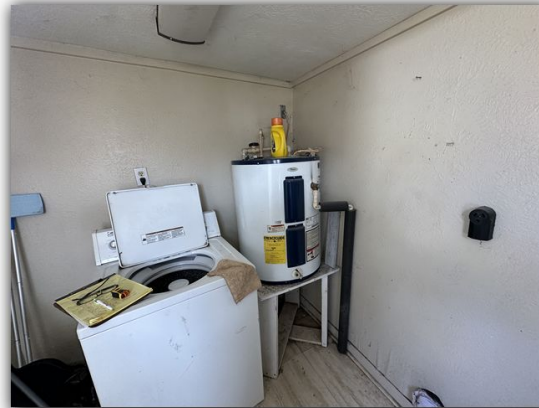
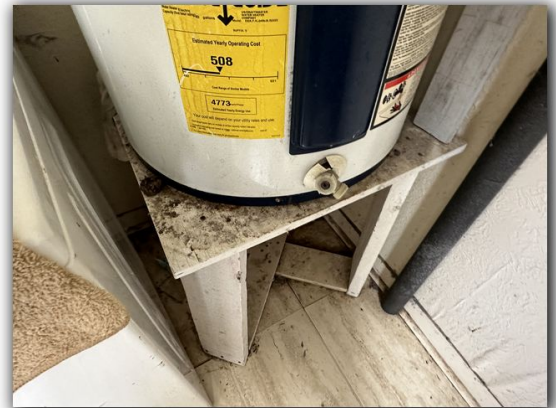
- Electrical disconnect missing within sight of the unit.
- Lack of pan and drain system. Terminate the drain to the exterior within 6 inches of grade.

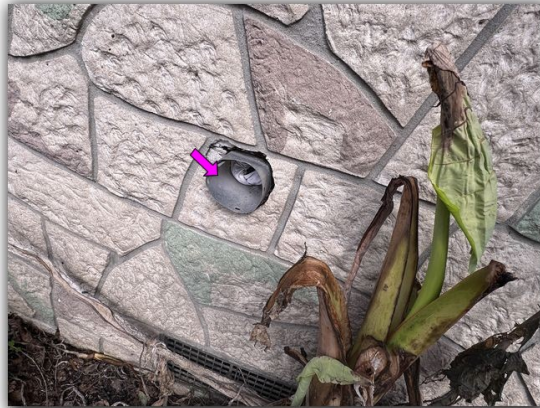
- Dryer vent cover is missing on the exterior.
