REDSTAR PROFESSIONAL HOME INSPECTION, INC

REDSTAR RESIDENTIAL INSPECTION REI 7-6

24327 Palomino Sage Trl
Katy, TX 77493

PROPERTY INSPECTION REPORT FORM

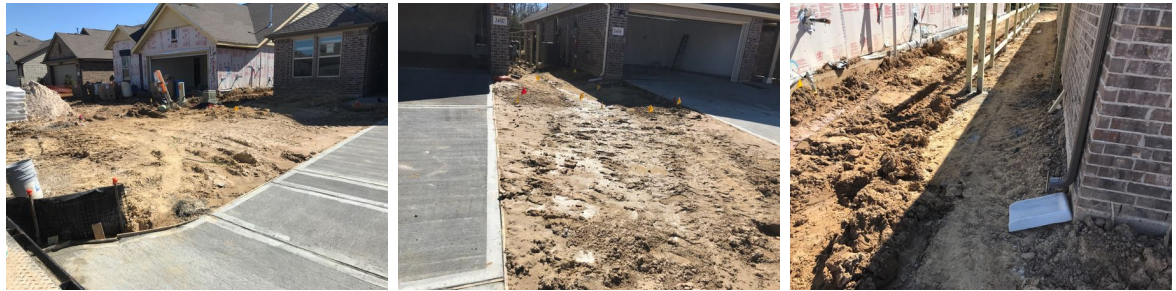
Front Multiple Locations

Incomplete: Grading :

Grading was incomplete at the time of inspection. Sod missing in multiple areas. Recommend further evaluation upon completion and install of all components.

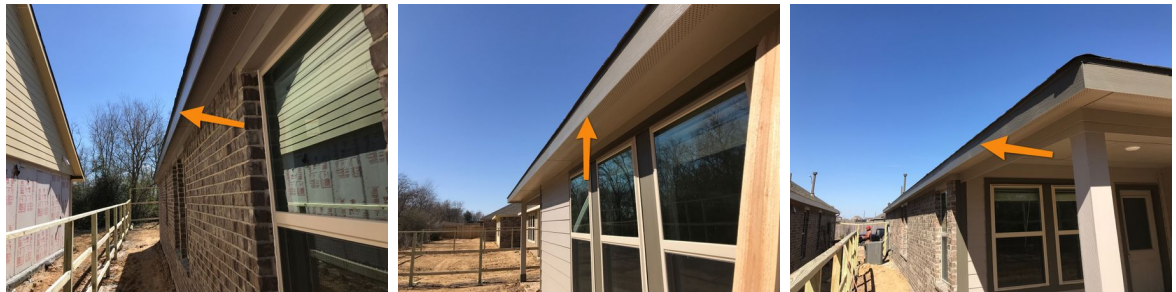
1: Gutters Absent

Multiple Locations

No gutters were observed to be installed along portions of the roof slopes. Installation is highly recommended to prevent further erosion of the soil resulting in standing water near the foundation.

Recommendation: Contact a qualified gutter contractor

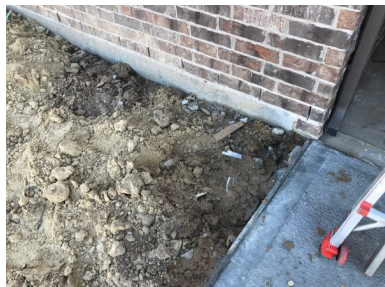
2: Grading and Drainage: Inadequate/Improper slope

Front

Improper slope was observed at the above stated locations. Improper drainage can result in excessive structural movement and potential standing water issues. Recommend further evaluation of these areas to

determine the best method of repair.

Note: The grade shall fall a minimum of 6 inches within the first 10 feet, and grade should be sloped towards drain systems.

Recommendation: Contact a qualified landscaping contractor

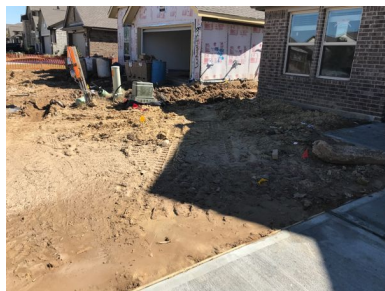
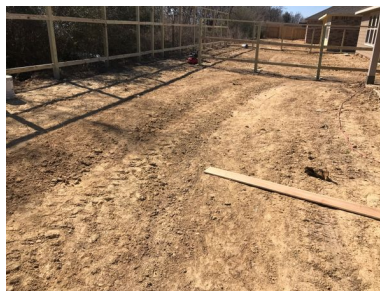
3: No Grass

Multiple Locations

The grass for the lawn around the property was observed to be not installed at the time of inspection. Recommend installation of gras at property to prevent further / future soil erosion issues.

Recommendation: Contact a qualified landscaping contractor

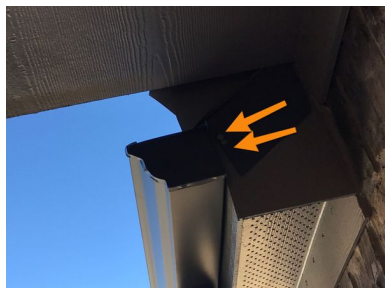
1: Exposed Nails

Front Porch

Several locations where the nail heads are exposed and need sealed. These locations include around vent jacks, flashings, and hip and ridge caps. Recommend correction as needed to prevent moisture penetration over time.

Recommendation: Contact a qualified roofing professional.

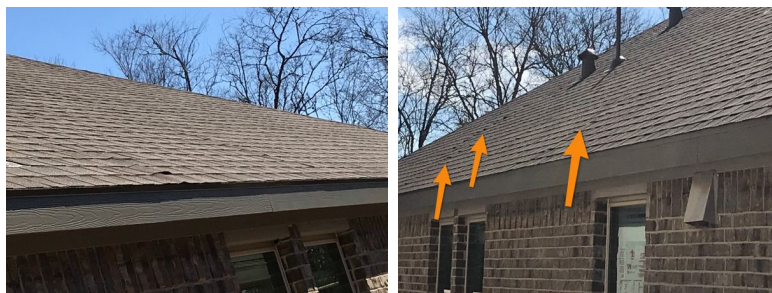
Left Multiple Locations

2: Shingles: Lifted/Cupped

Left & Right Exterior

Observed buckled/lifted shingles on the roof covering. This condition is where the shingles are lifted or are not laying flat due to wrinkling of the underlayment or a shingle issue. High humidity and moisture issues at decking can also contribute to this condition. Recommend further evaluation by a roofing contractor to determine the extent of necessary repair.

Recommendation: Contact a qualified roofing professional.

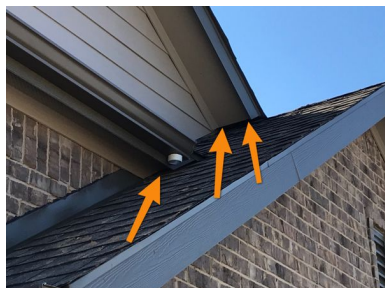
3: Gap Between Roof and Soffit

Front Multiple Locations

A gap was observed where the roof meets the soffit. This area could possibly allow water intrusion or unwanted pests to enter the home. Recommend ceiling all these areas by a qualified person.

Recommendation: Contact a qualified professional.

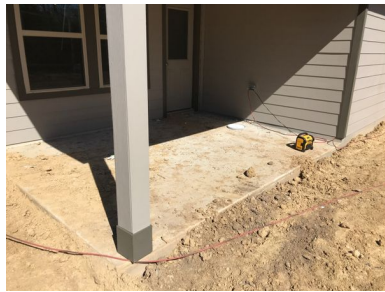
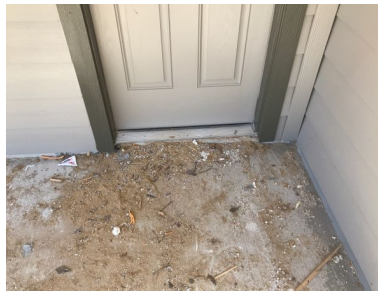
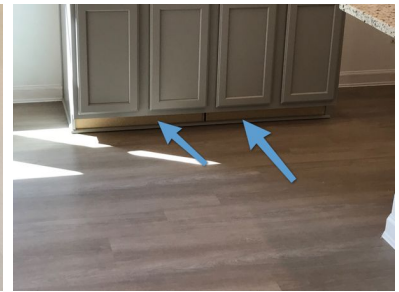
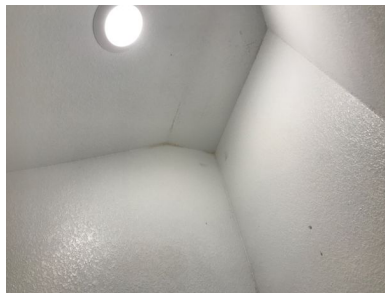
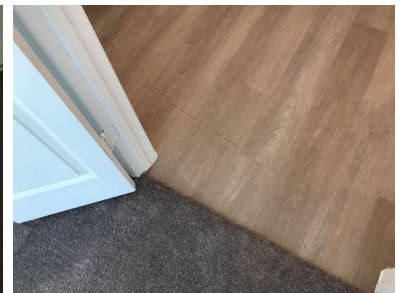
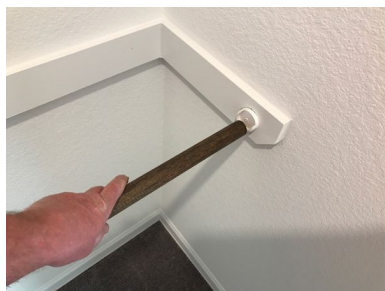
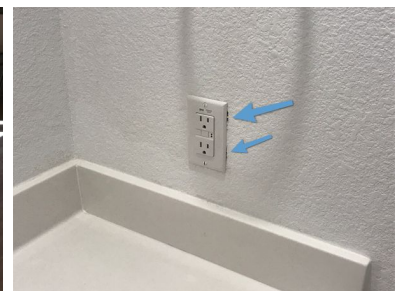
1: New Home Cosmetic Issues

Multiple Locations

Cosmetic deficiencies (dings, dents, missing paint, etc.) were observed at various locations around the home. Cosmetic issues are not included in the scope of this inspection, and these items should be addressed during your builder walkthrough.

Recommendation: Contact your builder.

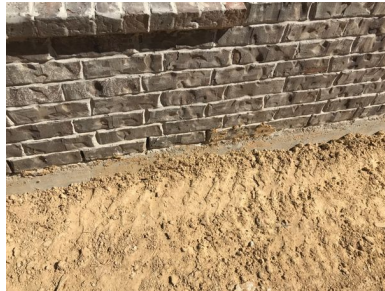
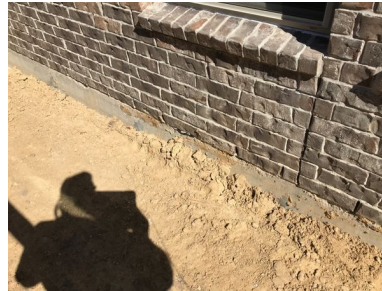
2: Minor cosmetic/maintenance Issues

Right Multiple Locations

Exterior Walls dirty -

The above stated issues were observed at the home at time of inspection. These items are related to cosmetic issues or maintenance due to expected wear and tear. Recommend you budget for repair of these issues for cosmetic reasons, or to avoid further deterioration.

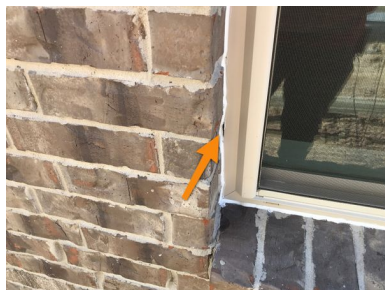
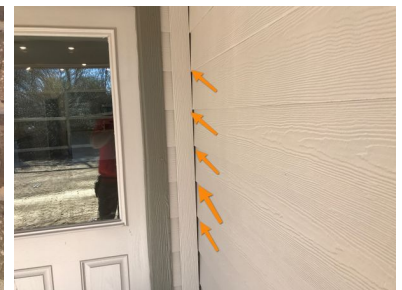
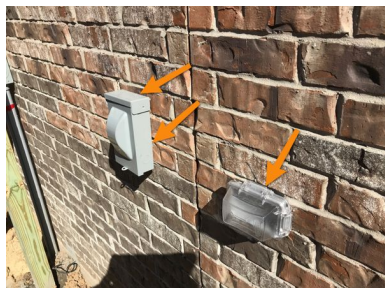
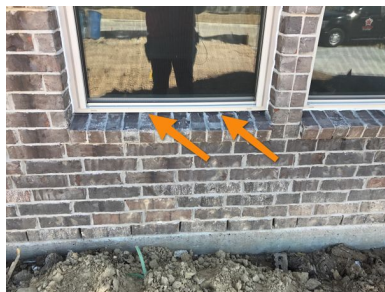
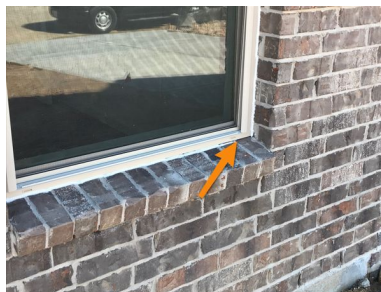
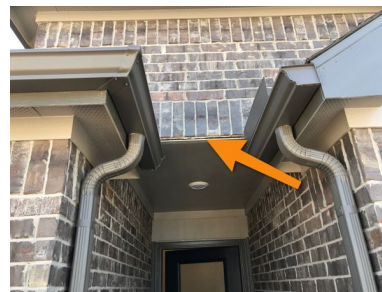
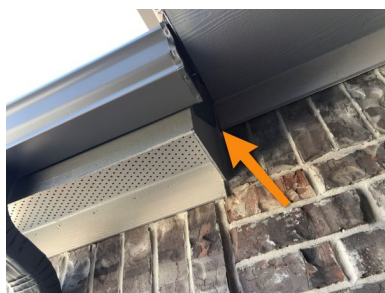
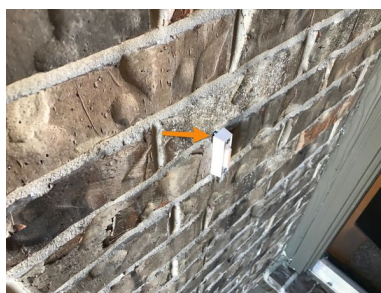
3: Caulking and Sealing Needed

Around windows, Plumbing penetrations, Various locations on trim and siding, Electrical penetrations, Electrical panel box, Light fixtures and outlets -

The above stated locations were identified as areas in need of proper caulking and sealing, or maintenance to the existing sealant. Examples of locations needing sealing are pictured for your reference. Recommend further evaluation of these areas and all others to determine the extent of needed repairs.

Recommendation: Contact a qualified handyman.

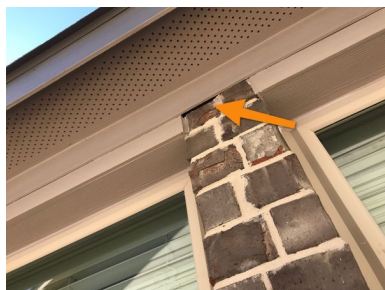
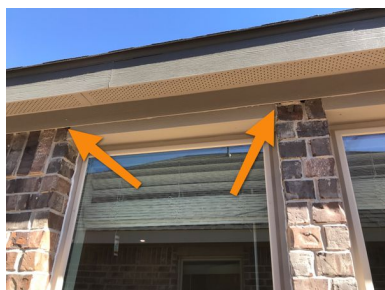
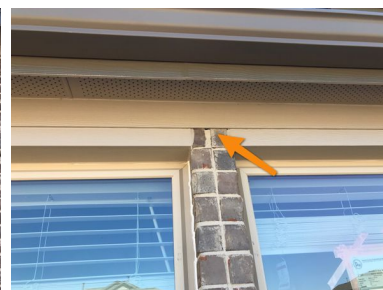
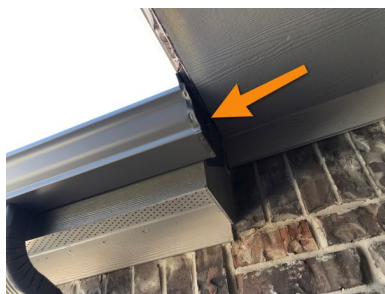
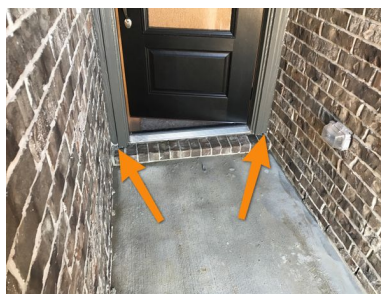
4: Exterior Walls: Seal Openings

Multiple Locations

The inspector observed one or more excessive gaps or openings in the exterior finishes that could be potential points of pest intrusion. Recommend these locations be properly sealed or that you contact a qualified pest control company to perform a proper exclusion on the property.

Recommendation: Contact a qualified pest control specialist.

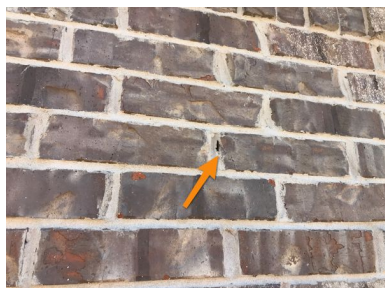
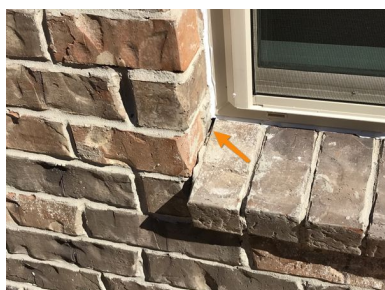
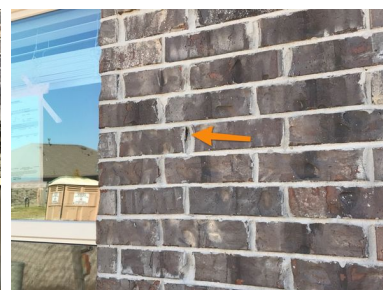
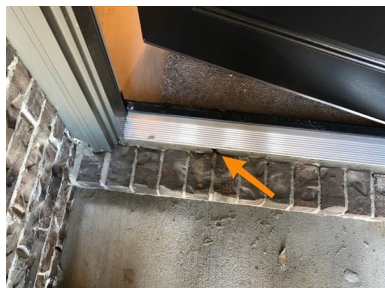
5: Masonry: Mortar Voids/Deterioration

Multiple Locations

Inspector observed areas on the masonry walls that displayed deterioration or voids to the mortar lines. These areas should be properly repaired to avoid further deterioration or excessive moisture issues. Recommend further evaluation and correction as needed.

Recommendation: Contact a qualified masonry professional.

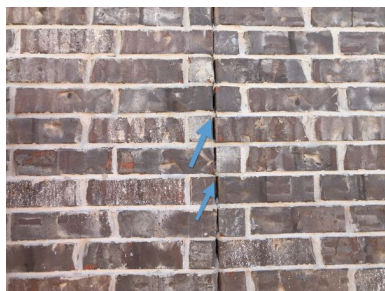
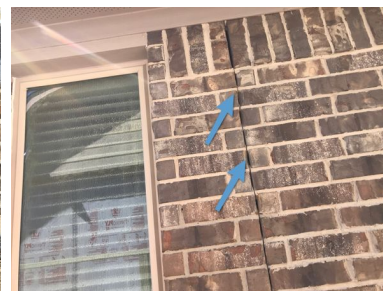
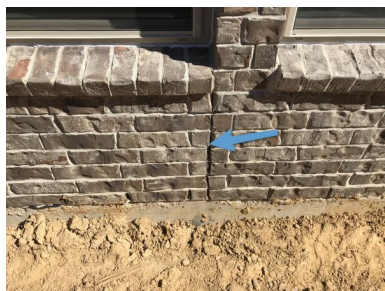
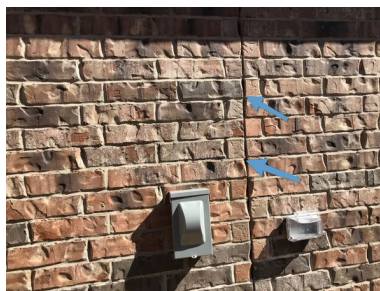
6: Masonry: Expansion joint issues

Multiple Locations

The inspector observed issues with the condition of the expansion joints on the masonry walls. Common issues include lack or proper sealant, deterioration to the sealant, or excessive separation. Recommend further evaluation of these locations and correction as needed.

Recommendation: Contact a qualified professional.

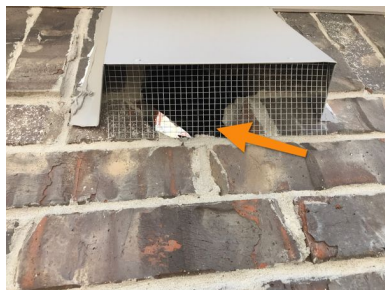
Left Exterior

7: Masonry: Damage/Sections Missing

Left Middle Exterior

Inspector observed water more bricks missing around the home or general damage. Recommend to replace all brickwork as necessary.

Recommendation: Contact a qualified masonry professional.

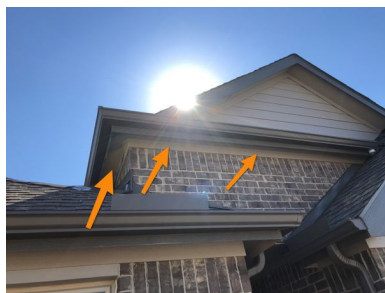
8: Siding: Paint/Finish Issues

Front Multiple Locations

There were some areas of the exterior siding or trim that needs painting or staining to prevent premature weathering of building materials. Remedy as needed.

Recommendation: Contact a qualified professional.

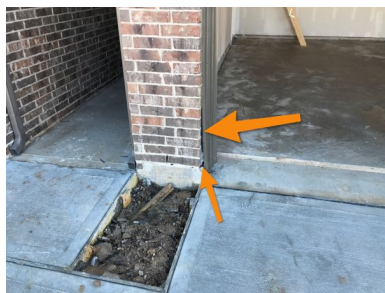
Front Left Garage

9: Siding: Trim issues

Sections of exterior trim was damaged / not properly installed. Recommend further evaluation and repair as needed to prevent possible moisture & pest intrusion.

Recommendation: Contact your builder.

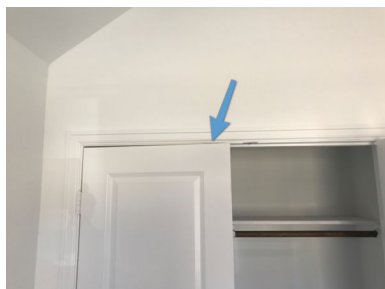
Front Bedroom Closet

1: Interior Door Hardware: Ball Catch Does not Engage

Front Bedroom

The ball hardware for the door does not engage on strike plate. Adjustment to the ball catch is recommended to allow it to close.

Recommendation: Contact a qualified professional.

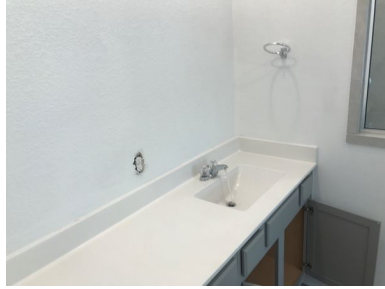
1: Vanity mirror: Missing

Rear Bathroom

The vanity mirror was observed missing at rear bathroom.

Recommendation: Contact a qualified professional.

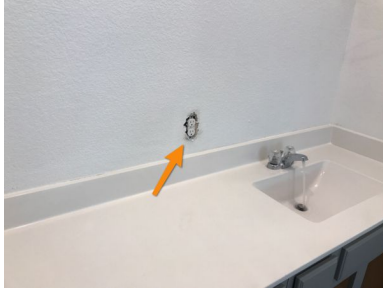
1: Cover Plates:Missing

Rear Bathroom

One or more switches/receptacles are missing a cover plate. Recommend correction as needed to avoid potential hazard.

Recommendation: Contact a qualified electrical contractor.

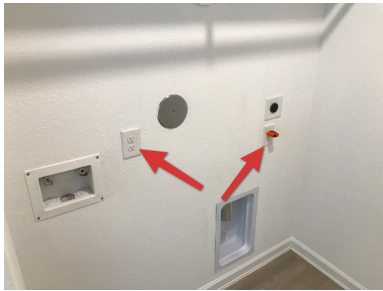
2: Outlets: GFCI Protection Inadequate

Laundry -

Multiple outlets throughout the homes wet locations were in need of GFCI protection. GFCI outlets weren't required when the home was built but updating to GFCI would avoid safety hazards.

Recommendation: Contact a qualified professional.

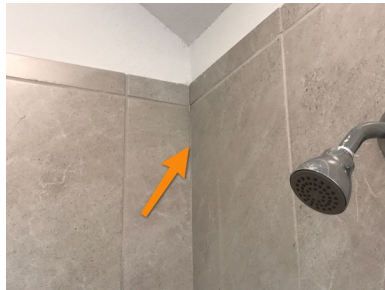
1: Shower: Missing/Deteriorated Caulk or Grout

Rear Bathroom

Grout or caulking is deteriorated and/or missing. This could lead to moisture penetration behind the wall. Remedy as needed.

Recommendation: Contact a handyman or DIY project

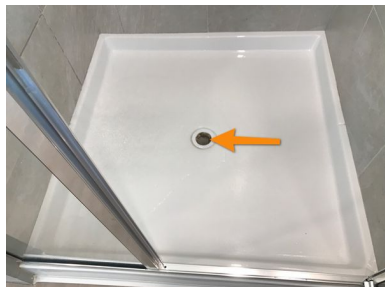
1: Drain Cover: Missing

Rear Bathroom Shower

The cover for the drain piping at the rear bathroom shower was observed missing at the time of the inspection. Recommend further evaluation by a plumbing contractor.

Recommendation: Contact a qualified plumbing contractor.

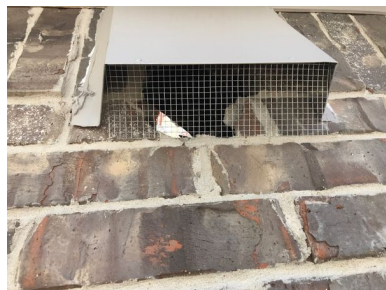
Left Exterior

The exterior vent cover was observed not properly sealed at left exterior. Remedy as needed.

Recommendation: Contact a qualified professional.
