Property Inspection Report

PROPERTY INSPECTION REPORT FORM

Date of Inspection: 2022-07-11

Address of Inspected Property: 10103 Mariner Oaks Missouri City, TX 77459

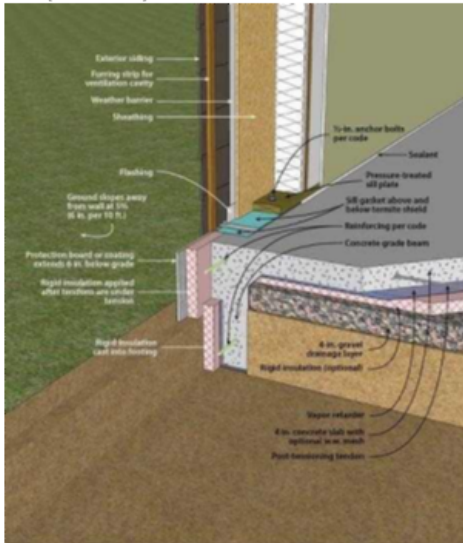
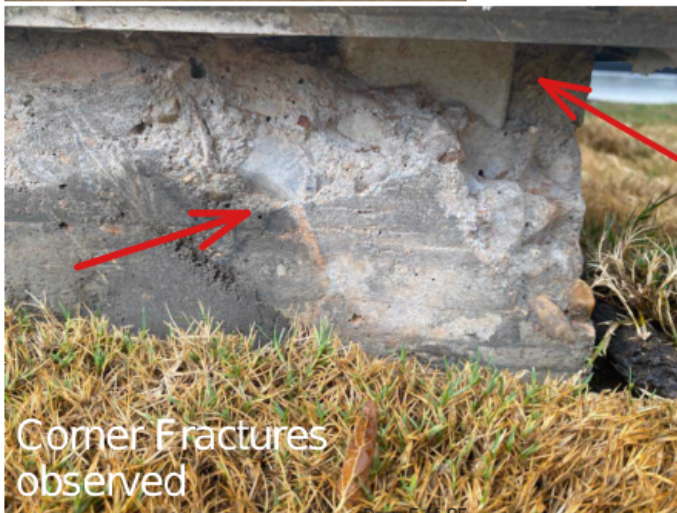
2. Rusty nails protruding from foundation (safety item).

Correction recommended by qualified contractor

Correction recommended by qualified contractor Type of Foundation(s): Post Tension

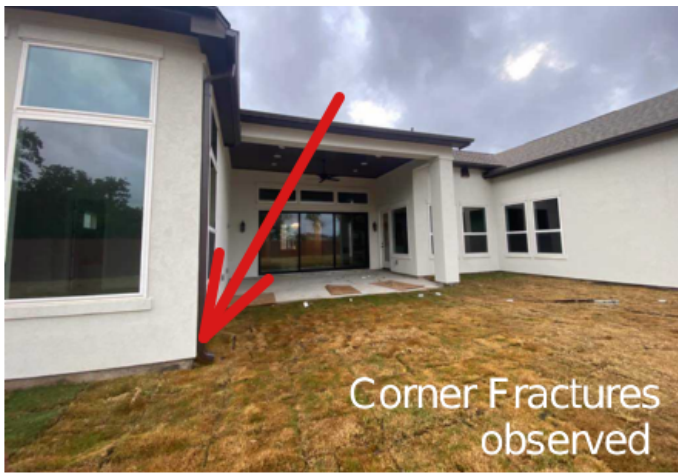
Corner fractures were noted on the corner(s) of the foundation, these are usually considered cosmetic nature unless other movement is noted.

Corner Fractures
observed

Recommend sealing all cracks to help prevent further deterioration.

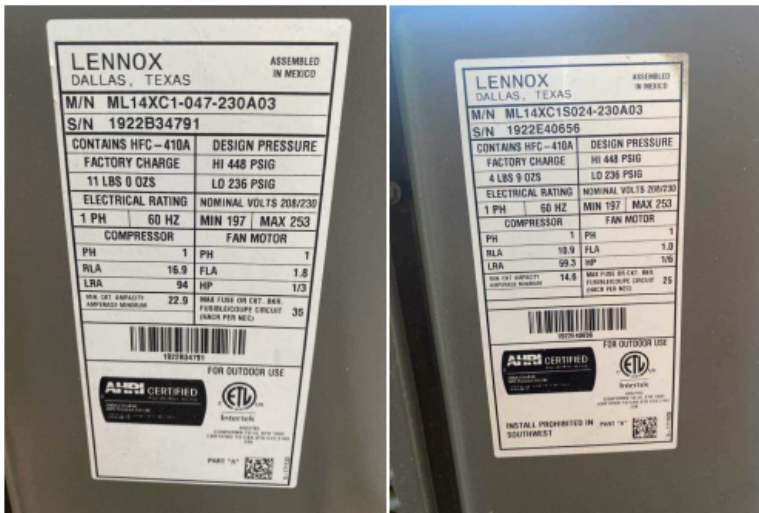
Unit appeared to be operating normally at time of inspection.

The A/C unit High/ Low differential for this unit is 19 degrees.

Differential should fall between 16 and 21 degrees at the unit for proper cooling.

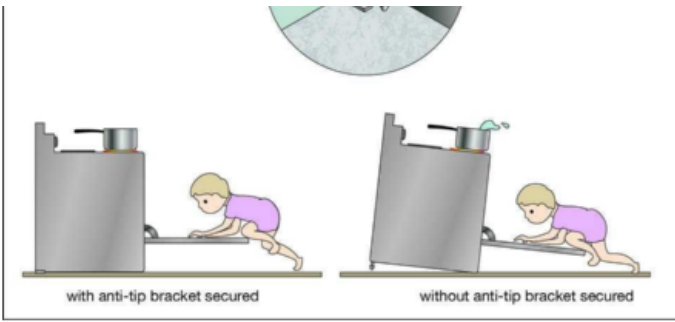
Anti-tip brackets

These are used to secure the range to the wall or floor to prevent tipping over and causing serious injury

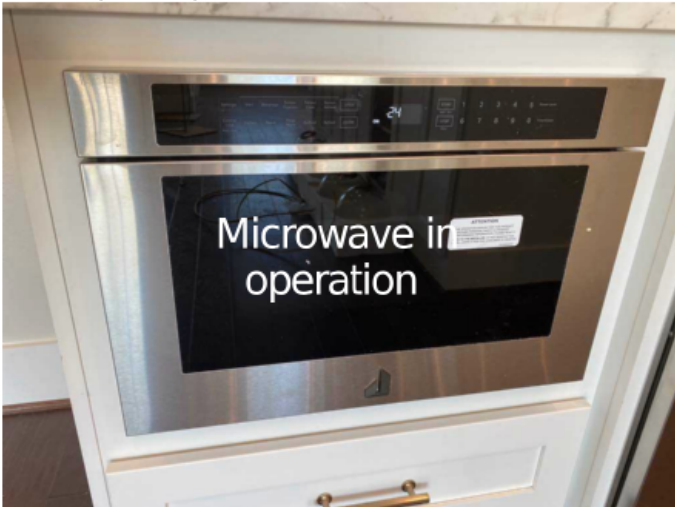
Comments: Jenn-air,
Microwave was operating as intended at time of inspection.

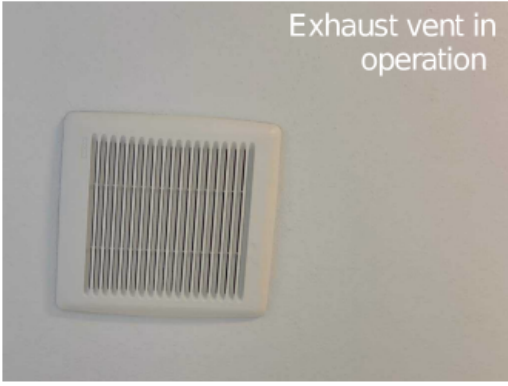
Comments: Broan,
Bathroom exhaust vent operated as intended at time of inspection.

Exhaust vent in
operation
