Inspection for Property located at 20259 Beechview Ln
04/23/2024
Prepared for : Jose R Peniche

PROPERTY INSPECTION REPORT FORM

20259 Beechview Ln, Katy, TX 77449

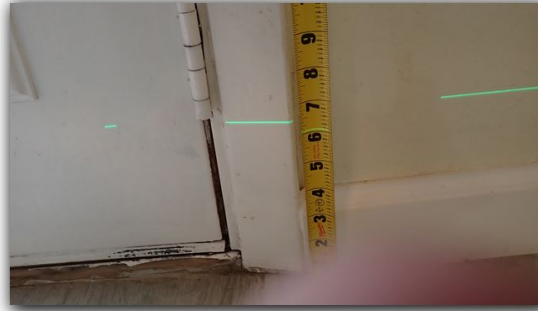
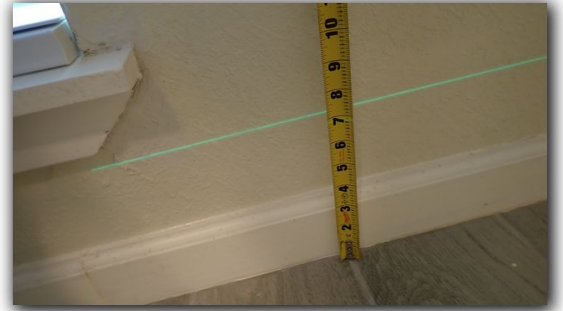
Comments: Differential movement / settlement observed; indicated by one or more of the following observed conditions; Cracks in brick veneer and/or foundation, Cracks in sheetrock over doors and windows, doors that are not square in jamb, etc. In my opinion the distress patterns observed at the time of inspection are/were not severe enough to recommend repair. Acceptance of present and future condition / performance / maintenance rests solely with the buyer / client.

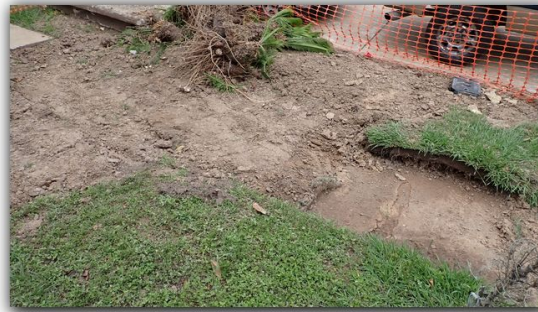
Comments: *The front yard is under construction.*

Mud District is repairing water line on their end. This is out of sellers control. Sidewalk and grass will be repaired within 30 days.

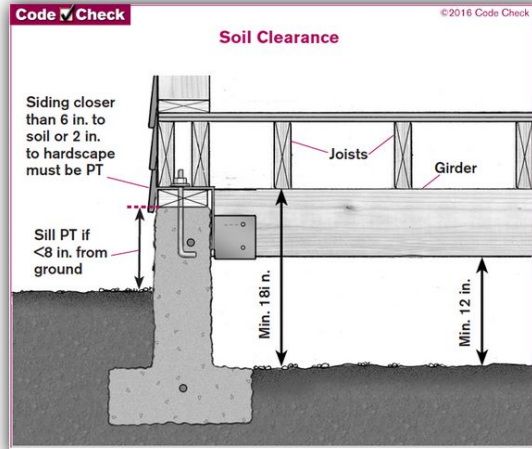
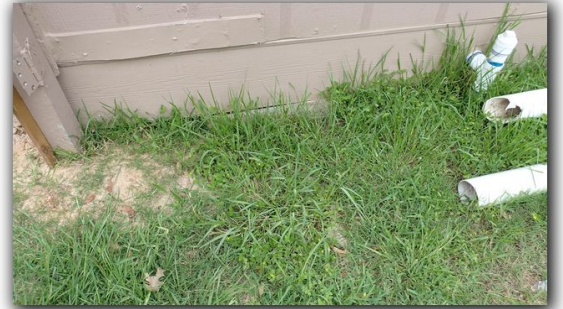
Soil level too high, in contact with wood siding and/or at/above brick weep holes at one or more locations around house/garage. Promotes wood rot and is considered a conducive condition to termite activity.

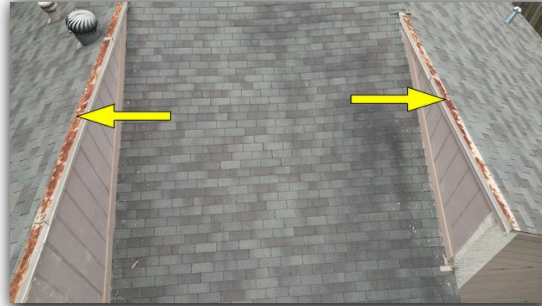
Comments: Observed one or more sections of rusting and/or rusted thru sections of flashing which indicates they are at/near end of serviceable life.

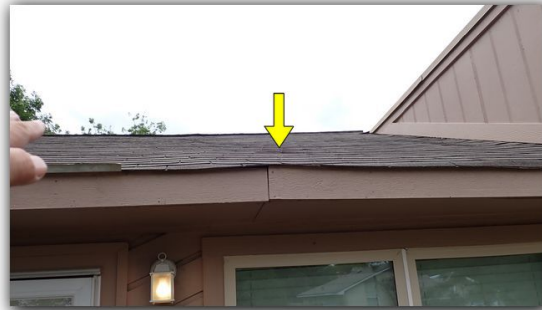
Sag(s) in roof decking observed. Probable cause is from improper/ inadequate framing in the attic or rotted/damaged roof sheathing.

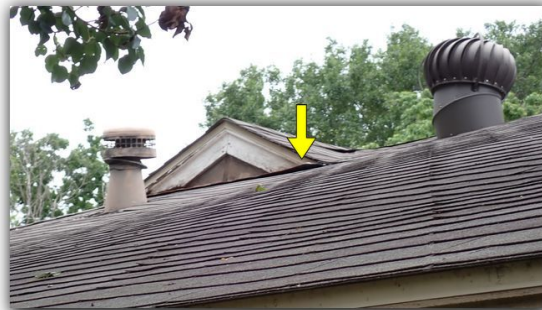
Lower side of flashing is not sealed down, wind driven rains can cause water penetration.

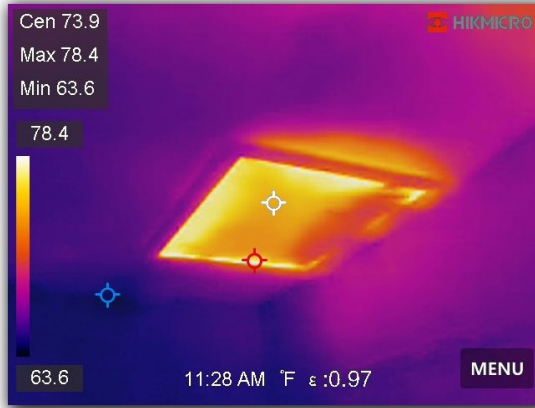
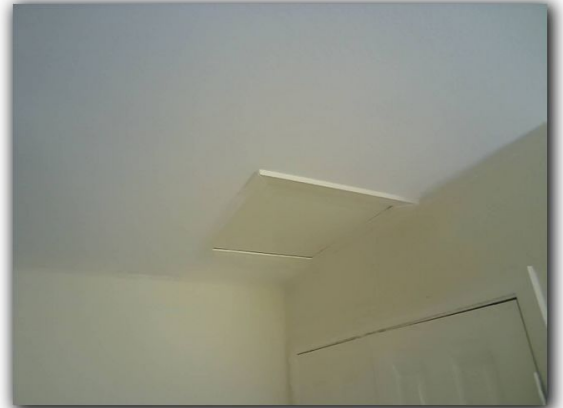
Comments: Recommend insulating and weather stripping the attic scuttle hole access.

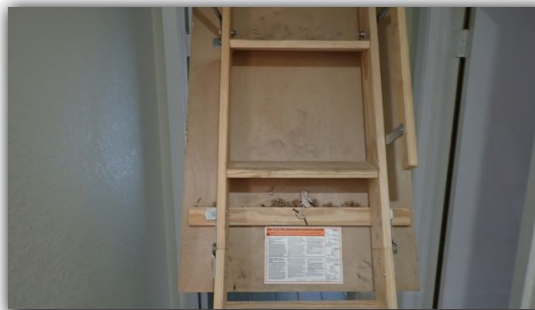
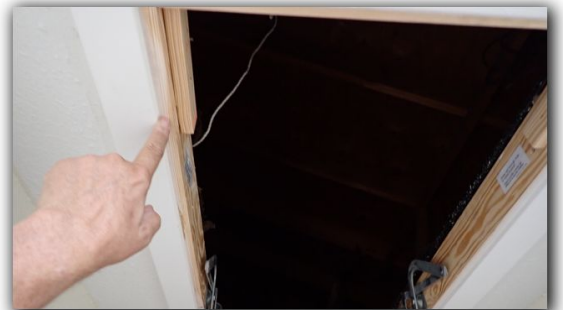
Stairway to attic is missing insulation on stairway and weatherstrip at the frame.

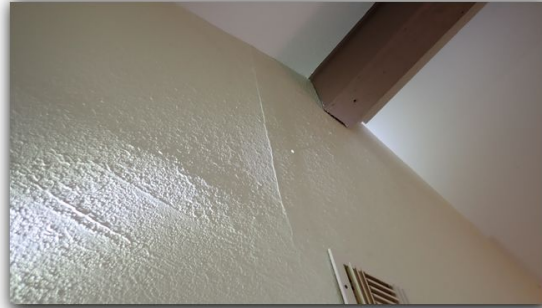
Cosmetic cracks and/or repaired cracks in sheetrock observed over Some doors, windows, and/or corners.

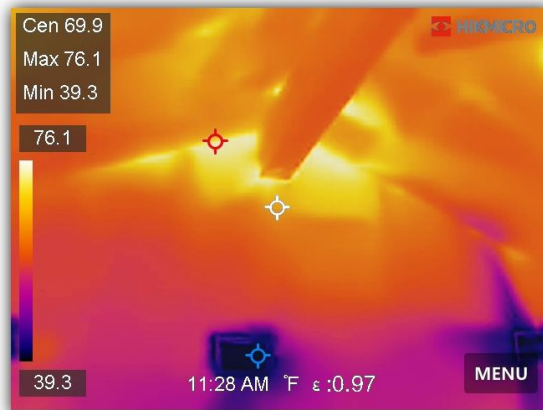
Thermal imaging detects some missing and/or inadequate insulation.

Batt insulation will be placed on cathedral portion of ceiling

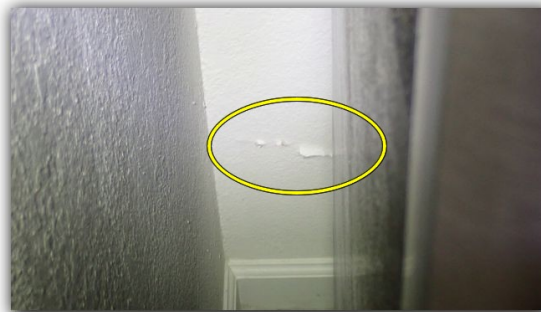
Peeling paint observed behind the refrigerator. Possible water stains.

Will inspect for possible condensation from refrigerator causing peeling paint.

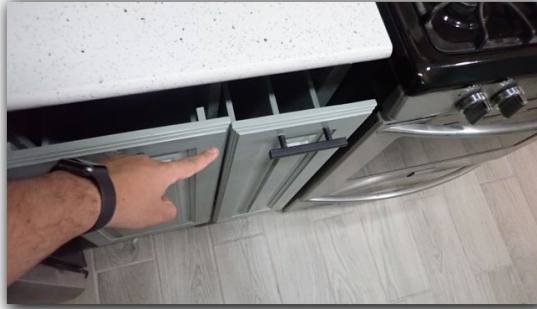
Cabinet Drawers located in Kitchen need adjustment and/or repairs.

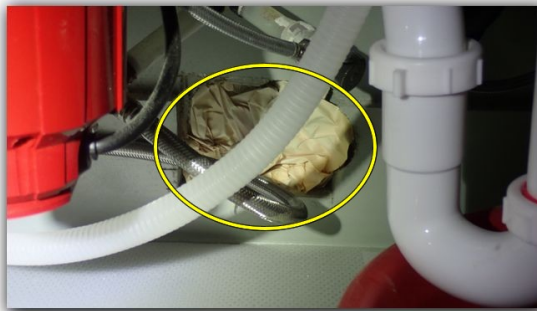
Excessive hole in wall, below kitchen sink.

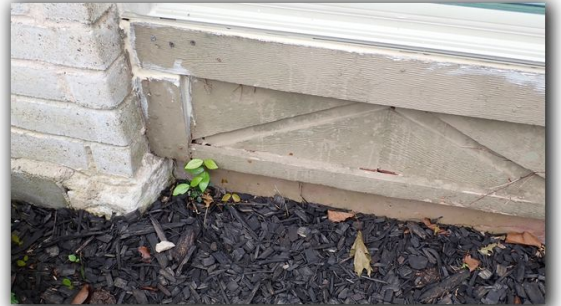
Wood rot observed on areas of house / garage.

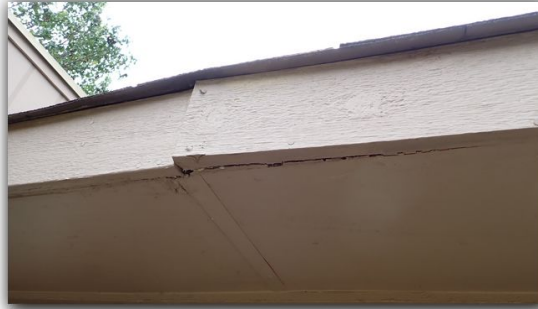
Damaged siding and/or trim at one or more locations.

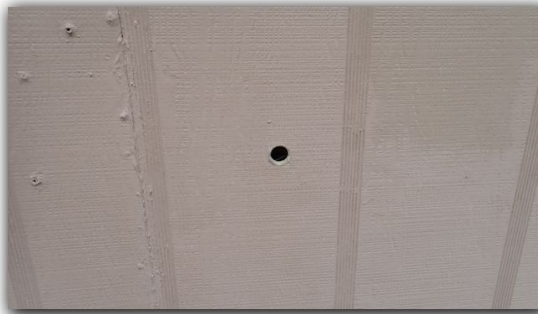
Need sealing / caulking around all holes and exterior siding penetrations on top and both sides, (leave bottom open) to prevent water entry. Including but not limited to dryer, bath and range top vents, light fixtures, etc.

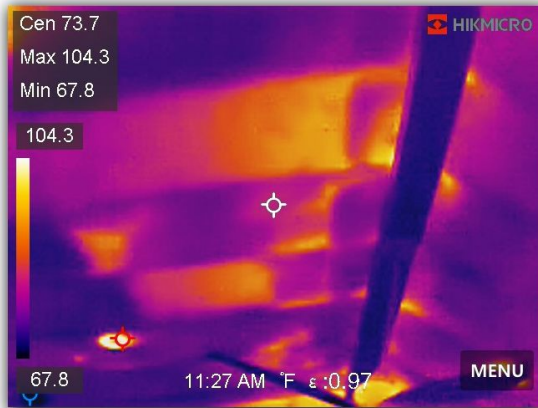
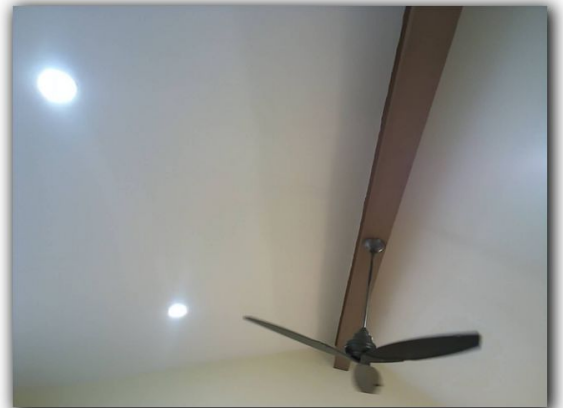
Thermal Imaging indicates missing/insufficient insulation from one or more locations of the ceiling joist cavities.

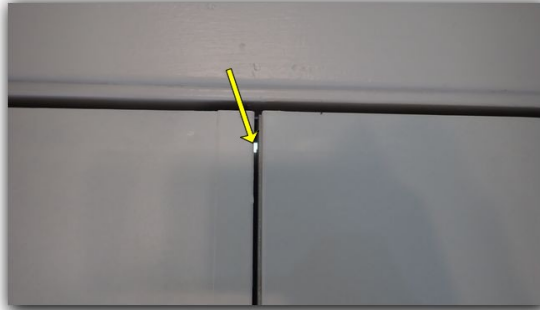
Comments: **Weather stripping torn/damaged and/or missing on one or more exterior door(s).**

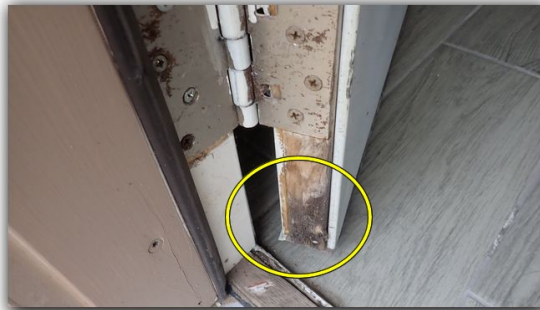
Wood rot of lower door and/or jamb;

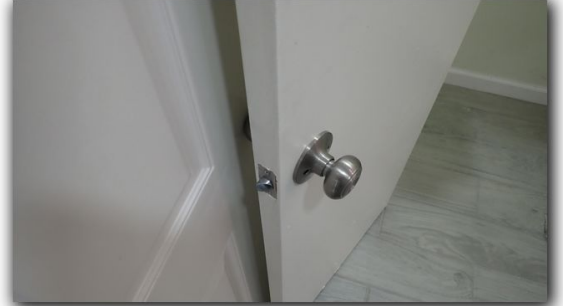
Missing or non-functioning door stop behind one or more doors which are needed to prevent damage to sheetrock and/or other surfaces.

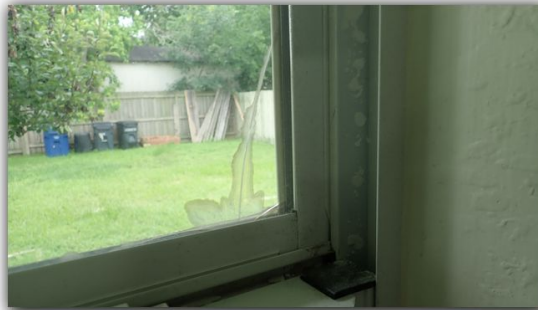
Comments: One or more windows had cracked / broken glass pane(s).

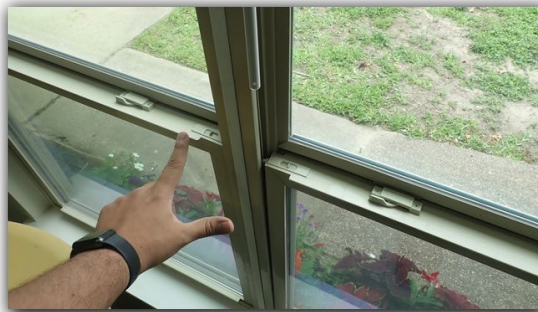
Front windows are very loose, appear to two separate windows improperly installed together.

Window mulling and installation will be revisited.

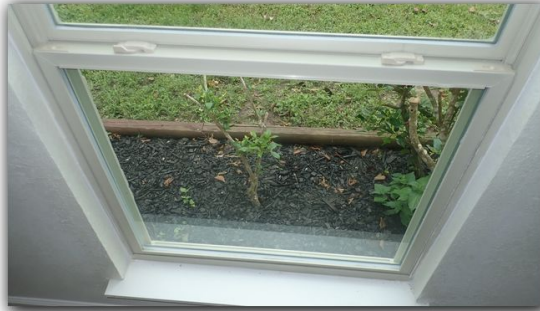
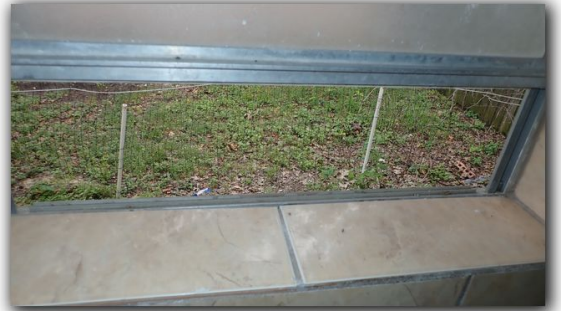
One or more screens are missing and/or damaged.

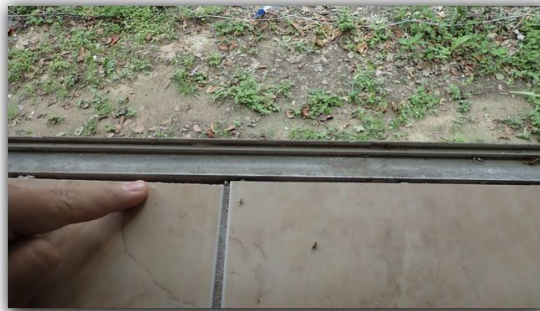
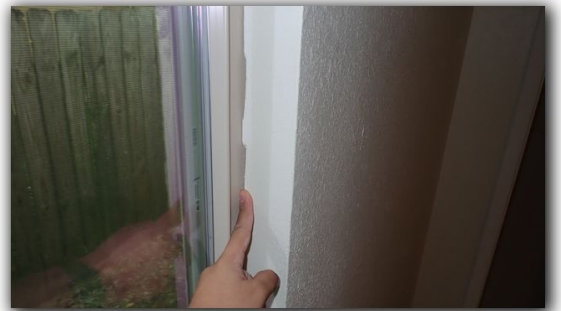
The window frames require caulk or caulk replacement.

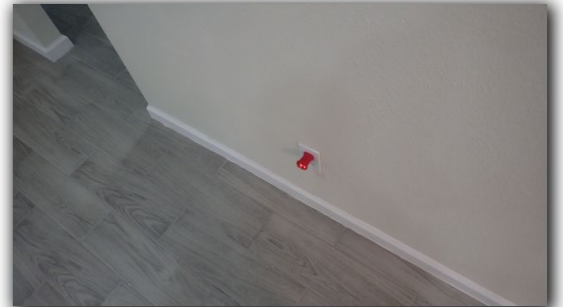
Comments: **Improperly wired, 3 prong outlet not grounded or polarity reversed, including but not limited to:**

Reversed polarity

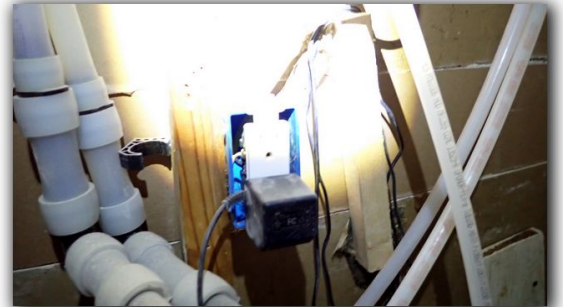
One or more cover plates were either missing or damaged.

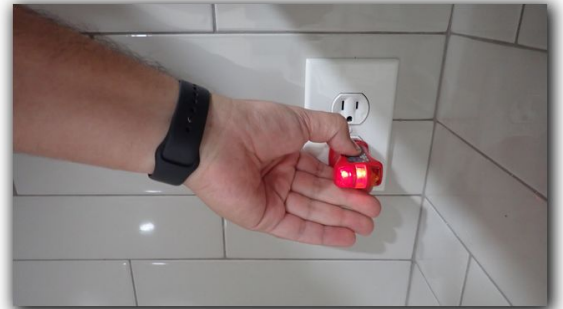
Did not observe GFCI protection of all outlets in required locations, including but not limited to the location marked below. This condition is a recognized safety hazard and is in need of repair.

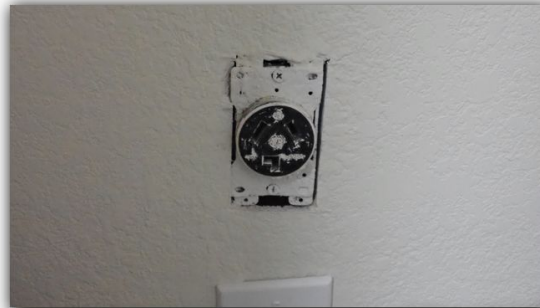
3-prong outlet for dryer with metal cover / screws is a recognized safety / shock hazard. Recommend replacing metal cover / screws with plastic to reduce chance of electrical shock.

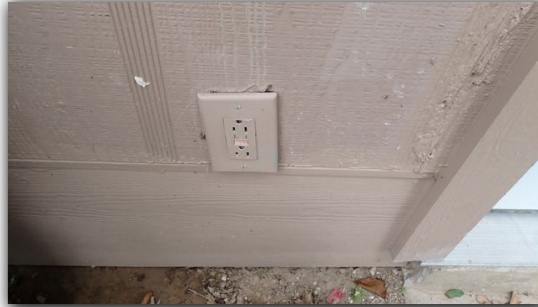
One or more outlets at the exterior are not rated for exterior use:

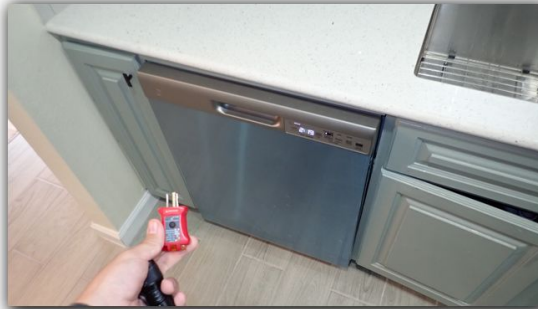
No electrical disconnect (switch) for dishwasher observed. Does not comply with current National Electric Code (NEC) or State Inspection minimum standards.

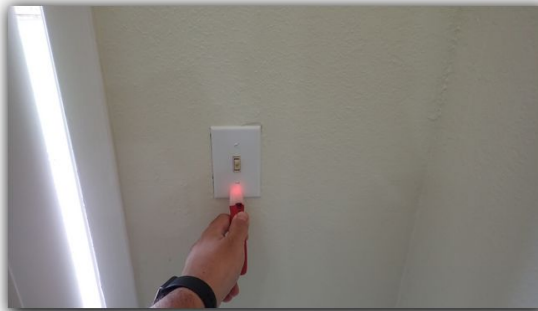
Voltage detector indicated switch(s) are not grounded as required by current industry standards (code) to reduce risk of electrical shock. Prior to 1999, grounding of switches was not required. Recommend grounding all non-grounded switches or replace all metal face plates and screws with non-conductive plastic face plates and screws.

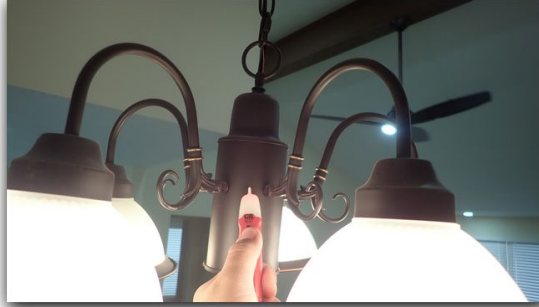
One or more light fixtures are not grounded.

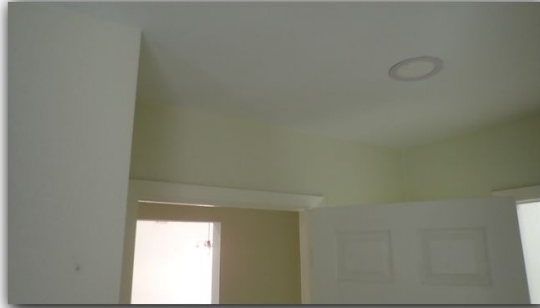
Inadequate number and/or improper location of smoke detectors in home. Smoke detectors should be located on each level of the home AND inside AND outside of all sleeping rooms. Consult the smoke detector manufacturer's instructions regarding specific placement of detectors.

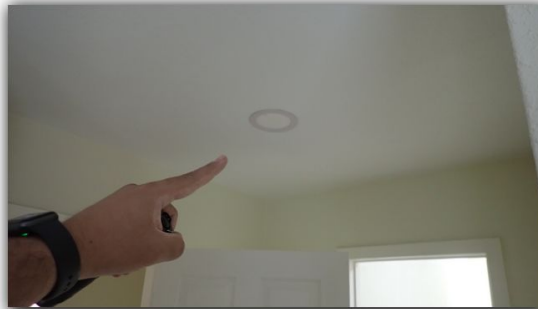
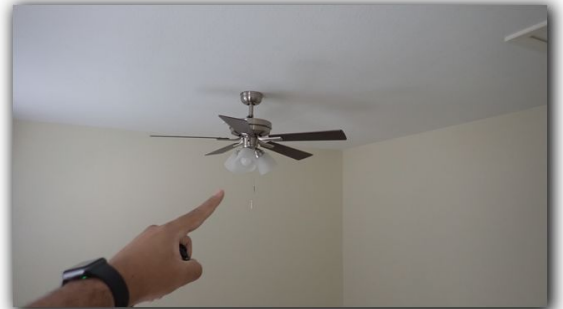
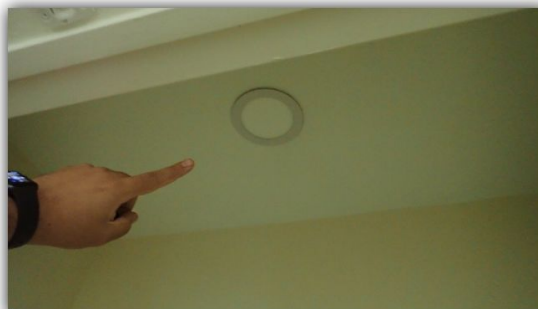
Multiple lights found to be not functioning. Probably just burned out bulbs, or it could be a broken fixture / switch or improper wiring. Observed at but not limited to the previous garage area.

Breaker must have been tripped during inspection. All lights are fully functioning.

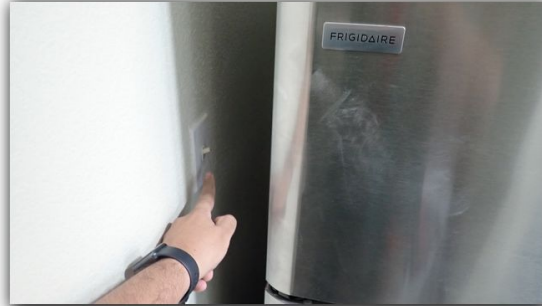
Unknown control, mystery switch(s) found, recommend inquiring current resident regarding use/control;

Switch is obsolete after garage conversion. Will remove and use flat plate cover.

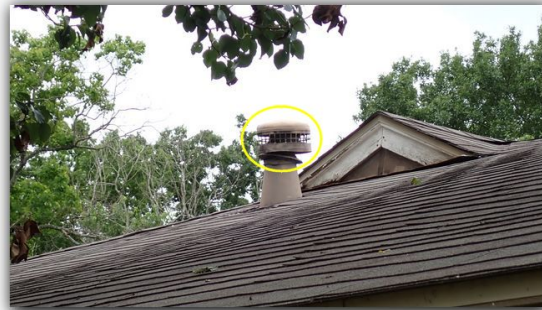
Comments: **The vent cap is damaged.**

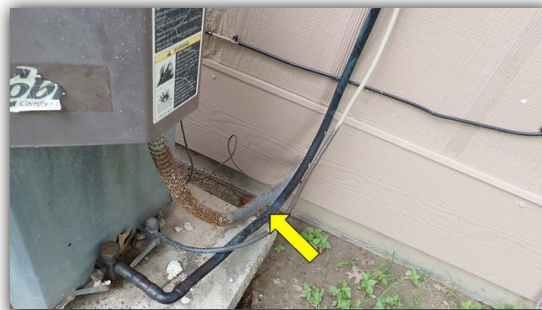
Section of suction line insulation missing or deteriorated near condenser.

AC will be serviced (i.e. plenum cleaned, Freon checked) and ductwork replaced. However, the system can be replaced in lieu of 5K concession.

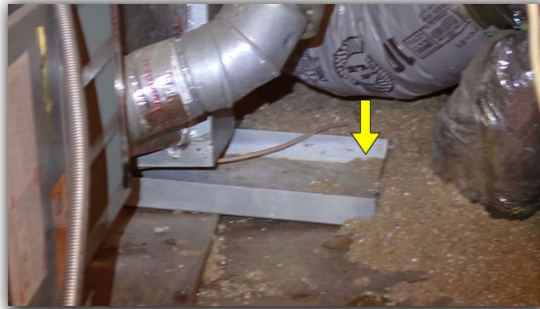
Insulation / debris in drain pan should be removed to prevent blocking of drain.

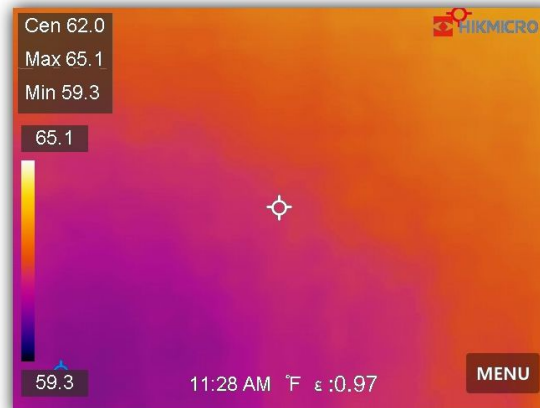
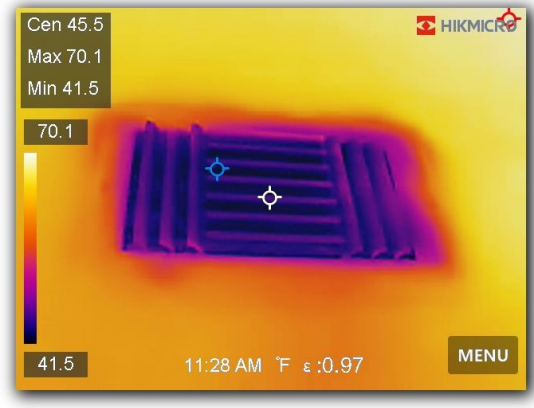
The air conditioner produces a differential temperature of 23.6 degrees F. Temperature differential is too great, indication of possible air flow restriction across coil and/or low Freon charge, needs service.

The condenser has a 3 ton cooling capacity and was manufactured by Resco in 1994.

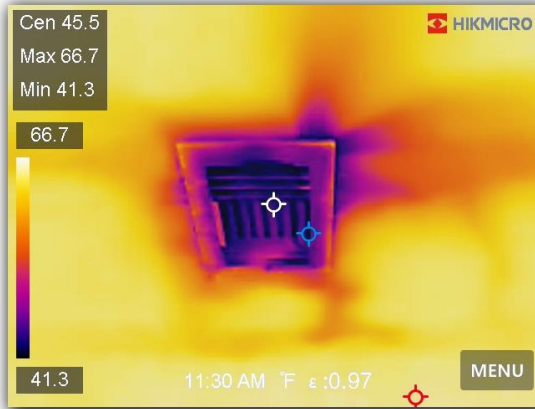
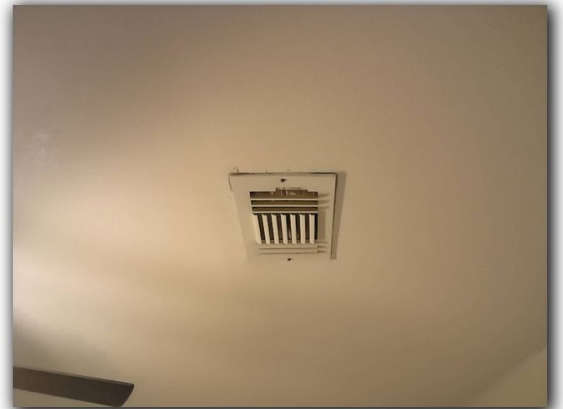
Comments: **One or more registers are not sealed to the vent. This allows air to leak out the sides.**

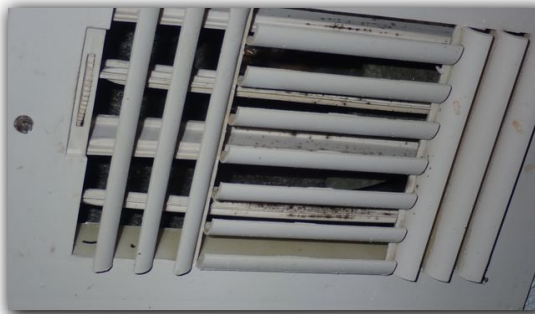
Observed possible micro-organism growth on air supply grills / vents which may be a concern due to increased awareness of environmental issues associated with molds. *If this is a concern or potential concern, Texas House Check recommends contacting us for a mold testing, etc. Suggest replacing vents and registers.*

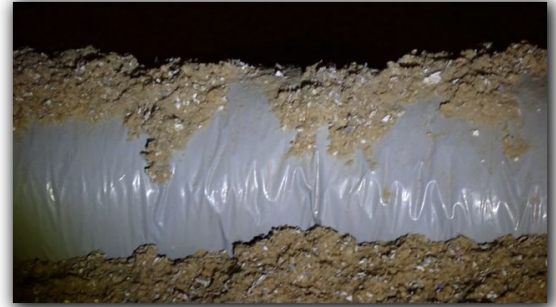
Some gray duct wrapping damaged on ducts in attic needs to be repaired. This product appears to be type that was recalled many years ago due to deterioration of exterior vapor barrier when exposed to light.

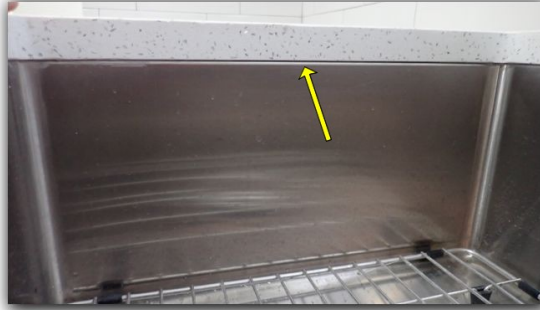
Comments: Where the sink connects to the countertop the caulk is either missing/damaged and should be reapplied to create a smooth surface to prevent surfaces prone to fouling. Refer to IRC P2701.1 Quality of fixtures

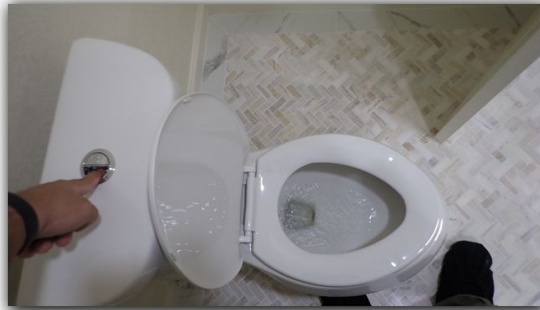
Does not flush properly, must hold down handle for proper flush;

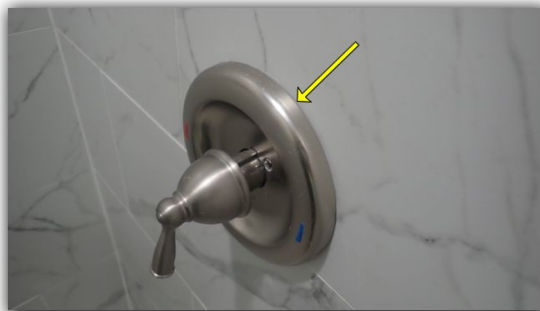
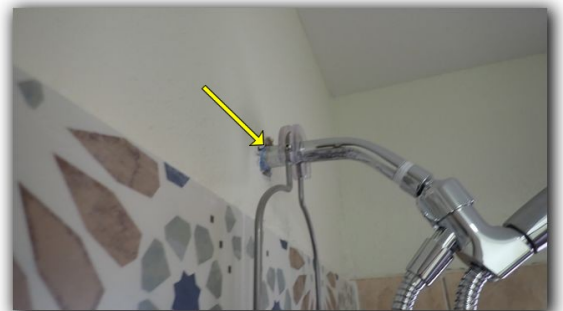
Recommend caulking around all tub/shower faucets and spouts to prevent water entry behind wall.

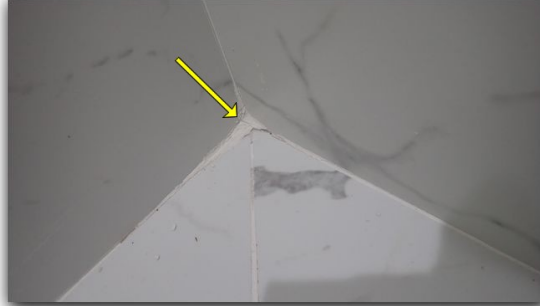
Grout / caulking needed at vertical tile corners, cracks in tile and/or mortar between tiles, and where tile meets tub to prevent water entry behind wall.

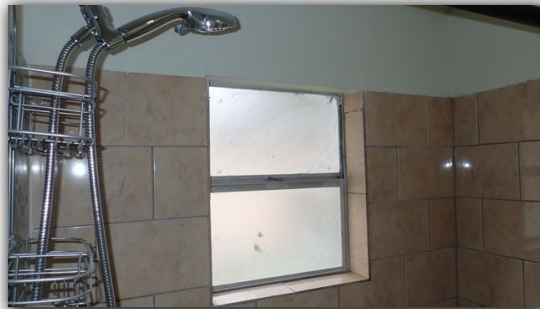
Recommend protecting window from shower spray to prevent water damage.

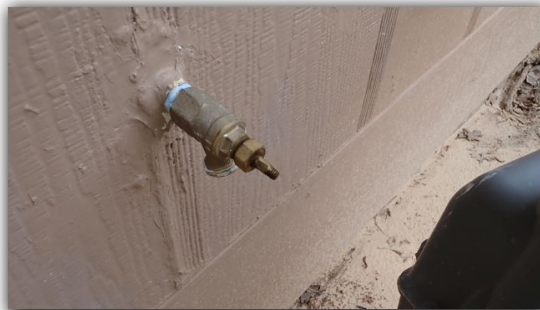
One or more hose bib handle(s) were damaged or missing.

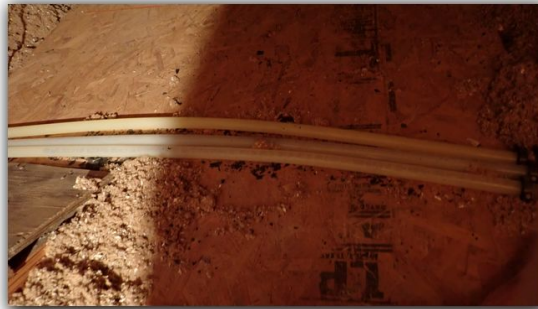
Recommend insulation of exposed water lines in attic.

Entire house was replumbed in 2023 by Sellers father. Pex plumbing, water heater and entire sewer was replaced. Seller will obtain paperwork/invoice.

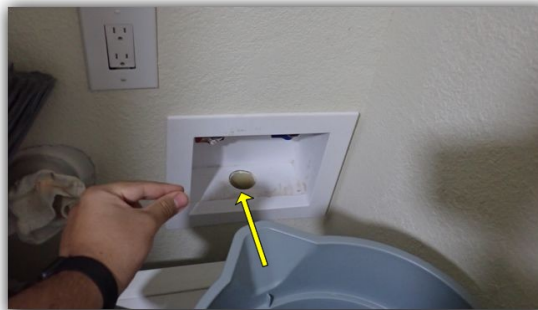
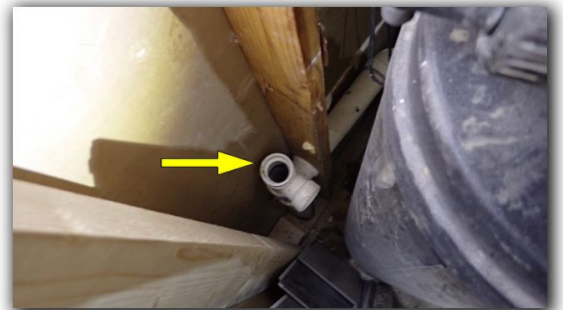
Possible sewer gas is entering the structure. Sewer gas is very dangerous and this condition should be evaluated and repaired by a plumbing contractor. Please read the document at this link concerning the dangers of sewer gas. Needs repair by a licensed plumber.

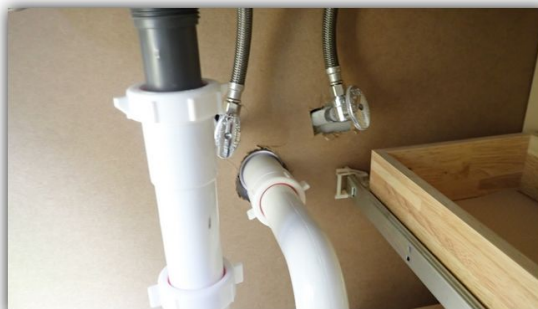
Escutcheon missing where plumbing penetrates the wall. Covering this penetration hole may help prevent air leaks and pest entry.

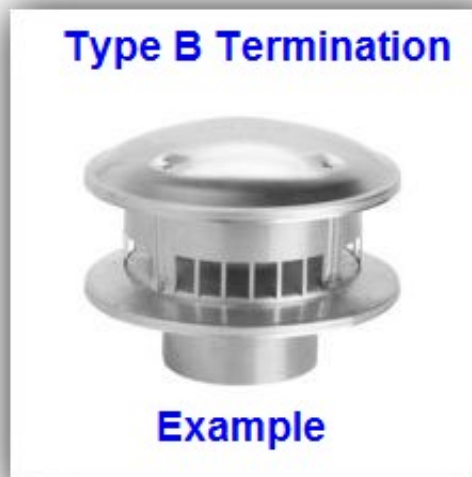
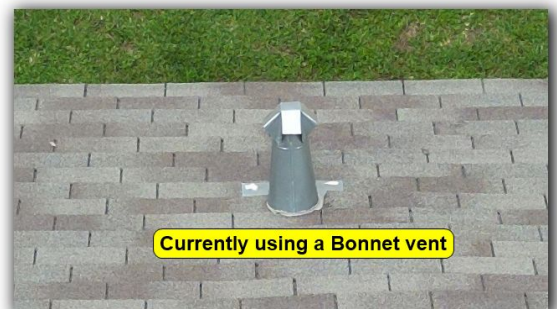
Improper vent termination. Replace old style bonnet type roof jack of gas fired house heater(s) with code approved class "B" vent cap to ensure proper venting of forced draft unit.

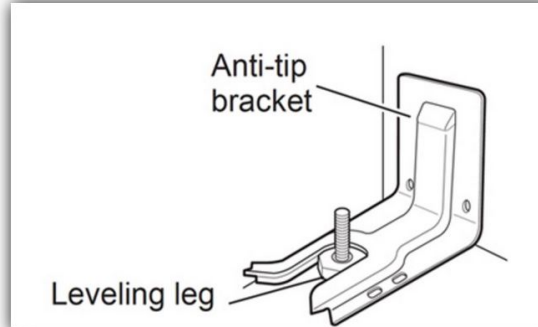
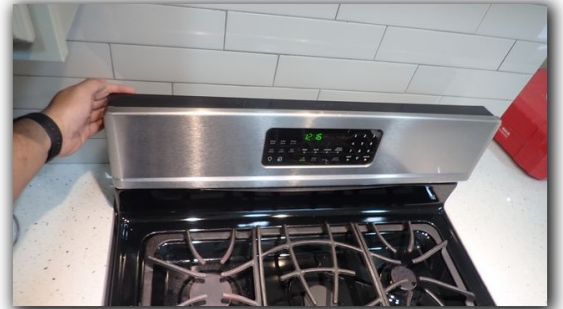
Comments: Does not have recommended anti-tip bracket on back side of unit.

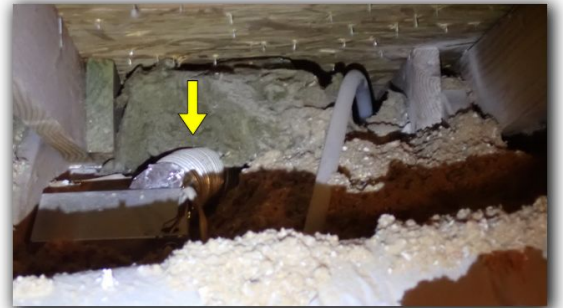
Fig. 7

Comments: Improperly vents to soffit. Should vent to exterior.

Terminating exhaust fans to soffits/eaves builds up condensation moisture within the soffit that can deteriorate the fascia board, soffit and/or plywood roof decking and cause paint peeling. A soffit/eave is part of attic air space where exterior air is drafted in to the attic space with the exhaust duct fumes and moisture.
