# PROPERTY INSPECTION REPORT

20223 Charlisa Springs Dr, Katy, TX 77449  
Inspection prepared for: Matt Messer  
Real Estate Agent: Open House - Open House

Date of Inspection: 5/7/2024 Time: 9:00 AM  
Age of Home: 2001 Size: 2299  
Weather: 79 degrees with partly cloudy skies  
Structure Type: Structure is a wood framed structure  
on a concrete slab foundation.

Inspector: Steve McElwee  
License 21679

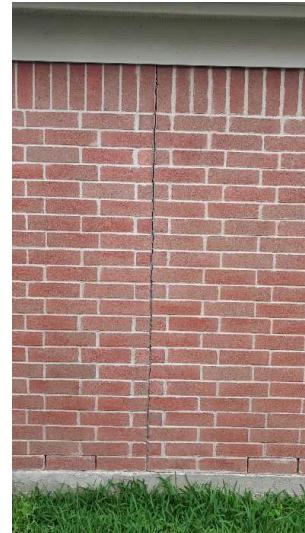
- The foundation, In my opinion, is showing signs of movement and structural engineering review is recommended. This conclusion was made from observations made while inspecting the exterior and interior components of the house.

Left side. Movement at the expansion joint.

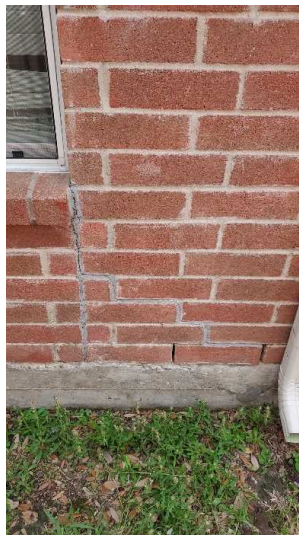
Right side. Brick separation.

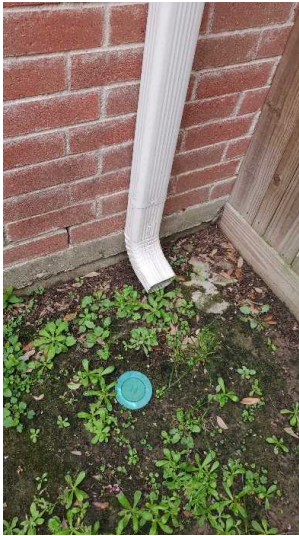
- The soil was noted to be too high on foundation in one or more locations.
- Gutters downspouts should extend out beyond 5' from foundation to allow for proper runoff. All gutter downspouts should have splash blocks or diverters to control erosion and direct the roof water away from the foundation

Gutter downspout discharging too close to the foundation.

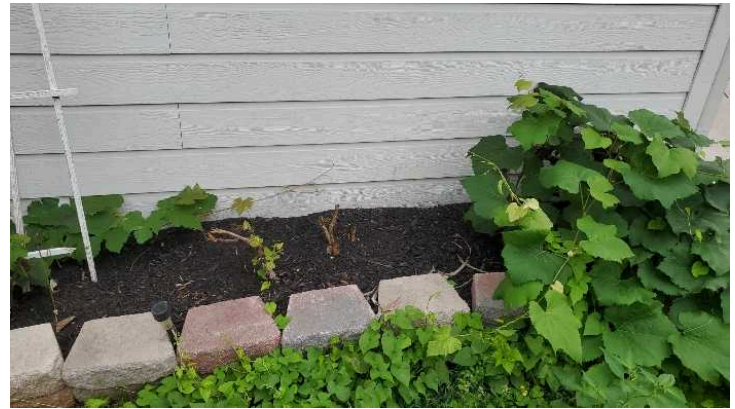
High soil, back side of house.

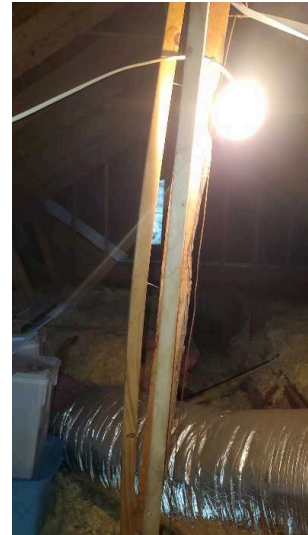
*One or more of the rafter supports are loose.*

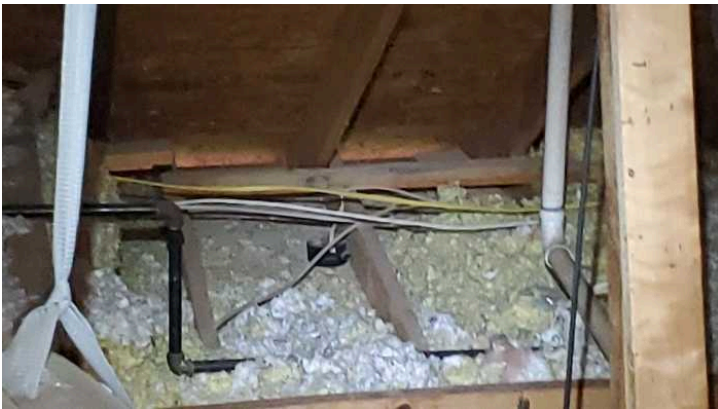
*The attic insulation was observed to be low or compacted in areas. It is recommended that additional insulation be added to achieve a minimum of R-30.*

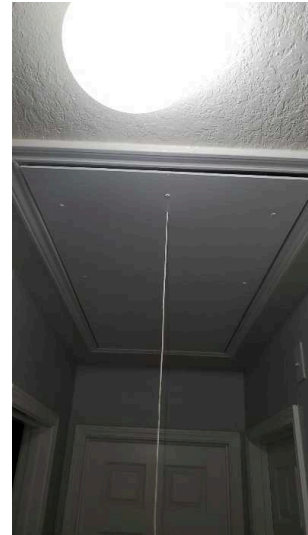
*The attic ladder does not close properly and should be further evaluated*

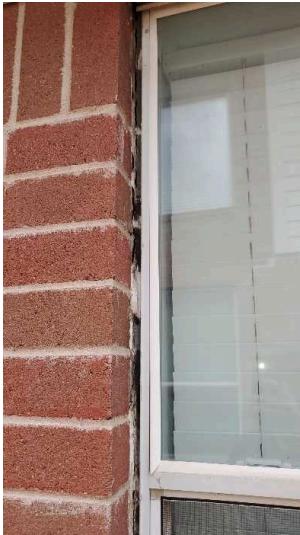
*Elastomeric caulking improvements are recommended between the exterior veneer and the window frames in one or more areas of the home.*

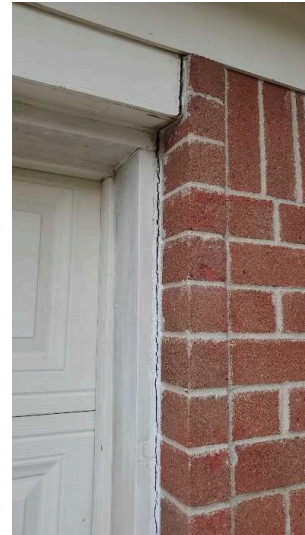
*Damaged caulking noted at exterior brick / siding, and the garage door trim boards*

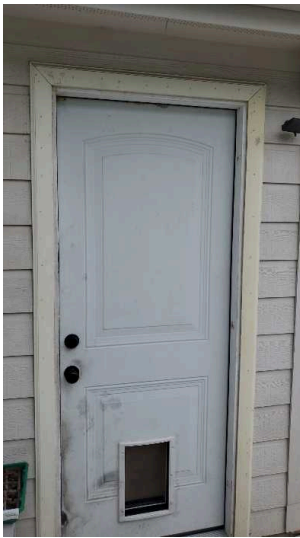
*The exterior trim around the rear door is interior trim used on the exterior.*

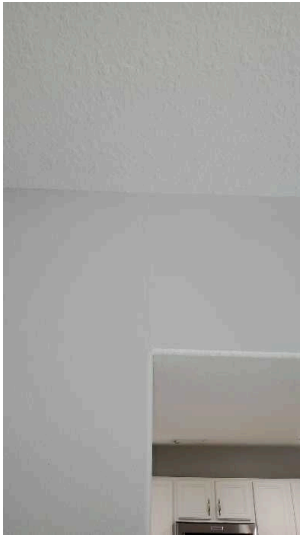
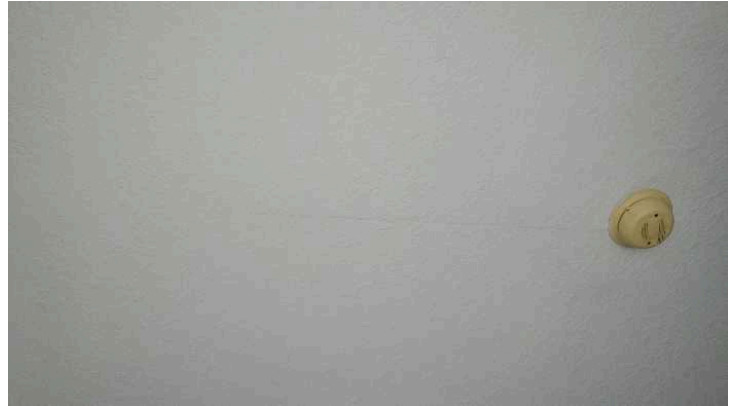
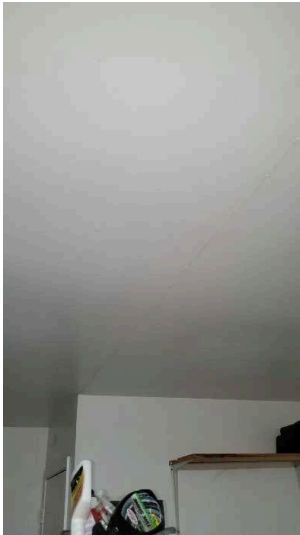
*Tape Joint fractures were observed in one or more areas.*

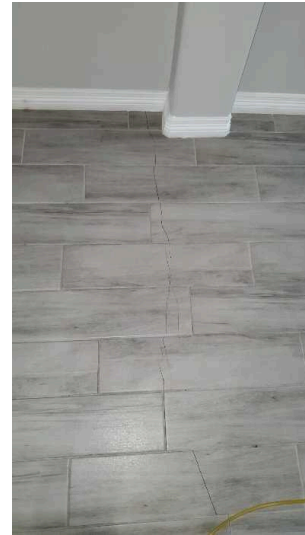
*Damaged floor tile.*

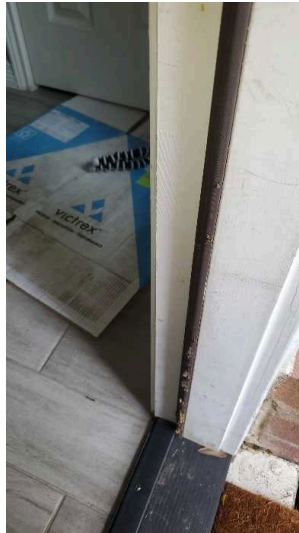
*Exterior doors at one or more locations were observed to need proper weatherstripping and/or bottom sweep*

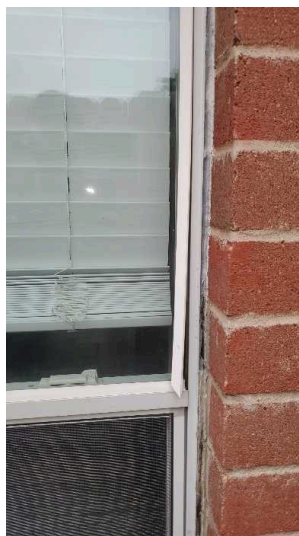
*Weather stripping and/or glazing was either damaged and/or missing at one or more windows.*

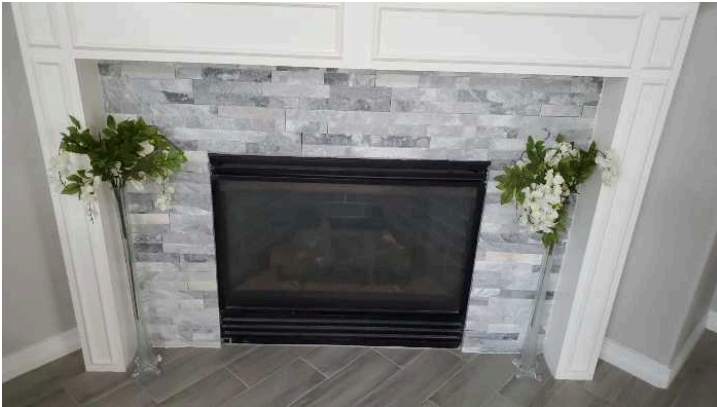
- **Fireplace missing a defined hearth extension.**

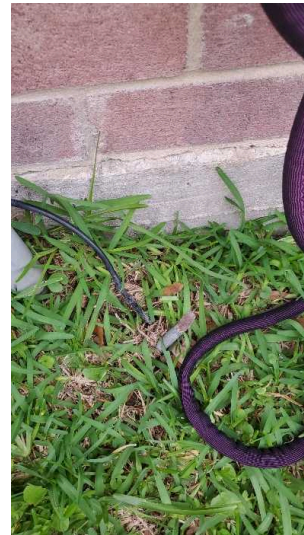
*The grounding connector on the ground rod is loose and should be corrected*

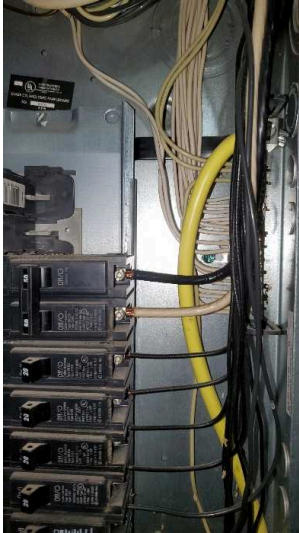
- Service entrance wiring is underground
- There are white wires in the panel connected to breakers that are required to be labeled / identified as hot wires.
- The grounding connector on the ground rod is loose and should be corrected

Hot white wires in the panel.

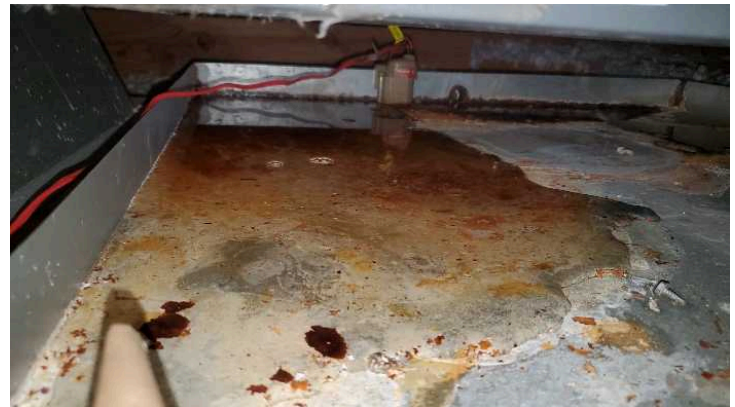
Rust and/or corrosion was noted in the condensate drip pan

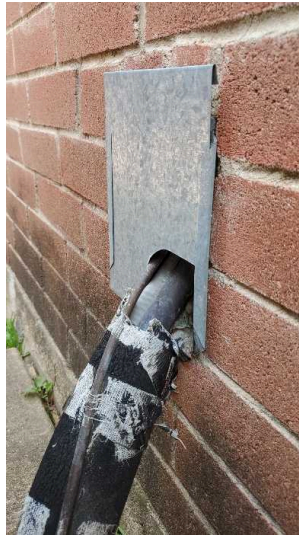
*Refrigerant lines noted with damaged / missing insulation at the Condensing Unit.*

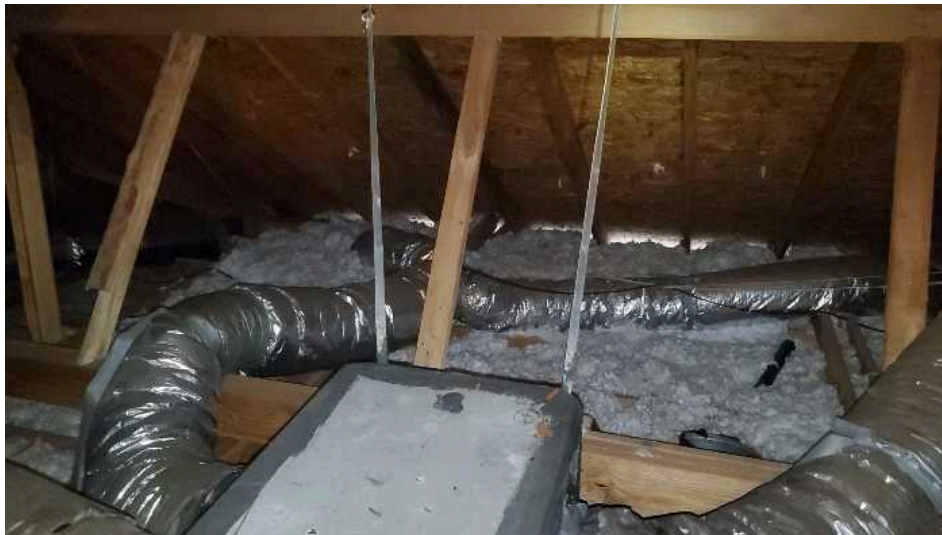
*Ductwork in attic space was observed to be sagging and/or kinked and is not supported at {4'} spacing as recommended*

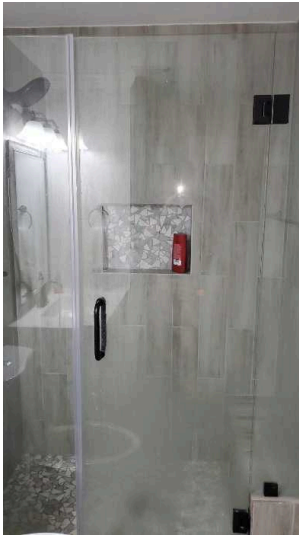
*The hallway bathroom shower door opens inward. Shower doors should open outward to prevent the unconscious occupant from becoming stuck in the shower.*

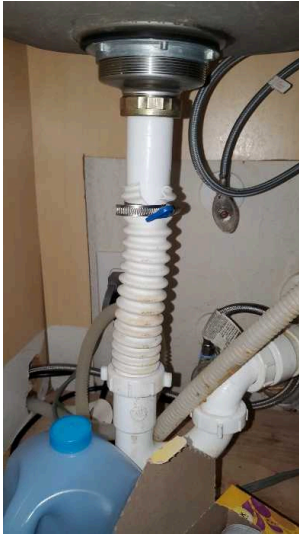
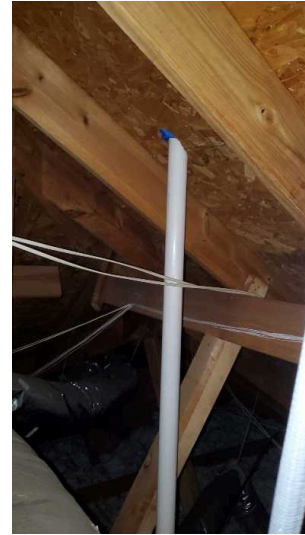
*One or more of the sink have accordion-style flexible drain pipe installed (also sometimes called flexible waste pipe). These drains are known to trap solids in the ridges and split along the seams. Recommend replacing with PVC piping.*

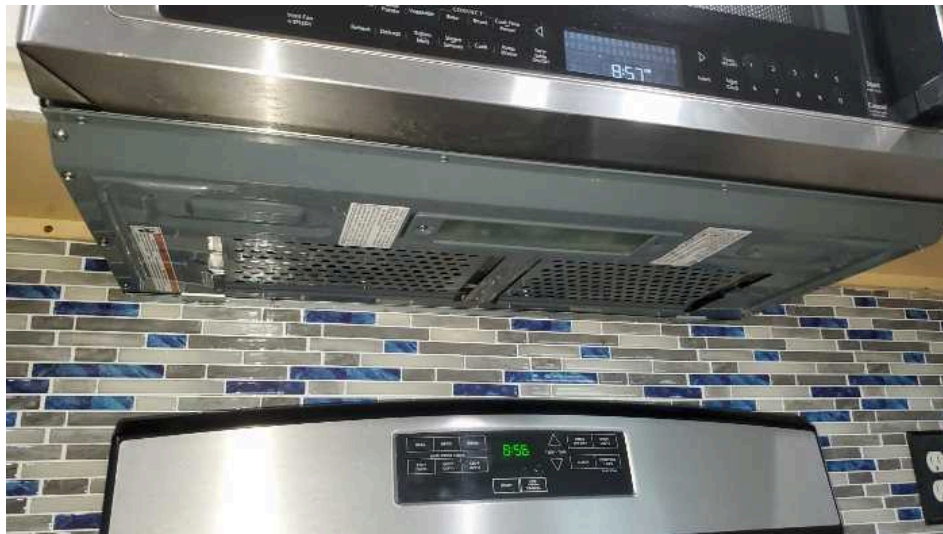
*One or more of the grease screens are missing.*

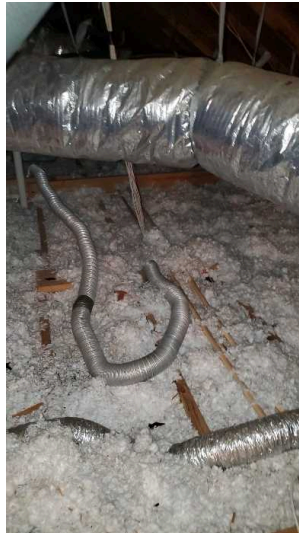
*The bathroom exhaust fan noted to be terminated in the attic space.*

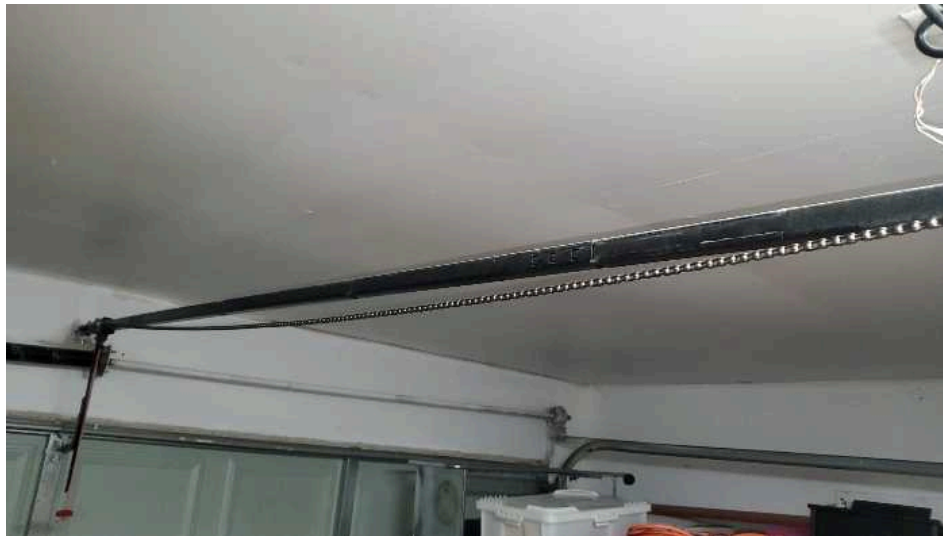
*The drive chain is loose and in need of adjustments.*
