21418 Park Rock Ln
Katy, TX 77450
Kachi Osuorji

06/27/2024

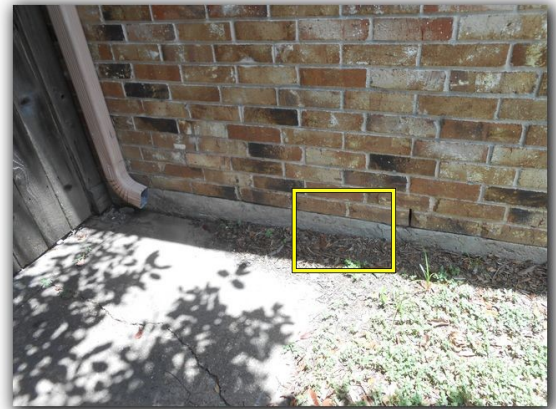
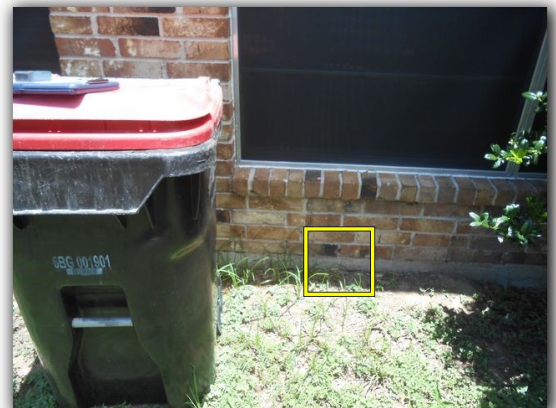
There is a hairline crack in the foundation on the at multiple locations around the home.

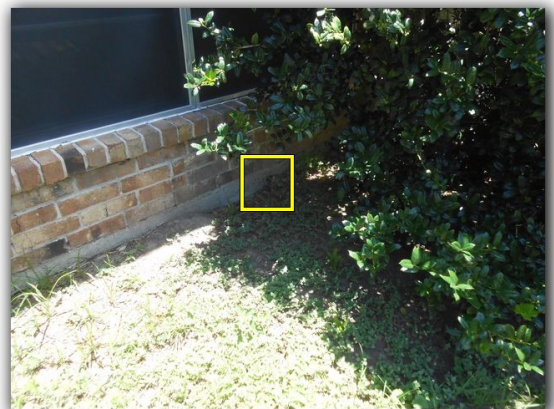
There are exposed cable ends on the left side of the home. These cable ends should be sealed to help prevent oxidation/rusting of the cable into the foundation.

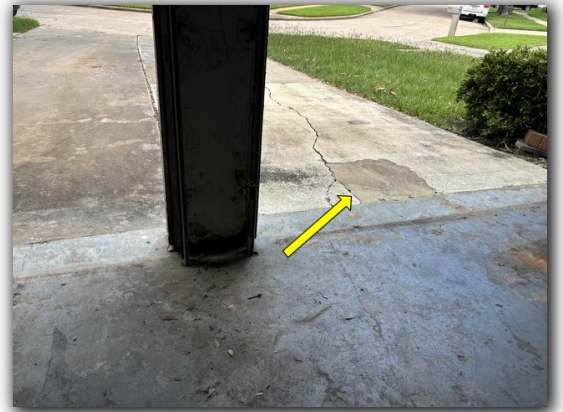
There is evidence of prior foundation repair. I recommend asking for any additional information regarding prior review and repair of the foundation, including who performed the repairs, when the repairs were completed, and where the repairs were made. I recommend asking the seller if there is a transferable warranty, and ask that all relevant forms be provided so that proper and timely transfer of any warranty may be completed accordingly.

Foundation shows evidence of minor movement. It appears that the home has had "hard settling" and in my opinion, there are no significant foundation issues. If the buyer has further concerns, they may consider consulting with a structural engineer.

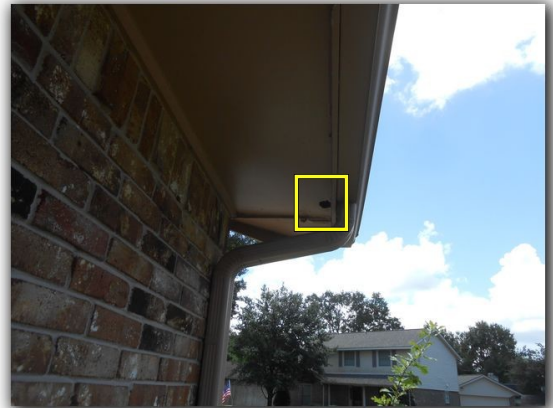
There is rot/deterioration on the soffit at the front left corner of the home.

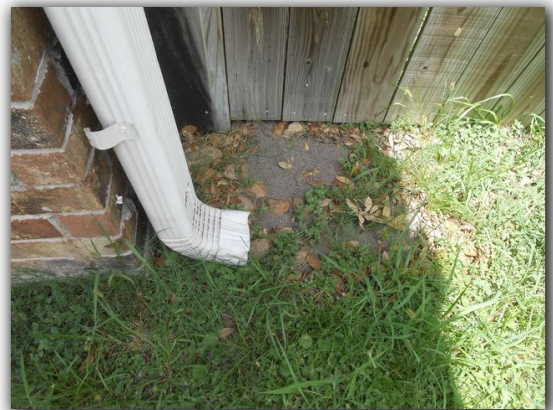
There are splash blocks missing at the base of the down spouts around the home.

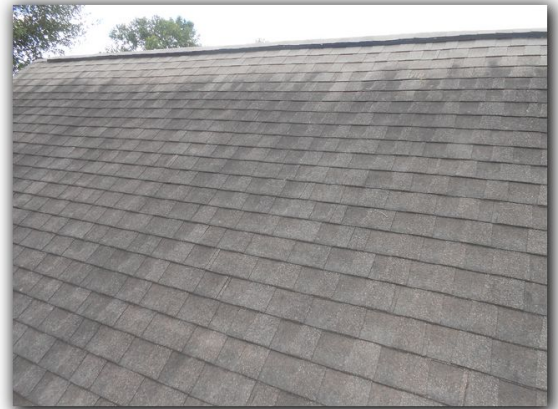
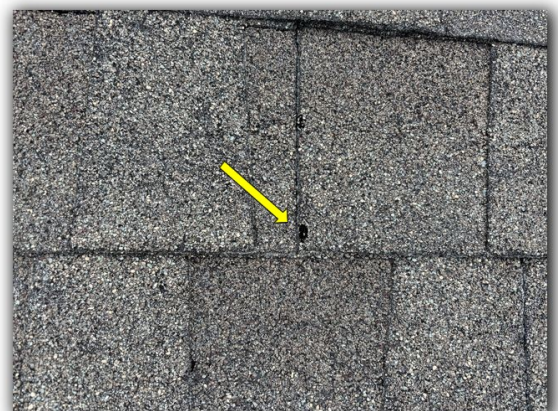
There are torn, worn, damaged shingles on multiple sides of the roof in more than one location.

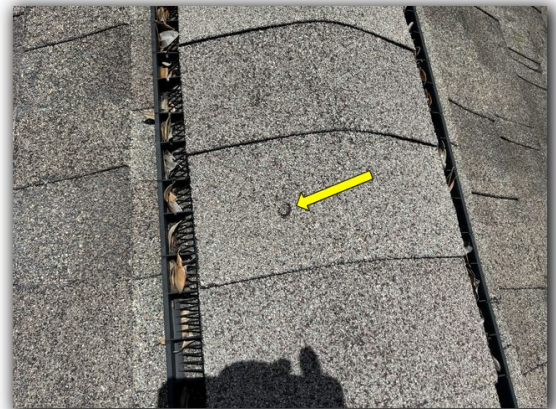
There are exposed nail heads on the roof. Nail heads should be sealed with roof caulking material. Over time, water may penetrate the roof around a rusted nail if they are not properly sealed.

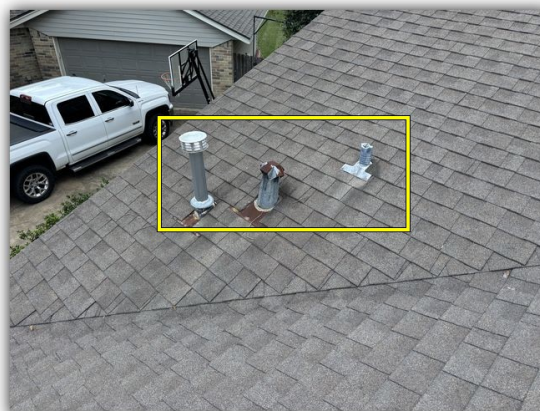
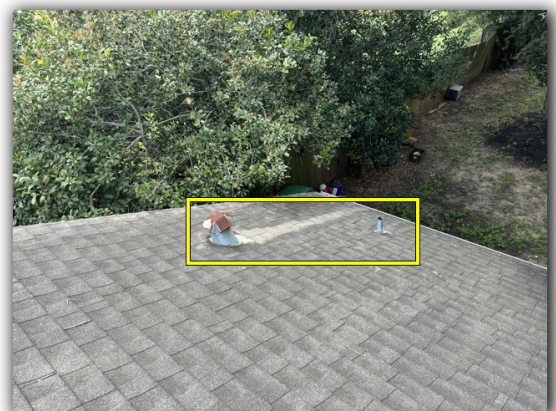
There are unpainted roof fixtures on the right side of the roof at multiple locations. All roof fixtures are recommended to be painted for protection against the weather and environmental elements. I recommend having the fixtures painted to help extend the life of the fixture.

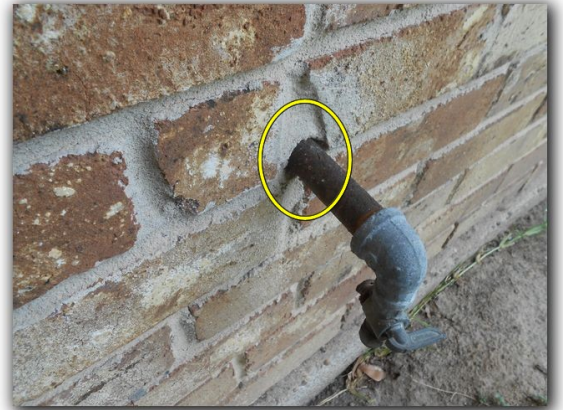
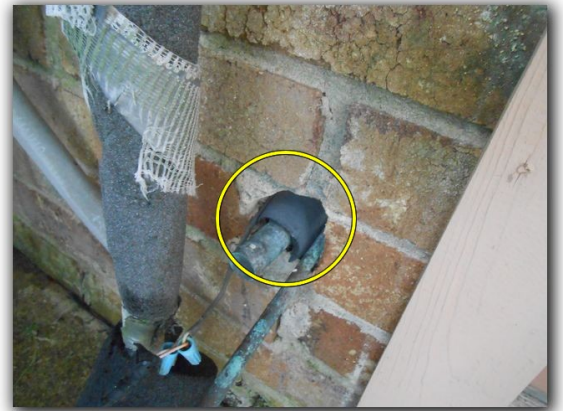
All wall penetrations and exposed openings should be sealed to help prevent pest and moisture penetration into the wall cavity including areas such as electrical outlets, exterior light fixtures, window and door frames, and water and gas supply lines.

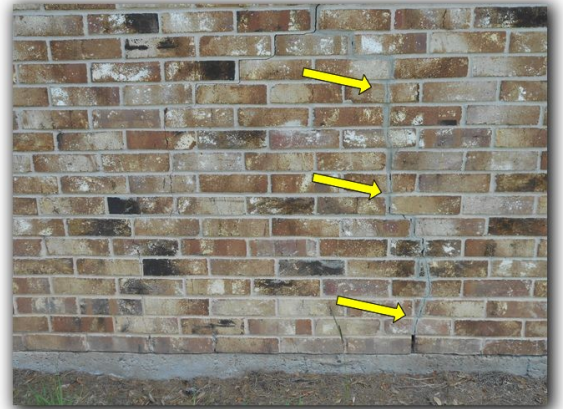
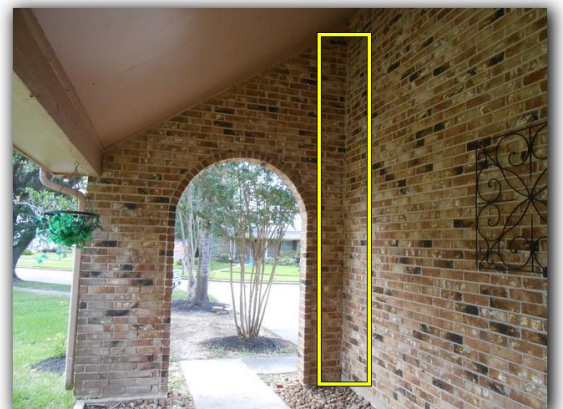
There are mortar joint/brick cracks on the exterior walls at multiple locations.

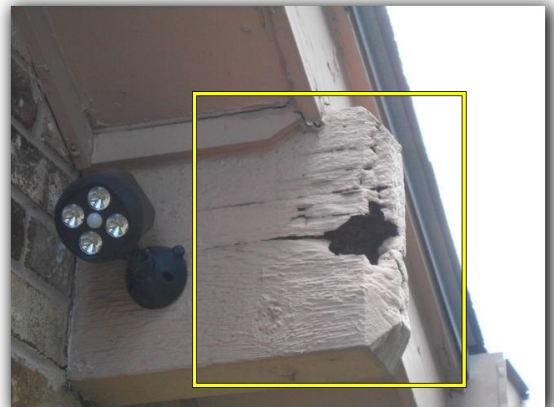
There is rot/deterioration at the decorative beams at the front of the home at multiple locations.

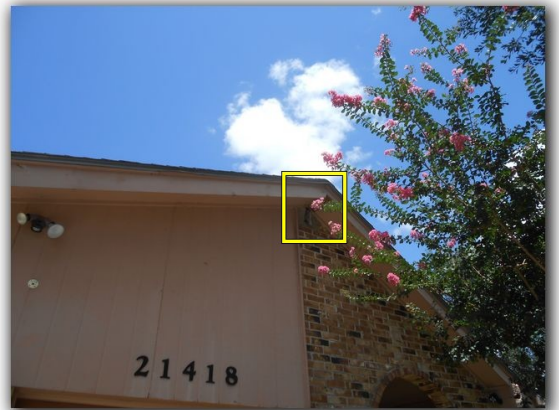
The decorative beam is missing at the peak at the front of the home exposing an opening into the attic space. This is an entry point of water and pests.

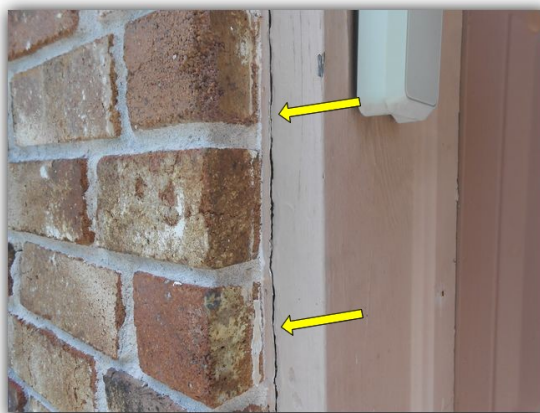
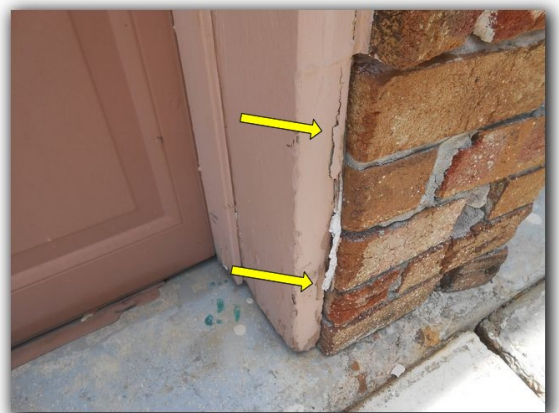
There are caulking gaps / deterioration at the trim around the garage door in more than one location.

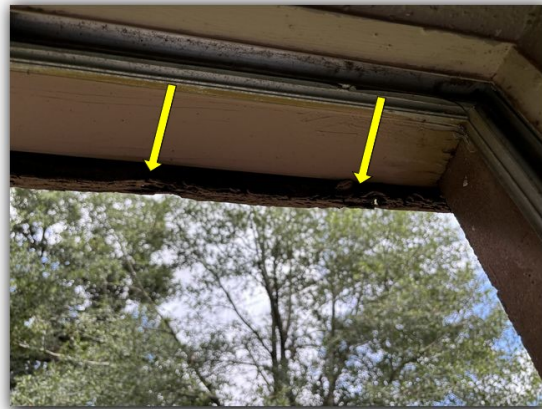
There are signs of rot/deterioration on the exterior siding at multiple locations around the home.

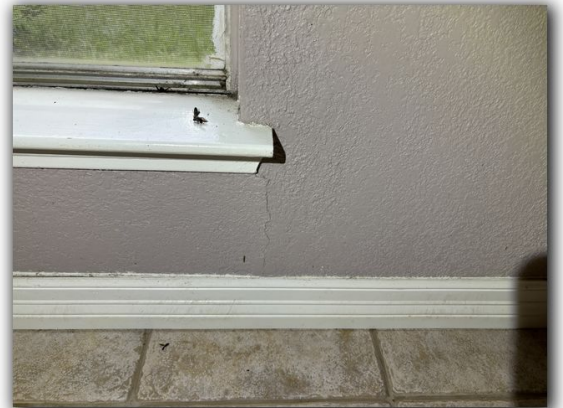
There are cracks on the walls at multiple locations throughout the home.

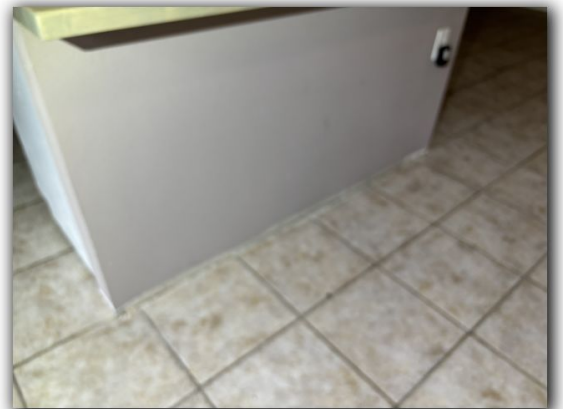
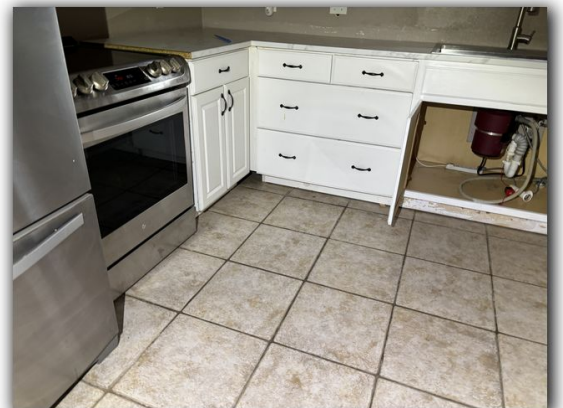
There is missing base boards in the kitchen and living room at multiple locations.

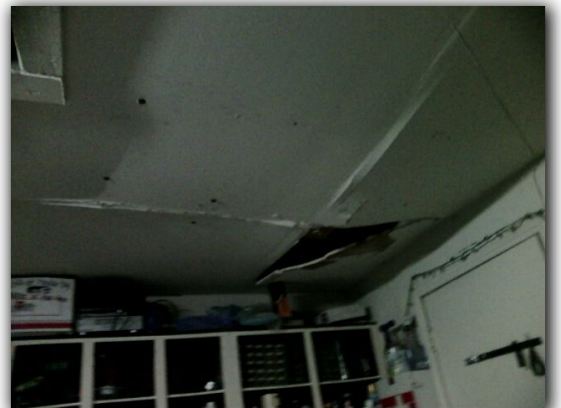
There are cracks in the walls in the garage at multiple locations.

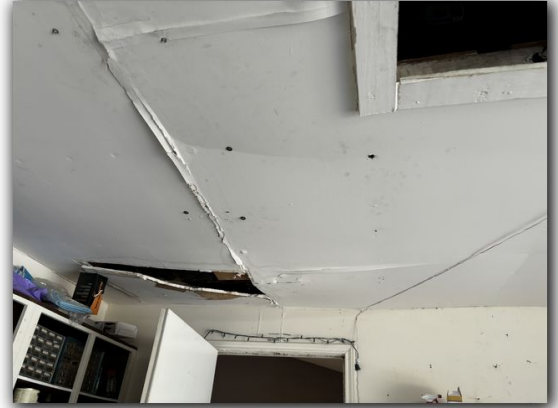
There is a stain on the ceiling in the garage at multiple locations. NOTE: I recommend further investigation at areas where moisture stains are present. I cannot determine what may be present.

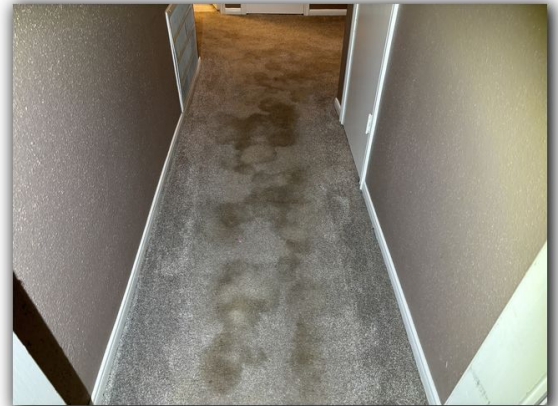
There is staining on the carpet in the front left bedroom and hallway.

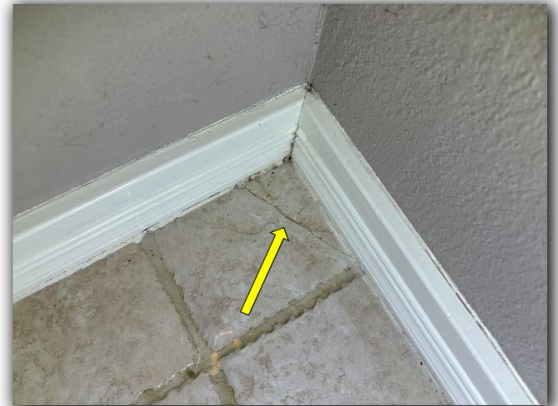
There are cracked tiles in the living room and master bathroom.

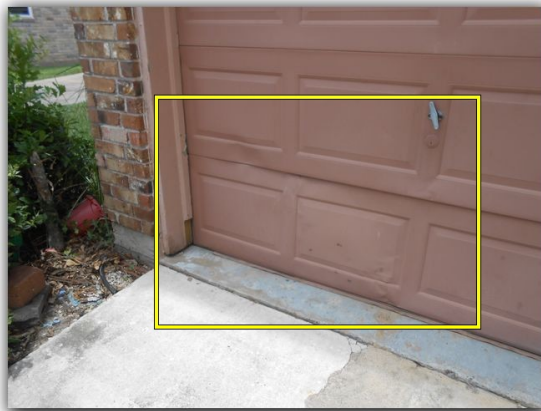
There is damage to the left garage door at the bottom left corner of the door.

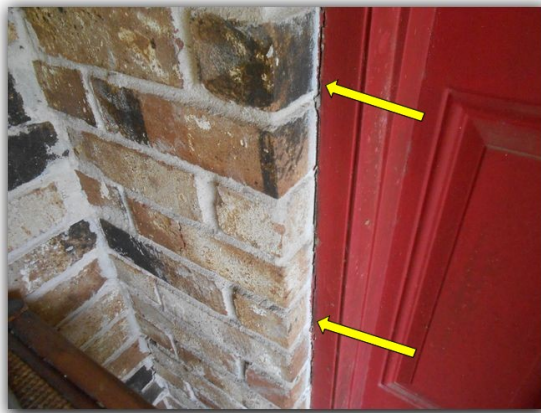
There is deteriorated caulking around the front door opening.

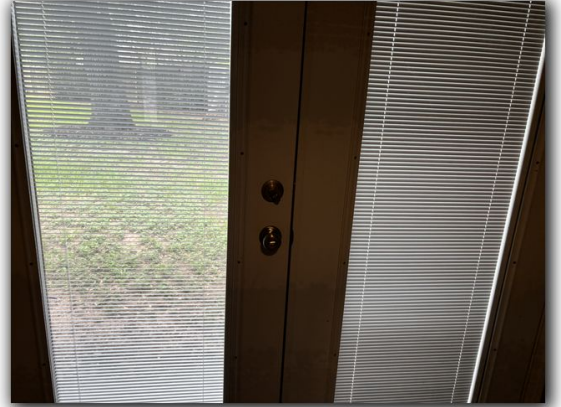
The front door deadbolt is not latching properly. The latch is hitting the strike plate causing the latch to not latch into the door frame. The door must be push against to get the latch to work. I recommend adjust the strike position to allow the deadbolt to latch properly.

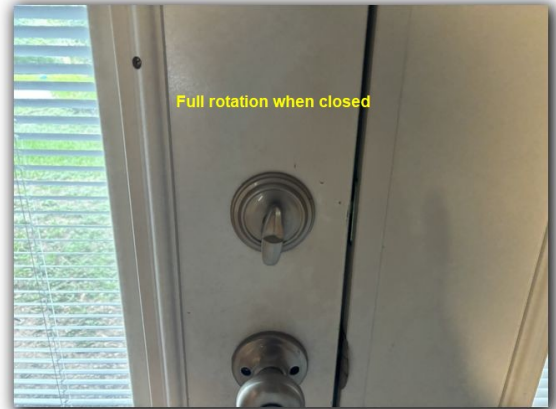
The deadbolt at the front is not locking properly. The deadbolt latch does not complete a full rotation locking the latch in place. The latch is hitting the door frame preventing the latch from locking. I recommend having the latch opening extended to allow for the latch to extend fully.

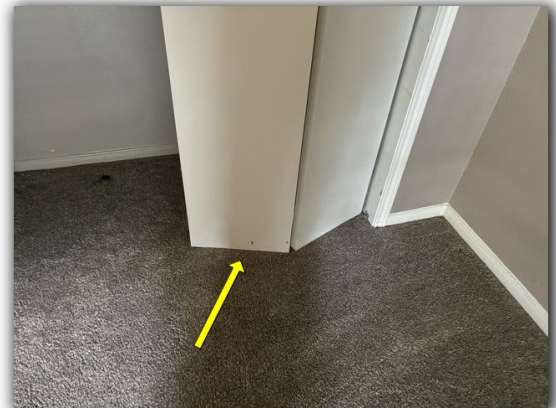
There are door rubbing the carpet at multiple locations in the home.

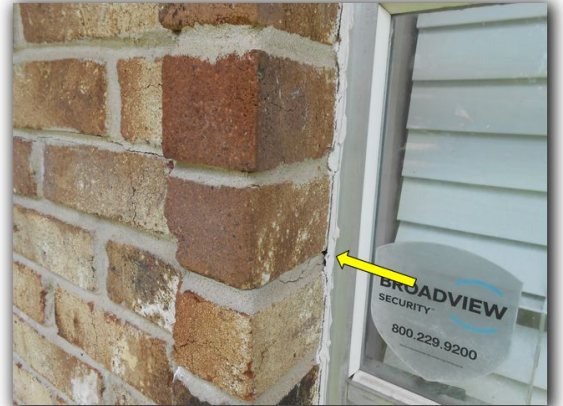
The caulking around the windows is showing signs of deterioration and may need to be replaced.

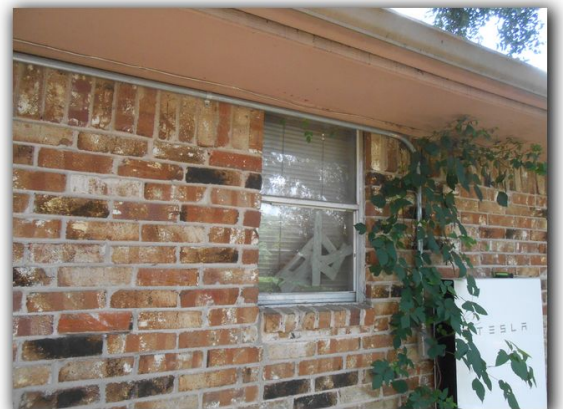
There is a cracked / broken window pane in the kitchen window and back living room window.

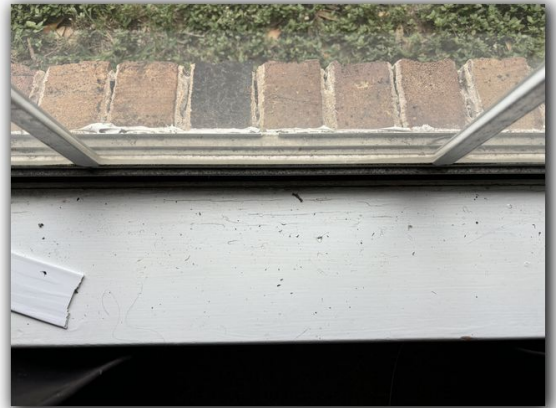
There is water/moisture damage at the window sills at multiple locations in the home. This is an indication that the windows are not properly sealed.

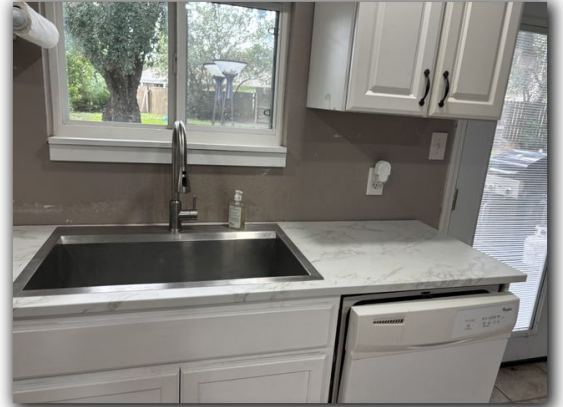
There is no back splash at the kitchen countertop and hall bathroom countertop.

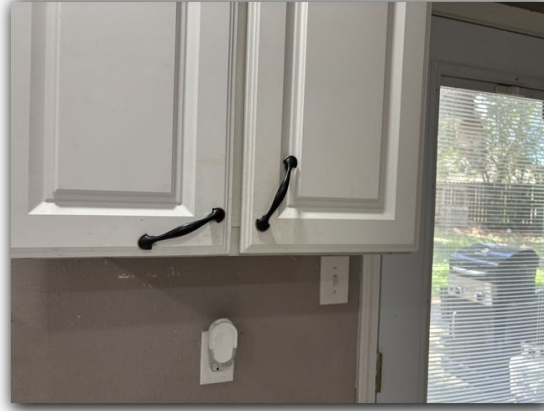
There are loose cabinet handles at the kitchen cabinets.

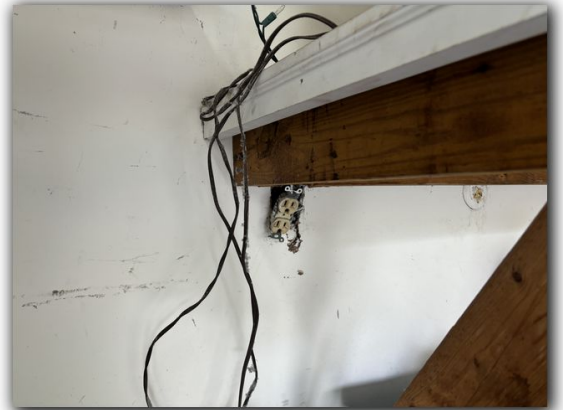
There are no GFCI outlets in the required locations in the unit.

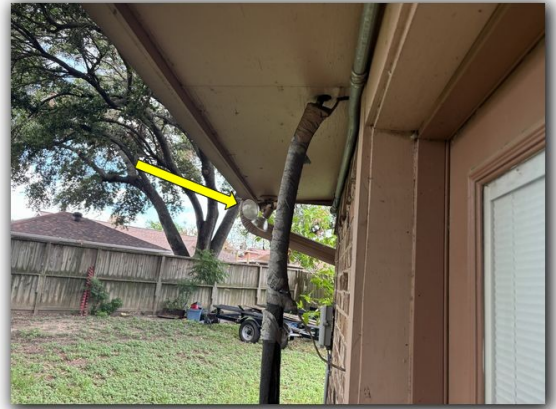
There are light fixtures that did not work when tested at multiple locations. I recommend replacing the light bulbs in these locations to see if that corrects the issue with the lights.

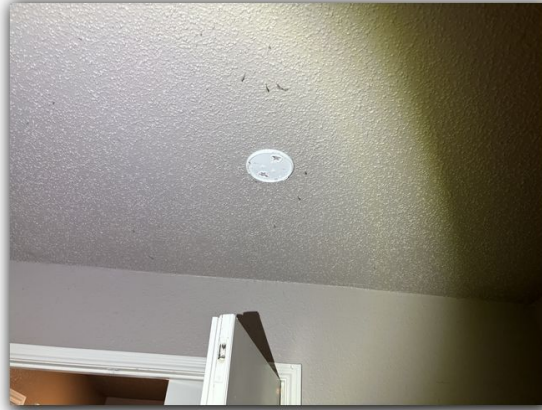
The smoke detectors are missing in the home.

Note: Smoke detectors are required inside each bedroom and in the hall / adjacent space within six linear feet of the bedroom. There is a missing smoke detector in all currently required locations. I recommend installing interconnected smoke detectors in all sleeping rooms and in the adjacent hallways within 6 linear feet of the doors. I also recommend installing carbon monoxide detectors in all currently required locations.

I recommend a complete review by a licensed electrician to review and repair any and all deficiencies.

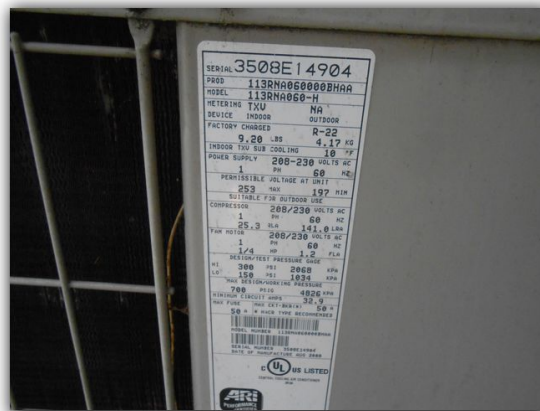
Based on the information label the AC unit was built in 2008.

NOTE: Due to the age of the HVAC unit, I recommend having the unit serviced by a licensed HVAC technician.

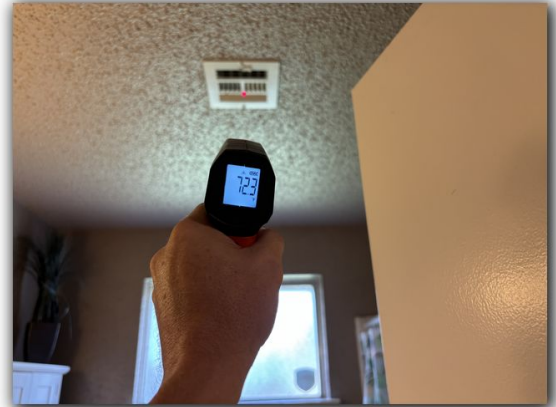
There is a temperature variance across the main living area of approximately 4-5 degrees. This may indicate a balancing issue and I recommend having the system reviewed by a qualified HVAC technician.

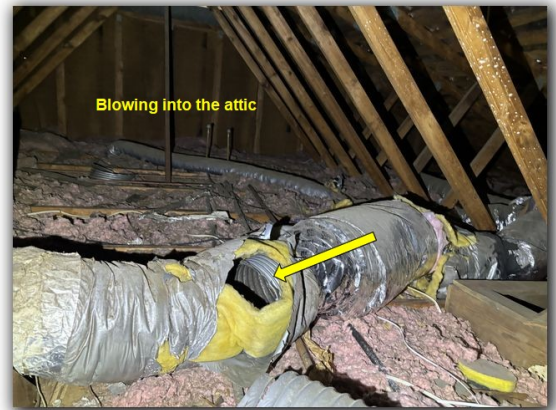
There is damage to the duct work at multiple locations in the attic and is blowing into the attic space. The cooling and heating of the home will not work as efficiently due to the damage to the duct work.

I recommend a complete review of the entire HVAC system by a qualified HVAC technician.

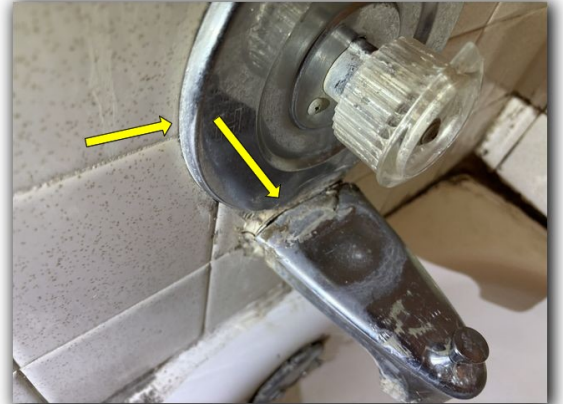
All bathtub wall penetrations and corners should be silicone sealed to help prevent water penetration into the wall cavity. The silicone is missing / deteriorated at the control knob, the tub faucet, and shower head as well as at the shower wall corners and tub edges in the master bathroom.

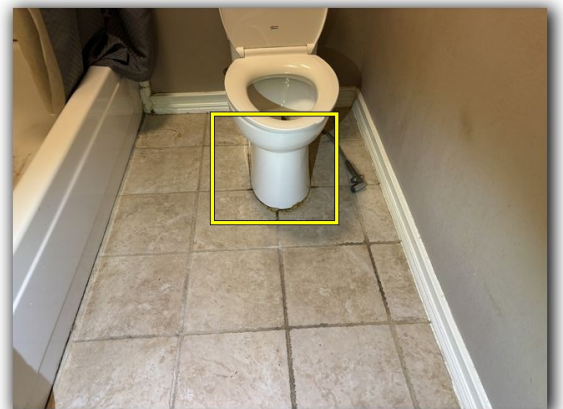
There is missing/deteriorated caulking at the base of the master bathroom toilet.

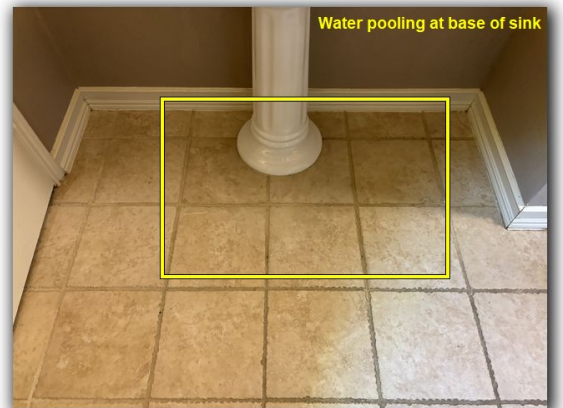
There is a leak at the master bathroom drain connection. Water is pouring on the floor when the water is running.

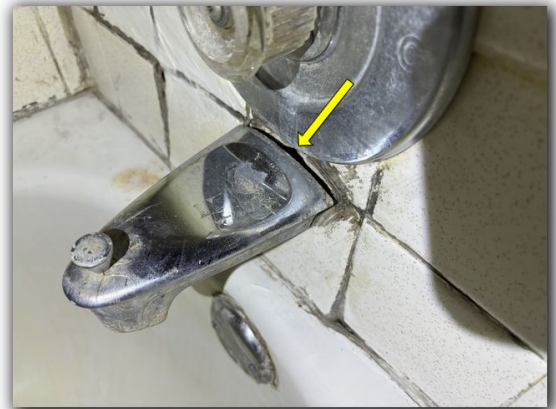
All bathtub wall penetrations and corners should be silicone sealed to help prevent water penetration into the wall cavity. The silicone is missing / deteriorated at the control knob, the tub faucet, and shower head as well as at the shower wall corners and tub edges in the hall bathroom.

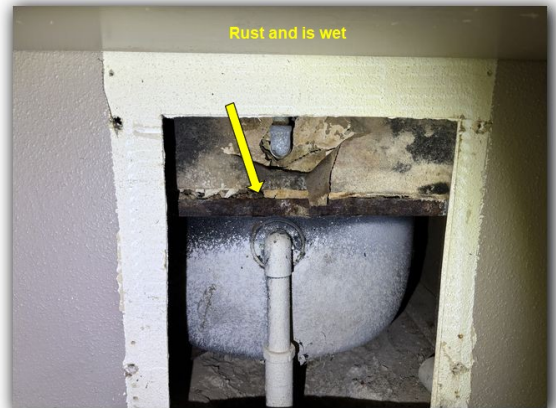
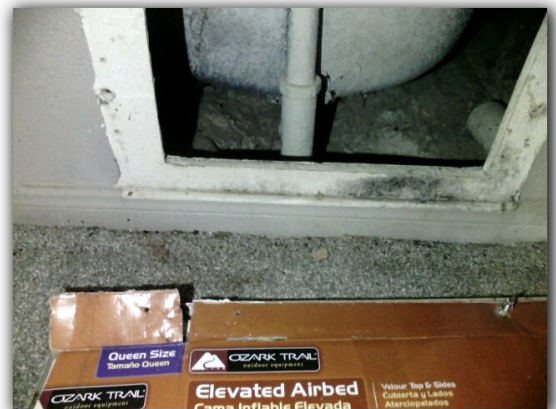
There is damage/cracking to the tub walls at the faucets. Water is leaking behind the shower wall and back wall of the hall closet.

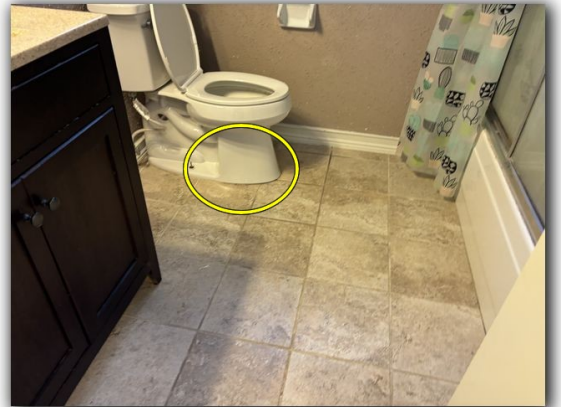
There is missing/deteriorated caulking at the base of the hall bathroom toilet.

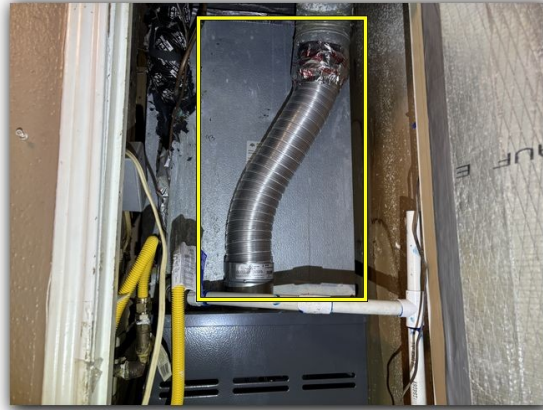
The vent pipe is corrugated material instead of smooth wall. Only smooth wall material is allowed as it promotes proper ventilation of exhaust gases. The vent pipe has been improperly installed at the connections. All connections should go into the adjoining pipe above to promote proper exhaust and help prevent spillage into the adjacent space. Approved flex vent material should have a label indicating that it is approved for gas venting. No label is present or visible.

I recommend having a licensed plumber review and repair the deficiencies.

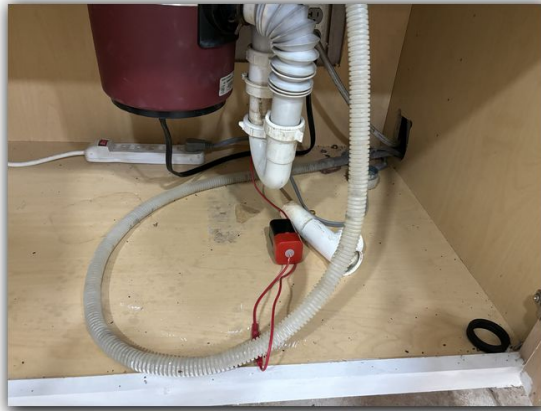
The high loop is missing. This can allow waste water to leak back into the dishwasher.

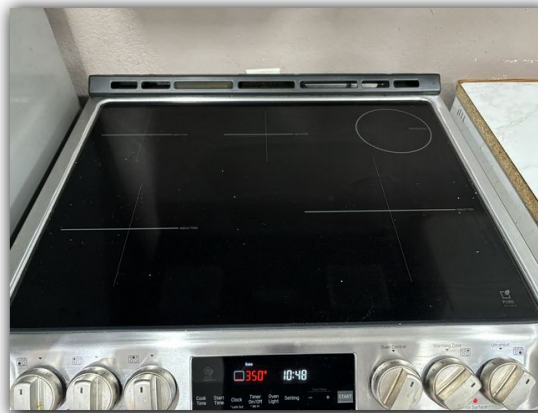
The burners on the cooktop top did not heat up when tested.

NOTE: I recommend having the unit reviewed by a qualified appliance contractor.
