## Exhibit A

on: 2562 Oilla Rd, Orange, TX 77630 - March 9, 2022

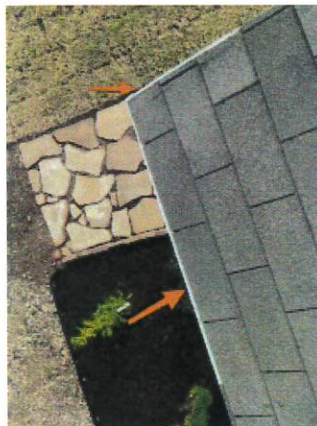
Front Right side

**4: Incomplete Drip edge**

Shingles should over hang min 1-inch. This can lead to water intrusion. Recommend having a professional roofer to repair as needed.

Recommendation: Contact a qualified roofing professional.

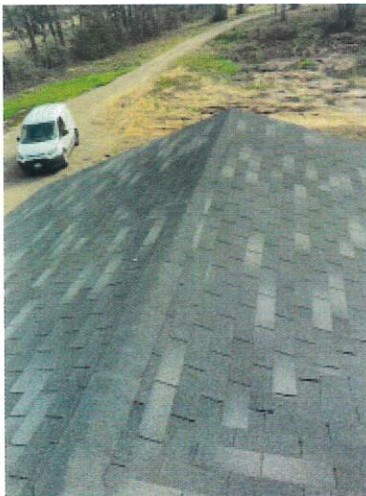
Right side

**8: Missing ridge vent**

Ridge vent missing this condition will effect the ventilation of attic. Recommend having a roofer to evaluate and repair as needed.

Recommend having a roofer to evaluate and repair as needed. Buyers agree to have **The Whirlybird turbine installed as opposed to adding vent ridge.**

Recommendation: Contact a qualified roofing professional.

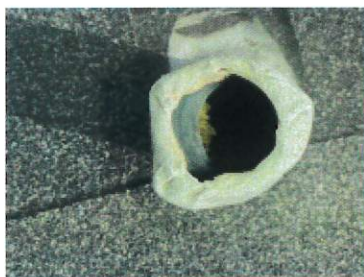
Over Kitchen

Hole in roof Hole to roof covering is a condition for water intrusion. Recommend having professional roofer to repair as needed.

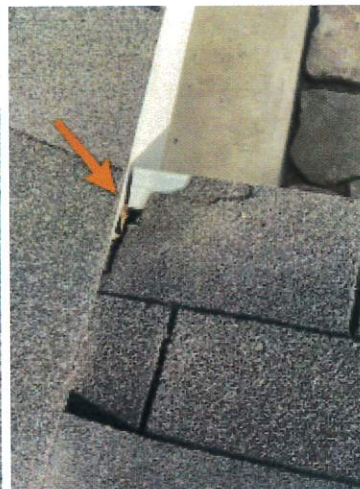
By electrical mask

### **10: Shingles over flashing**

Shingles enclosing flashing can cause water to be trapped and cause water intrusion. Recommend having professional roofer to repair as needed.

Recommendation: Contact a qualified roofing professional.

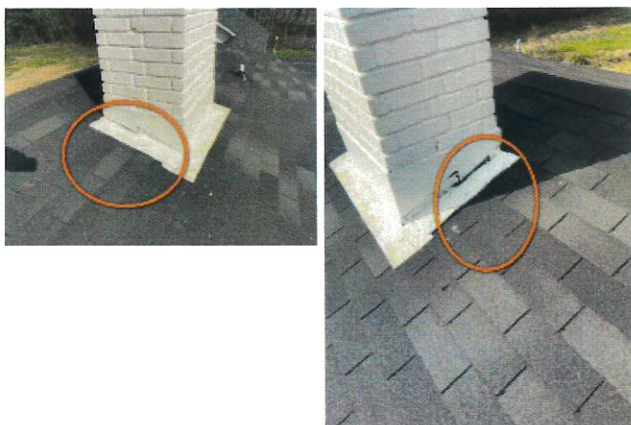
### **11: Apron flashing**

Recommend having shingles installed over apron flashing. This will help prevent water intrusion. Recommend having a professional roofer to repair as needed.

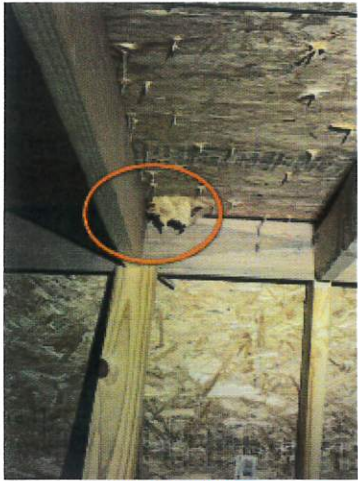
Garage Attic

**2: Missing purlin**

Purlin brace missing. Recommend having a qualified professional to fully evaluate and repair as needed.

Recommendation: Contact a qualified professional.

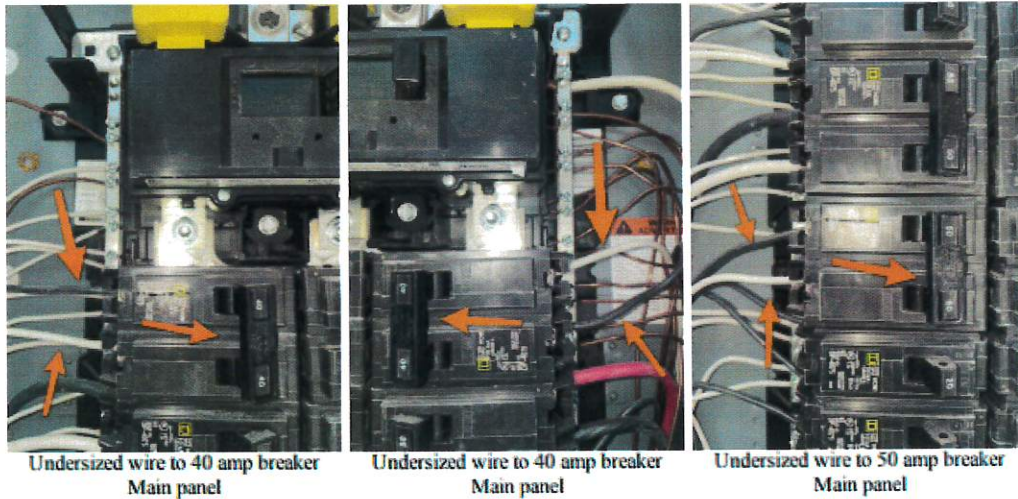
**3: Panel noise**

Panel has some sizzling noise. Recommend having professional electrician to repair as needed.

Recommendation: Contact a qualified electrical contractor.

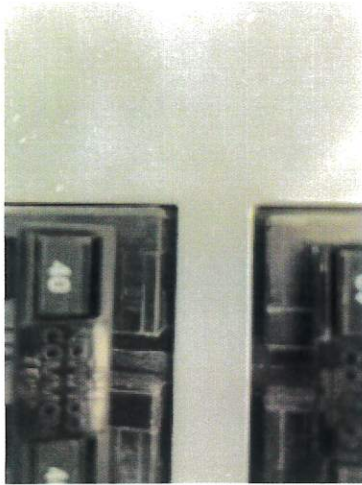
**5: Breaker tripping**

Breaker trips and will not reset. Recommend having electrician to fully evaluate and repair as needed.

Recommendation: Contact a qualified electrical contractor.

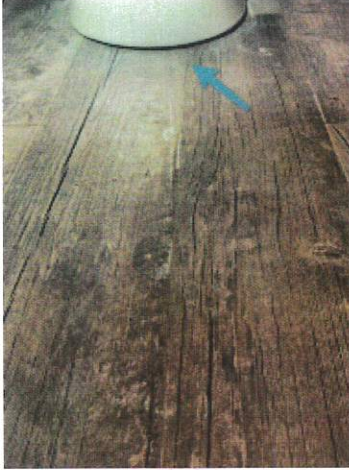
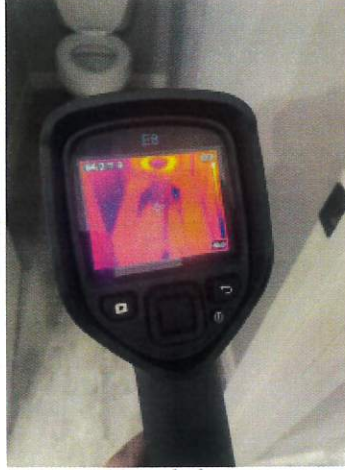
Master bathroom

**1: Loose toilet**

Toilet was loose at the base. Recommend having a plumber to repair.

Recommendation: Contact a qualified plumbing contractor.

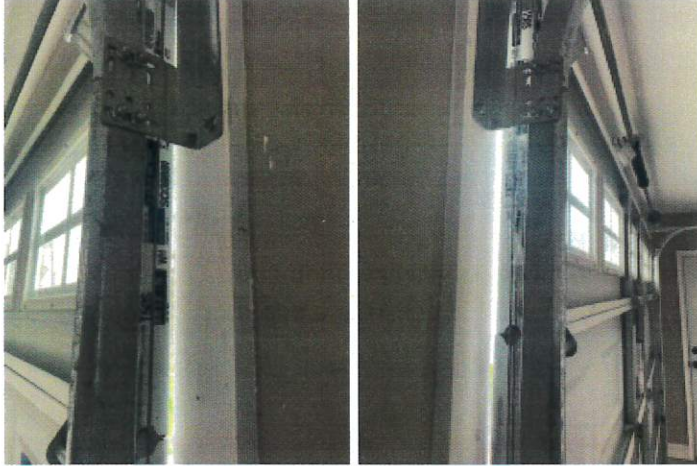
Missing rubber seal Garage door was installed without rubber seal out water when opening/closing. Recommend a qualified garage door contractor evaluate and repair.
