For the Property at:
136 HOLLY TRAIL
TRINITY, TX 75862

Prepared for: DALLAS ENYEART
Inspection Date: Thursday, May 30, 2024
Prepared by: Steven Grimm, 25943

PROPERTY INSPECTION REPORT FORM

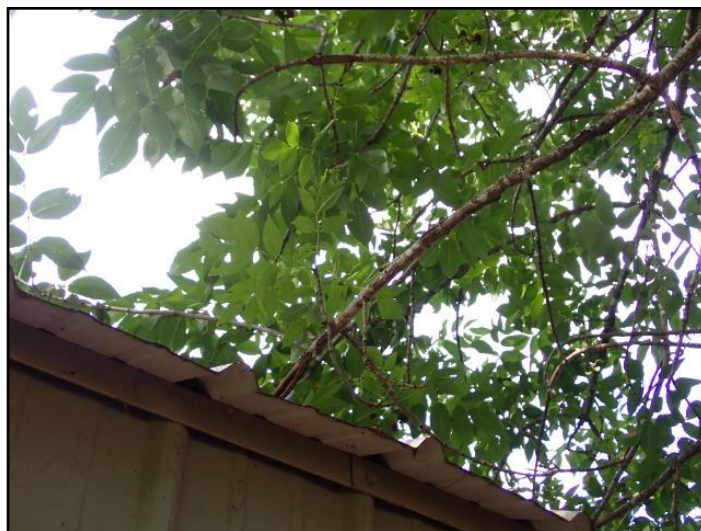
2. **Condition:** • Tree branches touching roof

5. *Tree branches touching roof*

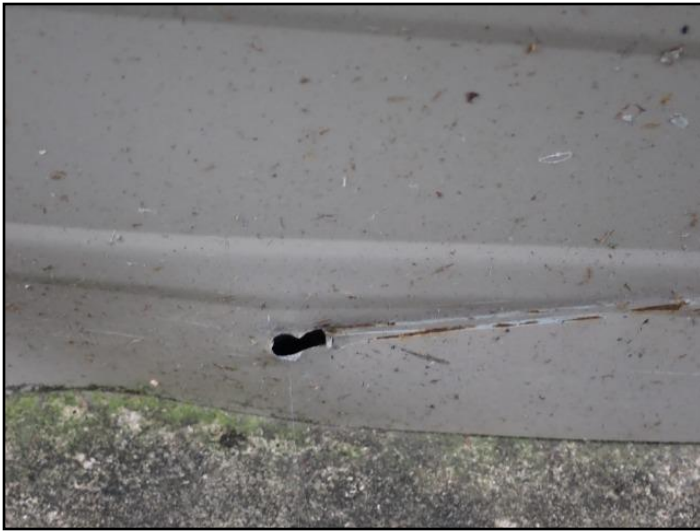
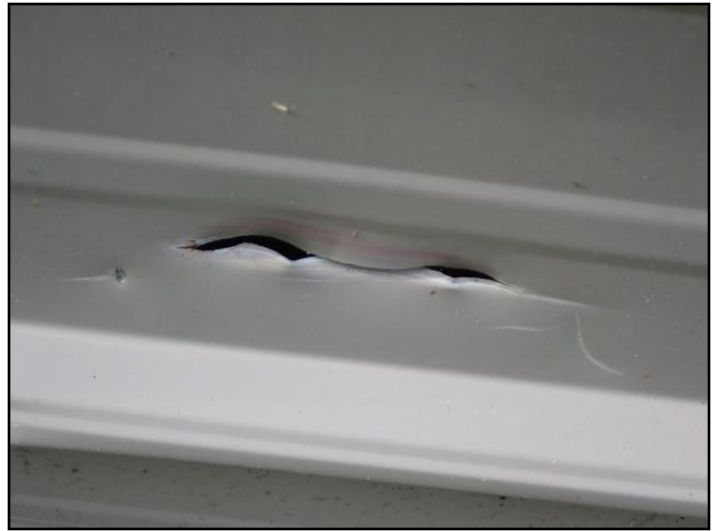
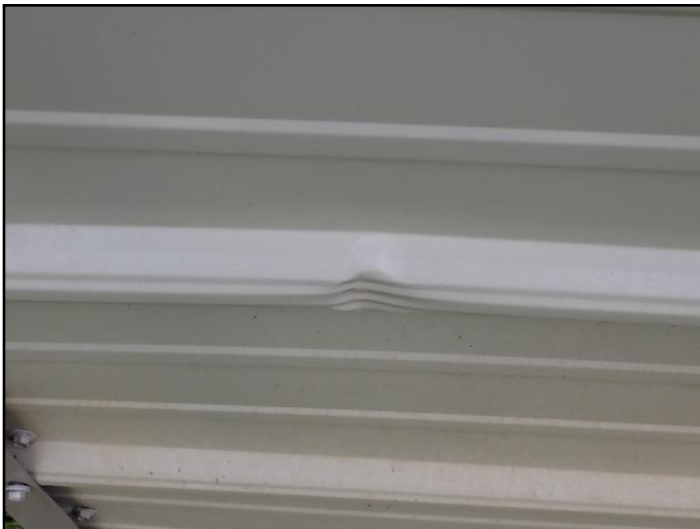
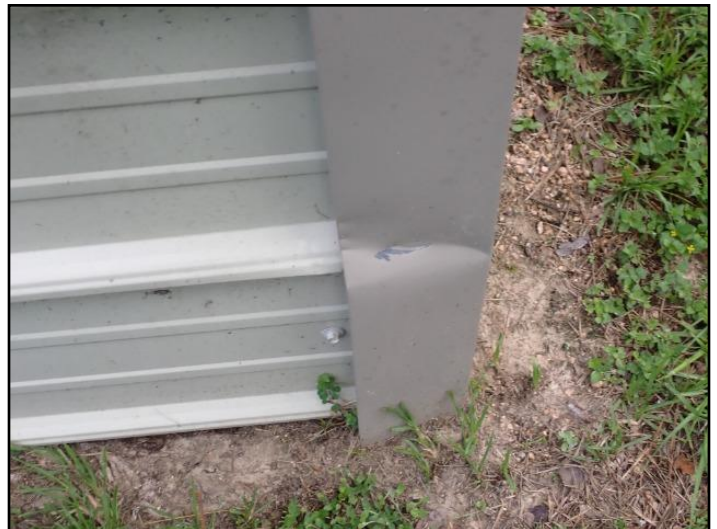
4. Condition: • [Damage](#)

6. Damage

7. Damage

8. Damage

9. Damage

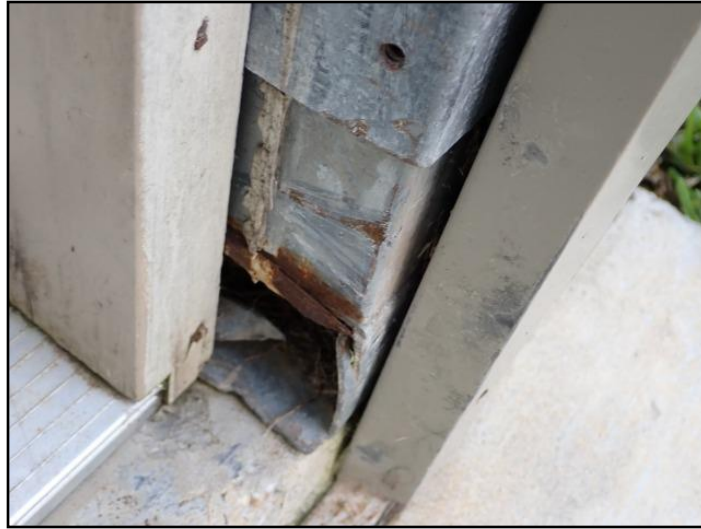
5. Condition: • [Loose or missing pieces](#)

10. Loose or missing pieces

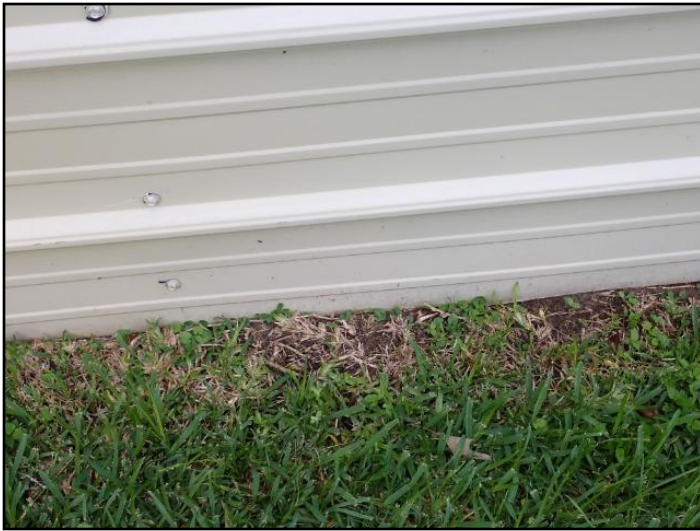
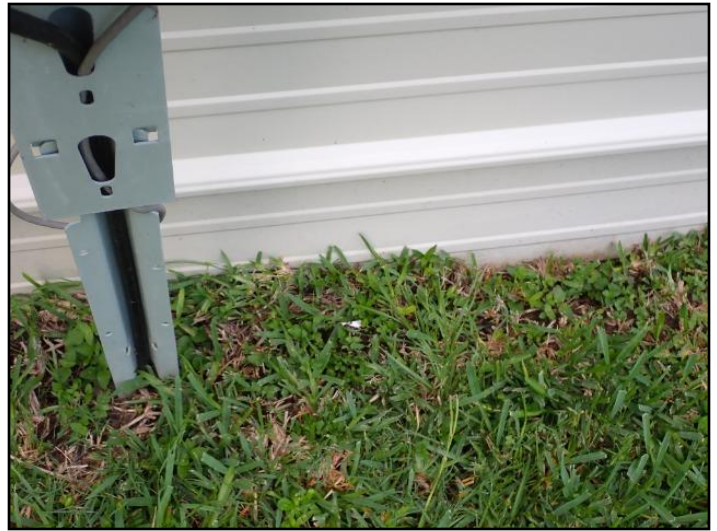
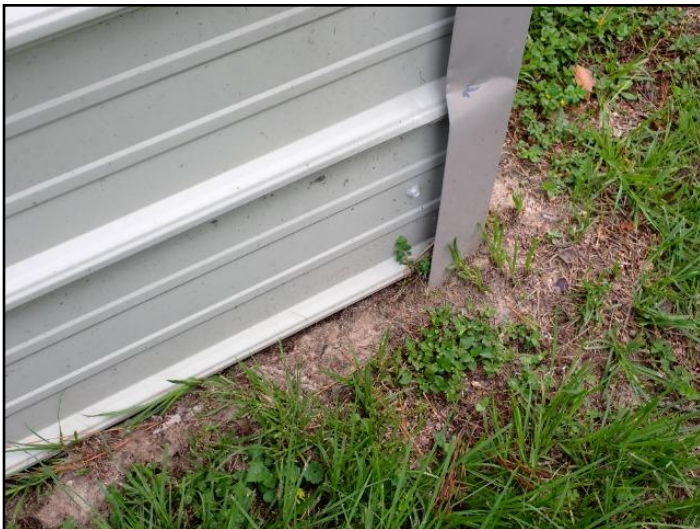
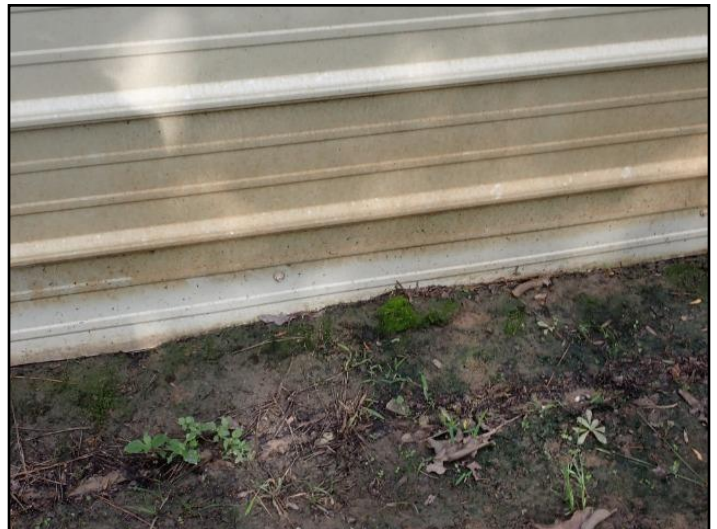
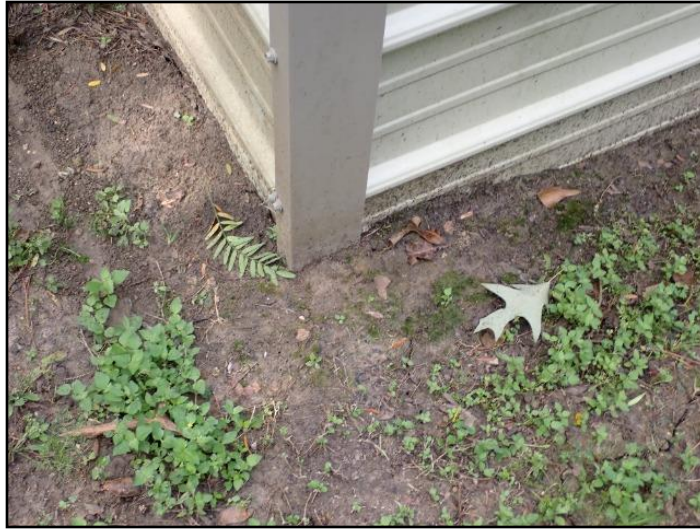
6. Condition: • [Too close to grade](#)

11. Too close to grade

12. Too close to grade

13. Too close to grade

14. Too close to grade

15. *Too close to grade*

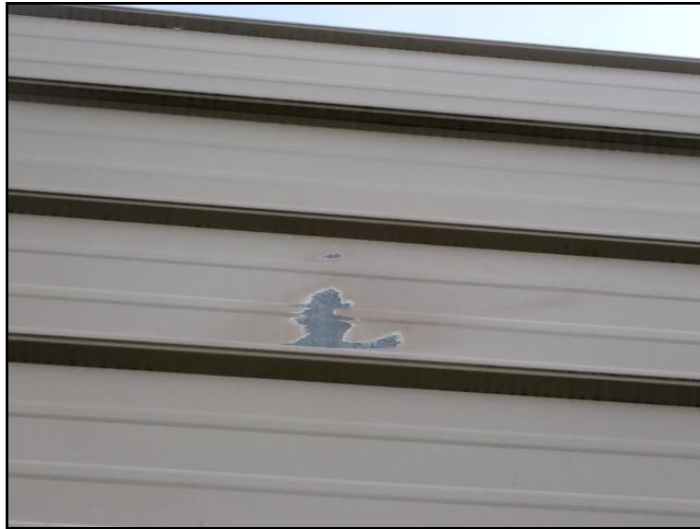
7. **Condition:** • Paint needed

16. *Paint needed*

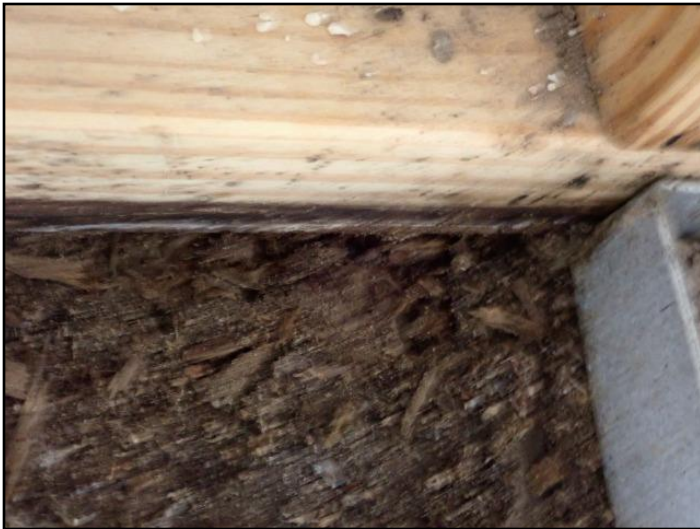
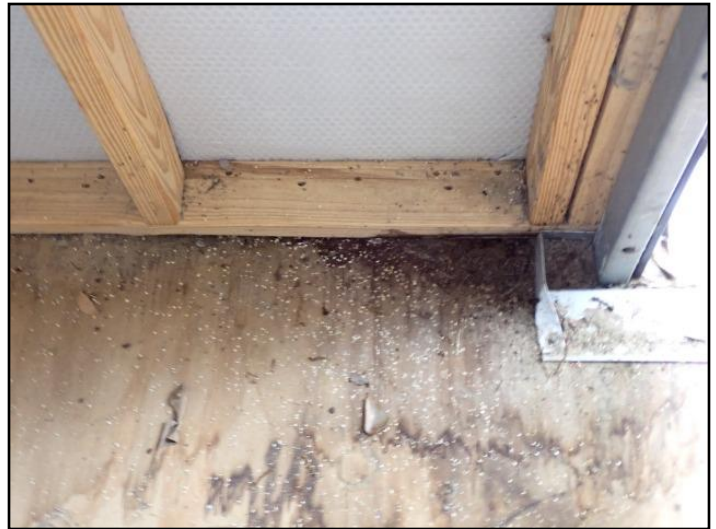
8. **Condition:** • Leak

17. Leak

18. Leak

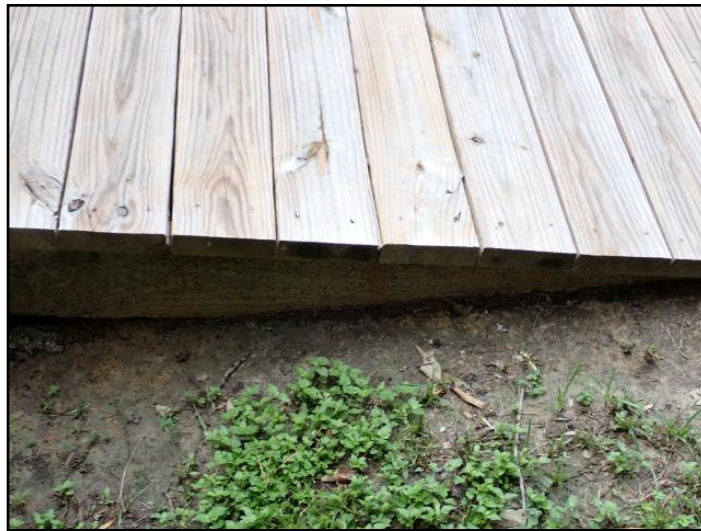
9. Condition: • Wood to soil contact

19. Wood to soil contact

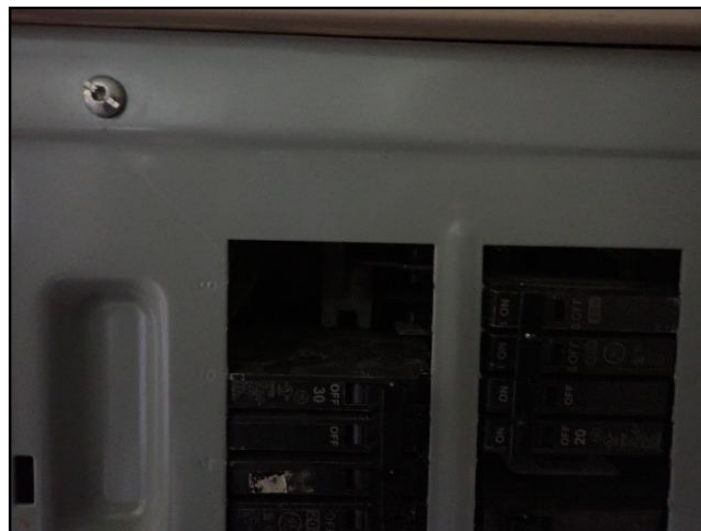
11. Condition: • [Openings in panel](#)

25. Openings in panel

any exposed panel openings (that would allow access to the inside of the panel) should be fitted with secure covers

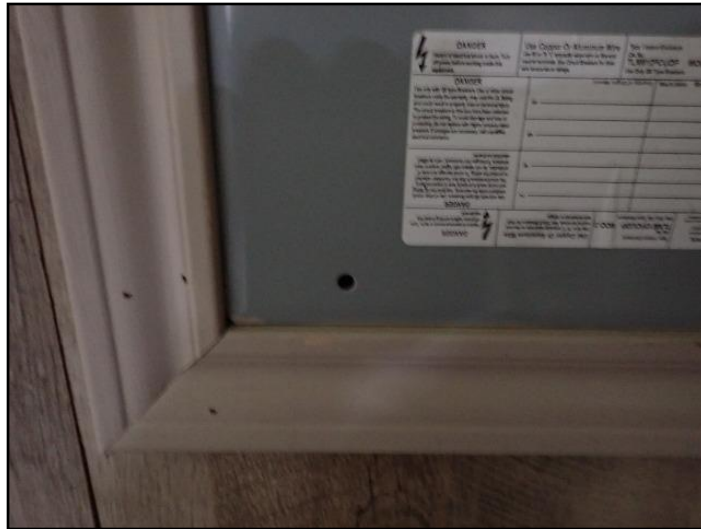
12. Condition: • Screw missing

26. Screw missing

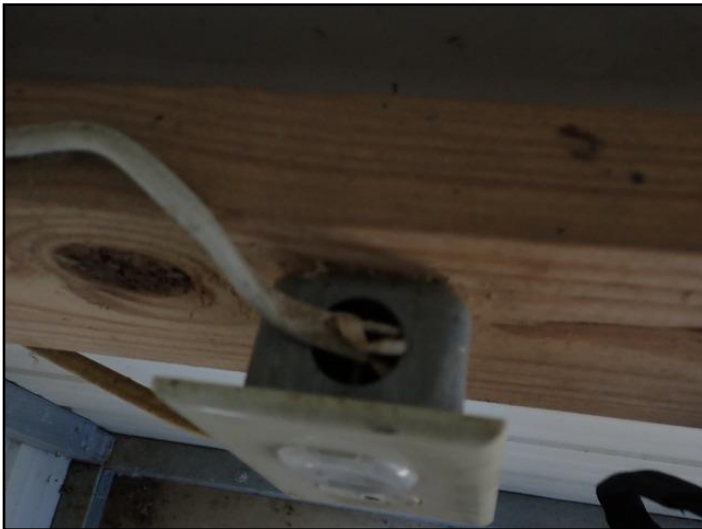
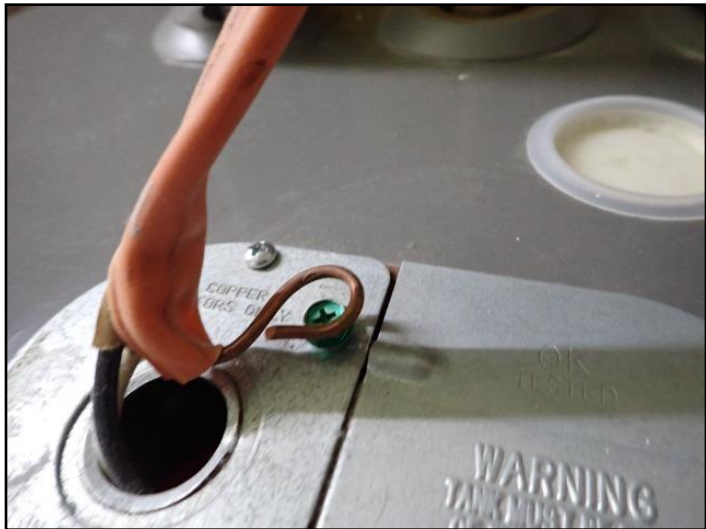
13. Condition: • [Not well secured](#)

27. Not well secured

28. Not well secured

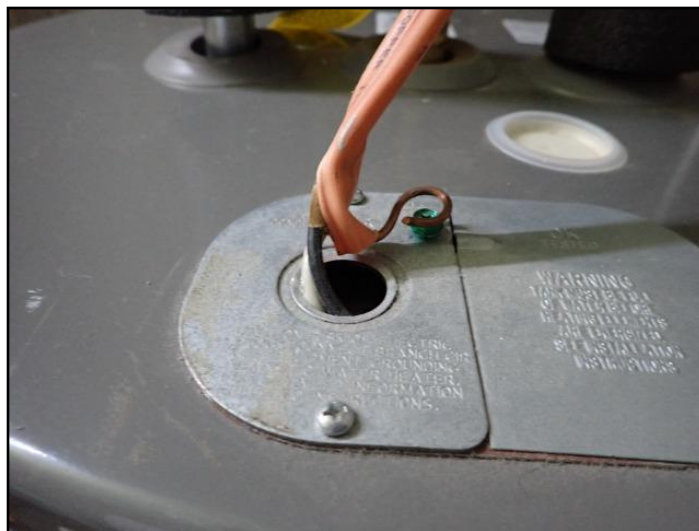
14. Condition: • [Loose connections](#)

29. Loose connections

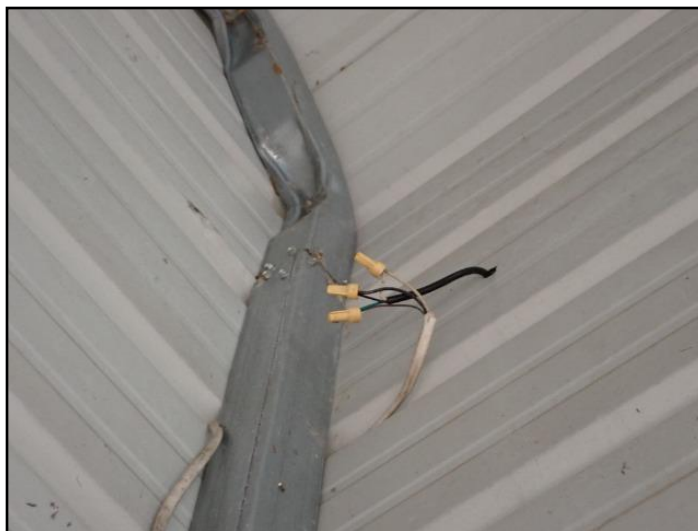
15. Condition: • [Missing](#)

30. Missing

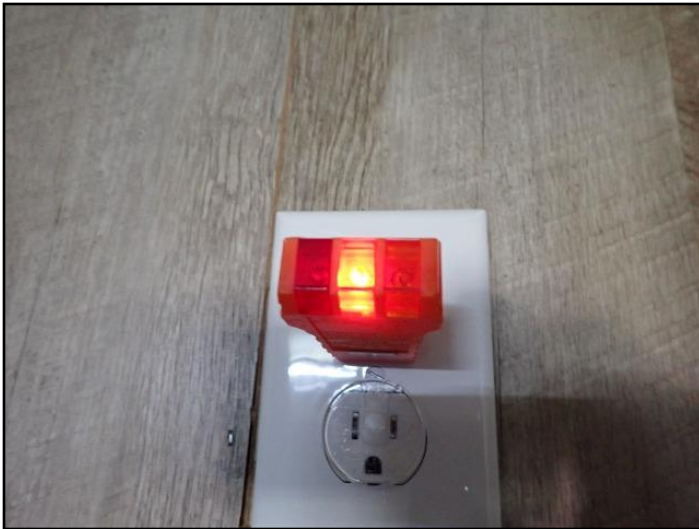
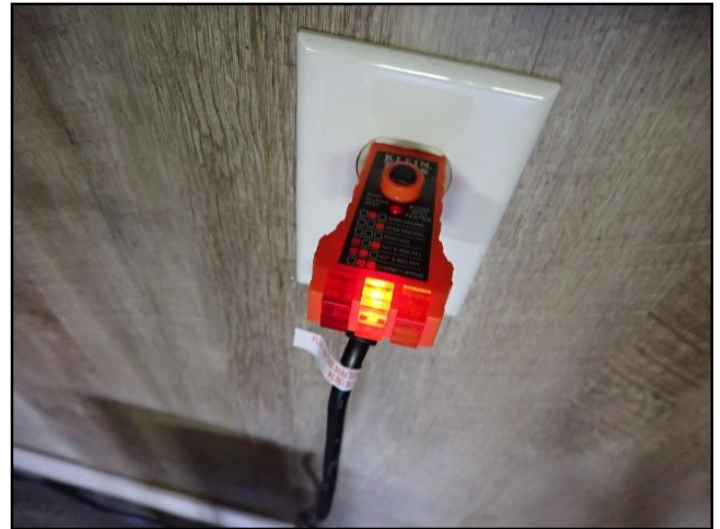
16. Condition: • [Ungrounded](#)

31. Ungrounded

32. Ungrounded

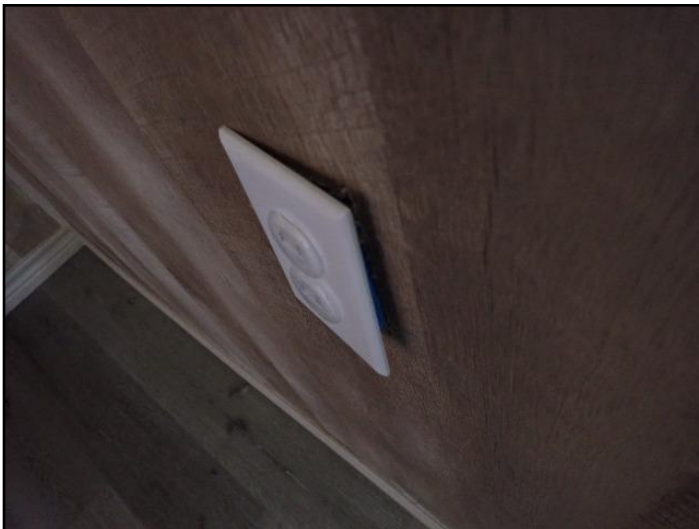
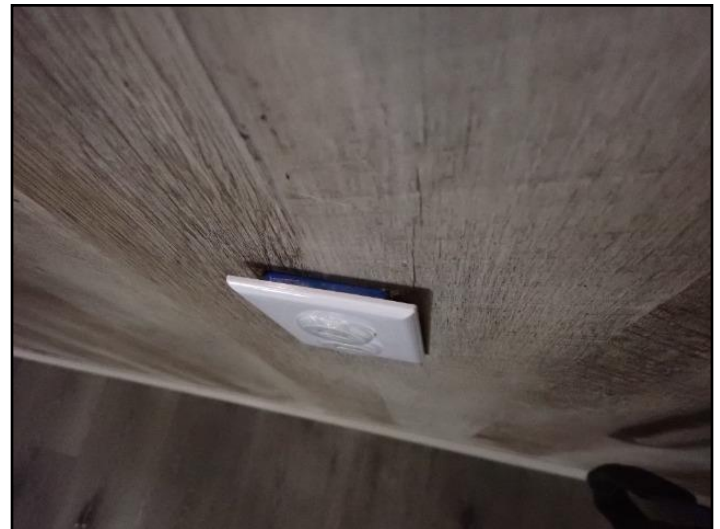
17. Condition: • [Loose](#)

33. Loose

34. Loose

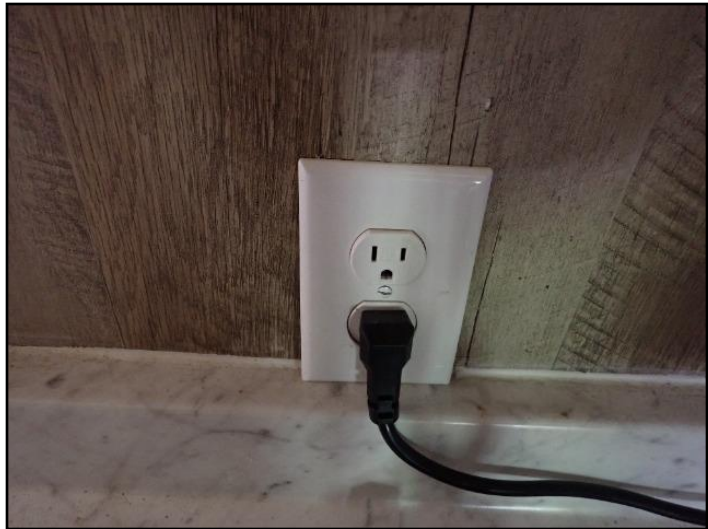
18. Condition: • Kitchen counters

35. Kitchen counters

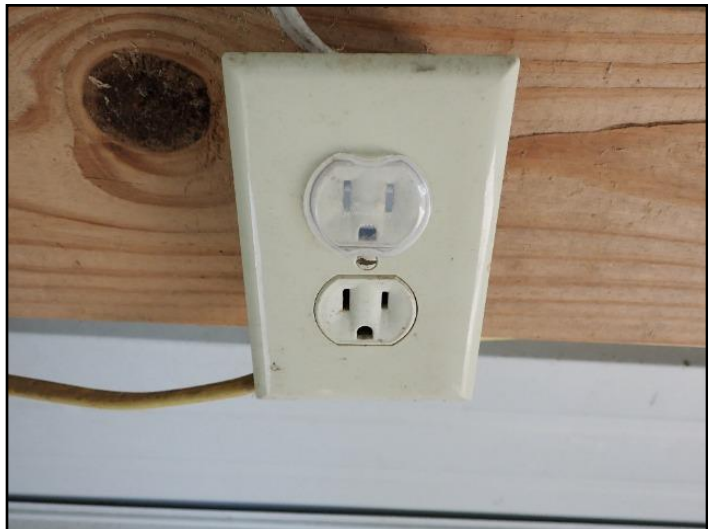
19. Condition: • Garage

36. Garage

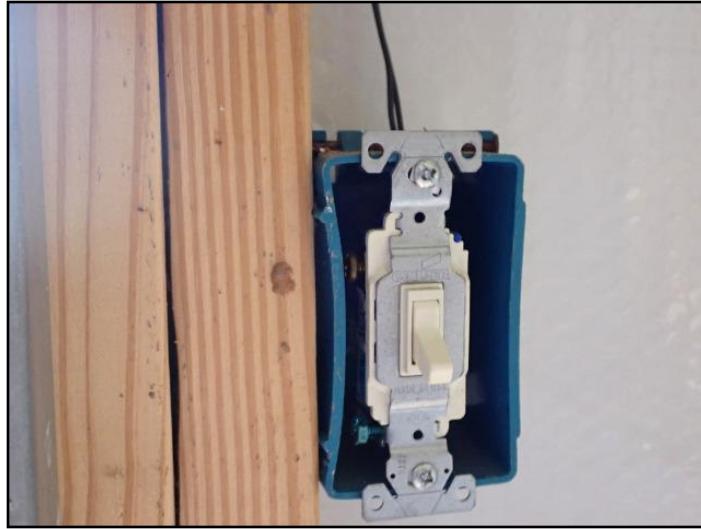
20. Condition: • [Missing](#)

37. Missing

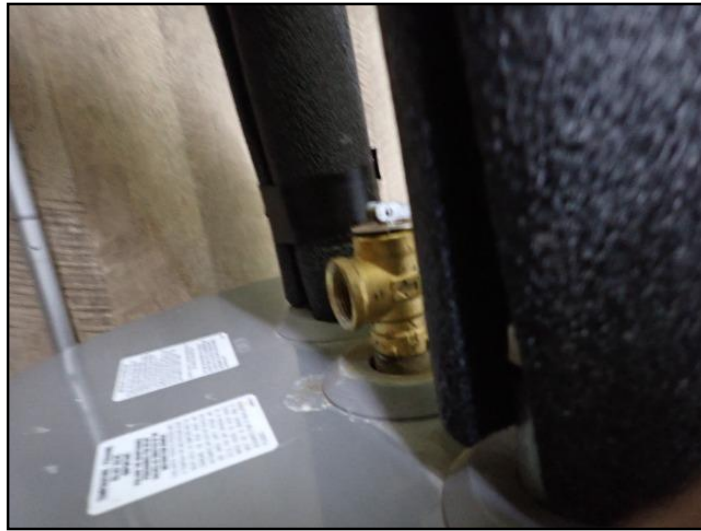
24. Condition: • [Discharge tube missing](#)

50. Discharge tube missing

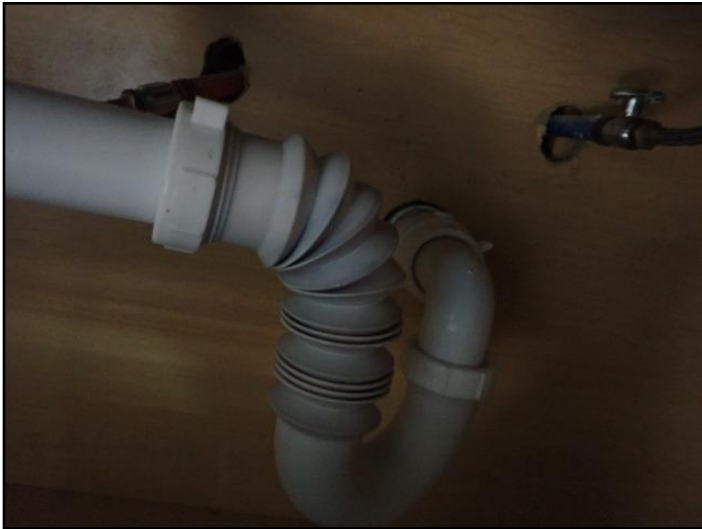
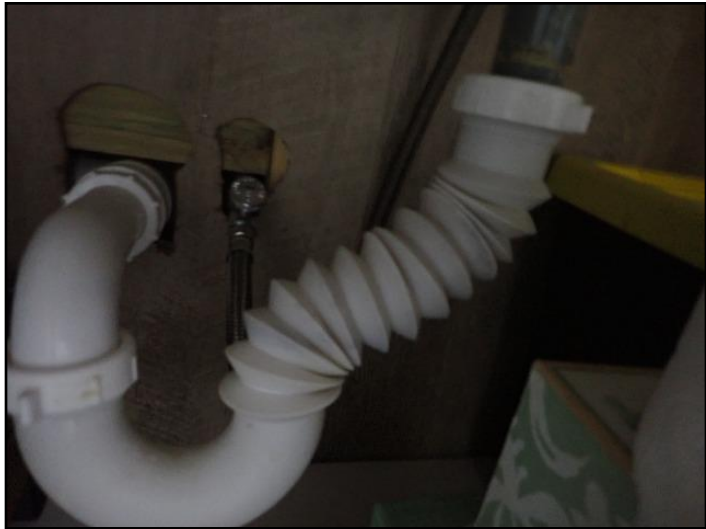
25. Condition: • [Wrong type](#)

51. Wrong type

52. Wrong type

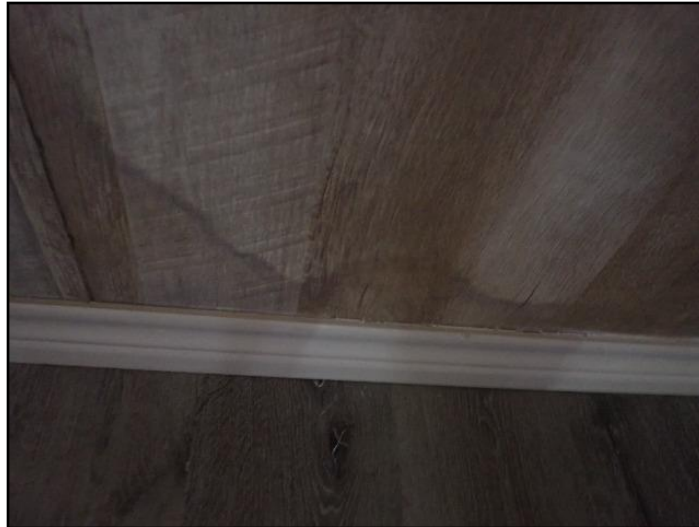
26. Condition: • Water staining

55. Water staining

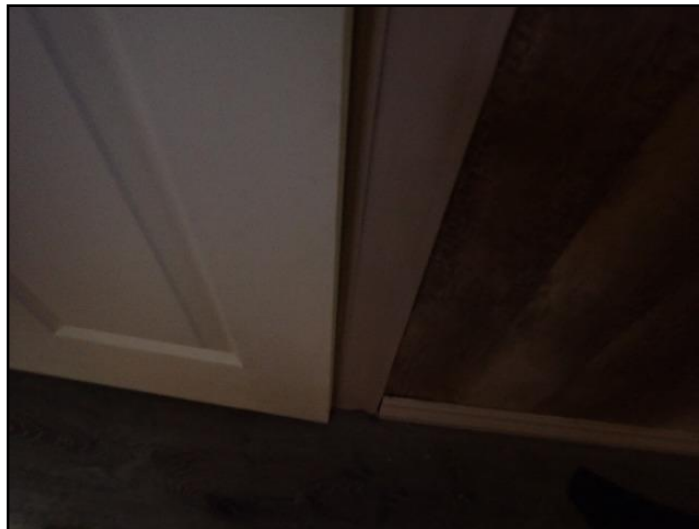
27. Condition: • [Loose or poor fit](#)

56. Loose or poor fit

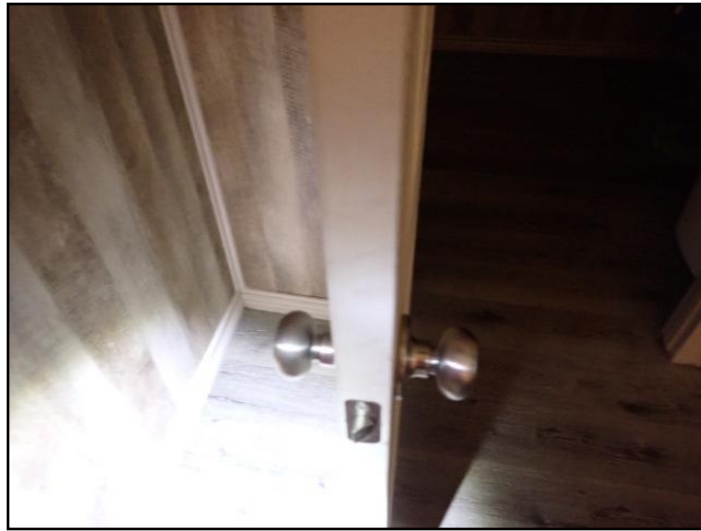
28. Condition: • [Swings open or closed by itself](#)

57. Swings open or closed by itself
