PROPERTY INSPECTION REPORT

Concerning: 139 N Greatwood Glen Pl, Montgomery, TX 77316
(Address or Other Identification of Inspected Property)

By: Sean Salinas, Lic # 21192 Hunter Lamb, Lic # 24864 09/08/2021
(Name and License Number of Inspector) (Date)

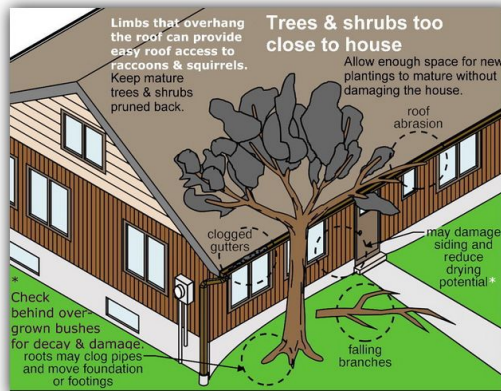
Recommend keeping vegetation cut back away from exterior of home to prevent damage.

Buyer's note; ensure flower bed soil does not rise above foundation to prevent water and wood destroying insect entry into house.

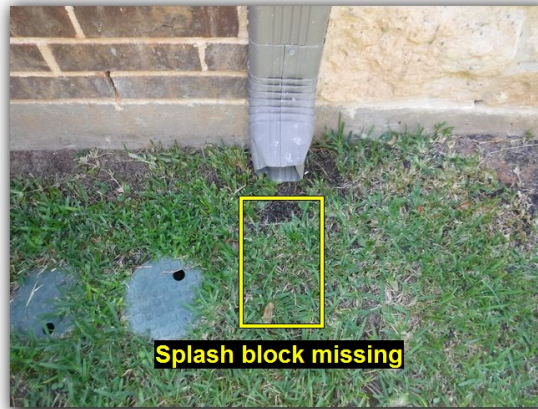
One or more splash blocks missing. Recommend adding splash blocks to divert water away from the foundation.

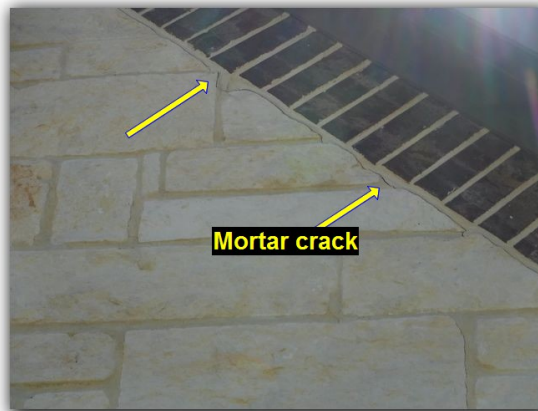
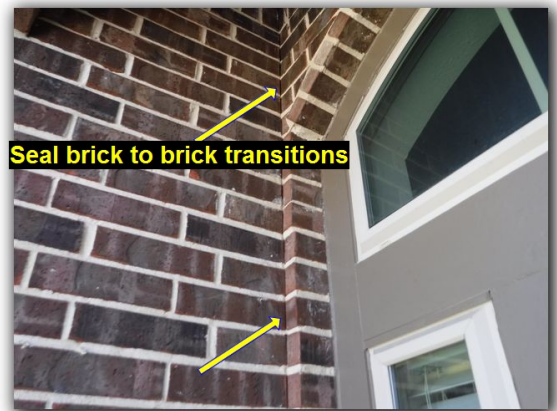
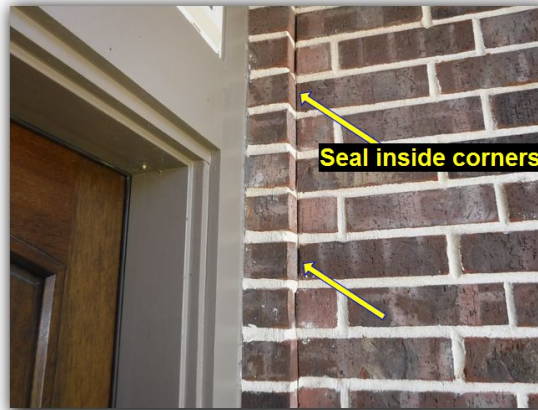
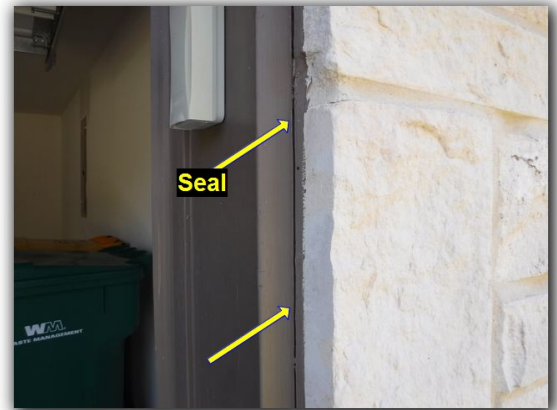
Observed cracks in the brick and/or mortar around the exterior in one or more areas. Recommend sealing/caulking around all holes, gaps, cracks and exterior siding penetrations to prevent water & pest entry.

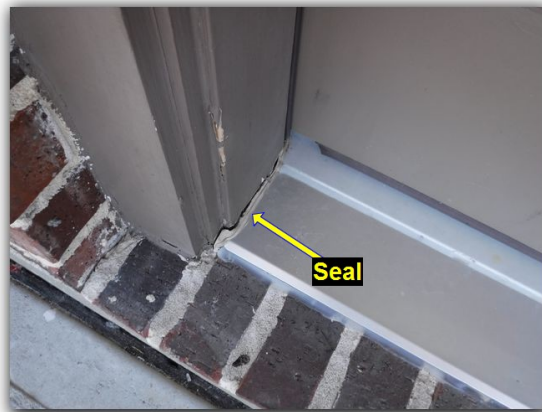
Recommend caulking the ends of all exterior door thresholds to help prevent water entry during wind driven rain.

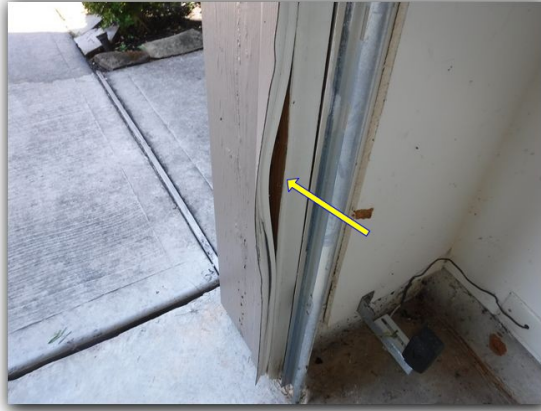
Observed some separation at the garage door seal. Recommend securing as needed.

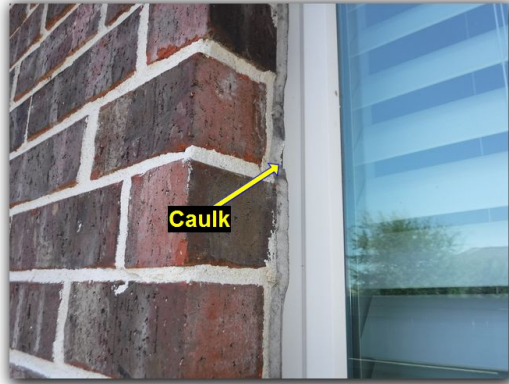
One or more windows needs exterior caulking.

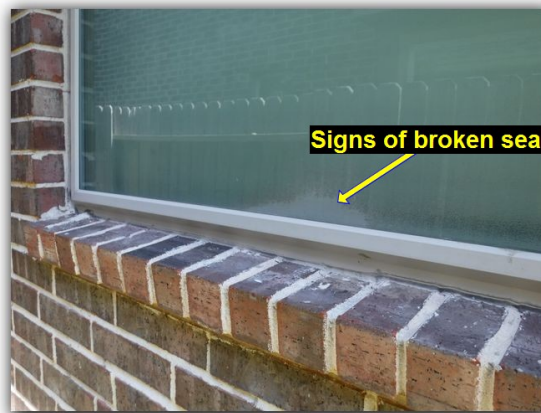
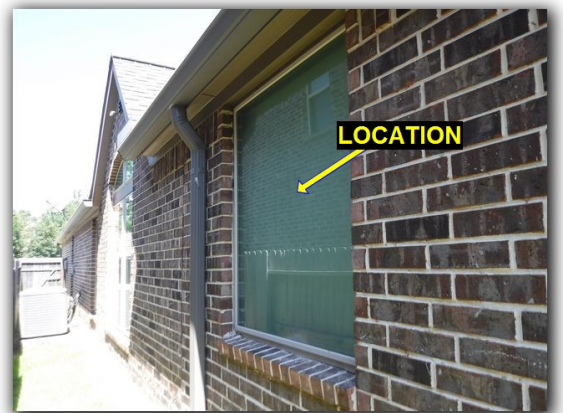
Observed the thermal seal was broken on one or more windows (including but not limited to: primary bathroom). A broken seal allows condensation to form between the panes which causes a cloudy film to develop. This cloudiness will continue to get worse until it is difficult to see out of the window.

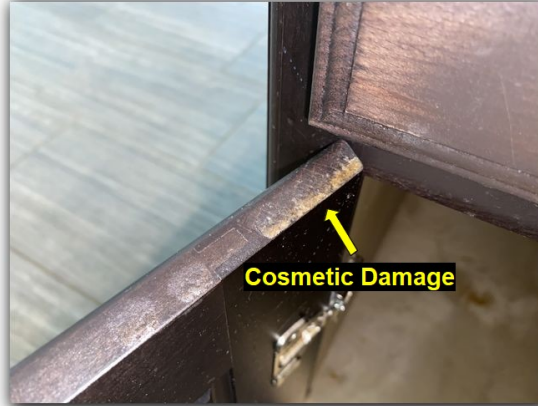
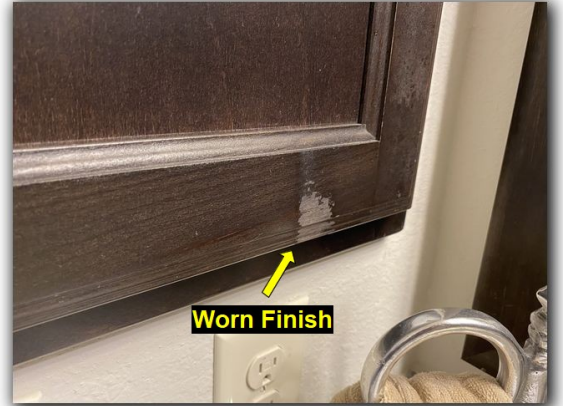
Observed minor cosmetic damage to the cabinets in one or more areas.

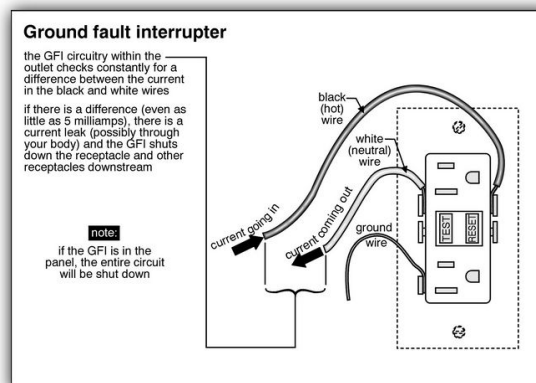
Did not observe GFCI protection for all outlets in required locations, including but not limited to; garage, laundry room. Current standards call for GFCI protection for all outlets in the kitchen, bathrooms, laundry room, garage, exterior and any outlet that is within 6 feet of a water source. This condition is a recognized safety hazard.

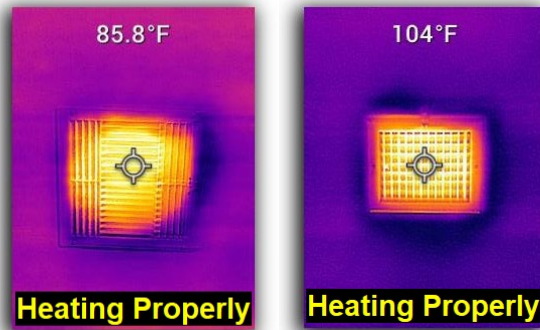
A thermal image of the air vents show the furnace(s) was / were heating properly at time of inspection.

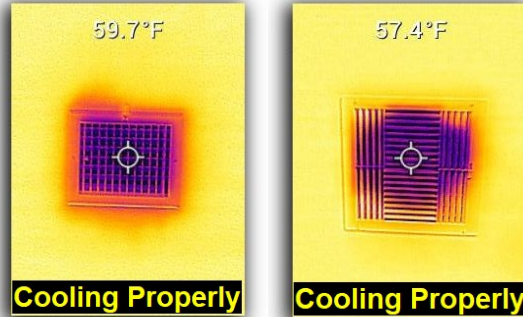
A thermal image of the air vents show the air conditioning unit(s) was / were cooling properly at time of inspection.

TEMPERATURE DIFFERENTIAL: 18 degrees (77, 59), 18 degrees (75, 57) **GOOD**

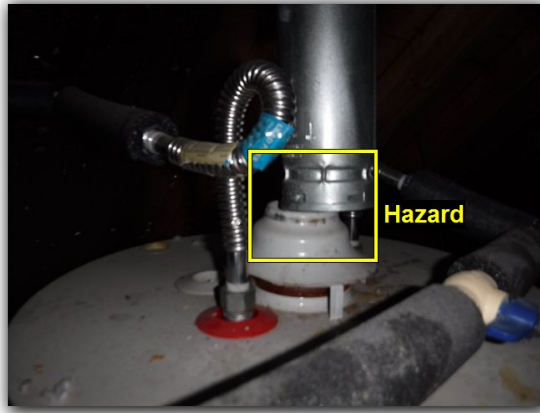
The water heater exhaust vent was not properly connected to the draft hood. This can allow carbon monoxide into the attic or garage. In need of immediate repair.

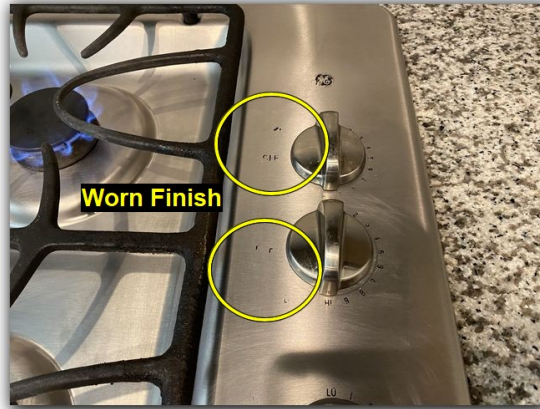
Observed worn / missing labels at one or more cooktop burners.

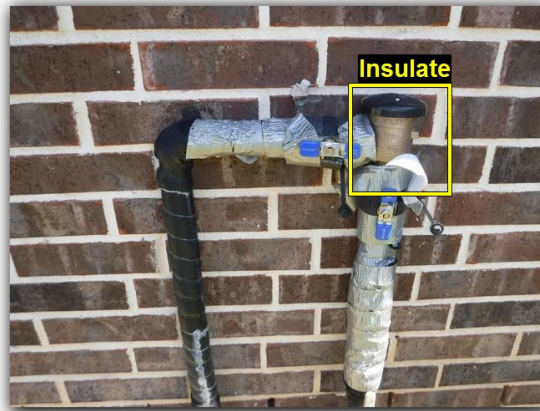
Recommend insulating the back flow preventer during the winter months to prevent damage during a freeze.
