FIG Services LLC d/b/a FOX INSPECTION GROUP  
 Property Inspection Report #220113JO-102 Phanturn Lane  
 8616 Daffodil St. Houston, TX 77063  
 (Office)713.723-3330 (Email) [office@foxinspectiongroup.com](mailto:office@foxinspectiongroup.com)

## ***PROPERTY INSPECTION REPORT***

**Prepared For:** Xiao Han  
(Name of Client)

**Concerning:** 102 Phanturn Lane, Bellaire, TX 77401  
(Address of Inspected Property)

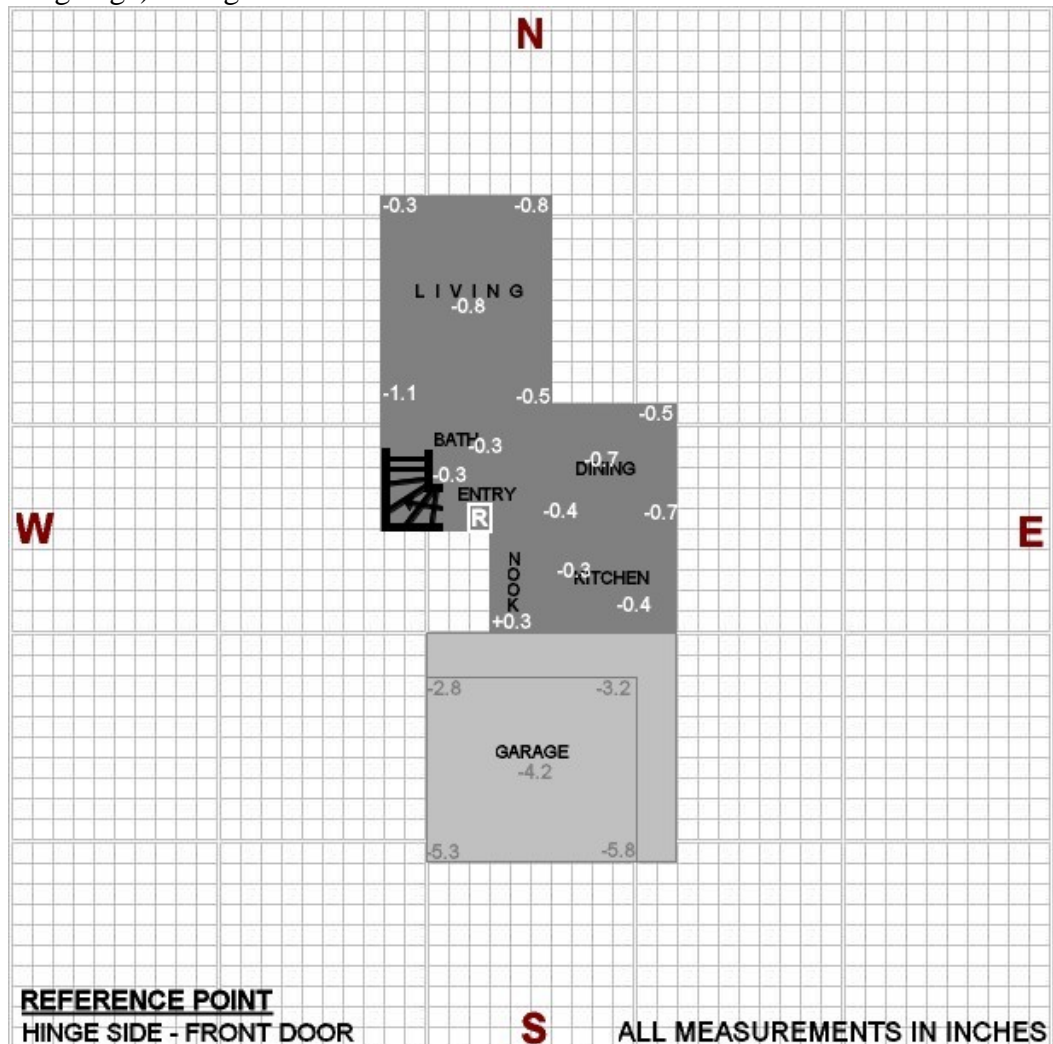
A foundation elevation survey was conducted during the inspection. The floor plan below represents data gathered using a Zip Level and adjusting for floor covering height differences. i.e. differences between tile, carpet and wood flooring (except step down to the garage). The greatest variance was 1.4".

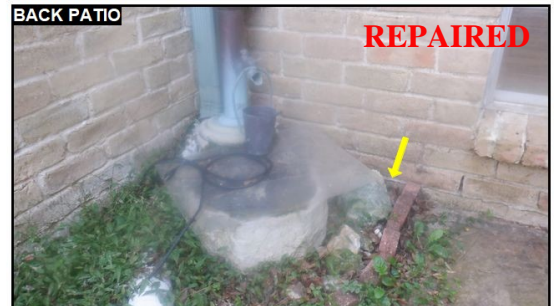
Soil level too high around areas including, but not limited to, multiple areas around house and garage. Common industry practice requires a clearance of at least 4 inches from the bottom of the siding to the soil. High soil level near the siding promotes wood rot and is considered a conducive condition to termite activity and water penetration.

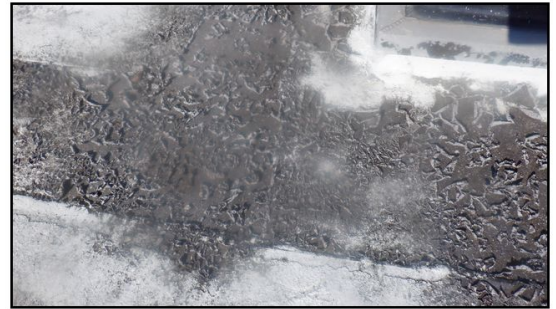
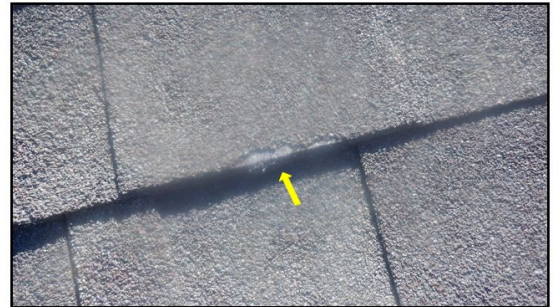
Both roof surfaces appears older. Observed deterioration / blistering of roll roof surface and brittle, cracked, curled ends and/or excessive granular loss of shingles. Recommend further evaluation by a qualified roofing specialist.

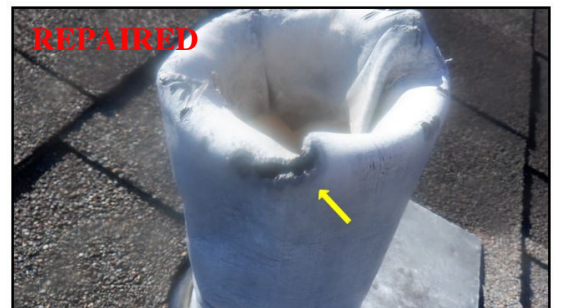
Not all lead flashing of drain waste vents are properly rolled down interior of plumbing vent pipes and/or are damaged by squirrels, which may allow some rainwater entry.

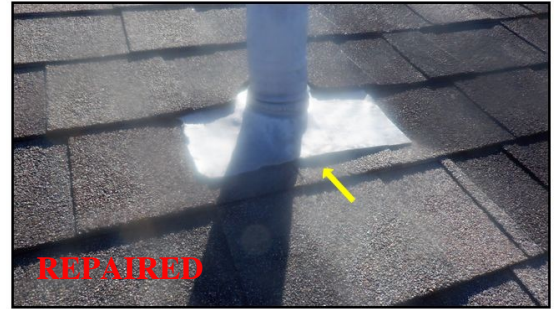
Lower side of flashing is not sealed down, wind-driven rains can cause water penetration.

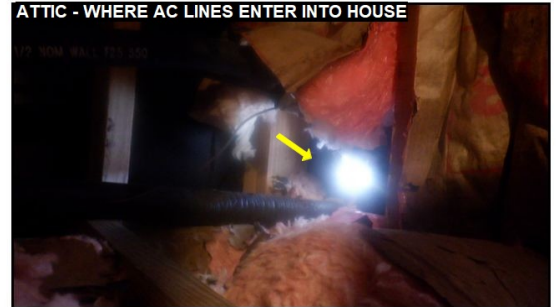
Daylight is visible from interior of attic at one or more locations. Recommend sealing these areas to prevent potential pest / rodent / water entry.

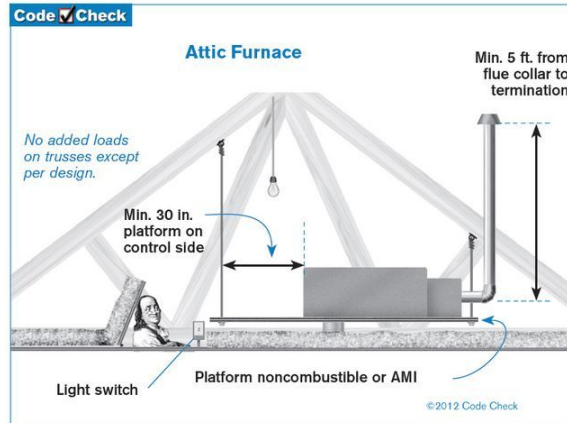
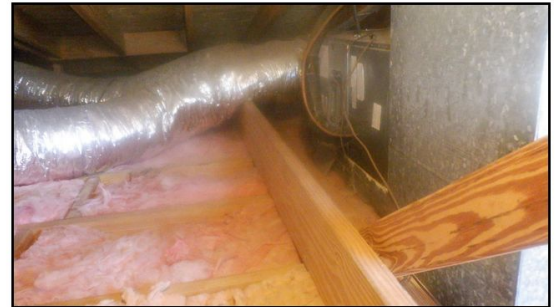
Inadequate attic walkway and/or platform to mechanical equipment in the attic. Code violation, [IRC M1305.1.3] requires 30-inch head clearance and a minimum 24 inch wide SOLID (no gaps or obstructions), floor to equipment for servicing and a 30 inch deep solid platform in front of the equipment.

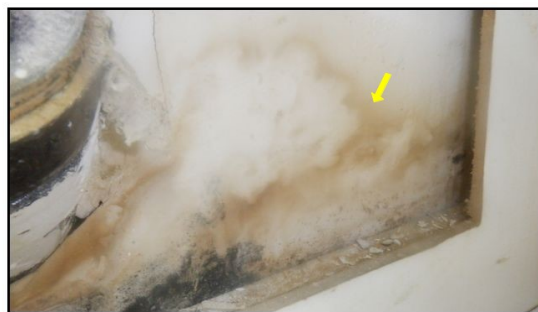
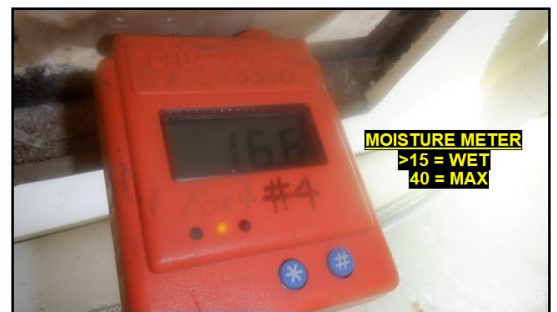
**Moisture meter registers water stains as active; kitchen cabinet below sink. Source of moisture is unknown. Recommend inquiry of seller and further investigation to determine root cause / possible remedy.**

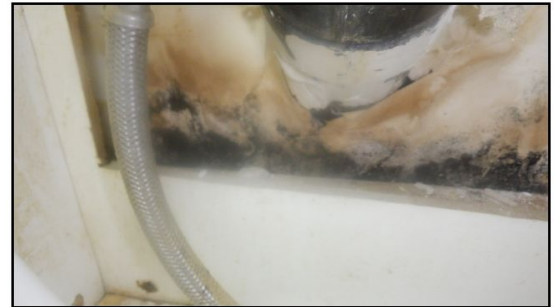
Observed possible micro-organism growth (kitchen cabinet below sink) which may be a concern due to increased awareness of environmental issues associated with molds. Recommend removal of all sheetrock containing visible mold growth plus an additional 2 feet surrounding area. This inspector does not inspect for and is not qualified to render opinions on any type of environmental or other biohazards. If this is a concern or potential concern, Fox Inspections recommends contacting our company or a qualified professional of your choice for further information/investigation.

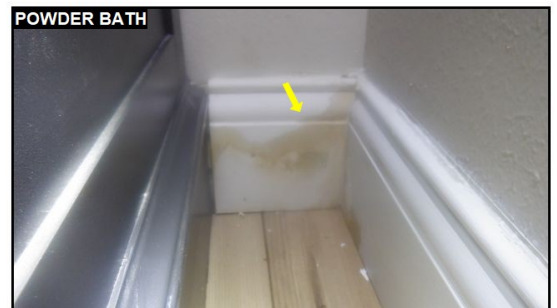
Water stains, damage or repairs observed, moisture meter indicated that stains are not active (wet) at the time of inspection; garage, powder bath.

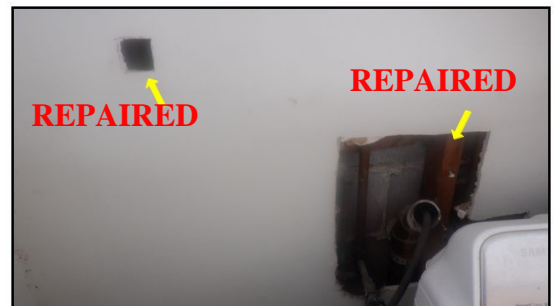
Recommend buyer consider installing sheetrock on unfinished garage walls / ceiling to serve as fire stopping to comply with current code and help protect the house.

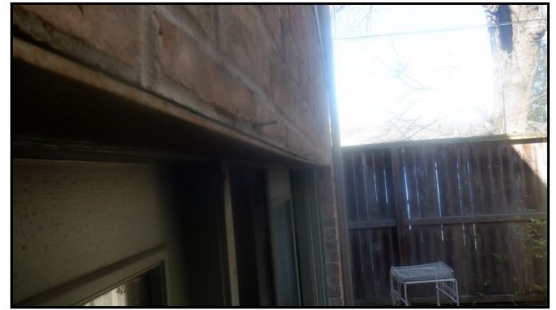
Sag observed in the lintel over the back door. Possible indication of improper/inadequate framing and/or foundation settlement.

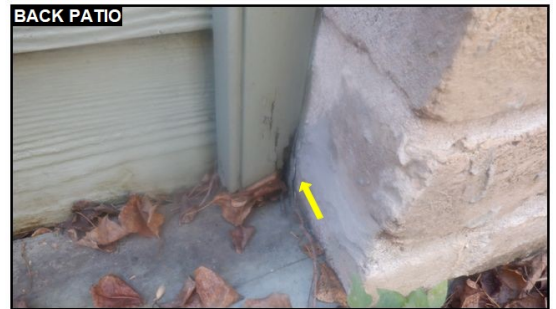
Wood rot observed on areas of house/garage.

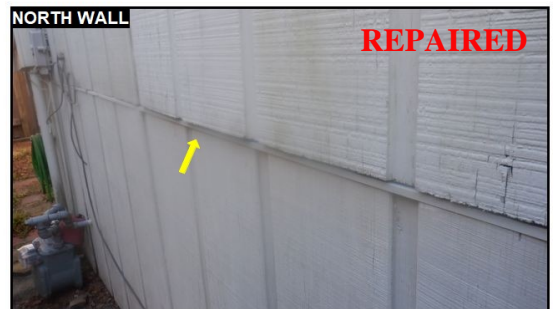
Trim / siding observed to be not secured down at one or more areas of house/garage.

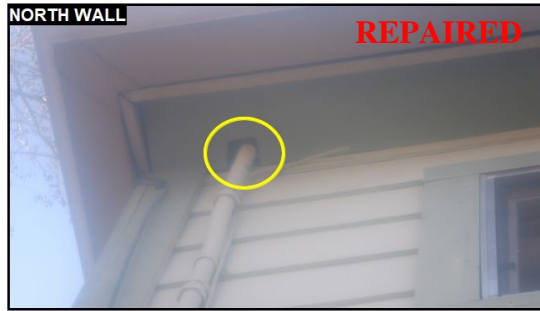
Recommend sealing holes / gaps in soffit to prevent potential pest / rodent entry.

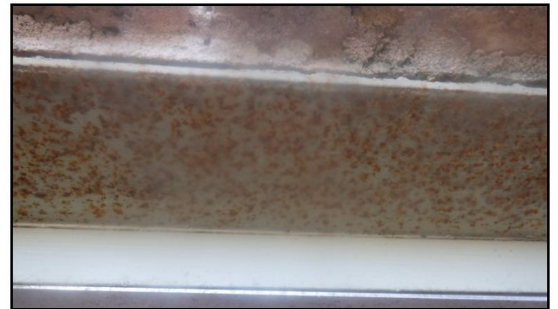
Metal lintel(s) over window/door openings need paint.

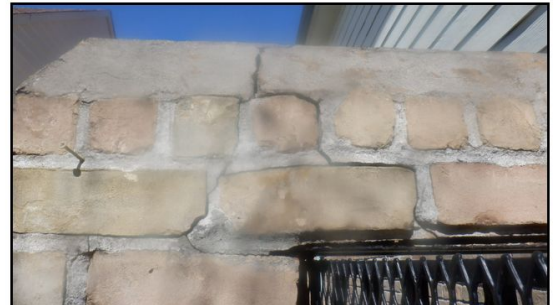
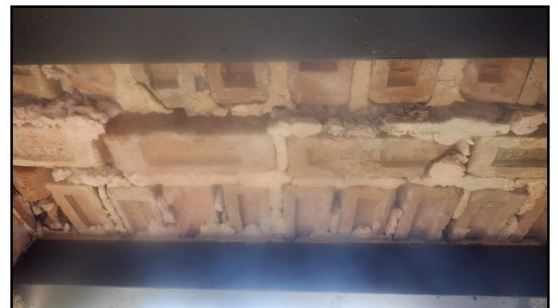
Cracks in the brick arch were observed. Loose bricks are hazardous.

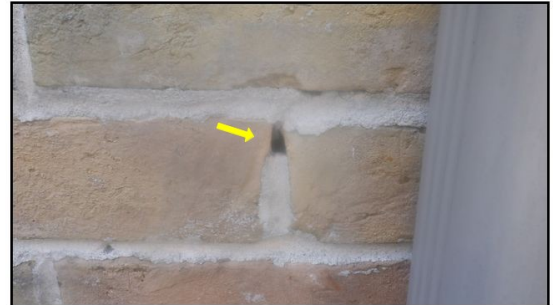
Mortar joints between brick ends are deficient in areas. This is an indication the brick-layer might not have properly "struck" the bricks (used enough mortar) - recommend re-pointing areas where voids in mortar are present.

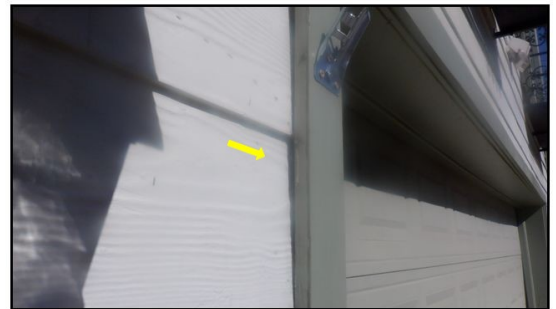
Caulking missing and/or deficient around windows / doors / vertical trim / joints in siding. May allow wind driven rain entry.

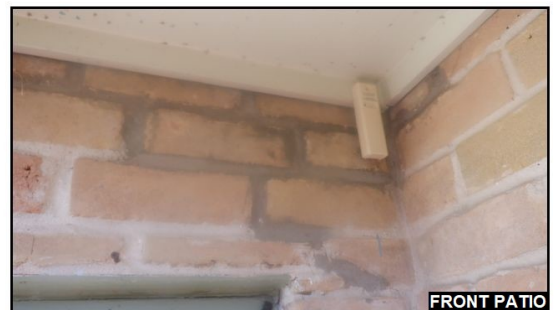
Cracks in brick / stone veneer and/or repairs, one or more locations, Recommend buyer take photographs of cracks, their location, and width [ruler across the crack] with a high-resolution camera that has a date stamp for future reference.

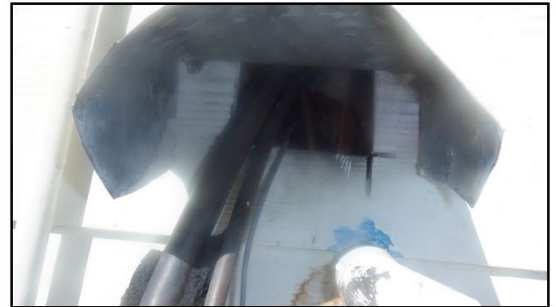
Recommend sealing / foaming exterior where AC lines enter the house. A weatherproof hood can be added for maximum prevention of water penetration.

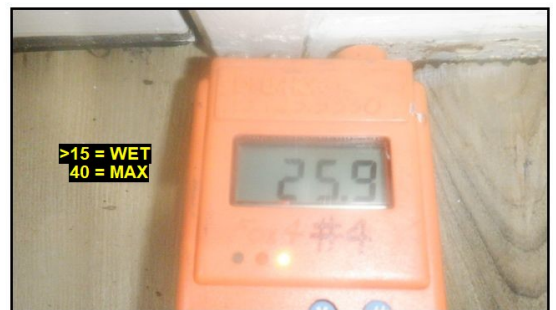
<b>Water penetration detected at back door. Could not confirm presence of door pan flashing or built-in water channel on door threshold (see Exterior Doors section below). Recommend further investigation / repair by a qualified professional.</b>
---

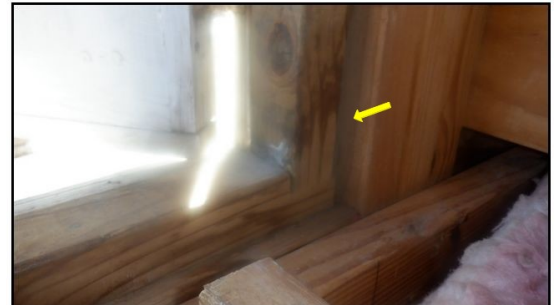
Water stains/damage to the interior of rooftop door jamb. Moisture meter indicated that the stains were not active (wet) at the time of inspection.

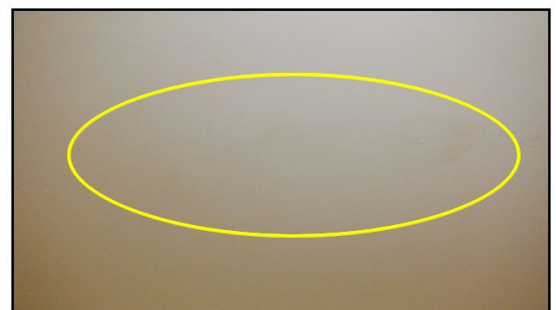
Water stains, damage or repairs observed, moisture meter indicated that stains are not active (wet) at the time of inspection; garage.

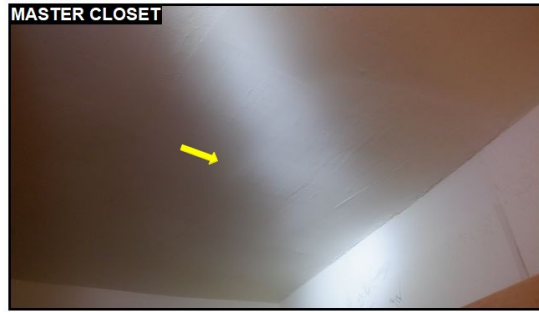
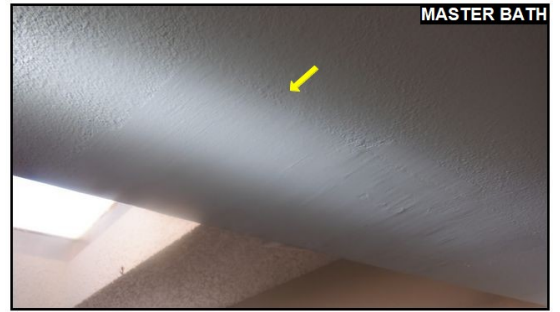
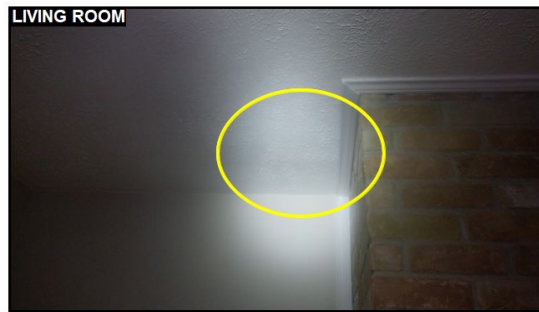
Observed cracks and/or repaired cracks in sheetrock observed in ceiling at one or more areas of house, possibly due to house settlement.

*Patch / repairs noted at master closet, master bath, living room near chimney; This inspection does not rate the substance or adequacy of these repairs.*

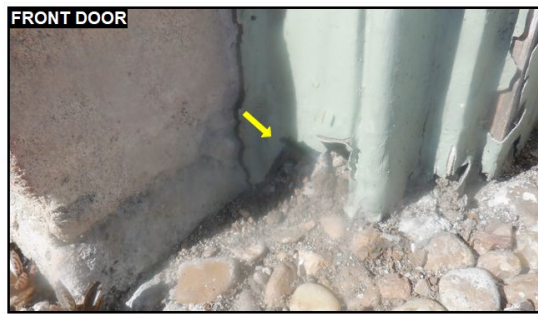
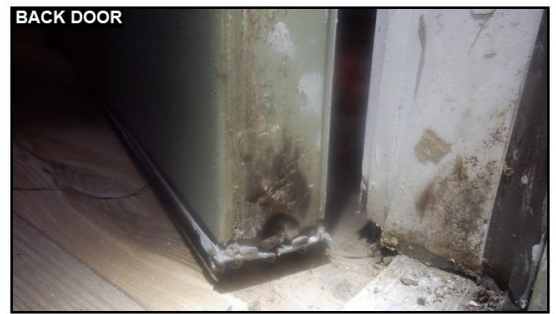
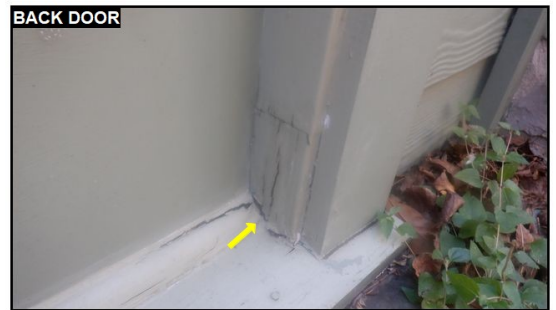
Wood rot of lower door and/or jamb; front and back doors.

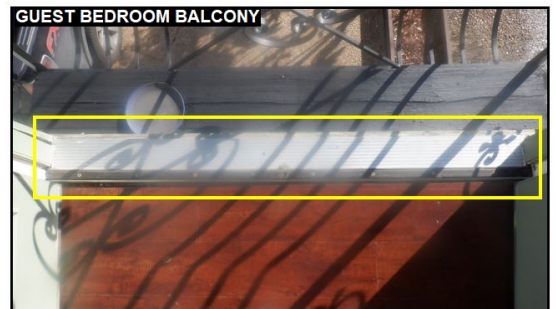
Improper threshold used on exterior doors without roof overhang protection from wind-driven rains can result in water damage from intermittent water entry.

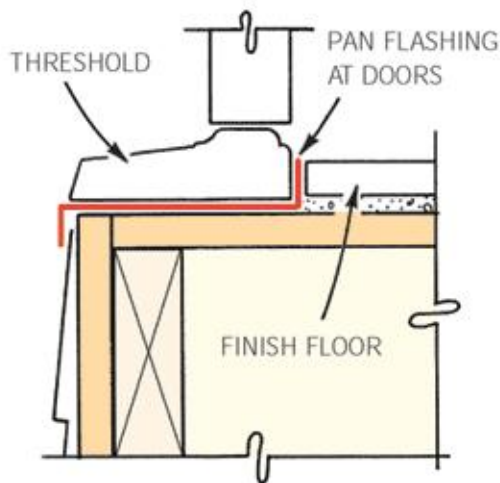
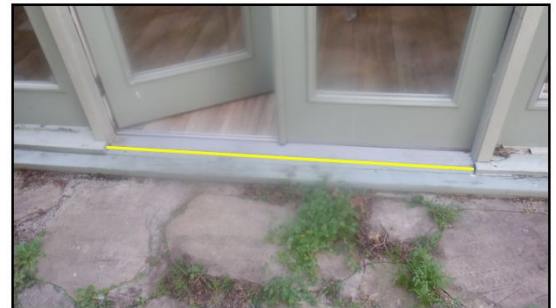
Did not observe door pan flashing at exterior door location(s). Properly installed door pan flashing helps prevent wind-driven rain/water penetration from damaging interior building components. High-risk areas include exterior doors with little to no roof or balcony overhang protection from the elements. It is not uncommon for Fox Inspection Group inspectors to observe evidence of water penetration (water damaged wood flooring or water-stained carpet tack strip) on the second-floor balcony doors. For additional information, you may watch a 5-minute video on flashing where the first few minutes show door pan flashing by clicking this link [YouTube - Class Exterior Door Pan Flashing](#). Active water penetration detected at back door (see Evidence of Water Penetration section above). Recommend further investigation / repair.

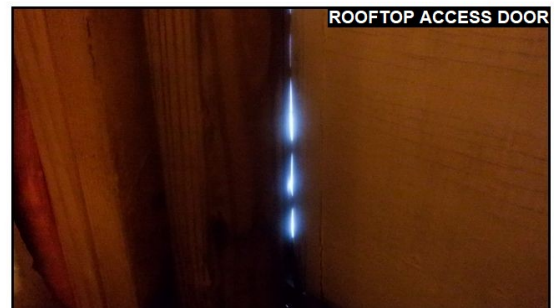
The lock set/deadbolt does not hold the door tight against the weather-stripping. Adjust striker plates or weather-stripping for proper seal.

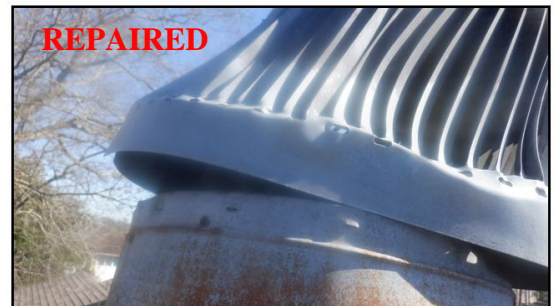
Chimney vent cap is loose / damaged on top of the chimney. Recommend repair by a qualified professional.

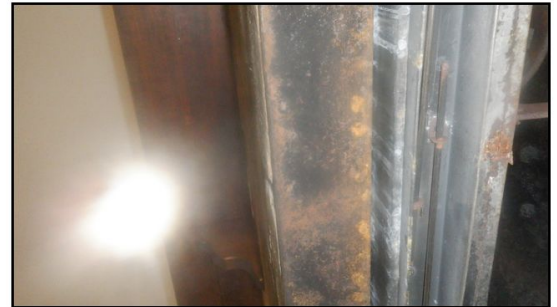
Apparent water entry at chimney/flue, resulting in water/rust stains around base of flue/damper area, water (effervescent) stained hearth bricks, and/or weak mortar. The condition should be addressed by a qualified chimney sweep.

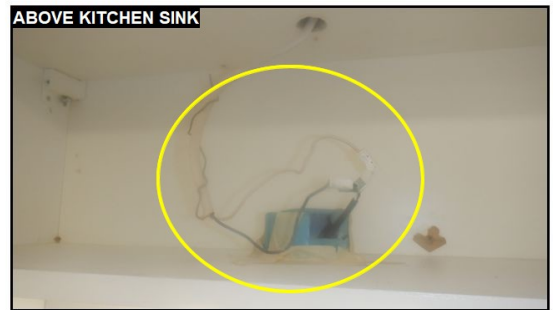
Handyman (amateurish) wiring observed, including but not limited to; multiple locations in kitchen cabinetry.

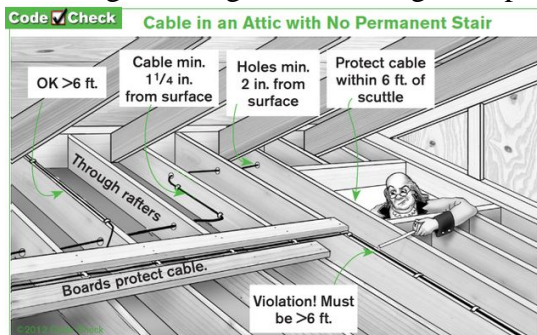
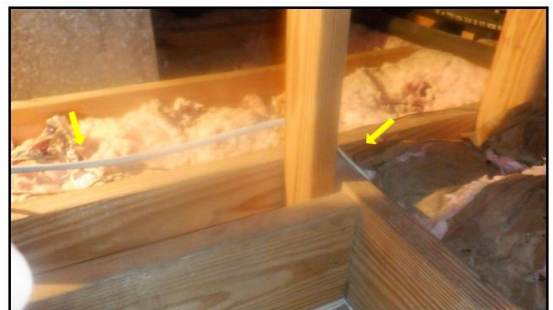
Electrical wiring run/routed too close to the attic access opening. This condition encourages damage to the wiring from personnel accessing the attic.

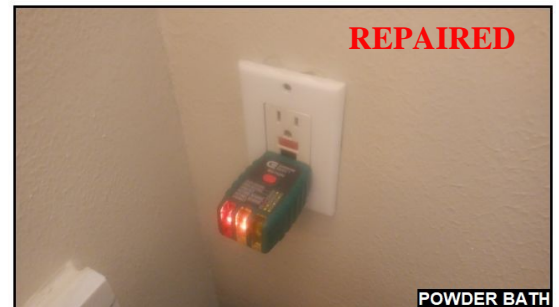
Improperly wired, 3 prong outlet not grounded or polarity reversed, including but not limited to; garage. powder bath.

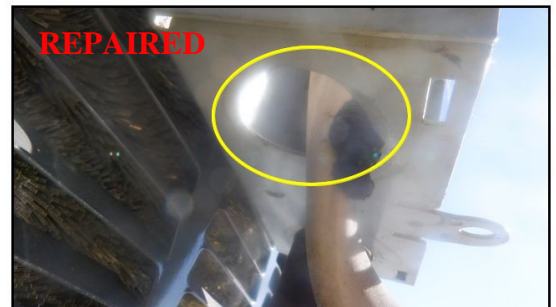
The electrical service disconnect is missing the dead front cover; main AC condenser. Protective bushing not present around electrical wire as it passes through metal box.

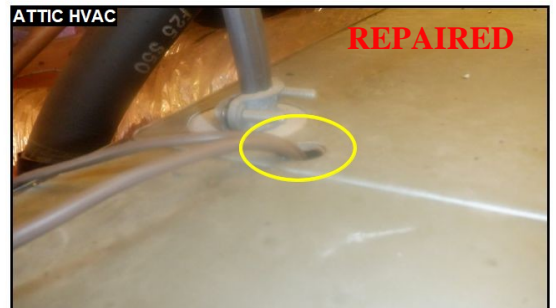
Thermostat wiring not secured to attic unit(s), missing small fitting that secures wiring to the cabinet to prevent pulling loose by service personnel or homeowner.

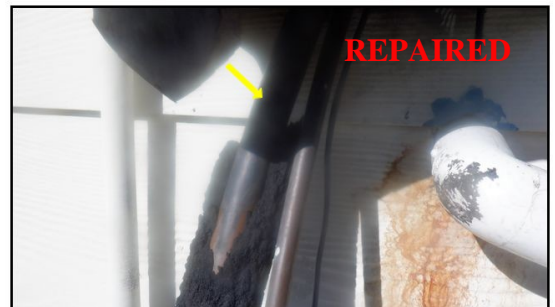
Section of suction line insulation missing or deteriorated near the condenser.

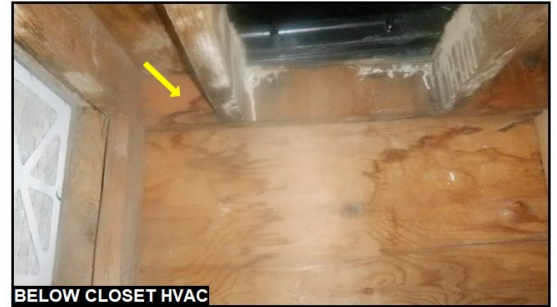
**No drain pan observed below closet HVAC unit. If unit should leak / drip condensation, interior finishes could be damaged.**

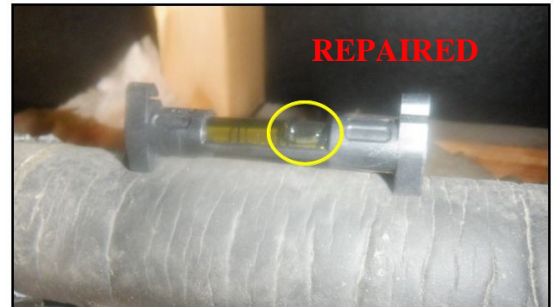
Primary drain line elevation improper, repair; attic unit.

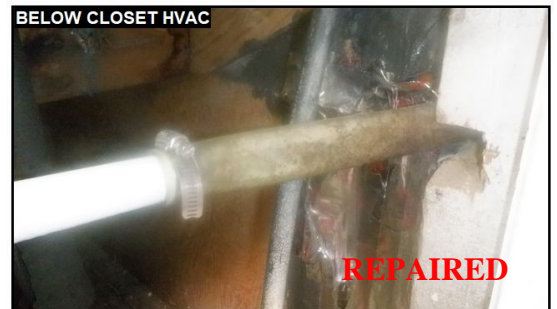
The primary drain line should be insulated along the entire length to prevent warm air condensing on the cool drain line and dripping condensation. Observed flexible drain line, these drain lines are easily routed up-hill and / or kinked / clogged. Recommend replacing with hard pipe.

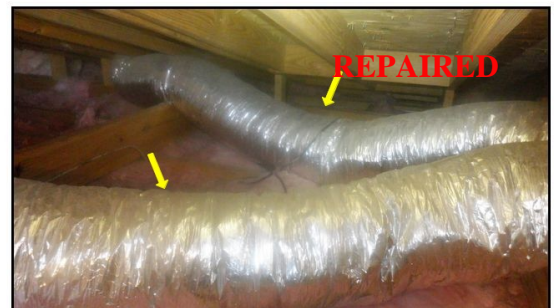
Some flex duct observed to be routed improperly, not to manufacturer's installation instructions. Recommend additional support and/or routing ducts to eliminate “snaking” drooping or crimping of flex duct more than 1” per foot which adds unnecessary additional resistance.

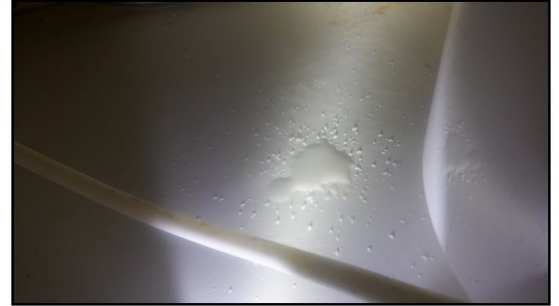
Small leak below the sink; kitchen sink.

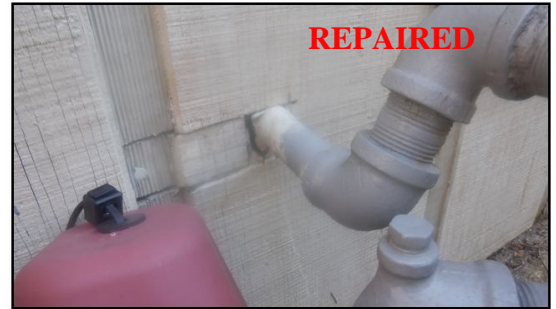
Unable to determine if above ground gas lines are properly bonded as required by 2006 IRC/G2411.1 (310). Recommend further evaluation by qualified contractor.

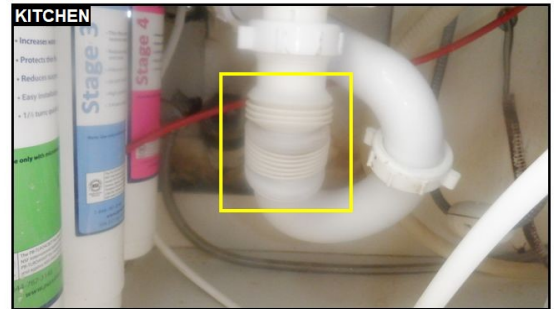
Amateurish plumbing observed; upstairs bath sink, kitchen sink.

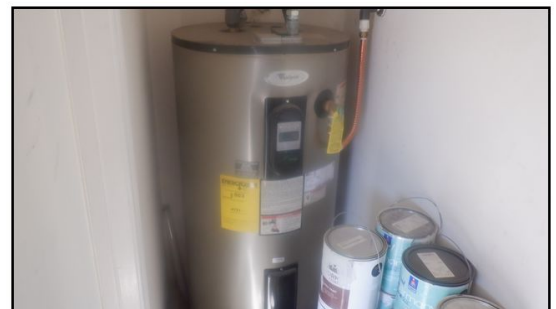
WATER HEATING UNIT(S): (2011) AMERICAN 50 GALLON

**At/near end of typical serviceable life. Buyers note: The water heater(s) were observed to be over 10 years of age, multiple plumbing companies will only replace and are not likely to repair water heaters over 10 years of age.**

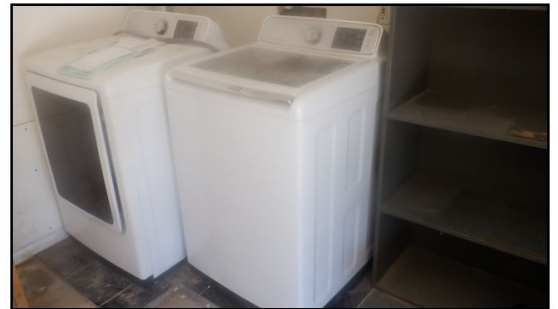
Corrosion observed on top of unit under lid.
