## Moisture Inspection Report

Inspected for  
Kenya Bosso  
4241 Bettis Dr  
Houston, TX 77027  
02/10/2021

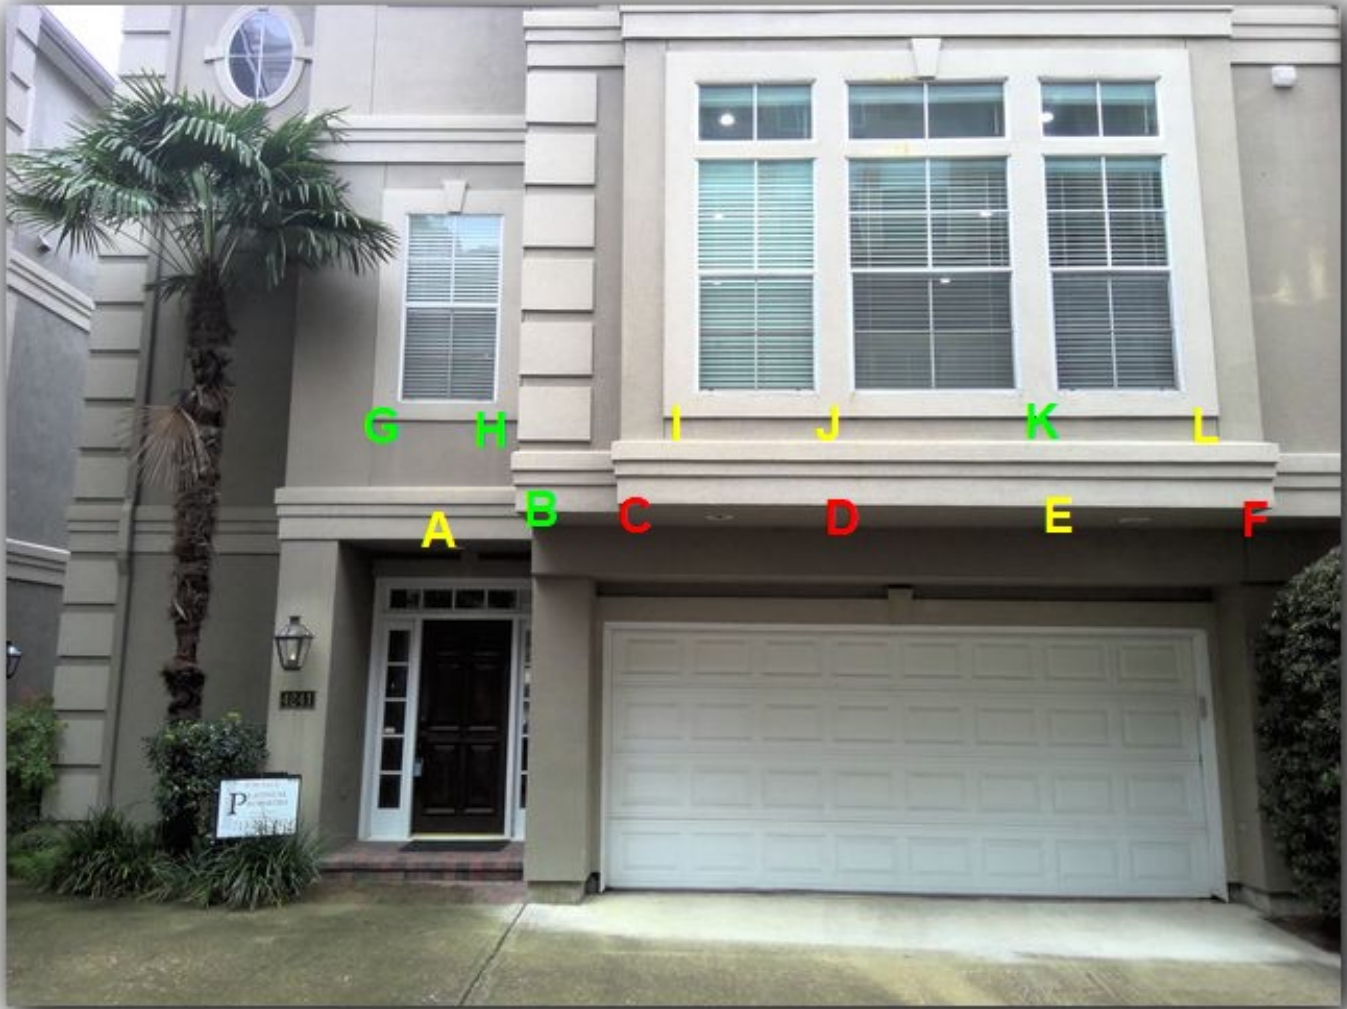
# Front Side of Structure - 1

Test Location	Moisture Content	Substrate Condition	Additional comments
A	17.4%	Firm	Drainage relief not installed
B	13.4%	Firm	Drainage relief not installed
C	n/a	None present	Drainage relief not installed, No substrate/possible wood rot
D	27.4%	Soft	Drainage relief not installed, Soft substrate/possible wood rot
E	16.7%	Semi Soft	Drainage relief not installed
F	n/a	None present	Drainage relief not installed, hairline crack present, No substrate/possible wood rot
G	11.7%	Firm	Damaged / aged window sealant.
H	10.5%	Firm	Hairline crack present, Damaged / aged window sealant.
I	16.3%	Firm	Damaged / aged window sealant.
J	18.5%	Firm	Damaged / aged window sealant.
K	14.5%	Firm	Damaged / aged window sealant.
L	17.3%	Firm	Damaged / aged window sealant.

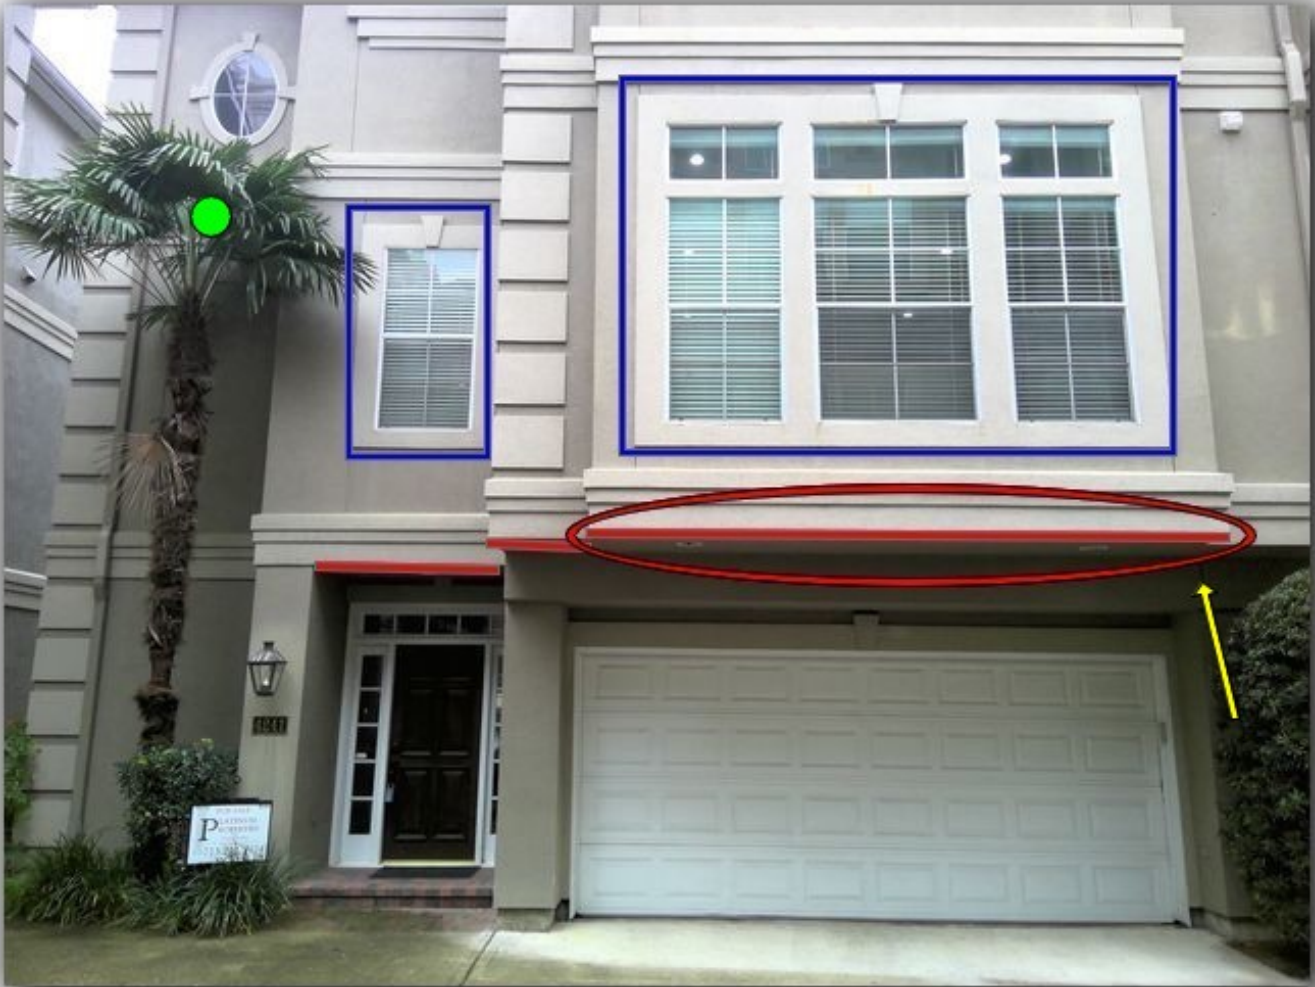
# Front Side of Structure - 1

Identifier	Comments
<b>Red line</b>	<b>Missing Drainage Openings:</b> Weep screeds / drainage openings missing at the stucco walls. Drainage openings assist with allowing incidental moisture to escape. Recommend installation of drainage openings during repairs.
<b>Red Circle</b>	<b>Moisture Intrusion / Soft or missing substrate / Elevated Moisture :</b> Areas of elevated moisture and / or possible substrate damage was found at this location. Substrate not present / possible wood rot . See Photo Observations for further information
<b>Blue Boxes</b>	<b>Damaged / Aged Sealant:</b> Damaged sealant / caulk was found at the windowsr. Properly installed sealant provides a barrier against moisture intrusion. Recommend repairs using a quality sealant recommended by the manufacturer of your system. <b>Rust:</b> Rust and separation were observed at the stucco bands
<b>Green Dot</b>	<b>Trees on Wall:</b> Trees were observed in contact or close to the exterior wall surfaces. Recommend improvements to maintain clearance between the exterior walls and trees / shrubs.

<b>Yellow Arrow</b>	<b>Hairline Cracks:</b> Hairline cracks were observed at the stucco walls. Hairline cracks (generally 1/16 of an inch) are commonly found with stucco systems. These cracks should be monitored and repaired as needed.

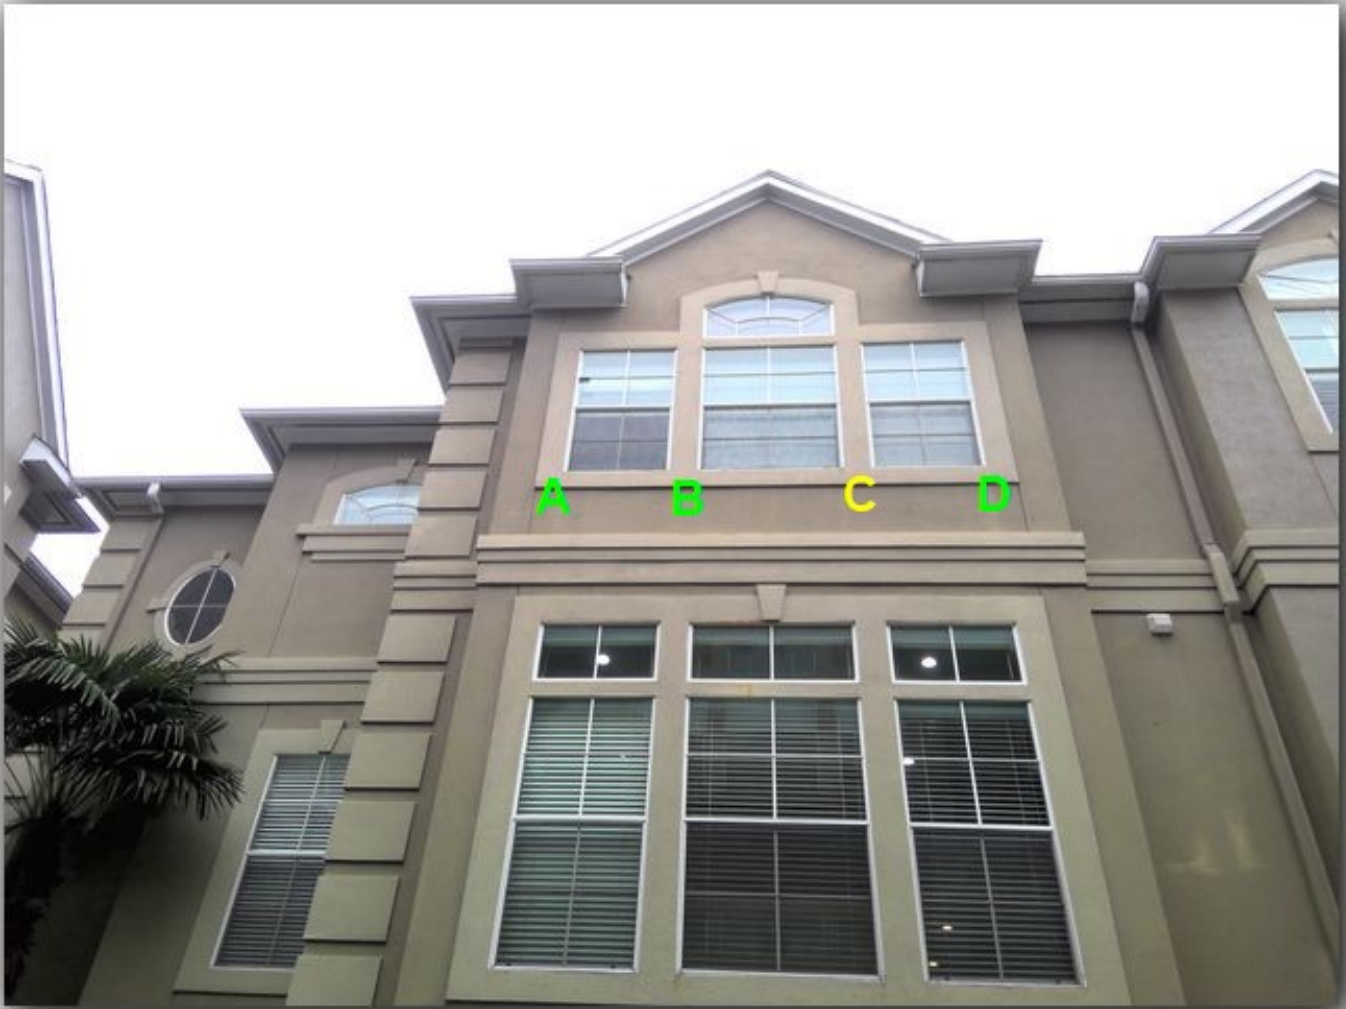
## Front Side of Structure - 2

Test Location	Moisture Content	Substrate Condition	Additional comments
A	10.4%	Firm	Damaged / aged window sealant.
B	11.2%	Firm	Damaged / aged window sealant.
C	17.2%	Firm	Damaged / aged window sealant.
D	10.7%	Firm	Damaged / aged window sealant.

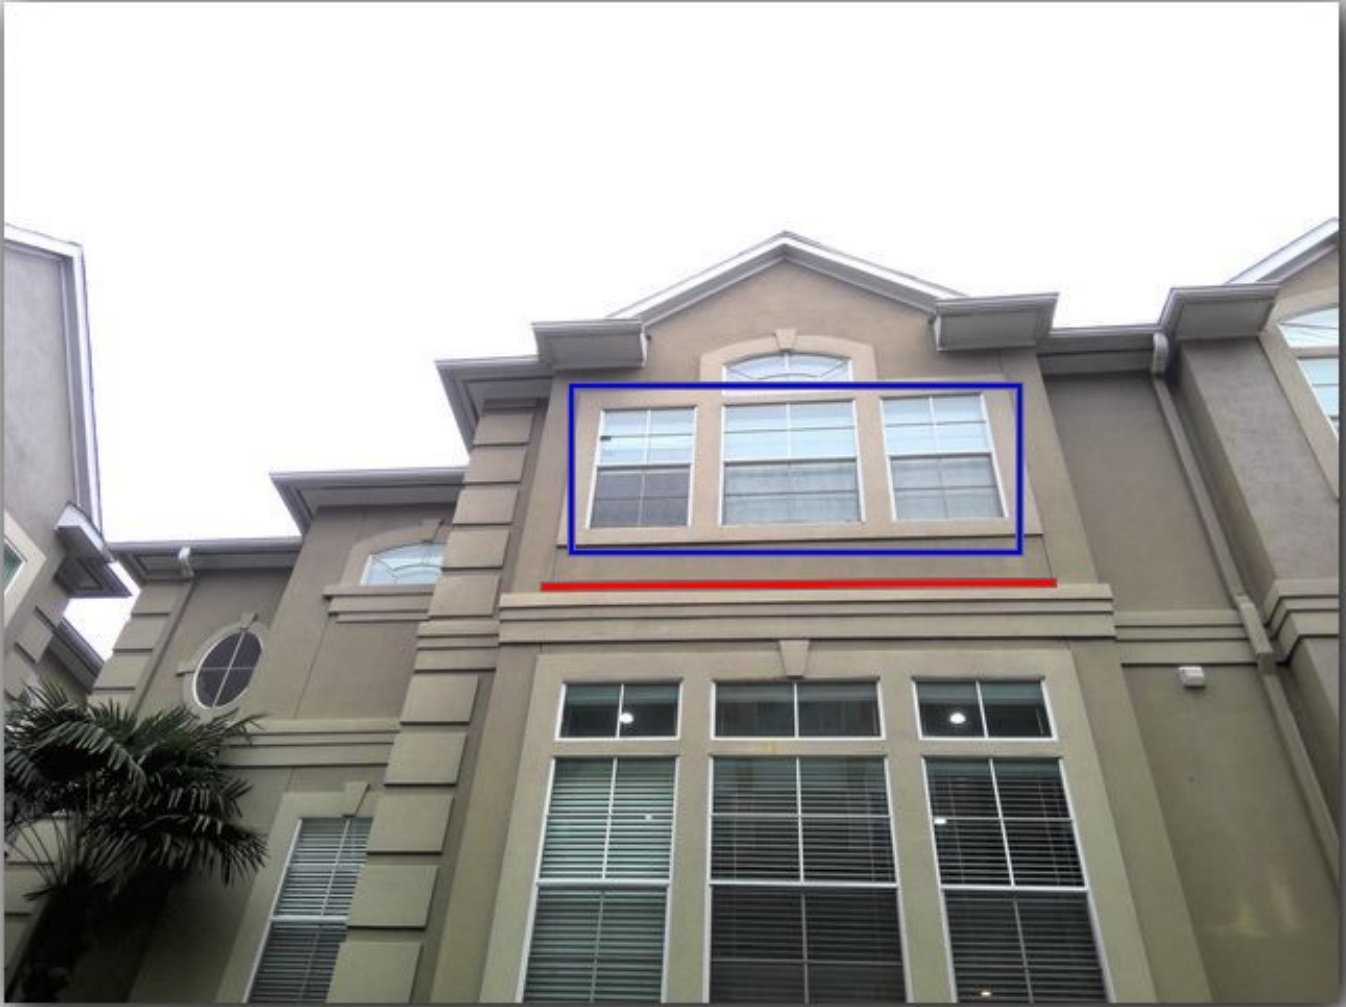
## Front Side of Structure - 2

Identifier	Comments
<b>Blue Box</b>	<p><b>Damaged / Aged Sealant:</b> Damaged sealant / caulk was found at the windows. Properly installed sealant provides a barrier against moisture intrusion. Recommend repairs using a quality sealant recommended by the manufacturer of your system.</p> <p><b>Rust:</b> Rust and separation were observed at the stucco bands</p>
<b>Red Line</b>	<p><b>Rust:</b> Rust was observed at the stucco bands</p>

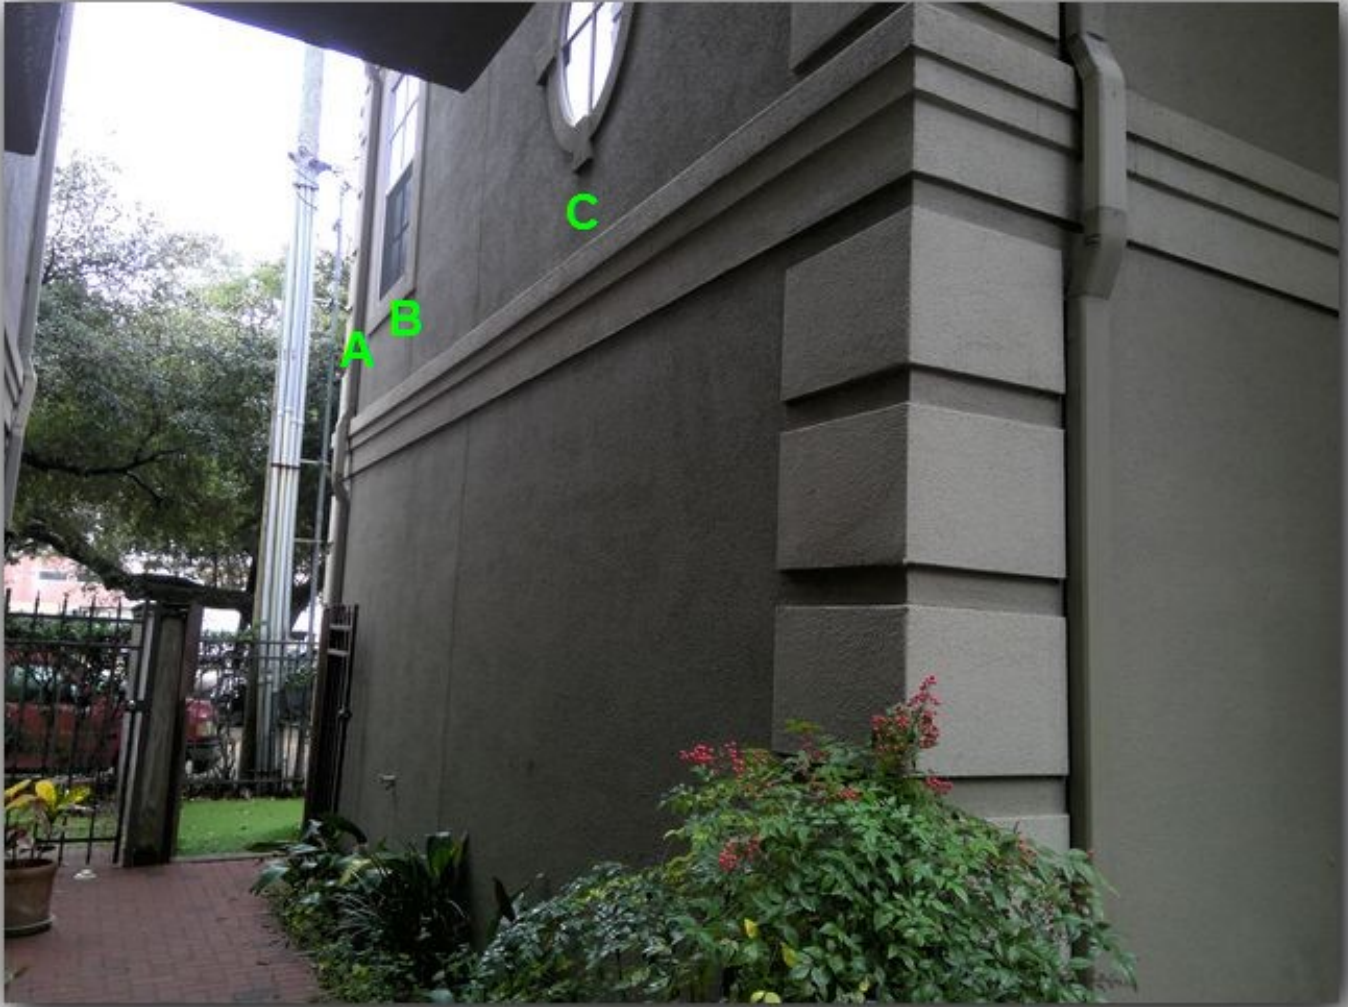
# Left Side of Structure

Test Location	Moisture Content	Substrate Condition	Additional comments
A	10.3%	Firm	Hairline cracks present, Damaged / aged window sealant.
B	12.7%	Firm	Hairline cracks present, Damaged / aged window sealant.
C	10.9%	Firm	Damaged / aged window sealant.

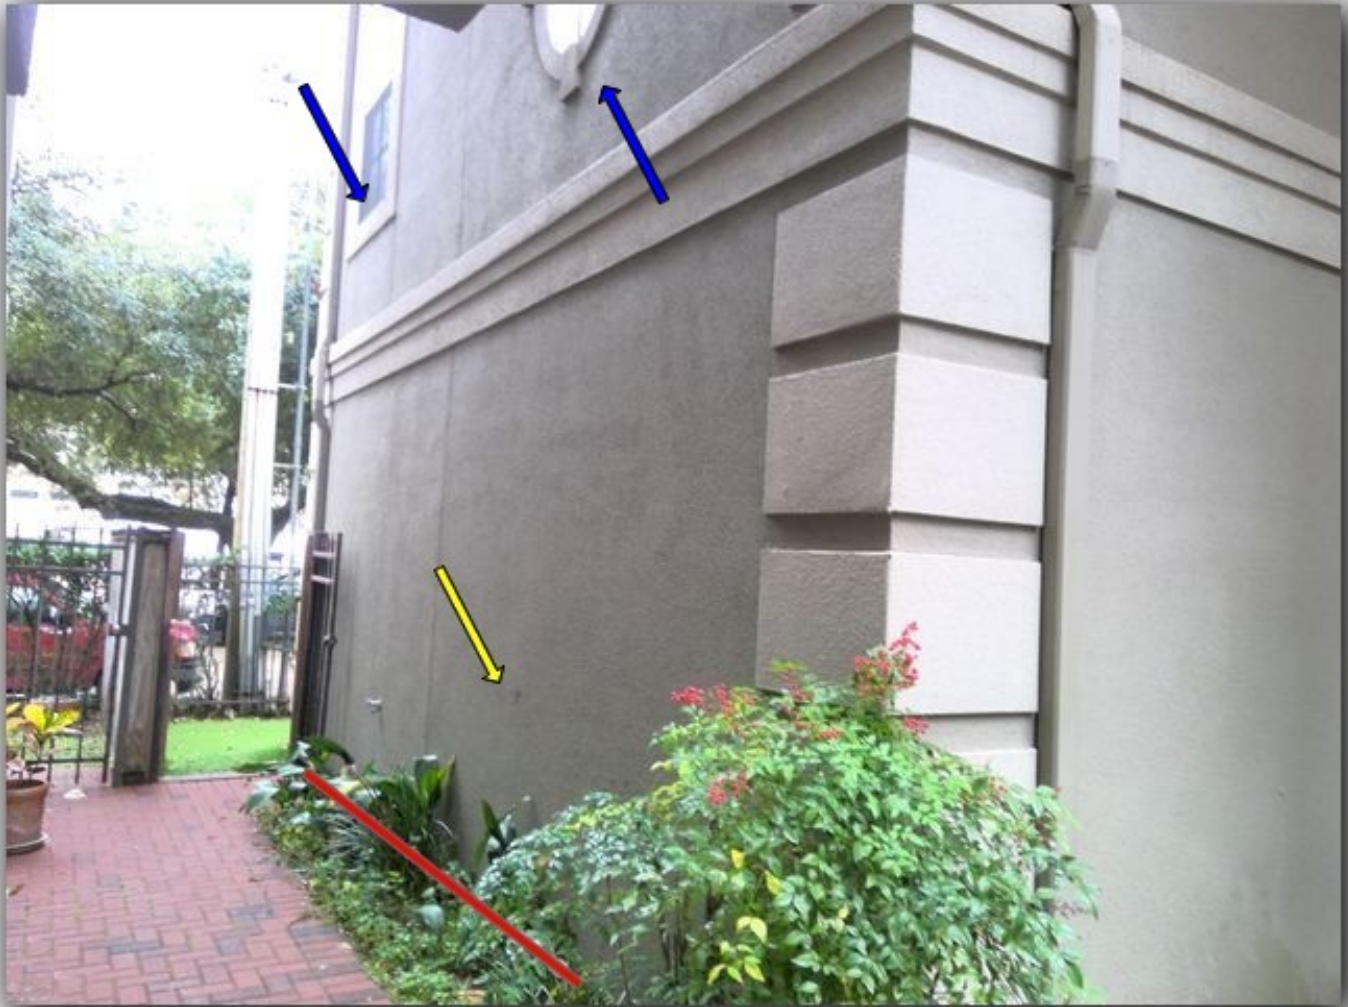
## Left Side of Structure Deficiencies

Identifier	Comments
<b>Red Line</b>	<b>Trees or Shrubs on Wall:</b> Trees / shrubs were observed in contact or close to the exterior wall surfaces. Recommend improvements to maintain clearance between the exterior walls and trees / shrubs.
<b>Yellow Arrow</b>	<b>Surface Damage:</b> Surface damage was observed on the left wall.
<b>Blue Arrows</b>	<b>Damaged / Aged Sealant:</b> Damaged sealant / caulk was found at the windows. Properly installed sealant provides a barrier against moisture intrusion. Recommend repairs using a quality sealant recommended by the manufacturer of your system.

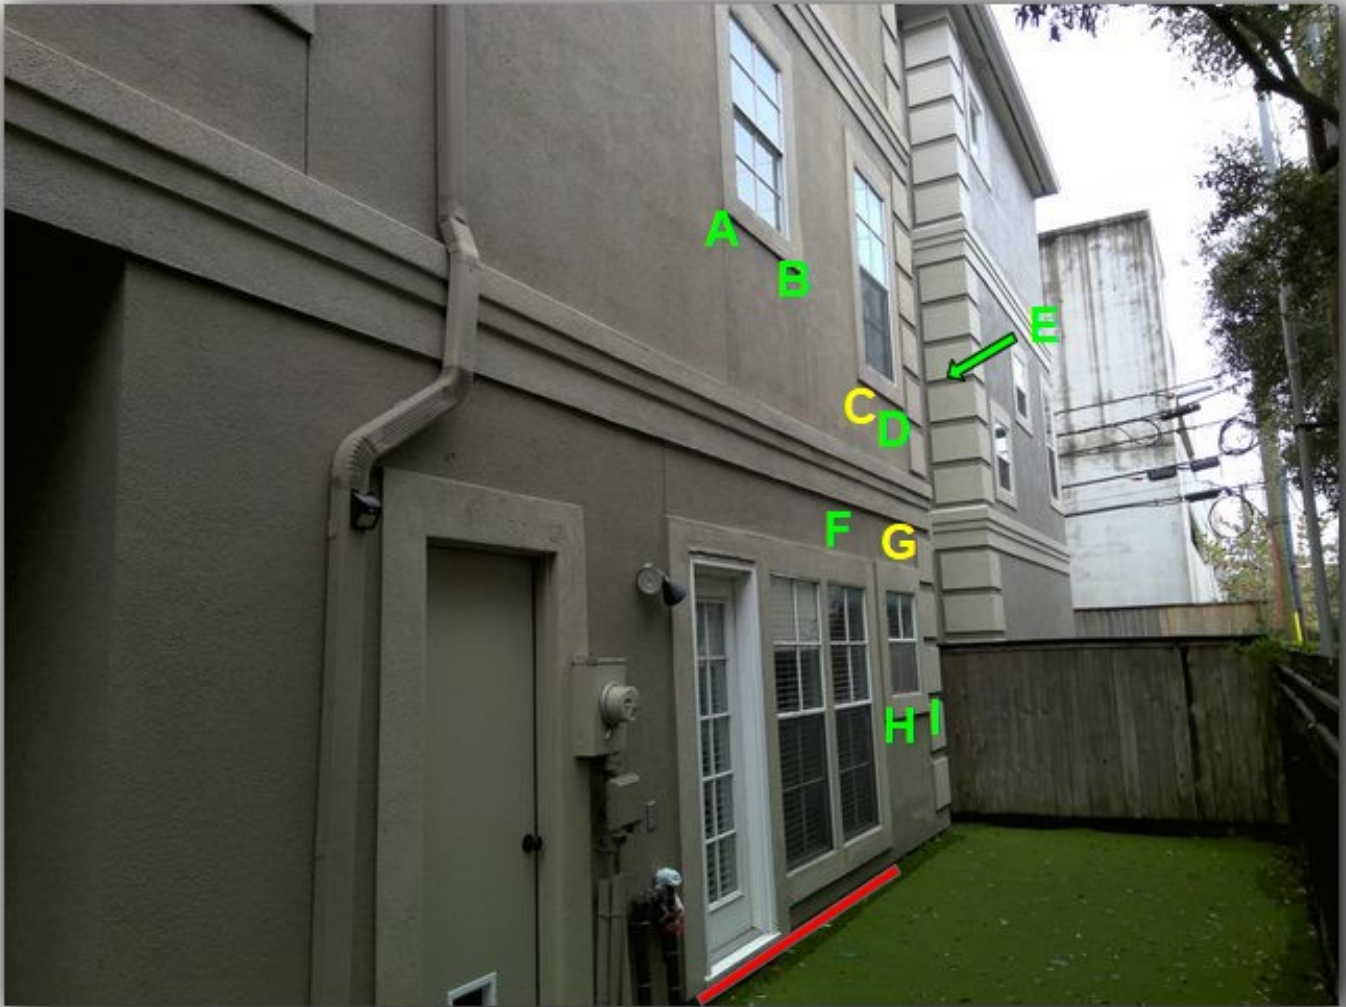
# Rear Side of Structure - 1

Test Location	Moisture Content	Substrate Condition	Additional comments
A	13.1%	Firm	Damaged / aged window sealant.
B	10.3%	Firm	Damaged / aged window sealant.
C	17.5%	Firm	Damaged / aged window sealant.
D	11.7%	Firm	Damaged / aged window sealant.
E	10.9%	Firm	
F	11.4%	Firm	
G	16.8%	Firm	
H	11.2%	Firm	Damaged / aged window sealant.
I	10.6%	Firm	Damaged / aged window sealant.
Red Line	n/a	Soft / Damaged	Soft / damaged substrate was observed at the bottom of the wall.

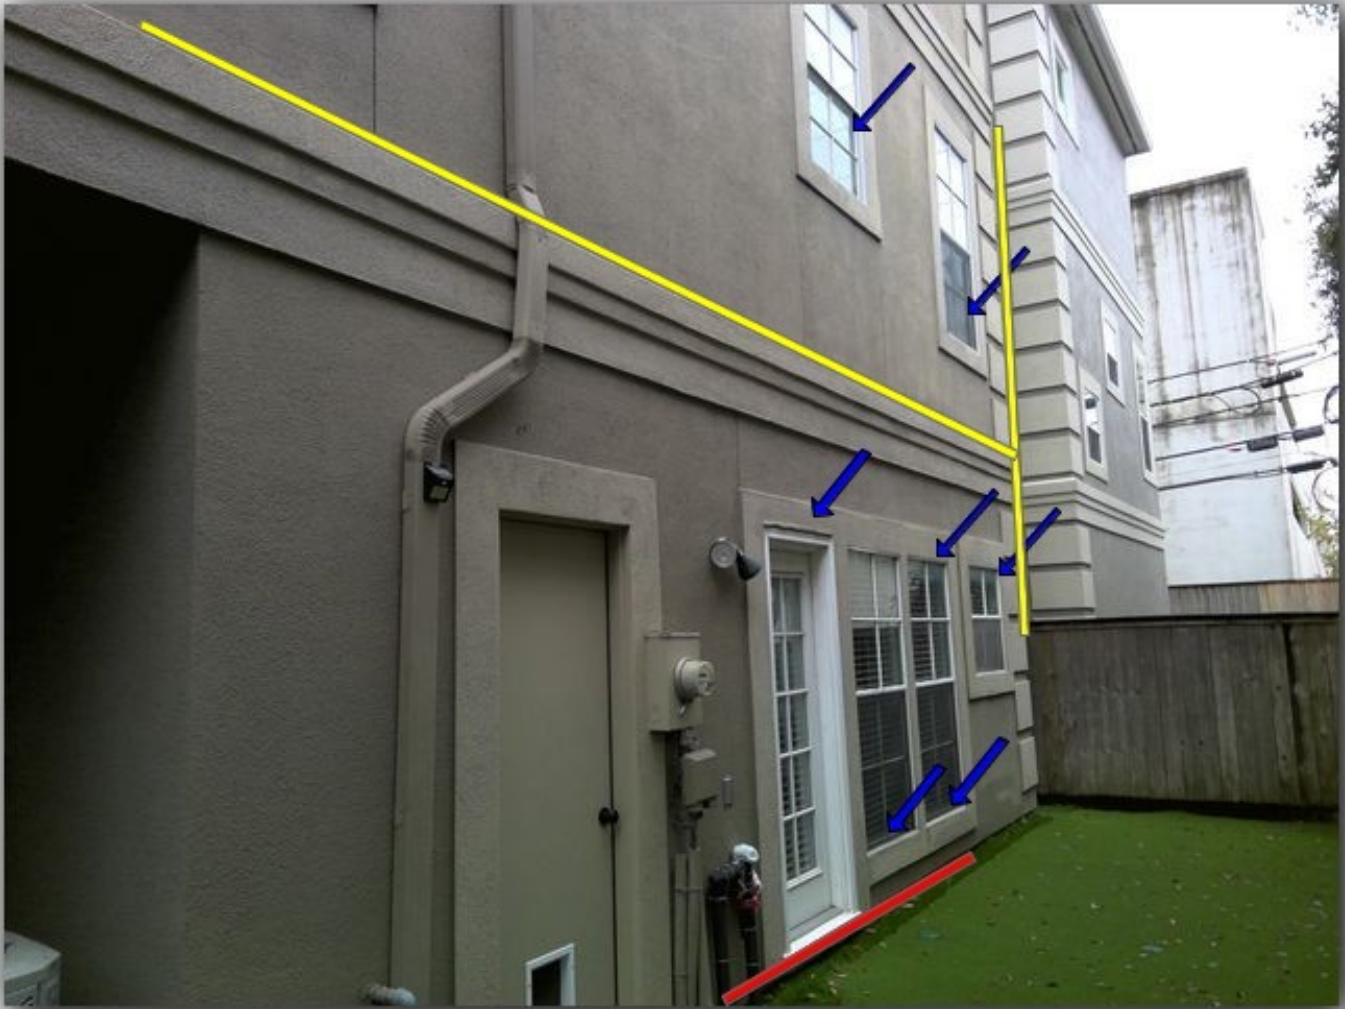
## Rear Side of Structure - 1

Identifier	Comments
<b>Blue Arrows</b>	<p><b>Damaged / Aged Sealant:</b> Damaged sealant / caulk was found at the windows. Properly installed sealant provides a barrier against moisture intrusion. Recommend repairs using a quality sealant recommended by the manufacturer of your system.</p> <p><b>Rust:</b> Rust and separation were observed at the stucco bands</p>
<b>Yellow Line</b>	<p><b>Rust:</b> Rust and separation were observed at the quins and stucco bands</p>
<b>Red Line</b>	<p><b>Soft or damaged substrate</b> - Damaged substrate was observed at the bottom of the wall by physically touching the wood. The wood crumbled when touched. Recommend repairs</p> <p><b>Improper Clearance at grade / hard surface:</b> Improper clearance was observed at the stucco wall termination and grade / hard surface. Stucco industry details require a minimum ground clearance of 4" above grade and 2" above hard surfaces. During rainfall, these areas may be susceptible to water wicking into the substrate. Improvements at these locations are recommended. .</p>

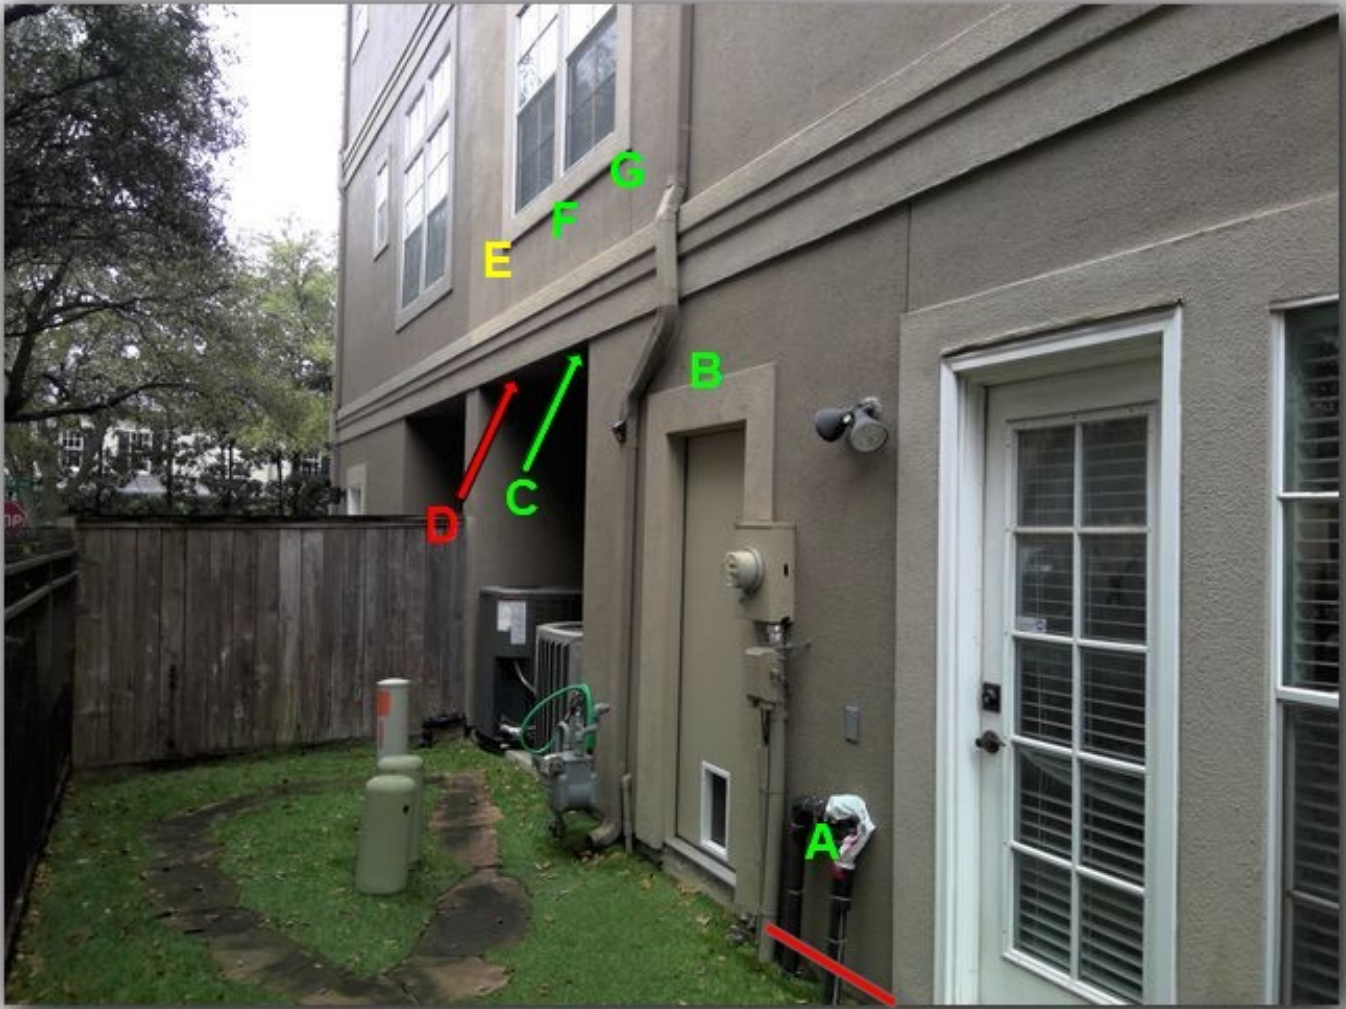
## Rear Side of Structure - 2

Test Location	Moisture Content	Substrate Condition	Additional comments
A	14.4%	Firm	Moisture reading taken above damaged area. Substrate was firm with no elevated moisture
B	12.6%	Firm	
C	10.7%	Firm	Hairline crack present, drainage relief not installed
D	N/A	None present	Substrate not present / possible wood rot, drainage relief not installed
E	17.9%	Firm	Damaged / aged window sealant.
F	13.1%	Firm	Damaged / aged window sealant.
G	10.6%	Firm	Damaged / aged window sealant.

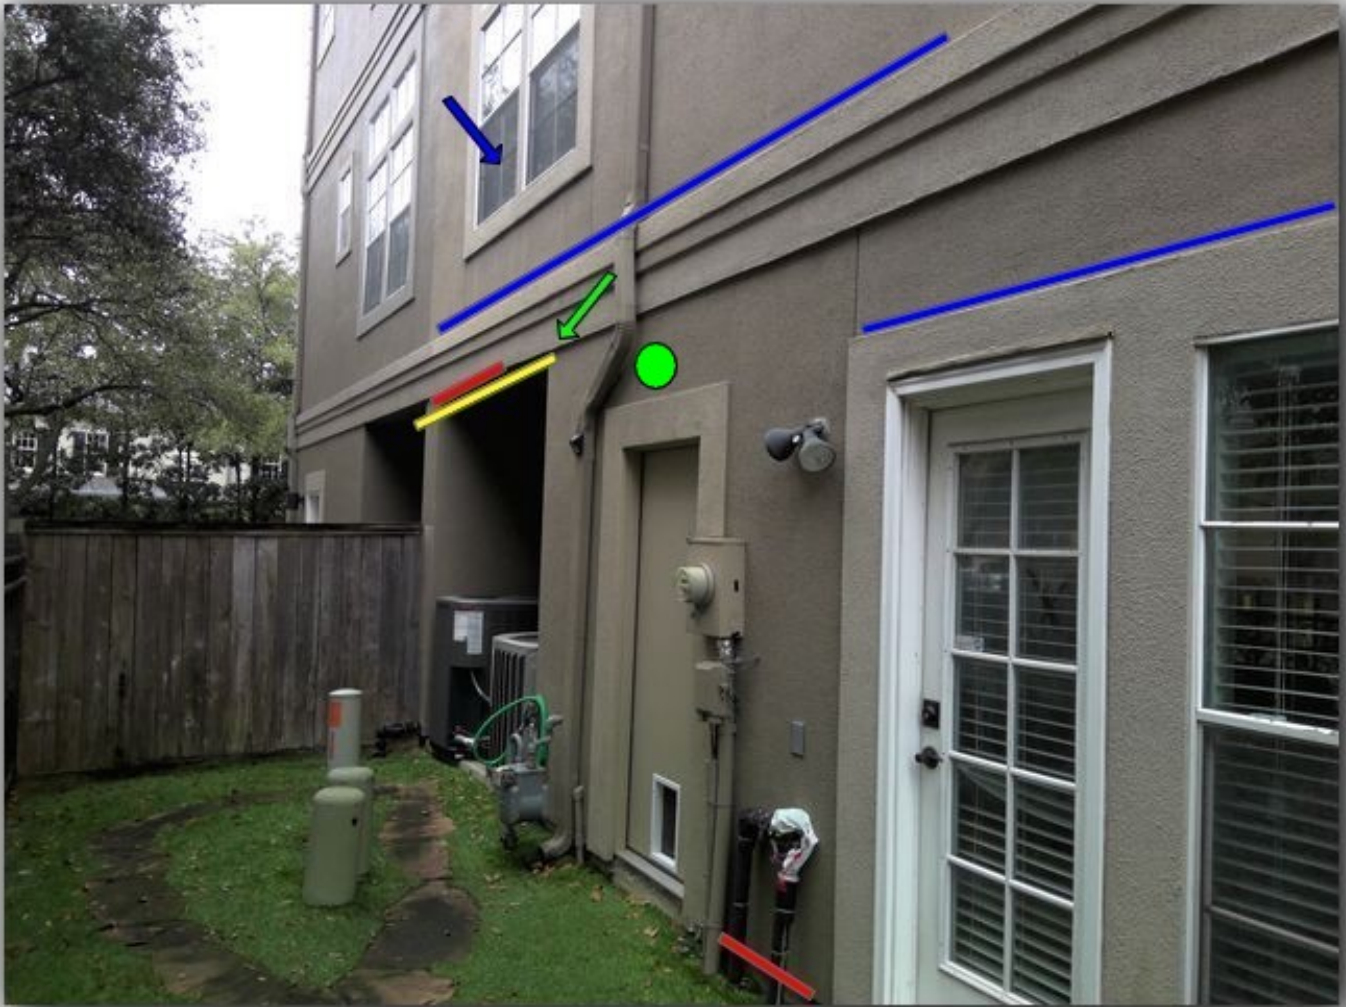
## Rear Side of Structure - 2

Identifier	Comments
<b>Red lines</b>	<b>Moisture Intrusion / Soft or missing substrate:</b> Areas of substrate damage was found at these locations. Substrate not present / possible wood rot . See Photo Observations for further information
<b>Yellow Line</b>	<b>Missing Drainage Openings:</b> Drainage openings missing at the stucco walls. Drainage openings assist with allowing incidental moisture to escape. Recommend installation of drainage openings during repairs.
<b>Green Line</b>	<b>Hairline Cracks:</b> Hairline cracks were observed at the stucco walls. Hairline cracks (generally 1/16 of an inch) are commonly found with stucco systems. These cracks should be monitored and repaired as needed.
<b>Blue arrow</b>	<b>Damaged / Aged Sealant:</b> Damaged sealant / caulk was found at the windows. Properly installed sealant provides a barrier against moisture intrusion. Recommend repairs using a quality sealant recommended by the manufacturer of your system. <b>Rust:</b> Rust and separation were observed at the stucco bands

<b>Blue Line</b>	<b>Rust:</b> Rust and separation were observed at the stucco bands
<b>Green Dot</b>	<b>Surface Damage / Hole:</b> Surface damage and a hole was observed above the rear garage door.

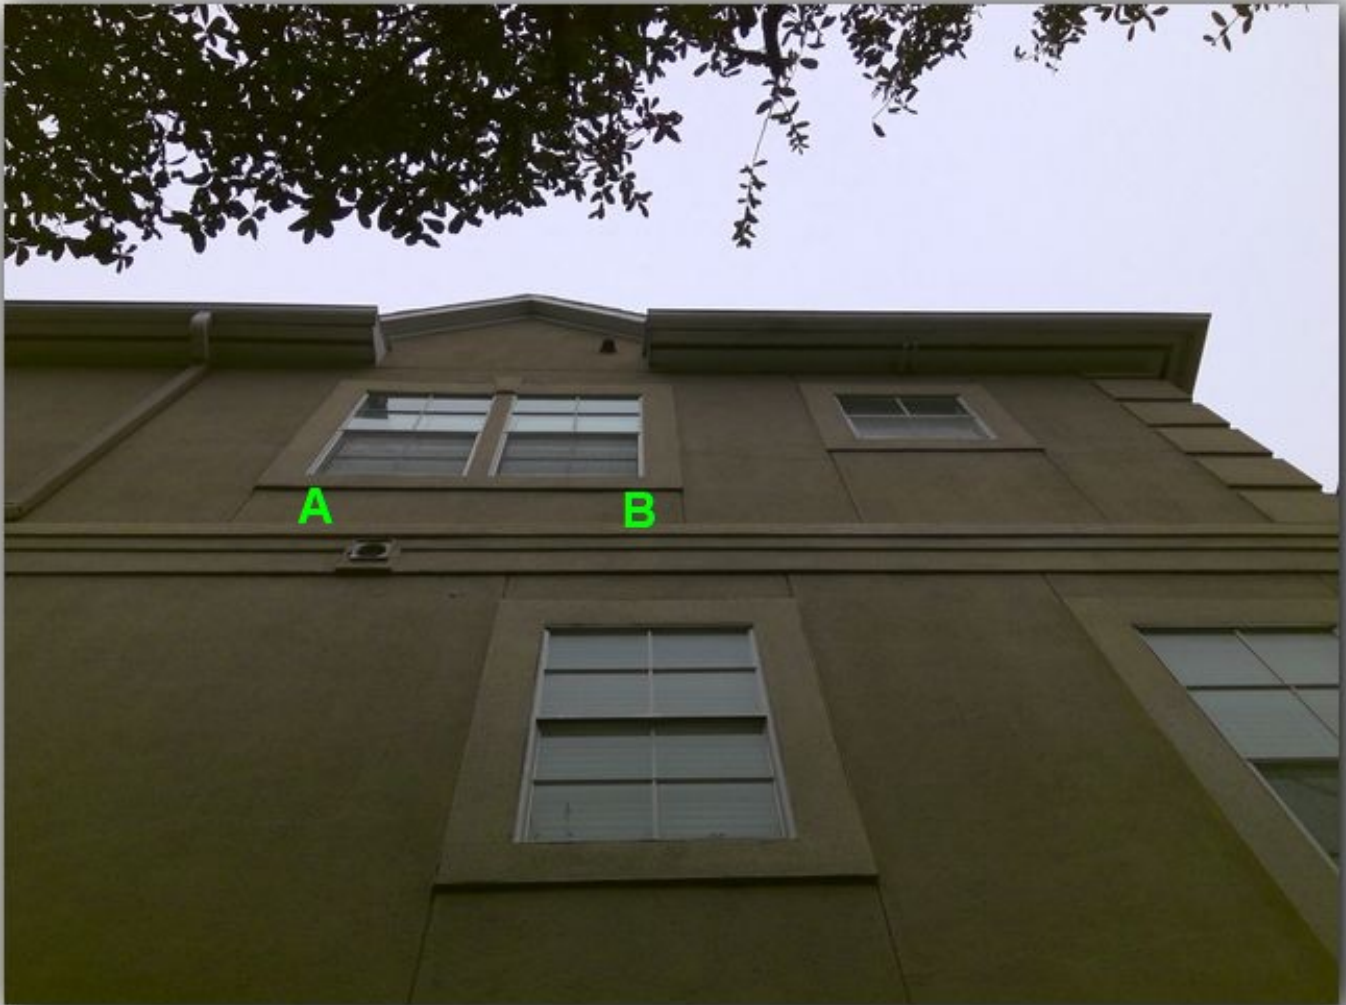
## Rear Side of Structure - 3

Test Location	Moisture Content	Substrate Condition	Additional comments
A	12.5%	Firm	Damaged / aged window sealant.
B	10.6%	Firm	Damaged / aged window sealant.

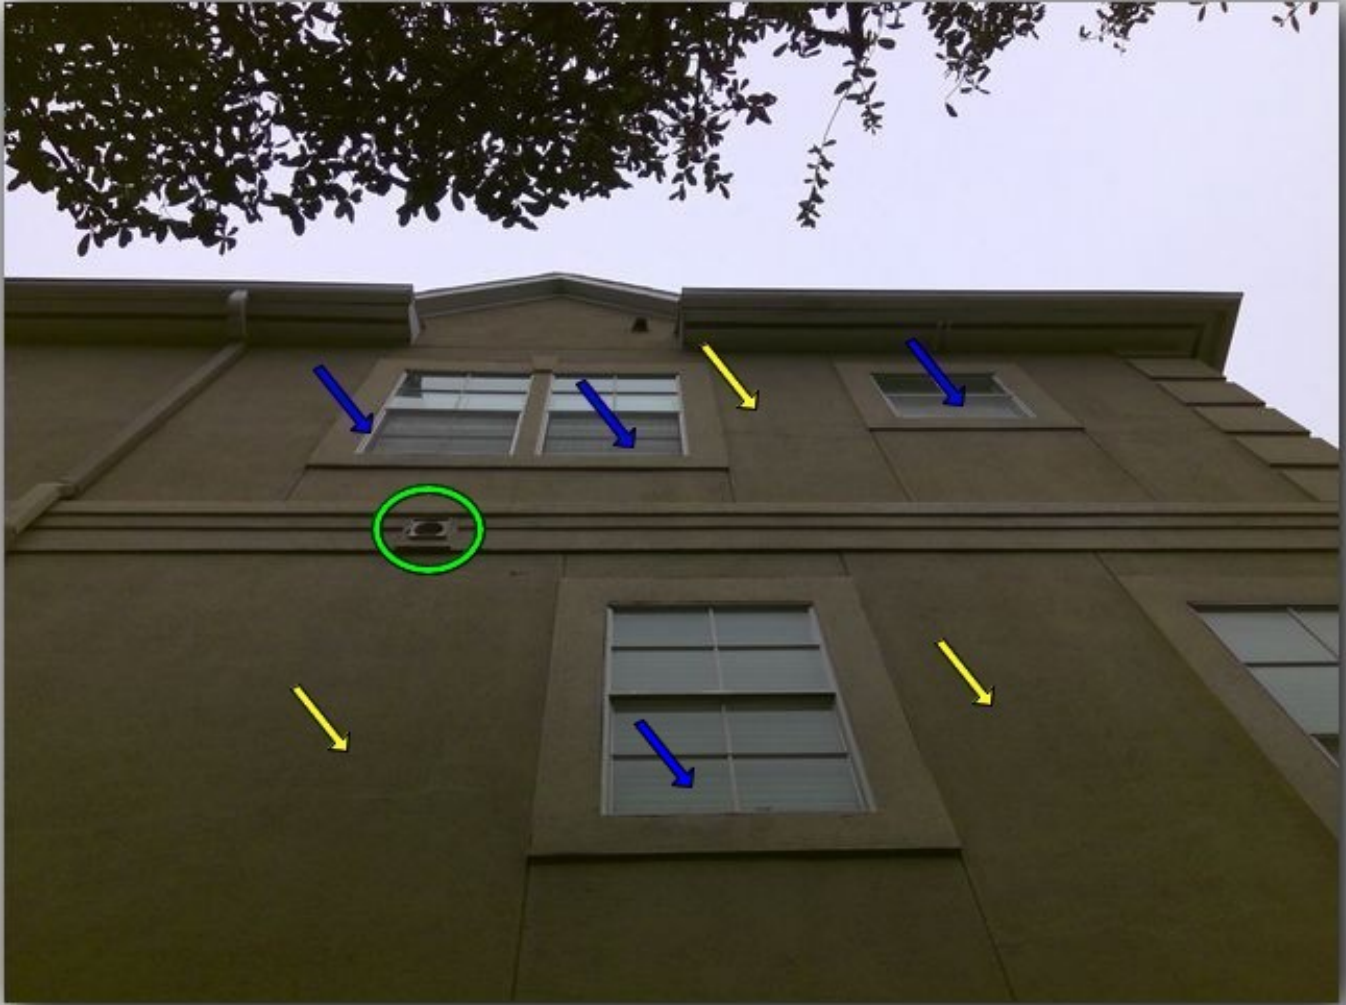
## Rear Side of Structure - 3 Deficiencies

Identifier	Comments
<b>Blue Arrows</b>	<b>Damaged / Aged Sealant:</b> Damaged sealant / caulk was found at the windows. Properly installed sealant provides a barrier against moisture intrusion. Recommend repairs using a quality sealant recommended by the manufacturer of your system. <b>Rust:</b> Rust and separation were observed at the stucco bands
<b>Yellow Arrows</b>	<b>Hairline Cracks:</b> Hairline cracks were observed at the stucco walls. Hairline cracks (generally 1/16 of an inch) are commonly found with stucco systems. These cracks should be monitored and repaired as needed.
<b>Green Circle</b>	<b>Vent Damper Missing:</b> Vent damper is missing. Recommend replacement

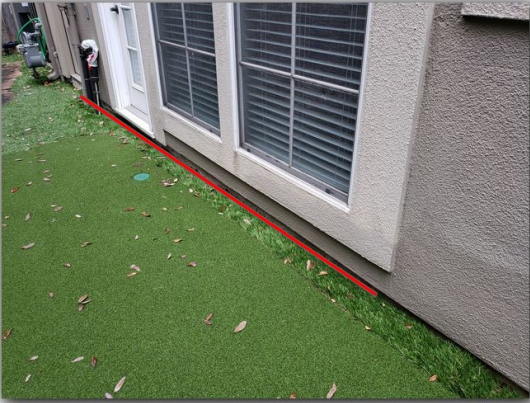
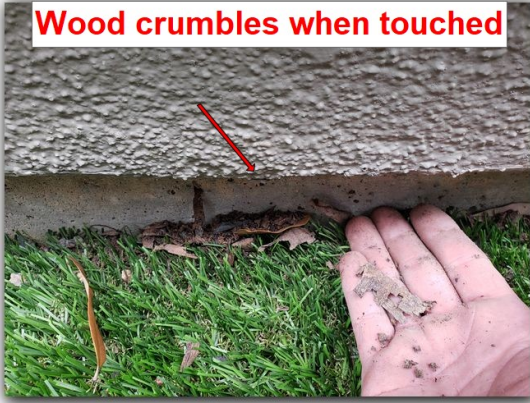
1.1 Location: Rear - Lower wall	1.2 Location: Rear - Lower wall

**1. Moisture Intrusion:** Areas of elevated moisture and / or possible substrate damage was found at the following locations:

**Soft or missing substrate** - If the substrate is not firm when inserting the moisture meter probes, this can indicate possible wood rot / damage due to previous or active water penetrations in the area near the probed location.

It is recommended that these areas be repaired by a qualified stucco contractor. Typical repairs to remedy soft or missing substrate include doing a partial tear-off of the stucco around the location until clean dry substrate is found. Additional information may be provided within this report regarding deficiencies at these locations.

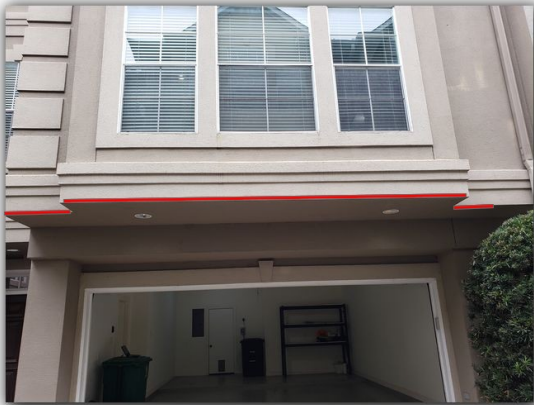
**2.1 Location: Front Overhang**

**2. Missing Drainage Openings:** Drainage openings missing at the stucco walls. Drainage openings assist with allowing incidental moisture to escape. When moisture becomes trapped, the wood can hold the moisture commonly referred to as a "stucco bucket". Recommend installation of drainage openings during repairs.

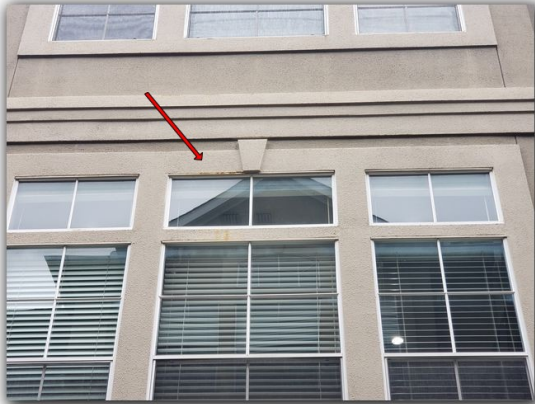
**3.1 Location: Front windows**

**3. Rust:** Rust and separation were observed at most of the stucco bands and the left side quoins. Some areas appear to have been previously patched with sealant. Recommend repairs by a qualified stucco contractor.

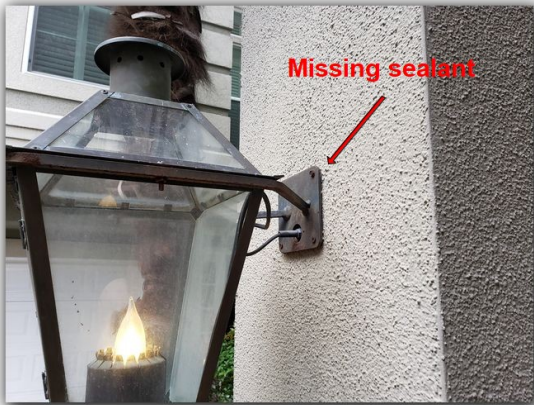
**4.1 Location: Front Light Fixture**

**4. Damaged / Aged Sealant:** Damaged sealant / caulk was found at various wall penetrations, joints, transitions, and / or other voids on the exterior. Properly installed sealant provides a barrier against moisture intrusion. Recommend repairs / replacement of all sealant locations using a quality sealant recommended by the manufacturer of your system.

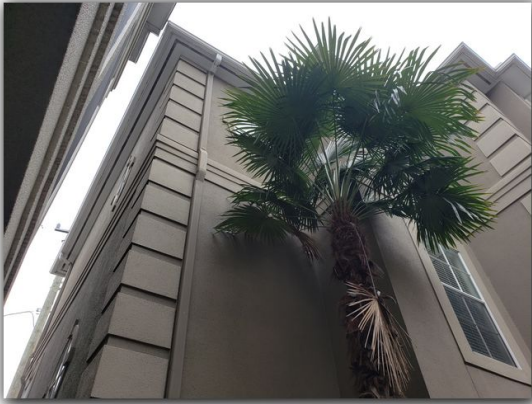
**5.1 Location: Front left**

**5. Trees or Shrubs on Wall:** Trees / shrubs were observed in contact or close to the exterior wall surfaces. Recommend improvements to maintain clearance between the exterior walls and trees / shrubs.

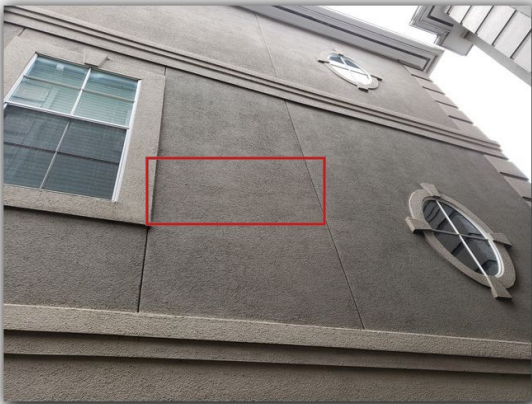
**6.1 Location: Left**

**6. Hairline Cracks:** Hairline cracks were observed at the stucco walls. Hairline cracks (generally 1/16 of an inch) are commonly found with stucco systems. These cracks should be monitored and repaired as needed. The pictures below do not represent **all** hairline cracks as cracks were found throughout the stucco walls.

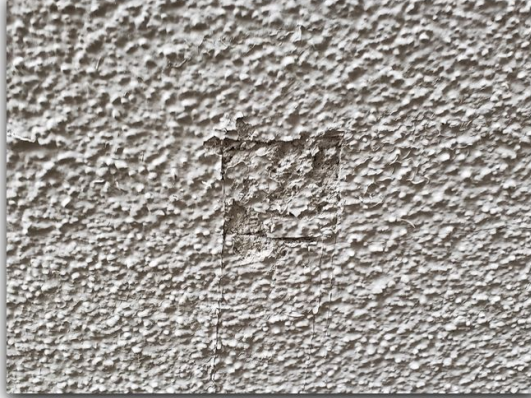
7.1 Location: Rear Garage Door - Hole	7.2 Location: Left wall

7. **Surface Damage:** Surface damage was observed above the rear garage door and on the left wall.

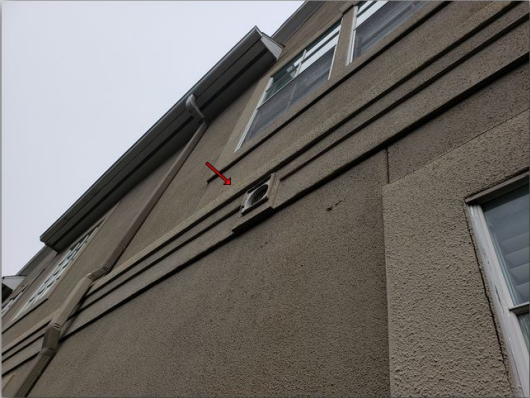
8.1 Location: Rear

8. **Vent Damper Missing:** Vent damper is missing. Recommend replacement

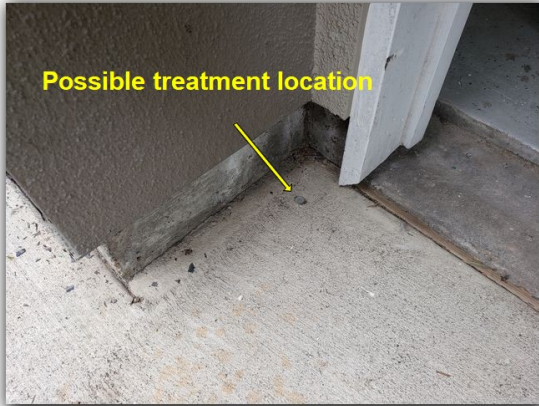
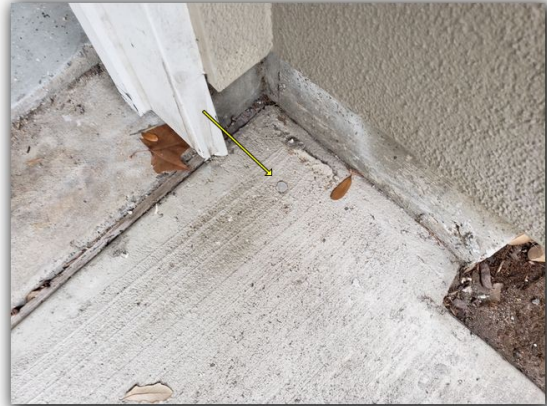
The home appears to have been treated for termites as evident by drill holes at the garage corner. Termite treatments can be due to previous infestation or only as a preventative to prevent termites. Termites can cause damage in areas typically not tested during an invasive stucco inspection. I recommend contacting the current homeowner to determine if a treatment was done, the extent of any damage that may have occurred, and if any warranties exist. Per the buyer's agent, a termite inspection was recently performed and no active termites were discovered.

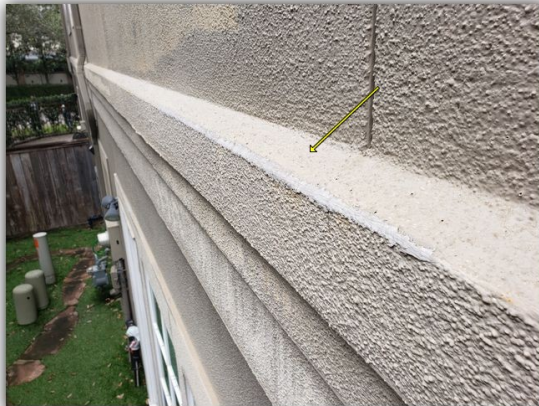
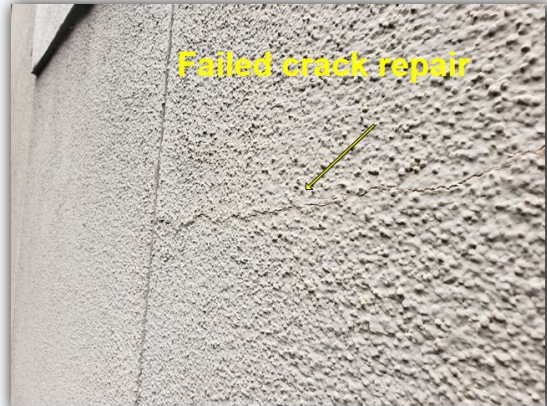
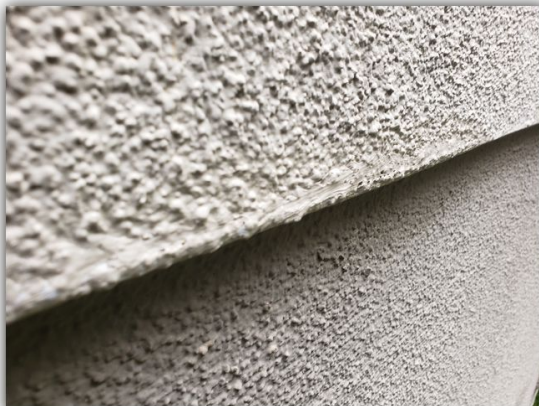
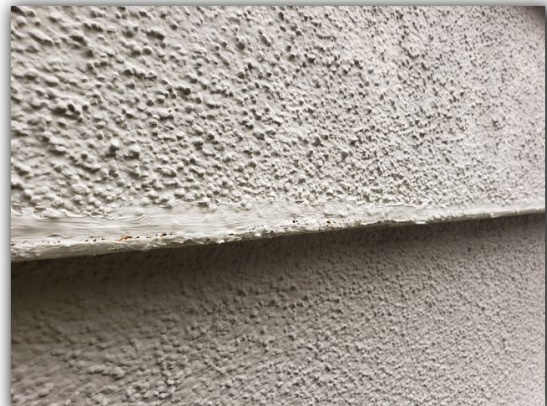
Previous patching was observed at various locations on the rear of the structure. These areas were patched with sealant. The repairs have failed and it is recommended proper repairs are made.
