# Home Inspection Report

4241 Bettis Dr  
Houston, TX 77027

## PROPERTY INSPECTION REPORT

**Inspection Date:** 02/08/2021

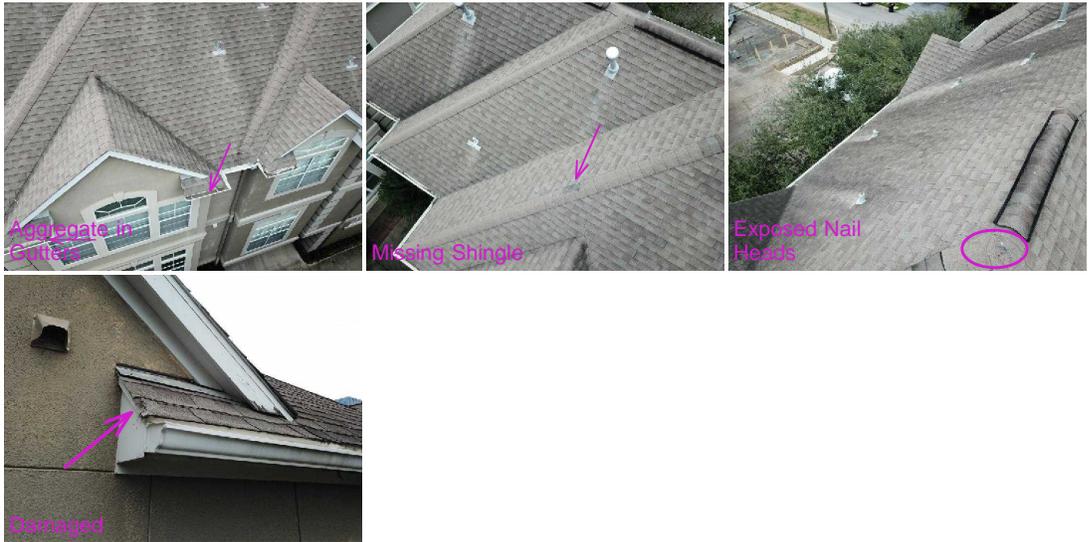
**C. Roof Covering Materials**

1. Found one missing shingle and some damage at the back edge. There were a few exposed nail heads that should be covered to prevent further rusting and there was aggregate in the gutter from wear. Otherwise the roof was as old as the home in my estimation, some of the aggregate had worn away over time and the covering had to have gone through storms due to being in S.E. TX, but it was performing at the time of the inspection. NOTE: Insurance companies have become more strict on underwriting an aged roof. Know that they may not cover full replacement value of this roof due to its age. Recommend contacting your carrier for details.

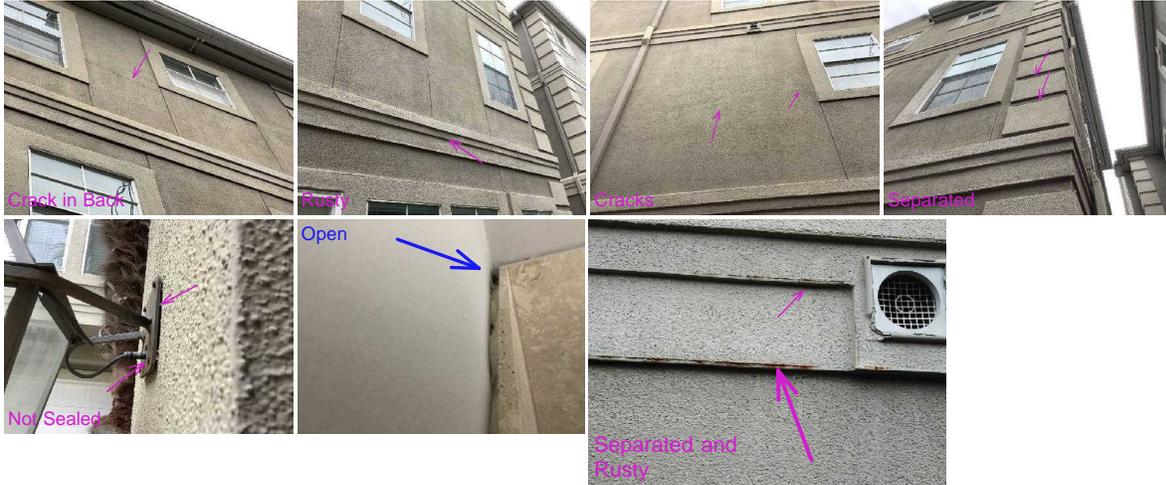
**E. Walls (Interior and Exterior)** - Comments:

1. The stucco system was in need of further evaluation. Some of the sheathing was crumbling at the bottom in the back. There were multiple cracks, fishers, unsealed equipment and rust showing through the finish. I recommend a professional stucco invasive evaluation be performed and estimates for repairs rendered.

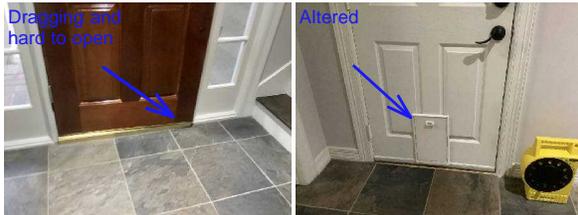
**G. Doors (Interior and Exterior)** - Comments:

1. Front door dragging on threshold and sticking.  
2. Garage access door modified to doggie door breaching design integrity.

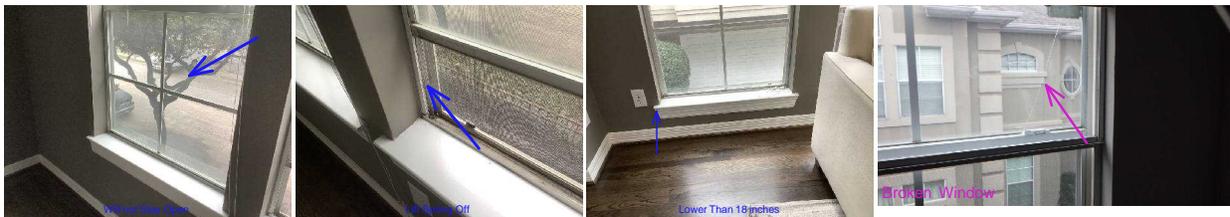
**H. Windows** - Comments:

1. Window in breakfast area off springs and would not stay open.  
2. Lift springs off a few of the window sashes.  
3. Windows with sills less than 18 inches from the floor and glass not labeled as safety glass.  
4. One broken pane in the front of the house, third story.

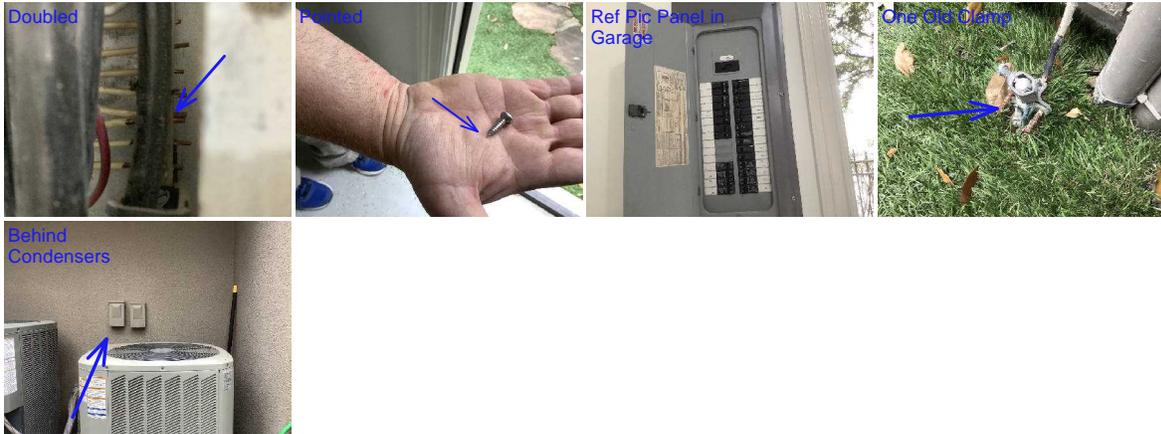
**A. Service Entrance and Panels** - Comments: 150 Amp Main,

1. White (Neutral) wires "Double Lugged" under lugs on the buss bar. There should only be one wire per lug.
2. Fasteners (screws) securing panel face were pointed, those are the wrong type, only blunt panel screws authorized by the manufacture should be used.
3. One of the ground clamp was the old type pipe clamp not the newer style acorn clamp.
4. Condenser electrical isolate panel installed behind the condenser unit, those panels should conform to standard panel clearances.
5. AC electrical isolate panel installed behind the condenser unit, those panels should conform to standard panel clearances.
6. No installed AFCI breakers, they were not required when the unit was built, but are a notable safety device.

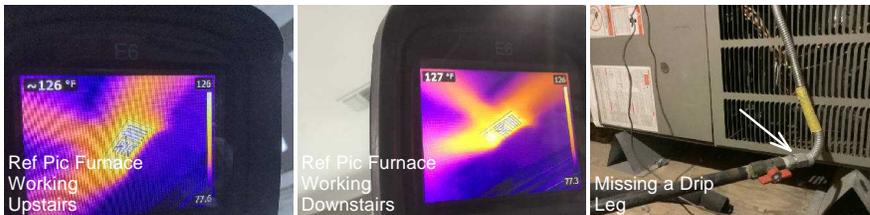
**A. Heating Equipment**

1. Missing a drip-legs (sediment traps) on the gas line servicing the unit(s). Otherwise the furnace(s) were working well.

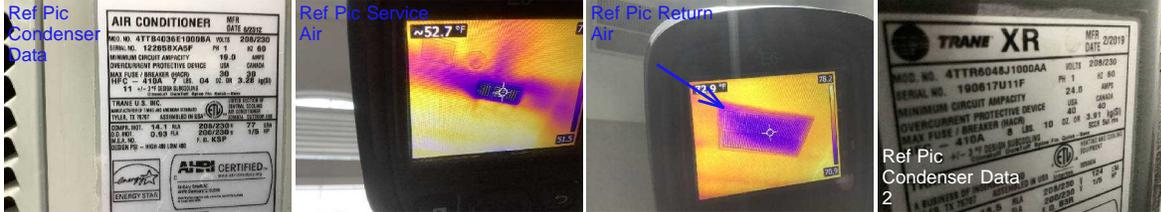
**B. Cooling Equipment**

Type of Systems: Central Forced Air  
 Comments: Trane 2012 R410A, Trane 2019 R410A  
 System in good order and cooling well at the time of the inspections.

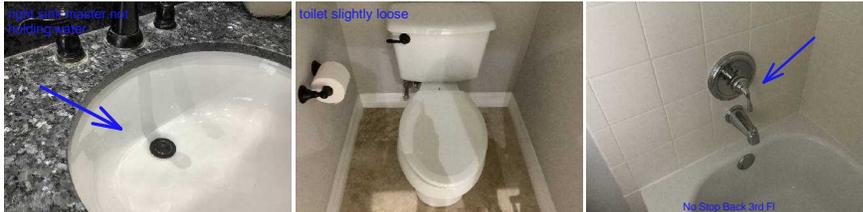
**A. Plumbing Supply, Distribution Systems and Fixtures**

Location of water meter: Unknown, curb Likely  
 Location of main water supply valve: Back  
 Static water pressure reading: 60 PSI  
 Comments: Copper  
 1. Right sink master bath not holding water  
 2. Toilet in master a bit loose on floor mounts, it wobbles a little.  
 3. Shower valve at third floor shower had no stop, it would spin around.

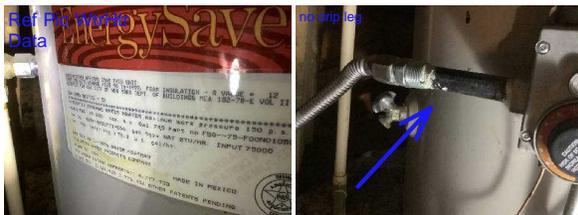
**C. Water Heating Equipment**

Energy Sources: Natural gas  
 Capacity: 75 Gal  
 Comments: A.O. Smith  
 1. Missing drip-leg/sediment trap from gas service line. The unit was likely original, that puts it at 21 years old. The normal life expectancy of a standard gas water heater is 8-12. The unit did pop and gurgle during operation. The unit was beyond the end of its normal life expectancy, but it was still working.

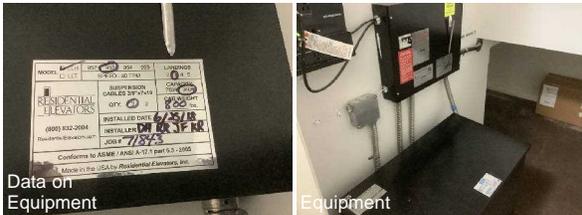
**☒☐☐☒ I. Other - Comments:**

There was an installed elevator. While I am not an elevator inspector I did operate the unit and it worked. There was limited information available to me. I do recommend attaining any relevant documents including service records.

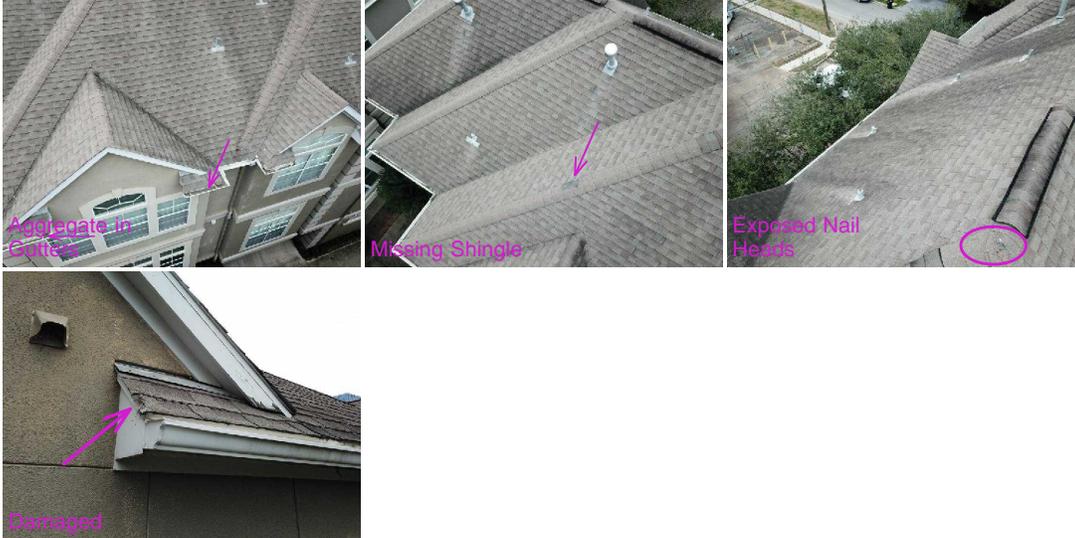
#### C. Roof Covering Materials

1. Found one missing shingle and some damage at the back edge. There were a few exposed nail heads that should be covered to prevent further rusting and there was aggregate in the gutter from wear. Otherwise the roof was as old as the home in my estimation, some of the aggregate had worn away over time and the covering had to have gone through storms due to being in S.E. TX, but it was performing at the time of the inspection. NOTE: Insurance companies have become more strict on underwriting an aged roof. Know that they may not cover full replacement value of this roof due to its age. Recommend contacting your carrier for details.

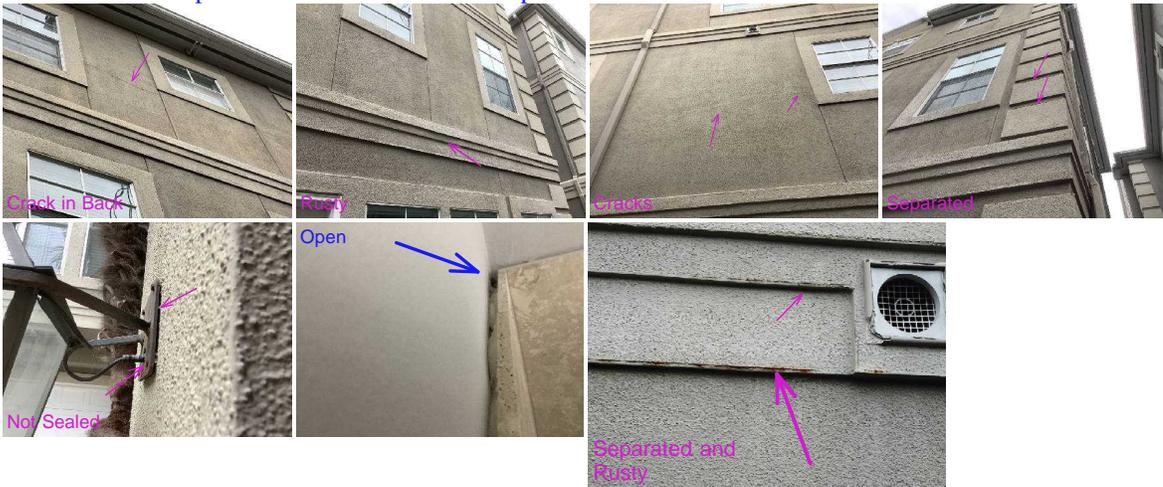
#### E. Walls (Interior and Exterior)

1. The stucco system was in need of further evaluation. Some of the sheathing was crumbling at the bottom in the back. There were multiple cracks, fishers, unsealed equipment and rust showing through the finish. I recommend a professional stucco invasive evaluation be performed and estimates for repairs rendered.

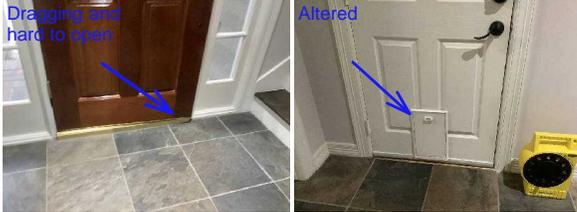
### G. Doors (Interior and Exterior)

1. Front door dragging on threshold and sticking.
2. Garage access door modified to doggie door breaching design integrity.

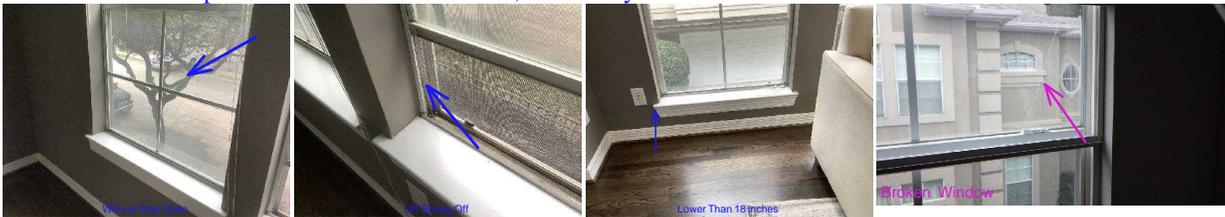
### H. Windows

1. Window in breakfast area off springs and would not stay open.
2. Lift springs off a few of the window sashes.
3. Windows with sills less than 18 inches from the floor and glass not labeled as safety glass.
4. One broken pane in the front or the house, third story.

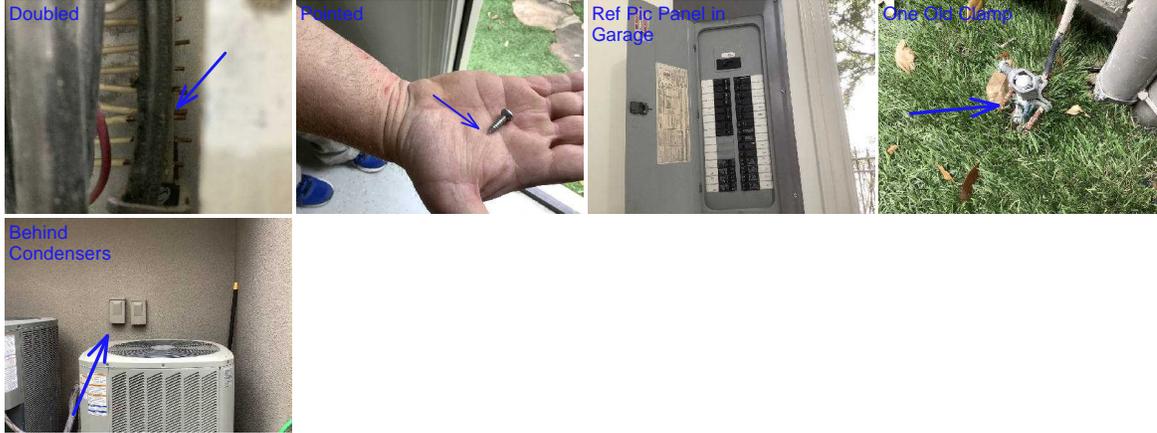
**A. Service Entrance and Panels (continued)**

1. White (Neutral) wires "Double Lugged" under lugs on the buss bar. There should only be one wire per lug.
2. Fasteners (screws) securing panel face were pointed, those are the wrong type, only blunt panel screws authorized by the manufacture should be used.
3. One of the ground clamp was the old type pipe clamp not the newer style acorn clamp.
4. Condenser electrical isolate panel installed behind the condenser unit, those panels should conform to standard panel clearances.
5. AC electrical isolate panel installed behind the condenser unit, those panels should conform to standard panel clearances.
6. No installed AFCI breakers, they were not required when the unit was built, but are a notable safety device.

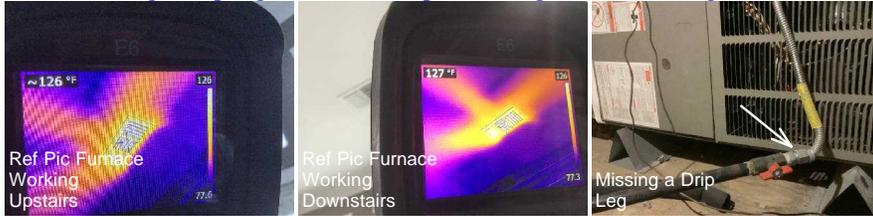
**A. Heating Equipment**

1. Missing a drip-legs (sediment traps) on the gas line servicing the unit(s). Otherwise the furnace(s) were working well.

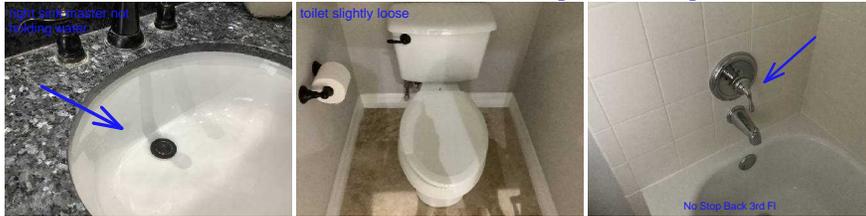
**A. Plumbing Supply, Distribution Systems and Fixtures Copper,**

1. Right sink master bath not holding water
2. Toilet in master a bit loose on floor mounts, it wobbles a little.
3. Shower valve at third floor shower had no stop, it would spin around.

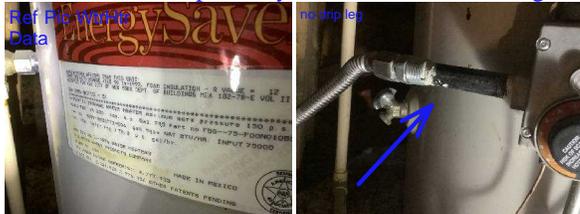
**C. Water Heating Equipment A.O. Smith,**

1. Missing drip-leg/sediment trap from gas service line. The unit was likely original, that puts it at 21 years old. The normal life expectancy of a standard gas water heater is 8-12. The unit did pop and gurgle during operation. The unit was beyond the end of its normal life expectancy, but it was still working.

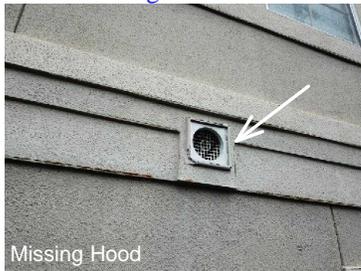
F. Mechanical Exhaust Vents and Bathroom Heaters

- 1. Missing Hood from one of the terminations at exterior wall.

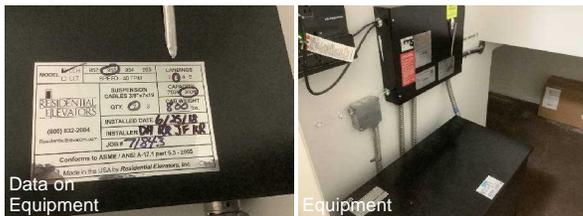
I. Other

There was an installed elevator. While I am not an elevator inspector I did operate the unit and it worked. There was limited information available to me. I do recommend attaining any relevant documents including service records.
