TREC REI 7-6 SUPER INSPECTOR RESIDENTIAL INSPECTION*

2506 Huckleberry Ln
Pasadena, TX 77502

PROPERTY INSPECTION REPORT FORM

Cristina Gutierrez <i>Name of Client</i>	03/09/2024 9:00 am <i>Date of Inspection</i>
2506 Huckleberry Ln, Pasadena, TX 77502 <i>Address of Inspected Property</i>	
Robert Dillin <i>Name of Inspector</i>	TREC #21702 <i>TREC License #</i>
<i>Name of Sponsor (if applicable)</i>	<i>TREC License #</i>

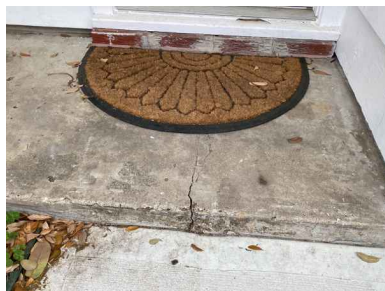
1: Foundation Wall Cracks

Cracks were observed in the foundation wall at one or more locations.

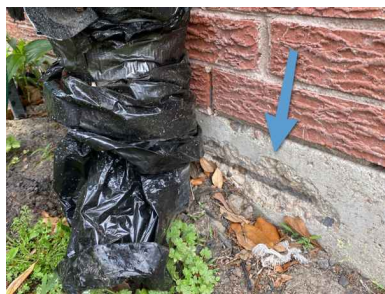
3: Exposed Rebar

There is exposed reinforcement steel at one or more locations on the foundation. Reinforcement steel should be covered with non-shrink / non-metallic grout. The grout used for this repair should not contain any chemicals known to be destructive to the reinforcing steel. Contact a qualified service company for corrective action. Please note that some areas of the perimeter beam(s) was/were hidden from view by soil or vegetation; therefore, other exposed reinforcing steel may exist.

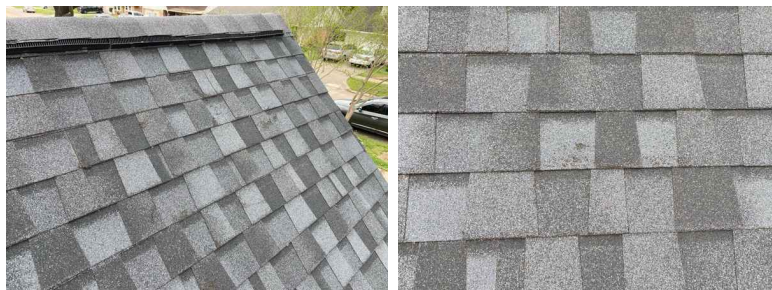
2: Scuffed shingles

There are multiple scuffed shingles on the roof. Scuffing commonly occurs during construction of new roofs as a result of excessive foot traffic on the roof. The scuffing does not normally affect the overall performance of the roof. The affected shingles should be monitored for premature aging and replaced as necessary.

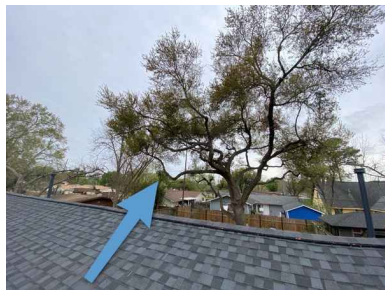
3: Tree limbs hanging over roof

There are tree limbs hanging over the roof. Tree limbs should be trimmed and maintained away from the house to prevent damage to the roof covering .

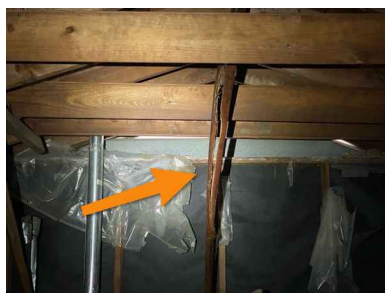
4: Roof bracing broken or not properly supported

Rafters are broken or not properly supported in one or more locations. The braces should be repaired to ensure the roof structure is properly supported.

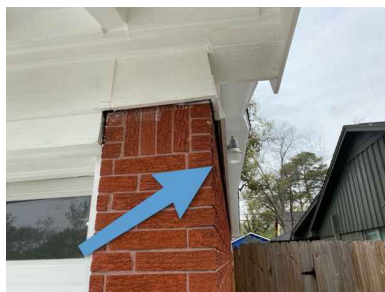
5: Frieze board separated from wall

The frieze board is separated from the brick or wall at one or more locations. This may indicate settling and/or seasonal movement in those areas. Monitor these areas for additional changes. Further evaluation may be necessary if other foundation related issues persist.

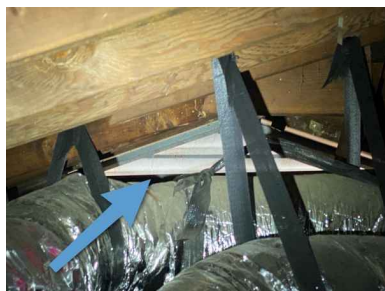
8: Gable screen damaged

One or more gable vent screens are damaged. This may allow for pests / rodents to gain access to the attic space. Repair of the gable screens is recommended.

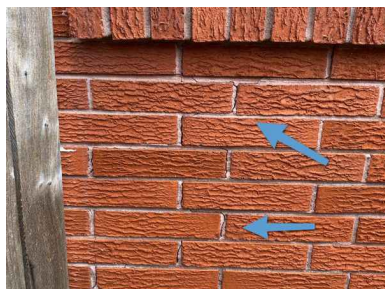
2: Exterior Wall Common Cracks

One or more common cracks were observed on the brick / stone veneer. This may be due to normal settling and/or thermal movement of the building materials. These areas should be sealed to prevent moisture penetration and monitored for further signs of movement.

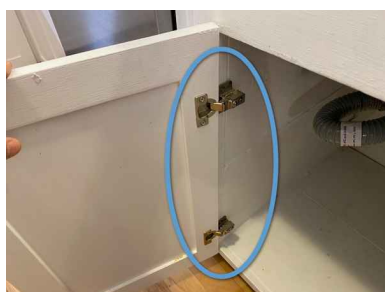
4: Damage to Cabinets

There is damage to the cabinets in various places. This could be from poor installation, heavy use, or a one time damage event. Repair as necessary.

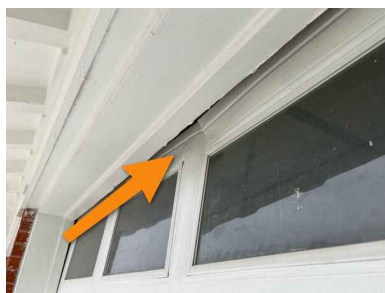
3: Cracked garage door panel

One or more garage door panels are cracked. The cracks will worsen over time, possibly causing the door to fail. Further evaluation of the door panels by qualified overhead door technician is advised.

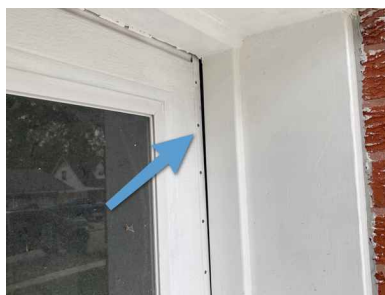
4: Garage Door needs adjustment

There's a gap between the garage door and the frame of the door. The door should be adjusted to prevent pest entry in the moisture penetration.

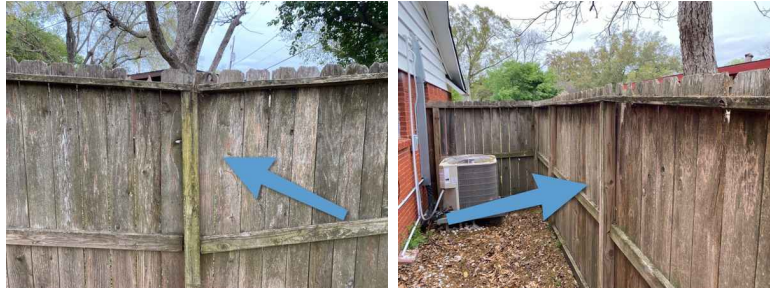
2: Leaning Fence

The fence is leaning over at one or more locations. Repair as necessary.

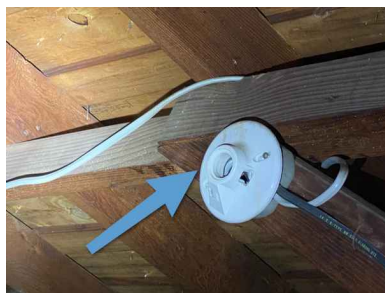
3: Light damaged

There are one or more lights that are damaged. The light fixture should be replaced to allow use in this area.

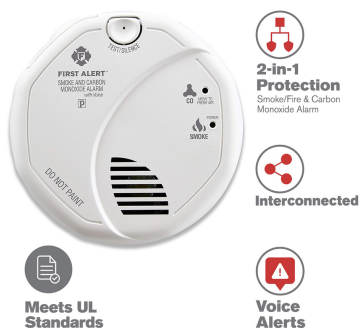
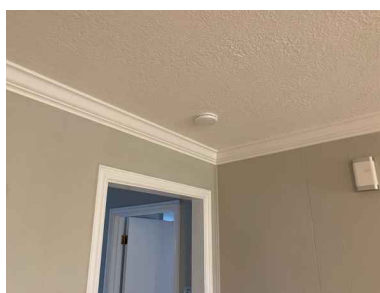
4: Missing CO alarms

There are missing carbon monoxide alarms in the home. Carbon monoxide alarms should be installed in accordance with current standards, as follows: 2009 International Residential Code R315.2.1 New construction. Carbon monoxide alarms shall be provided in dwelling units when either or both of the following conditions exist: 1.) **The dwelling unit contains a fuel - fired appliance.** 2.) The dwelling unit has an **attached garage with an opening that communicates with the dwelling unit.** R315.3 Location. Carbon monoxide alarms in dwelling units shall be **installed outside of each separate sleeping area in the immediate vicinity of the bedrooms.** When a fuel - burning appliance is located within a bedroom or its attached bathroom, a carbon monoxide alarm shall be installed within the bedroom. Carbon monoxide is an odorless, colorless, and tasteless gas that is near impossible to identify without a proper detector. It is caused by fuels not burning completely, including wood, gasoline, coal, propane, natural gas, gasoline, and heating oil. This unburned fuel can come from anything from clothes dryers, water heaters, and ovens to ranges, a fire - burning fireplace, or a car left running in a closed garage.

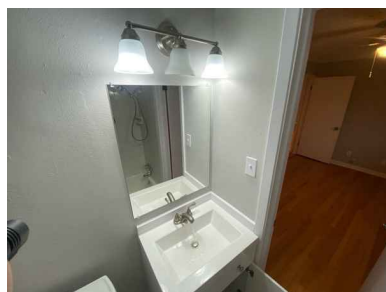
5: Missing, outlets

The vanity in the master bathroom does not have outlet service. This will limit the use of electrical devices at the sink. Install an outlet as needed.

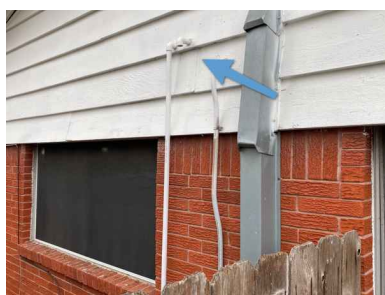
2: ECD improperly located

The emergency condensate drain is improperly located. The drain should be conspicuously located, usually over a door or window, to alert the home owner when the drain is active.

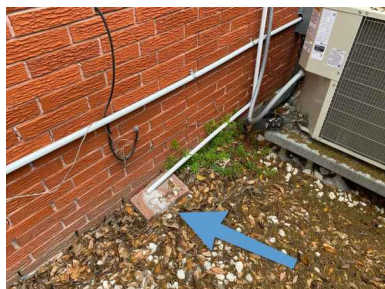
3: Condensate drains near foundation

The primary condensate drain line terminates near the foundation. This is an acceptable practice on this age of a house. However, this could excessively hydrate the soil in this area and may possibly cause foundation settling. It is my recommendation that an 18" to 24" extension be installed to remove the condensation produced by the AC unit from terminating next to the foundation.

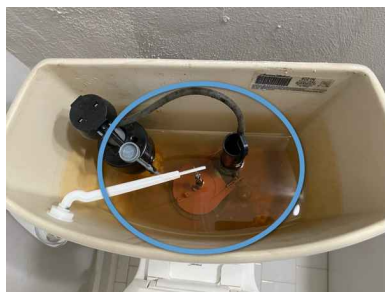
1: Tank bolts rusted

One or more toilet tank bolts are rusted. The bolts should be monitored for leaks and replaced as required.

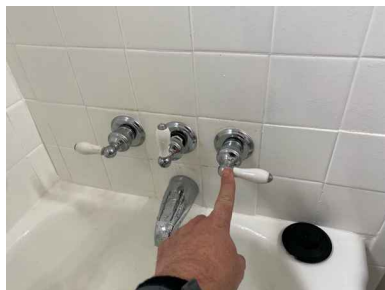
4: Faulty Faucet Valve Stop

The valve stop for the temperature control knob at the **sink/bathtub/shower** is damaged or missing. This may also allow the valve handle to rotate 360 degrees. A valve stop should be installed to prevent confusion when setting the water temperature. Further evaluation by a licensed plumber is recommended.

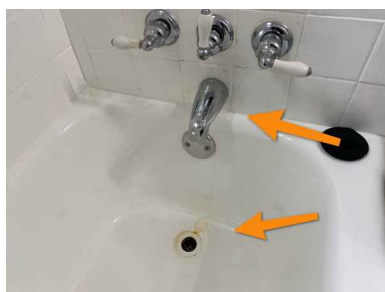
6: Interior Faucet Leaks

One or more interior faucets drips when turned off. Recommend a qualified plumber evaluate and repair.

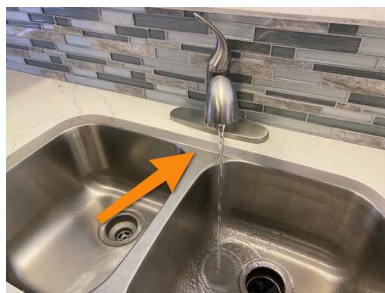
7: Interior Faucet Restricted flow

Water flow to one or more faucets appears to be restricted. This often occurs as sediment builds up at valves or inside the faucet, but may also indicate a blockage, or low water pressure. Further evaluation and/or repair by a licensed plumber is advised.

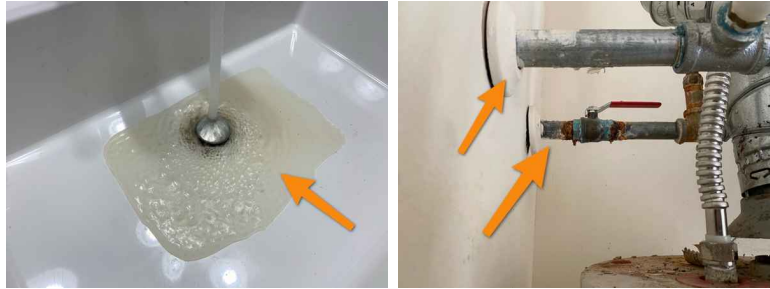
11: Galvanized water pipe

The presence of galvanized piping can increase the risk of water damage as the material ages. Galvanized piping will eventually need to be replaced if housing stock is to outlast a 50 to 70 year life expectancy.
