Susan Skinner 12800 Melville Dr Unit #B110 Montgomery, TX 77356 September 29, 2021

Inspected By: Erik Placker TREC # 21184

ESP Home Inspection

PROPERTY INSPECTION REPORT

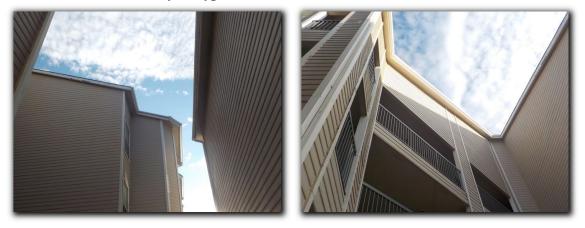
This structure has a 25 - 30 year type Roof. Unknown Condition

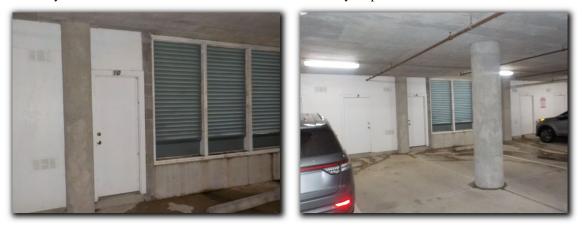
There appears to be a storage room for each unit located in the lower parking garage. This door was locked and no key was found. Unknown defects and/or deficiencies may be present.

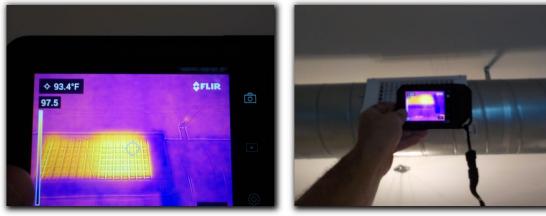
Model Number A36-10 Serial Number 9605019178

Approximate System Age: 1996

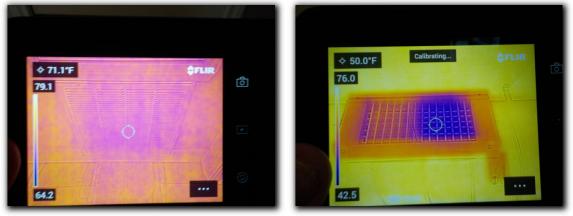
Today's Temperature Differential (Delta-T): 21 Degrees (normal range 14° - 23°).

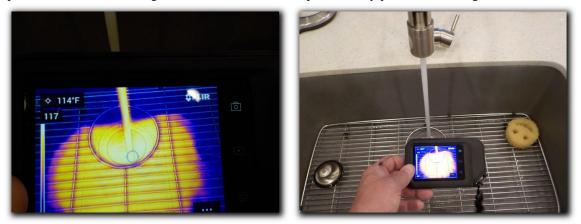
Avg. Hot Water Temperature: 114° Recommended Hot Water is between 115 – 120°
