Moisture Assessment Report

Nishant Shah and Mita Das

2629 Westgate Street, Unit A

Project Information

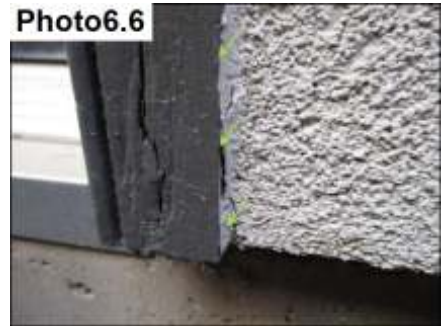
Photo6.6

Door Sealants / Seal

Grid Location	Item Description	Moisture Readings	Substrate Condition	Observations
Green Arrows	Doors			The door trim and miter sealants are aged, separated or missing at these locations. The inspector suggests to have a qualified waterproofing contractor seal these areas with a low modulus sealant in an effort to prevent moisture intrusion. These types of sealants are of high quality and compatible with stucco and other termination points. Please refer to photos #6.2, #6.3, #6.4, #6.5 and #6.6 for more detail.

All noted areas have been sealed/caulked.

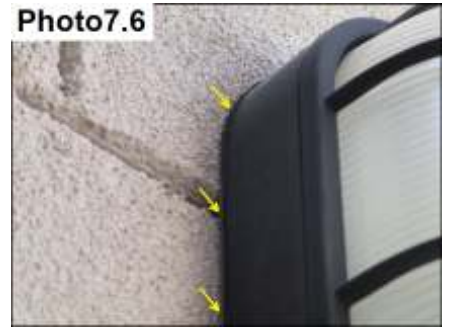
Photo7.6

Penetration Sealants / Seal

Grid Location	Item Description	Moisture Readings	Substrate Condition	Observations
Yellow Arrows	Penetrations			The penetration sealants are aged, separated or missing in these locations. The inspector suggests to have a qualified waterproofing contractor seal these areas with a low modulus sealant in an effort to prevent moisture intrusion. These types of sealants are of high quality and compatible with stucco and other termination points. Please refer to photos #7.2, #7.3, #7.4, #7.5 and #7.6 for more detail.

All noted areas have been sealed/caulked.

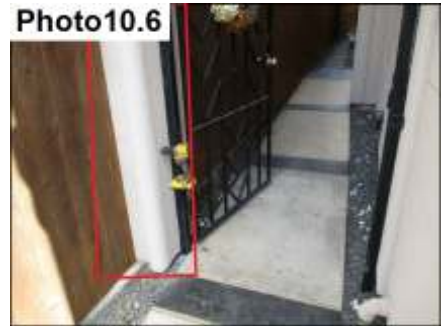
Photo10.6

Damaged Entryway / Assess And Repair

Grid Location	Item Description	Moisture Readings	Substrate Condition	Observations
Red Box	Damage			The entryway accent wall is missing a metal cap with sizable cracks at the wall of the structure allowing excess moisture into the system. Confirmed substrate and potential frame damage is noted at this location. The inspector recommends having a qualified waterproofing contractor further assess the extent of damage, repair as needed and install a proper relief and metal cap in an effort to prevent moisture intrusion. Please refer to photos #10.2, #10.3, #10.4, #10.5, 10.6, #11.1, #11.2, #11.3 and #11.4 for more detail.

A metal cap was placed on the top of the entry flat accent area. All cracks were caulked/sealed.

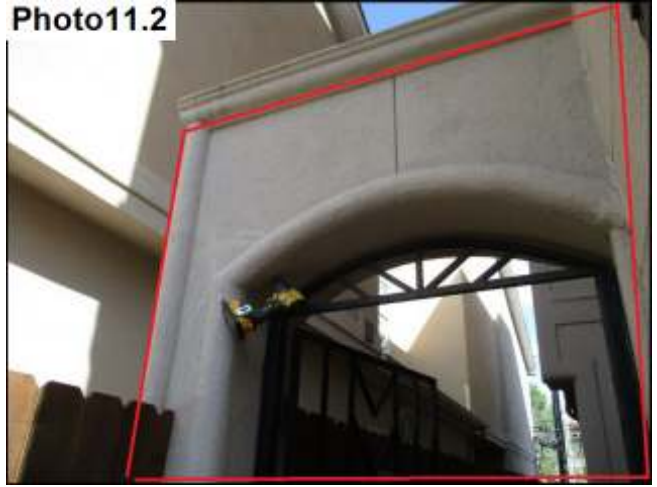
Photo11.2

Damaged Entryway / Assess And Repair

[The entry area has been waterproofed.](#)

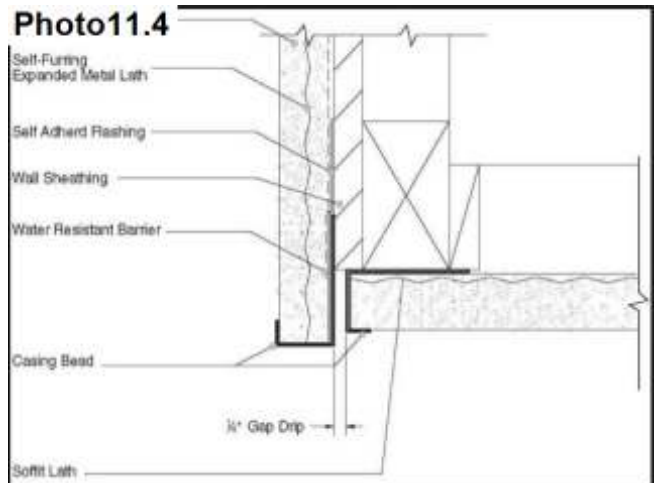
Photo11.4

Proper Relief Detail

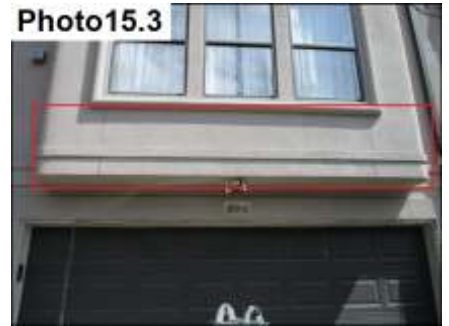
Photo15.3

Substrate Damage /
Assess, Repair & Install Relief

Grid Location	Item Description	Moisture Readings	Substrate Condition	Observations
Red Box	Damage			Confirmed substrate and potential frame damage is noted at the bottom of the bumpout wall below the bank of windows. The inspector recommends having a qualified waterproofing contractor further assess the extent of damage, repair as needed and install a proper relief in an effort to prevent moisture intrusion. Please refer to photos #15.2, #15.3, #15.4, #15.5 and #15.6 for more detail.

All damaged areas were replaced and a relief was added.

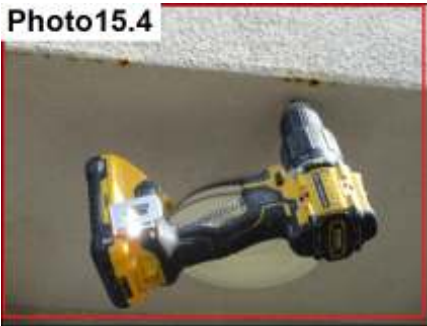
Photo15.4

Substrate Damage /
Assess, Repair & Install Relief

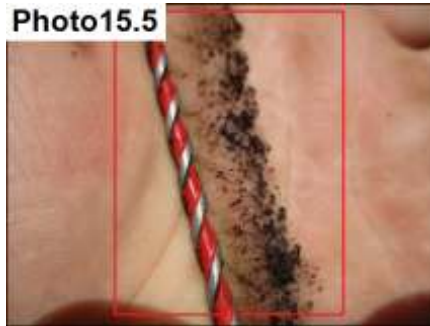
Photo15.5

Substrate Damage /
Assess, Repair & Install Relief

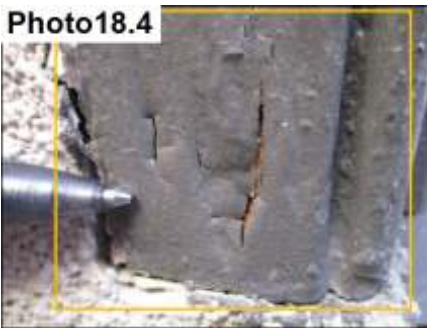
Photo18.4

Wood Rot on Door Trim / Repair

Grid Location	Item Description	Moisture Readings	Substrate Condition	Observations
Orange Boxes	Wood Rot			The door trim at this area has wood rot. The inspector suggests to have a qualified contractor further assess and repair this area as needed in an effort to prevent moisture intrusion. All wood rot was not necessarily identified in this report. Please refer to photos #18.2, #18.3, #18.4, #18.5 and #18.6 for more detail.

All rotted wood was replaced and painted.

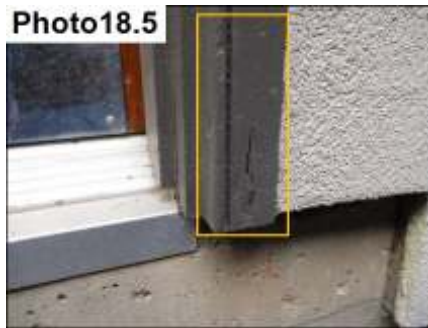
Photo18.5

Wood Rot on Door Trim / Repair

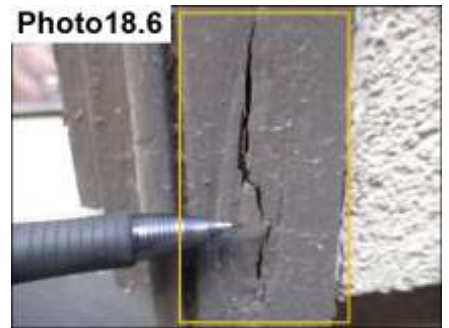
Photo18.6

Wood Rot on Door Trim / Repair

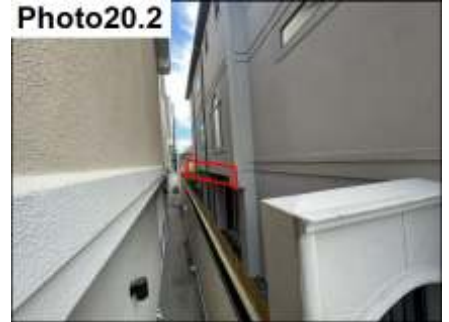
Photo20.2

Damage / Core Sample & Repair As Needed

Grid Location	Item Description	Moisture Readings	Substrate Condition	Observations
Red Box	Potential Damage			Soft substrate is noted at the bottom of the wall below the bank of windows. The inspector recommends having a qualified waterproofing contractor core sample to further assess the extent, then repair if needed and install a proper relief in an effort to prevent moisture intrusion. Please refer to photos #20.2, #20.3, #20.4, #20.5 and #20.6 for more detail.

All damage substrate was replaced and a relief was added.

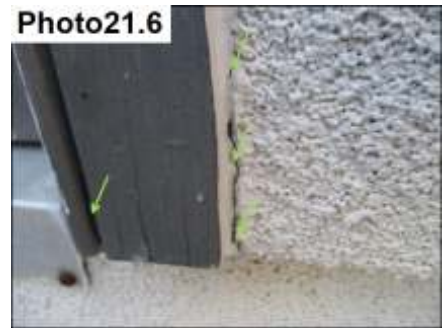
Photo21.6

Door Sealants / Seal

Grid Location	Item Description	Moisture Readings	Substrate Condition	Observations
Green Arrows	Doors			The door trim and miter sealants are aged or separated at these locations. The inspector suggests to have a qualified waterproofing contractor seal these areas with a low modulus sealant in an effort to prevent moisture intrusion. These types of sealants are of high quality and compatible with stucco and other termination points. Please refer to photos #21.2, #21.3, #21.4, #21.5 and #21.6 for more detail.

All noted areas have been sealed/caulked.

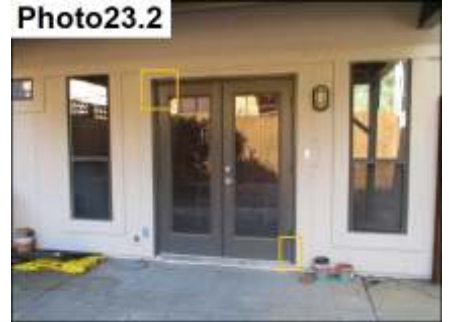
Photo23.2

Wood Rot on Door Trim / Repair

Grid Location	Item Description	Moisture Readings	Substrate Condition	Observations
Orange Boxes	Wood Rot			The door trim at this area has wood rot. The inspector suggests to have a qualified contractor further assess and repair this area as needed in an effort to prevent moisture intrusion. All wood rot was not necessarily identified in this report. Please refer to photos #23.2, #23.3, #23.4, #23.5, #23.6, #24.1, #24.2, #24.3 and #24.4 for more detail.

All wood rot has been replaced and painted.

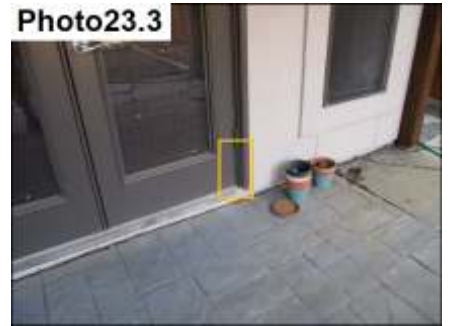
Photo23.3

Wood Rot on Door Trim / Repair

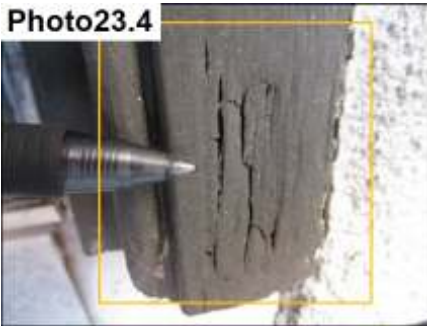
Photo23.4

Wood Rot on Door Trim / Repair

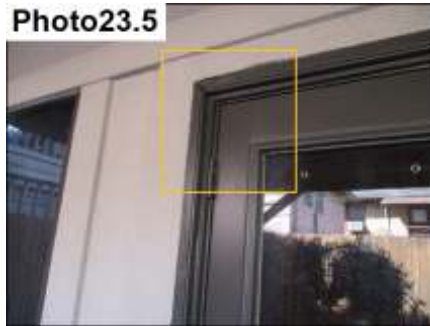
Photo23.5

Wood Rot on Door Trim / Repair

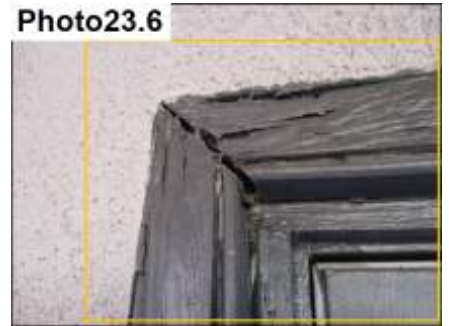
Photo23.6

Wood Rot on Door Trim / Repair

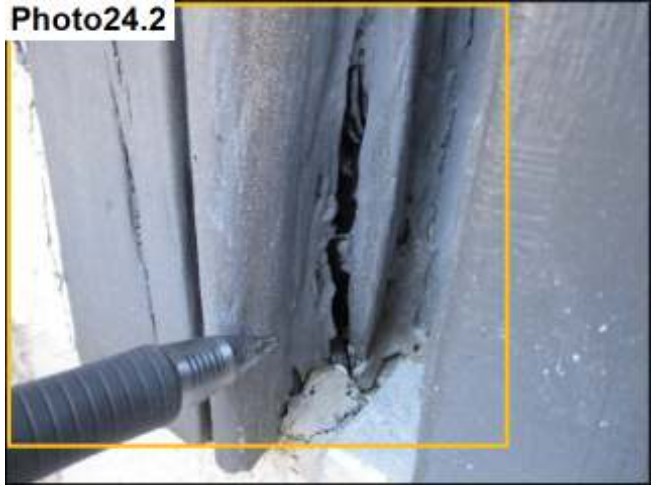
Photo24.2

Wood Rot on Door Trim / Repair

All wood rot has been replaced and painted.

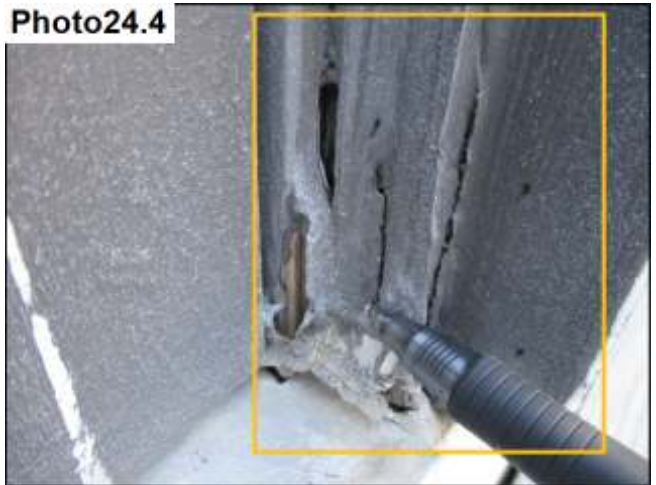
Photo24.4

Wood Rot on Door Trim / Repair

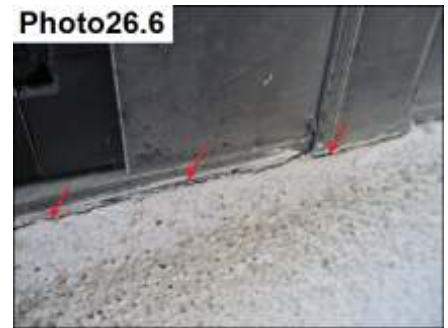
Window Sealants / Seal

Grid Location	Item Description	Moisture Readings	Substrate Condition	Observations
Red Arrows	Windows			The window sealants are aged or separated. The inspector suggests to have a qualified waterproofing contractor further assess and seal these areas with a low modulus sealant in an effort to prevent moisture intrusion. These types of sealants are of high quality and compatible with stucco and other termination points. Please refer to photos #26.2, #26.3, #26.4, #26.5 and #26.6 for more detail.
E5	Window Lower Right	12%	Firm	A moisture probe was taken at the window lower right. The substrate was firm with no damage noted at this time.
F5	Window Lower Left	12%	Firm	A moisture probe was taken at the window lower left. The substrate was firm with no damage noted at this time.
E4	Window Header	12%	Firm	A moisture probe was taken at the window header below the window lower left. The substrate was firm with no damage noted at this time.

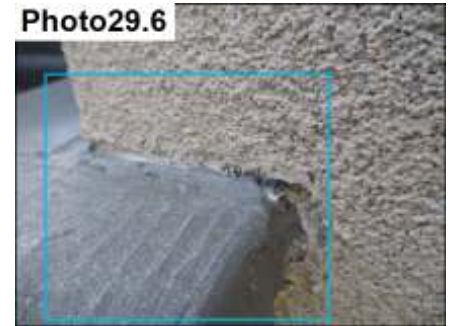
Railing & Stucco Termination / Seal

Grid Location	Item Description	Moisture Readings	Substrate Condition	Observations
Blue Boxes	Railing & Stucco Termination			Railing/stucco termination sealants are aged or separated at these locations. The inspector suggests to have a qualified waterproofing contractor further assess and seal these areas with a low modulus sealant in an effort to prevent moisture intrusion. These types of sealants are of high quality and compatible with stucco and other termination points. Please refer to photos #29.2, #29.3, #29.4, #29.5 and #29.6 for more detail.
D6	Below Railing & Stucco Termination	12%	Firm	A moisture probe was taken below the railing and stucco termination. The substrate was firm with no damage noted at this time
G5	Below Railing & Stucco Termination	12%	Firm	A moisture probe was taken below the railing and stucco termination. The substrate was firm with no damage noted at this time

All noted areas have been caulked/sealed.

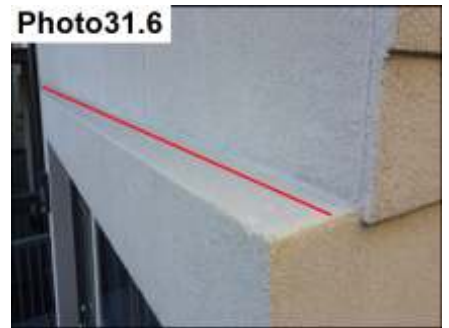
Photo31.6

Flat Accent / Install Metal Cap or Apply Elastomeric Coating

Grid Location	Item Description	Moisture Readings	Substrate Condition	Observations
Red Line	Flat Accent			A flat accent has been noted in this area. Although the moisture levels were acceptable the inspector suggests to have a waterproofing contractor further assess and to apply elastomeric coating or install a metal cap as needed, in an effort to prevent moisture intrusion. Please refer to photos #31.2, #21.3, #31.4, #31.5 and #31.6 for more detail.

The noted flat accent area was painted 3 times with an elastomeric paint.

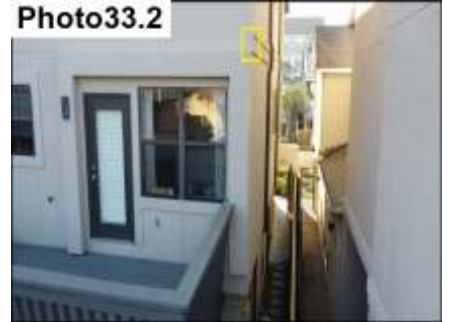
Photo33.2

Cracks / Seal or Paint (Aesthetic)

Grid Location	Item Description	Moisture Readings	Substrate Condition	Observations
Yellow Box	Cracks			Cracks are noted at the stucco accent and stucco termination this location. The inspector suggests to have a qualified waterproofing contractor seal or paint for aesthetic concerns only. All cracking was not necessarily identified in this report. Please refer to photos #33.2, #33.3, #33.4 and #33.5 for more detail.
