Lone Star Stucco, LLC

Moisture Assessment Report

2629 Westgate Street, Unit A

Project Information

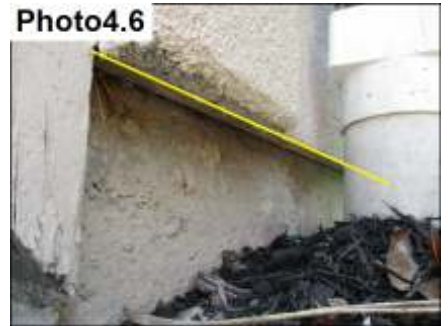
Photo4.6

Proper Grade Termination with Plaster Stop / Positive Detail

Grid Location	Item Description	Moisture Readings	Substrate Condition	Observations
Yellow Lines	Grade Termination			Stucco appears to be typically detailed at grade for the time of this construction. The inspector suggests that this is a positive detail and recommends no modification at this time but to always keep soil away from the structure. Please refer to photos #4.2, #4.3, #4.4, #4.5 and #4.6 for more detail.

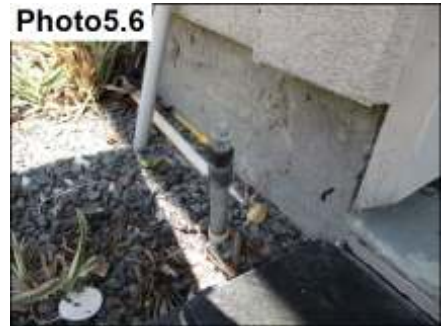
Photo5.6

Sprinklers / Redirect as Needed

Grid Location	Item Description	Moisture Readings	Substrate Condition	Observations
Orange Arrows	Sprinklers			Sprinklers have been noted on this home. The inspector suggests to always redirect sprinkler heads away from the system and windows as needed in an effort to prevent moisture intrusion. Please refer to photos #5.2, #5.3, #5.4, #5.5 and #5.6 for more detail.

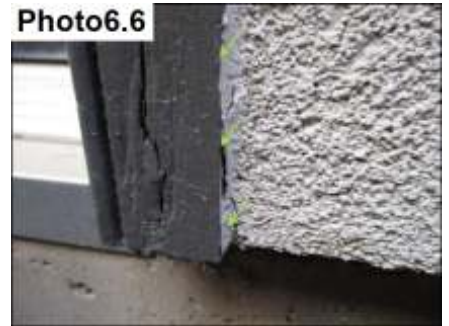
Photo6.6

Door Sealants / Seal

Grid Location	Item Description	Moisture Readings	Substrate Condition	Observations
Green Arrows	Doors			The door trim and miter sealants are aged, separated or missing at these locations. The inspector suggests to have a qualified waterproofing contractor seal these areas with a low modulus sealant in an effort to prevent moisture intrusion. These types of sealants are of high quality and compatible with stucco and other termination points. Please refer to photos #6.2, #6.3, #6.4, #6.5 and #6.6 for more detail.

All noted areas have been sealed/caulked.

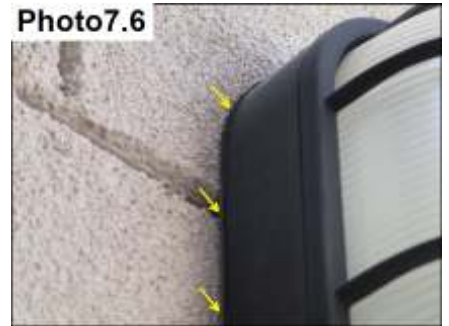
Photo7.6

Penetration Sealants / Seal

Grid Location	Item Description	Moisture Readings	Substrate Condition	Observations
Yellow Arrows	Penetrations			The penetration sealants are aged, separated or missing in these locations. The inspector suggests to have a qualified waterproofing contractor seal these areas with a low modulus sealant in an effort to prevent moisture intrusion. These types of sealants are of high quality and compatible with stucco and other termination points. Please refer to photos #7.2, #7.3, #7.4, #7.5 and #7.6 for more detail.

All noted areas have been sealed/caulked.

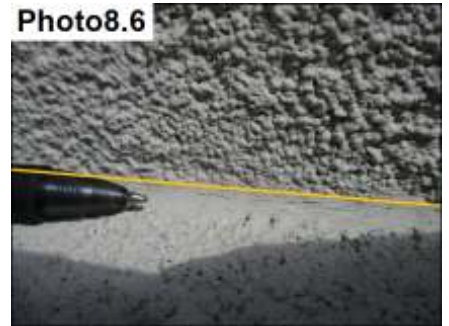
Photo8.6

Accent & Stucco Termination / Seal

Grid Location	Item Description	Moisture Readings	Substrate Condition	Observations
Orange Lines	Accent & Stucco Termination			Accent terminations/stucco termination sealants are aged or separated at these locations. The inspector suggests to have a qualified waterproofing contractor further assess and seal these areas with a low modulus sealant in an effort to prevent moisture intrusion. These types of sealants are of high quality and compatible with stucco and other termination points. Please refer to photos #8.2, #8.3, #8.4, #8.5 and #8.6 for more detail.

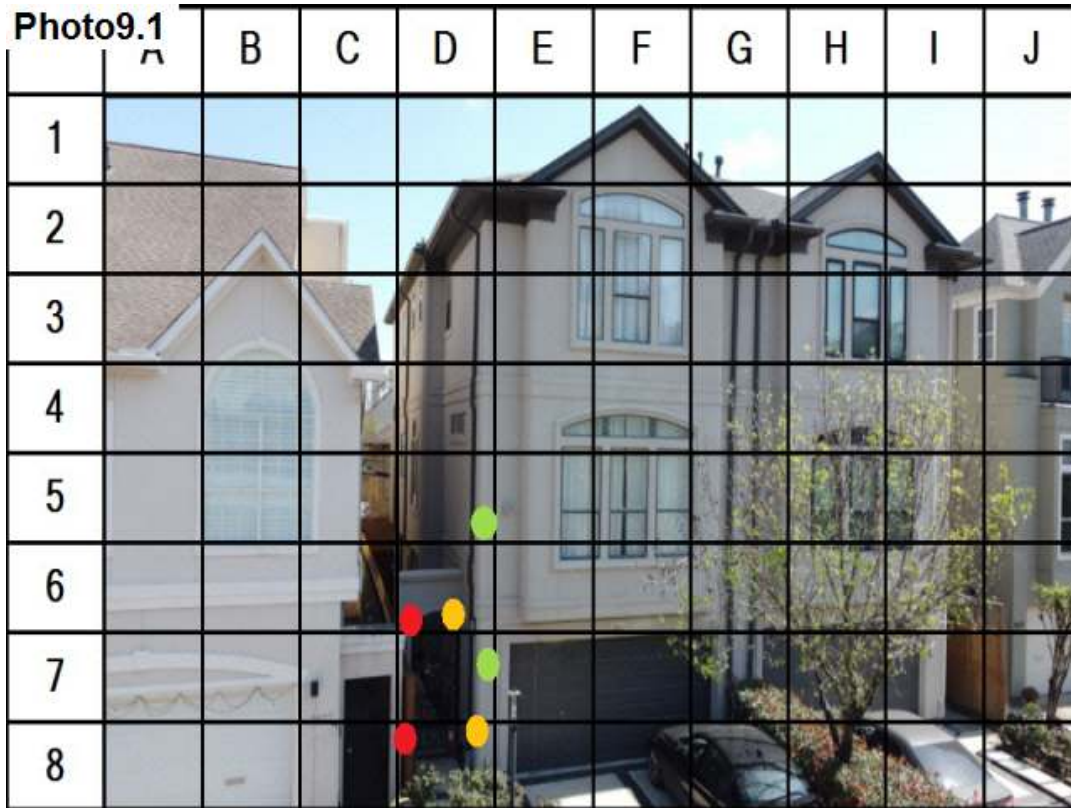
Grid Location	Item Description	Moisture Readings	Substrate Condition	Observations
D8 Red	Below Flat Accent		None	A moisture probe was taken at the left wall below the entryway flat accent. No substrate was noted at this time, modify as needed.
D8 Orange	Below Flat Accent	24%	Semi-Firm	A moisture probe was taken at the right wall below the entryway flat accent. An elevated moisture reading was noted with a semi-firm substrate.
D6 Red	Below Flat Accent		None	A moisture probe was taken below the bottom wall entryway flat accent. No substrate was noted at this time, modify as needed.
D6 Orange	Below Flat Accent		None	A moisture probe was taken at the bottom wall below the entryway flat accent. No substrate was noted at this time, modify as needed.
D7	Corner Wall	14%	Firm	A moisture probe was made at corner wall. The substrate was firm with no damage noted at this time.
D7	Corner Wall	13%	Firm	A moisture probe was made at corner wall. The substrate was firm with no damage noted at this time.

A metal cap was placed on the top of the entry way arch.

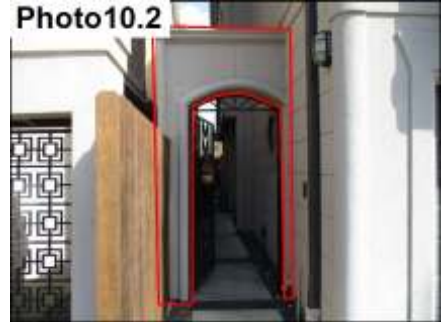
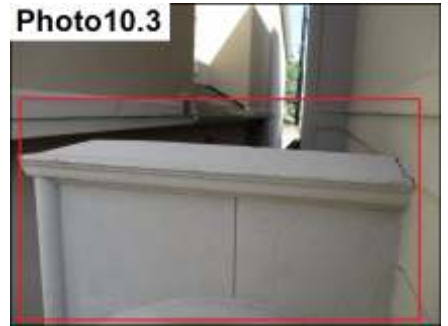
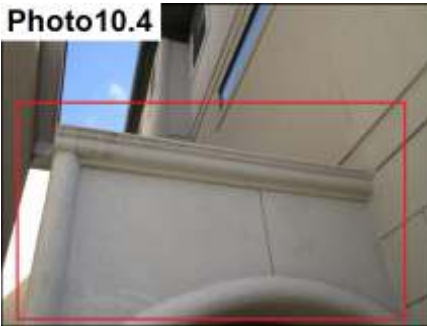
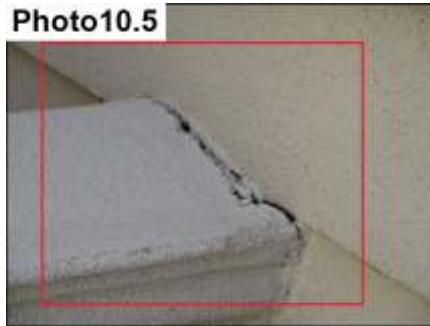
Damaged Entryway / Assess And Repair

Grid Location	Item Description	Moisture Readings	Substrate Condition	Observations
Red Box	Damage			The entryway accent wall is missing a metal cap with sizable cracks at the wall of the structure allowing excess moisture into the system. Confirmed substrate and potential frame damage is noted at this location. The inspector recommends having a qualified waterproofing contractor further assess the extent of damage, repair as needed and install a proper relief and metal cap in an effort to prevent moisture intrusion. Please refer to photos #10.2, #10.3, #10.4, #10.5, 10.6, #11.1, #11.2, #11.3 and #11.4 for more detail.

A metal cap was placed on the top of the entry flat accent area. All cracks were caulked/sealed.

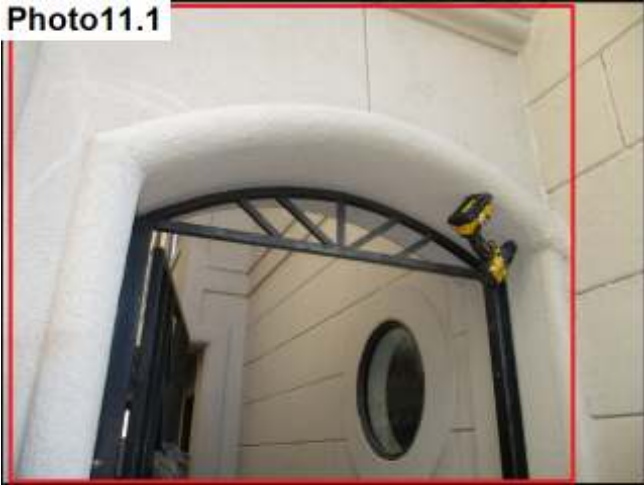
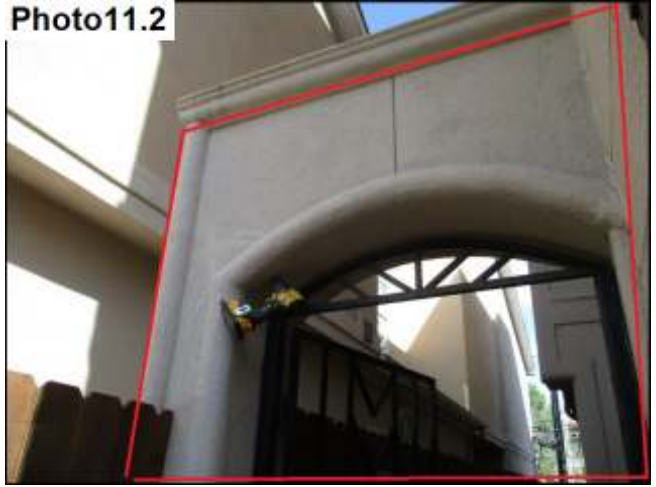
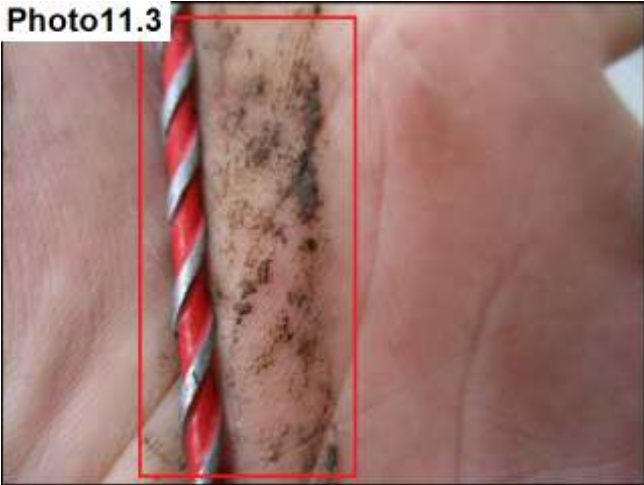
Damaged Entryway / Assess And Repair

The entry area has been waterproofed.

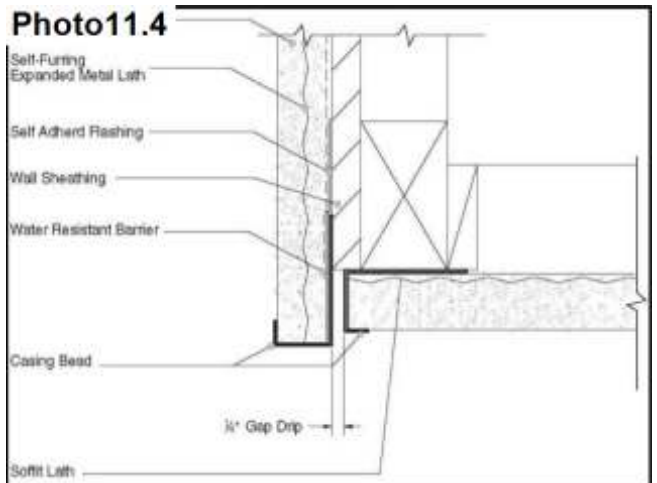
Photo11.4

Proper Relief Detail

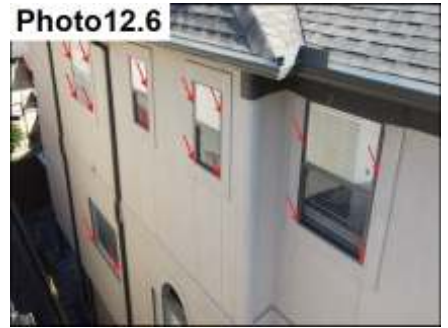
Photo12.6

Window Sealants / Seal

Grid Location	Item Description	Moisture Readings	Substrate Condition	Observations
Red Arrows	Windows			The window sealants are aged or separated. The inspector suggests to have a qualified waterproofing contractor further assess and seal these areas with a low modulus sealant in an effort to prevent moisture intrusion. These types of sealants are of high quality and compatible with stucco and other termination points. Please refer to photos #12.2, #12.3 #12.4, #12.5, #12.6, #13.1, #13.2, #13.3 and #13.4 for more detail.

All noted areas have been sealed/caulked.

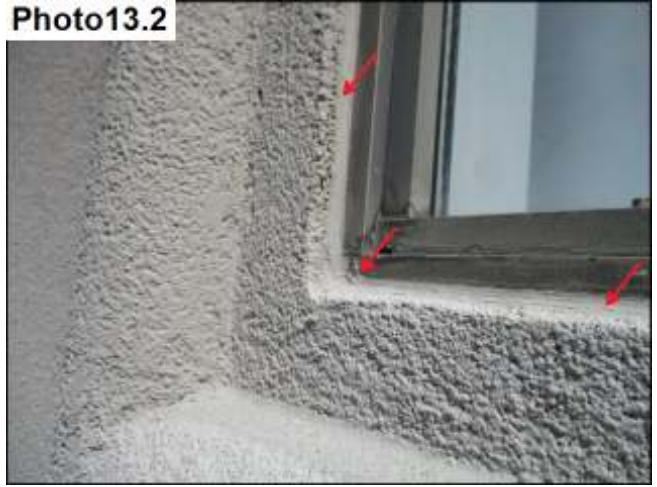
Photo13.2

Window Sealants / Seal

All noted areas have been sealed/caulked.

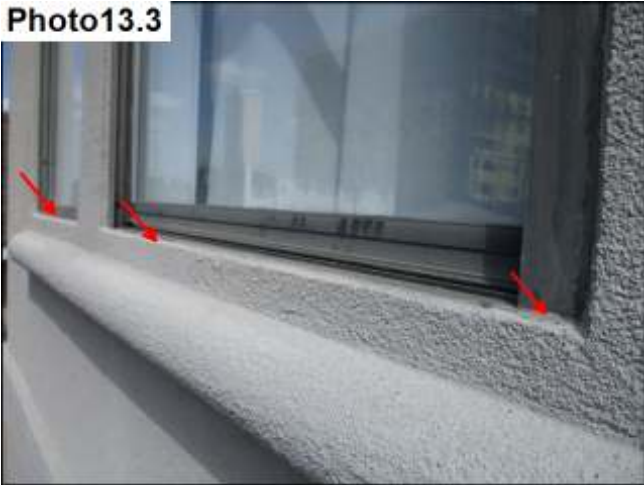
Photo13.3

Window Sealants / Seal

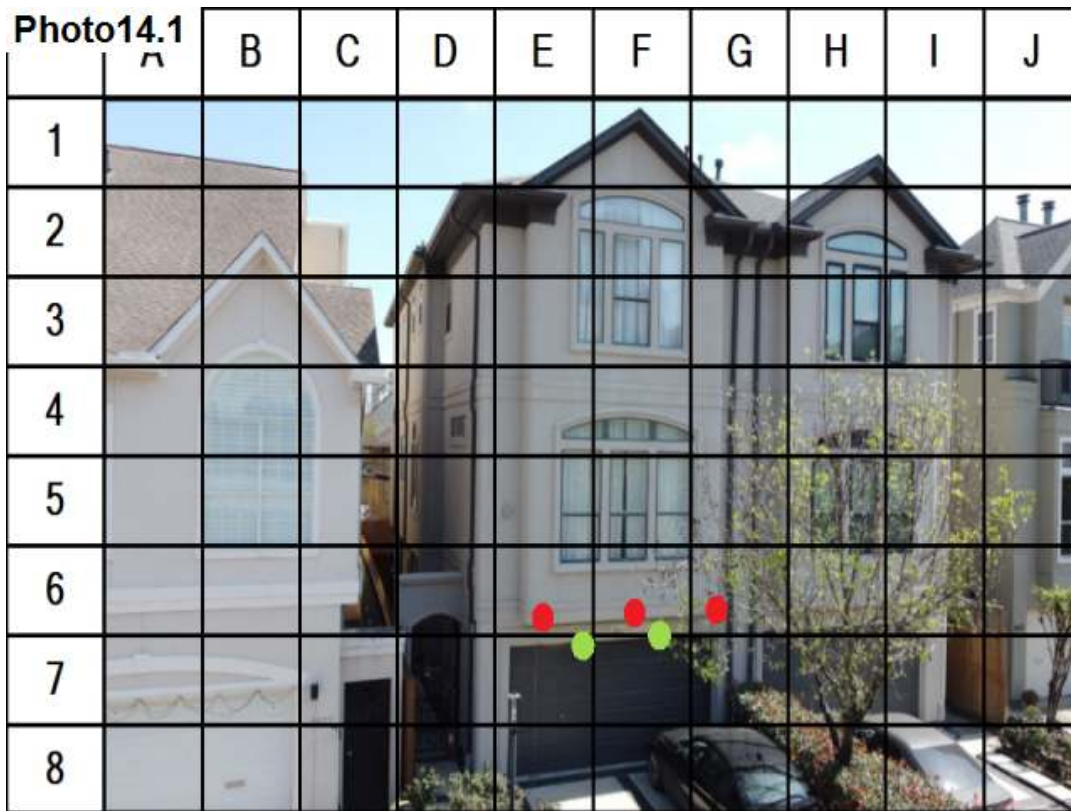
Grid Location	Item Description	Moisture Readings	Substrate Condition	Observations
E7	Garage Header	12%	Firm	A moisture probe was taken at the garage header below the bumpout wall. The substrate was firm with no damage noted at this time.
F7	Garage Header	12%	Firm	A moisture probe was taken at the garage header below the bumpout wall. The substrate was firm with no damage noted at this time.
E6	Bottom Bumpout Wall		None	A moisture probe was taken at the bottom bumpout wall below the bank of windows. No substrate was noted at this time, modify as needed.
F6	Bottom Bumpout Wall		None	A moisture probe was taken at the bottom bumpout wall below the bank of windows. No substrate was noted at this time, modify as needed.
G6	Bottom Bumpout Wall	29%	Semi-Firm	A moisture probe was taken at the bottom bumpout wall below the bank of windows. An elevated moisture reading was noted with a semi-firm substrate.

The bottom area of the bump out was removed, the damaged substrate was replaced. A relief has been added.

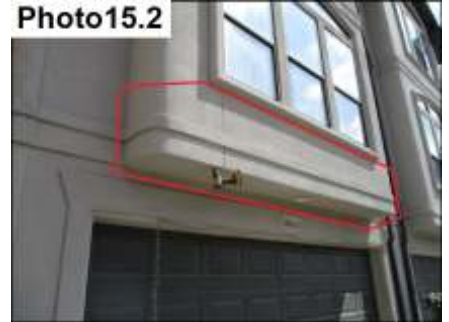
Substrate Damage /
Assess, Repair & Install Relief

Grid Location	Item Description	Moisture Readings	Substrate Condition	Observations
Red Box	Damage			Confirmed substrate and potential frame damage is noted at the bottom of the bumpout wall below the bank of windows. The inspector recommends having a qualified waterproofing contractor further assess the extent of damage, repair as needed and install a proper relief in an effort to prevent moisture intrusion. Please refer to photos #15.2, #15.3, #15.4, #15.5 and #15.6 for more detail.

All damaged areas were replaced and a relief was added.

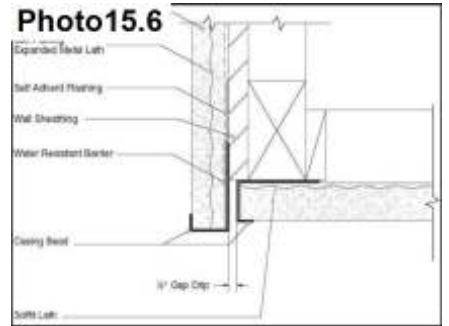
Photo15.6

Relief / Proper Detail

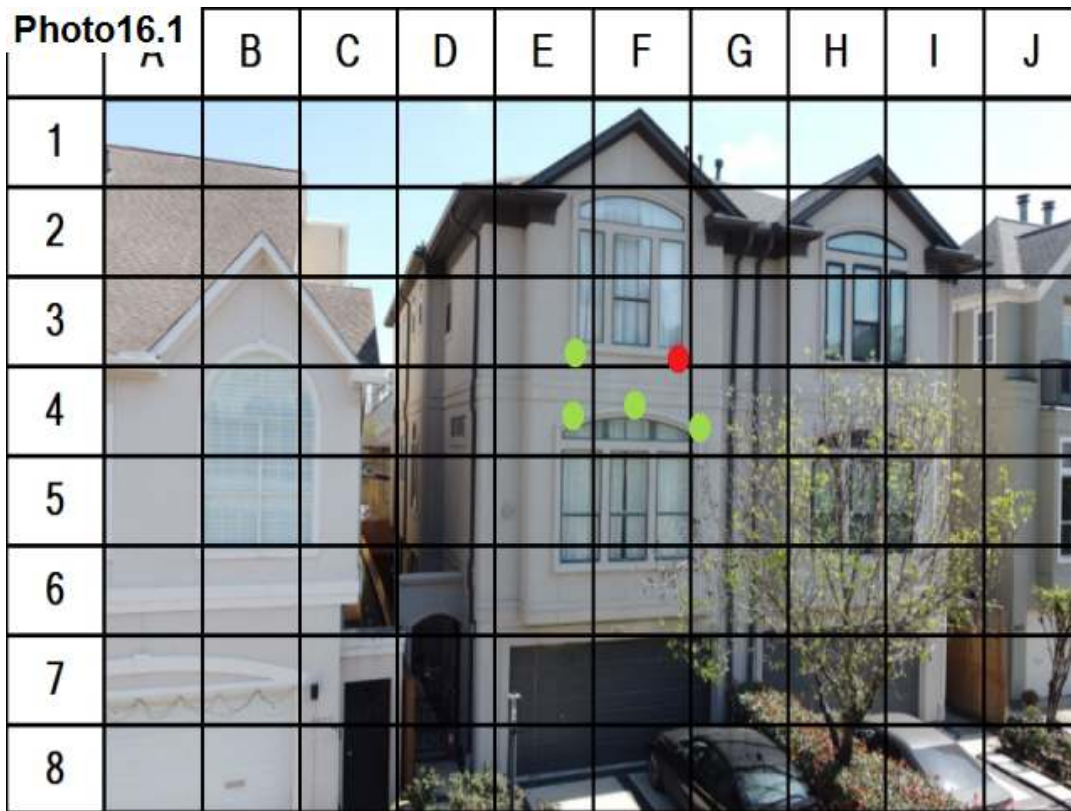
Grid Location	Item Description	Moisture Readings	Substrate Condition	Observations
E4	Window Header	12%	Firm	A moisture probe was taken at the window header below the third floor bank of windows. The substrate was firm with no damage noted at this time.
F4	Window Header	12%	Firm	A moisture probe was taken at the window header below the third floor bank of windows. The substrate was firm with no damage noted at this time.
G4	Window Header	12%	Firm	A moisture probe was taken at the window header below the third floor bank of windows. The substrate was firm with no damage noted at this time.
E3	Window Lower Left	14%	Firm	A moisture probe was taken at the window lower left. The substrate was firm with no damage noted at this time.
F3	Window Lower Right	19%	Firm	A moisture probe was taken at the window lower right. An elevated moisture reading was noted with a firm substrate.

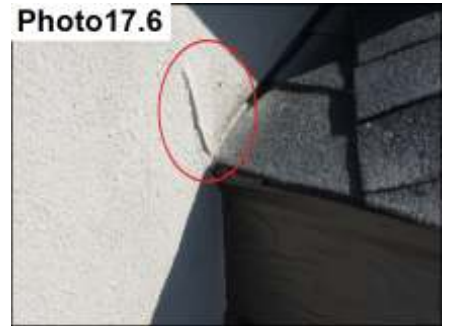
Photo17.6

Roof Termination / Seal

Grid Location	Item Description	Moisture Readings	Substrate Condition	Observations
Red Circles	Roof Termination			The roof and stucco termination is aged or separated at these locations. The inspector suggests to have a qualified waterproofing contractor further assess and seal these areas with a low modulus sealant in an effort to prevent moisture intrusion. These types of sealants are of high quality and compatible with stucco and other termination points. Please refer to photos #17.2, #17.3, #17.4, #17.5 and #17.6 for more detail.

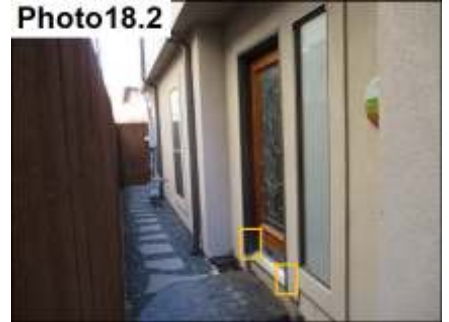
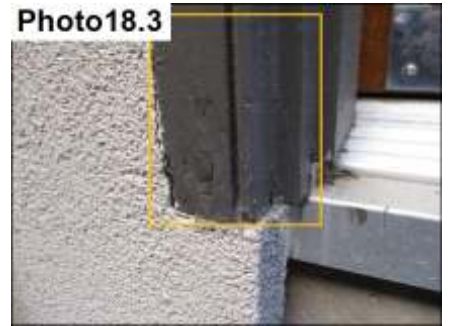
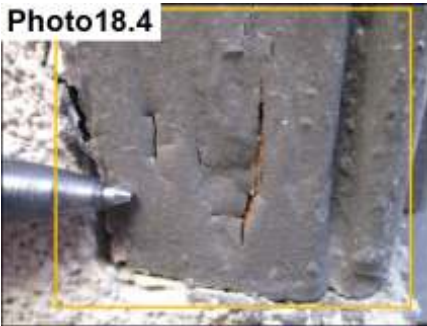
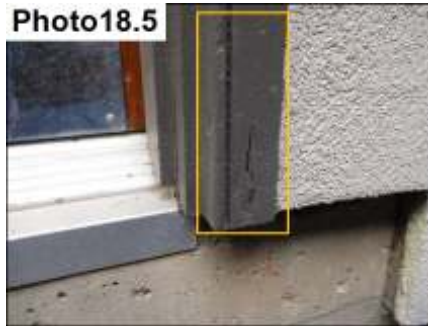
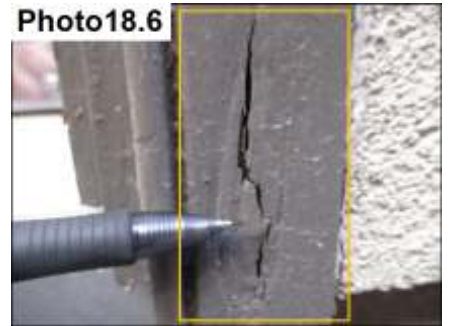
Wood Rot on Door Trim / Repair

Grid Location	Item Description	Moisture Readings	Substrate Condition	Observations
Orange Boxes	Wood Rot			The door trim at this area has wood rot. The inspector suggests to have a qualified contractor further assess and repair this area as needed in an effort to prevent moisture intrusion. All wood rot was not necessarily identified in this report. Please refer to photos #18.2, #18.3, #18.4, #18.5 and #18.6 for more detail.

All rotted wood was replaced and painted.

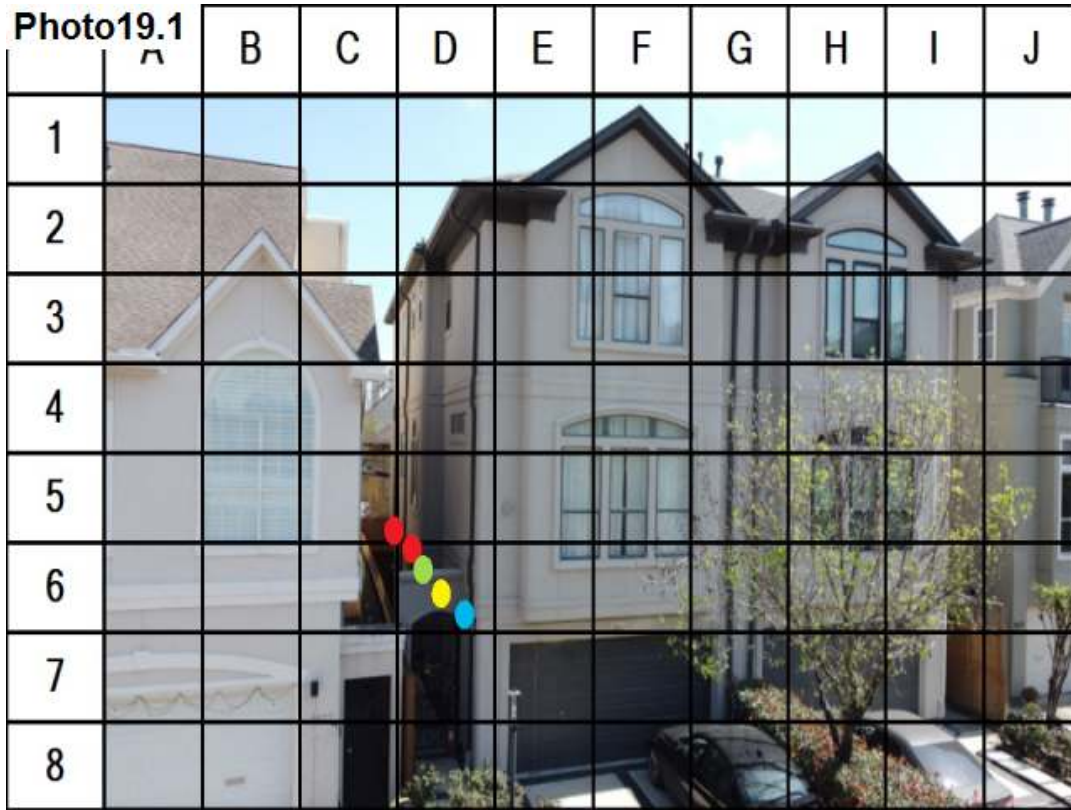
Grid Location	Item Description	Moisture Readings	Substrate Condition	Observations
C5	Bottom Wall	36%	Semi-Soft	A moisture probe was taken at the bottom wall below the windows. An elevated moisture reading with semi-soft substrate was noted. It is suggested by the inspector to consult with a waterproofing contractor to core sample and modify this area as needed.
D6 Red	Bottom Wall	24%	Semi-Firm	A moisture probe was taken at the bottom wall below the windows. An elevated moisture reading was noted with a semi-firm substrate.
D6 Green	Bottom Wall	12%	Firm	A moisture probe was taken at the bottom wall below the windows. The substrate was firm with no damage noted at this time.
D6 Yellow	Bottom Wall	12%	Firm	A moisture probe was taken at the bottom wall below the windows. The substrate was firm with no damage noted at this time.
D6 Blue	Bottom Wall	12%	Firm	A moisture probe was taken at the bottom wall below the windows. The substrate was firm with no damage noted at this time.

All damaged substrate was replaced and a relief was added.

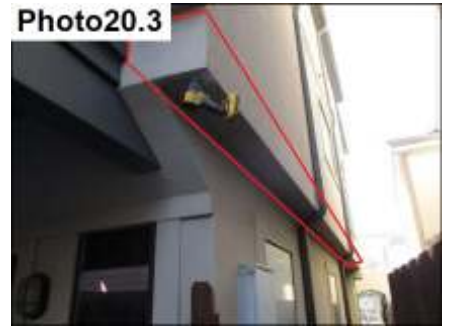
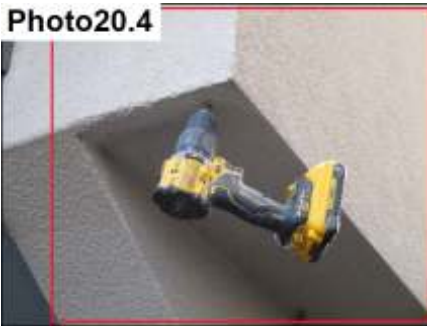
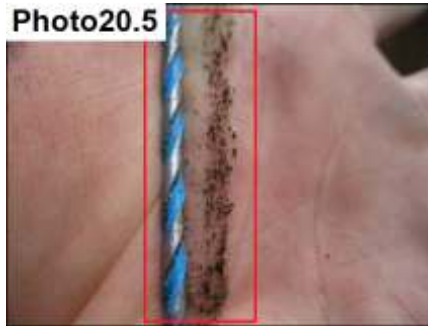
Damage / Core Sample & Repair As Needed

Grid Location	Item Description	Moisture Readings	Substrate Condition	Observations
Red Box	Potential Damage			Soft substrate is noted at the bottom of the wall below the bank of windows. The inspector recommends having a qualified waterproofing contractor core sample to further assess the extent, then repair if needed and install a proper relief in an effort to prevent moisture intrusion. Please refer to photos #20.2, #20.3, #20.4, #20.5 and #20.6 for more detail.

All damage substrate was replaced and a relief was added.

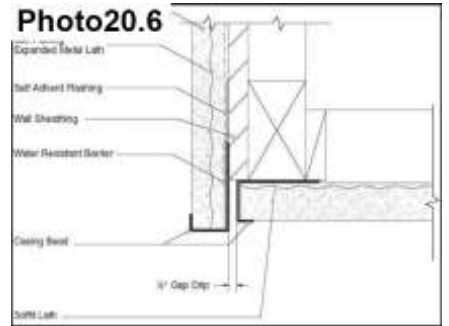
Photo20.6

Relief / Proper Detail

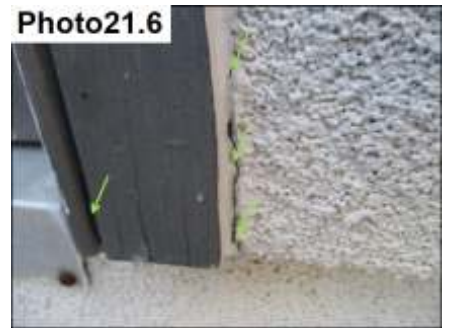
Photo21.6

Door Sealants / Seal

Grid Location	Item Description	Moisture Readings	Substrate Condition	Observations
Green Arrows	Doors			The door trim and miter sealants are aged or separated at these locations. The inspector suggests to have a qualified waterproofing contractor seal these areas with a low modulus sealant in an effort to prevent moisture intrusion. These types of sealants are of high quality and compatible with stucco and other termination points. Please refer to photos #21.2, #21.3, #21.4, #21.5 and #21.6 for more detail.

All noted areas have been sealed/caulked.

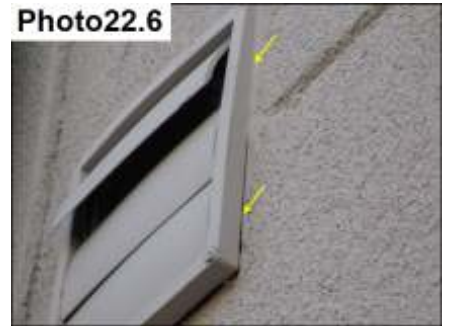
Photo22.6

Penetration Sealants / Seal

Grid Location	Item Description	Moisture Readings	Substrate Condition	Observations
Yellow Arrows	Penetrations			The penetration sealants are aged, thin, separated or missing in these locations. The inspector suggests to have a qualified waterproofing contractor seal these areas with a low modulus sealant in an effort to prevent moisture intrusion. These types of sealants are of high quality and compatible with stucco and other termination points. Please refer to photos #22.2, #22.3, #22.4, #22.5 and #22.6 for more detail.

All noted areas have been sealed/caulked.

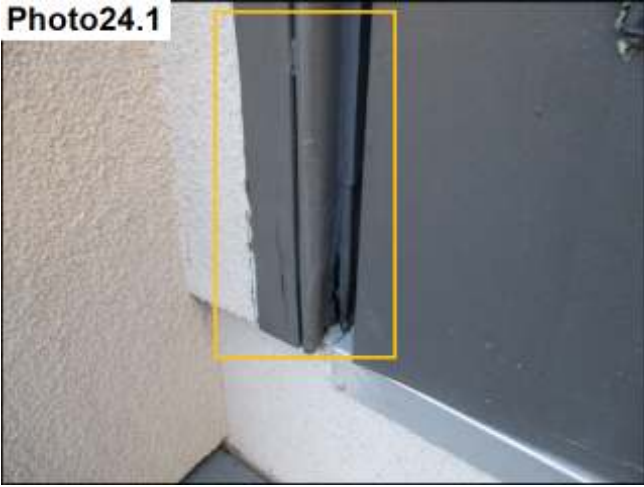
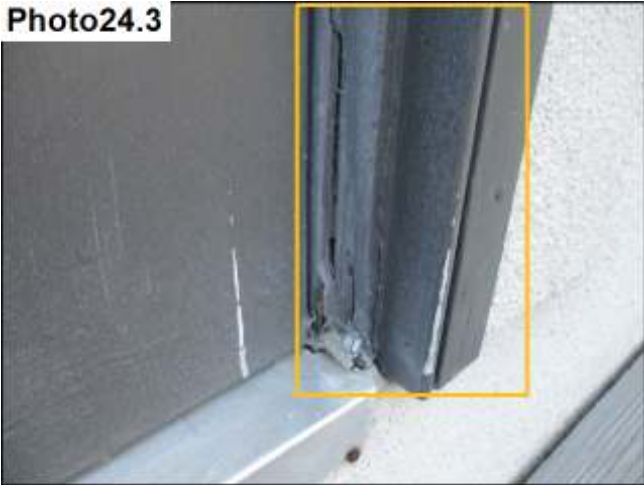
Wood Rot on Door Trim / Repair

All wood rot has been replaced and painted.

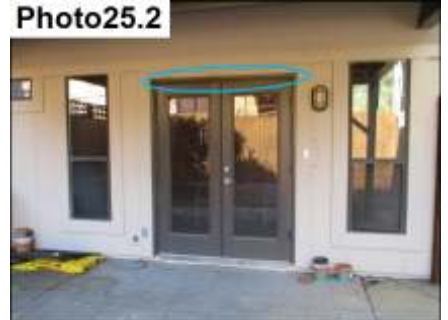
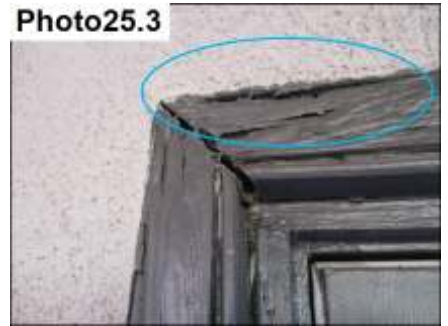
Missing Door Head Flashing / Install

Grid Location	Item Description	Moisture Readings	Substrate Condition	Observations
Red Circle	Missing Door Head Flashing			The door header below the second floor door pan flashing is missing a proper head flashing with wood rot noted. The inspector suggests to have a qualified waterproofing contractor further assess and install a proper door head flashing to this area as needed in an effort to prevent moisture intrusion. Please refer to photos #25.2 and #25.3 for more detail.

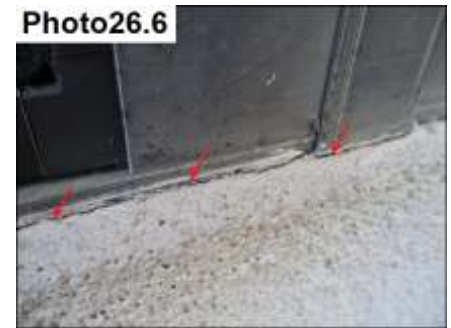
Window Sealants / Seal

Grid Location	Item Description	Moisture Readings	Substrate Condition	Observations
Red Arrows	Windows			The window sealants are aged or separated. The inspector suggests to have a qualified waterproofing contractor further assess and seal these areas with a low modulus sealant in an effort to prevent moisture intrusion. These types of sealants are of high quality and compatible with stucco and other termination points. Please refer to photos #26.2, #26.3, #26.4, #26.5 and #26.6 for more detail.
E5	Window Lower Right	12%	Firm	A moisture probe was taken at the window lower right. The substrate was firm with no damage noted at this time.
F5	Window Lower Left	12%	Firm	A moisture probe was taken at the window lower left. The substrate was firm with no damage noted at this time.
E4	Window Header	12%	Firm	A moisture probe was taken at the window header below the window lower left. The substrate was firm with no damage noted at this time.

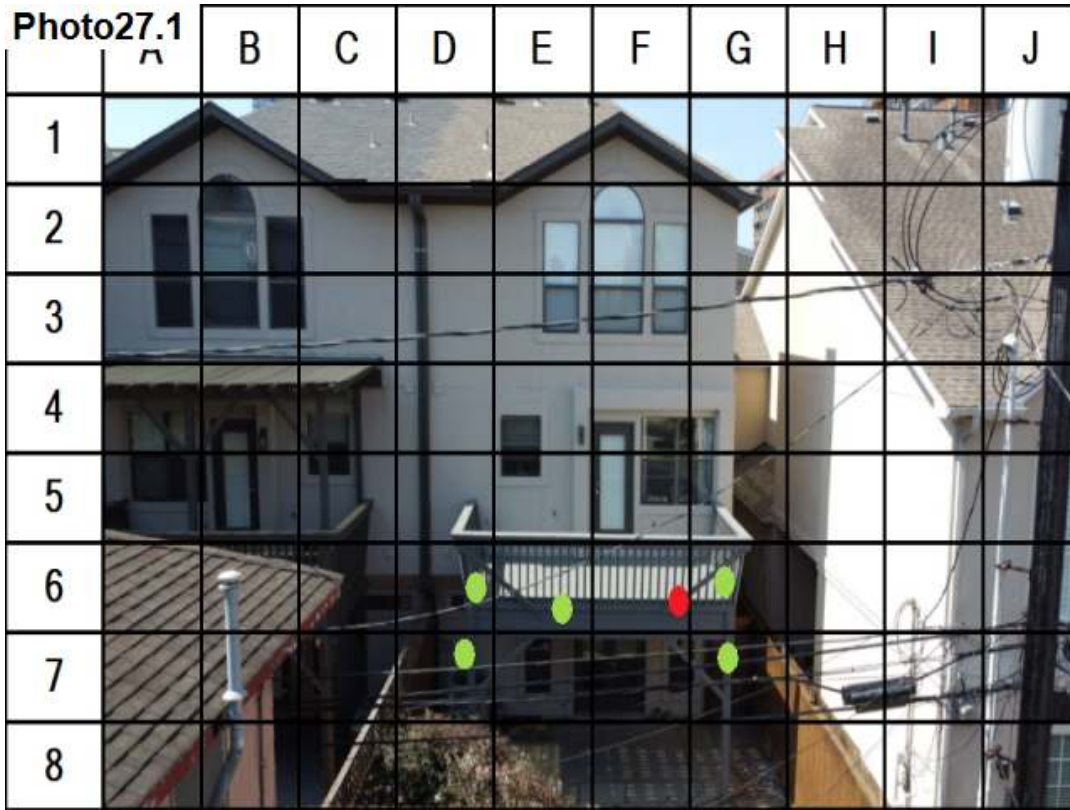
Grid Location	Item Description	Moisture Readings	Substrate Condition	Observations
D7	Corner Wall	12%	Firm	A moisture probe was taken at the corner wall below the balcony. The substrate was firm with no damage noted at this time.
G7	Corner Wall	12%	Firm	A moisture probe was taken at the corner wall below the balcony. The substrate was firm with no damage noted at this time.
D6	Below Balcony	13%	Firm	A moisture probe was taken at the bottom of the balcony. The substrate was firm with no damage noted at this time
E6	Below Balcony	17%	Firm	A moisture probe was taken at the bottom of the balcony. The substrate was firm with no damage noted at this time
F6	Below Balcony	21%	Firm	A moisture probe was taken at the bottom of the balcony. An elevated moisture reading was noted with a firm substrate.
G6	Below Balcony	12%	Firm	A moisture probe was taken at the bottom of the balcony. The substrate was firm with no damage noted at this time

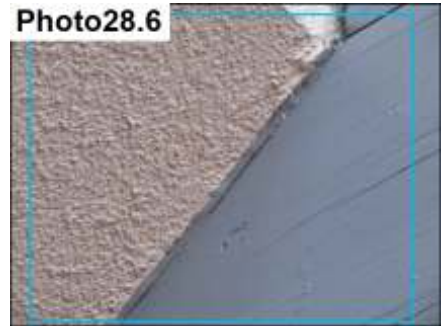
Photo28.6

Balcony & Stucco Termination / Seal

Grid Location	Item Description	Moisture Readings	Substrate Condition	Observations
Blue Boxes	Balcony & Stucco Termination			Balcony/stucco termination sealants are aged or separated at this location. The inspector suggests to have a qualified waterproofing contractor further assess and seal this area with a low modulus sealant in an effort to prevent moisture intrusion. These types of sealants are of high quality and compatible with stucco and other termination points. Please refer to photos #28.2, #28.3, #28.4, #28.5 and #28.6 for more detail.

All noted areas have been caulked/sealed.

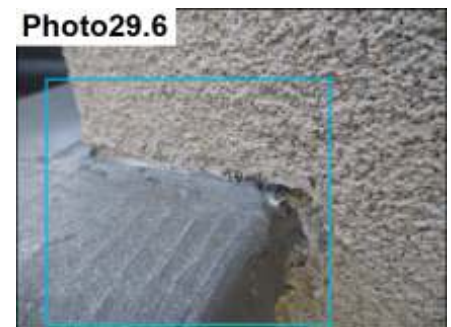
Railing & Stucco Termination / Seal

Grid Location	Item Description	Moisture Readings	Substrate Condition	Observations
Blue Boxes	Railing & Stucco Termination			Railing/stucco termination sealants are aged or separated at these locations. The inspector suggests to have a qualified waterproofing contractor further assess and seal these areas with a low modulus sealant in an effort to prevent moisture intrusion. These types of sealants are of high quality and compatible with stucco and other termination points. Please refer to photos #29.2, #29.3, #29.4, #29.5 and #29.6 for more detail.
D6	Below Railing & Stucco Termination	12%	Firm	A moisture probe was taken below the railing and stucco termination. The substrate was firm with no damage noted at this time
G5	Below Railing & Stucco Termination	12%	Firm	A moisture probe was taken below the railing and stucco termination. The substrate was firm with no damage noted at this time

All noted areas have been caulked/sealed.

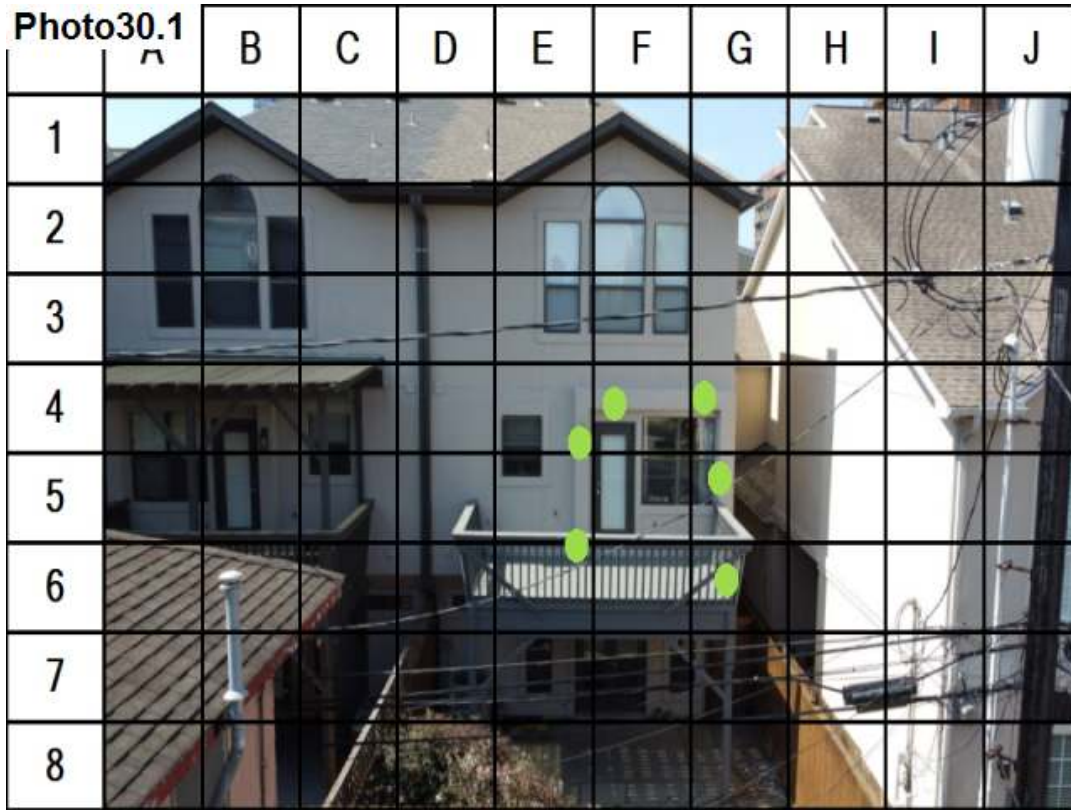
Grid Location	Item Description	Moisture Readings	Substrate Condition	Observations
E6	Below Flat Accent	12%	Firm	A moisture probe was taken below the flat accent. The substrate was firm with no damage noted at this time
E4	Below Flat Accent	13%	Firm	A moisture probe was taken below the flat accent. The substrate was firm with no damage noted at this time
F4	Below Flat Accent	16%	Firm	A moisture probe was taken below the flat accent. The substrate was firm with no damage noted at this time
G4	Below Flat Accent	17%	Firm	A moisture probe was taken below the flat accent. The substrate was firm with no damage noted at this time
G5	Below Flat Accent	12%	Firm	A moisture probe was taken below the flat accent. The substrate was firm with no damage noted at this time
G6	Below Flat Accent	12%	Firm	A moisture probe was taken below the flat accent. The substrate was firm with no damage noted at this time

The flat accent area was painted 3 times with an elastomeric paint.

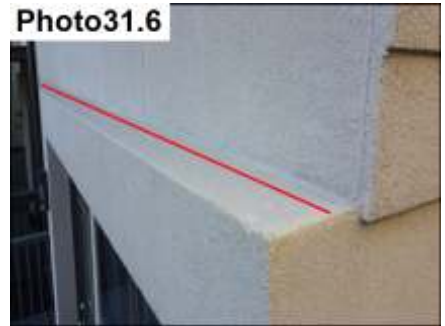
Photo31.6

Flat Accent / Install Metal Cap or Apply Elastomeric Coating

Grid Location	Item Description	Moisture Readings	Substrate Condition	Observations
Red Line	Flat Accent			A flat accent has been noted in this area. Although the moisture levels were acceptable the inspector suggests to have a waterproofing contractor further assess and to apply elastomeric coating or install a metal cap as needed, in an effort to prevent moisture intrusion. Please refer to photos #31.2, #21.3, #31.4, #31.5 and #31.6 for more detail.

The noted flat accent area was painted 3 times with an elastomeric paint.

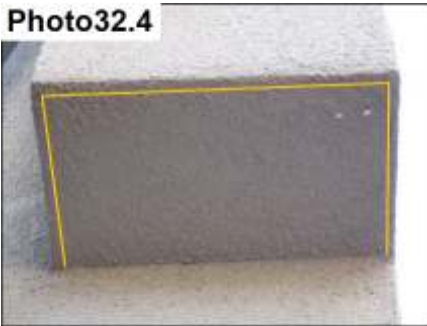
Photo32.4

Relief / No Modification

Grid Location	Item Description	Moisture Readings	Substrate Condition	Observations
Orange Line	Relief			Although the bottom of the wall noted does not have a proper relief, this was a proper detail at the time of construction. Upon invasive testing at this location, the substrate was firm with low moisture readings. The inspector recommends no modification at this point in time but recommends to maintain all sealants above this location to prevent potential moisture intrusion. Please refer to photos #32.2, #32.3 and #32.4 for more detail.

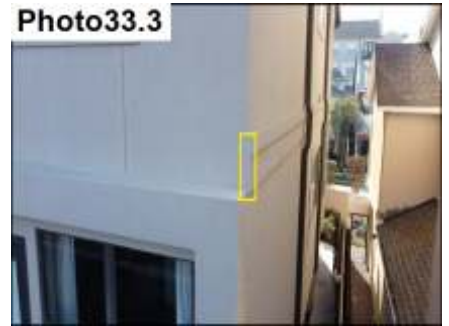
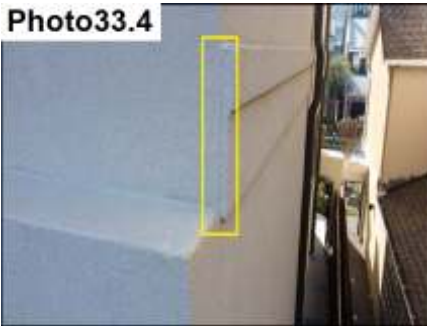
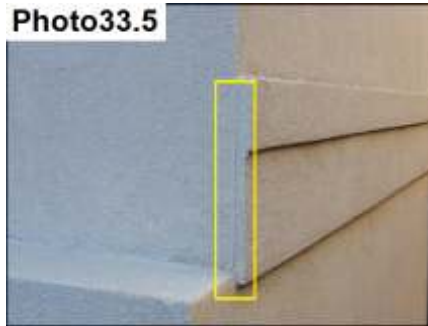
Cracks / Seal or Paint (Aesthetic)

Grid Location	Item Description	Moisture Readings	Substrate Condition	Observations
Yellow Box	Cracks			Cracks are noted at the stucco accent and stucco termination this location. The inspector suggests to have a qualified waterproofing contractor seal or paint for aesthetic concerns only. All cracking was not necessarily identified in this report. Please refer to photos #33.2, #33.3, #33.4 and #33.5 for more detail.
