RE: Foundation Inspection
Job #21471

The residence inspected was located at 24714 Hickory Hill Road in Spring, Texas.

24714 Hickory Hill Road

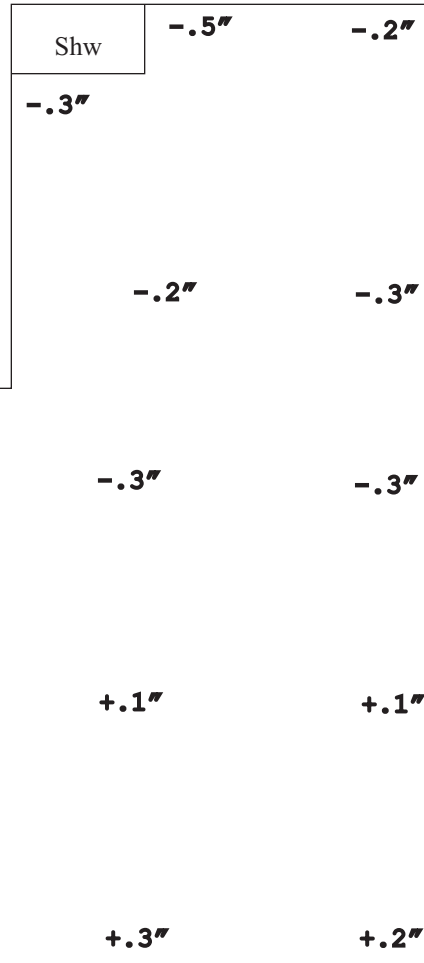
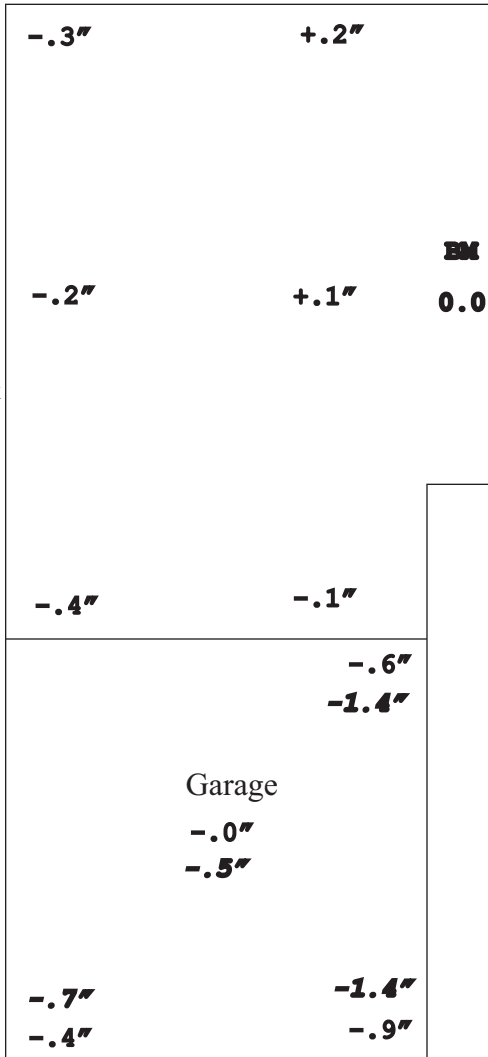
Minor movement was observed in the *middle* of the house as evidenced by the master entry and front left bedroom entry doors rubbing the frame, 1/8" trim separation, and multiple minor brick veneer cracks. FYI: Some minor movement is not unusual for the extremely dry hot weather last year.

Elevation Differential 0.9" Measured 10-04-23
Instrument Repeatability Error/Drift 0.2"

Elevation Differential 0.8" Measured 04-11-24
Instrument Repeatability Error/Drift 0.2"

1/16" Brick
Veneer Crack

Hairline Brick
Veneer Crack

1/8" Brick
Veneer Crack

1/8" Trim
Separation

Slope built-in Garage slab floor
facilitates the movement of liquids
or gases toward the vehicle door
*Elevations in Bold Italic were
Measured during Inspection 10-04-23*
