# **Property Inspection Report**

Horsley Home Inspection

238 Birch St
Inspection Prepared For: Kara Gresslin
Agent: -

Date of Inspection: 1/2/2023

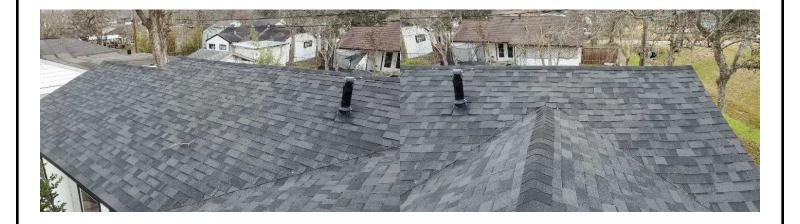
Current standards mandate all plumbing vents stacks extend a minimum of {6"} above the roof.

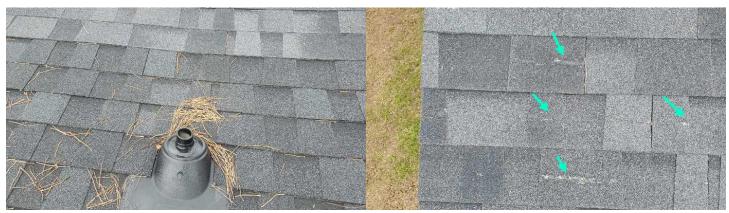
Damage to the shingles.

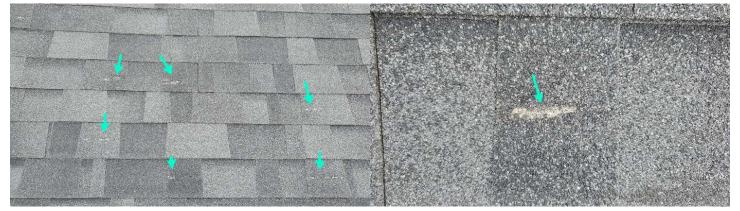
Exposed fibers.

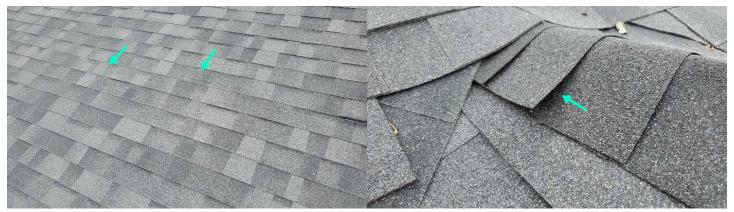
The singles at the start of the front ridge cap are not sealed at the edges.

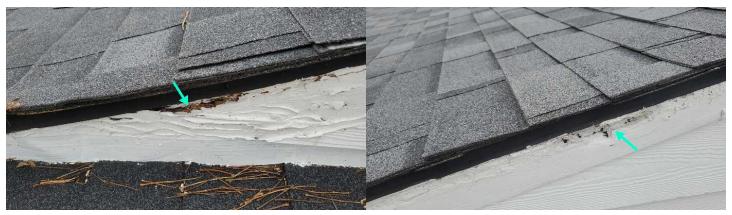
Damaged fascia board on the roof to wall connection on the left side of the house.

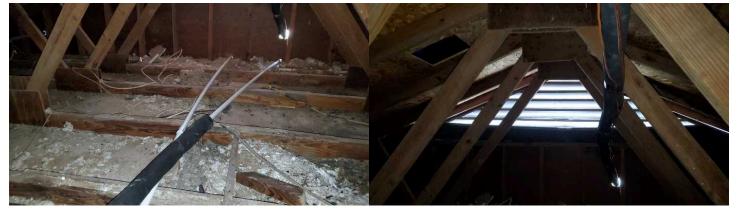
The hallway and main bedrooms do not have insulation installed in the attic space of above them.

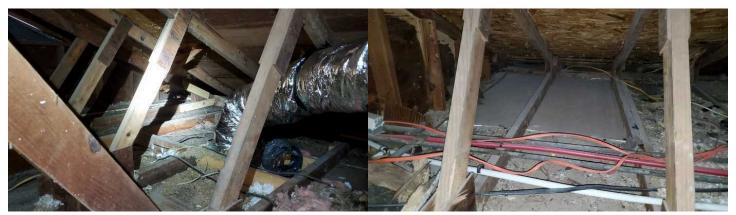
Missing insulation.

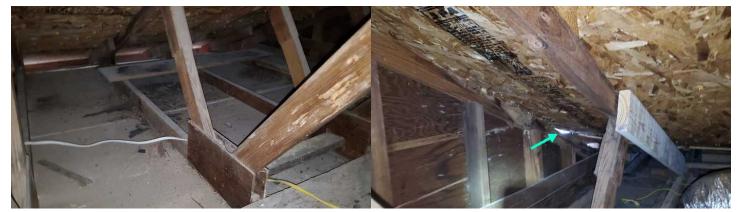
Missing insulation.

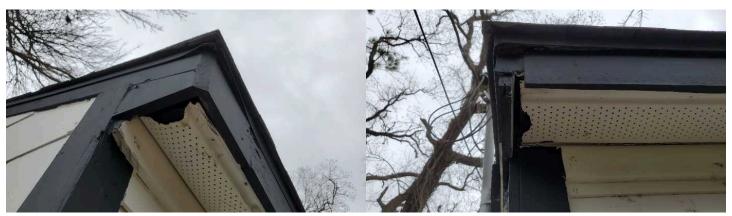
The soffit vents have openings. Recommend having them sealed to prevent rodent entry.

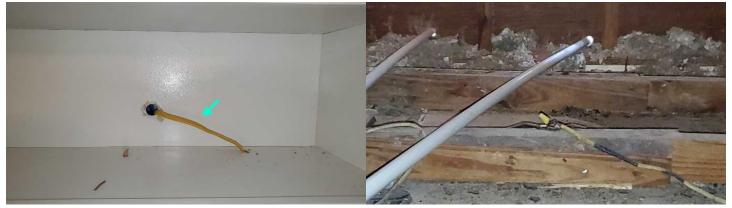
The wiring for the oven vent hood should be protected from damage with conduit.

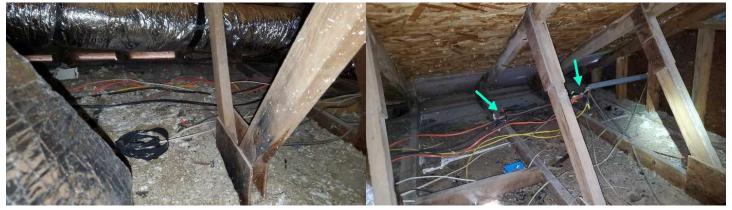
The wire connections to the main electrical panel have been spliced in the attic. These splices should be contained in a junction box or made inside the electrical panel.

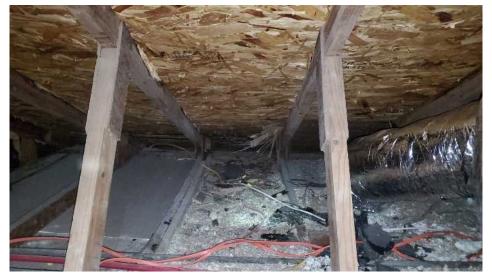
Multiple open wire splices in the attic. Wire splices should be contained in junction boxes to prevent contact with live wires.

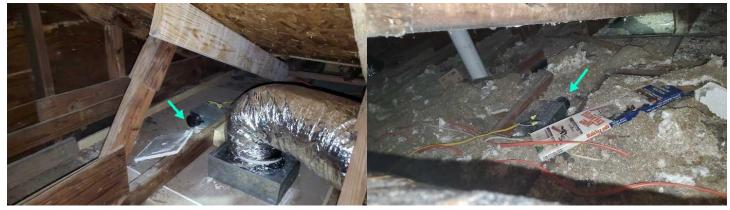
Main bathroom.

• The vent fan terminated in the attic space and should be vented to the exterior as per current building standards

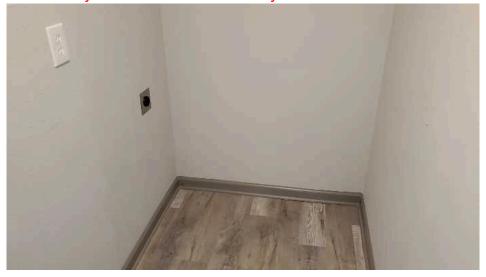
• The utility room does not have a dryer vent installed.
