RESIDENTIAL INSPECTION

217 Cresta Cove Ct
Montgomery, TX 77356

PROPERTY INSPECTION REPORT FORM

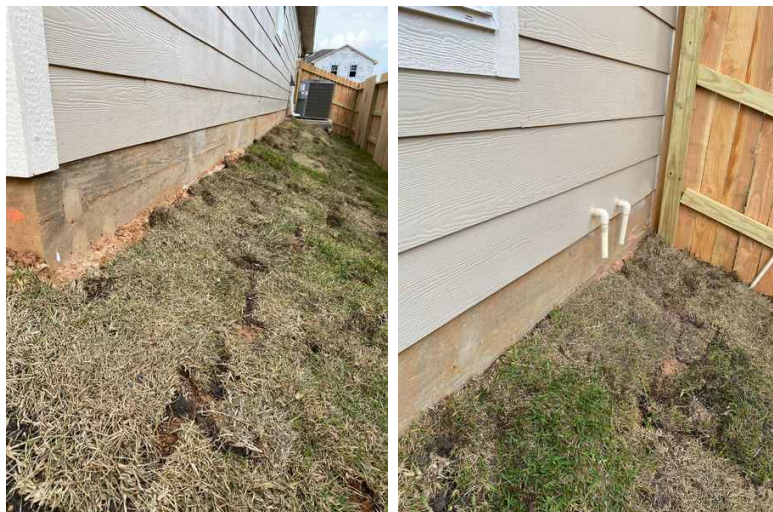
1: Water Overspray

The right side sprinkler system was spraying onto the siding and potentially the sheathing underneath. Redirect spray heads to avoid damage to wall structure.

Recommendation: Contact a qualified structural engineer.

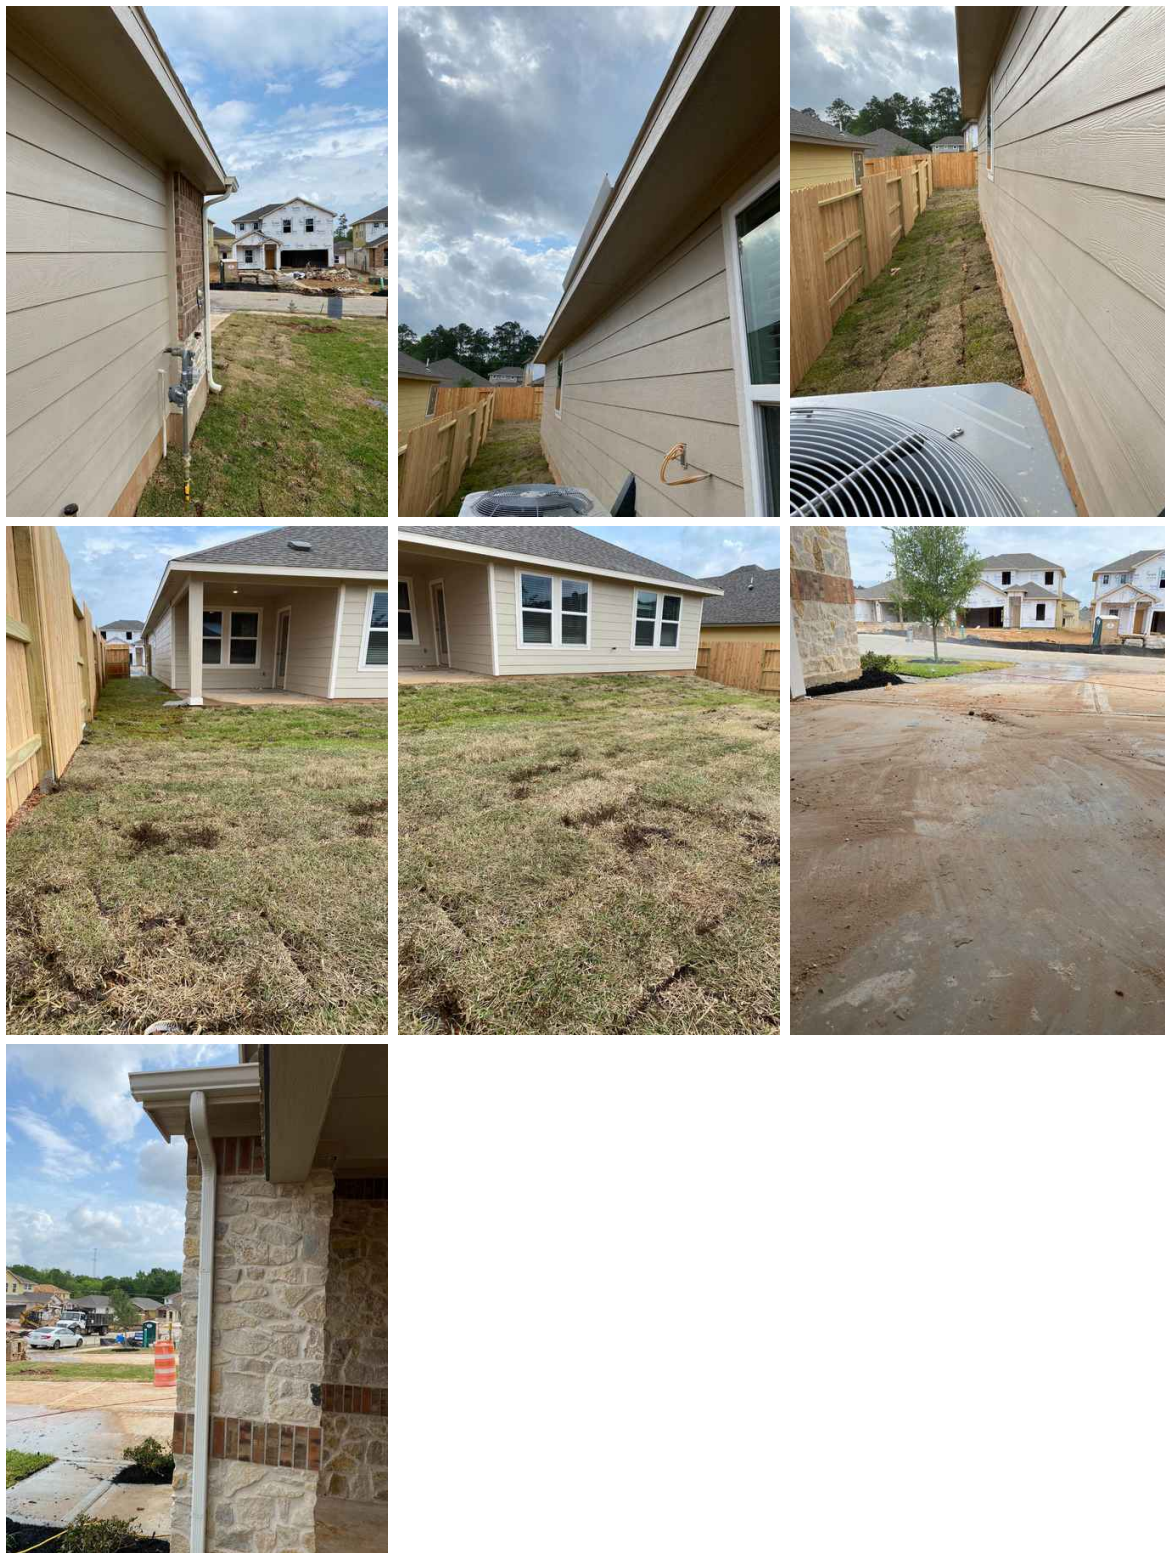
1: Additional Gutters Recommended
Maintenance Item

Lack of gutters on large roof sections can lead to soil erosion and water damage to building exterior. Recommend adding gutters along the back exterior wall.

Recommendation: Contact a qualified gutter contractor

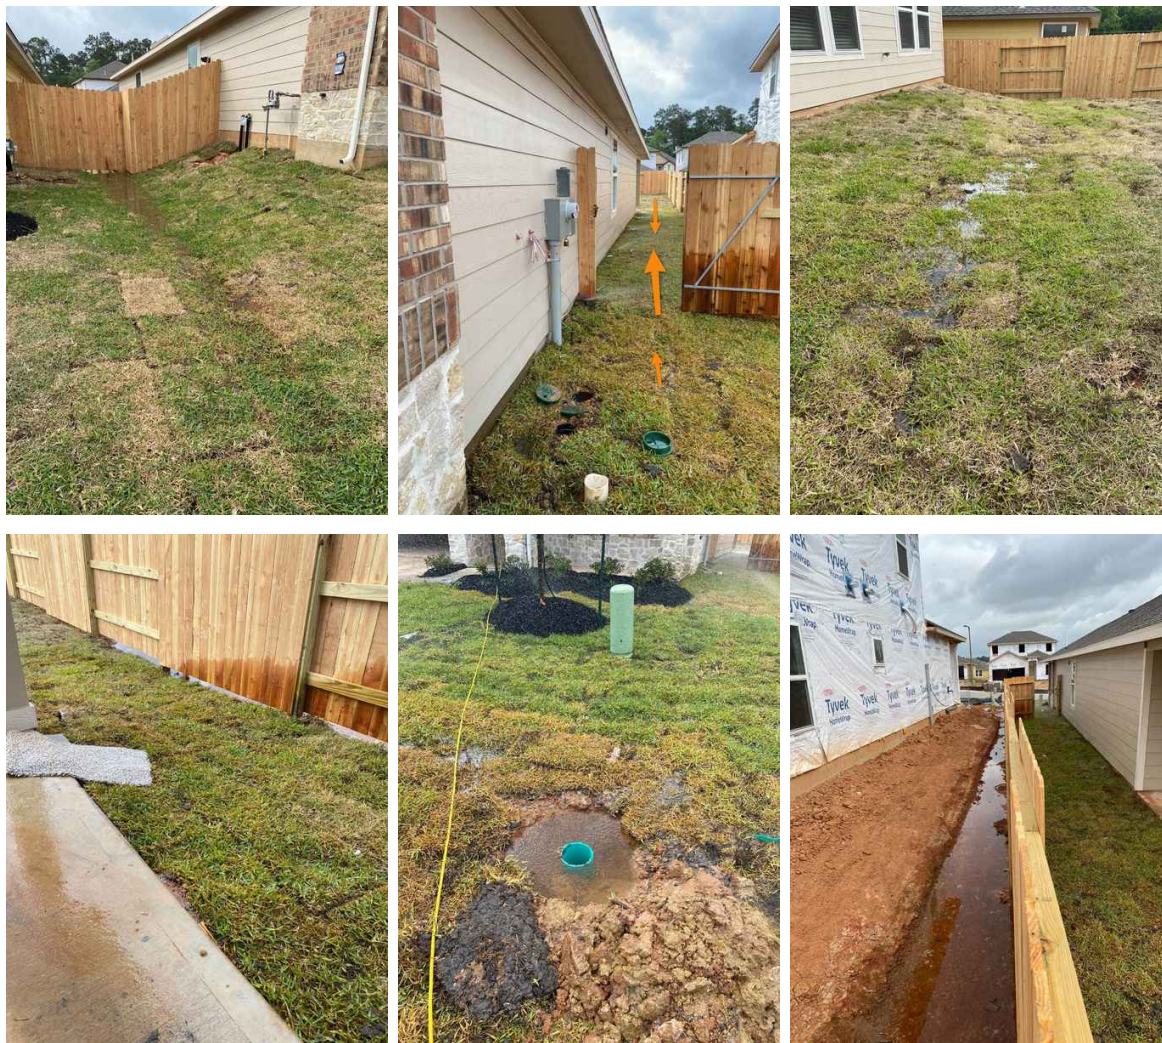
2: Standing Water

Standing water observed, which could indicate poor drainage and/or grading. Recommend monitor and/or have landscaper correct.

Recommendation: Contact a qualified landscaping contractor

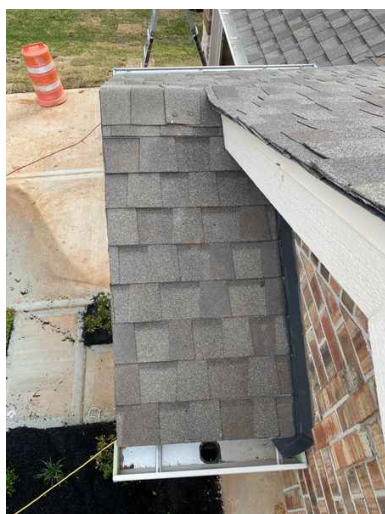
1: Exposed Nails

One ridge shingle at the front of the house was buckling upward and loose, exposing the under-layers and nails.

Recommendation: Contact a qualified roofing professional.

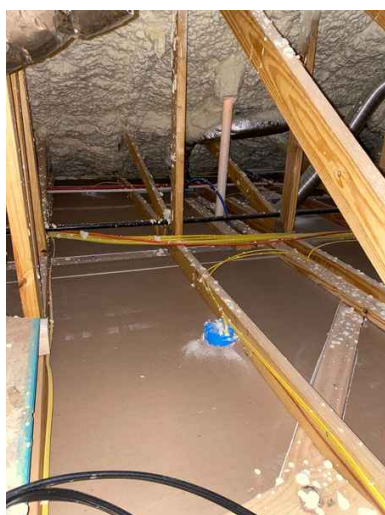
1: Damaged Insulation

Minor damage to spray foam insulation in two spots in the attic.

Recommendation: Contact a qualified insulation contractor.

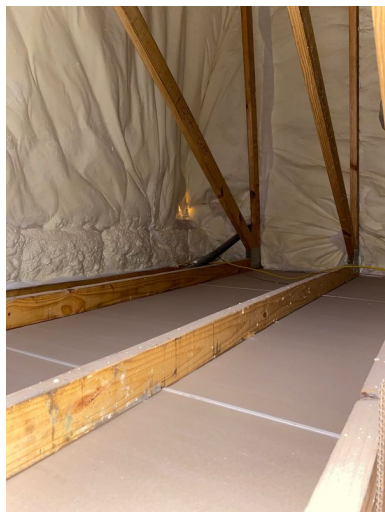
Not sealed at right side wall eaves

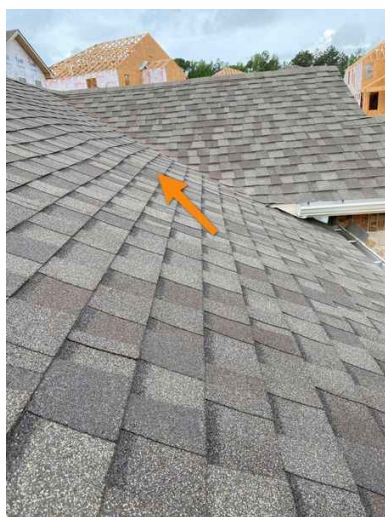
2: Thin/Soft Sheathing

Roof sheathing appears to be unsecured and “bouncy” between the front door and garage where there is a noticeable ridge. Recommend builder investigate and secure sheathing.

Recommendation: Contact a qualified roofing professional.

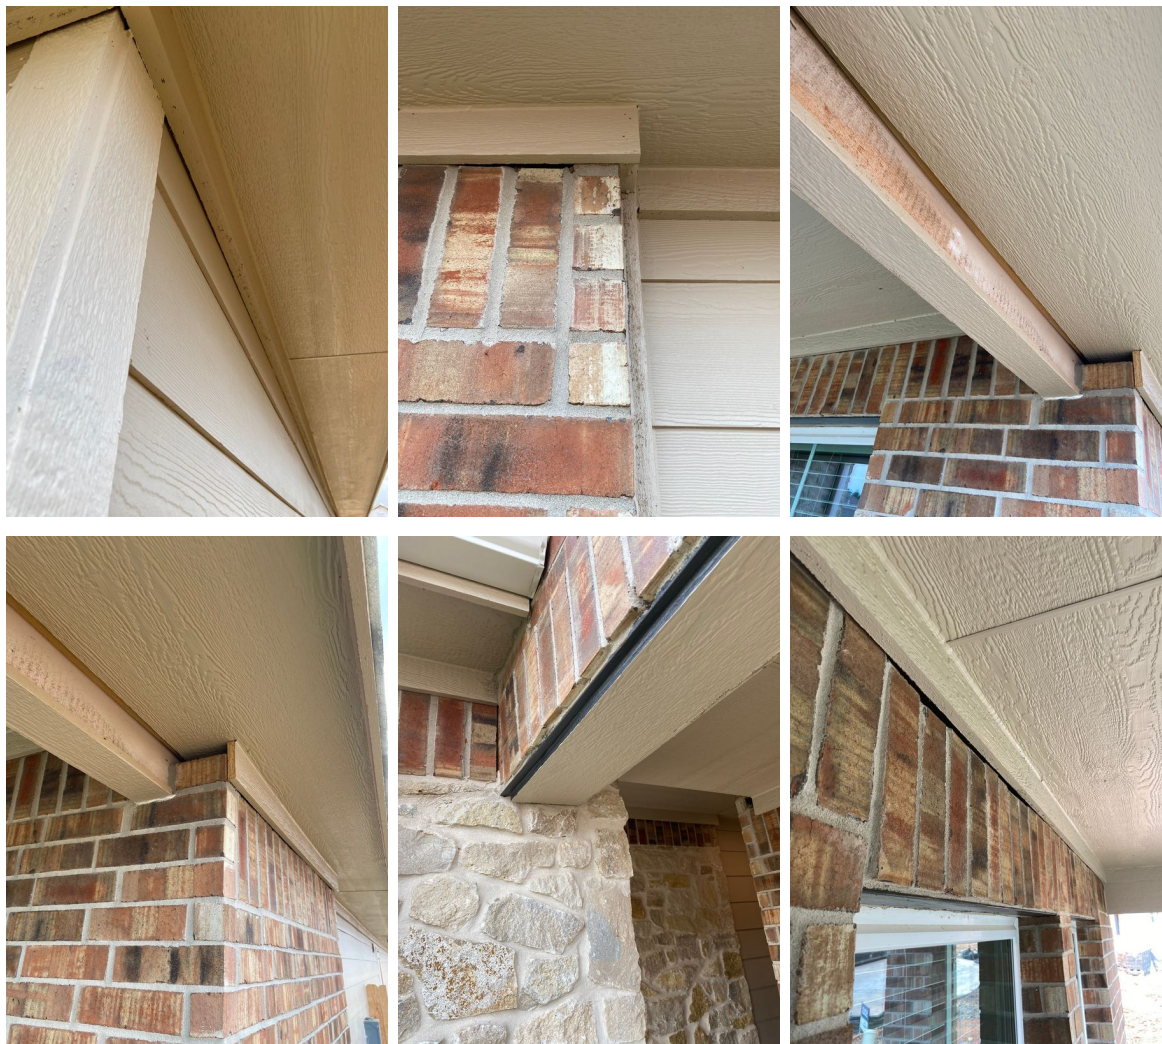
3: Eaves Not Finished

A roof's eaves provide shade and prevent water intrusion into the home. Damaged eave components (soffits, fascia, molding) can lead to moisture intrusion and significant damage to building components.

Recommendation: Contact a qualified general contractor.

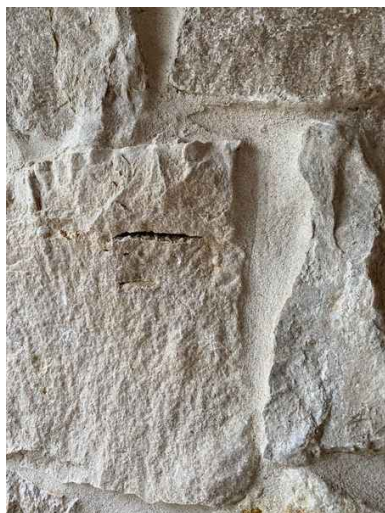
2: Unfinished Wall Areas

The exterior and interior walls had several areas in need of repainting, sealant, or repairs.

Recommendation: Contact your builder.

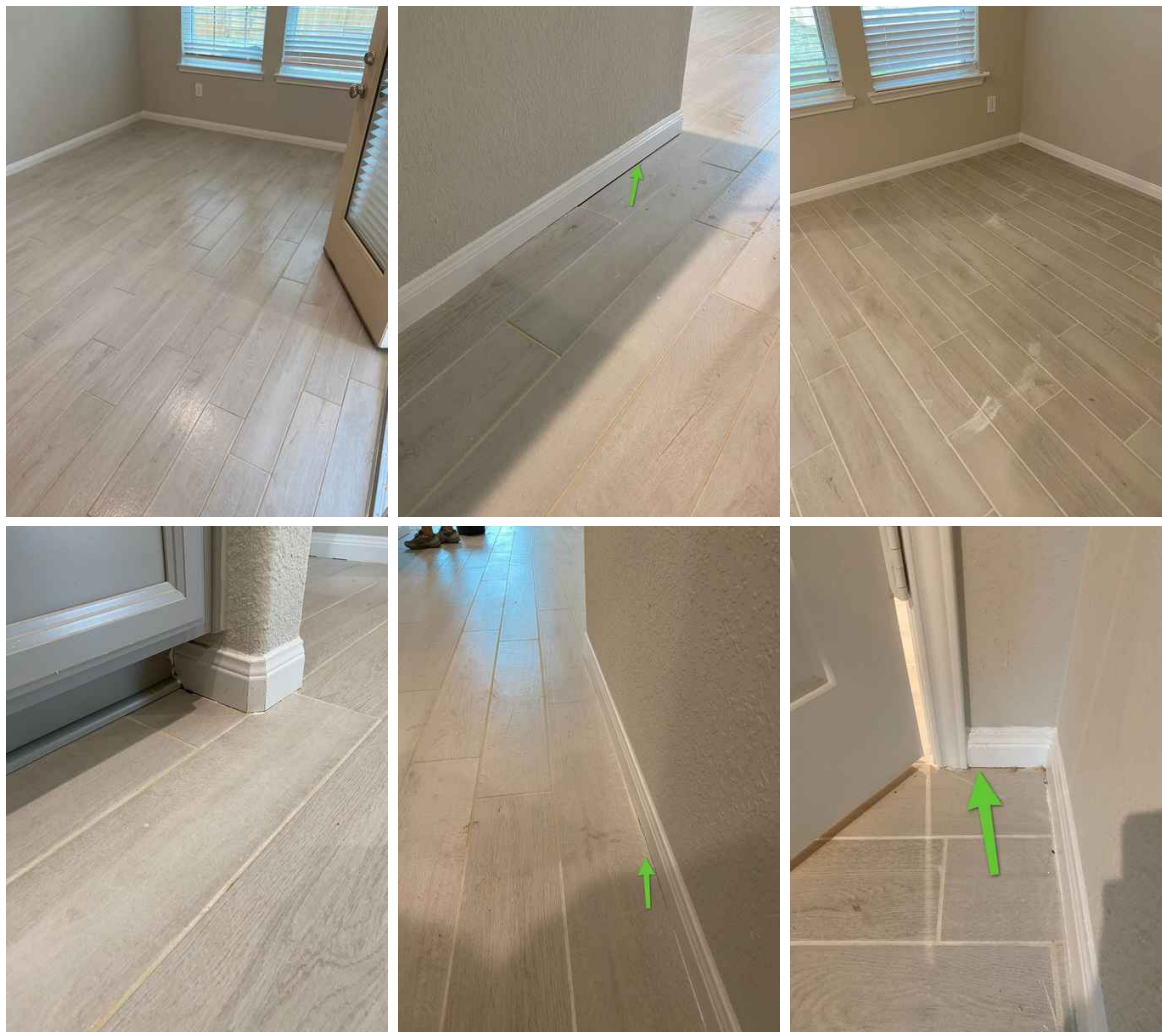
1: Flooring - Damaged

Two damaged areas of tiles were noted. Next to the fridge and the master closet.

Recommendation: Contact a qualified professional.

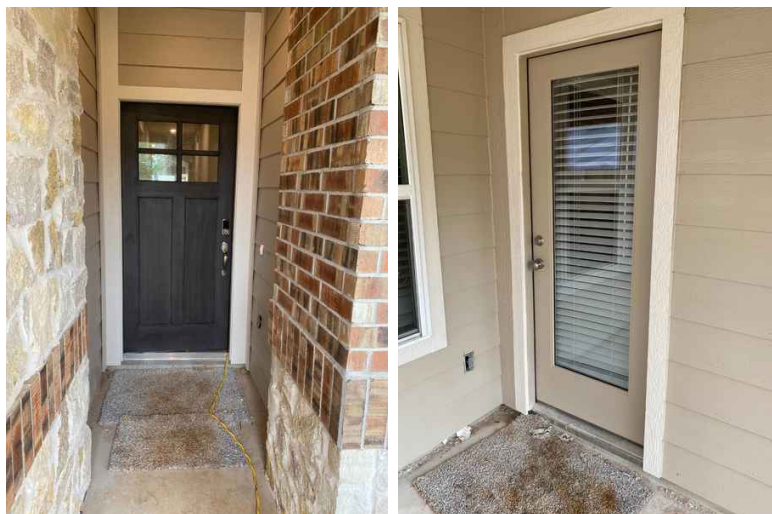
1: Door Sticks

The front door and garage door were both tough to close. After cleaning and further inspection, this may be easily remedied.

Recommendation: Contact your builder.

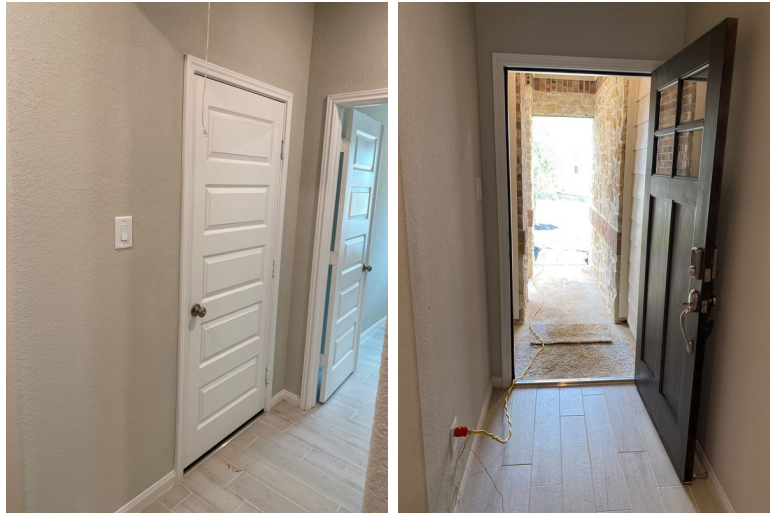
2: Non-Fire Resistant Garage Access

The garage door did not self close as it needs to per building and fire codes. The weather stripping was also unsecured at the bottom.

Recommendation: Contact a qualified door repair/installation contractor.

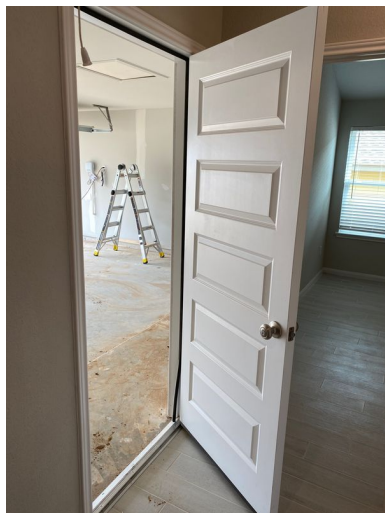
3: Ants

These ants appeared to be travelling back inside of the garage door trim after scavenging in the garage area.

Recommendation: Contact your builder.

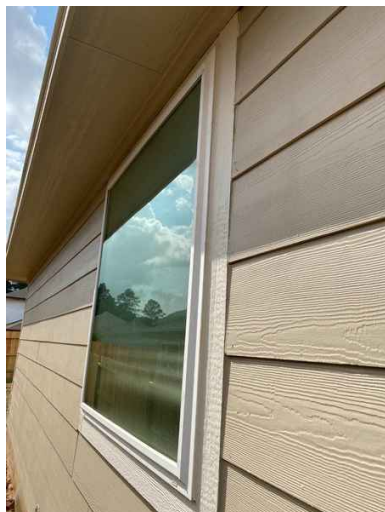
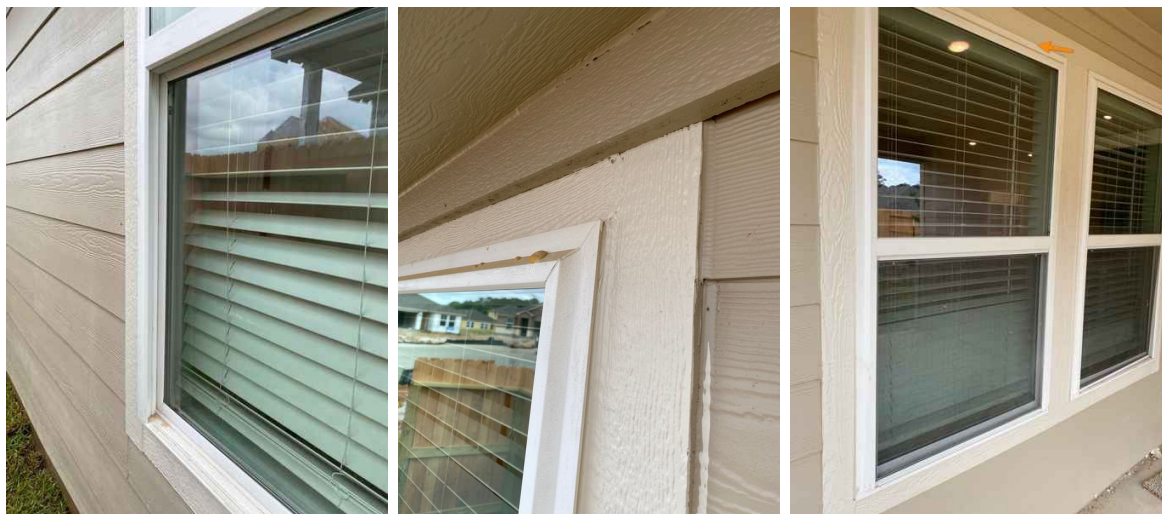
1: Unfinished Windows

Right wall window needed cleaning, as it had spray foam insulation debris stuck to it. Same wall had a missing screen.

The rear facing windows appeared to be unfinished and lacking sealant at the top surface, which could allow moisture intrusion.

Recommendation: Contact your builder.

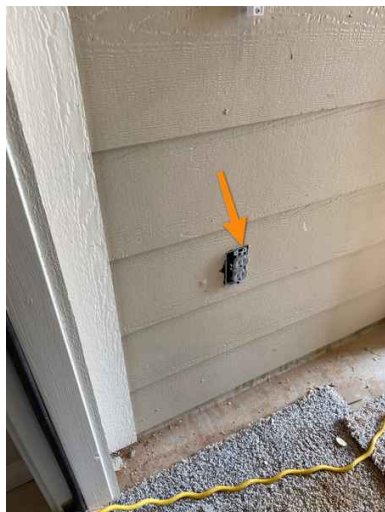
Several cover plates were missing and outlets were unsecured. But only the front door exterior did not appear to have power on the day of the inspection.

No power

Recommendation: Contact your builder.
