HEDDERMAN SERVICES

MECHANICAL INSPECTION

4920 Laurel Street
Bellaire Tx 77401

PROPERTY INSPECTION REPORT

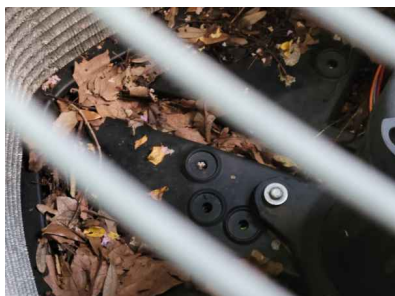
Debris was observed to be inside of the housing and needs to be removed and the inside of the unit thoroughly cleaned by a service company.

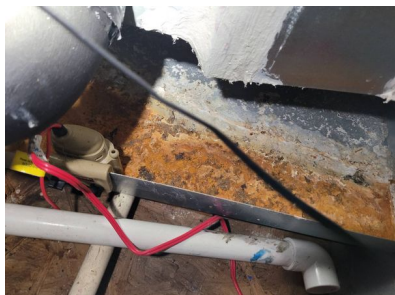
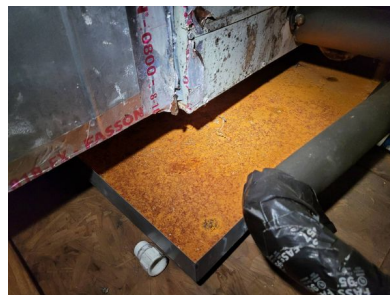
2: Overflow Pan - Rust

Rust was observed in the overflow pan under the coil, apparently due to water backing up at the primary drain line and overflowing into the pan. No water was observed in the overflow pan at the time of the inspection, however since the equipment was only operated for a short time during the inspection, It is recommended that the primary drain line and the coil be checked by an air conditioning service company.

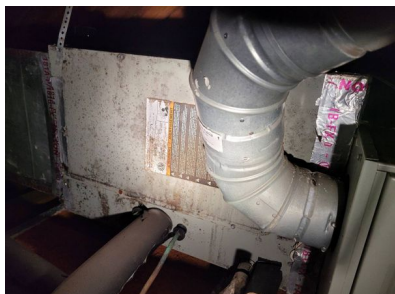
3: Microbial growth on equipment in attic

Microbial growth was observed on the outside of the air handler and/or evaporator coil casing. This condition is indicative of a moisture/condensation problem, possibly due to air leaks at the equipment and/or a lack of adequate attic ventilation. Further investigation is recommended with a service company to determine the source of the growth and to determine if the growth is present inside the equipment and/or air ducts. It is recommended that you obtain a cost estimate for any needed repairs.

Further investigation is recommended

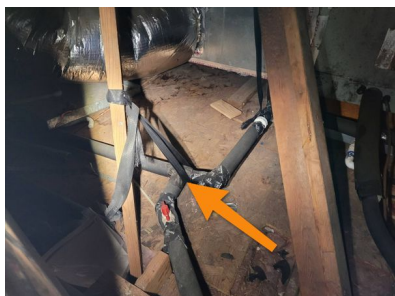
4: Primary Drains - Connected together in attic

The primary condensation drain line for the evaporator coils connect together in the attic rather than terminating independently. The condition can reduce drain performance. Consideration be given to separating the drain lines and terminating each drain line independently in an approved manner.

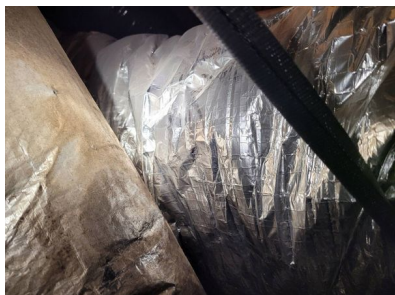
3: Ducts - No clearance between ducts

We observed that some of the air ducts in the attic were in contact with each other, which can cause condensation to form on the outside of the ductwork. It is recommended that the ducts that are touching be separated. Typically, this is done by inserting a piece of fiberglass batt insulation or duct board between the ducts.

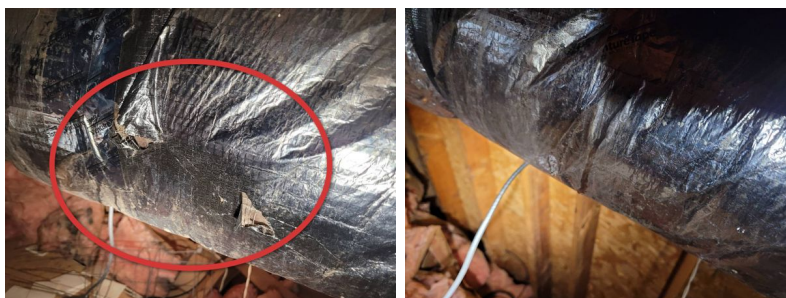
4: Ducts - Sheathing/Insulation damaged

The sheathing and/or insulation around the air ducts is damaged/missing, and the damaged duct work needs to be repaired or replaced.

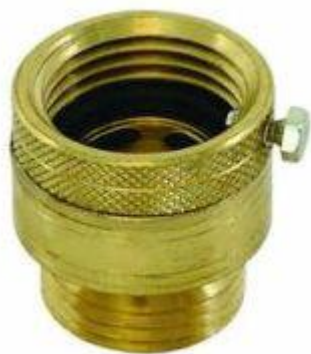
1: Vacuum Breaker - Missing

The atmospheric vacuum breaker devices were missing at one or more of the hose bibbs, and it is recommended that they be installed to prevent cross connections, which can allow contaminated water to enter the potable water supply.

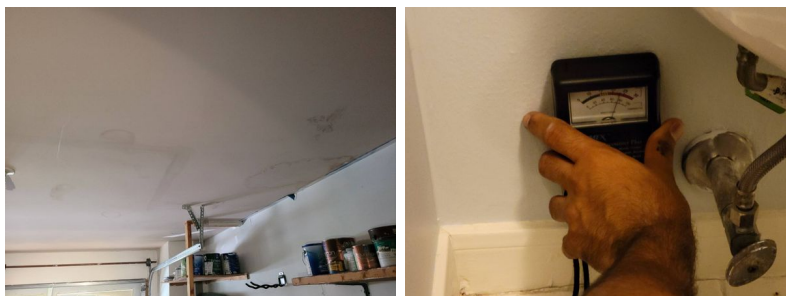
2: Water Stains - High moisture detected

Garage and 2nd Floor Bathroom toilet area

Further investigation is recommended with a contractor to determine the source of the condition and to make any necessary repairs to correct the moisture condition and, if present, any secondary damage.

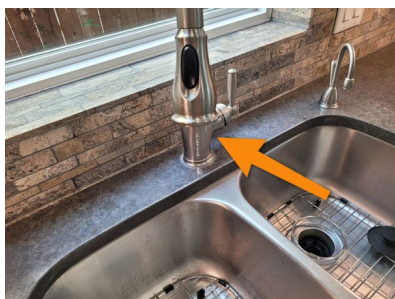
3: Faucet - Drip leaking

A drip leak that needs to be repaired was observed at a faucet.

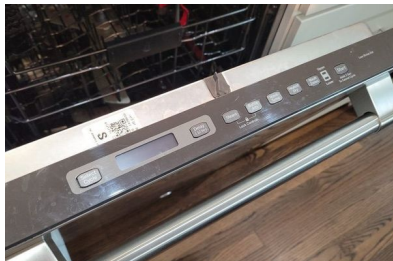
1: Nonfunctional

The right dishwasher was nonfunctional at the time of the inspection. The reason for the condition was not apparent. The unit should needs to be checked by a service company who should provide a cost estimate to repair or replace the equipment.

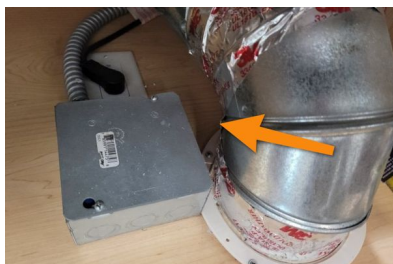
1: Vent Pipe - leaking air

The vent pipe was leaking air into the kitchen cabinet and needs to be sealed.

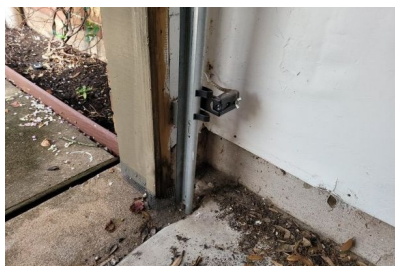
2: Sensors too high

The infrared device was located too high on the garage door, and should be located no more than six inches above the floor. It is recommended that the device be lowered.
