STRUCTURAL INSPECTION

4920 Laurel Street
Bellaire Tx 77401

JULY 13, 2021

REF: CONDITION OF PROPERTY SURVEY

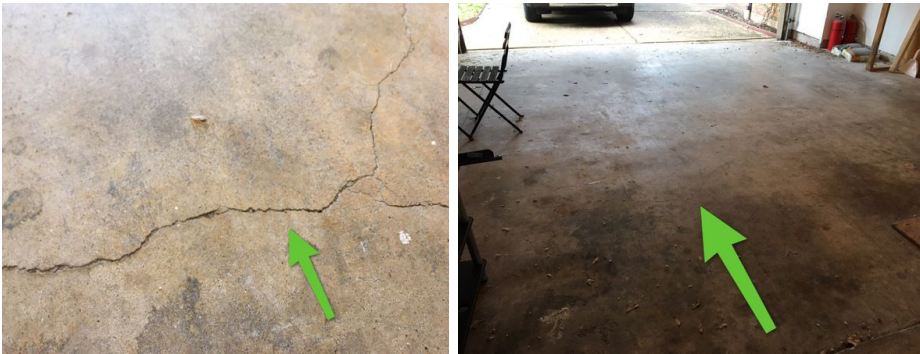
Differential Movement: Concrete Cracks - Garage

Cracking of the foundation concrete exists in virtually all foundations. It is pointed out that cracking is a normal property of concrete and other brittle materials, and Hedderman Engineering, Inc. assumes no responsibility should cracks be found that are not mentioned in this report. Some cracking was observed in this concrete foundation, including at the garage floor.

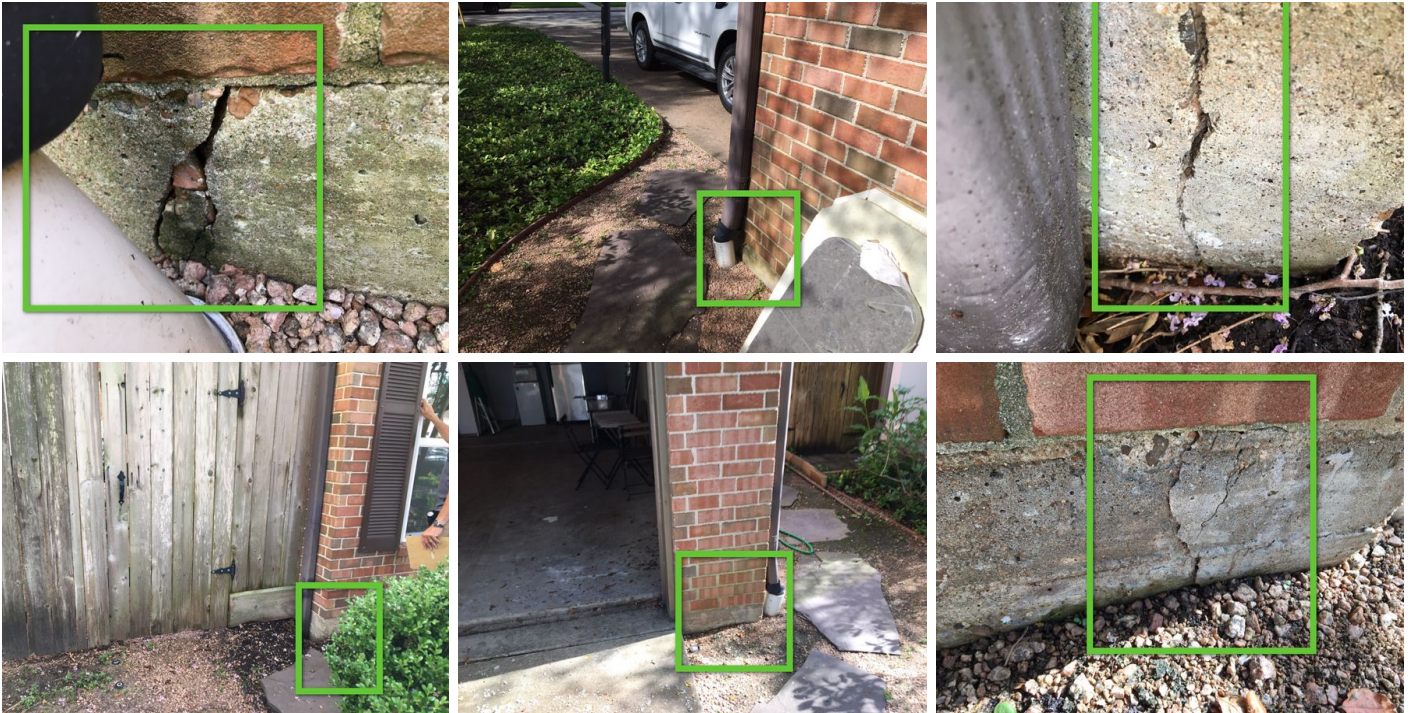
Differential Movement: Corner Chipped

Some of the corners of the foundation were observed to be chipped. This condition is typically caused by differences in thermal expansion between the brick veneer and the concrete foundation. Also, this condition can be caused by a lack of reinforcement in the corner of the foundation during original construction. In our opinion, this condition does not affect the overall structural integrity of the foundation, nor is it an indication of foundation movement.

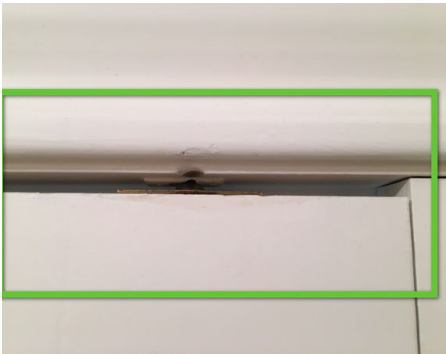
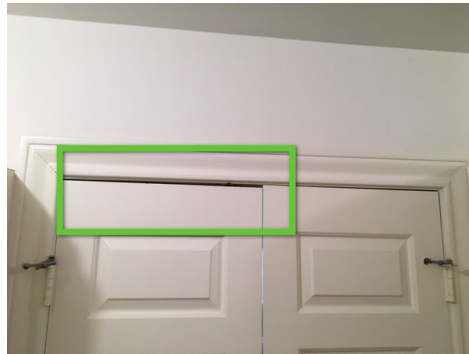
Separation of Materials: Sticking doors

Doors that were sticking due to movement of the house were observed at the time of the inspection.

Door frames that were out of square, leaving a triangular separation between the door and the door frame at the top of the door were observed where a separation was visible at the top of the door.

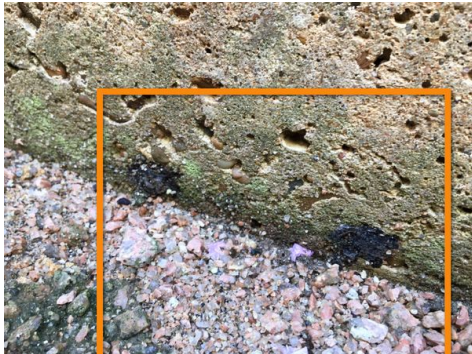
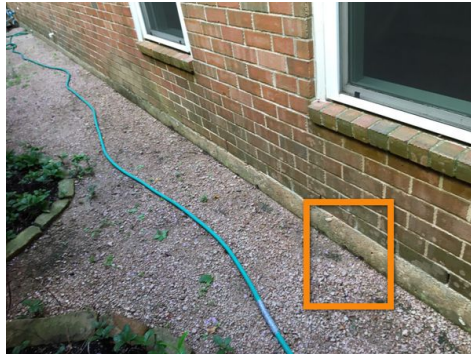
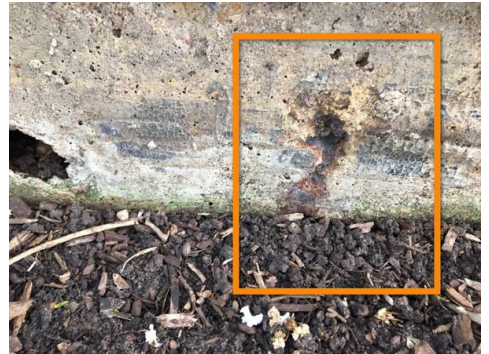
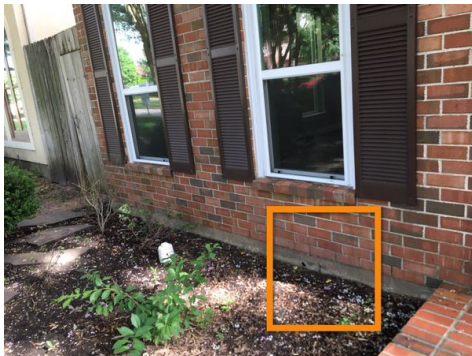
FOUNDATION - SPALLED

The face of the foundation concrete was spalled, and the reinforcing steel used in the construction of the foundation was observed to be exposed. The rust should be removed from the rebar, and the rebar grouted to prevent further deterioration.

Contact a qualified professional.

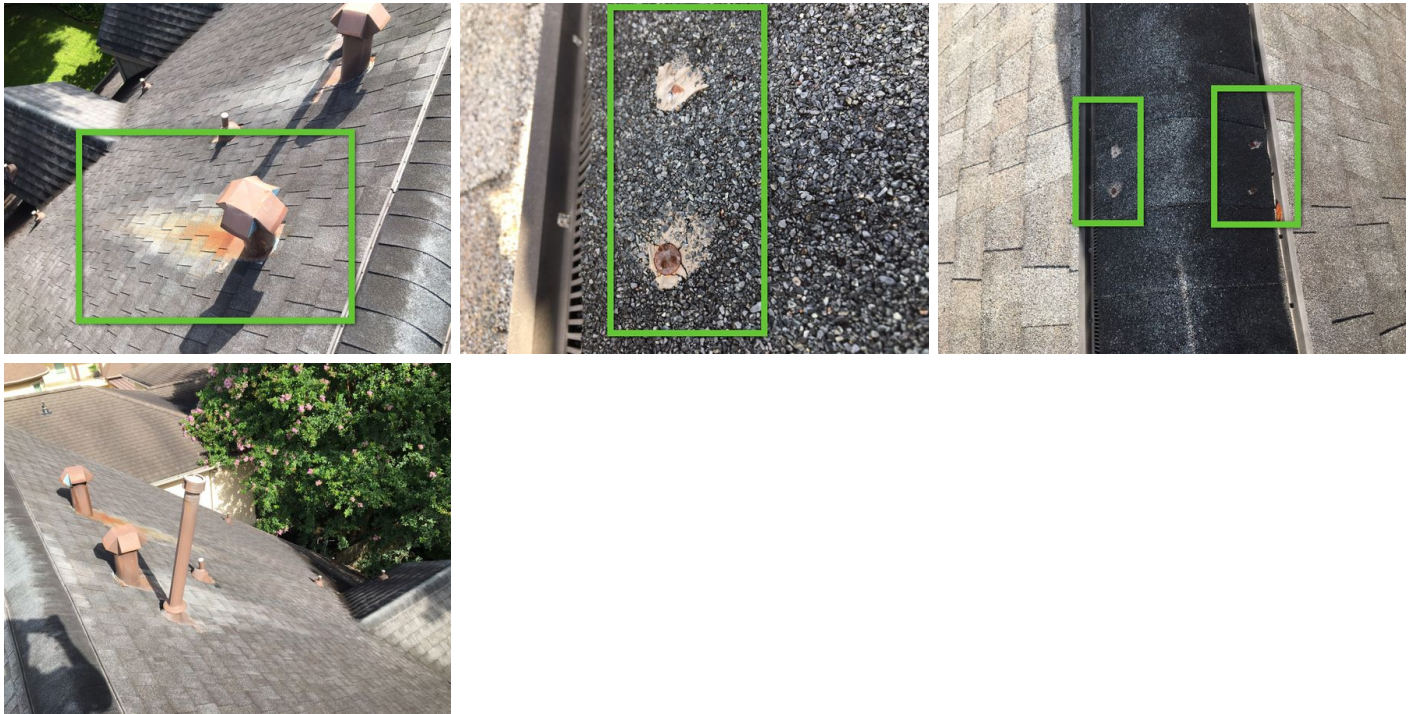
Wear and Deterioration: Composition - Some

Discolored, Nail Heads not Sealed, Rusted Roof Jack

The composition roof surface was showing evidences of some deterioration of the roof surface as described above and shown below.

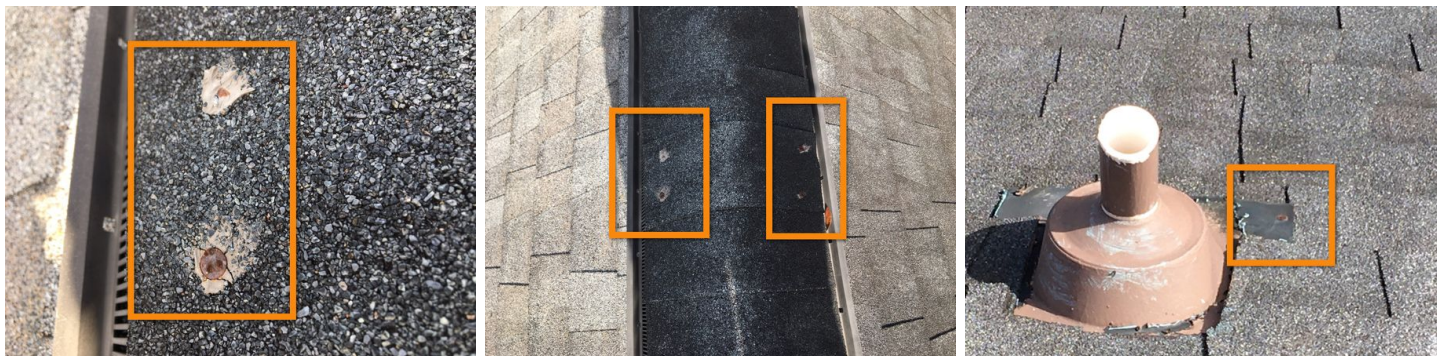
DETERIORATED SEALANTS

We observed sealants that were cracked/separated/missing and repair is needed.

Contact a qualified professional.

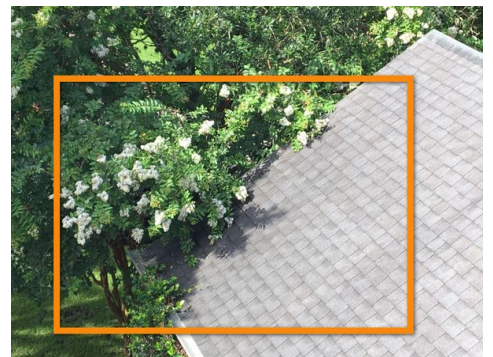
5.5.2 Roof Details

ROOF: MISCELLANEOUS

We observed some miscellaneous items related to the surface of the roof, including the items listed above. Have a roofing contractor provide a cost estimate to make any needed repairs.

Contact a qualified professional.

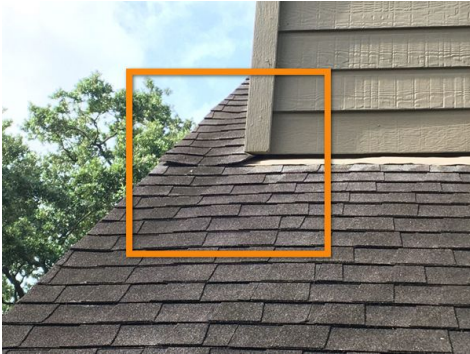
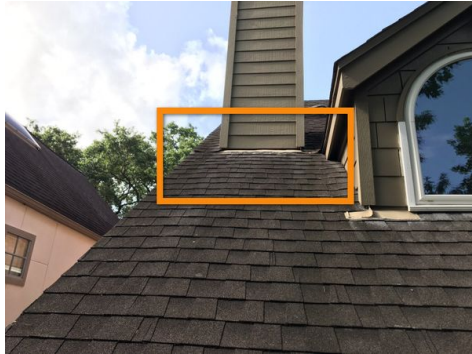
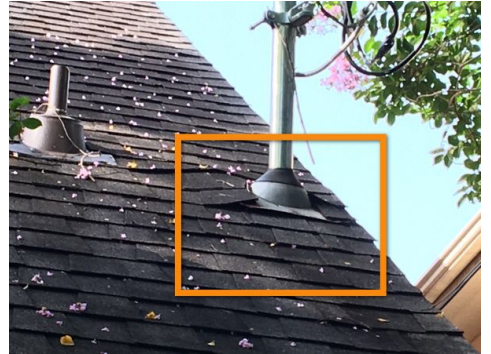
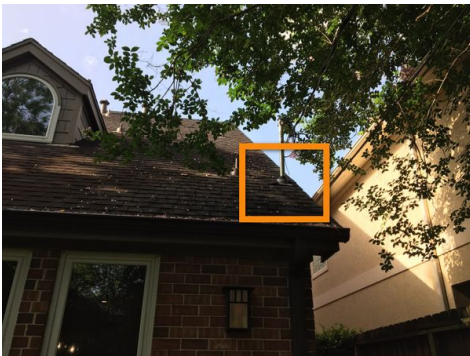
5.5.3 Roof Details

FLASHING/COUNTER FLASHING

We observed one or more conditions with the roof flashing as pointed out above. Have a roofing contractor provide a cost estimate to make all needed repairs

Contact a qualified professional.

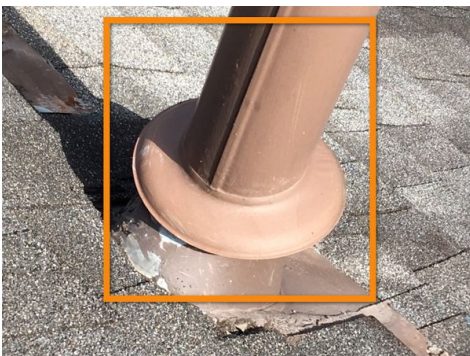
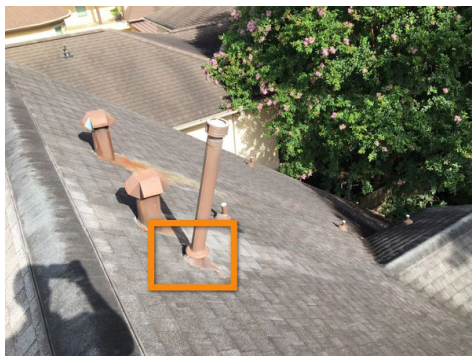
5.5.4 Roof Details

METAL VENT PIPES

Storm Collar Sealant Deteriorated

We observed metal vent pipe(s) that were in need of repair, including the conditions listed above.

Contact a qualified professional.

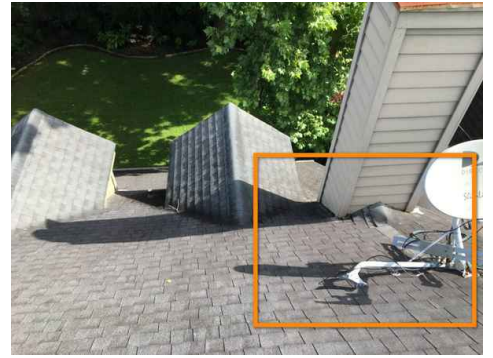
5.5.5 Roof Details

LOOSE ANTENNA

A loose antenna was observed over the roof and the antenna needs to be secured or removed.

Contact a qualified professional.

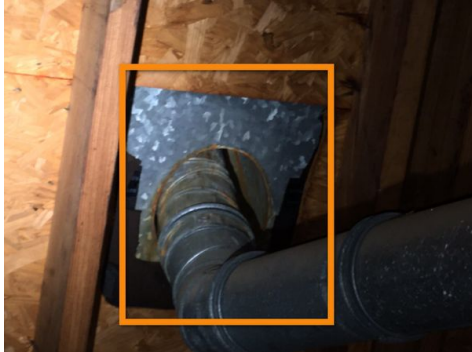
5.6.1 Roof Leaks

ATTIC ROOF DECKING AND/OR FRAMING MEMBERS

After observing the interior of the structure, evidences of roof leaks were visible in the attic, where the roof decking and/or roof framing members were water stained. It is recommended that a roofing contractor be contacted to find the source of the leaks, and to make any needed repairs.

Contact a qualified professional.

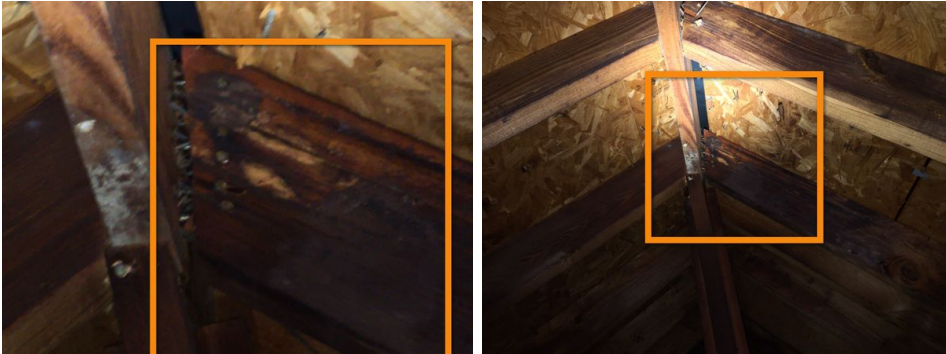
One or more rafters in the attic were observed to be split, and need to be repaired.

Contact a qualified professional.

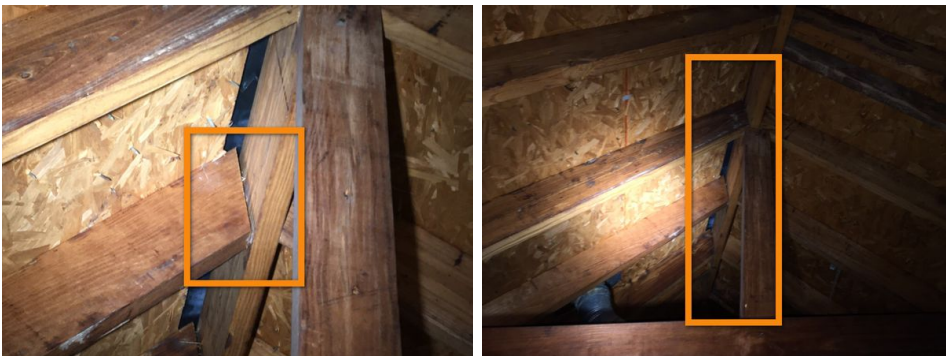
6.4.2 Rafters

RAFTER NOT FLUSH ON RIDGE BEAM

We observed rafters that were separated at the top of the rafter, where the rafter meets the top ridge beam. Rafters should be flush against the ridge beam, and it is recommended that 3 foot make-up pieces be "sistered" onto the rafters, so that the make-up pieces are flush against the ridge. This will allow the rafters to bear against the ridge beam for the entire length of the miter cut on the rafter.

Contact a qualified professional.

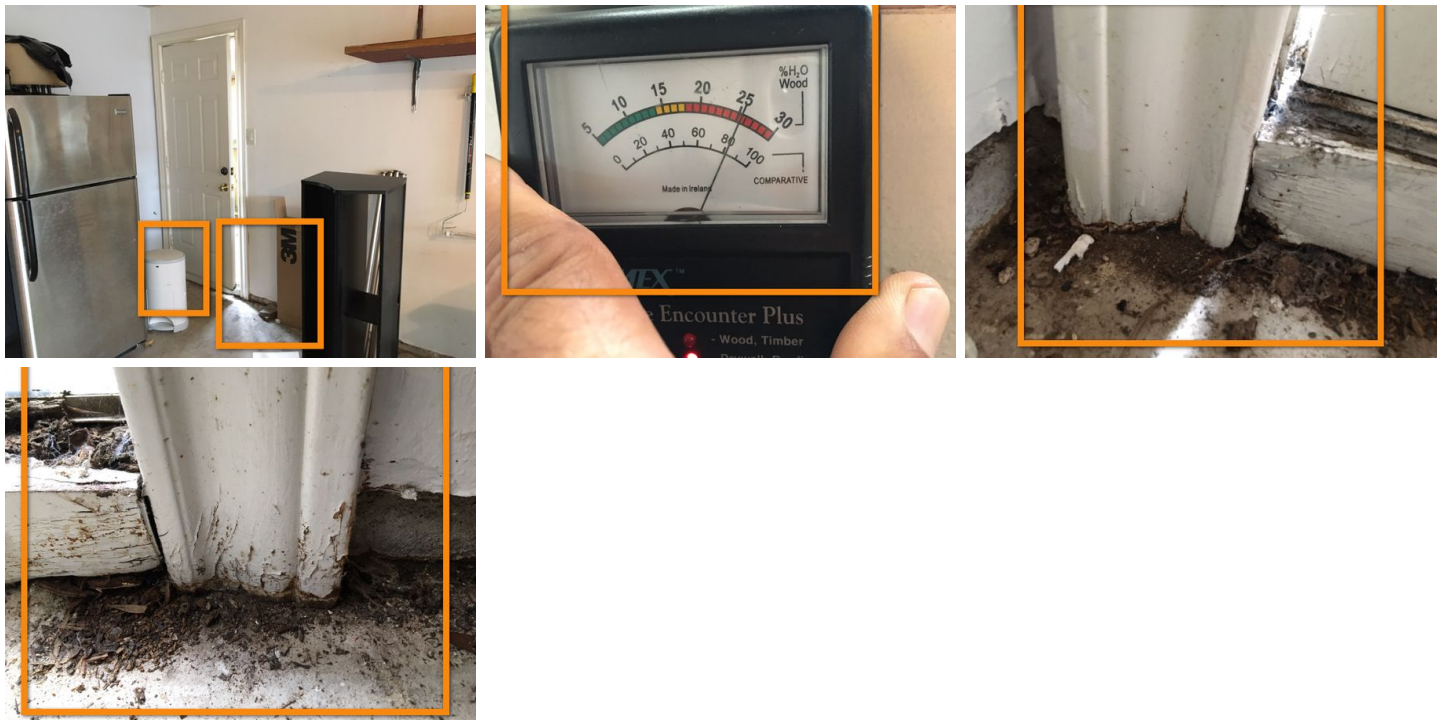
MOISTURE METER - HIGH READING

Our moisture meter showed a higher than normal reading near the bottom of the door. Also, water stains and water damage were observed at the bottom of the door trims.

Contact a qualified professional.

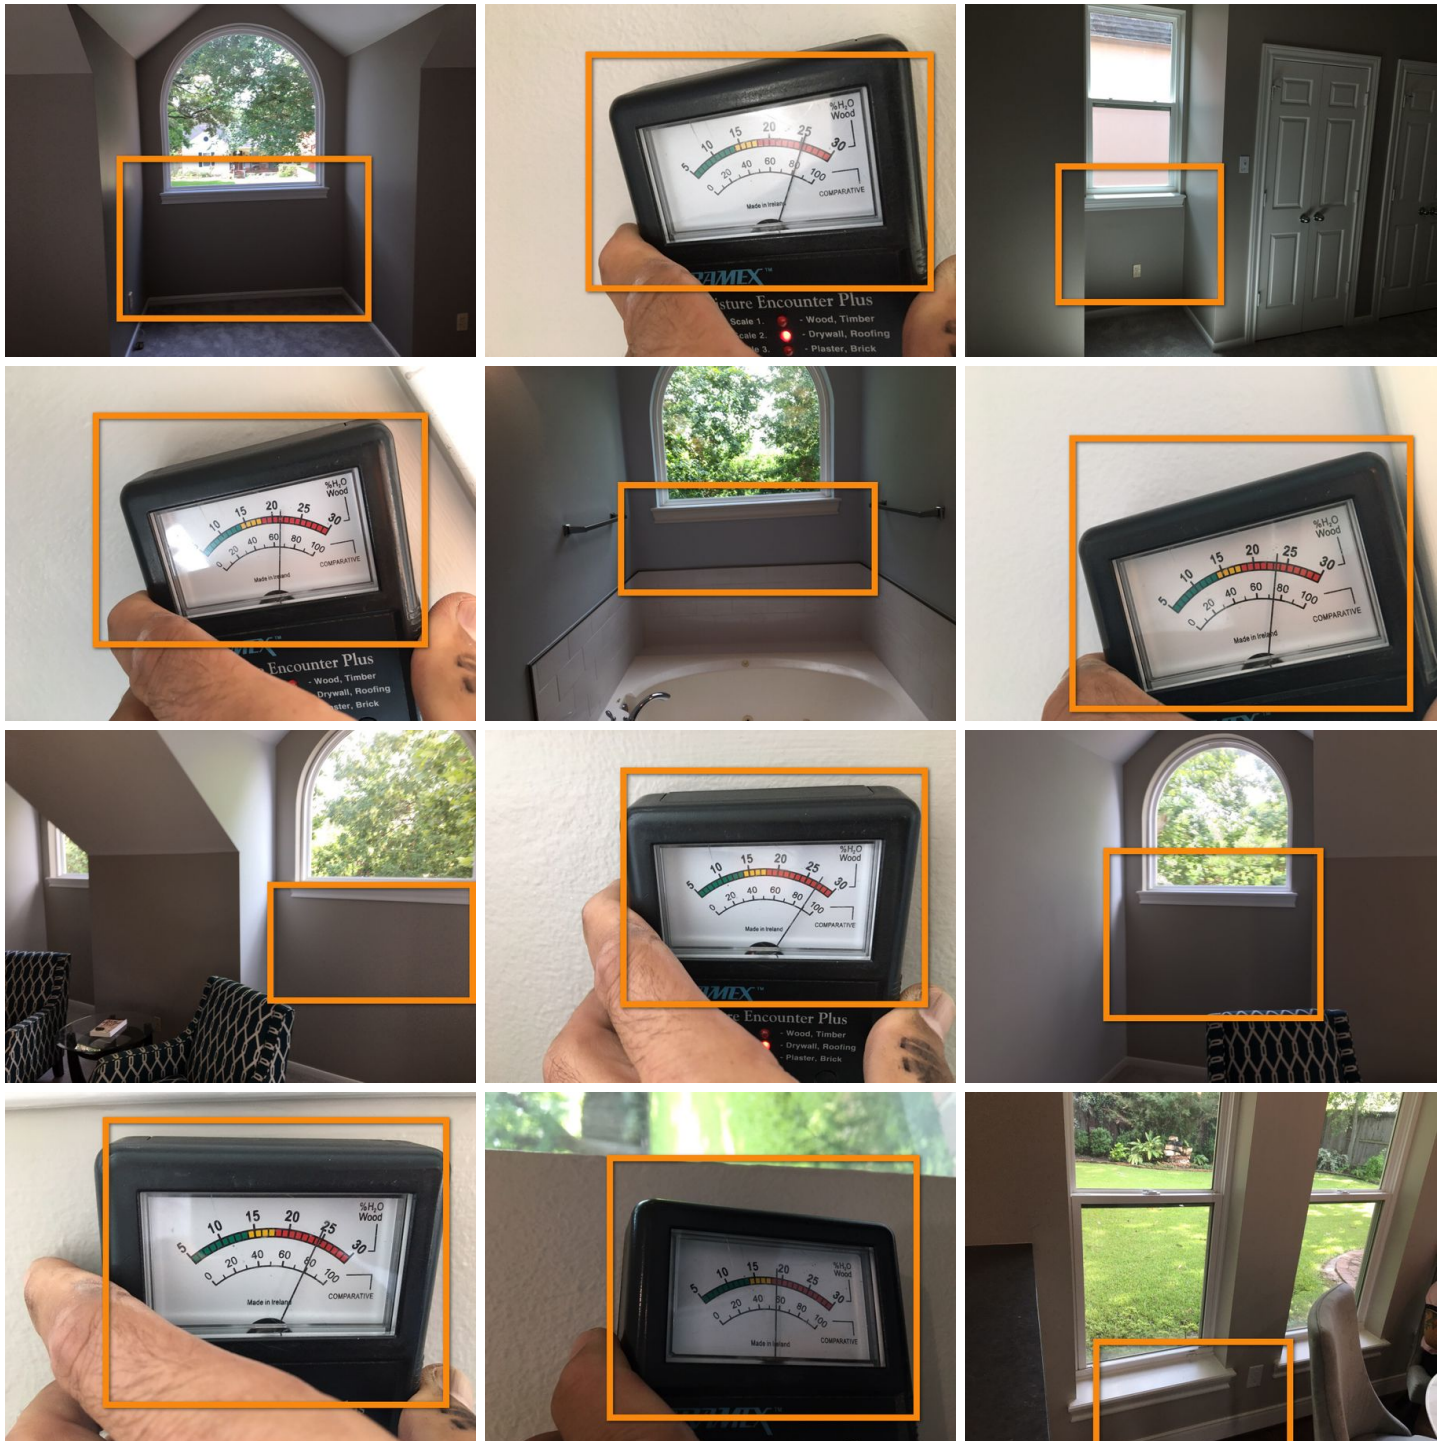
7.1.2 Water Penetration

MOISTURE METER - HIGH READING

Our moisture meter showed a higher than normal reading below and around some of the windows.

Contact a qualified professional.

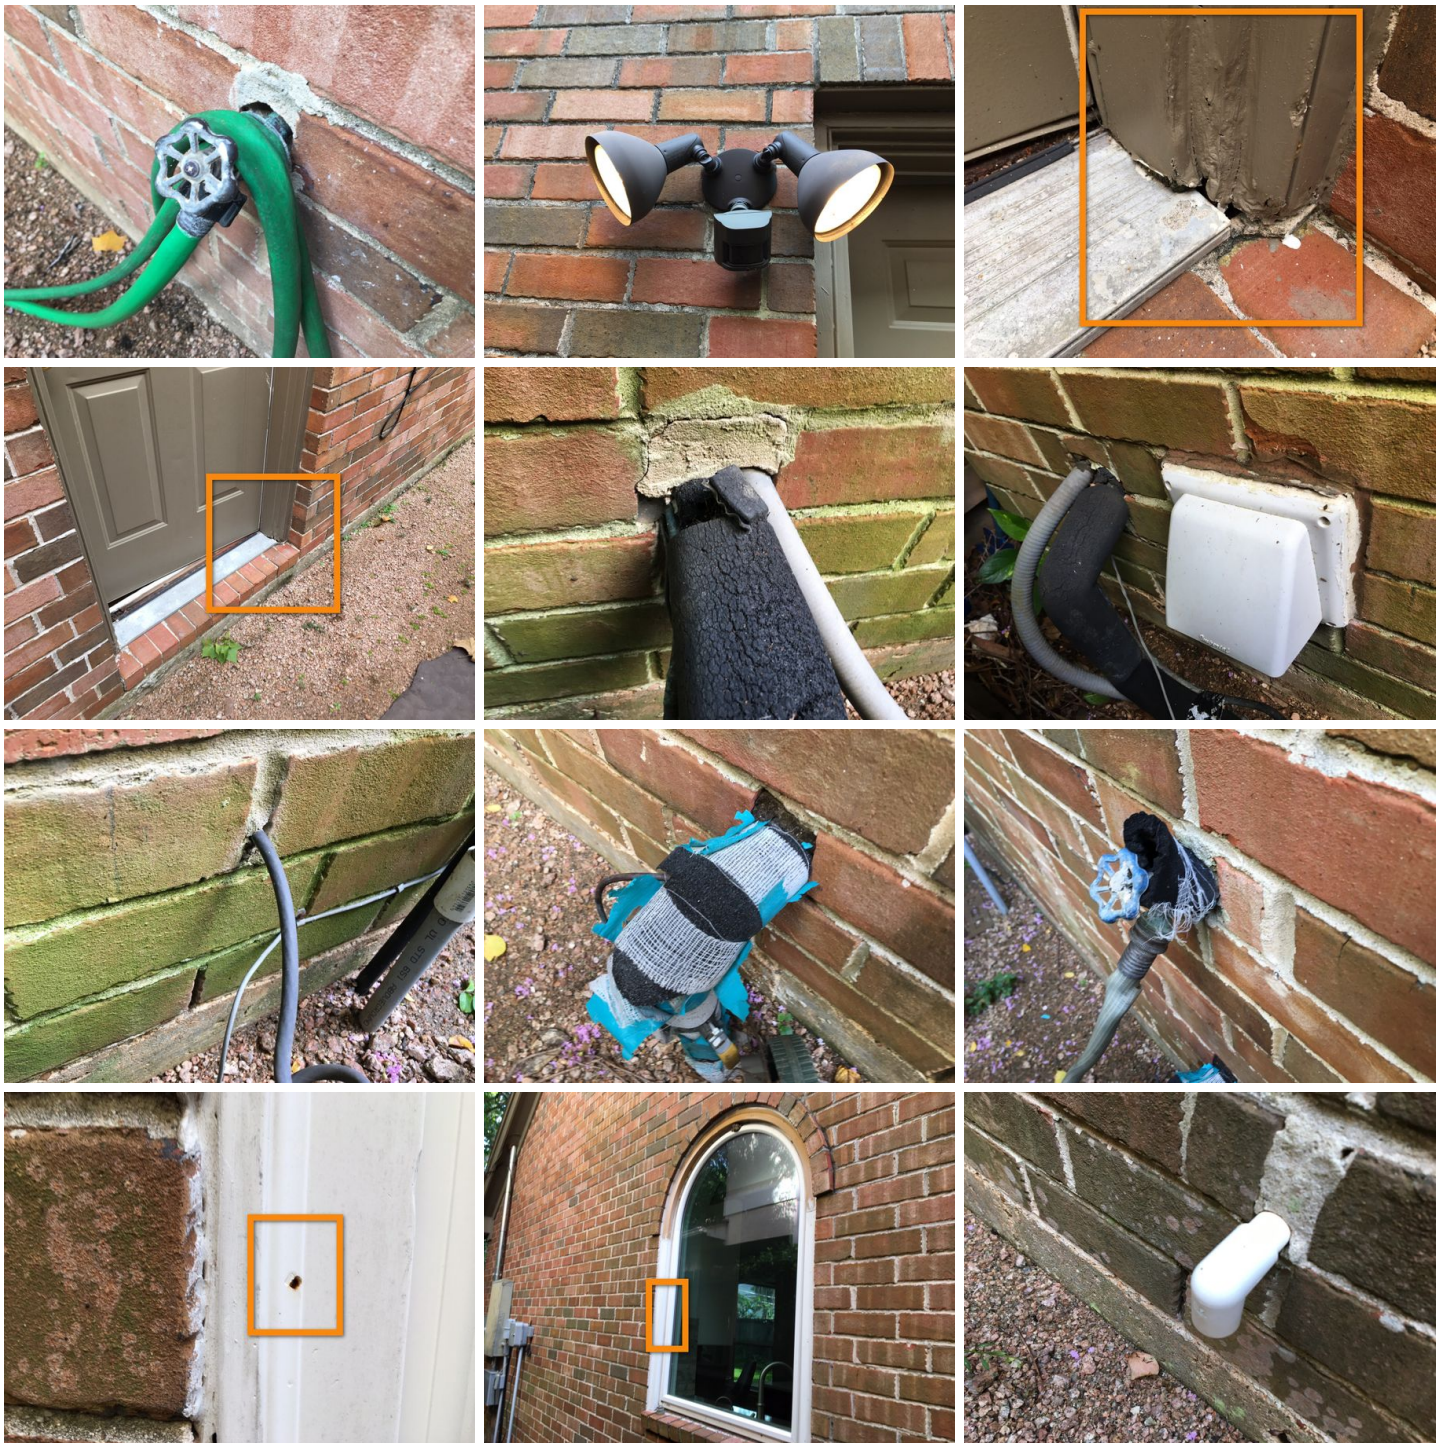
7.1.3 Water Penetration

VULNERABILITY TO WATER PENETRATION

Sealants deteriorated/missing, Window sealants, HVAC Lines, Light Fixtures, Hose Bibb, Gas Line, Electrical Wiring, Vent Caps, Piping, Finish nail heads on the window trims.

A substantial vulnerability to water penetration was observed at penetrations/openings through the exterior building envelope, and it is recommended that all penetrations/openings be sealed against water penetration. Typical examples on a structure may include light fixtures, air conditioning refrigerant lines, water piping, gas piping, vent caps, windows, doors, expansion joints, etc. Below is a representative sample of locations and/or photographs showing some, but not necessarily all, locations where there is a vulnerability to water penetration. Have a contractor provide a cost estimate to seal all vulnerable areas on the exterior building envelope against water penetration and/or open up any clogged weepholes in the veneer.

Contact a qualified professional.

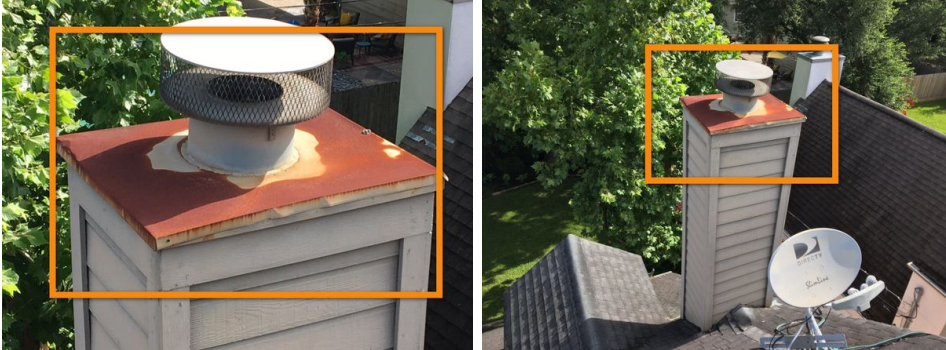
METAL CAP RUSTED

The metal cap on top of the chimney was rusted, and needs to be cleaned and properly sealed to prevent further deterioration.

Contact a qualified professional.

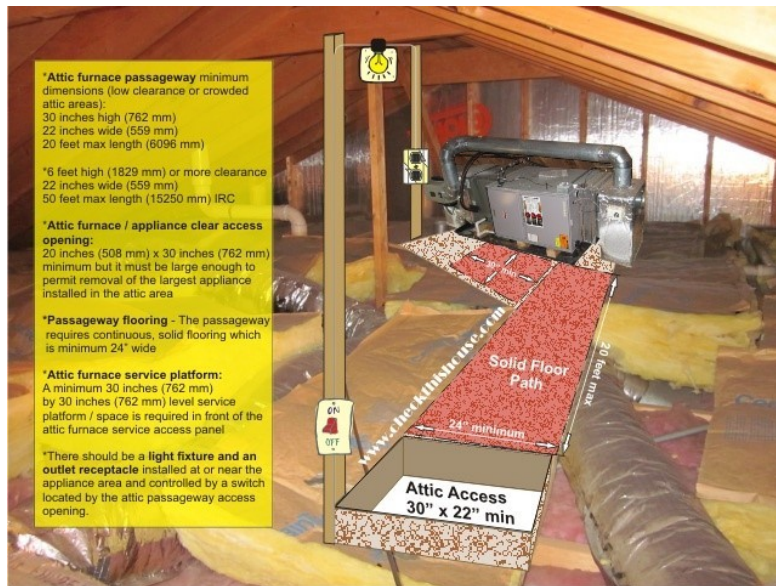
INADEQUATE WALKWAY DECKING

The attic did not have adequate service decking to all the equipment in the attic. The service decking should be a continuous deck that is a minimum of 24 inches wide, that extends from the attic access opening to all equipment in the attic. In addition, the decking should be free from any obstructions, such as gas lines, electrical wiring, ductwork, framing members, etc.

Recommendation
Contact a qualified professional.

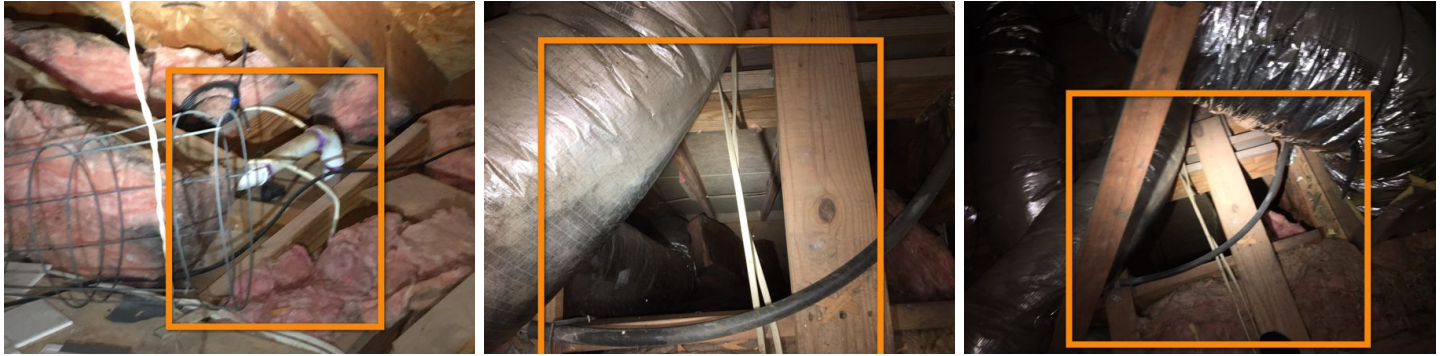
9.4.1 Insulation

INSULATION MISSING - BETWEEN JOISTS

The insulation in the attic was missing from between some of the joists. Have a service company provide a cost estimate for repairs.

Contact a qualified professional.

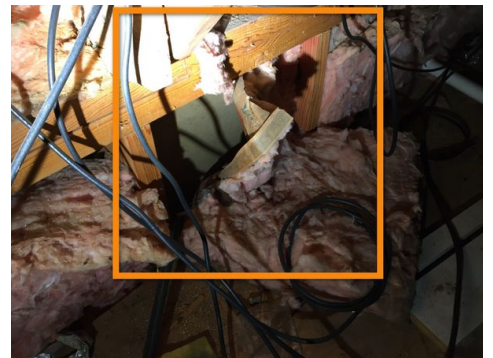
9.4.2 Insulation

INSULATION LOOSE/MISSING - WALLS

The insulation in the attic was loose/missing at some of the vertical walls, and needs to be repaired.

Contact a qualified professional.

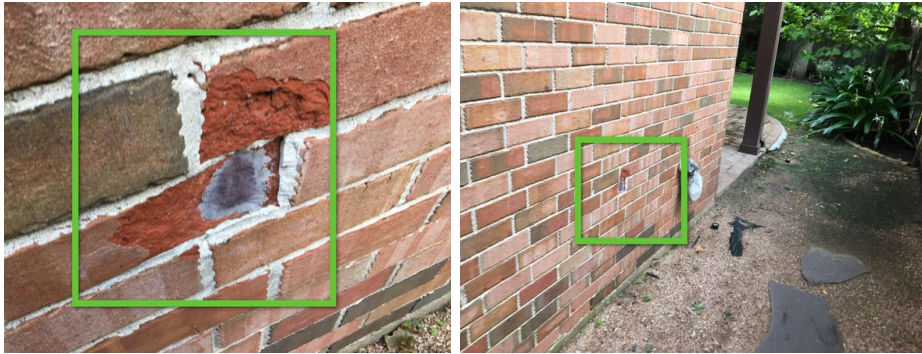
North east side of the house

Some of the bricks were eroded slightly at various locations of the house. The degree of the erosion was not such that the bricks need to be repaired. The condition needs to be monitored in the future, and repairs made if the condition worsens.

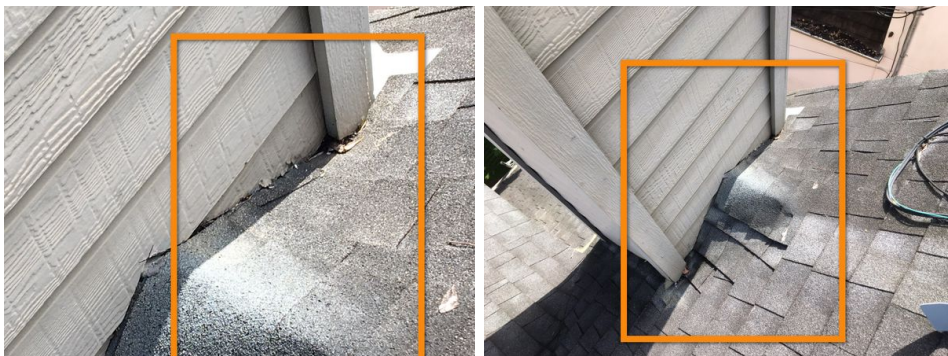
10.4.1 Fiber Cement Siding

The fiber cement siding at the upstairs area was not installed in accordance with the manufacturers recommendations. The siding did not have a one inch gap between the siding and the shingles on the roof, which can possibly allow water to affect the bottom edge of the siding. Further investigation with a contractor is recommended concerning this condition.

Contact a qualified professional.

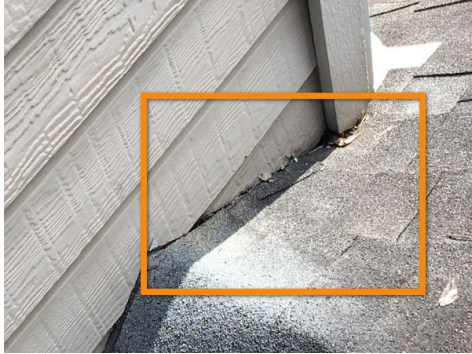
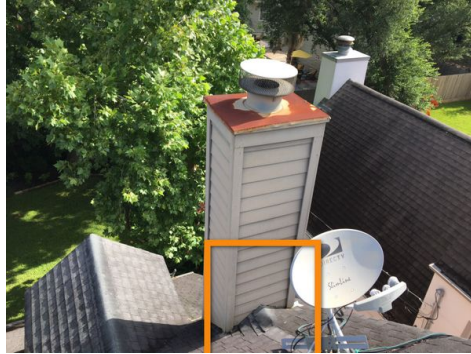
10.4.2 Fiber Cement Siding

DAMAGED AT BOTTOM

The siding was observed to be damaged at the bottom of the wall and needs to be repaired.

Contact a qualified professional.

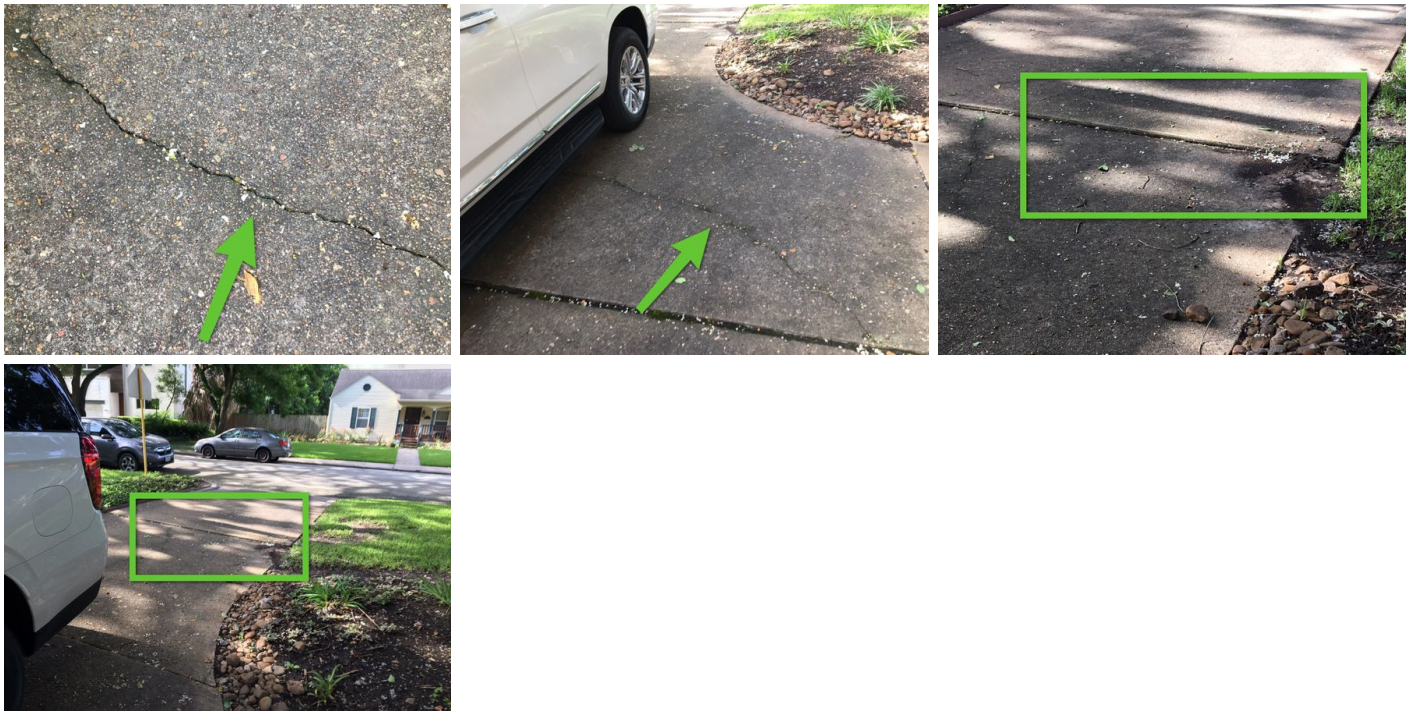
Flatwork Concrete/Patios/Walkways: Cracks Driveway

Cracks and some separations were observed in the driveway concrete. In our opinion, the driveway is still in serviceable condition at this time.

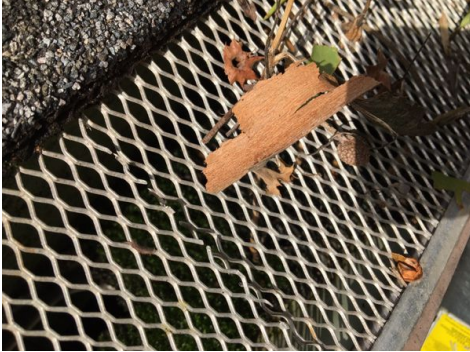
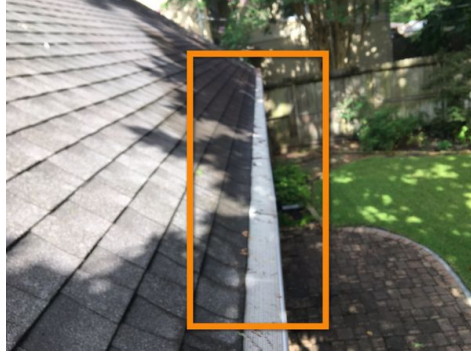
The gutters were observed to have debris in them under the screens and are in need of cleaning.

Contact a qualified professional.

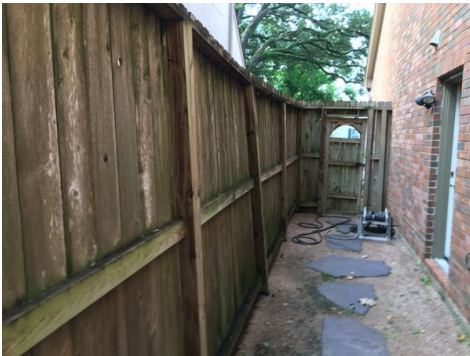
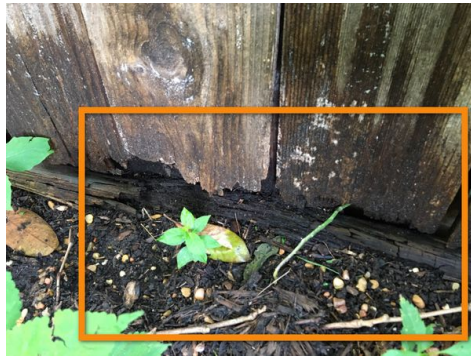
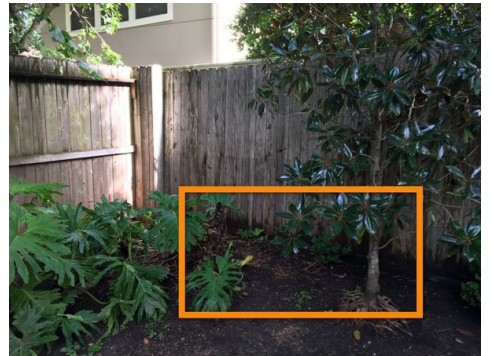
11.3.1 Gates and Fences

WOOD FENCE

Leaning, Starting to rot

The wood fence was in need of some repairs.

Contact a qualified professional.

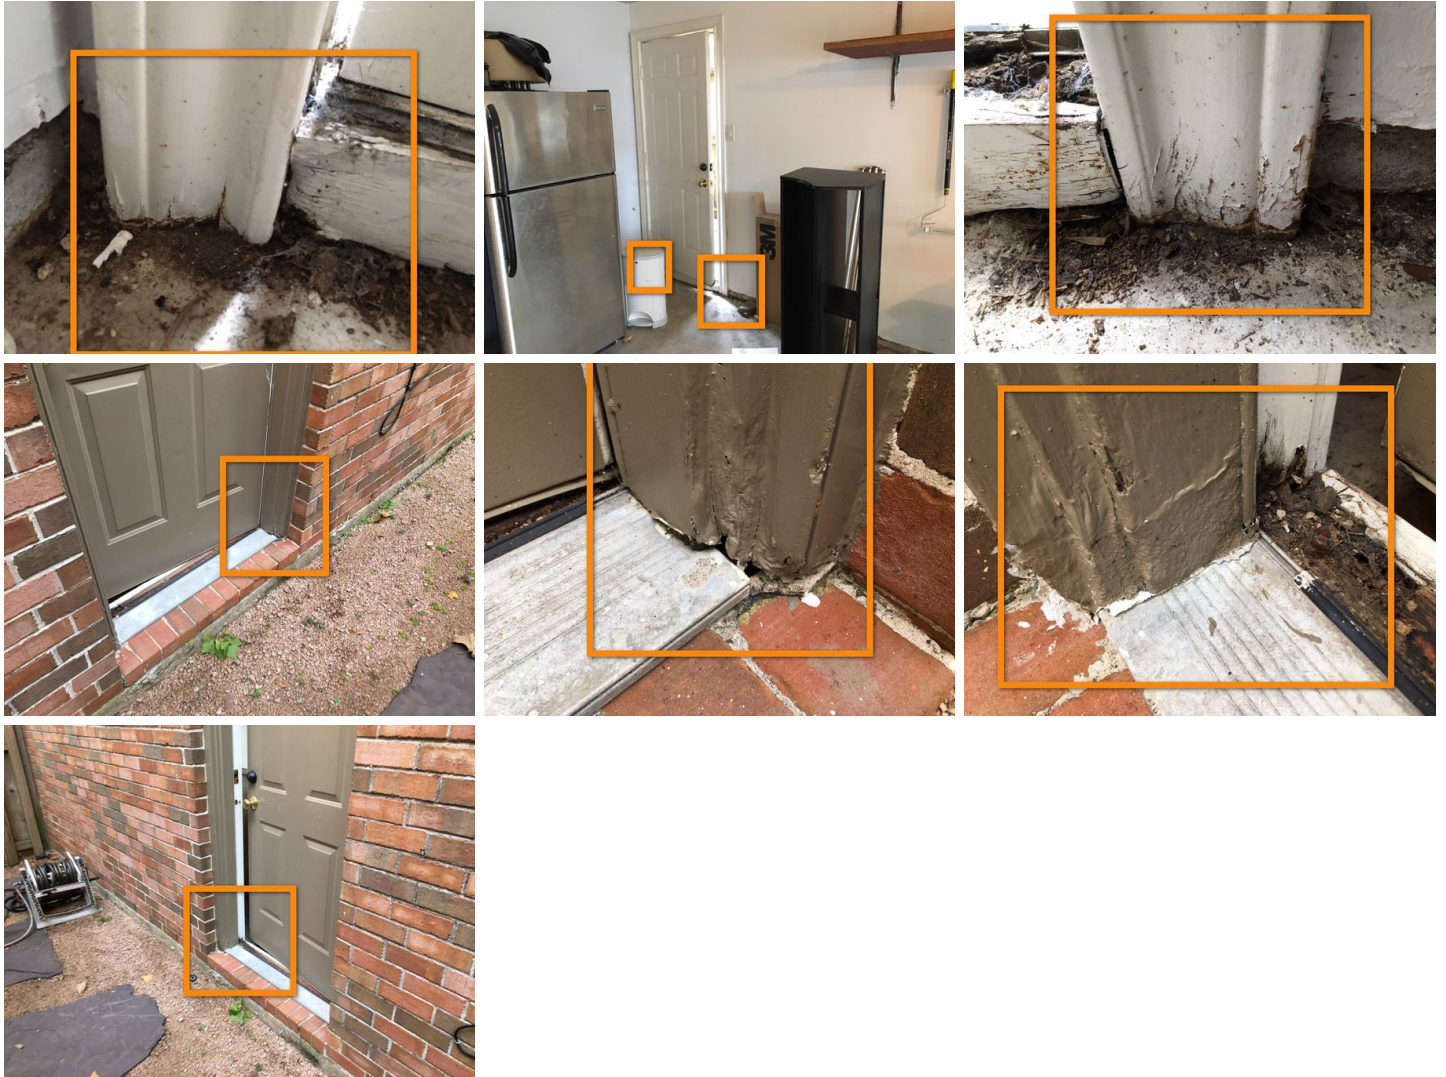
11.4.1 Wood Rot

WOOD ROT

Wood rot was observed and needs to be replaced. Have a contractor provide a cost estimate to determine the entire scope of the wood rot, and provide a cost estimate to replace all rotted wood in the house.

Contact a qualified professional.

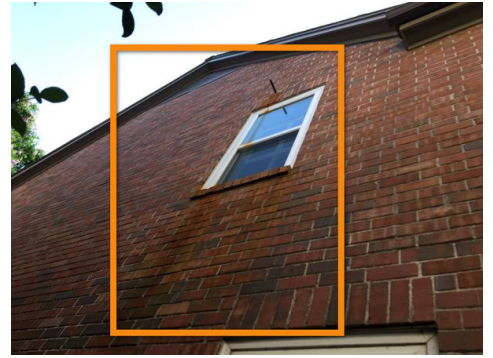
RUST STAIN

A rust stain was observed over the brick wall and a window at the west side of the house. It is recommended to clean the brick wall and the window.

Contact a qualified professional.

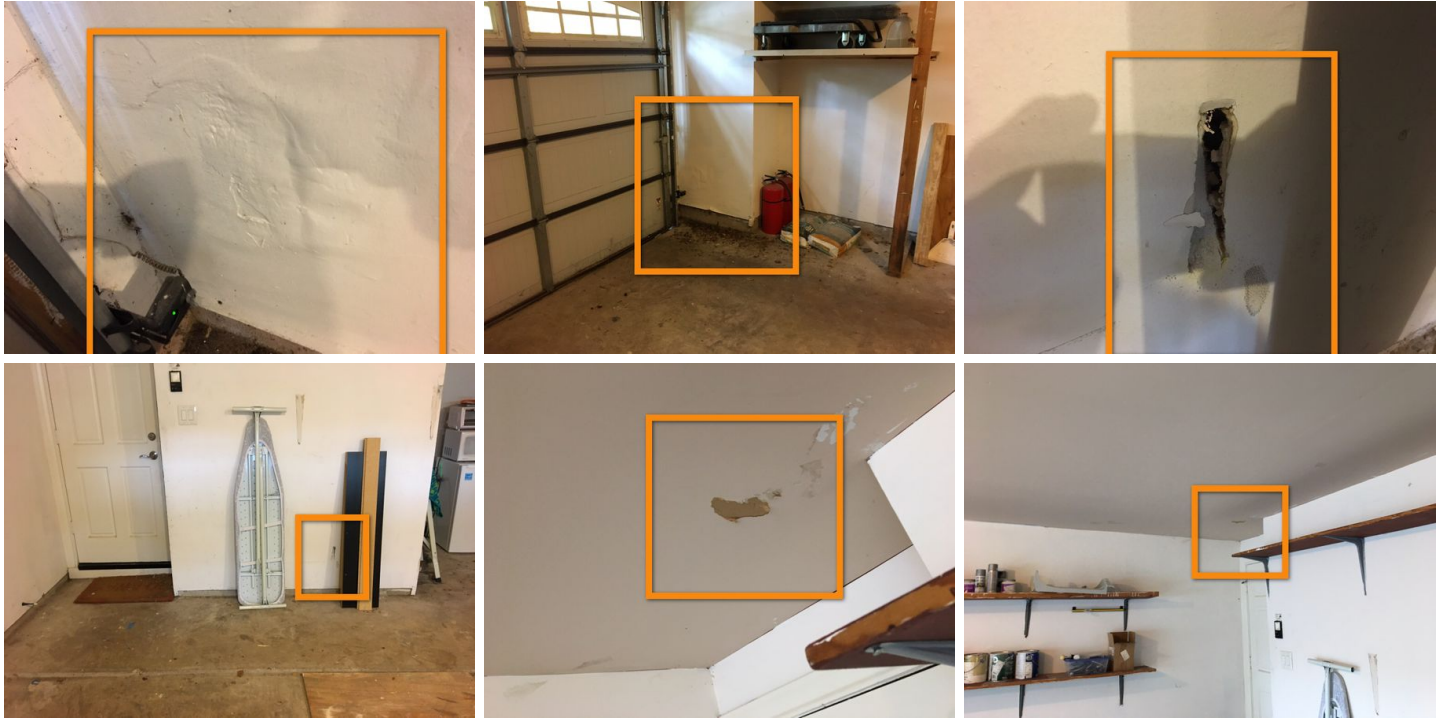
12.4.1 Sheetrock

DAMAGED

The sheetrock was damaged and needs to be repaired.

Contact a qualified professional.

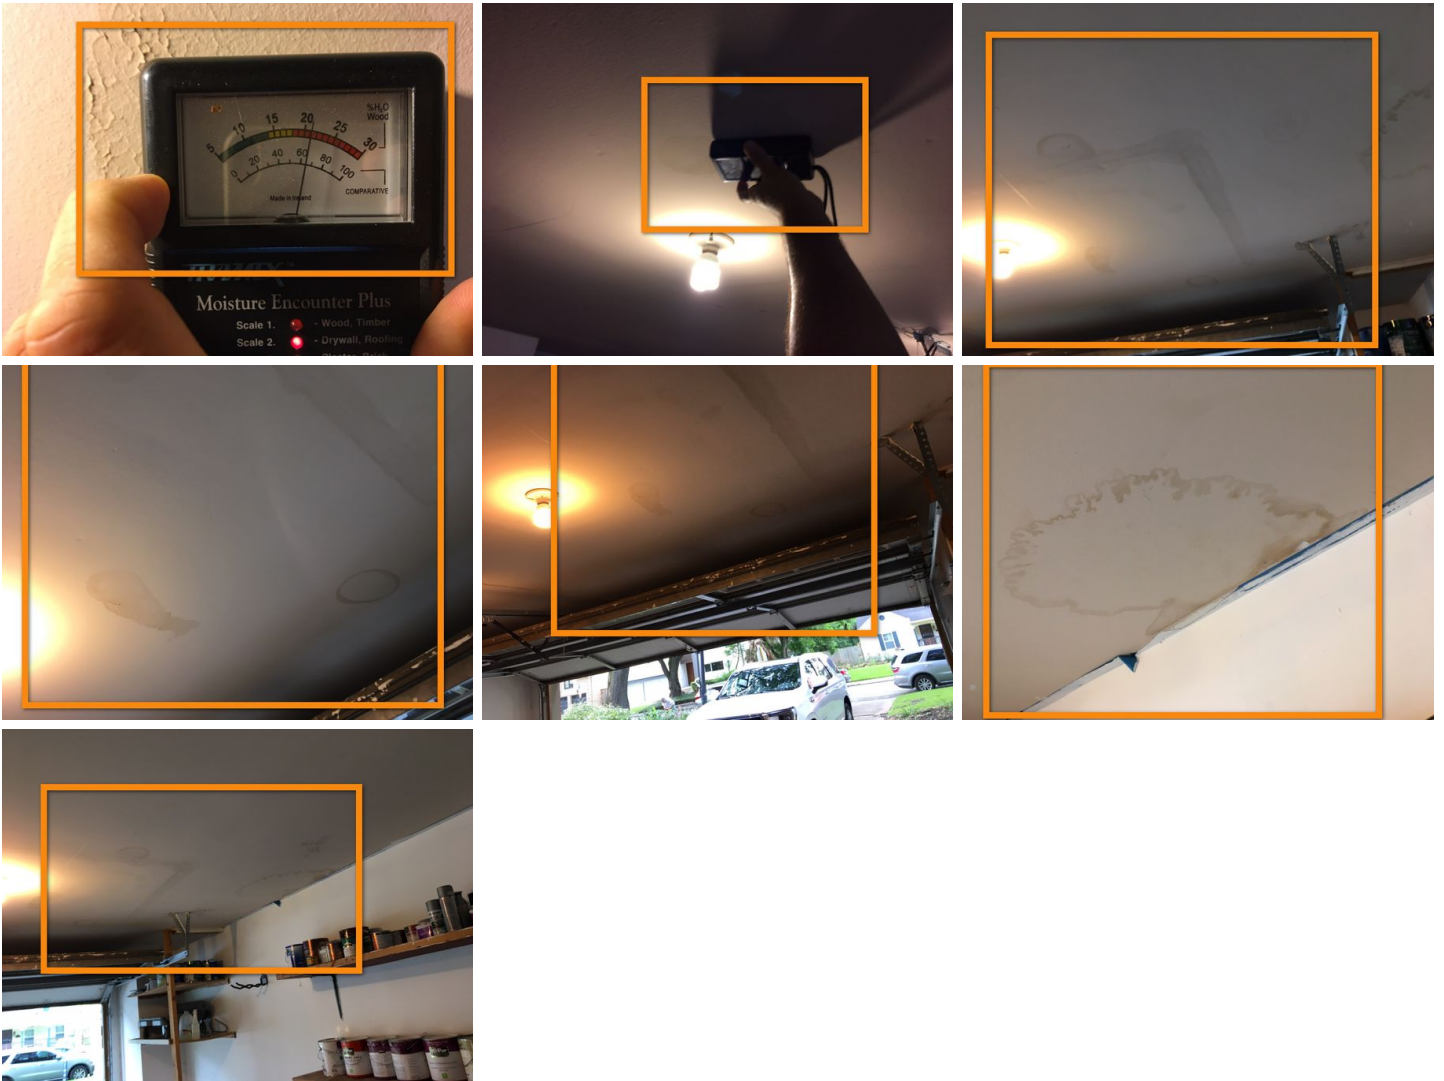
WATER STAINS - SOURCE UNKNOWN-ACTIVE

Contact a qualified professional.

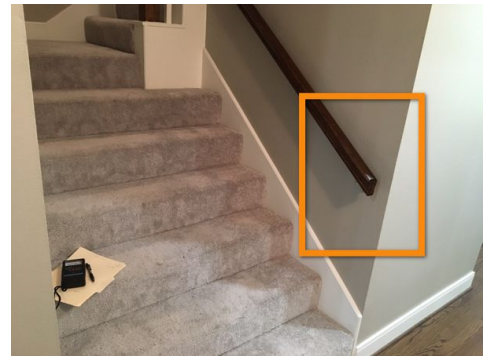
The handrails for the stairway were not constructed according to the current building code standards, which is expected given the age of the house. Therefore, the ends of the handrails do not terminate into the wall, which could allow loose clothing or a purse or bag to catch on the open end, causing tripping and/or falling down the stairs.

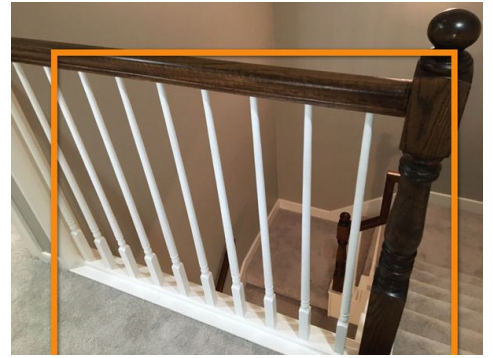
The handrail was not constructed according to the current building code standards (obviously, given the age of the house). Therefore, the width between the balusters is greater than four inches. If this condition is of a concern to you, then further investigation with a contractor is recommended.

Obtain Cost Estimate
