STRUCTURAL INSPECTION

4920 Laurel Street
Bellaire Tx 77401

JULY 13, 2021

REF: CONDITION OF PROPERTY SURVEY

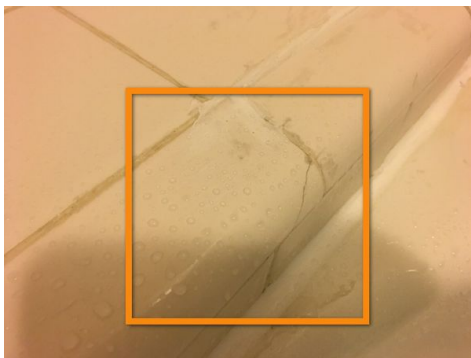
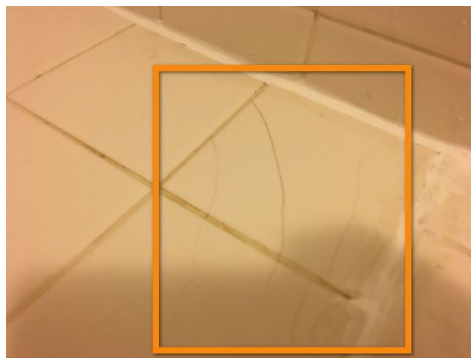
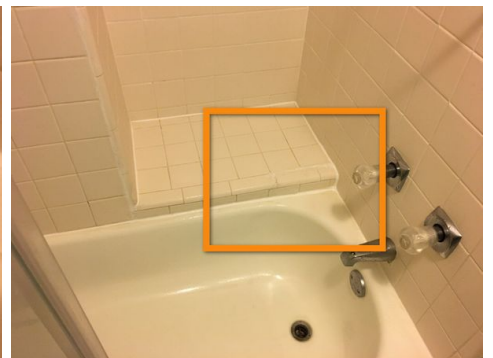
12.9.1 Miscellaneous interiors

BATHROOM TILES CRACKED

Contact a qualified professional.

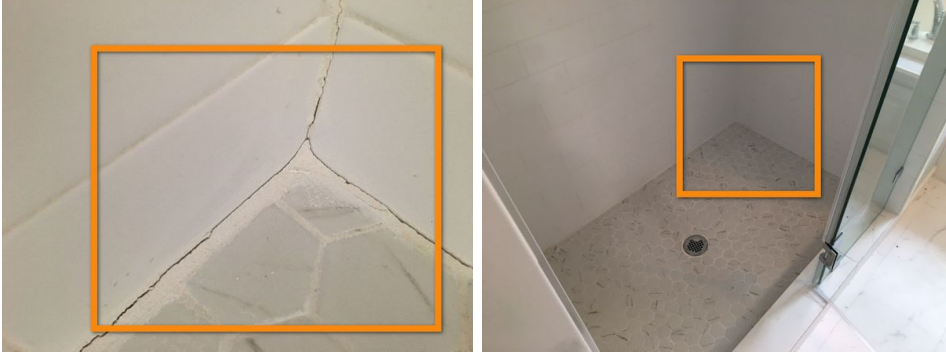
12.9.2 Miscellaneous interiors

SEAL SEPARATIONS

Contact a qualified professional.

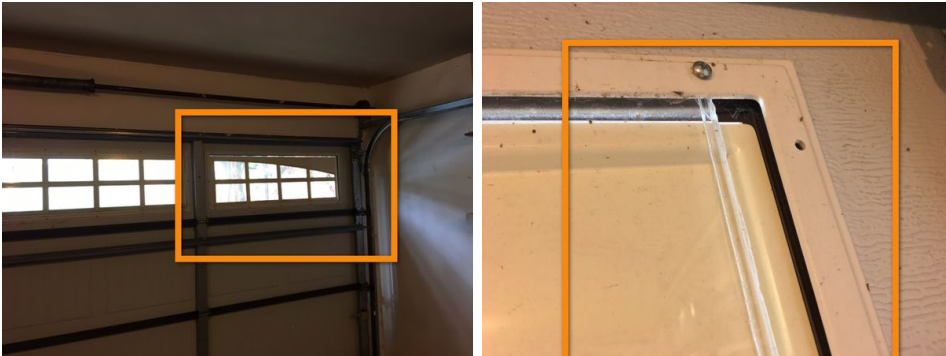
12.9.3 Miscellaneous interiors

GARAGE WINDOW

Contact a qualified professional.

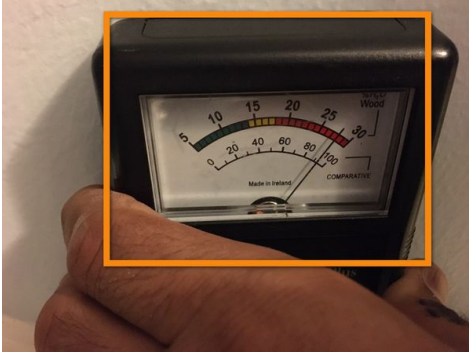
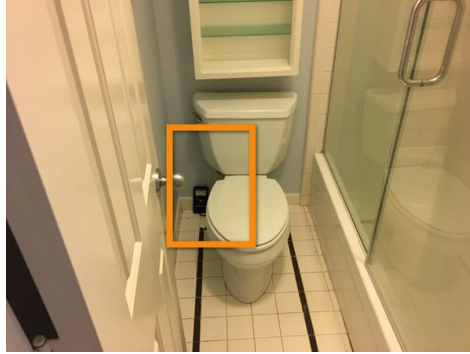
12.9.4 Miscellaneous interiors

HIGH MOISTURE

Contact a qualified professional.

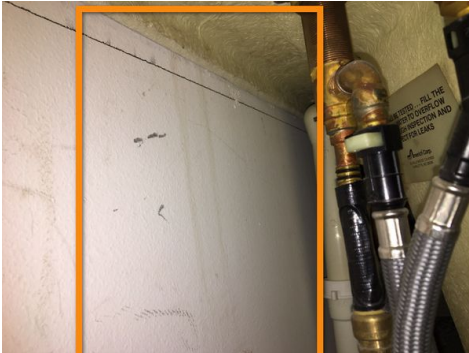
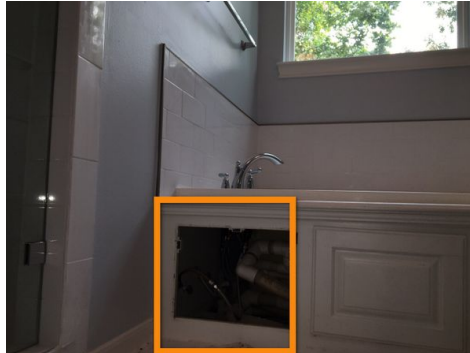
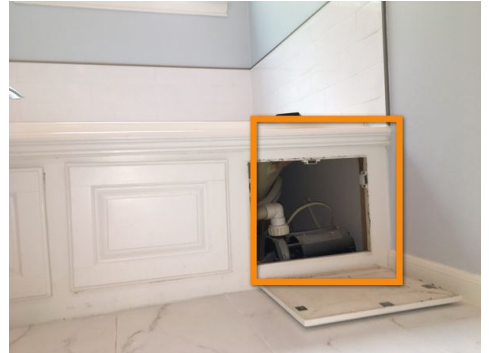
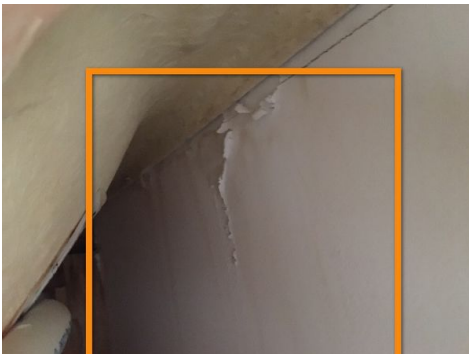
12.9.5 Miscellaneous interiors

WATER STAINS

Contact a qualified professional.
