Inspection Report

Property Address:
1450 N 23rd St
Beaumont TX 77706

PROPERTY INSPECTION REPORT FORM

Edwardo & Leticia Gutierrez	2/21/2022
<i>Name of Client</i>	<i>Date of Inspection</i>
1450 N 23rd St, Beaumont, TX 77706	
<i>Address of Inspected Property</i>	
Joe Askew	TREC# 0010495
<i>Name of Inspector</i>	<i>TREC License #</i>
<i>Name of Sponsor (if applicable)</i>	<i>TREC License #</i>

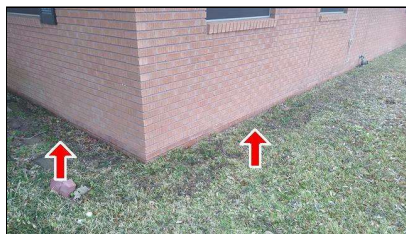
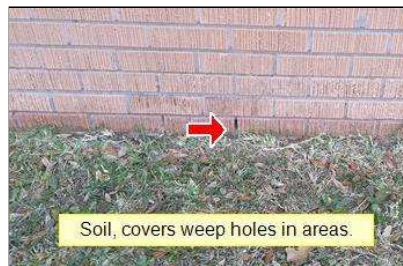
(1) High soil line was noted around portions of the exterior of home. This is conducive to moisture intrusion, pests, and wood destroying insects. Recommend maintaining a 4-6 inch clearance from the ground to the bottom of the brick/siding where possible and at least 1 foot between vegetation and home. The ground should also be graded to allow rain to drain away from the home.

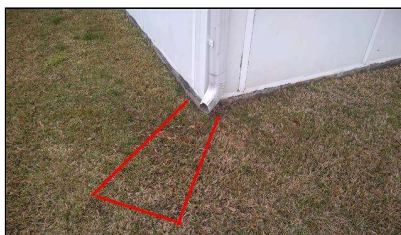
B. (Picture 3)

(2) Splash blocks needed at various downspouts around home to carry rain water away from the foundation.

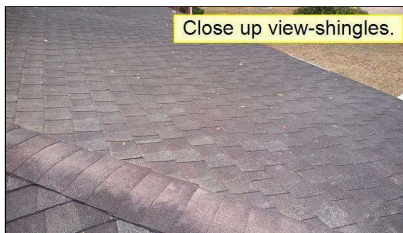
C. (Picture 1)

(1) Architectural shingles present. No shingles were forcefully lifted due to possible damage. Fasteners were evaluated from the attic/interior side of decking as best as possible.

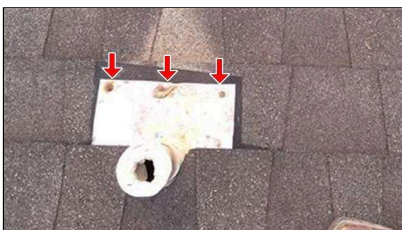
C. (Picture 2)

(2) Inspector recommends tarring/sealing over any exposed nails at the roof.

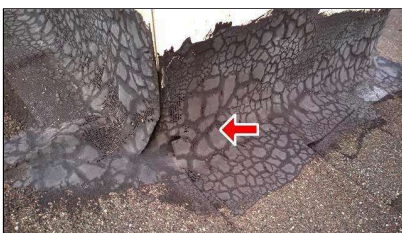
C. (Picture 4)

(4) The sealant around the chimney penetration was weathered/splitting. Maintenance may be needed soon.

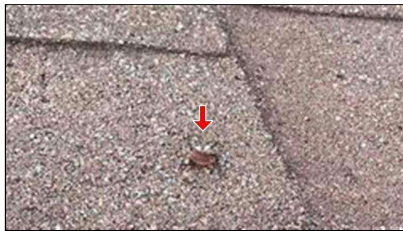
C. (Picture 5)

(5) Inspector found a nail sticking through a shingle adjacent to the chimney. Recommend having repaired as necessary.

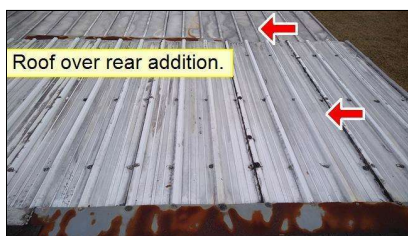
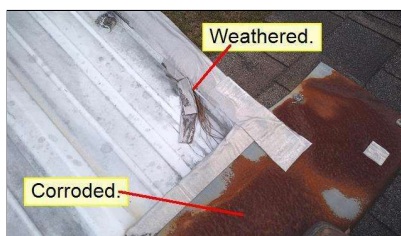
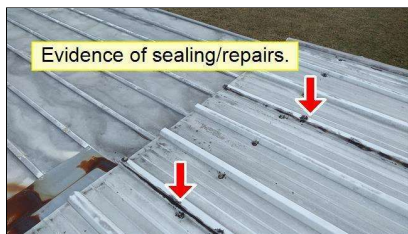
(6) The roof over the rear addition/sun room was in fair condition. Corrosion was noted. One of the transition flashings was cut short on two sides. Debris/leaves were also noted at the gutters in areas. Evidence of previous sealing/repair was observed.

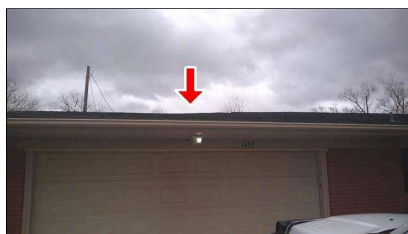
D. (Picture 1)

(2) Visual deflection was noted at the roof decking in areas. Portions of the framing over the garage were reinforced at some point.

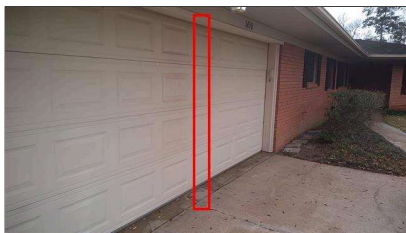
E. (Picture 1)

(1) It appears that a support post or column was removed from the front of the garage. Slight visual sagging was noted at the framing above the overhead door.

The ceiling structure in the garage was also slightly irregular.

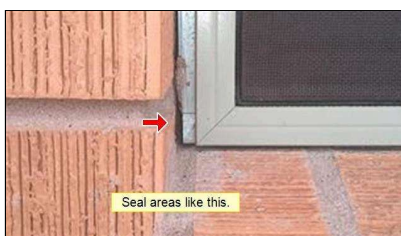
E. (Picture 3)

(2) Client may wish to re-grout, re-point brick work at transitions and at window sills/around house where gaps exist as needed. Also seal/caulk all exterior window frame to help prevent water intrusion during wind driven rain. This is a normal maintenance item that will need to be done periodically.

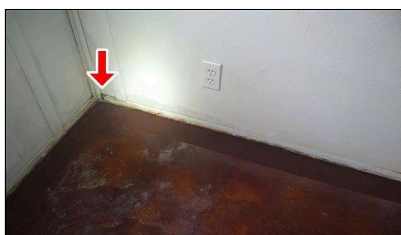
E. (Picture 4)

(3) Staining/possible evidence of moisture intrusion was noted along the bottom of the walls in the rear sun room.

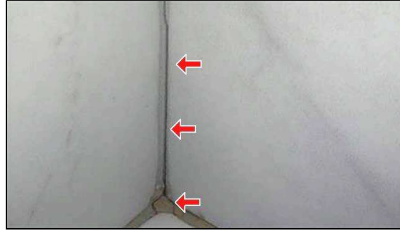
E. (Picture 5)

(4) The shower/tub surround at the rear bath could benefit from sealing/maintenance.

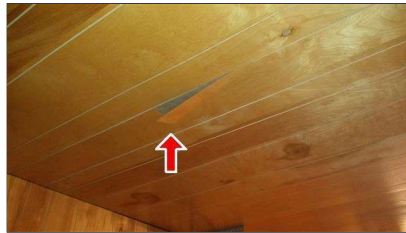
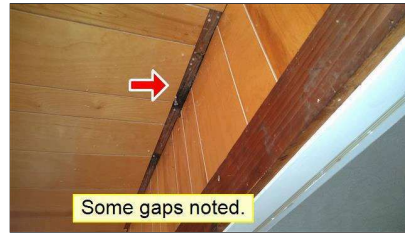
(5) Some of the paneling in the garage was weathered. Gaps were also observed in areas.

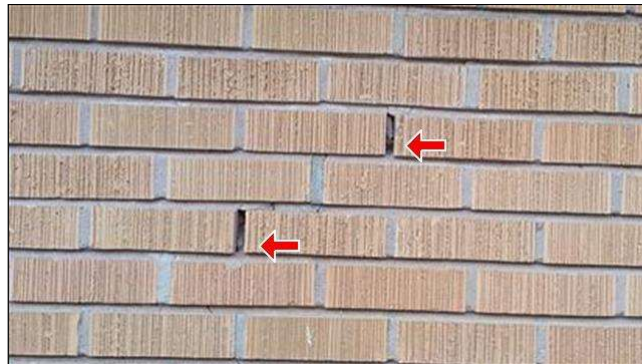
E. (Picture 8)

(7) Minor cracking as noted at the brick in areas (mostly concentrated in the mortar joints). This is not a structural concern.

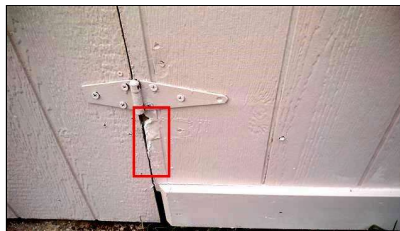
E. (Picture 9)

(8) Minor deterioration was noted at the exterior of the work shop in areas.

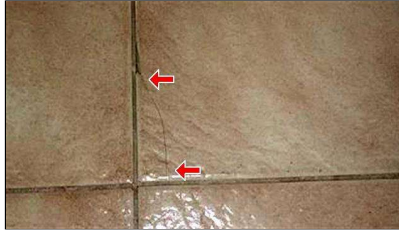
F. (Picture 1)

(1) Some cracked or damaged tile were observed in the kitchen.

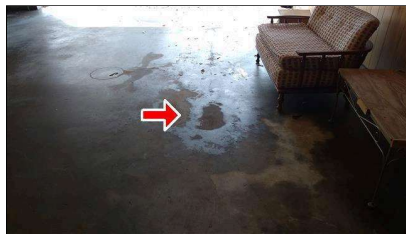
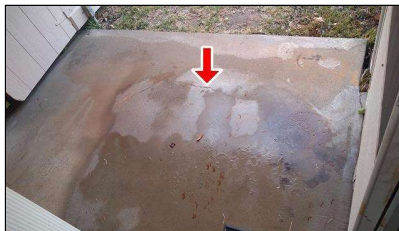
(2) **Note:** The slab was visibly damp in the garage, sun room, and at a portion of the back porch. No obvious reason or explanation was found

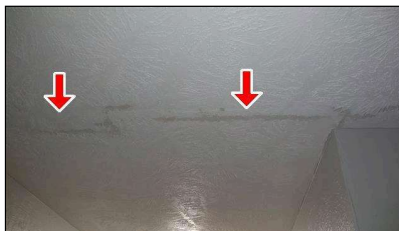
F. (Picture 5)

(3) Some repaired drywall tape seams were noted. This is not unusual to find in homes of this age in the area.

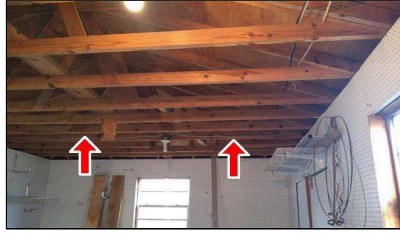
F. (Picture 6)

(4) The ceiling was unfinished in the rear work shop.

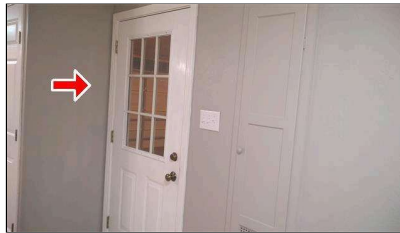
G. (Picture 1)

(1) One of the doors from inside garage to inside the home did not appear to be a fire rated door (has window). The Texas Real Estate Commission requires inspectors to note this as a deficiency. Correction would typically involve replacing with a steel door or a solid wood door at least 1 3/8" thick. This is a newer requirement in this area.

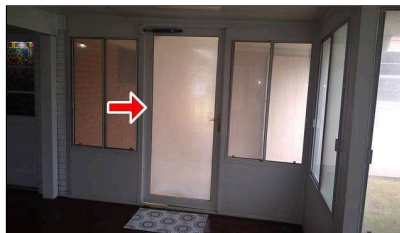
G. (Picture 2)

(3) The glass door in the rear sun room exhibited evidence of failed seal.

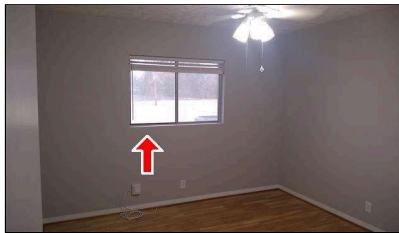
H. (Picture 1)

(1) **Note:** The bottom of some bedroom windows were found to be over 44" above the floor. Client should be aware that these windows could hinder emergency escape or rescue during a fire or other emergency. Few existing homes from this era comply with the modern recommendation for 44" sill heights for emergency escape and rescue openings for bedrooms and sleeping rooms. The Texas Real Estate Commission has asked inspectors to point this out.

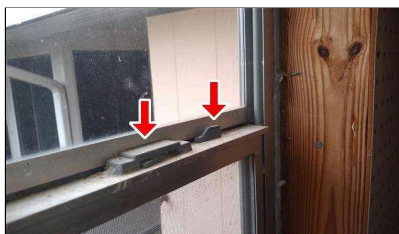
H. (Picture 2)

- (7) The windows in the work shop had damaged/missing locks.

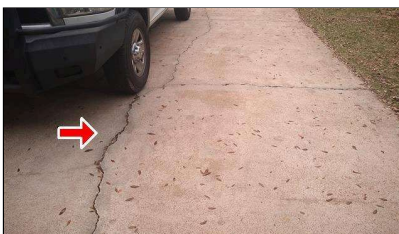
L. (Picture 1)

The driveway exhibited cracking in areas. This is not unusual to find.

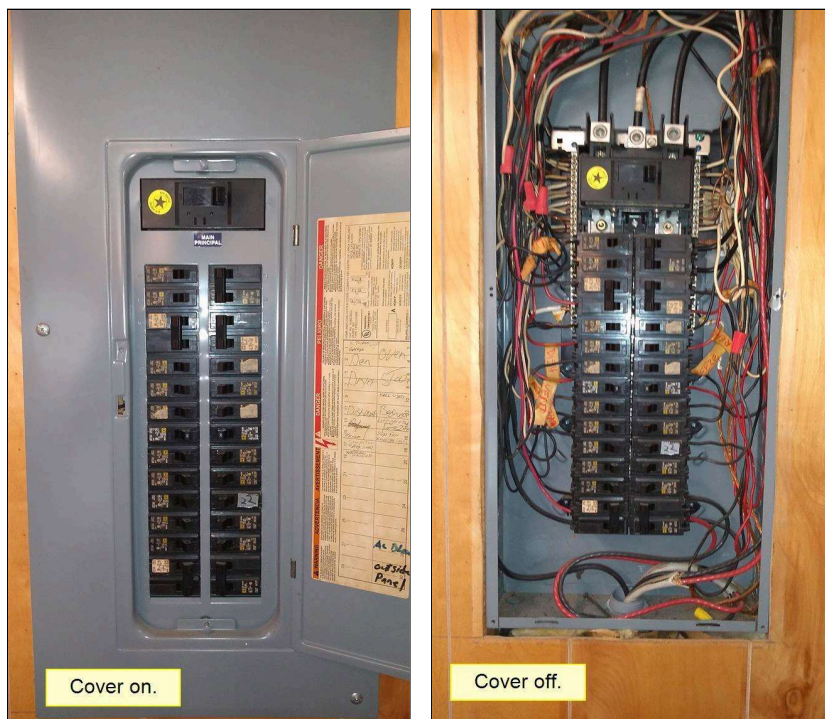
A. (Picture 1)

(1) A 150 amp panel box was noted at the rear of the garage.

-Portions of the labeling were missing. Some of the labeling that was present appears to be inaccurate (for example a 60 amp breaker was labeled as oven). Client may wish to have properly labeled.

-One 30 amp breaker was intentionally turned off (appears to be breaker for the dryer).

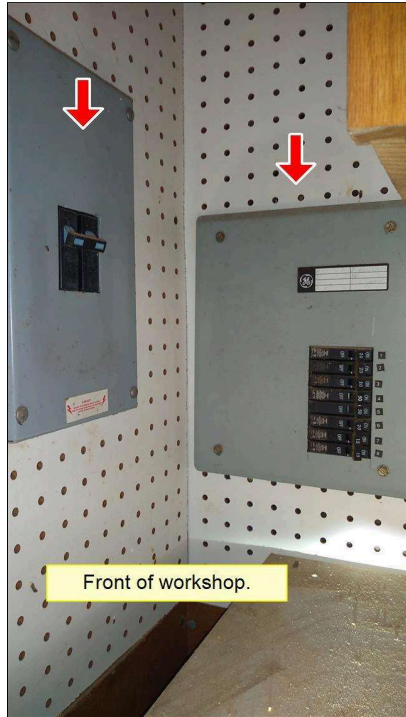
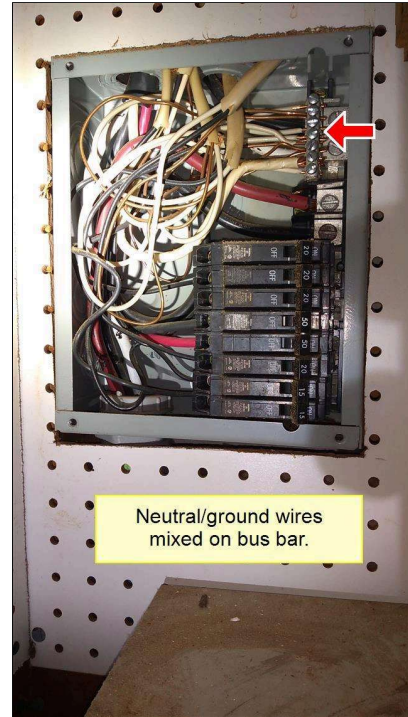
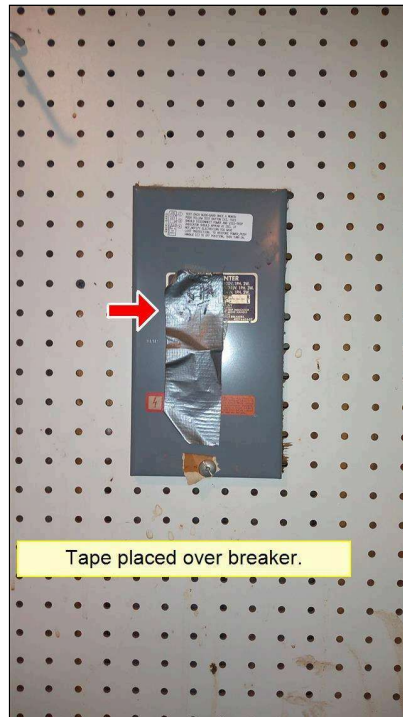
(2) Two panels were noted at the front wall in the rear work shop. These panel boxes do not have the currently recommended amount of clearance. Inspector was not able to remove the cover for the small sub panel (due to lack of clearance). This equipment was not installed to current Industry standards. When installing a sub panel, the neutral and ground wires should be on separate bars, with the neutral bar isolated and a ground ran to the ground bar from the main GEC.

One sub panel was noted near the entry door at the work shop. The breaker in this panel was taped over/off. Inspector was not able to determine what circuit this breaker is for. Client may wish to inquire with seller.

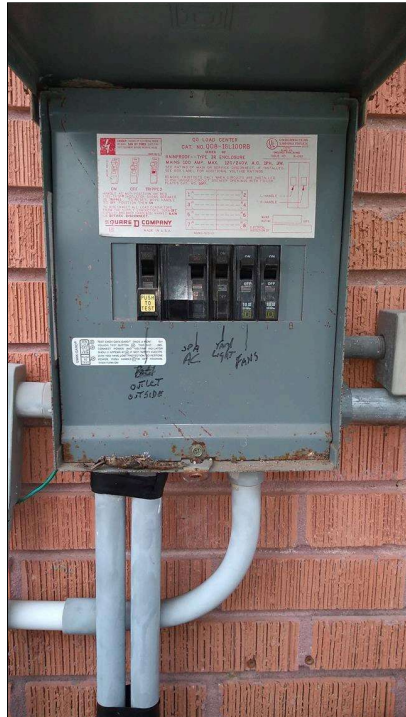
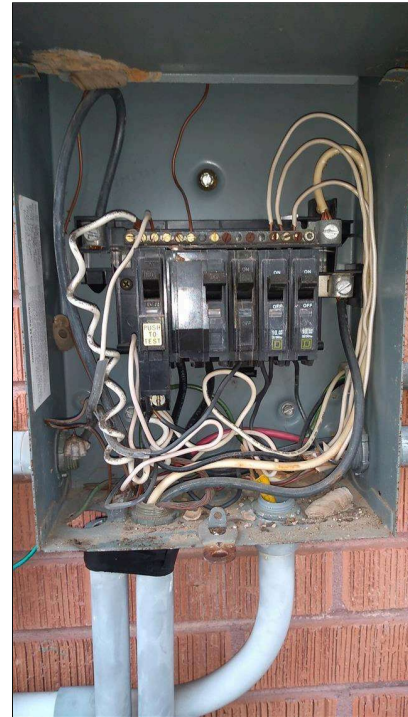
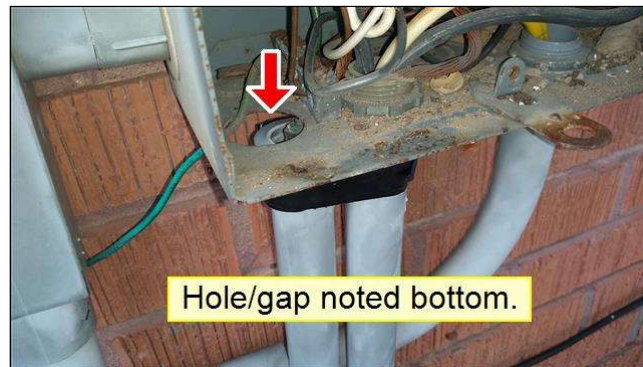
(3) A sub panel was noted at the rear right exterior of home.

-Portions of the labeling were missing.

and ground wires should be on separate bars, with the neutral bar isolated and a ground ran to the ground bar from the main GEC.

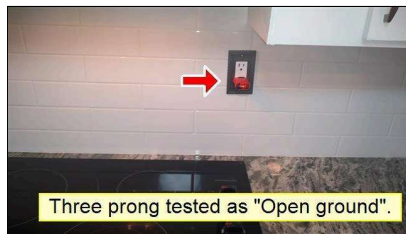
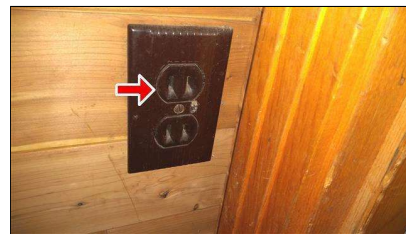
(2) 2-wire (ungrounded) wiring and receptacle outlets noted. Multiple 3 prong receptacles tested as "open ground". This is typical of this age house, however, new wiring may be required to accommodate some modern appliances.

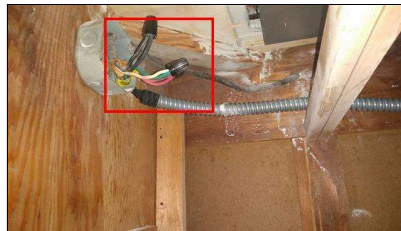
B. (Picture 4)

(3) A missing junction box cover was noted under the stove top.

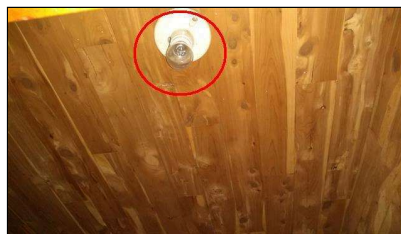
B. (Picture 5)

(5) It is generally recommended to install light covers/globes on all closet light fixtures (to help prevent flammable items from contacting bulbs). Client may wish to install.

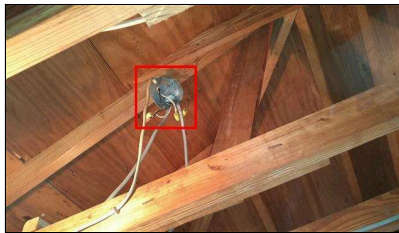
B. (Picture 6)

(7) A missing junction box cover was noted at the rear work shop.

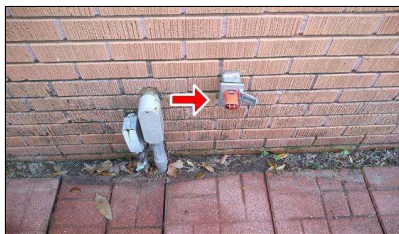
B. (Picture 7)

(8) An exterior receptacle at the rear of the garage did not have power when tested. Client may wish to have checked.

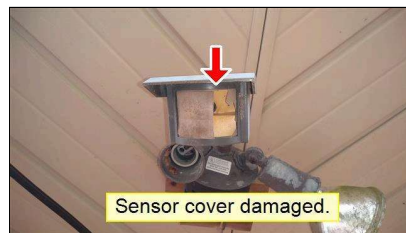
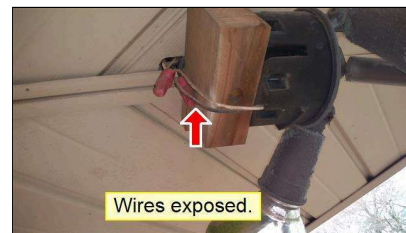
(9) The security light at the rear left exterior had a damaged cover. The wiring ran to this light was also left exposed.

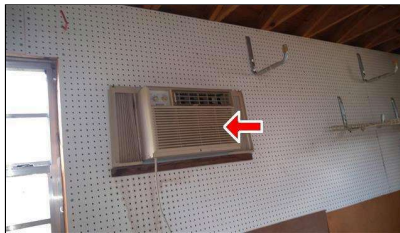
B. (Picture 2)

(3) The window unit in the rear work shop made an unusual amount of noise when turned on. Client may wish to have checked.

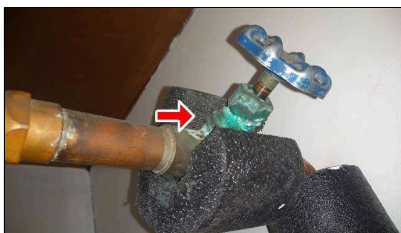
A. (Picture 1)

(3) The supply valve above the water heater exhibited corrosion.

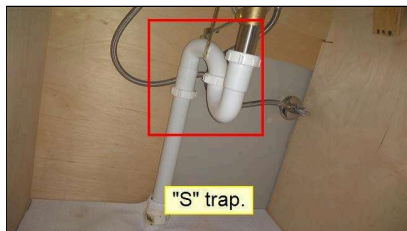
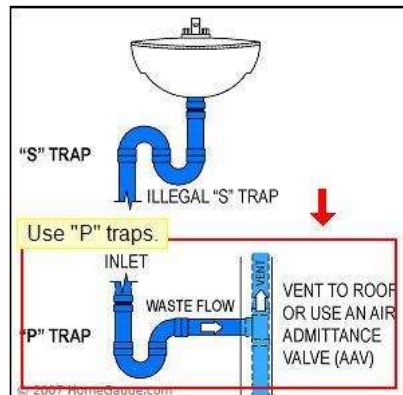
(1) The drain under the sink at the rear bath was installed in a "S" trap configuration. "S" type drain traps are an older design. Inspector did not detect signs of malfunction during the inspection/testing. Client should plan to upgrade when drain repair or renovation work is performed.

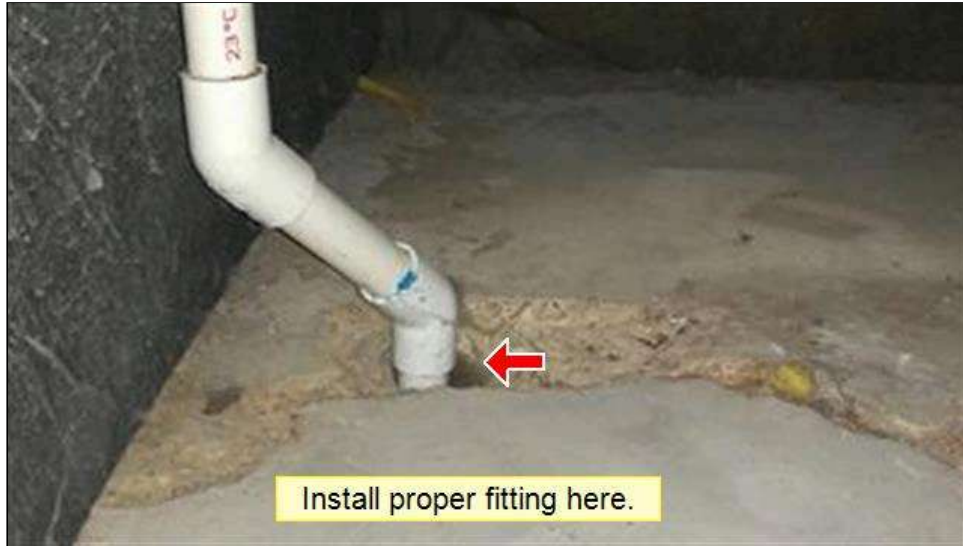
B. (Picture 3)

(2) Inspector recommends having the proper fitting installed where the HVAC condensation drain terminates into the sewer (in HVAC return). This drain also did not appear to have a "P" trap.

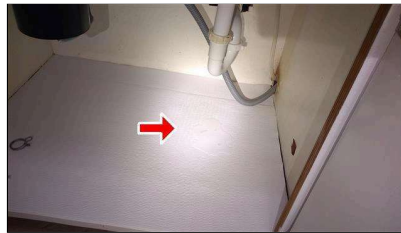
B. (Picture 4)

(3) A light leak was noted under the kitchen sink. Recommend having corrected as necessary.

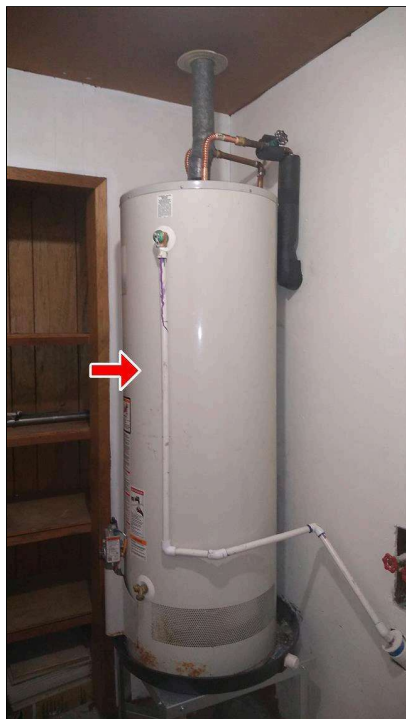
C. (Picture 1)

(1) A 40 gallon water heater was noted in the garage utility closet. It was manufactured in 2010.

-Corrosion was noted at the bottom of the water heater (aging equipment).

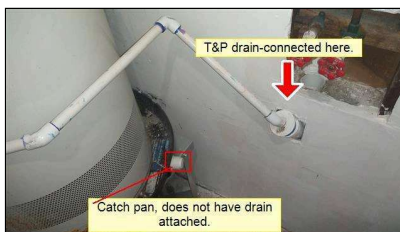
C. (Picture 4)

The catch pan under the water heater also did not have a drain attached (would typically be terminated to exterior when possible).

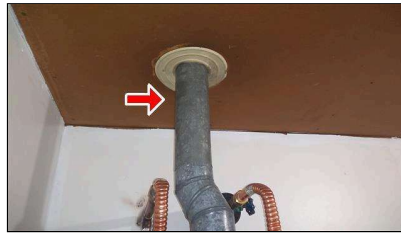
C. (Picture 5)

(3) The water heater is installed with a single-walled flue pipe, which is common to find in homes of this age. Current guidelines recommend changing out single walled combustion vents with double-walled. The

Texas Real Estate Commission requires inspectors to point out single walled vents as a defect. Client may wish to upgrade to a double-walled vent.

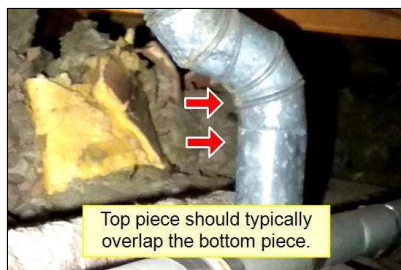
C. (Picture 6)

(4) Part of the flue pipe in the attic was not over-lapped/installed correctly.

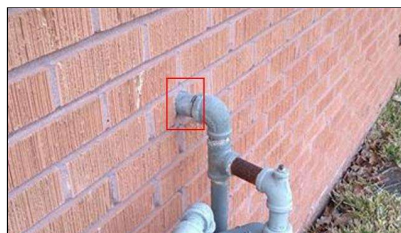
E. (Picture 1)

(2) The main gas line did not have a sleeve where it enters the exterior wall. The Texas Real Estate Commission requires inspectors to note this as a deficiency.

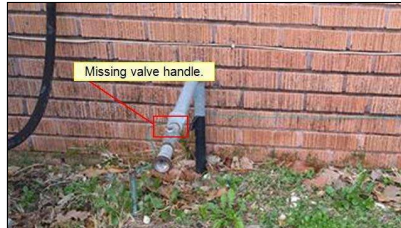
E. (Picture 2)

This gas line was missing the handle for its valve

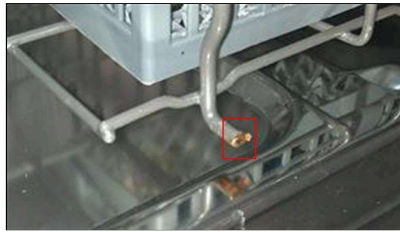
A. (Picture 1)

Rust was noted on the dish basket of the dishwasher. This condition can stain dishes that have a porous surface. There are products available for painting on a protective rubbery coating at most home improvement stores.

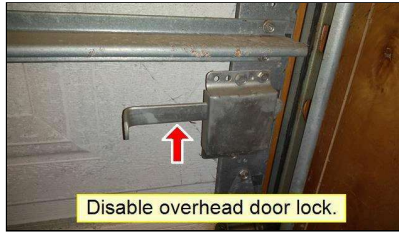
G. (Picture 1)

(1) The garage door still has the locking hardware in place. This can cause damage to powered garage doors if they are operated while locked. Recommend removing or disabling the manual locking hardware.

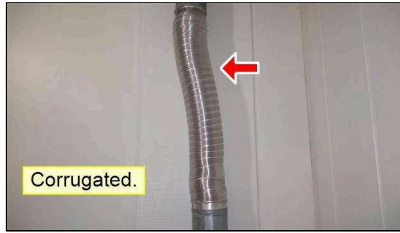
H. (Picture 2)

(2) A portion of the dryer vent pipe is corrugated. Current standards call for dryer vent materials to have a smooth interior finish.
