Stucco Check Inspections, LLC

Invasive Stucco Inspection

1208 E 29th St
Houston, TX 77009

June 15, 2022

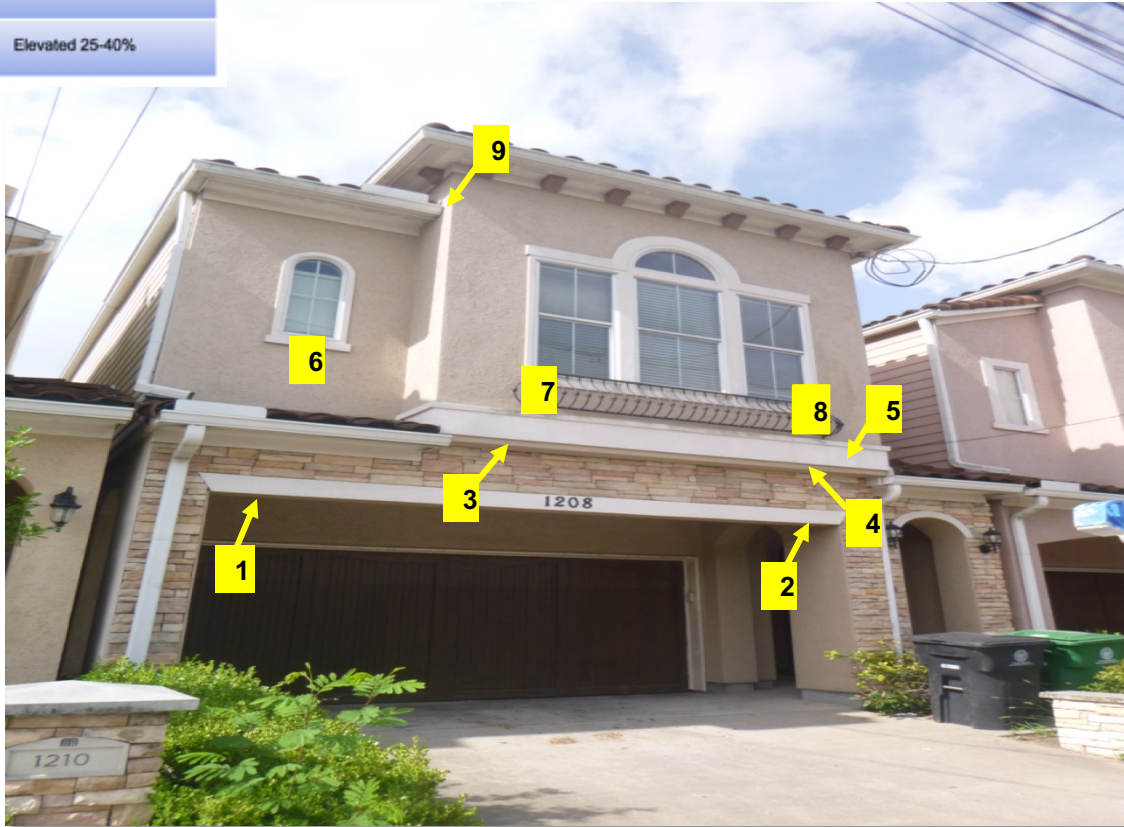
Front Elevation Moisture Analysis

Location	Moisture Reading	Substrate Condition	Comments
1	10%	Firm	Probes taken below the front elevation overhangs. Firm substrate and Low-to-Mid moisture at the time of inspection.
2	12%	Firm	
3	13%	Firm	
4	9%	Firm	
5	20%	Firm	
6	9%	Firm	Probes taken below the front elevation windows. Firm substrate and Low-to-Mid moisture at the time of inspection. This is favorable.
7	14%	Firm	
8	16%	Firm	
9	9%	Firm	Probes taken below the roof junction. Firm substrate and Low moisture at the time of inspection. This is favorable.

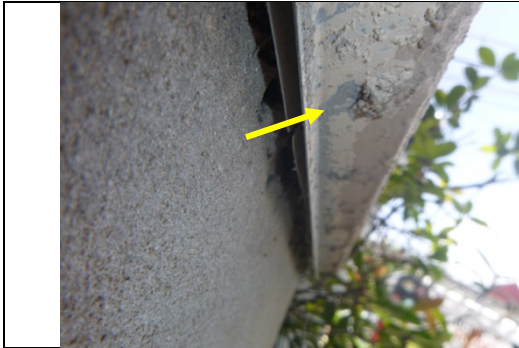
The base of the stucco walls terminates with a weep screed and proper clearance above grade. This is a favorable condition.

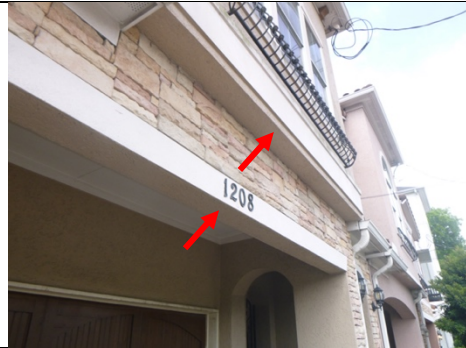
The front overhangs are closed in with stucco & have no drainage accessory. This can lead to trapped moisture and possible future damages. To help prevent future issues it is suggested to install drainage accessories at all locations noted with this deficiency.

- Suggested to seal all hairline cracks throughout home. Paint is suggested at the 8-10-year mark as well, to alleviate all staining and cracks.
- Front stucco overhang terminates with no drainage accessory and are closed in with stucco. To repair and prevent further damages, it would be suggested to remove necessary stucco at these overhangs to properly install an industry approved drainage accessory/provision. Upon testing, the front overhang noted to no underlying damages at time of inspection. Suggested to further investigate and repair accordingly. Below is an example of a proper overhang drainage accessory detail:

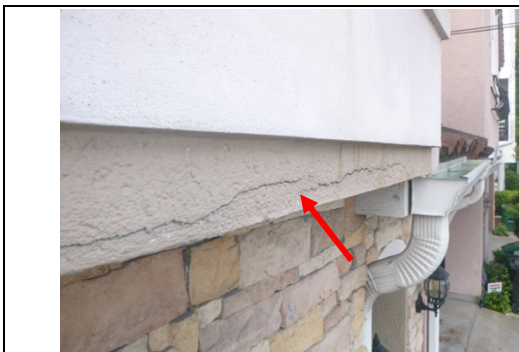
Severe cracking noted along the front right corner of the overhang. This can lead to moisture intrusion if not sealed/repaired.

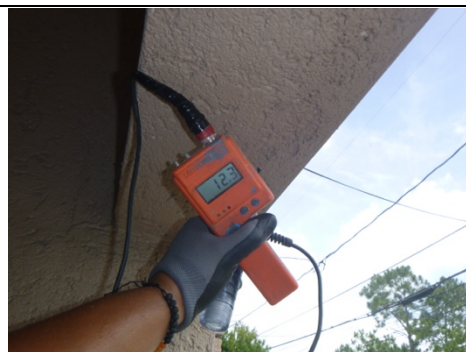
Low moisture and firm substrate (possible framing) below the front elevation overhang at the time of inspection. This is favorable.

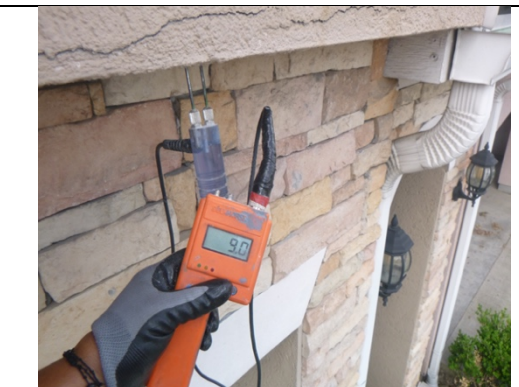
Low moisture and firm substrate (possible framing) below the front elevation overhang at the time of inspection. This is favorable.

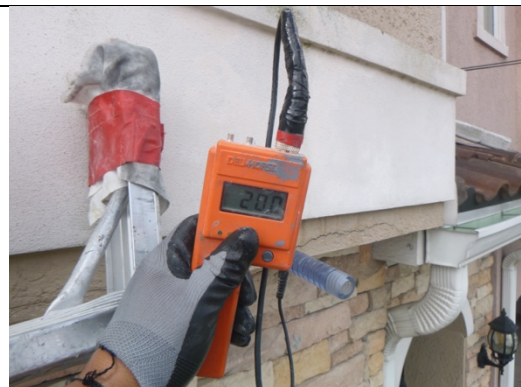
Mid moisture and firm substrate (possible framing) at the crack along the overhang at the time of inspection.

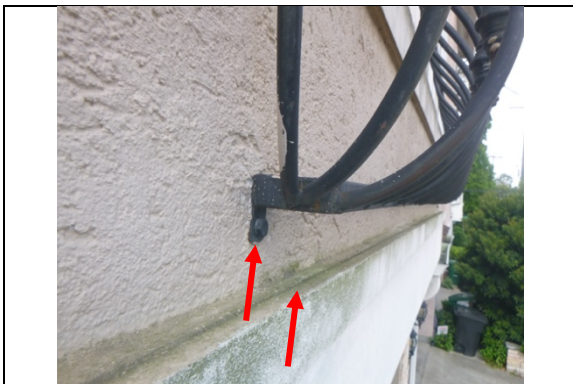
The accent bands are noted to be hard coat build outs. These are potential points of possible moisture intrusion if not maintained. It is suggested to seal the top and sides of all bands, as well as the railing attachments.

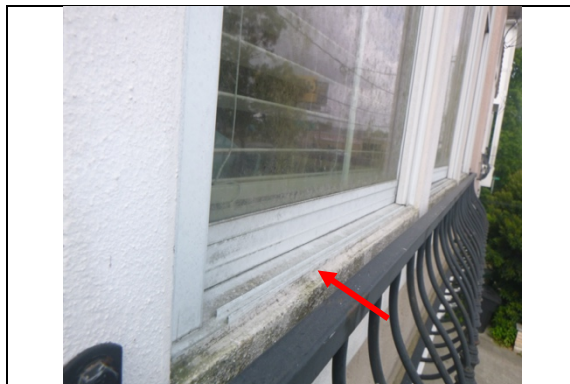
The sealant application that was previously done has exceeded their life expectancy. It is suggested to reseal all windows, accent bands, openings, flashings and penetrations at this time and every 2-3 years.

- All windows, doors, and penetrations through the system should be professionally sealed every 2-3 years, using a high quality, professional sealant, suggested by manufacturer of your system and properly tooled into joints to help prevent moisture intrusion and sealant separation. See photo observations for several suggested locations to seal. It is suggested to reseal all windows, accent bands, openings, flashings and penetrations at this time and every 2-3 years.

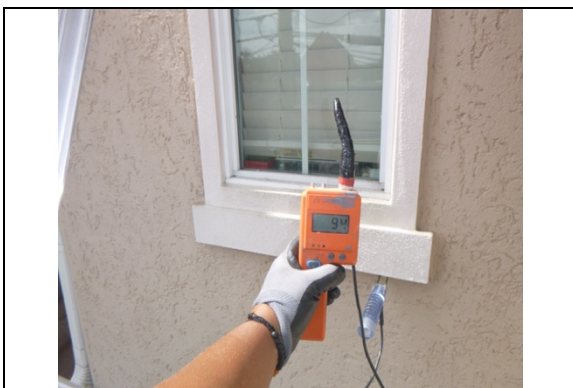
Low-to-mid moisture and firm substrate (possible framing) below the front elevation windows at the time of inspection. This is favorable.

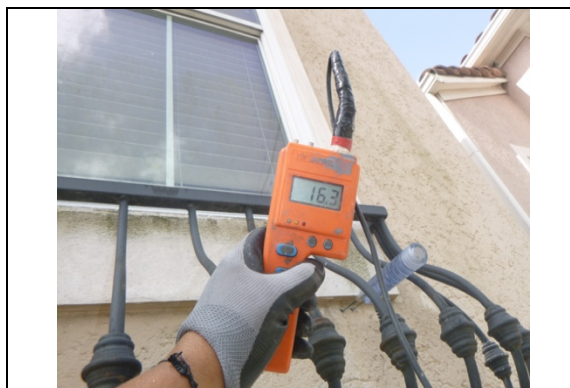
Low-to-mid moisture and firm substrate (possible framing) below the front elevation windows at the time of inspection. This is favorable.

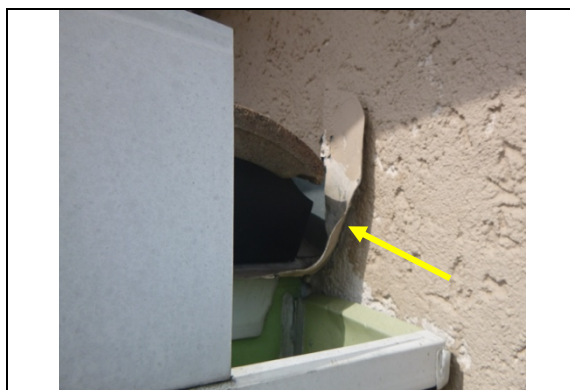
Properly sized and angled kickout flashing noted at the roof junctions throughout. This is a favorable condition. It is suggested to reseal all locations with a stucco approved sealant at this time.

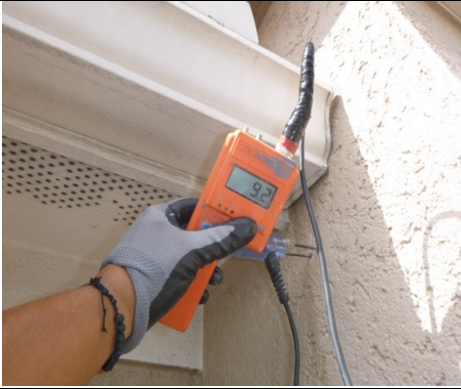
Low moisture and firm substrate (possible framing) below the roof junction at the time of inspection. This is favorable.

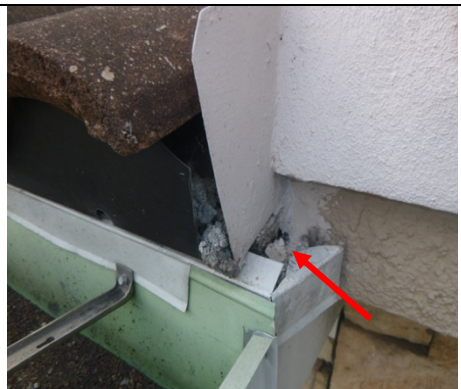
A small opening noted at the corner of the roof junction. This can lead to moisture intrusion and underline issues. It is suggested to seal all locations noted with this deficiency.

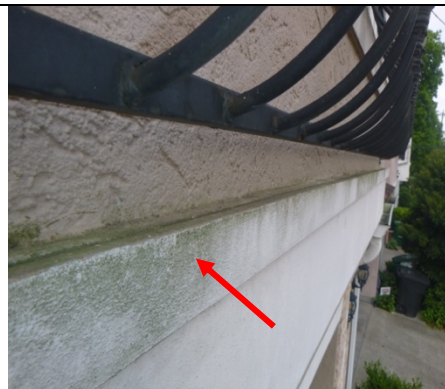
Surface staining noted throughout the front elevation. This is a common condition with stucco. It is suggested to use a light power wash with a solvent-based solution to help remedy this condition. It is recommended to repaint the home with an elastomeric paint every 8-10 years.

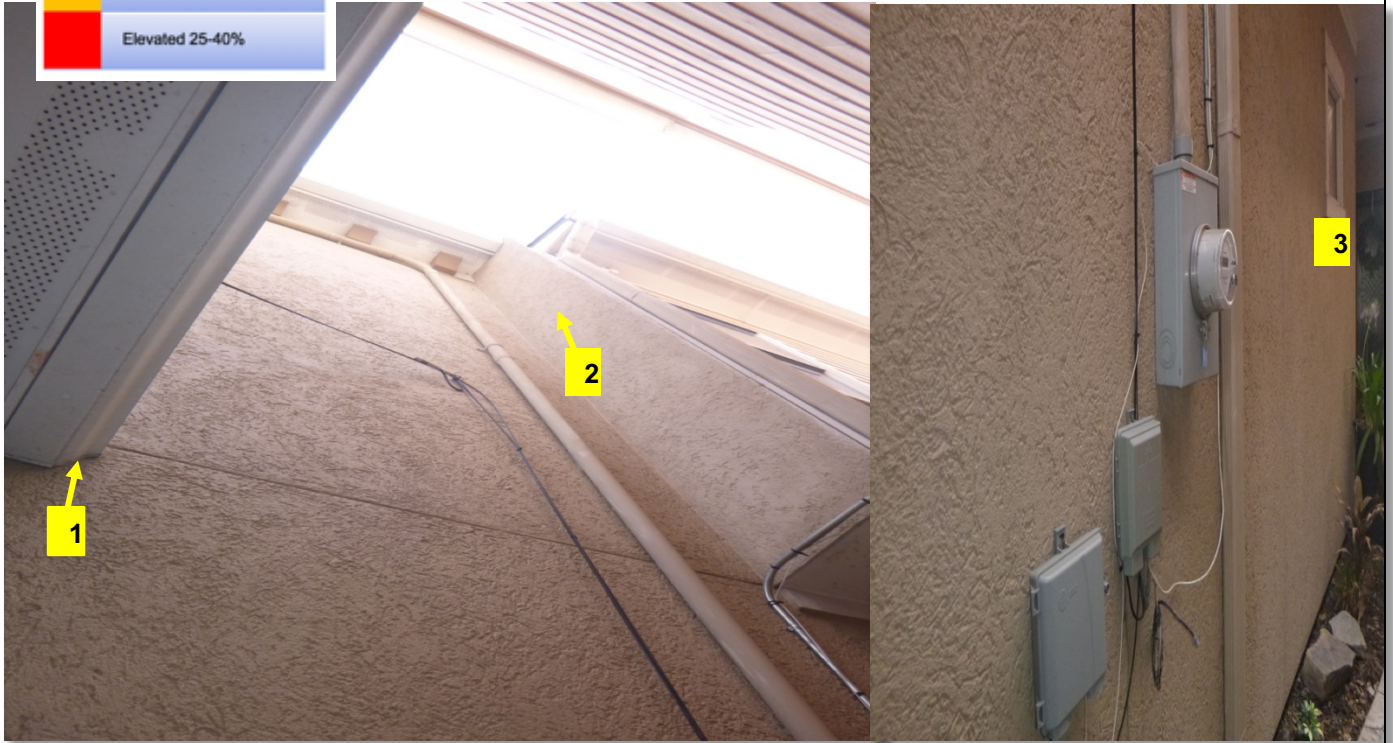
Right Elevation Moisture Analysis

Location	Moisture Reading	Substrate Condition	Comments
1	11%	Firm	Probes taken below the side elevation roof junctions.
2	8%	Firm	Firm substrate and Low moisture at the time of inspection. This is favorable.
3	10%	Firm	Probe taken below the right elevation window. Firm substrate and Low moisture at the time of inspection. This is favorable.

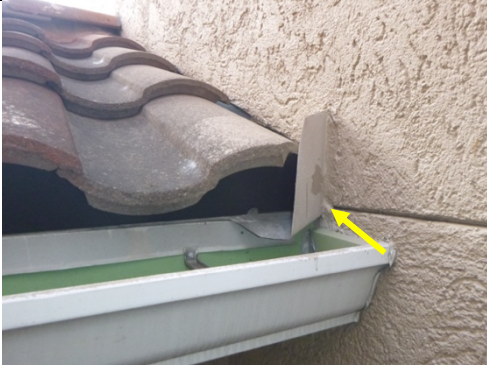
The roof junction at this highlighted location has a properly sized and angled kickout flashing (probe 1). This is favorable. It is suggested to seal all flashings at this time and every 2-3 years.

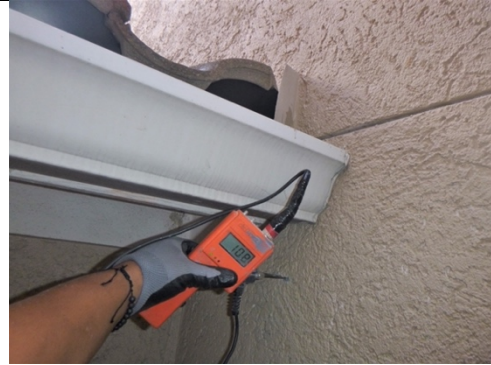
Firm substrate and Low moisture below the roof junction (probe 1) at the time of inspection. This is favorable.

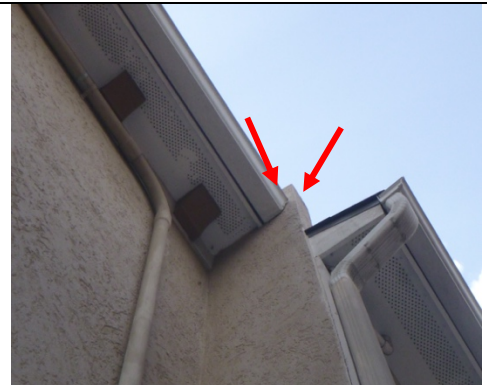
The inspector could not confirm if a kickout flashing is installed at this roof junction. It is suggested to have a stucco contractor verify the flashing at this location.

A missing cap flashing at the small parapet wall. It is suggested to install a metal cap flashing to help prevent future standing water issues.

- Suggested to verify if the side elevation, top, roof junction is noted to have a properly sized and angled kick out flashing. SCI was unable to confirm at time of inspection.
- Suggested to add a metal cap flashing to the top, side elevation parapet wall to prevent any future standing water intrusion issues.
- Acceptable moisture and firm substrate/framing noted at all probed locations at time of inspection. This is favorable. Suggested to monitor, take care of all deferred maintenance, and periodically test home to ensure moisture levels remain at this acceptable range.
- If any anomalies found in the future (i.e., cracks, stains, interior leaks, etc.), it is suggested to follow up with a stucco inspector, or qualified stucco contractor.

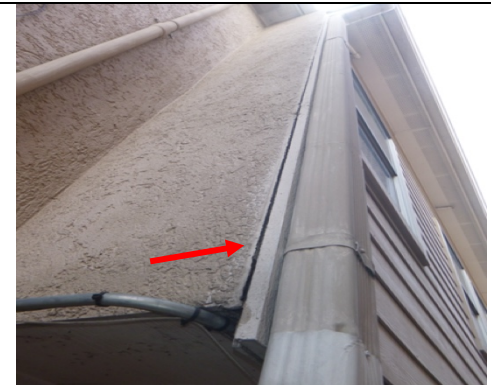
A separation crack noted along the stucco and siding transition. This can lead to moisture intrusion and possible underline issues. It is suggested to seal along all locations noted with this deficiency.

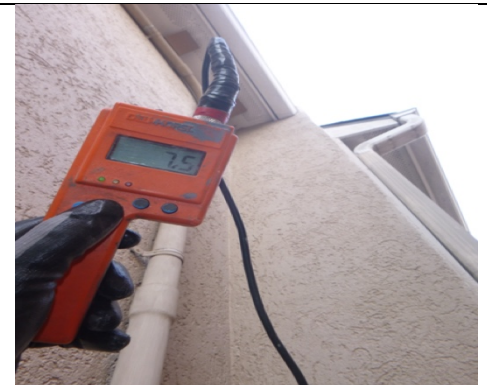
Firm substrate and low moisture noted at the probed location (several feet below the roof junction/small parapet wall) at the time of inspection. This is favorable.

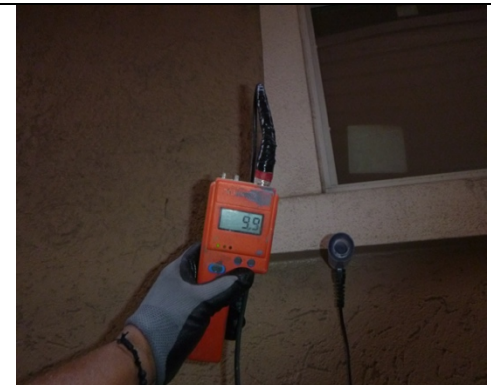
Firm substrate and low moisture below the right elevation window at the time of inspection. This is favorable. It is suggested to reseal all side elevation windows, accent bands, flashings, and penetrations (i.e., electrical boxes) at this time and every 2-3 years.
