7169 Morningbrook Dr Montgomery, TX 77316

# **PROPERTY INSPECTION REPORT FORM**

Mike Thakur	04/01/2024
Name of Client	Date of Inspection
7169 Morningbrook Dr, Montgomery, TX 77316 Address of Inspected Property	
Justin Hale	22124
Name of Inspector	TREC License #
Chris Stull	20945
Name of Sponsor (if applicable)	TREC License #

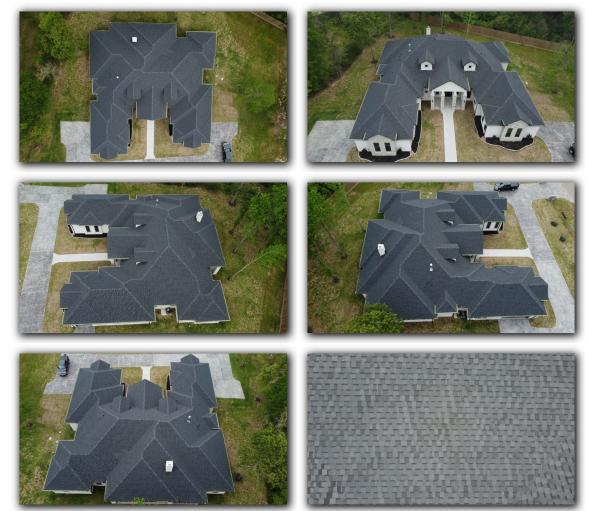
Type of roof covering observed to be composition over solid decking.

Observed some granule loss on the shingles. Granule loss is a normal part of the aging process of a roof.

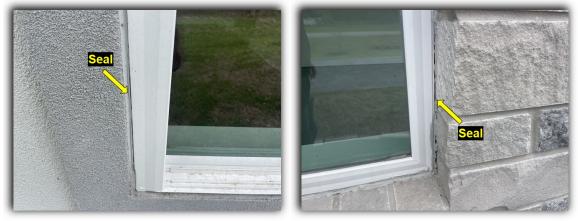
Observed gaps and cracks in the caulking around multiple windows. Recommend sealing around the exterior of all windows.

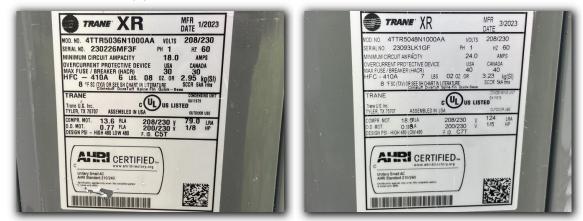
CONDENSING UNIT(S): Both Units - Trane - 2023

A thermal image of the air vents show the air conditioning unit(s) was / were cooling properly at time of inspection.

TEMPERATURE DIFFERENTIAL: 18 degrees (73, 55) GOOD

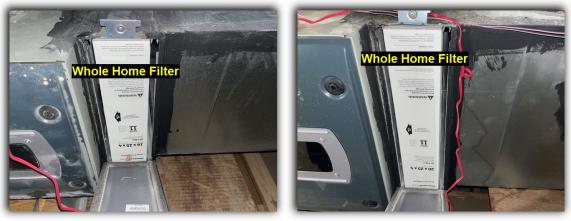
Observed the AC / Heating systems are equipped with a whole home filter systems. Recommend changing the filters as directed by the manufacturers recommendations. Filter Size(s): 16 X 25 X 4 and 20 X 25 X 4

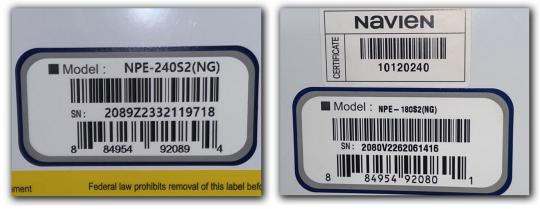
WATER HEATING UNIT(S): Navien - 2022 and 2023

No significant deficiencies observed.
