Property Inspection Report

16283 Wrangler Ave
Conroe, TX 77302

By: Jerry W Lowry, Lic #23830 12/20/2021
(Name and License Number of Inspector) (Date)

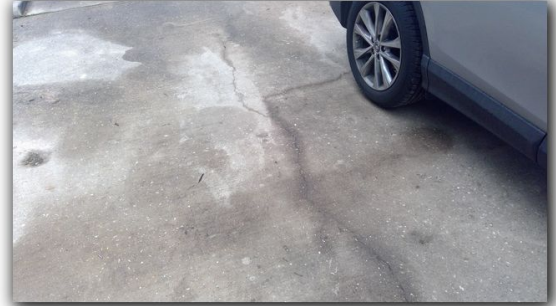
Cracks observed in flatwork (Driveways, sidewalks, etc. Not related to foundation of structure but noted on report for potential buyer to be fully informed.

Would recommend that a licensed and / or qualified contractor be consulted to make any further recommendations and / or repairs

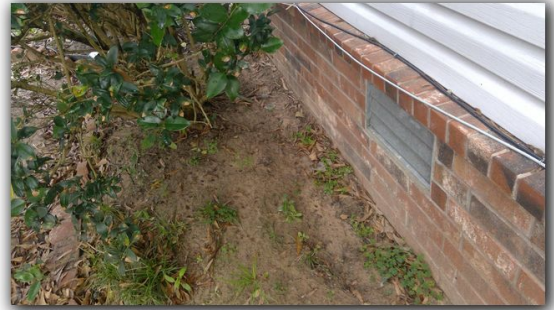
- Soil too high or footing level too low around the perimeter of the slab: Grade does not conform to current code requiring a 4" slab exposure between the finished grade and exterior brick.

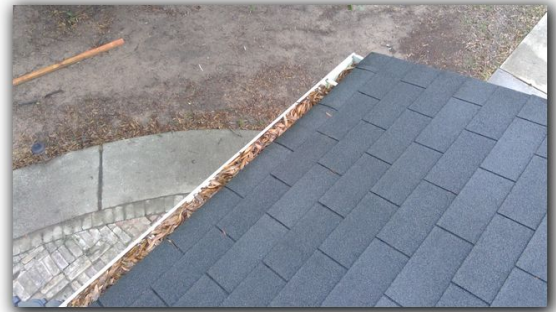
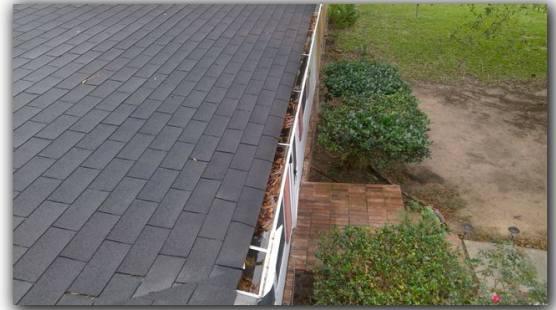
Gutters / downspouts observed to be damaged / dented at one or more locations.

Low areas observed in gutters that appear to be pooling water and not draining properly.

Would recommend that a licensed and / or qualified contractor be consulted to make any further recommendations and / or repairs

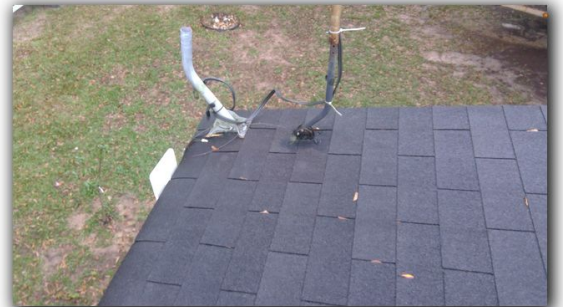
Satellite dish bases and an antenna screwed into the roof covering.

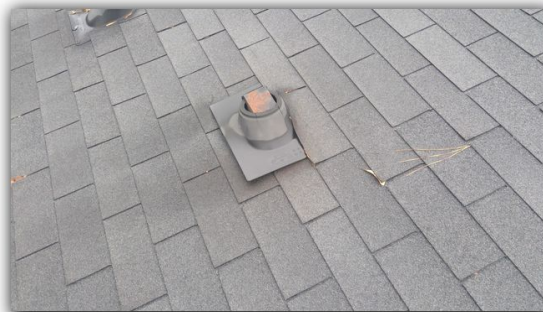
Vent roof jacks missing or improper installation.

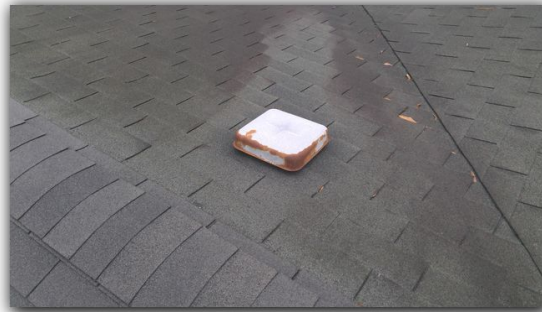
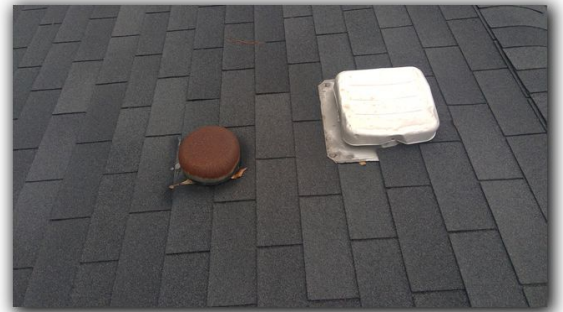
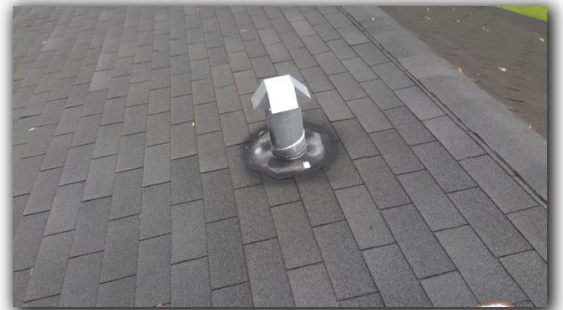
Exposed nails at multiple locations need to be properly caulked / sealed.

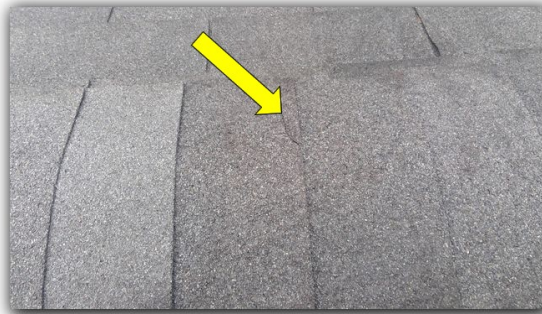
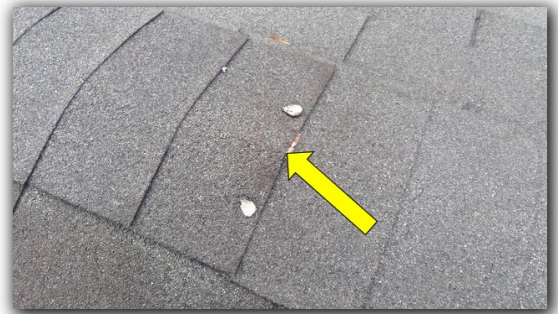
Shingles lifted up and not properly laying down / sealed in some areas.

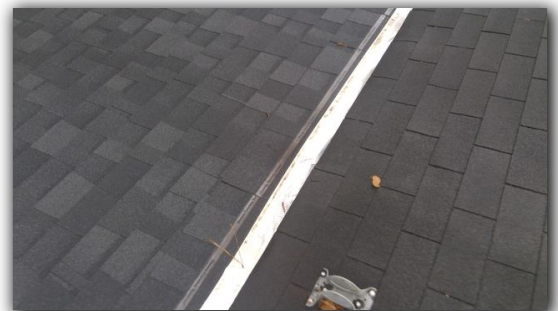
Inappropriate roof covering for slope of the roof. Dimensional / tab shingles should not be used in low slope roof applications. Consult manufacturer's specifications for details, see rear porch addition.

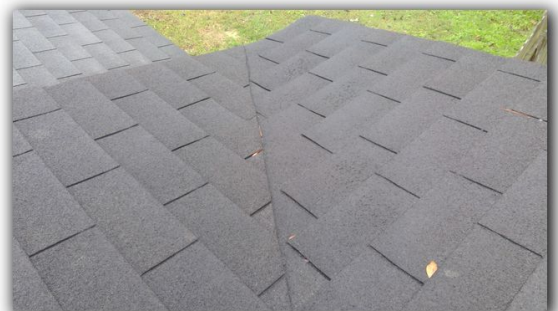
Significant signs of roof deterioration were observed. Gravel coming loose, pitted surfaces, fiberglass threading showing at edge of shingles, shingle corners are turning up. Would recommend contacting a roof professional to make any further recommendations and / or repairs.

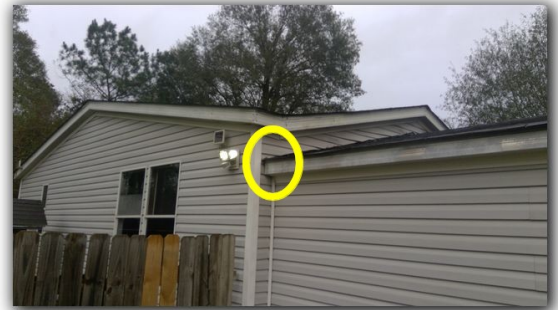
Flashing is incorrectly installed. Diverter flashing needed at all roof / wall intersections.

Would recommend that a licensed and / or qualified contractor be consulted to make any further recommendations and / or repairs

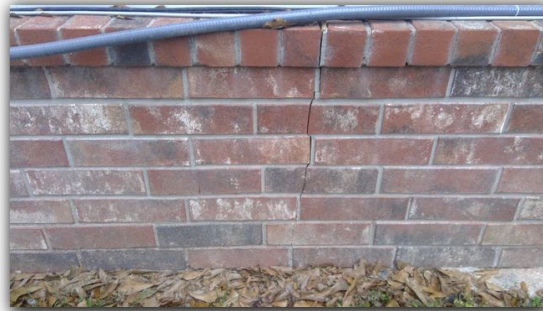
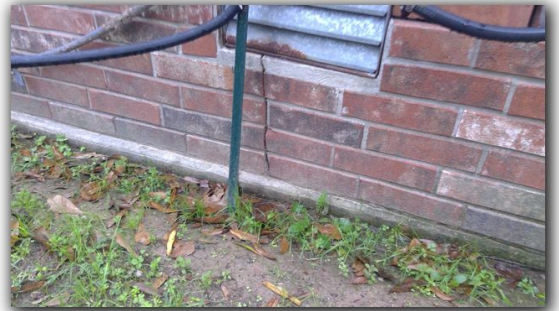
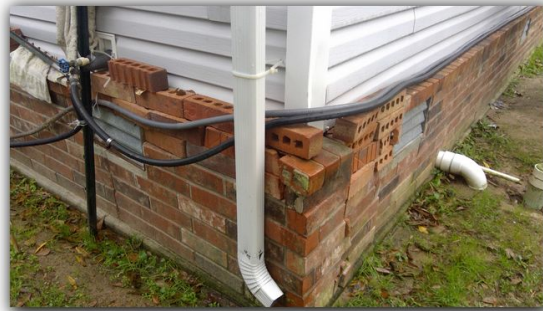
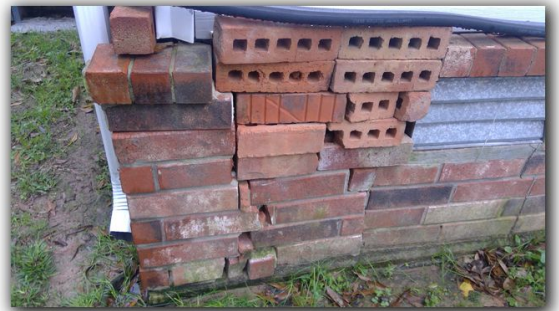
Cracks observed in exterior brick walls showing some evidence that the foundation has moved / settled, see exterior wall section for photos.

Some mortar and / or brick cracks observed at the brick siding

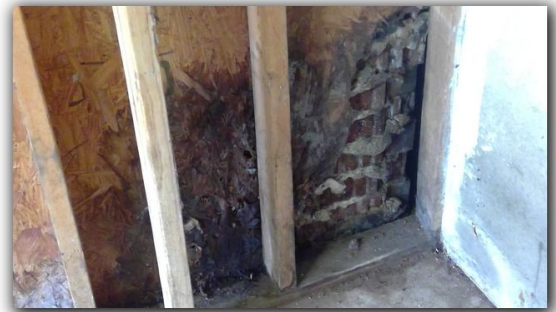
Wood rot observed in attached garage interior wood structure at one or more areas.

Would recommend that a licensed and / or qualified contractor be consulted to make any further recommendations and / or repairs.

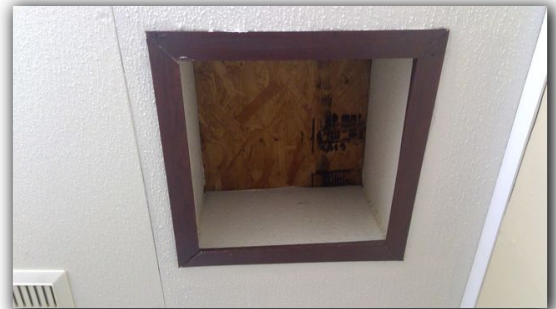
Evidence of previous repair observed in primary and hall bathrooms where skylights were removed and decked over. Work was not performed per usual and customary building practices.

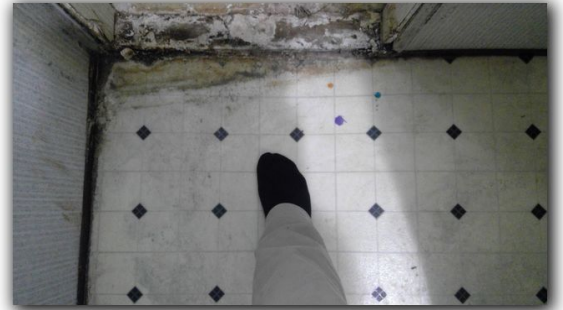
Floor appears to be rot damaged around the water heater and into the floor of the primary bedroom closet.

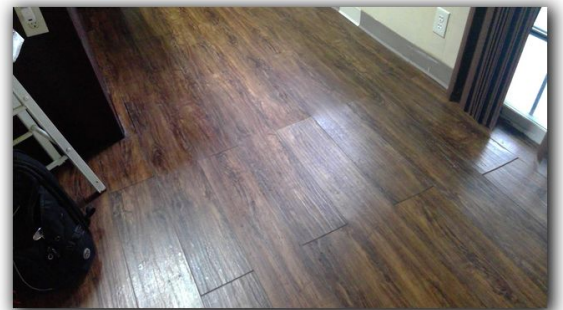
Higher and lower areas observed in floor surface noticeable when walking across the floor.

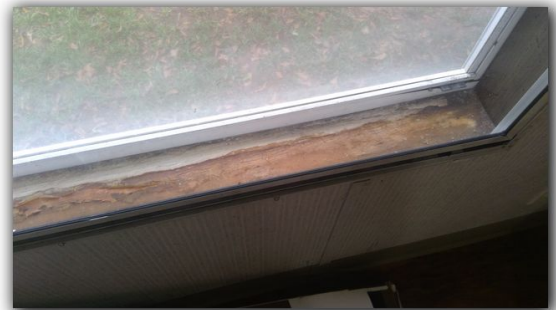
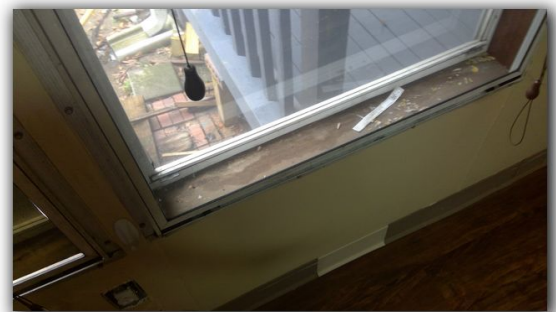
Moisture penetration observed on the window sill areas of one or more window locations. This moisture damage is typically caused by condensation on the interior side of the window soaking into the window sill area.

Would recommend that a licensed and / or qualified contractor be consulted to make any further recommendations and / or repairs

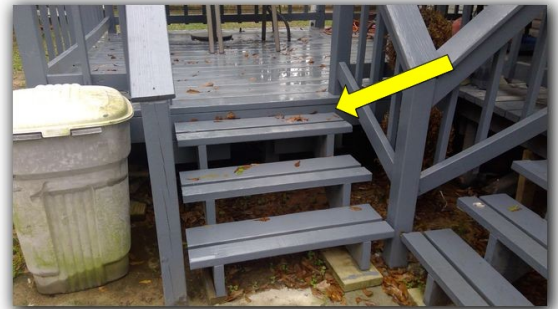
Improper dimensions of exterior stair risers: riser height cannot vary more than 3/8" from the lowest riser to the top riser per current code.

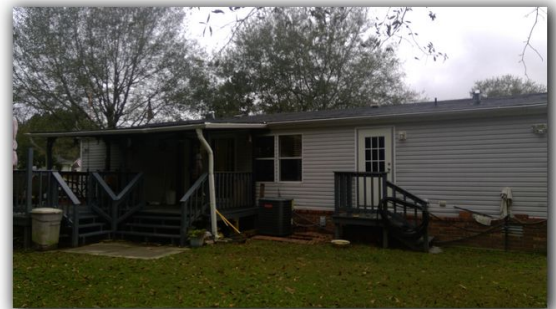
Structural deficiencies: rear porch covering structure was not constructed per usual and customary building practices.

Would recommend that a licensed and / or qualified contractor be consulted to make any further recommendations and / or repair

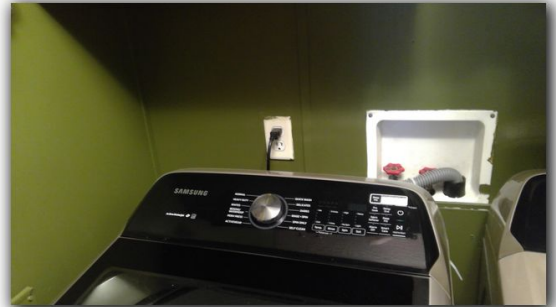
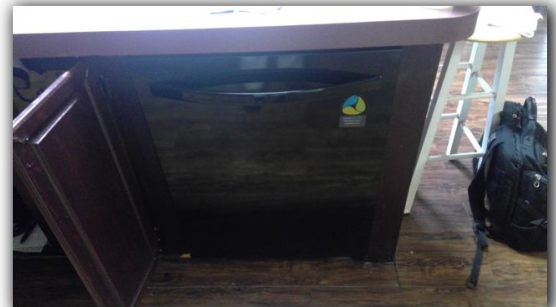
- No GFCI protection at one or more location. This is considered a recognized safety hazard: All kitchen, bathroom, **garage, exterior**, crawl space, **washing machine, dryer 220 receptacle, dishwasher**, disposer, Outdoor Equipment, Hydro-massage therapy equipment and wet bar locations are required by current code to be GFCI protected.

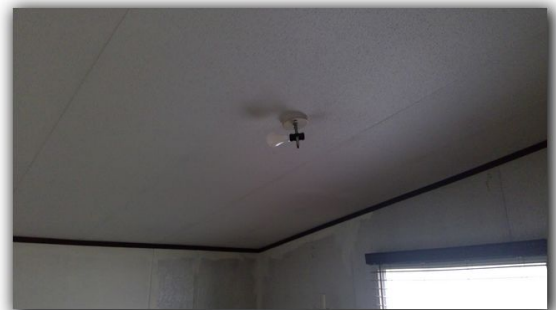
- Electrical fixture missing parts / parts not installed properly

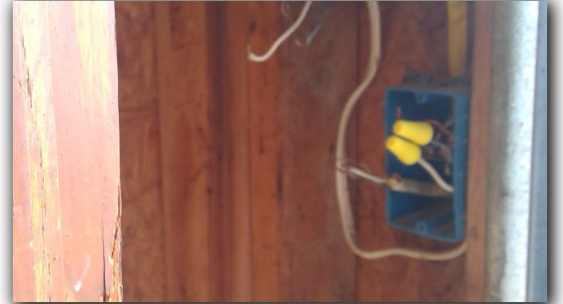
- Electrical wiring observed that was not properly terminated in a junction box, see garage..

- Would recommend that a licensed and / or qualified contractor (Electrician) be consulted to make any further recommendations and / or repair

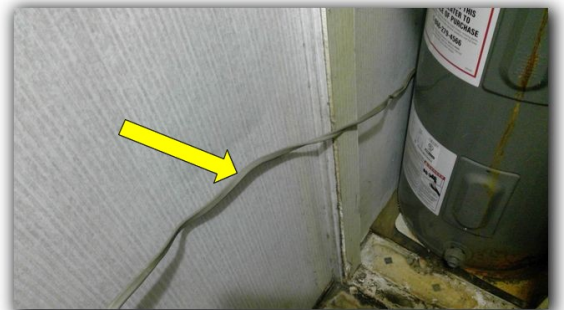
- Water heater electrical connection is not professionally installed per usual and customary building practices and is unsafe in current condition.

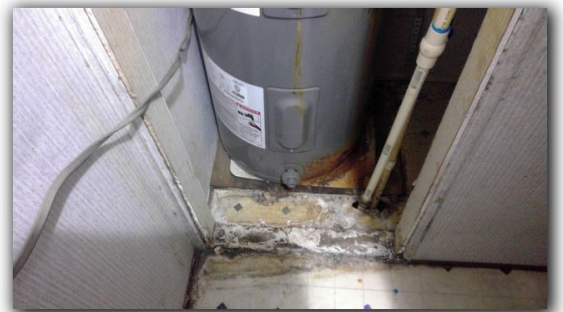
Leakage / Floor rot observed around water heater and water heater appears to be in danger of collapsing through the floor.
