REDFISH INSPECTIONS LLC

TREC REI 7-6 - REDFISH

5302 Blue Cypress Ln  
League City, TX 77573

# PROPERTY INSPECTION REPORT FORM

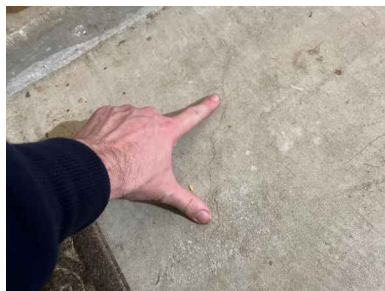
Example Garage

Hairline cracks were noted on the foundation. Cracking in post tensioned slabs prior to tensioning the strands/tendons is very common and this situation has a specific name called “Restrained to Shortening” or RTS cracks. As concrete shrinks during the drying process it would not crack if it were supported by a perfectly smooth frictionless surface, but in reality this is not the case. The ground surface the slab is poured on will restrain the concrete from sliding, which develops stresses in the concrete causing cracks to develop, i.e. RTS cracking. If reinforcing steel or wire mesh were added near the surface ( 1.5” to 2” below the top) it would strengthen the concrete and help resist the dry shrinkage forces that develop, however most post tensioned residential slabs typically do not have any reinforcement other than the post tension cables, which are not designed for dry shrinkage. The good news is **these RTS cracks are typically harmless** and may partially close up if not too much debris has fallen in these cracks before the cables are tensioned.

No Issue. No action taken.

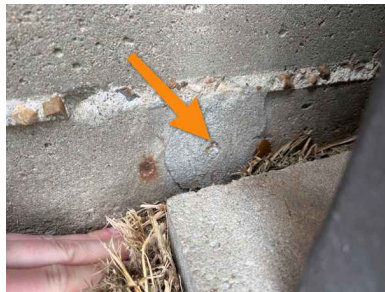
Example Right

Post tension cable ends were observed on the exterior of the foundation. These should be repaired by a professional, competent and qualified foundation specialist to prevent corrosion/deterioration of the foundation's reinforcement. All exposed tendons should be patched with an approved material and method by the Post Tensioning Institute (PTI). Extract from PTI: 1. The pocket former recesses should be filled with concrete patch material immediately after the tendon tails have been cut. 2. The patch material used should be non-shrink grout that will attain the same minimum compressive strength as the concrete foundation. 3. Prior to installing the concrete patch material, the pocket former recesses should be cleaned of any dirt, grit, oil or other substances so that a good bond is attained between the concrete and the patch material. A bonding agent can be used to enhance bond of the patch material to the concrete; however, it is important that the recommended application instructions from the bonding agent manufacturer are followed. 4. If an encapsulated system is used, the posttensioning material supplier's recommendations for cutting, capping and patching should be followed. 5. Under no circumstances should the concrete patch material used for filling the pocket former recesses contain chlorides or other chemicals known to be deleterious to the pre-stressing steel. 6. The pocket former recesses should be completely filled eliminating all voids and finished to match as closely as possible the surrounding edge of the foundation.

No Issue. No action taken.

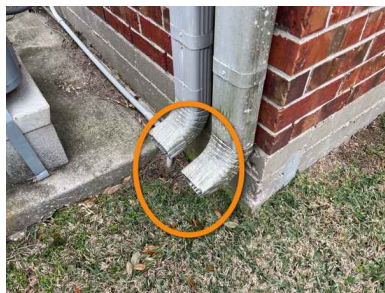
Example Right

One or more downspouts were discharging too close to the foundation. We recommend having downspouts discharge water at least five (5) feet from the structure. Storm water should be encouraged to flow away from the building at the point of discharge.

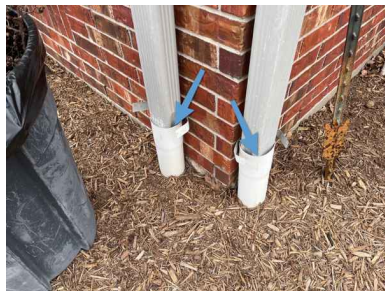
The downspouts that discharged below grade level should be monitored. If they are ever suspected to be clogged or disconnected below grade, We recommend they be redirected to discharge at least five (5) feet from the building.

Downspouts tie to underground drainline that runs to road at the front of the property. No Issue. No action taken.

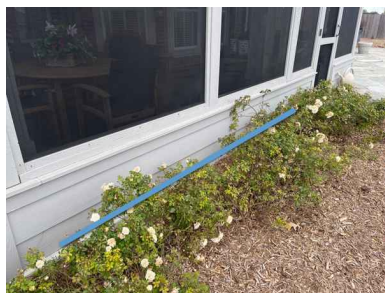
Example Rear

Foliage was noted close to the structure. We recommend trimming all bushes and tree limbs at least 1 foot away from buildings. Bushes and trees too close to the structure can prevent the walls from drying properly, their roots can affect the foundation, and their branches can damage the roof.

Drift roses have a limited root system and are unlikely to damage the roof. No Issue. No action taken.

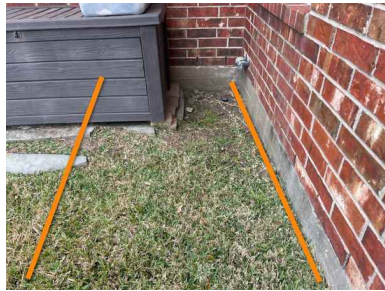
Example Right

Low elevation of grading noted. The grading should be improved to promote the flow of storm water away from the house. This can usually be accomplished by the addition of top soil. The ground should slope away from the house at a rate of one inch per foot for at least the first ten feet. Ideally, at least eight (8) inches of clearance should be maintained between soil level and the top of the foundation walls.

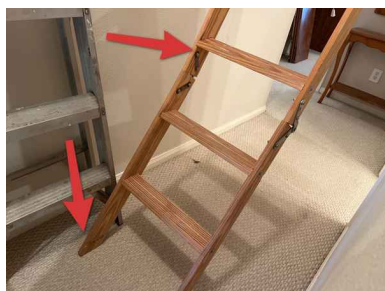
The attic pulldown stairs was overextended. For safety reasons, we recommend repair prior to using.

Bottom hinge of pull down stairs slightly misaligned. This hinge has successfully supported the weight of recent air conditioner and water heater changeouts without issue. No Issue. No action taken.

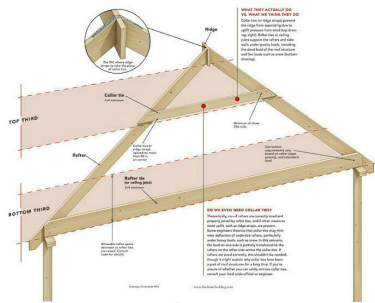
Example

recommend to add a sister board to the side of the rafter and tie into ridge (also known as "Scabbing"). The addition of collar ties can also help prevent any further separation. Repairs should be performed by a qualified contractor.

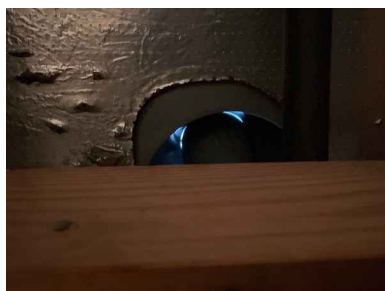
Example Water heater flue

Daylight was visible from the attic space at one or more roof protrusions. We recommend having these areas sealed to prevent water intrusion.

RESOLVED  
Water heater roof flashing replaced.

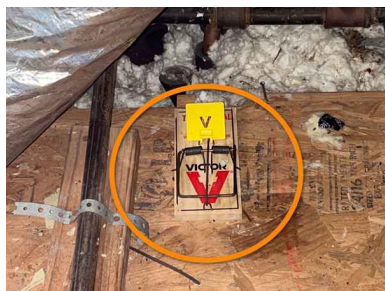
Example

There was evidence of past vermin activity. A pest control specialist should be consulted in this regard. Vermin and other pests are part of the natural habitat, but they often invade homes. Rats and mice have collapsible rib cages and can squeeze through even the tiniest crevices. And it is not uncommon for them to establish colonies within crawlspaces, attics, closets, and even the space inside walls, where they can breed and become a health-hazard. Therefore, it would be prudent to have an exterminator evaluate the residence to ensure that it is rodent-proof, and to periodically monitor those areas that are not readily accessible.

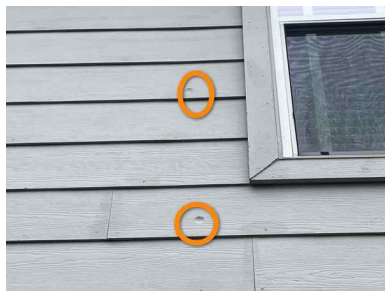
Example Right

General damaged was found to the exterior siding and/or trim. We recommend to repair as needed.

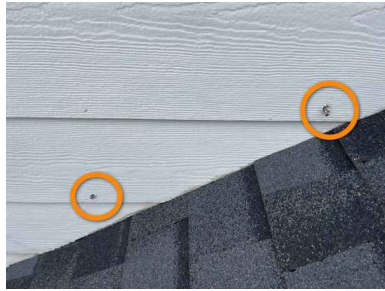
Example Rear

Nails were not fully seated in the exterior siding. We recommend repair.

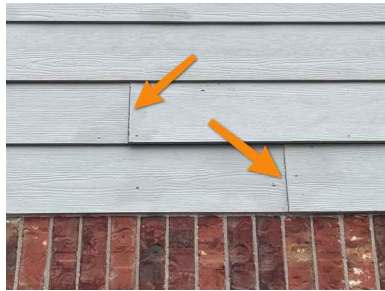
Example Right

The siding joints were open. Because these appeared to have been previously caulked, we recommend having them recaulked to prevent moisture intrusion.

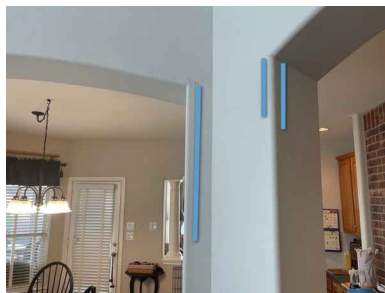
Example Living Room

Hairline/shrinkage cracks were noted in the interior walls. This condition was mainly cosmetic in nature and should be patched.

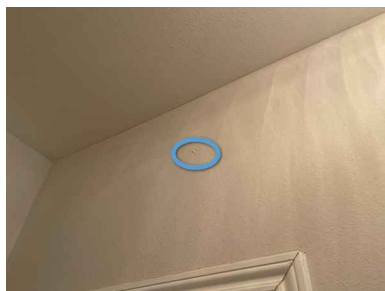
Example Hall

Nailpops, which are typically cosmetic in nature, were noted in the interior wall finishes. We recommend having these resecured, caulked and painted as needed.

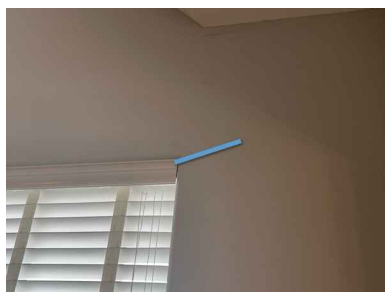
Example Living Room

A jagged/diagonal crack, or patching consistent with diagonal cracking, was observed on an interior wall. This typically indicates foundation movement. We recommend patching any open cracks and monitoring for future signs of movement.

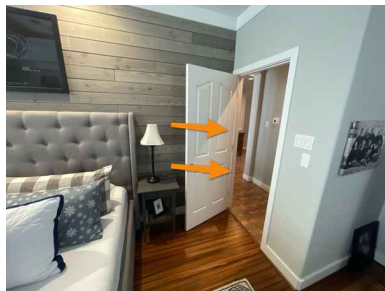
Example bedroom 1

recommend rehanging the door.

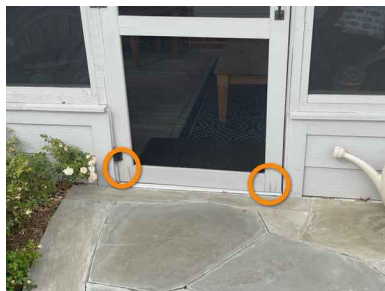
Example Rear

An exterior door had wood decay at the base of its frame/trim. No moisture was noted on the interior. We recommend replacing all deteriorated wood to prevent further damage to the structure and creating conducive conditions for wood destroying insects.

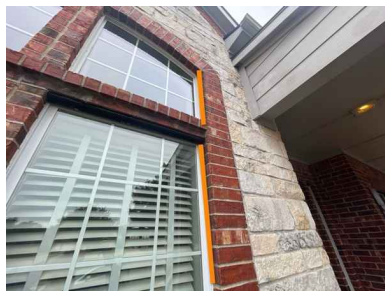
Example Front

tight home. In addition, good caulking and sealing will reduce dust and dirt in the home and prevent damage to structural elements.

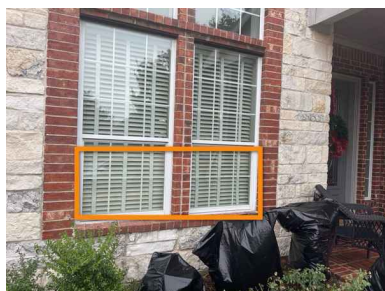
Example Front

One or more windows are missing a screen. Recommend replacement.

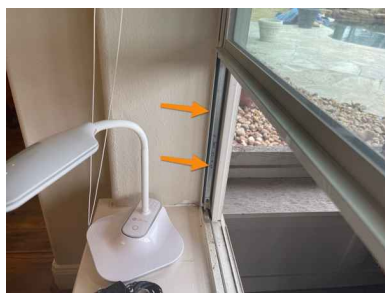
Example Breakfast Nook

Window hardware was damaged/inoperative. We recommend repair.

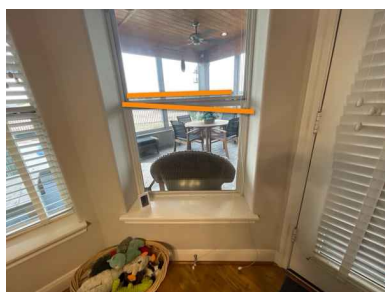
Example breakfast nook

A window was out of square however it still operated as designed. We recommend monitoring this for future movement.

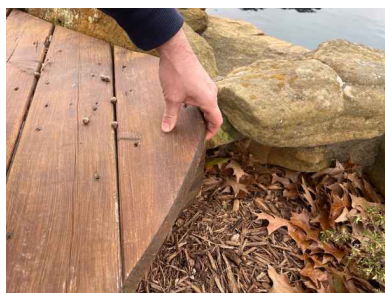
Example

Deck boards were uplifted. This represented a trip hazard, we recommend having this repaired.

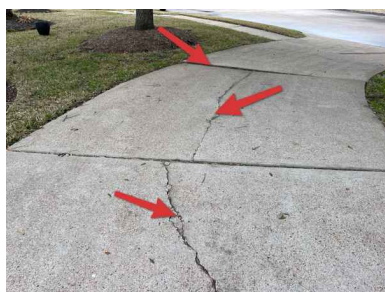
The driveway/sidewalk had settled/upheaved/cracked in places. Severe movement can cause trip hazards We recommend to repair as needed.

**Driveway cracks shrink and grow in response to rain and drought conditions. No Issue. No action taken.**

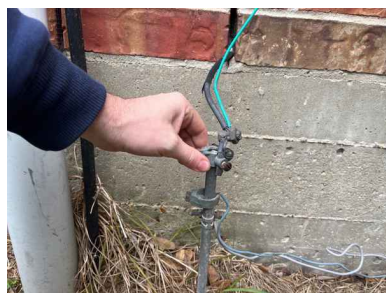
The grounding clamp was loose and improperly secured to the grounding rod. We recommend having this tightened.

RESOLVED  
Grounding clamp screw tightened.

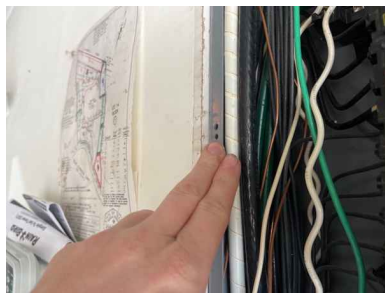
Sub panel

The conductors were installed too close to the dead front screw holes. This is a potential safety hazard when installing and removing the dead front. We recommend that a spacer be installed to keep the conductors a safe distance away.

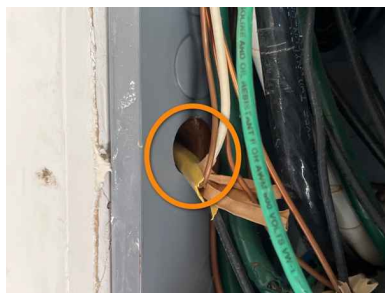
Sub panel

Cable clamps (sometimes referred to as bushings or grommets) were missing. They are required where wiring passes into the subpanel. Cable clamps serve to protect the wiring from the metal edges of the panel openings. We recommend having this repaired.

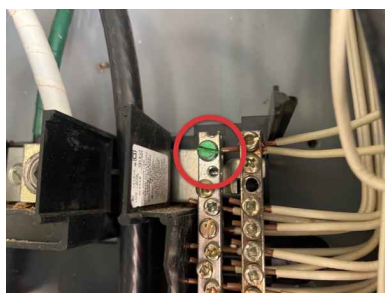
Sub panel

The subpanel was improperly wired. In a downstream subpanel, the white neutral and the equipment grounds must not be bonded together. The neutral MUST be insulated from contacting the metal enclosure and any equipment grounds. Bonding these conductors is hazardous because it will cause neutral currents to travel on metal services of electrical boxes and conduits. These need to be repaired.

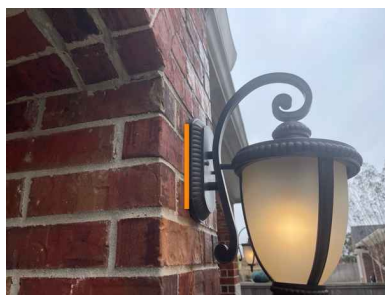
Example Front

All exterior fixtures exposed to the elements should be caulked at the wall connection to prevent water and insect intrusion. We recommend caulking.

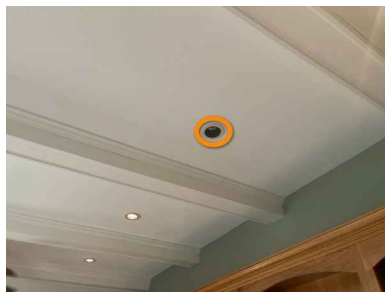
Example Game room

An inoperative light fixture was noted. We recommend replacing the bulb. Should this not resolve the issue, we recommend having the fixture repaired/replaced.

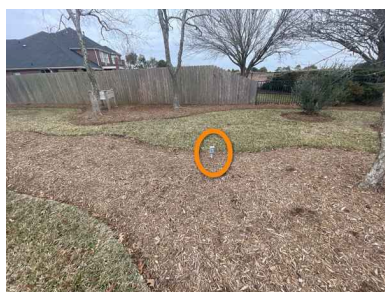
Example Rear

An outlet did not have power at the time of inspection. We were unable to determine the cause. We recommend having this further investigated and repaired.

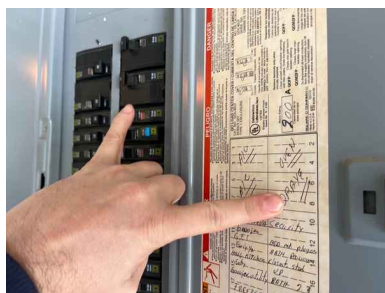
Example Dryer outlet

One or more outlets lacked proper Ground Fault Circuit Interrupter (GFCI) protection. **Today's standards** require GFCI protection be installed at all 120 and 240 volt circuits in the kitchen, laundry rooms, basements, crawl spaces, garages, exterior outlets, as well as any interior receptacles located within 6 feet of a plumbing fixture as measured by flexible cord, in order to avoid potential electric shock or electrocution hazards. We recommend having proper GFCI protection installed per today's standards.

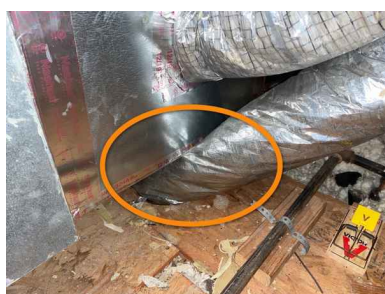
Example

Restrictions in ducts. Recommended to repair

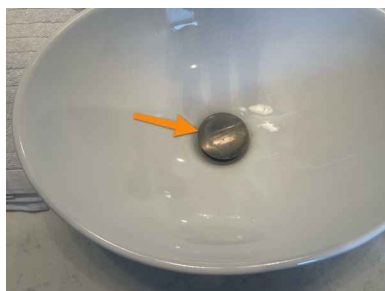
Example bathroom 1

Drain stopper found to be not working / not working properly. Recommend to repair.

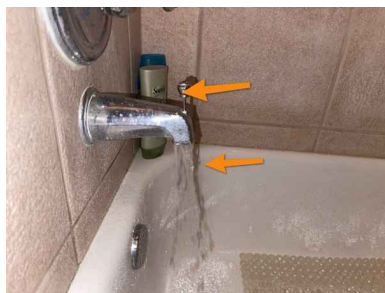
Example Bathroom 2

The bathroom shower diverter did not fully divert the water from the spout to the shower head or visa versa. We recommend having this repaired/adjusted to operate as intended.

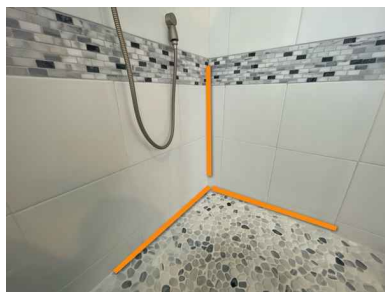
Example Bathroom 1

Deteriorated caulking/grout was noted, which may allow damage from moisture intrusion of the wall assembly at a bathroom. We recommend having this recaulked.

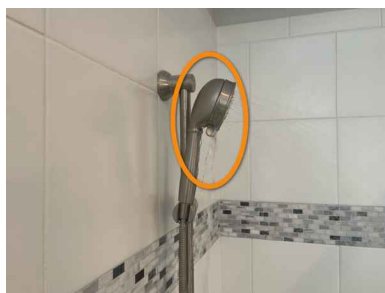
Example Bathroom 1

We observed a leak at a shower head at the time of inspection. We recommend having this repaired.

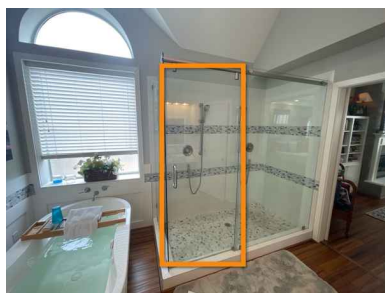
Example bathroom 1

The shower door did not operate freely. We recommend having the door adjusted for safe, smooth operation.

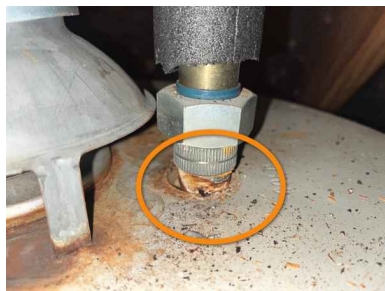
Unit 1

Pipe fittings at the water heater were corroded. We recommend having these repaired.

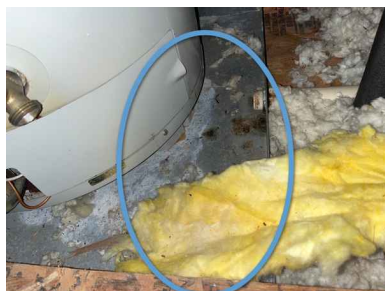
Unit 1

It is not uncommon for insulation or other debris to enter into the drain pan. We recommend to clean drain pan upon move in and then reinspect annually.

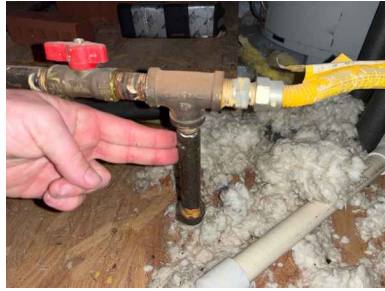
Example Water heaters

service by a licensed plumbing or mechanical contractor is recommended, but immediate service is not critical.

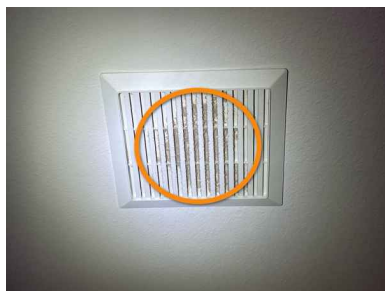
Example

The bathroom exhaust fan was excessively dirty at the time of the inspection. We recommend having the grill cleaned.

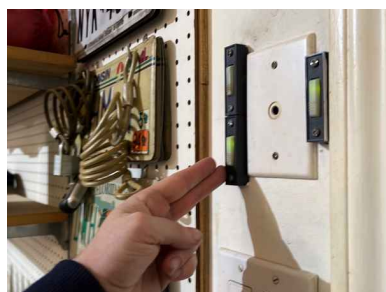
Closing right the garage vehicle door using the wall-installed switch required holding the switch until the door was completely closed. We recommend service by a qualified contractor or technician.

**RESOLVED**

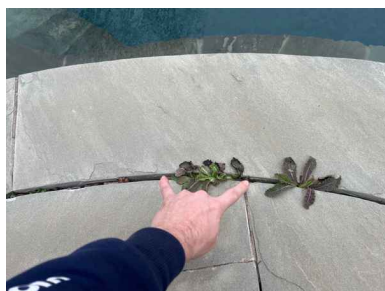
Caulk gap at coping/deck

Caulking repairs needed.

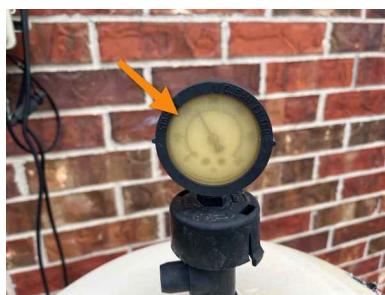
The Pressure Gauge was damaged or fogged. We recommend replacement.

Pressure gauge has a yellowed lens but pressures can still be clearly viewed. No Issue. No action taken.

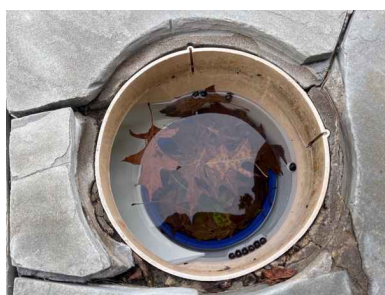
Filtration baskets need to be emptied and cleaned.

RESOLVED  
Skimmer baskets are cleaned weekly by pool service.
