REPORT OF FINDINGS

Location: 24811 Meadow Oaks Dr.
Katy, TX 77494

Engineer of Record: Travis C. Tatum, P.E. / TX PE#: 110343

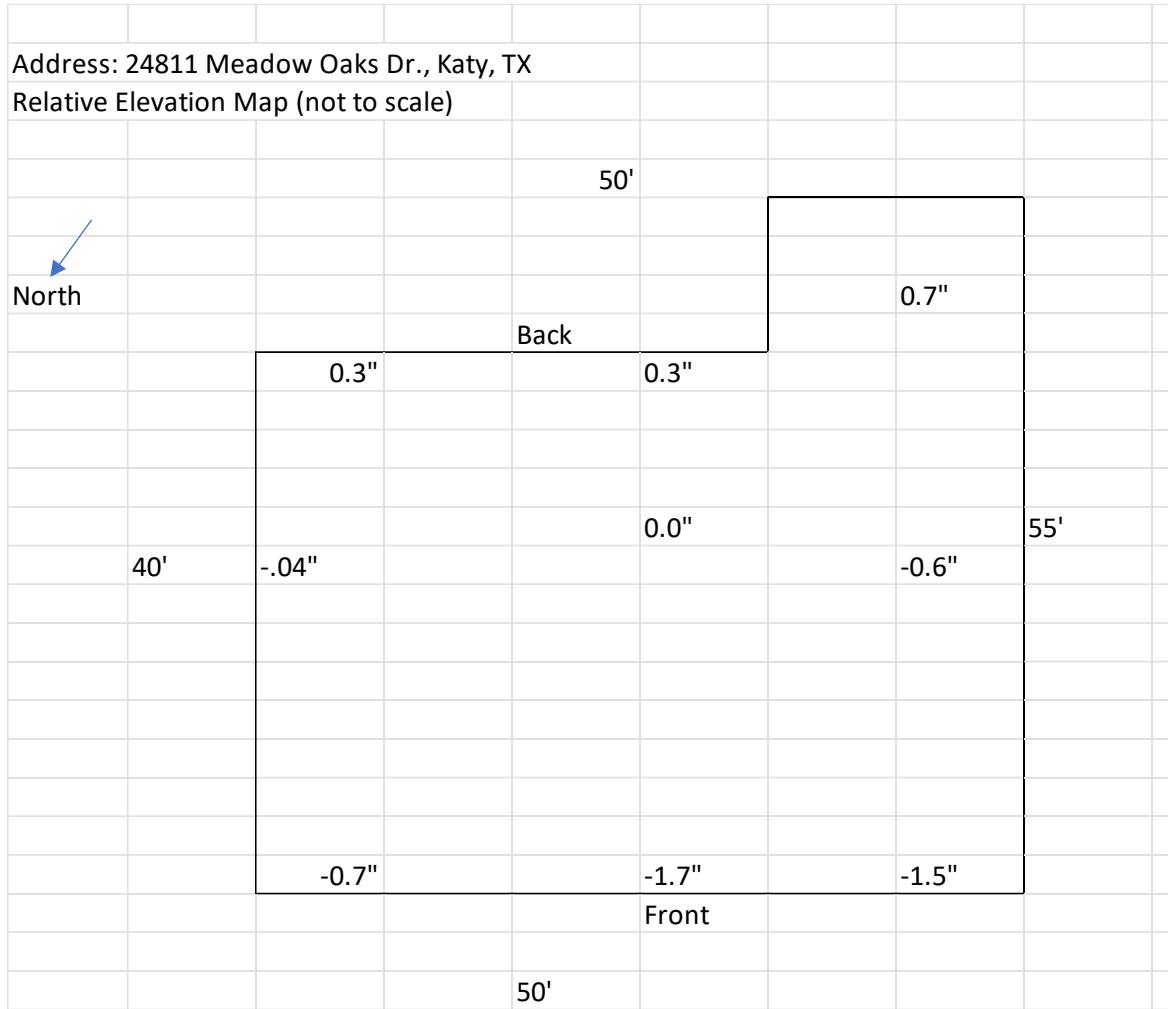
Figure 1: Relative elevation survey map

Relative elevation measurements were made throughout the residence using a ZipLevel 2000 precision altimeter. The maximum differential settlement and/or the slopes observed were within acceptable limits. Relative elevations were not measured in the garage, as garage measurements are notoriously inaccurate due to highly varying as-built slopes.

Maximum foundation relative elevation difference was measured to be approximately 1.7 inches over a 30-foot span. While this exceeds the ASCE deflection limit guidelines, the absence of corollary damage indicates that not all of

the measured elevation difference is due to foundation movement. In the absence of corollary damage, it is reasonable to assume that the foundation was poured with a slight slope. All floor slopes are less than the ASCE recommended limit of 1%.

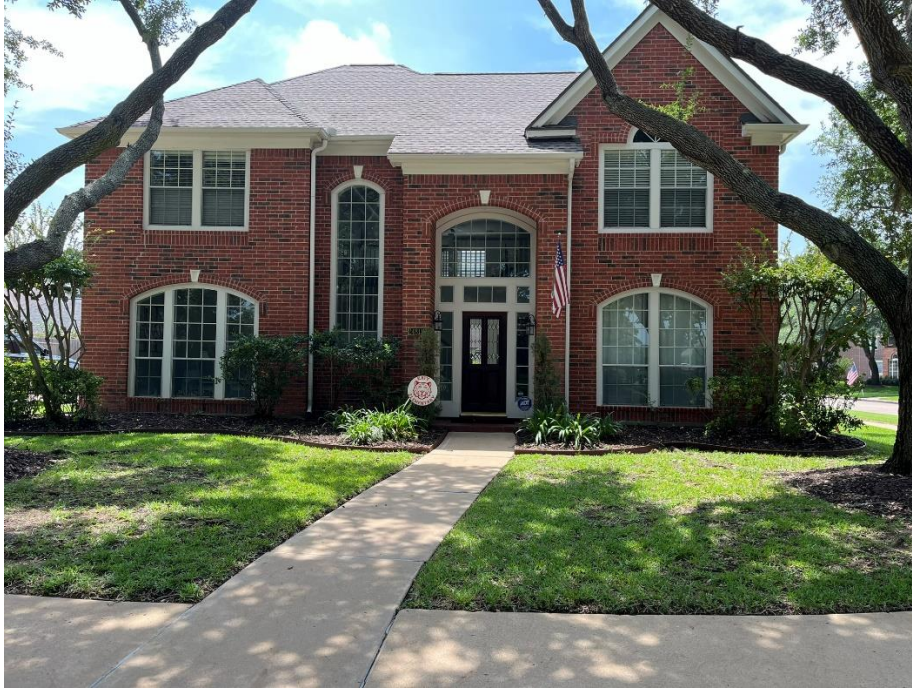
Photograph 1: Overview of front of residence.

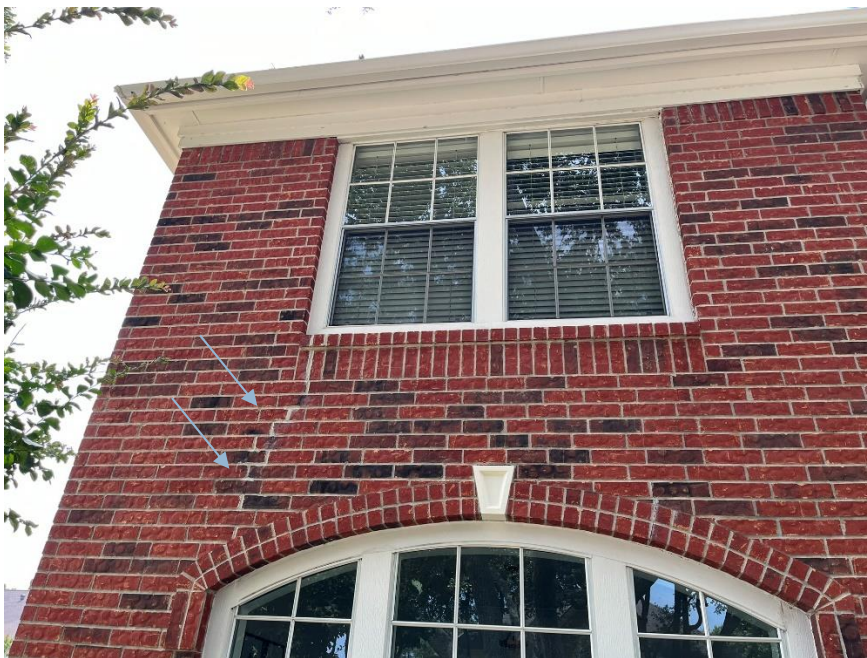
- Cracked mortar in the second story brick veneer shows evidence of prior repair with no further cracking, indicating no recent movement.
- Minor, non-structural corner cracking was observed.
- Possible missing post-tensioned cable patches were observed along the left side of the home. These should be closed, but do not appear to be adversely affecting the performance of the foundation.
- Dense foliage along the back and right side of the detached garage was pulled away to ensure the exposed foundation was in good condition. No structural deficiencies were observed.
- Cracks in the driveway consistent with differential movement on expansive soils was observed. The driveway and surrounding flatwork is independent of the main residence foundation and does not adversely affect the performance of the house foundation.

Photograph 2: Repaired cracks in front brick veneer.

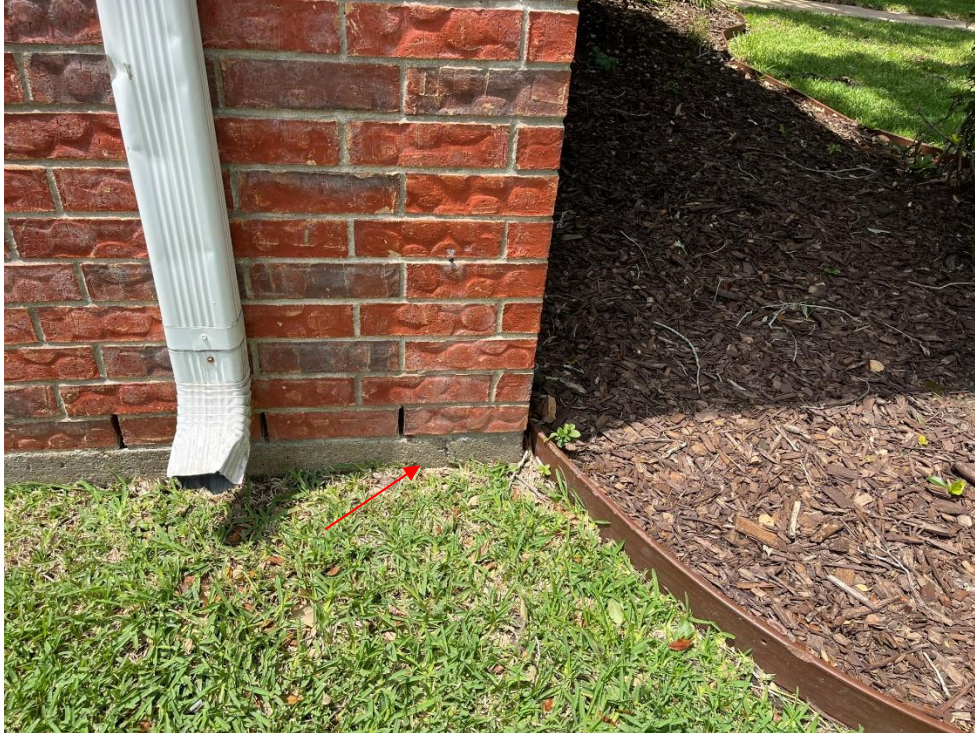
Non-structural corner cracking was observed. Corner cracking of this type occurs not due to differential settlement, but instead because of differences in expansion and contraction of the brick veneer and the concrete foundation. Corner cracking of this type is not a structural concern.

Photograph 3: Non-structural corner cracking.

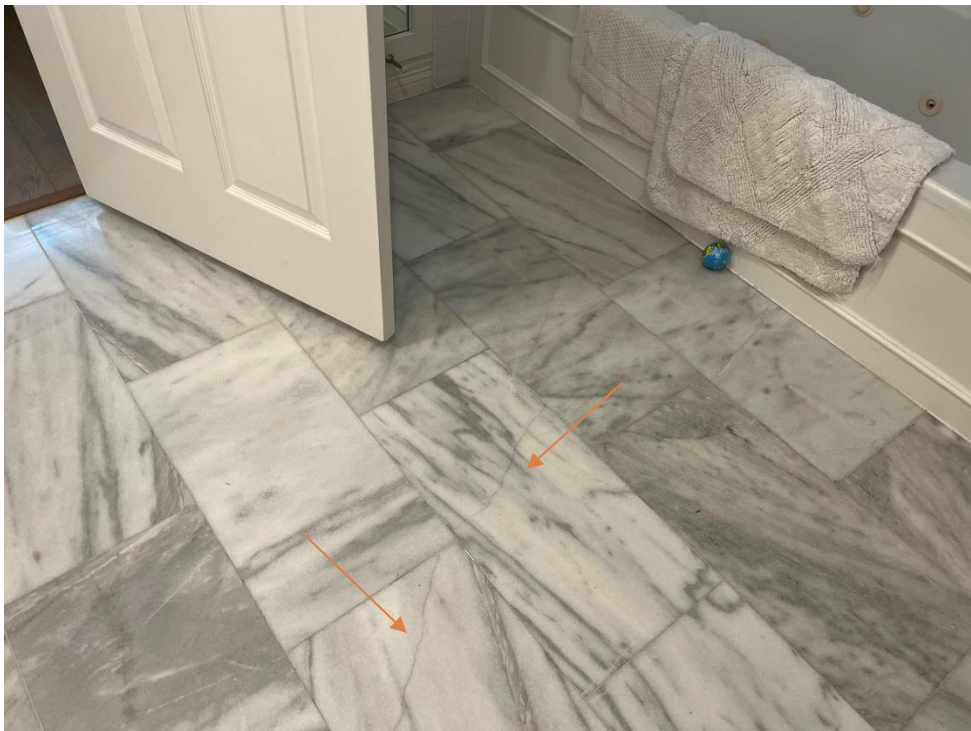
- Minor separations in drywall and molding seams were observed. Minor cracks in the front entry tile was observed.
- Doors functioned properly.
- Significant cracking in the newly laid master bathroom floor tile was observed. No other similar tile cracking was observed. The cracking in the master bathroom appears to be due to material defect and/or improper installation, not foundation movement.

Photograph 4: Cracks in master bathroom tile

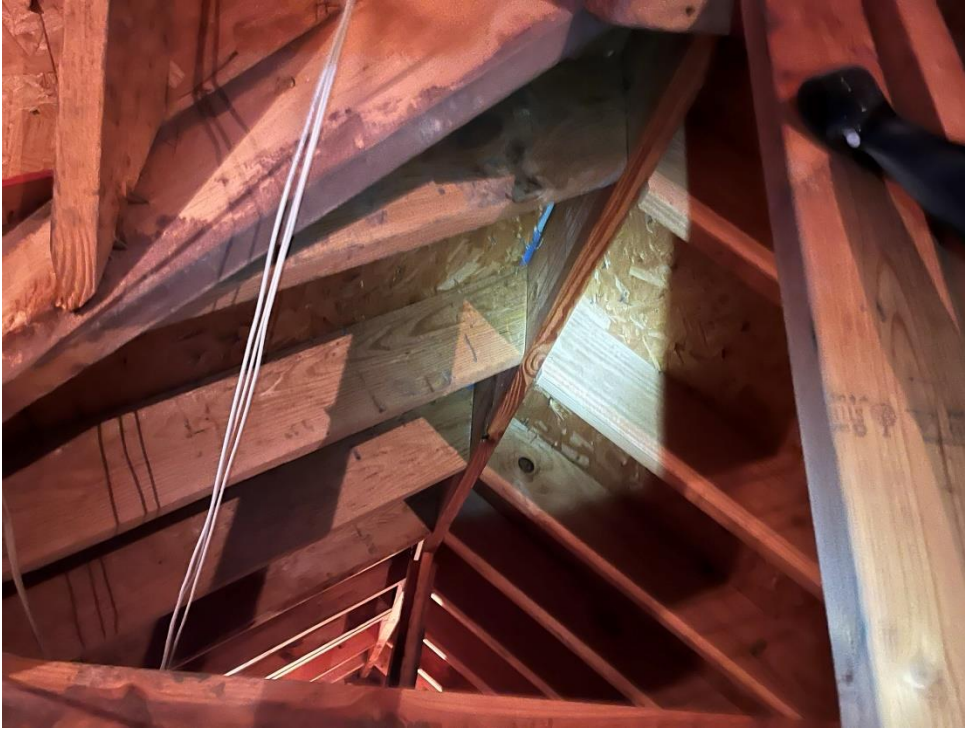
- Rafters and framing are in good condition with no signs of excessive stress or foundation movement (i.e. pulling, cracking, twisting, etc.).

Photograph 5: Attic Framing – Good condition. No twisting, pulling or cracked structural members.
