## Inspection Report

**Property Address:**  
8610 Cedar Walk Dr  
Tomball Texas 77375

**By:** Stephen Weston TREC #21249 / Weston Inspection 4/28/2021

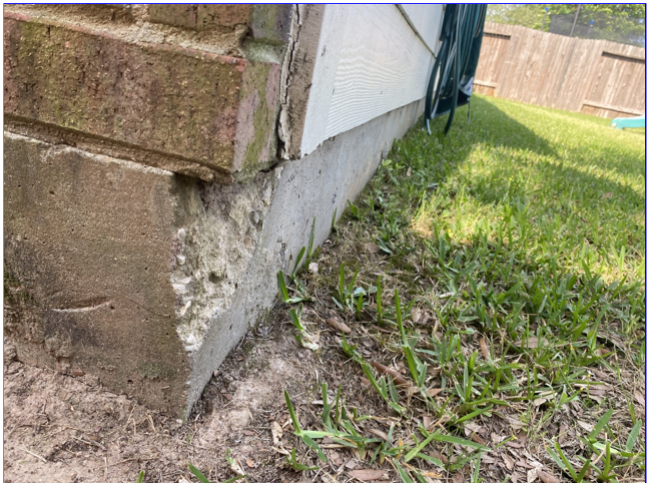
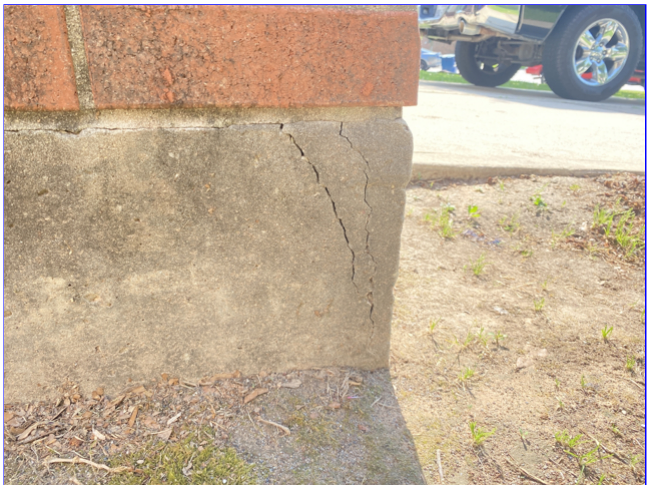
(1) **Cosmetic-** Break observed on one or more corners of foundation. This is referred to as a "corner pop". "Corner pops" are considered to be cosmetic and are common due to excessive pressure at these locations. Recommend monitoring location, repairs may be necessary if breaks begin to grow or widen.

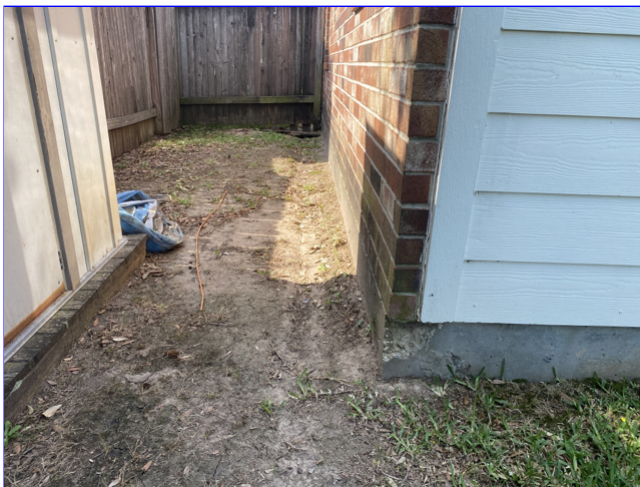
B. Item 1(Picture)

The home had areas of negative, neutral or insufficient slope, this restricts drainage and runoff and will cause water to pond in close proximity to the foundation. The ground should slope away from the home a minimum of 6 inches within the first 10 feet from the foundation wall.

**Partial Gutters:** Only portions of the roof had gutters installed. The Inspector recommends installation of a full gutter system to help protect the home structure.

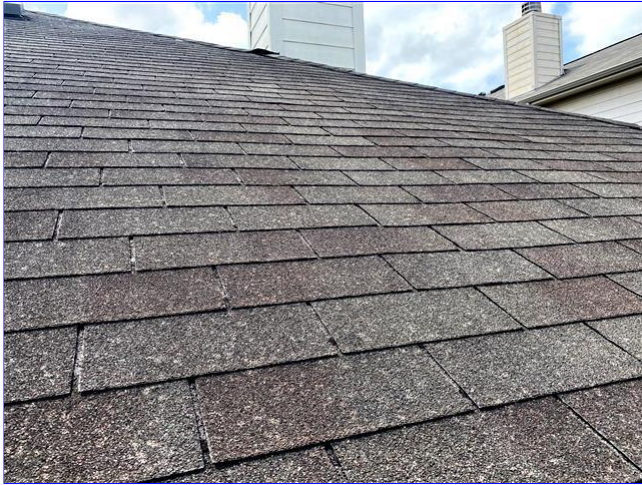
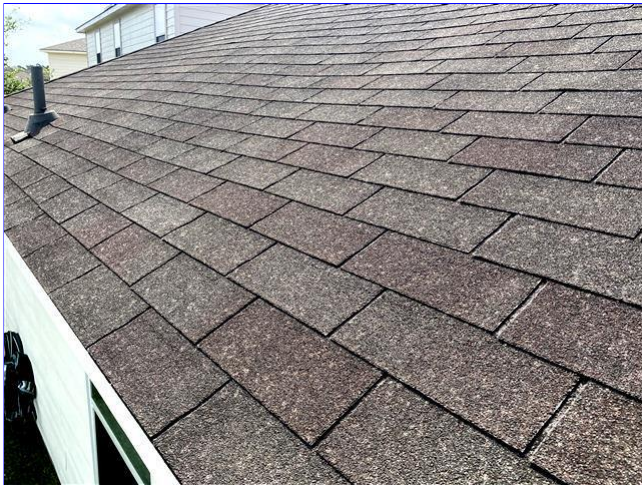
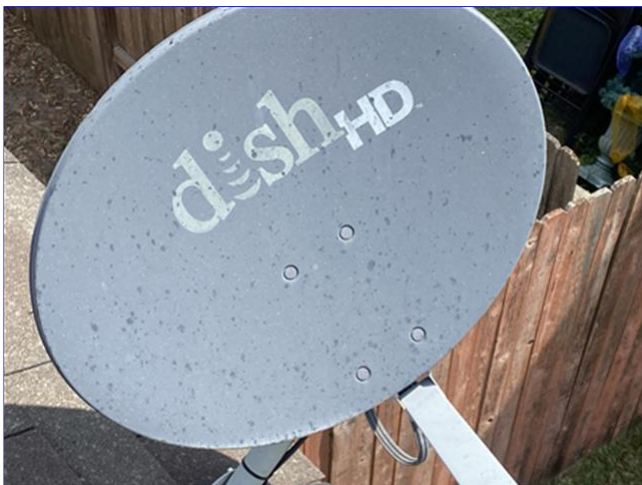
**damage and wide spread hail damage were observed. The inspector recommends further evaluation of the entire roof to advise on any necessary plans of repairs or replacement.**

C. Item 1(Picture) Hail Damage

C. Item 2(Picture) Hail damage

C. Item 3(Picture) Hail damage

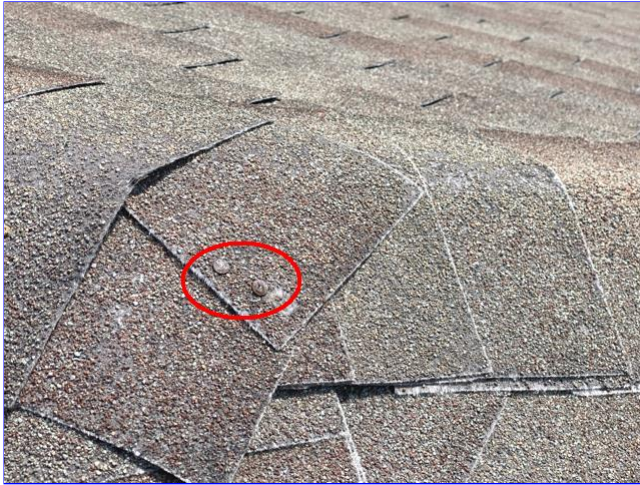
C. Item 4(Picture)

(2) Exposed and rusted nail heads observed at one or more flashing detail or ridge shingle. Rusted nail heads can break and cause leaks. Recommend sealing over nail head to avoid potential roof leaks.

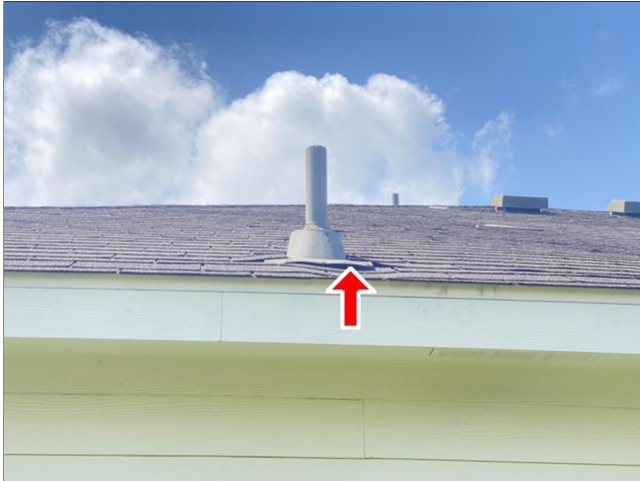
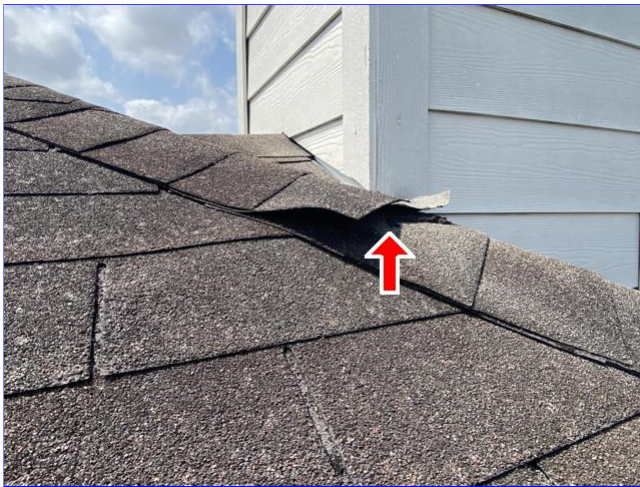
(3) Voids observed at one or more flashing detail. Recommend securing and sealing over nail heads to prevent moisture intrusion from wind driven rain.

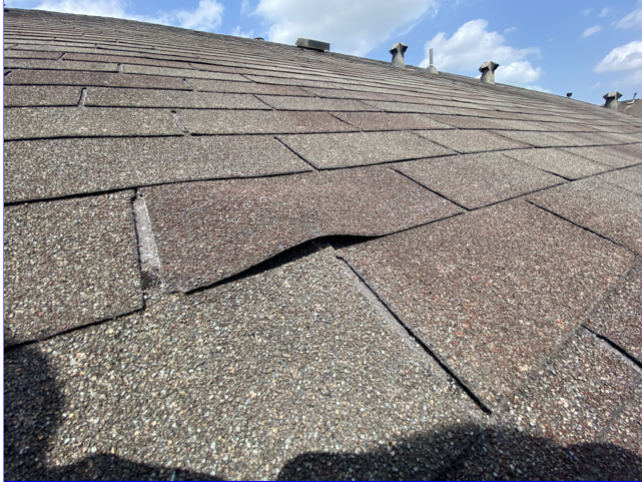
C. Item 7(Picture)

(4) Multiple buckled shingles observed on roof. This is typically caused by nails that are not completely driven into the shingles below. This condition makes the shingles vulnerable to uplift in heavy winds. Recommend repair.

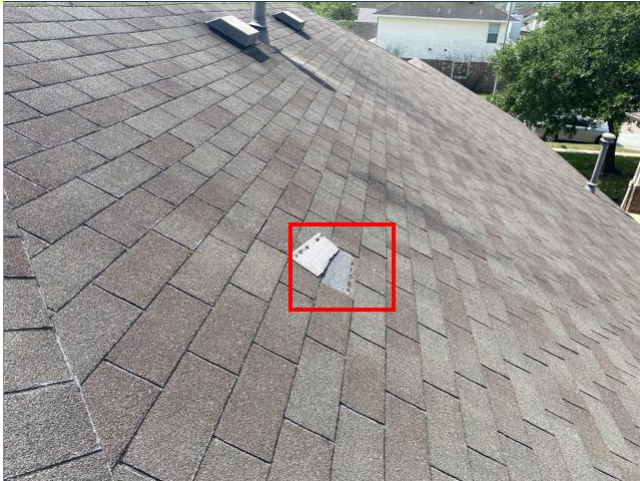
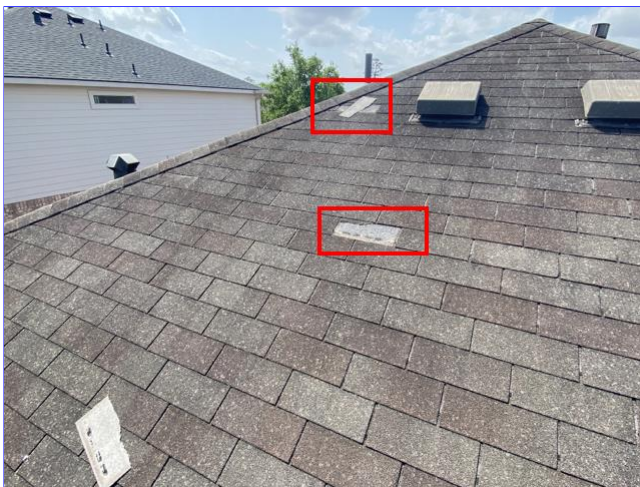
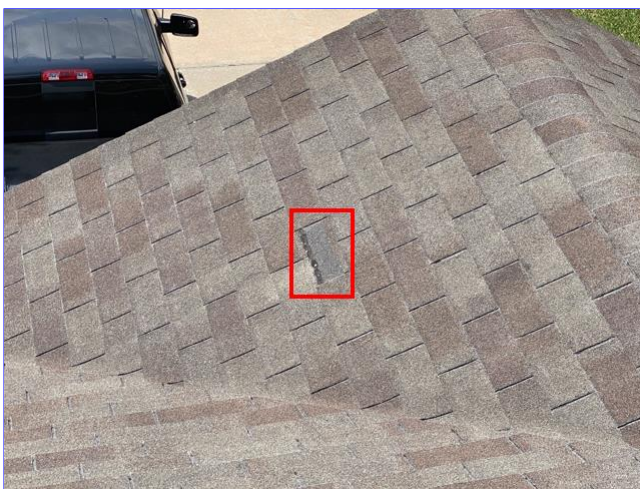
(5) The roof had creased and/or broken shingle tabs typical of wind damage. This condition often indicates a poorly-bonded roof, improper fastening methods or a combination of the two. Inspector recommends repairing locations to prevent potential roof leaks. All work should be performed by a qualified roofing contractor.

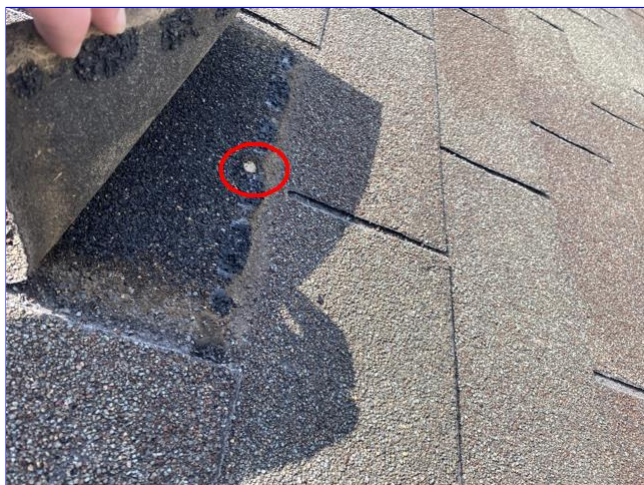
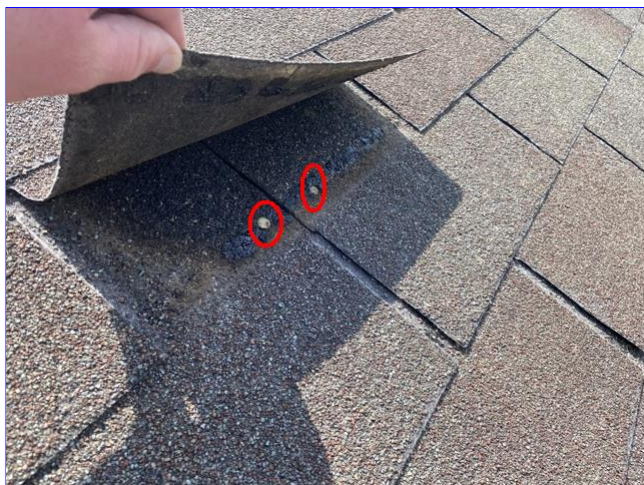
(6) Asphalt composition shingles covering the roof of this home had fasteners installed too high on the

shingles. This condition will result in reduced wind resistance which can result in shingles being torn off from heavy winds. Inspector recommends further evaluation by a roofing contractor.

C. Item 11(Picture) Nails driven into adhesive strip

C. Item 12(Picture) Nails driven into adhesive strip

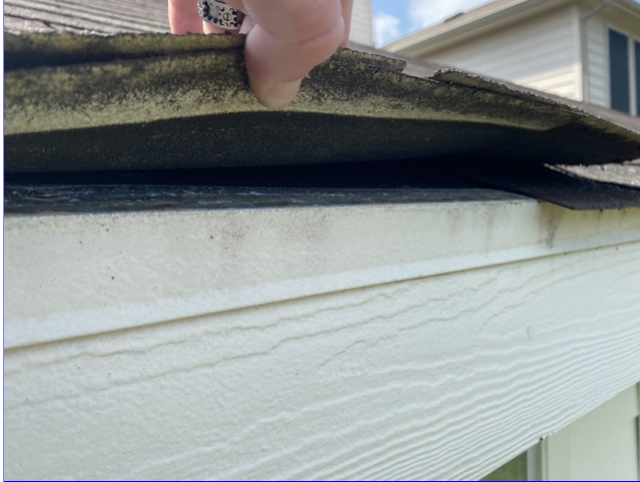
C. Item 13(Picture)

(7) Bottom row shingles are not bonded down at the roof eaves. This makes these shingles vulnerable to uplift in heavy winds. Recommend improvement by a qualified roofing contractor.

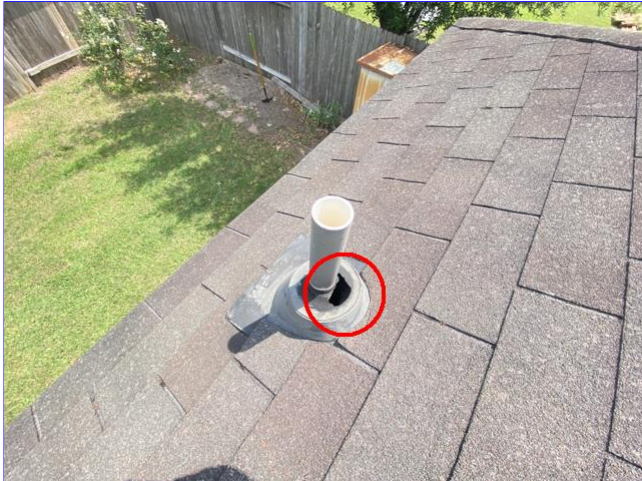
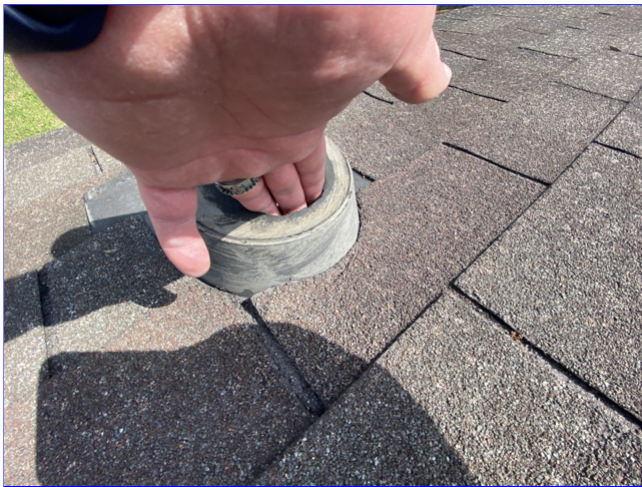
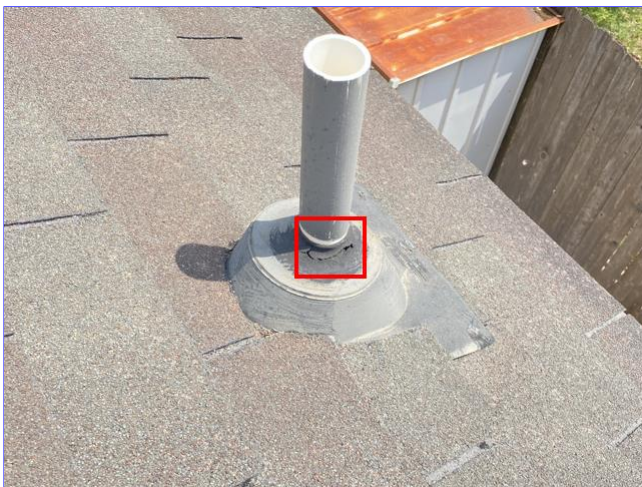
(8) Active roof leaks observed at multiple damaged plumbing vent roof boots. Inspector recommends repair by a qualified contractor.

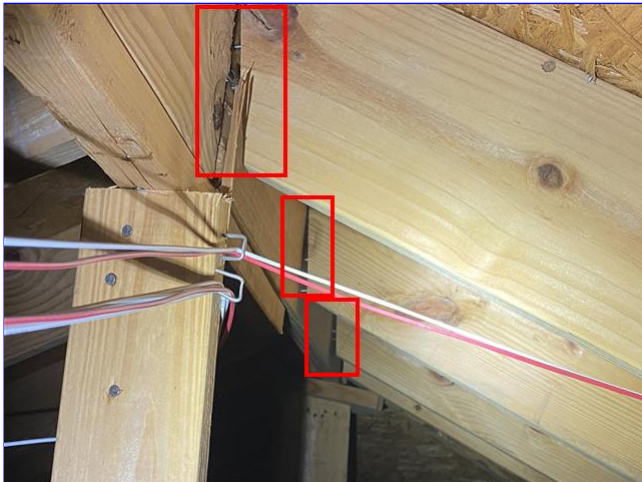
D. Item 1(Picture)

- (1) Insulation was insufficient throughout the attic space floor. Insulation should be added to increase energy efficiency and overall comfort within the home.
- (2) One or more rafters do not fit snugly against the ridge board due to inaccurate framing cuts. Rafters should be in full contact with the ridge board or opposing rafter. These rafters are prone to splitting.

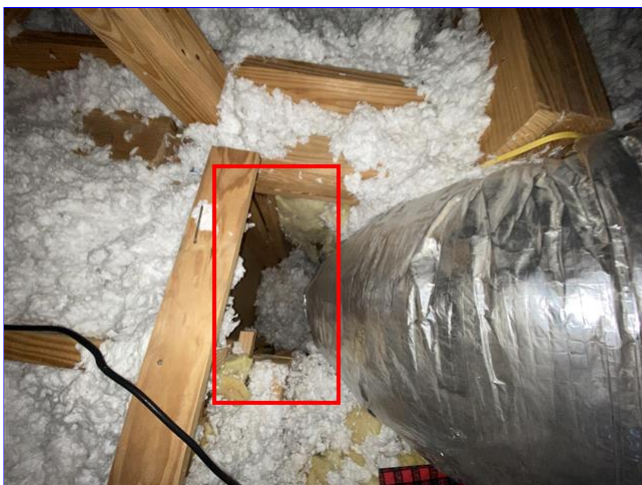
D. Item 2(Picture)

- (3) Fire protection (firewall) is not provided where an air duct passes through the ceiling. Fire resistant boards are required at these locations to reduce the risk of flame spread, in the event of fire.

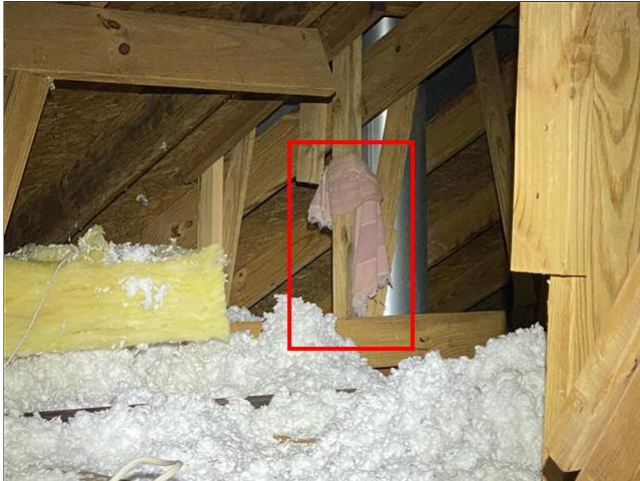
D. Item 3(Picture)

- (4) A towel was observed next to the chimney, inside the attic space. This could indicate that a leak or prior leak at this location. Inspector was unable to inspect this area up close due to no safe pathway provided.

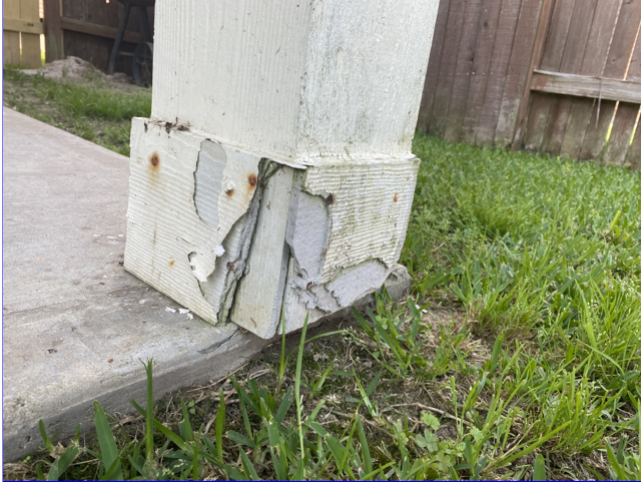
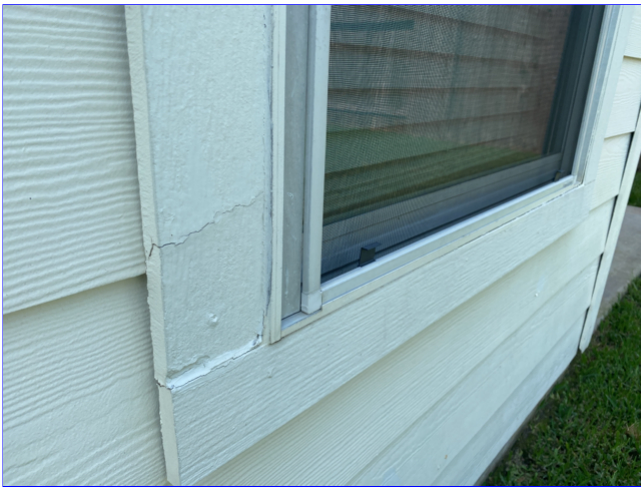
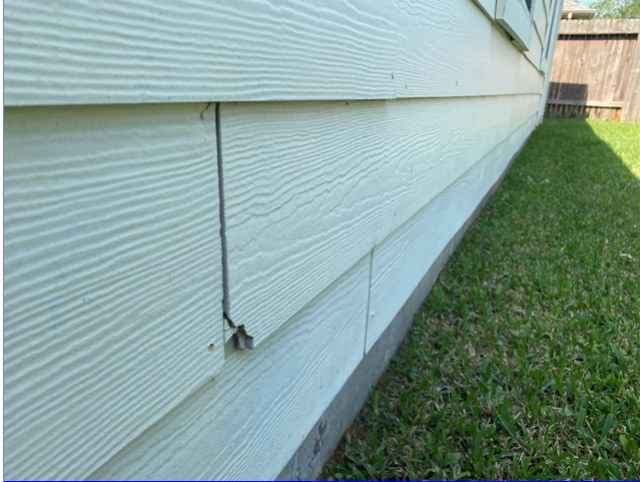
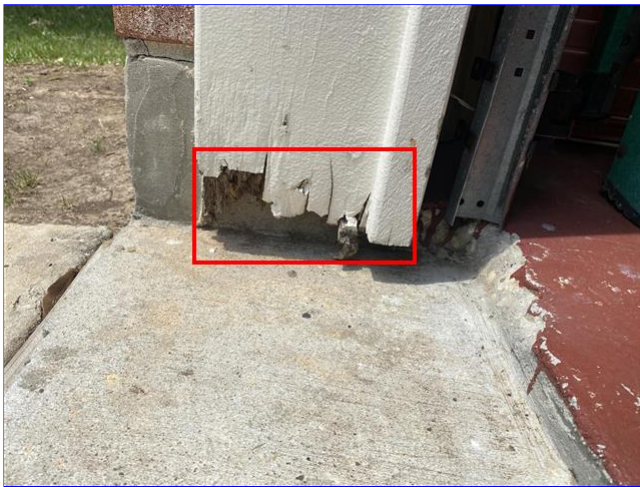
- (1) Sealant or touch up sealant (caulk) is needed at multiple exterior wall locations. This includes but is not limited to trim boards, brick expansion joints, wall penetrations and fixtures.
- (2) One or more exterior siding and/or trim boards are damaged or deteriorated. Recommend repair or replace as necessary.

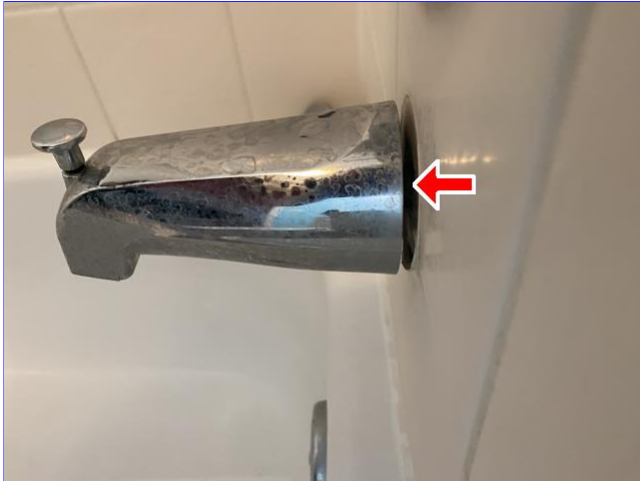
E. Item 5(Picture)

(3) Sealant where bathroom fixtures or enclosure meet the wall was old or had sections of missing sealant that may allow damage from moisture intrusion of the wall assembly. Inspector recommends applying fresh sealant at these locations.

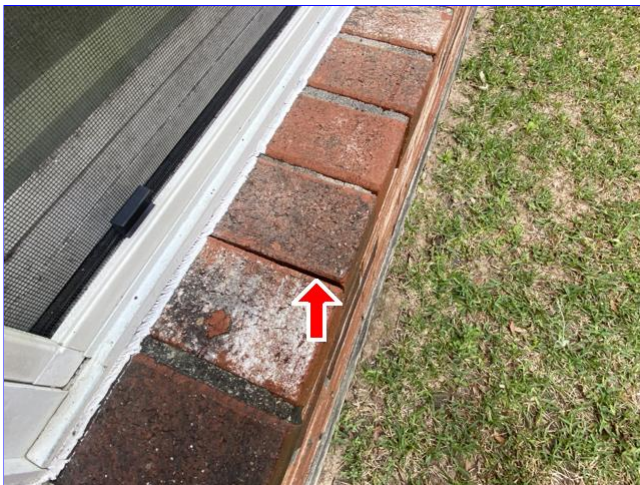
E. Item 6(Picture)

(4) Mortar joint at front right window should be patched.

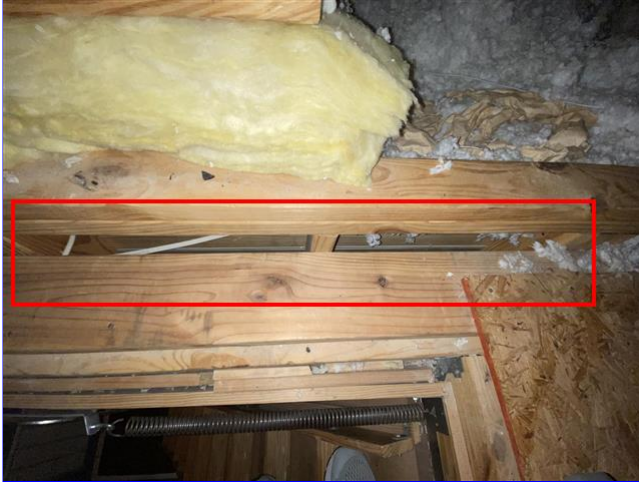
(5) Insulation was missing at one or more attic sidewalls. Inspector recommends correction to increase energy efficiency and overall comfort within the home.

E. Item 7(Picture) Next to attic opening

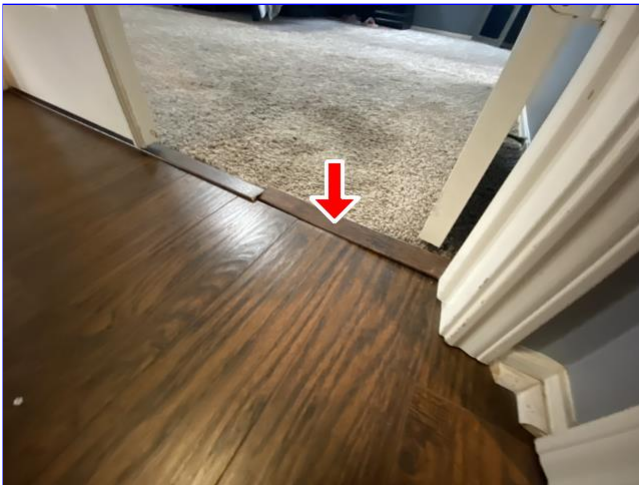
F. Item 1(Picture)

T Moulding at master bedroom entry door was damaged and loose.

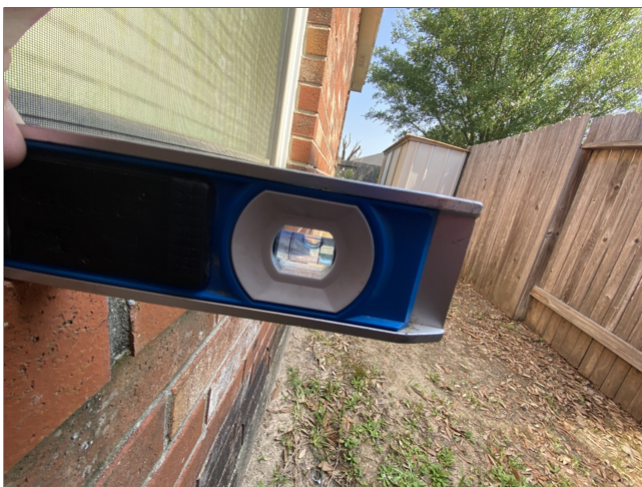
H. Item 1(Picture)

(1) Multiple brick window sills were improperly sloped. Window sill should slope away from the home.

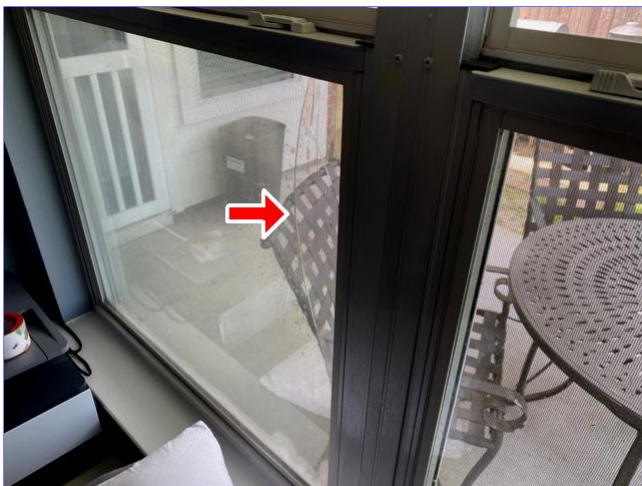
H. Item 2(Picture)

(4) Cracked window pane observed at master bedroom window.

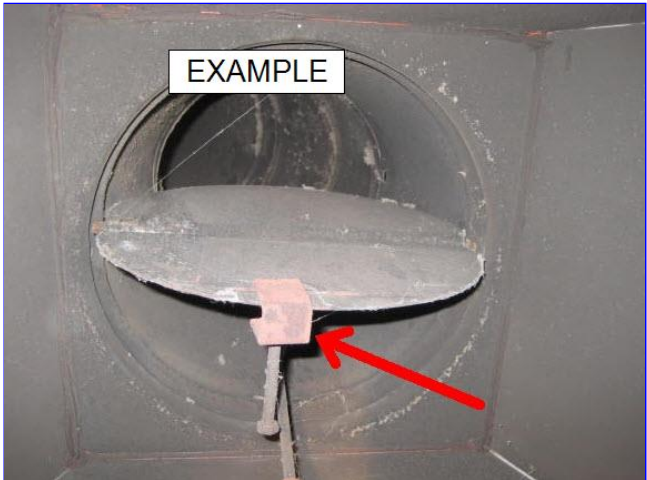
A draft damper clamp was not installed on the fireplace damper. A clamp should be installed on the damper to ensure that the damper remains open at all times. Operating the fireplace with the damper closed may allow the highly toxic, invisible products of gas combustion (carbon monoxide) to enter the living space.

J. Item 1(Picture) Damper clamp

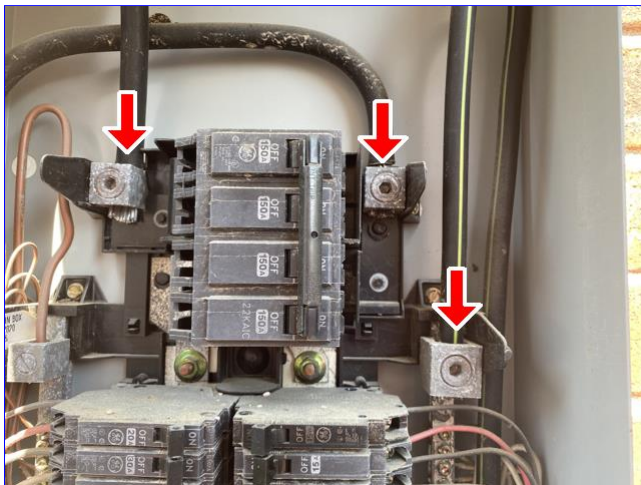
A. Item 1(Picture)

(2) Anti-oxidizing paste is needed on the aluminum service wires. Aluminum wires in outdoor breaker boxes can over heat and corrode in the hot summer months. Aluminum wires have been known to catch fire as a result. Anti-oxidizing paste will prevent over heating and corrosion.

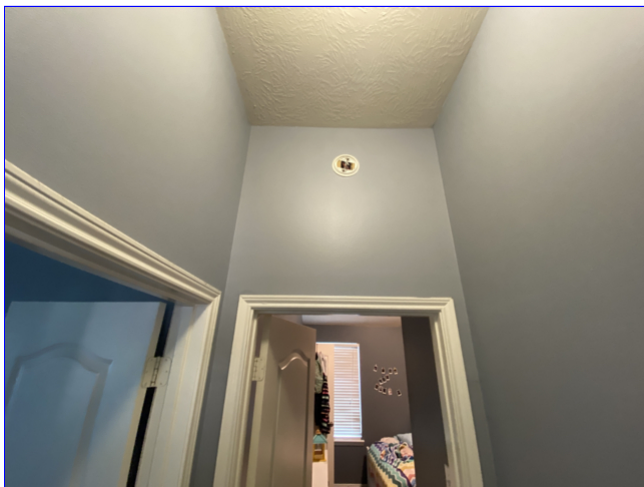
B. Item 1(Picture)

(1) Smoke detector at master bedroom hallway was missing at the time of inspection.

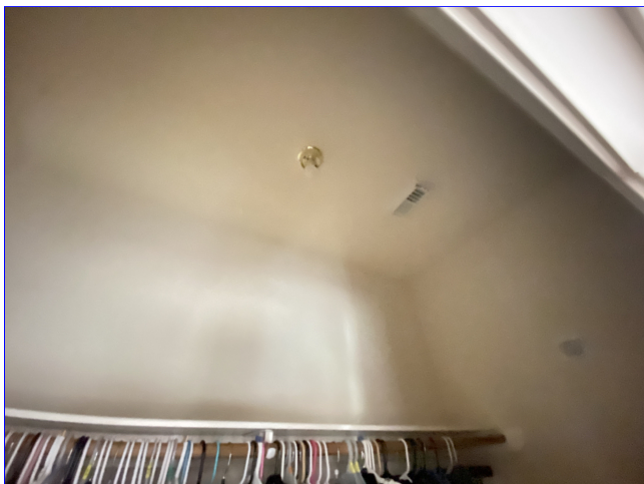
B. Item 2(Picture)

(2) One or more light fixture covers were missing. This is considered a **FIRE HAZARD** inside of clothes closets.

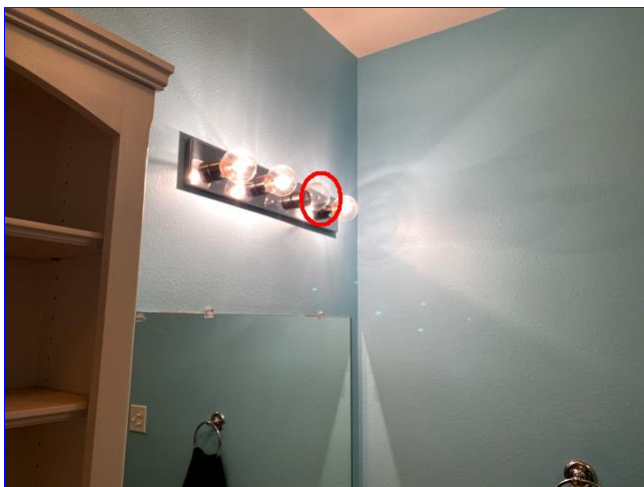
B. Item 3(Picture)

(4) One or more light fixtures in the home appeared to be inoperable. The bulbs may be burned out, or a problem may exist with the fixtures, wiring or switches.

If after the bulbs are replaced, these lights still fail to respond to the switch, this condition may represent a potential fire hazard, and the Inspector recommends that an evaluation and any necessary repairs be performed by a qualified electrical contractor.

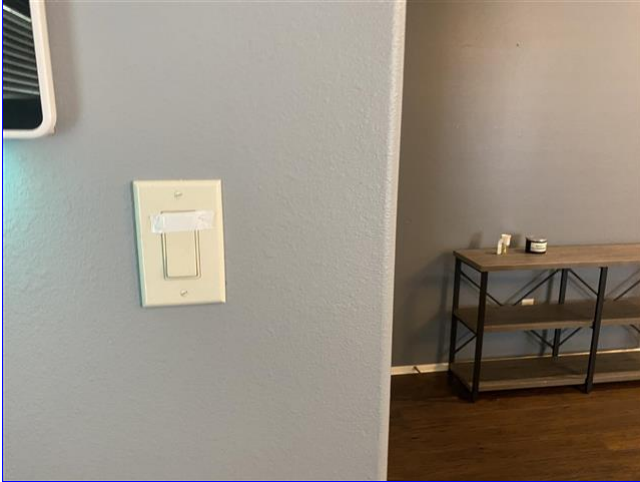
B. Item 4(Picture)

(5) Inspector was unable to operate the switch at the front entryway. The switch was covered with tape prior to the inspection.

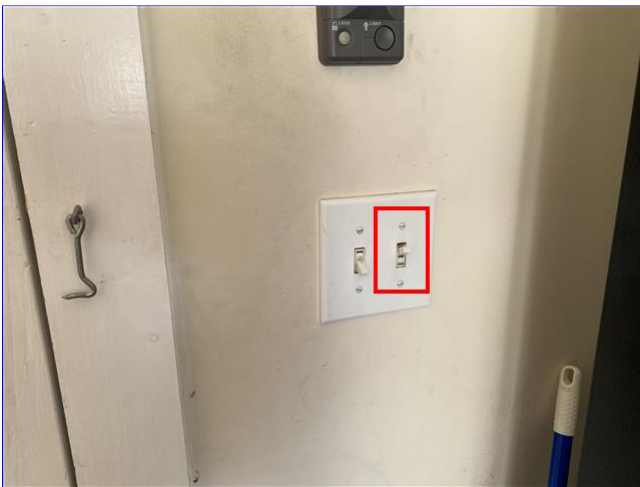
B. Item 5(Picture)

(6) Inspector was unable to determine the use and/or purpose of a light switch located inside the garage.  
(It may be used to control the exterior flood lights)

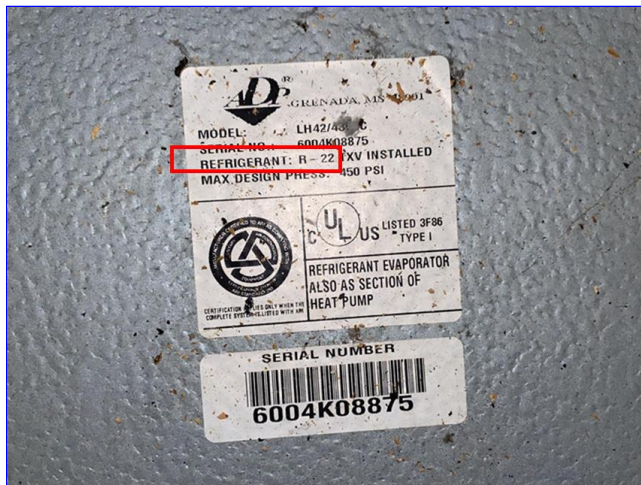
B. Item 1(Picture)

(1) **NOTICE-** The A/C unit was manufactured to only operate on R-22 coolant. R-22 was phased out and is now illegal to sell in the U.S. as of January 1, 2020. The industry has now switched to R410a (Puron). Some units can be retrofitted to R410a and do not require complete replacement of the cooling equipment. Inspector recommends further evaluation by a licensed HVAC technician to confirm if the current system can be converted or if complete replacement is required. (This is not considered a deficiency and is purely FYI)

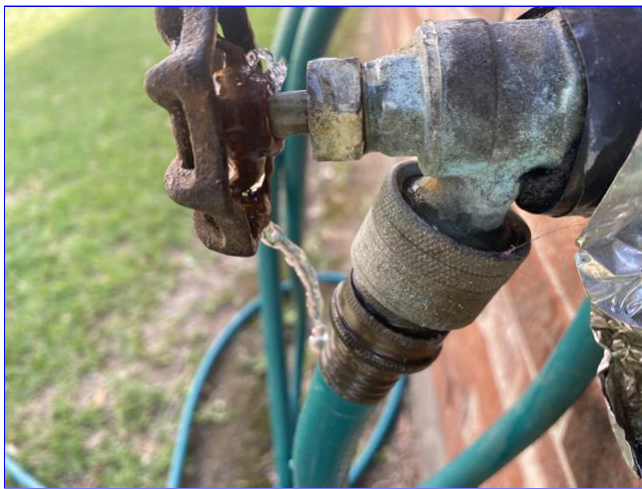
A. Item 1(Picture)

(2) Water was leaking from the front left hose bib valve, when the water was turned on.

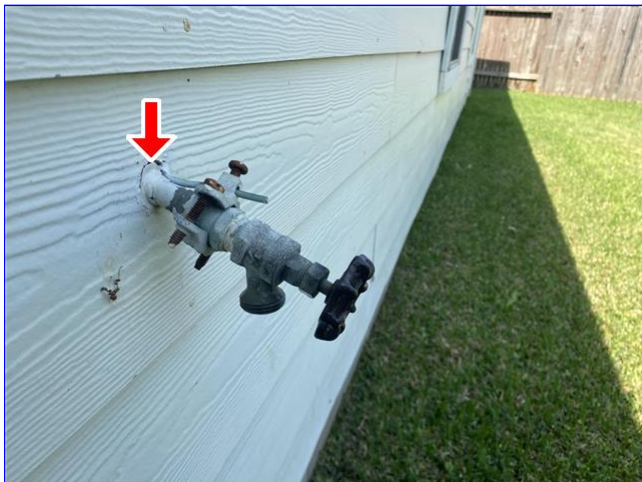
A. Item 2(Picture)

(4) Water supply pipe at the rear hose bib was loose where it passed through the wall.

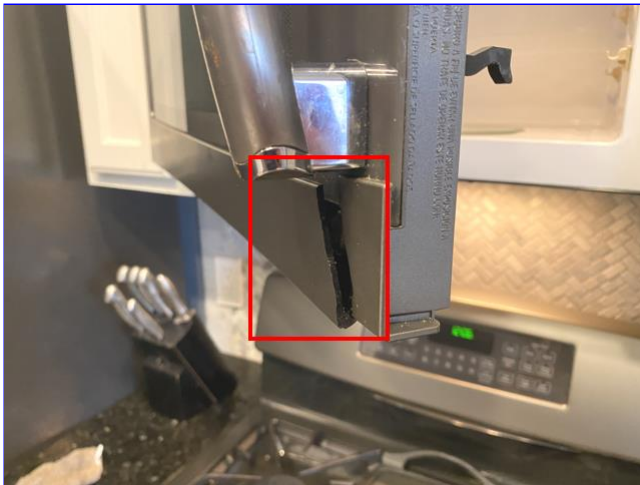
E. Item 1(Picture)

Damage observed at microwave door.

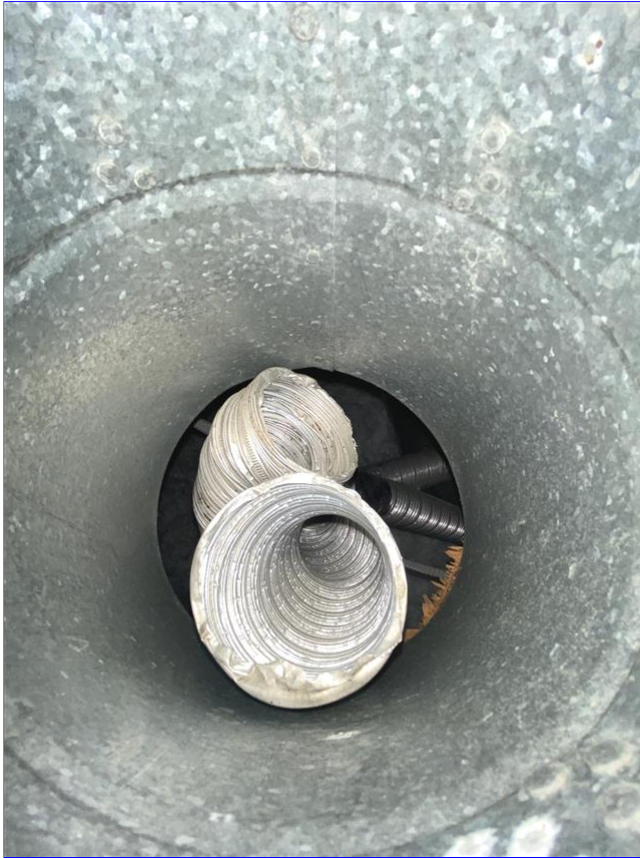
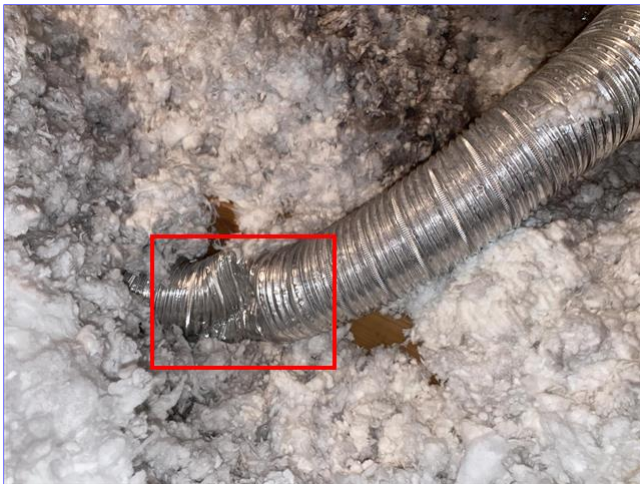
(2) One or more bathroom exhaust vent is crushed or damaged inside the attic. This can restrict ventilation and create moist conditions inside the bathroom. Recommend repair by a qualified contractor.

F. Item 2(Picture) Laundry room vent

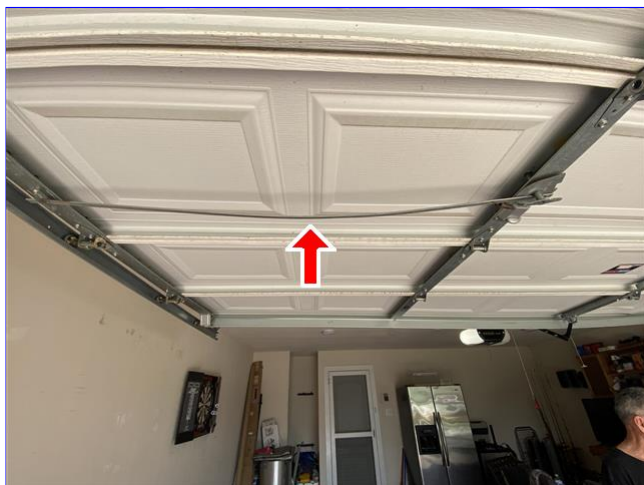
G. Item 1(Picture)

entering and exiting in the event of an emergency and to prevent damaging the door. Disabling can be achieved by installing a nut and bolt in the latch.

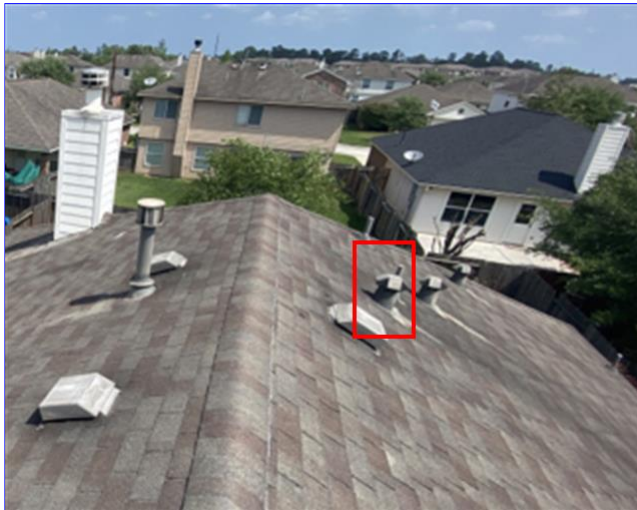
H. Item 2(Picture) Not approved
