8610 Cedar Walk Dr
Tomball, TX 77375

PROPERTY INSPECTION REPORT FORM

Denise Lautenschleger <i>Name of Client</i>	05/15/2024 <i>Date of Inspection</i>
8610 Cedar Walk Dr, Tomball, TX 77375 <i>Address of Inspected Property</i>	
Sean Salinas <i>Name of Inspector</i>	21192 <i>TREC License #</i>
Chris Stull <i>Name of Sponsor (if applicable)</i>	20945 <i>TREC License #</i>

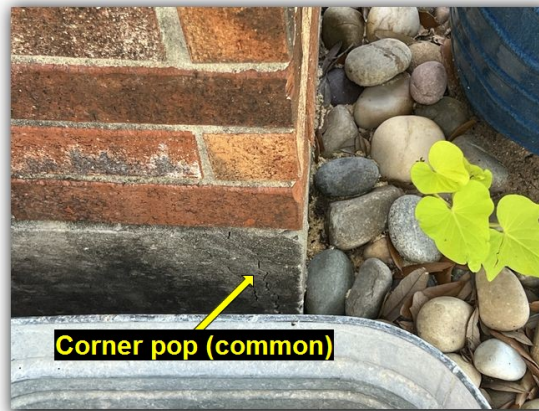
Spalling (i.e., corner pops) at one or more corner(s). Corner spalling is common to slab foundations and does not affect the structural integrity of the foundation.

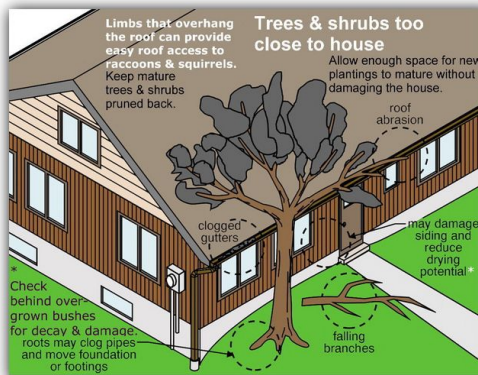
Recommend vegetation be cut back away from exterior of home to prevent damage.

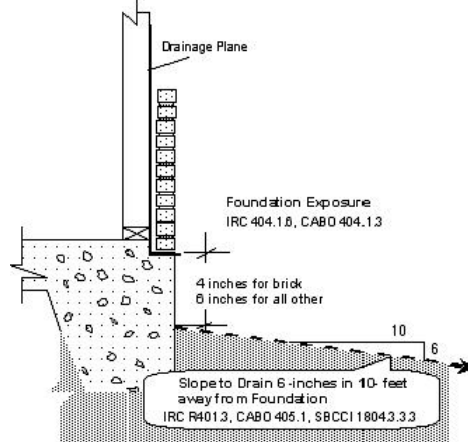
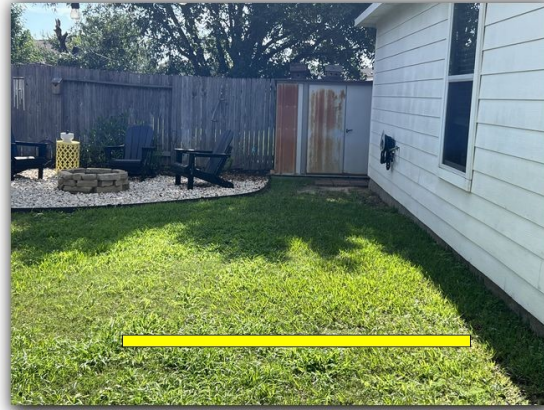
Observed the grading did not slope away from the home in one or more areas around the exterior. Current standards call for the grading to slope away from the home at least 6 inches per 10 feet. This is to prevent water from pooling close to the foundation which can cause damage. Remedies may include adding rain gutters, French drains or re-grading around the home.

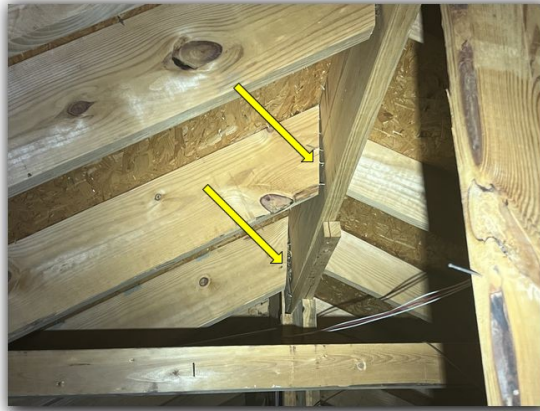
Observed some gaps between rafters and the ridge board which is an indication of structural movement but is sometimes due to poor rafter cuts during construction. In my professional opinion not in need of repair.

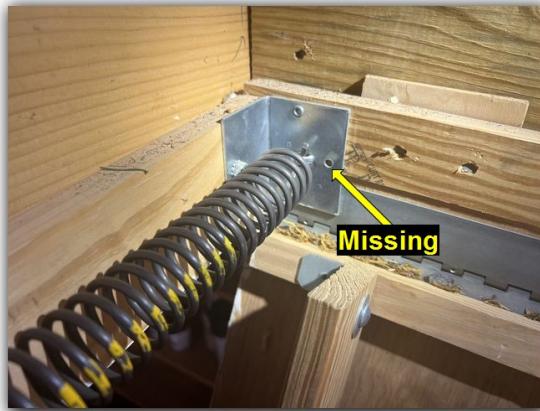
Observed one or more nails/screws missing from attic access ladder frame. Recommend installing a 16d nail or 1/4 inch diameter lag screw to properly secure stairway frame to ceiling.

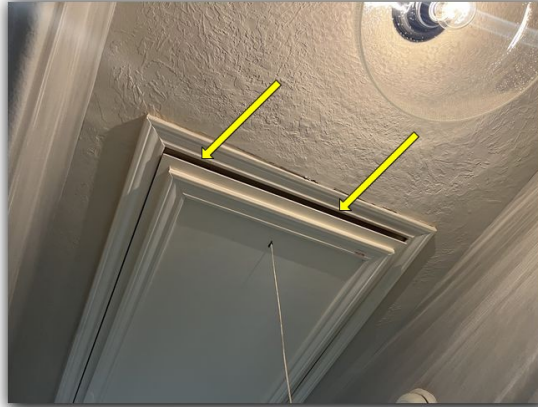
The attic ladder in the hallway does not close completely. This can allow hot attic air to escape into the living space (or vice versa). Recommend having a qualified contractor adjust as needed.

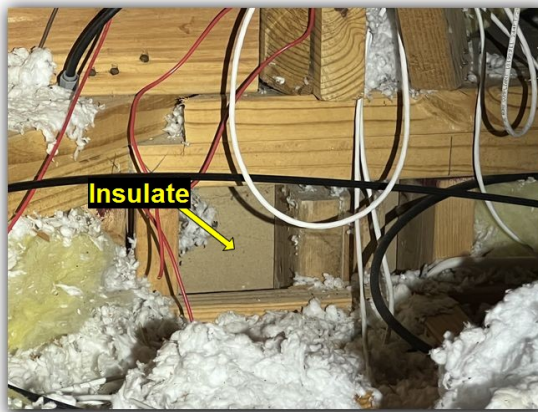
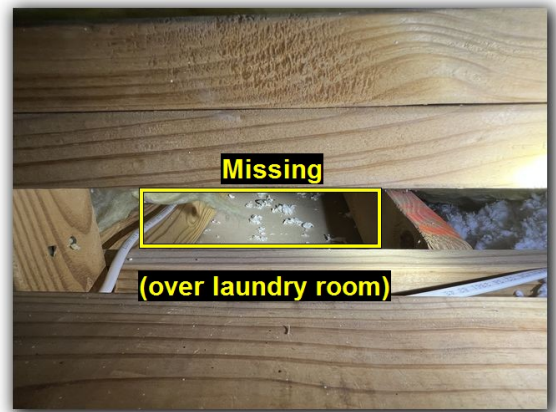
Observed insulation removed/missing in one or more areas of the attic. Recommend adding or reattaching insulation for optimum energy efficiency.

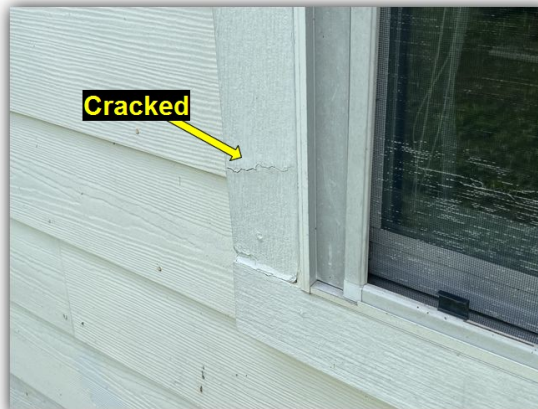
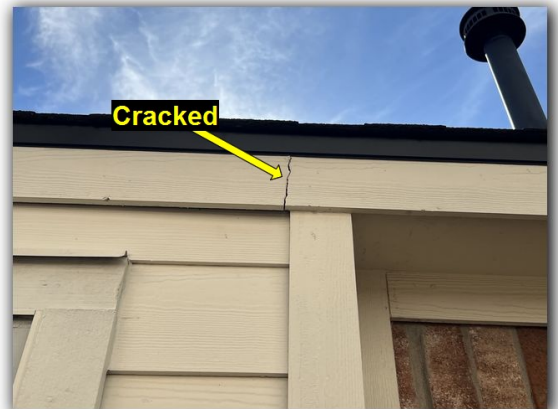
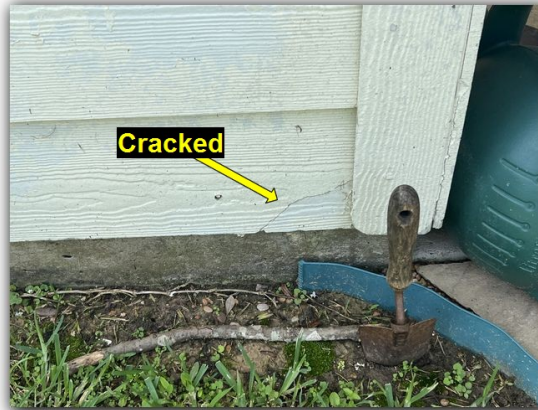
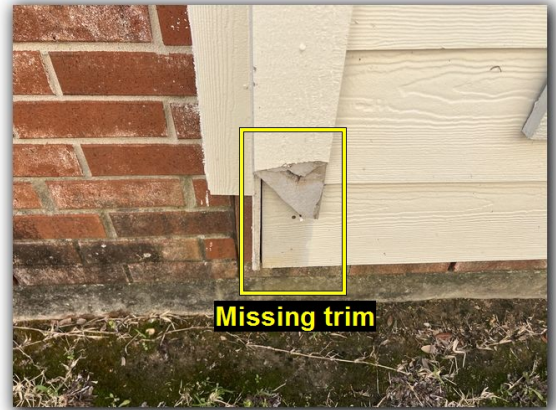
Damaged siding, trim & fascia board observed at one or more locations.

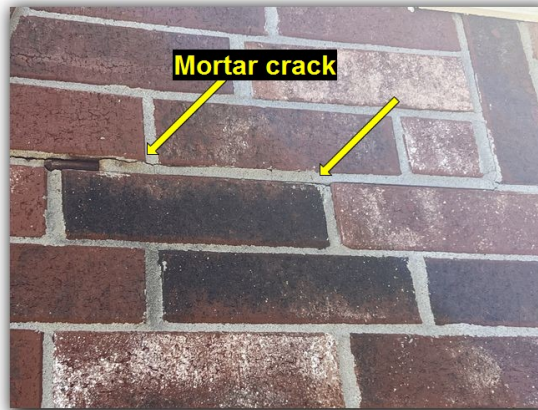
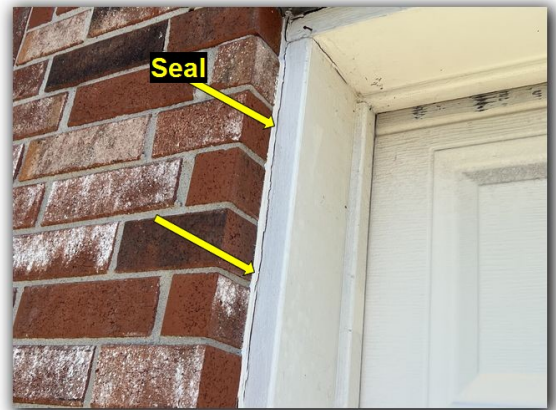
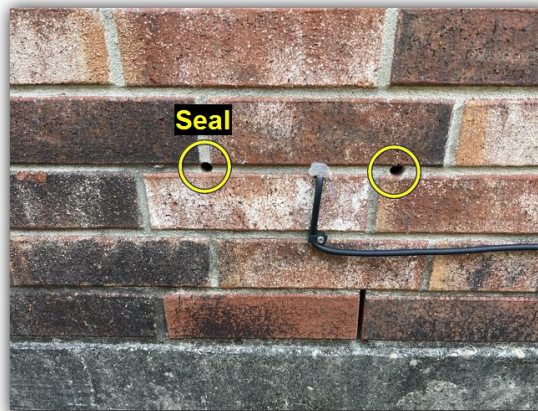
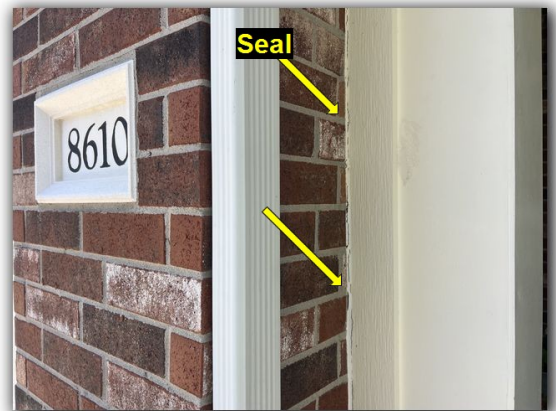
Observed cracks in the brick and/or mortar around the exterior in one or more areas. Recommend sealing/caulking around all holes, gaps, cracks and exterior siding penetrations to prevent water & pest entry.

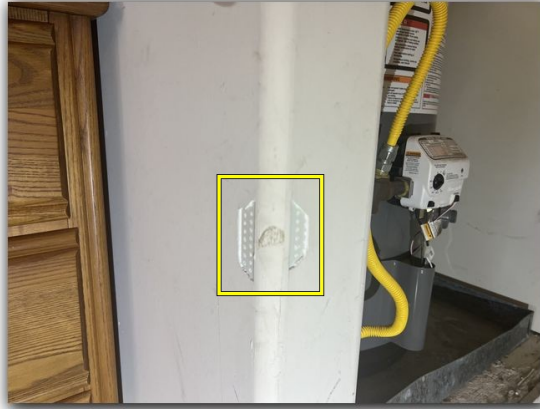
Observed some typical damage on drywall in the garage.

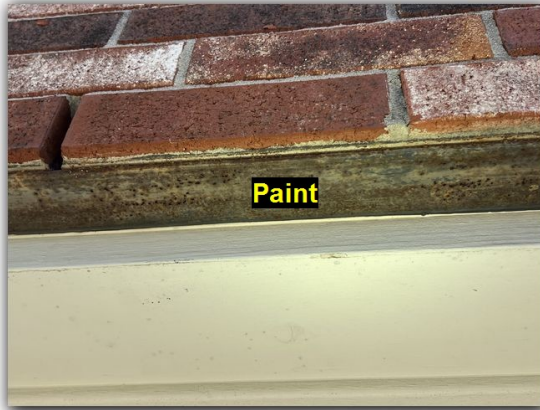
Recommend painting door / window lintels with rust resistant paint to prevent rust & preserve the integrity of the lintels.

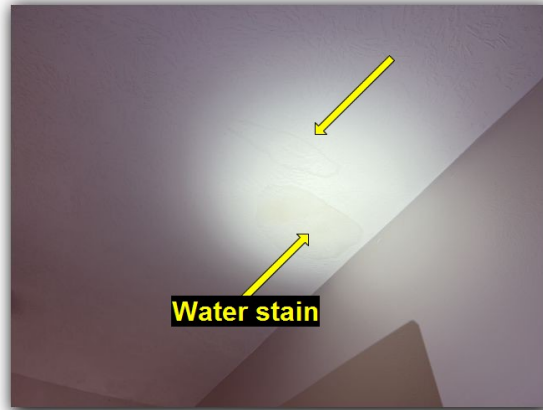
Observed water stains on the ceiling in the living room over the fireplace. Moisture readings were low at time of inspection which usually indicates the stains are from a previous leak, but I could not be certain. Recommend asking the seller about a previous leak that may have been repaired or having further evaluation by a contractor.

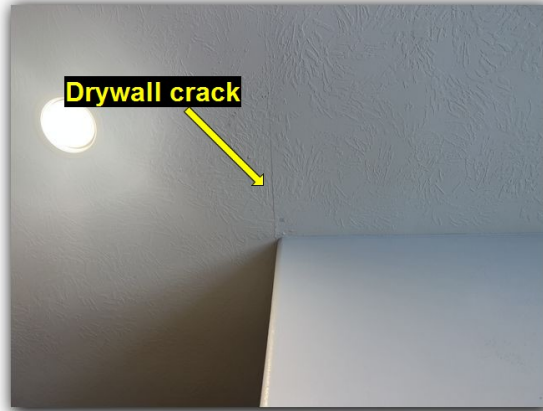
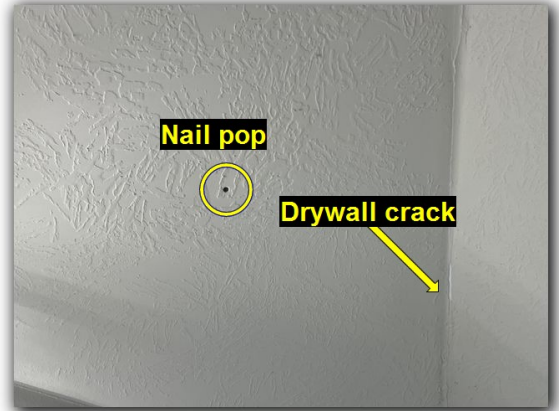
Observed cracks, nail pops and other cosmetic issues in one or more areas.

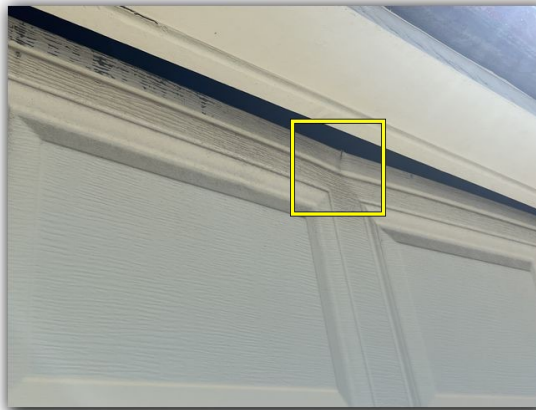
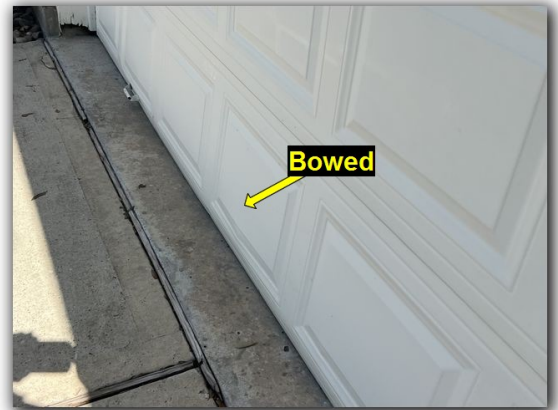
Damage / dents were observed on the garage door.

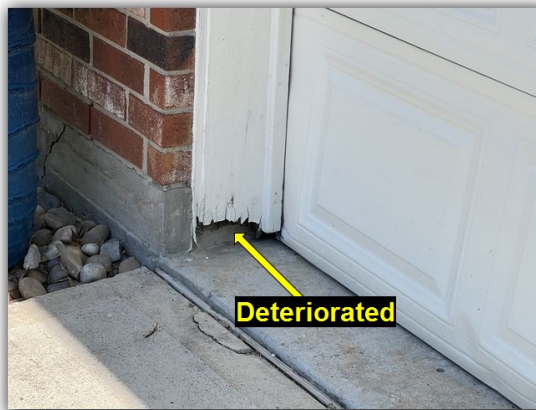
Deterioration observed at the garage door frame.

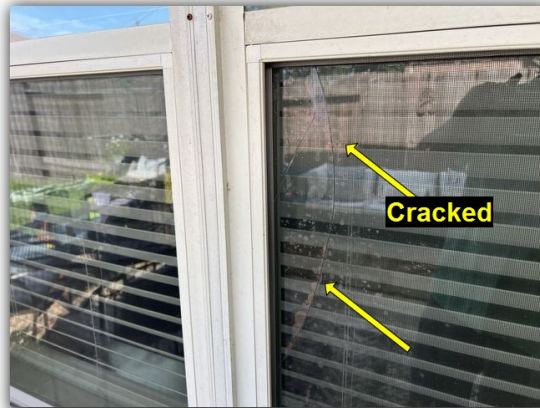
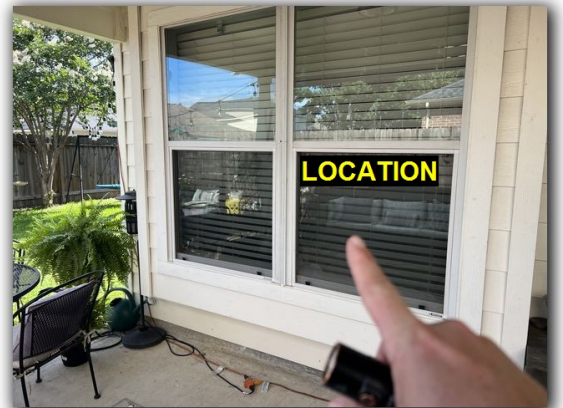
Cracked window observed at the primary bedroom. Recommend having a qualified company replace the broken window.

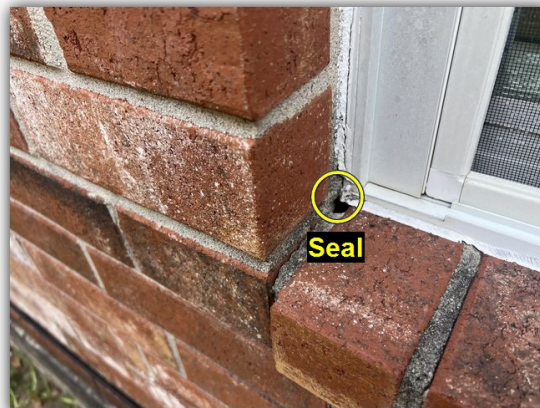
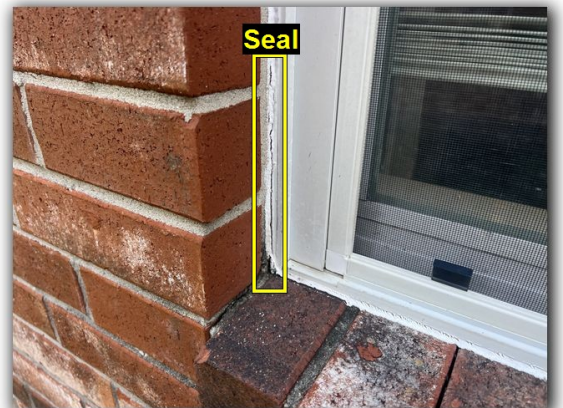
One or more windows needs exterior caulking.

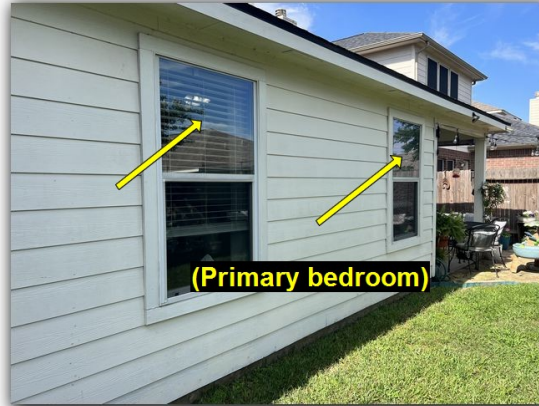
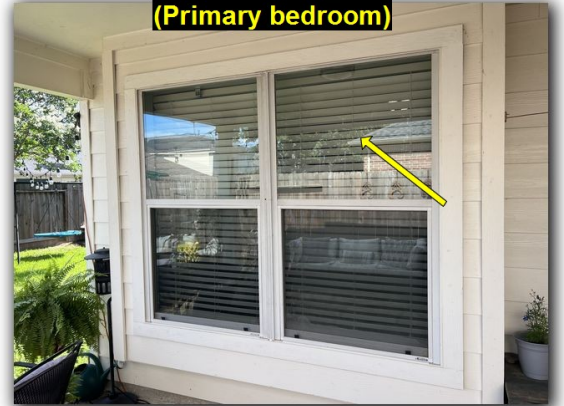
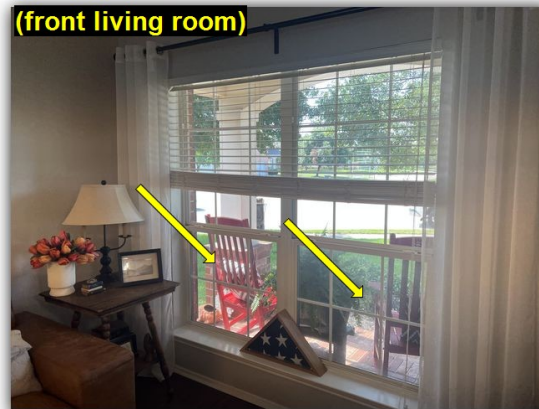
The thermal seal appears to be compromised on five or more windows, but I could not be certain. Recommend the windows be further evaluated by a window professional.

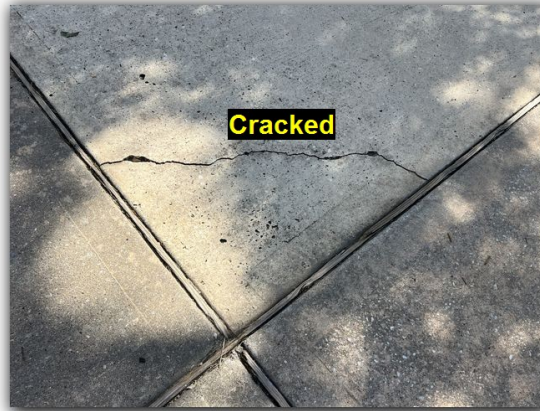
Cracks in walkways, driveway and/or garage concrete observed, typical.

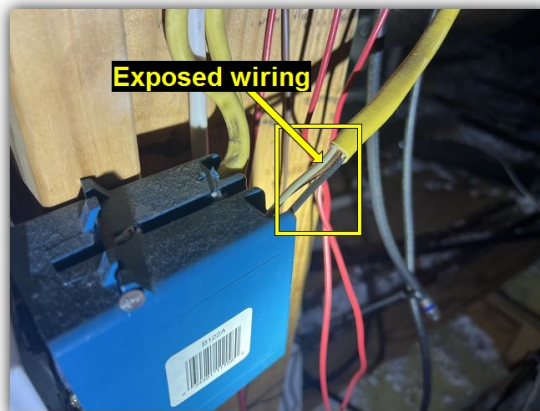
Observed exposed wiring at the outlet in the attic near the furnace. Recommend having a licensed electrician repair as needed to prevent a safety hazard.

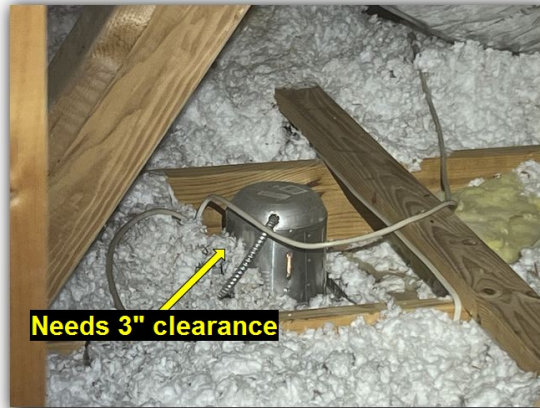
Did not observe an IC (insulation contact) rating for the can lights in the attic. Most can lights require a 3 inch clearance from all combustibles, including insulation. Recommend moving insulation away from the can lights at least 3 inches to reduce the risk of fire or using LED bulbs which do not get as hot as incandescent bulbs.

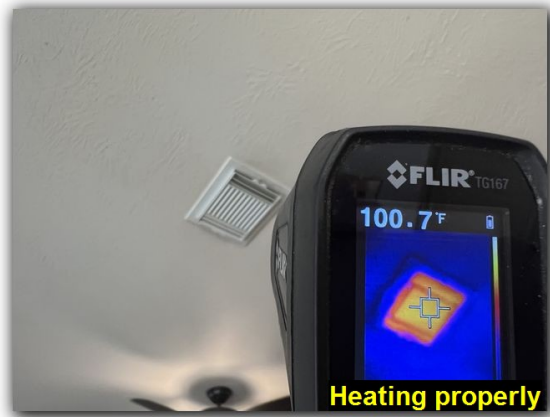
A thermal image of the air vents show the furnace(s) heating properly at time of inspection.

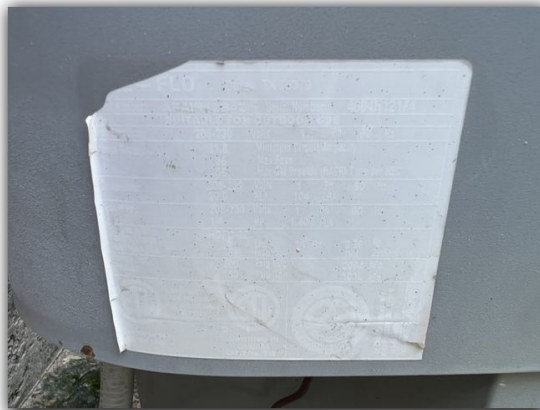
CONDENSING UNIT(S): AIR FLO, data plate faded appears to be 2004 unit

Based on the age of the AC unit(s) and the average life expectancy of 15 years, I recommend the HVAC system be evaluated and serviced by a professional HVAC company.

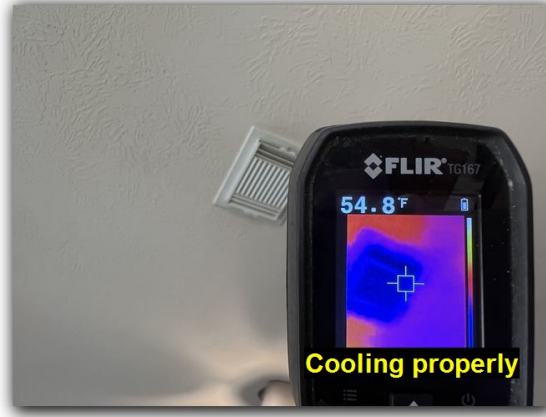
A thermal image of the air vents show the air conditioning unit(s) cooling properly at time of inspection.

TEMPERATURE DIFFERENTIAL: 18 degrees (73, 55) **GOOD**

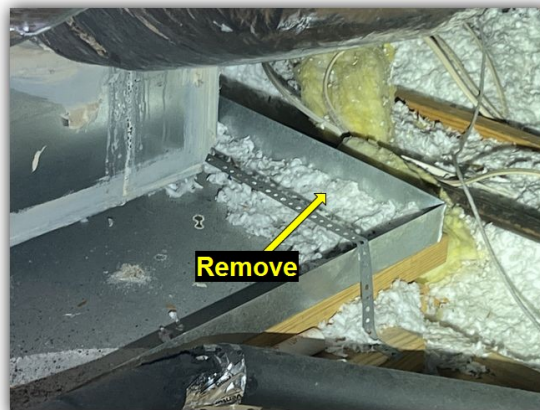
Recommend removing all insulation from the secondary drain pan to prevent clogging of the drain line.

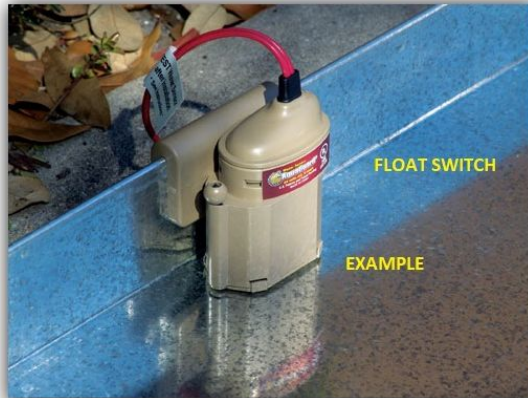
Did not observe float switches installed for the A.C. drain pan(s). Recommend adding a float switch to the secondary drain pan(s) to help prevent accidental flooding of the attic / drywall damage during a leak.

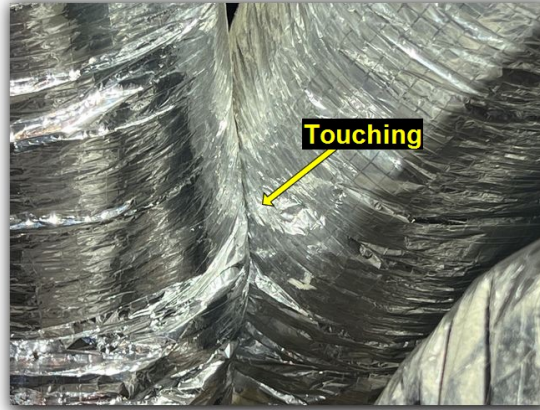
Observed ducts touching in one or more areas in the attic. This can allow condensation to form between the ducts which can drip onto the attic floor or ceilings below. Recommend separating the ducts or placing a piece of insulation between the ducts to prevent condensation from forming.

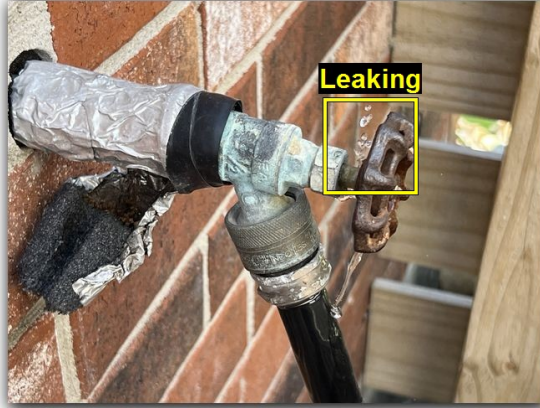
Leaky control handle observed at the left front hose bib. Recommend having a licensed plumber repair as needed.

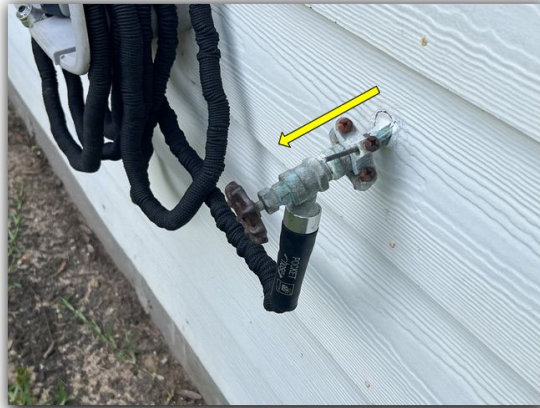
The hose bib at the rear side of the house was slightly bent / sagging.

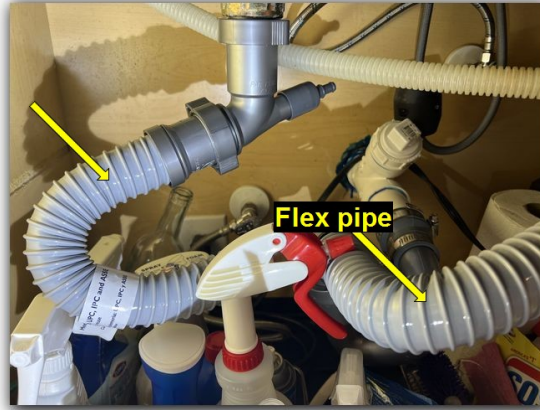
Observed flexible/corrugated piping being used under one or more sinks. Although I have never observed a problem with this setup, flexible or corrugated piping is not an approved material for drains.

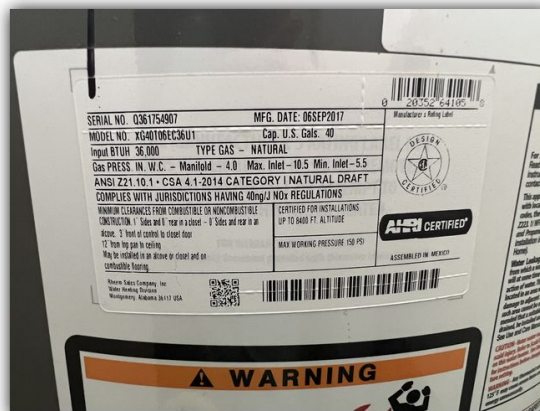
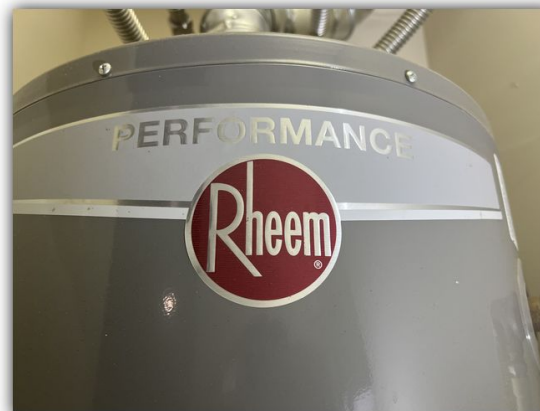
WATER HEATING UNIT(S): RHEEM (2017)

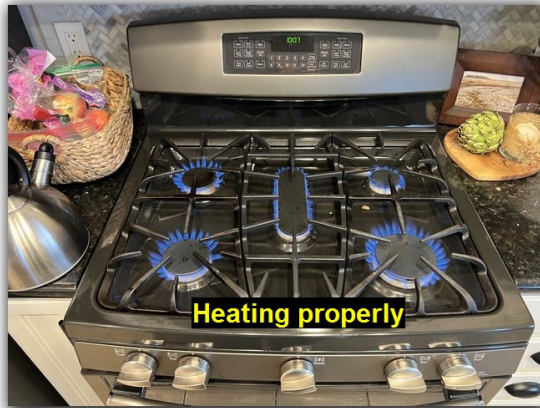
No significant deficiencies observed.

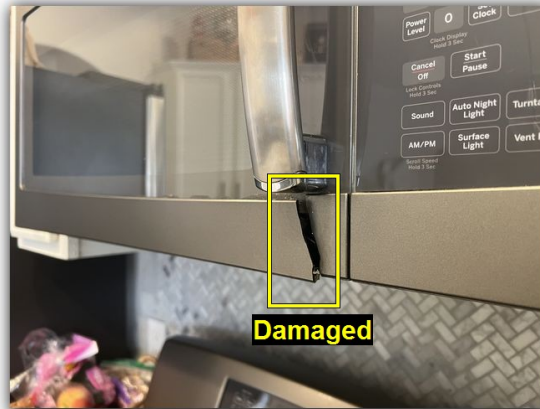
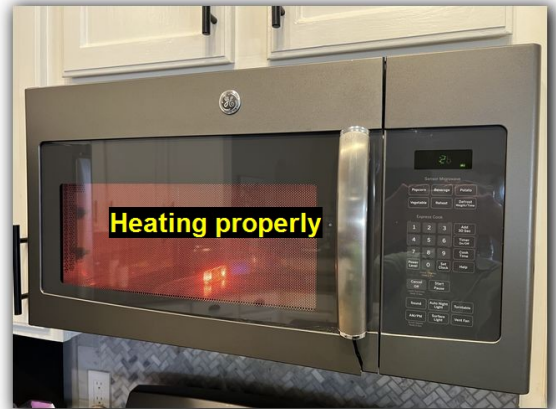
Observed some damage on the exterior of the microwave.

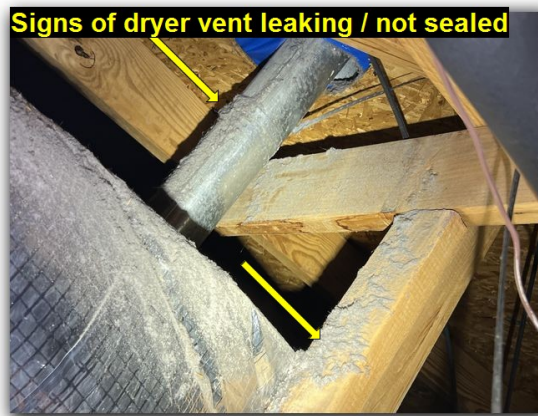
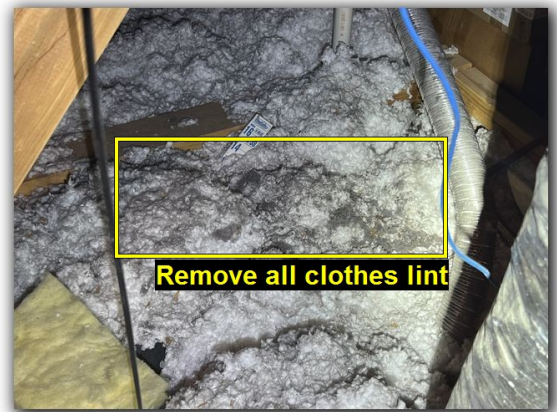
The dryer vent was clogged and not sealed to the roof exit. As a result clothes lint is leaking into the attic space. Recommend unclogging & sealing the dryer vent to the roof exit. Also recommend removing all clothes lint from the attic space.

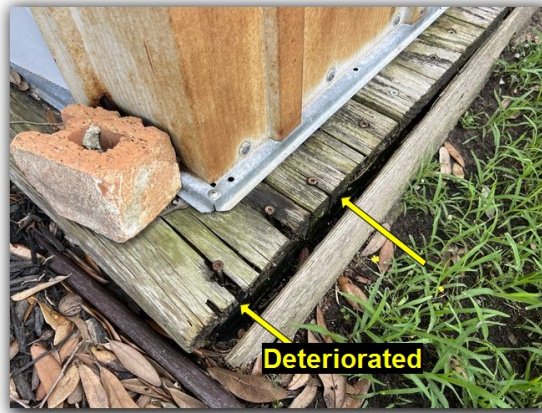
Typical rust observed on the outbuilding / shed siding. Deteriorated wood observed at the decking that supports the outbuilding.
