Subject: Post-Repair Foundation Repair Completion Letter
Slab Foundation
4614 Ingersoll St., Houston, TX 77027

LIMITED REPAIR PLAN

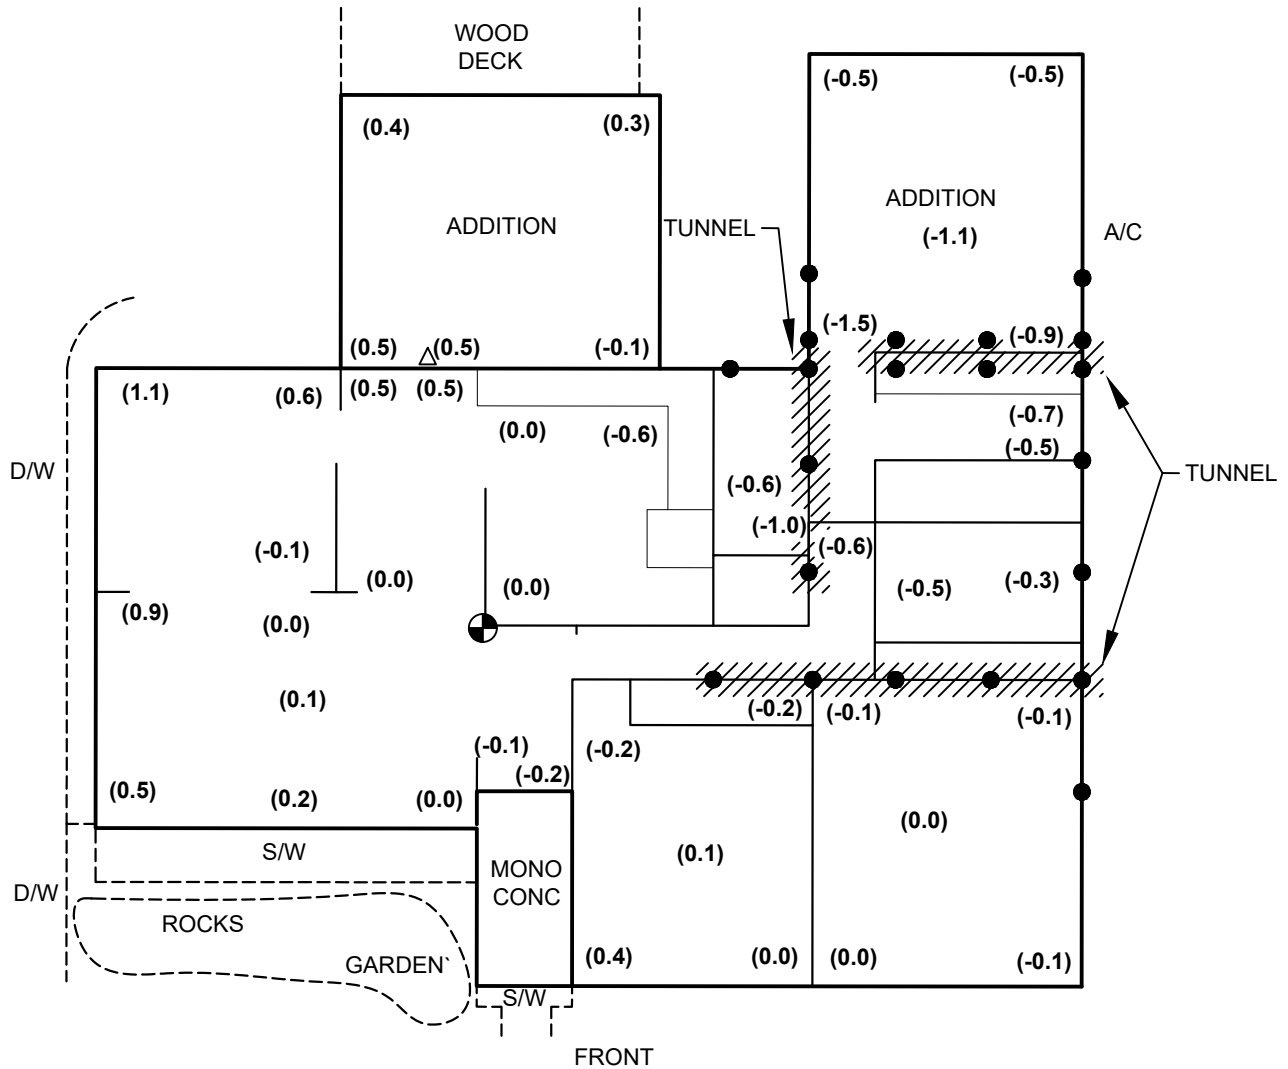
Based on our observations and review of the limited repair plan provided by the contractor, the structure has experienced general foundation movement over the life of the structure, resulting in the right of the structure being low with respect to the rest of the structure. List patterns of damage. We observed drywall cracks.

- Installed 21 total pilings (11 exterior, 10 interior via tunnel).
- Tunneled 40 LF.

- INSTALLED 21 TOTAL PILINGS (11 EXTERIOR, 10 INTERIOR VIA TUNNEL).
- TUNNELED 40 LF.
