Inspection Report

Property Address:
5920 Petty St
Unit C
Houston TX 77007

PROPERTY INSPECTION REPORT FORM

Mr. Ty Renfrow	22/04/13
<i>Name of Client</i>	<i>Date of Inspection</i>
5920 Petty St, Unit C, Houston, TX 77007	
<i>Address of Inspected Property</i>	
C.e.Schultz	Trec# 20824
<i>Name of Inspector</i>	<i>TREC License #</i>
<i>Name of Sponsor (if applicable)</i>	<i>TREC License #</i>

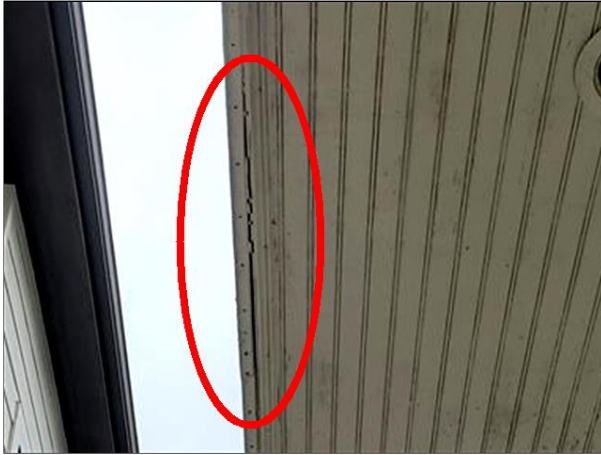
Observed an upper stucco wall that did not have an open water relief/drainage assembly, which appeared to be trapping water along the bottom of the wall (as opposed to having an open water relief, where water can be discharged). The trapped water was causing minor separation at the base of the wall. Recommend having a qualified professional clean the stucco water reliefs to prevent water from diverting into the structure and causing damage.

Location: The only location with visible damage was above the front balcony, however; the front stucco wall systems water relief channels were all clogged

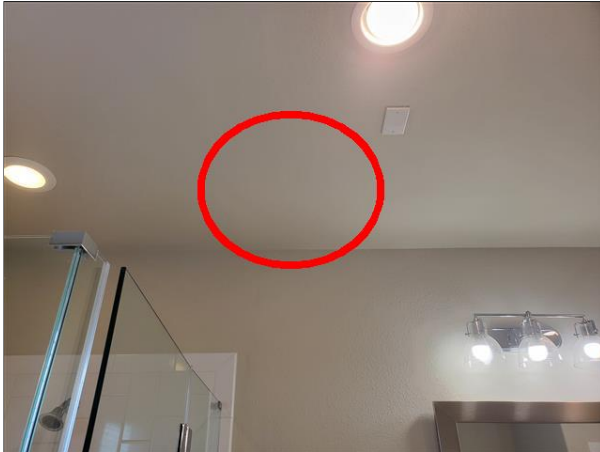
Observed water staining on the master bath ceiling. The staining was painted over, making it difficult to detect. The source of the water damage was not confirmed, but it was likely related to a malfunction/overflow of the HVAC system located in the attic, directly above the water stain. It is recommended that the seller be asked about the defect to help determine possible causes.

NOTE: The ceiling was probed with a moisture meter and scanned with a thermal imager and there were no elevated moisture levels detected. However, negative readings do not guarantee that the area will not leak in the future, it only relays that the material was at the same relative moisture level. An active leak would saturate the material and when probed, the wetted areas would be at a higher moisture level than the non-wetted areas.

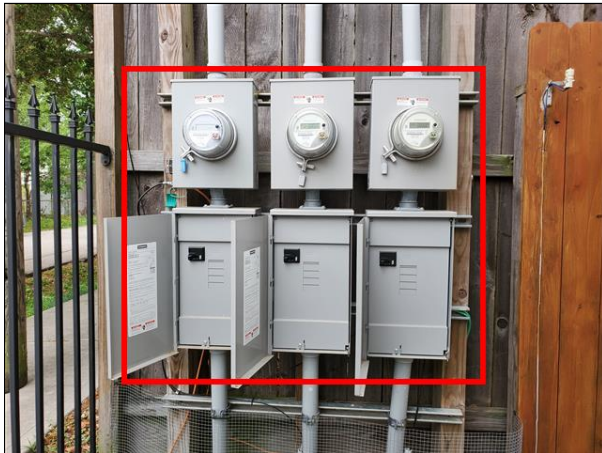
The electrical meter and main panel were located at the front of the development, in a three-panel cluster. None of the panels were labeled, which prevented identifying and inspecting the panels for the home. To help ensure that there are no wiring or connection issues inside the panel, it is recommended that the correct panel be identified, clearly marked, and inspected by a qualified electrician.

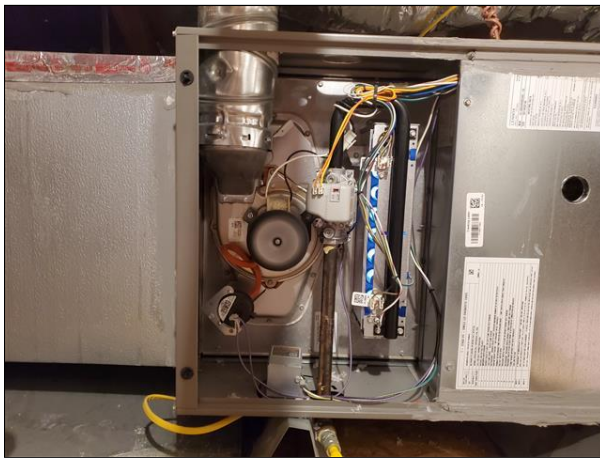
There were no significant defects noted with the function of the home's gas furnace at the time of inspection.

Furnace in operation

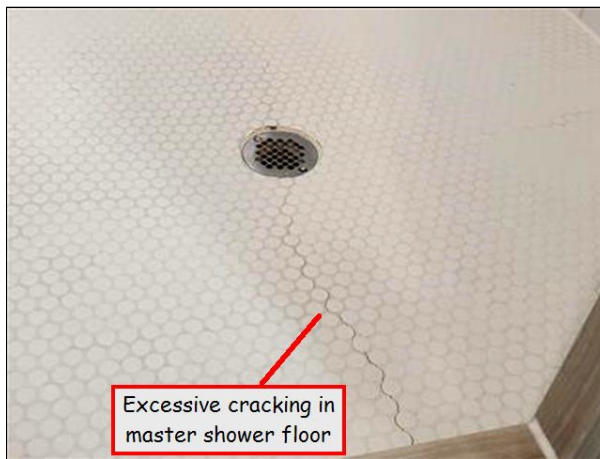
Location: Master bath shower

The master bath shower floor had a moderate size crack that spanned the length of the floor. It is strongly recommended that the cracked shower floor be repaired in a timely manner to prevent water from escaping the pan flashing system and damaging the structure.

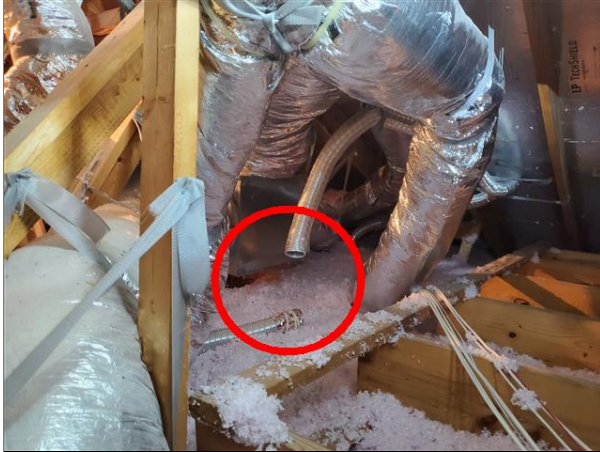
One of the bathroom exhaust vents was disconnected in the attic. Bathroom exhaust fans collect large amounts of moisture over time, which needs to be deposited to the exterior of the home to prevent damage to building components and creating an environment conducive to organic growth.

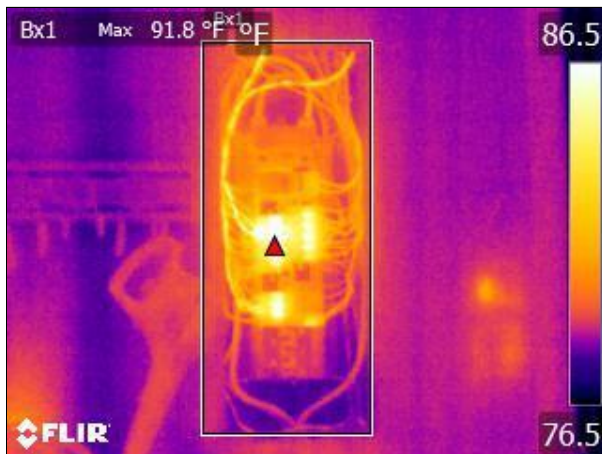
Thermal image (example) taken of the home's subpanel. No significant thermal anomalies were observed
