Concerning: 13600 Breton Ridge Street unit 31, Houston, TX 77070

By: Murray Campbell TREC #22455 / BPG Inspection, LLC 11/18/2020

SECTION I. KEY FINDINGS

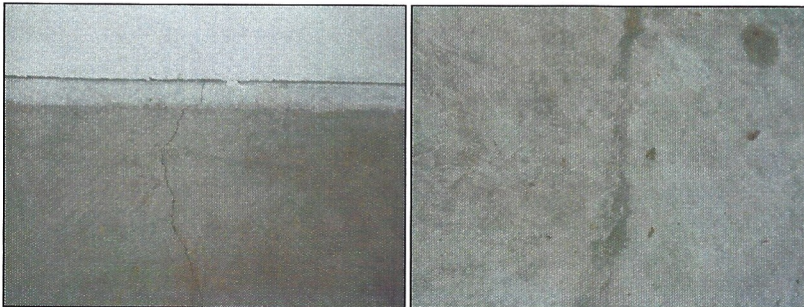
Cracks were observed in the parging layer on the garage side(s) of the home. These cracks appear to be typical cracks with no visible displacement. Seal and repair to prevent further flaking and deterioration. (Parging is a surface coat of cement which will not only improve the foundation appearance but will also help keep out moisture and prevent further cracking).

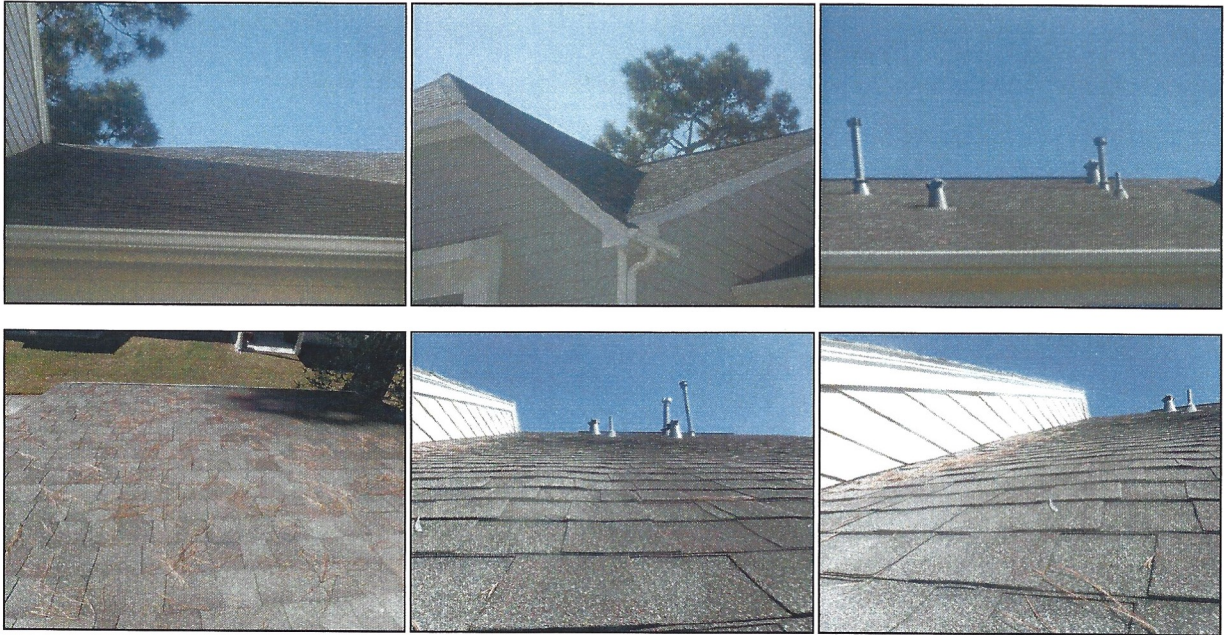
The roof covering appeared in fair condition. No leaks were active at time of inspection. Shingles appeared to be properly fastened.

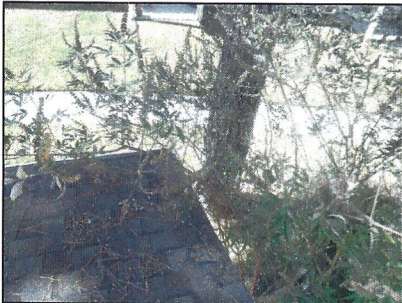
Tree limbs that are in contact with roof or hanging near roof should be trimmed back 3-5' to prevent any damage to the roof covering.

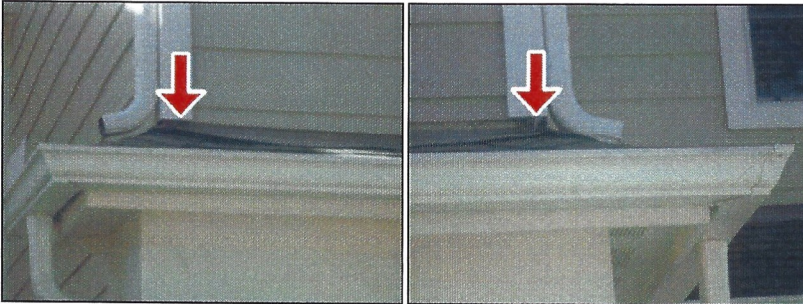
- 1. There were vent, counter or step flashings observed to be raised and improperly sealed. A qualified roofer should reseal and seal these roofing components as needed to prevent any future water penetration.

There were vent, counter or step flashings observed to be raised and improperly sealed. A qualified roofer should reseal and seal these roofing components as needed to prevent any future water penetration.

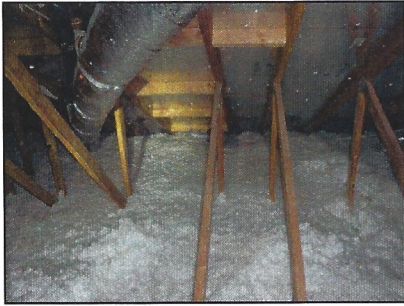
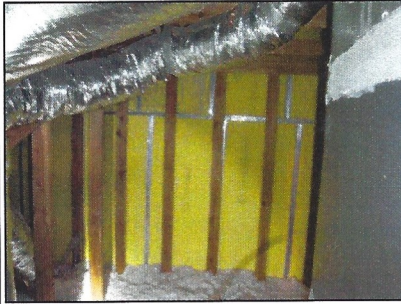
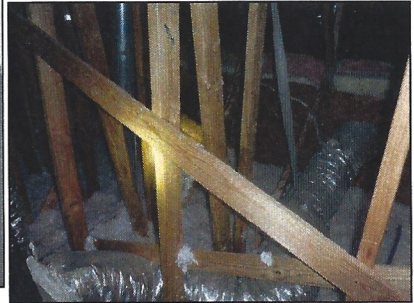
The structure was in good condition. No leaks were active or apparent at time of inspection. Insulation determined to be at acceptable levels/depths. At accessible areas inspected.

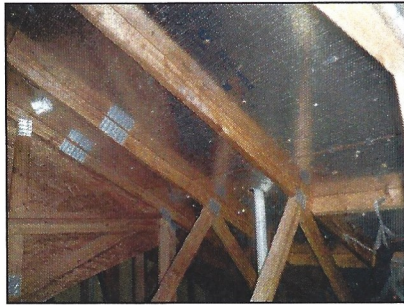
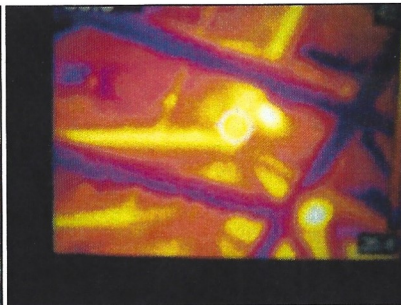
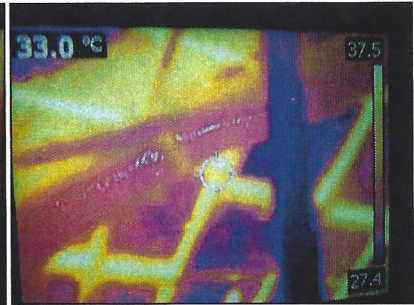
Fire wall in place.

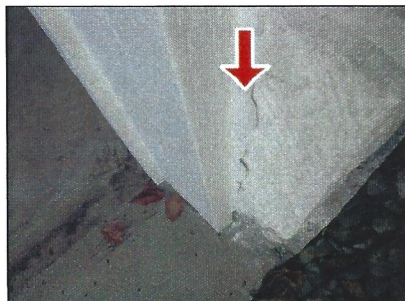
Noted areas of siding trim and edges that have missing or deteriorated caulking. These areas can be a point of water infiltration if not addressed. Noted no evidence at interior sides of home areas with previous water infiltration at time of inspection. Recommend fully and properly sealing all areas affected.

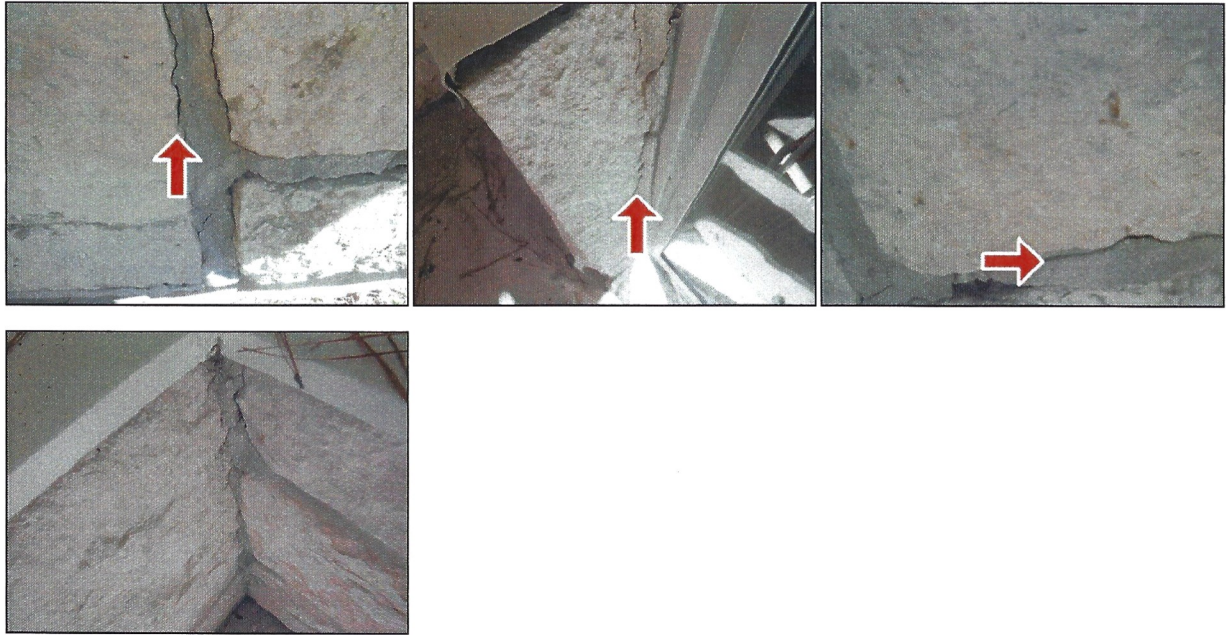
There are joint cracks on the walls in various locations. These cracks appear to be typical settlement/shifting joint cracks with no other visible displacement. Recommend sealing (mortar) crack to prevent moisture incursion and monitor for further settlement/separation

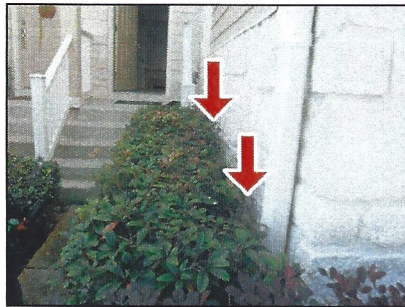
Trim all hedges, ivy and trees away from exterior wall surfaces. Heavy foliage against walls may be conducive to insect, rub or moisture damage. (Limited view of surfaces in these locations)

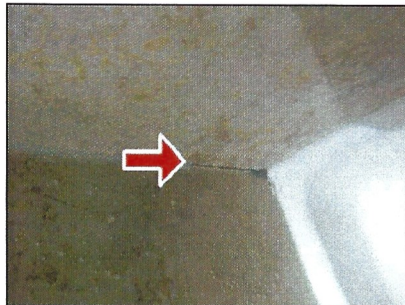
- 2. Seal (grout/caulk) around the tub and shower tile to wall abutment joints in the master bath.

Seal (grout/caulk) around the tub and shower tile to wall abutment joints in the master bath.

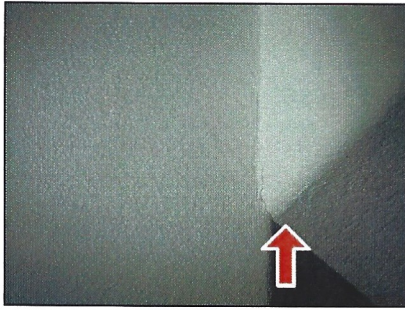
Cracks on ceiling in various areas, consistent with structural settling. Repair as needed.

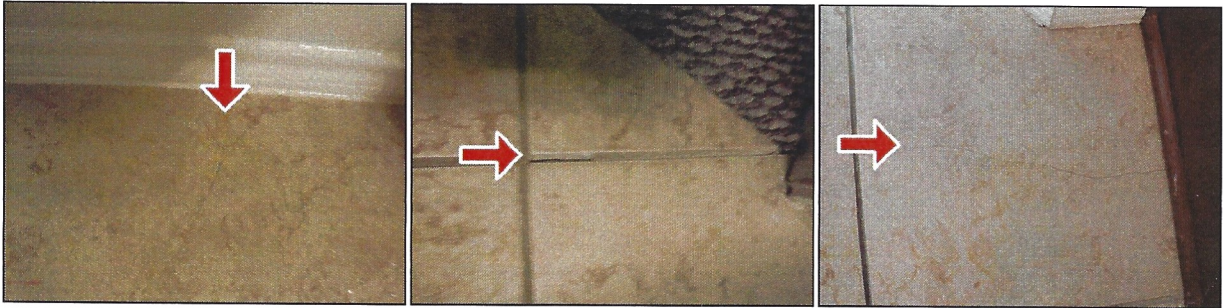
Cracks were observed in the tiles of the kitchen guest bath floor. This is common with foundation settling especially during dry months or drought. See foundation section for any maintenance recommendations.

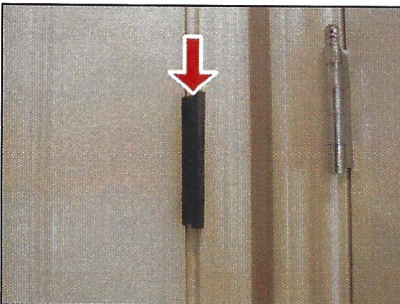
- 3. The occupant door leading from the attached garage into the house is not self closing. I recommend installing/ adjusting self closing hinges on the door leading from the garage to the living space as a safety feature to prevent exhaust gases (car, appliance) from entering the house.
- 4. Door does not close/latch properly into strike plate at the master bedroom, upstairs right rear guest bedroom door(s).

The occupant door leading from the attached garage into the house is not self closing. I recommend installing/adjusting self closing hinges on the door leading from the garage to the living space as a safety feature to prevent exhaust gases (car, appliance) from entering the house.

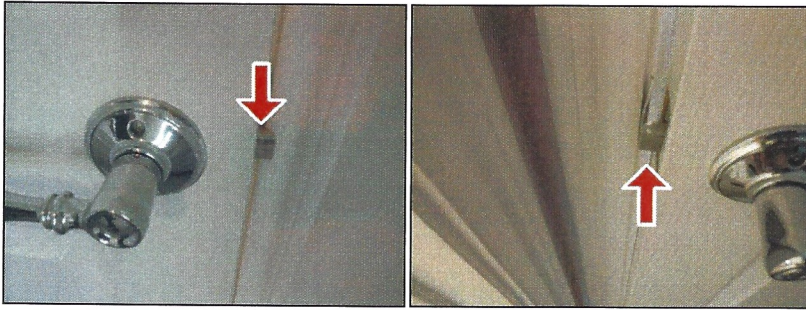
Door does not close/latch properly into strike plate at the master bedroom, upstairs right rear guest bedroom door(s).

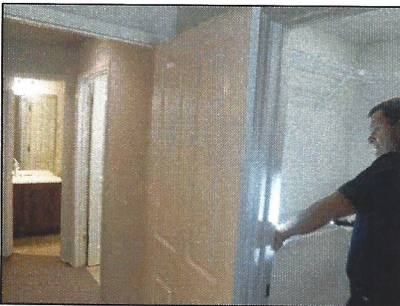
Noted in the master bedroom door is not plumb. Door attempts to close with no assistance and has door wedge currently holding door open. Recommend having door properly re-hung and aligned to operate as designed.
