MECHANICAL INSPECTION

PROPERTY INSPECTION REPORT

Concerning: 10818 Moonlight Dr, Houston TX 77096
(Address or Other Identification of Inspected Property)

By: Daniel Koteles - TREC #21157 08/31/2021 9:00 am
(Name and License Number of Inspector) (Date)

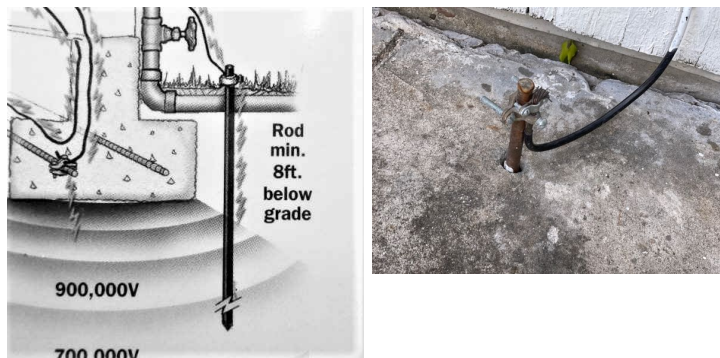
The ground rod was sticking out of the ground a few inches, and, since ground rods are typically 8 feet long and all 8 feet of the rod are required to be in the ground, it is recommended that the ground rod be pounded down flush with the top of the ground. The clamp on the rod should be an acorn clamp is approved for direct burial in the ground.

Obtain Cost Estimate

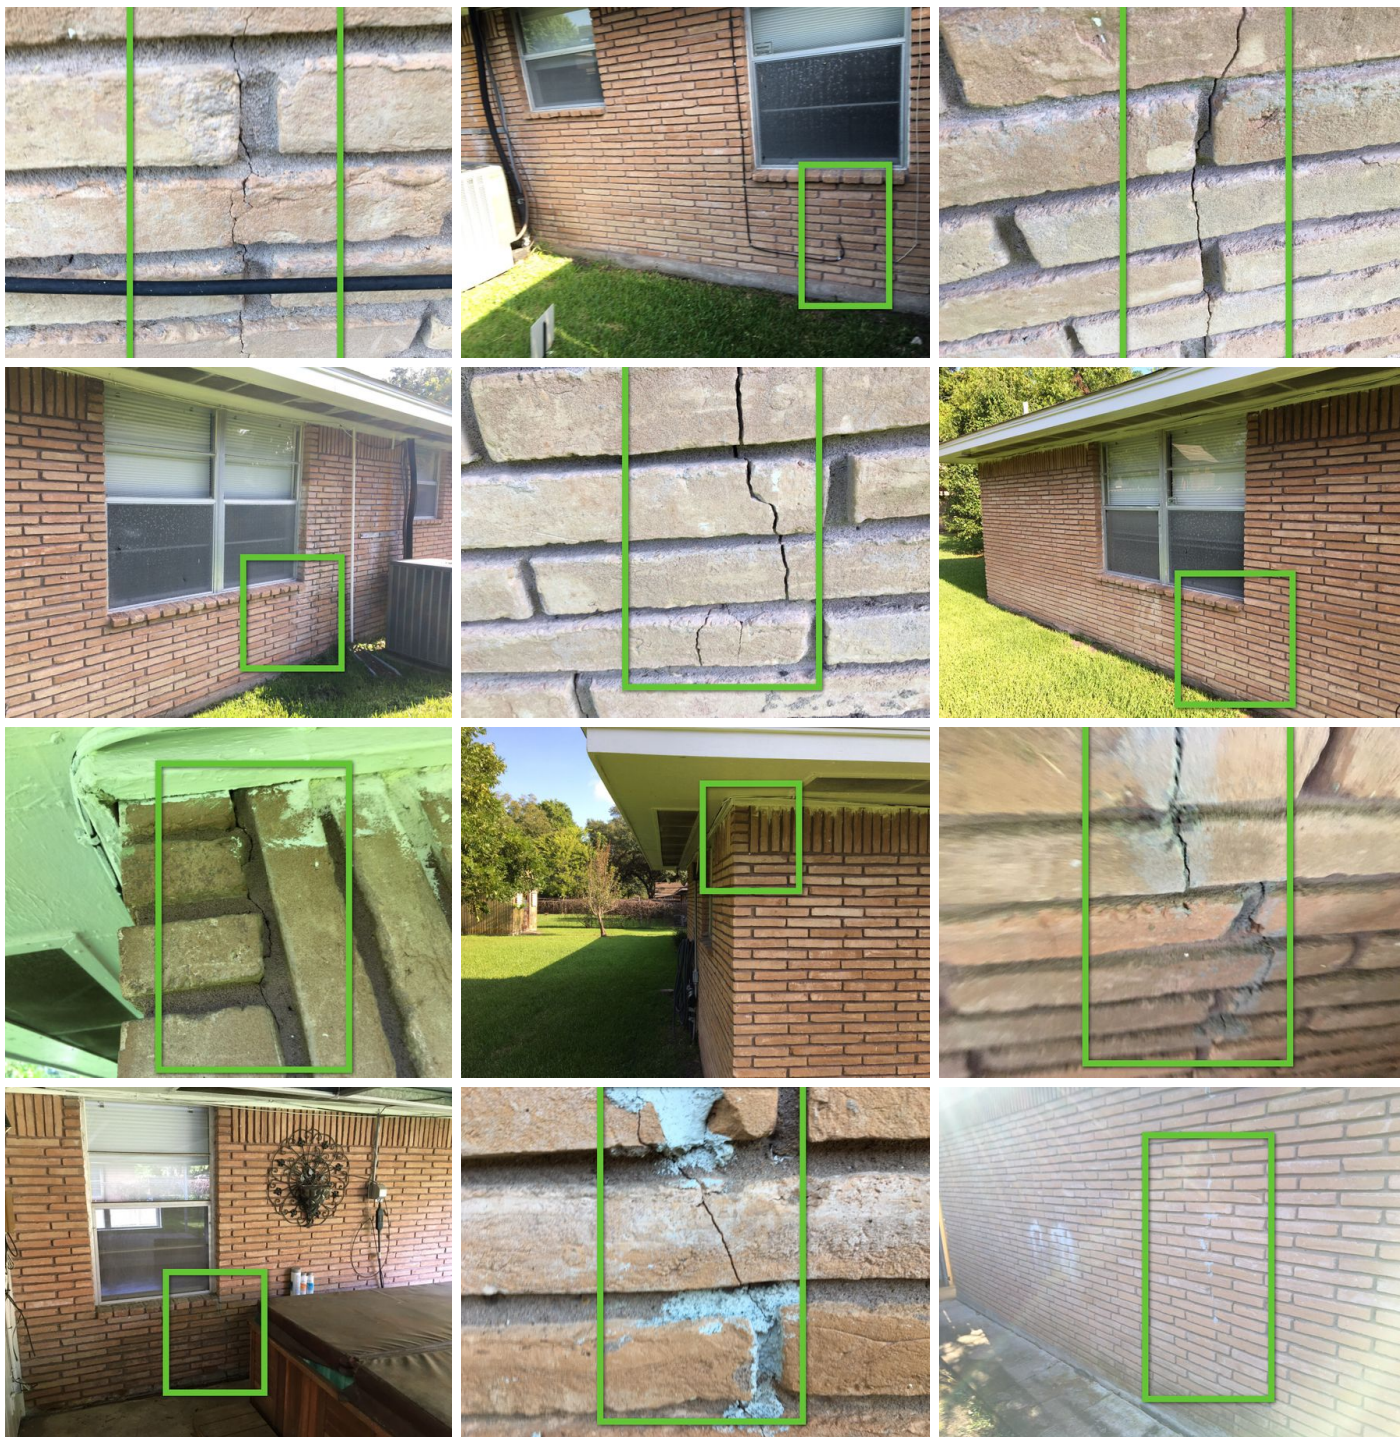
Veneer - Cracks/Patches

Cracks and/or patches were observed in the exterior veneer at the time of the inspection, including at the locations shown in the photos. It is recommended to repair the cracks.

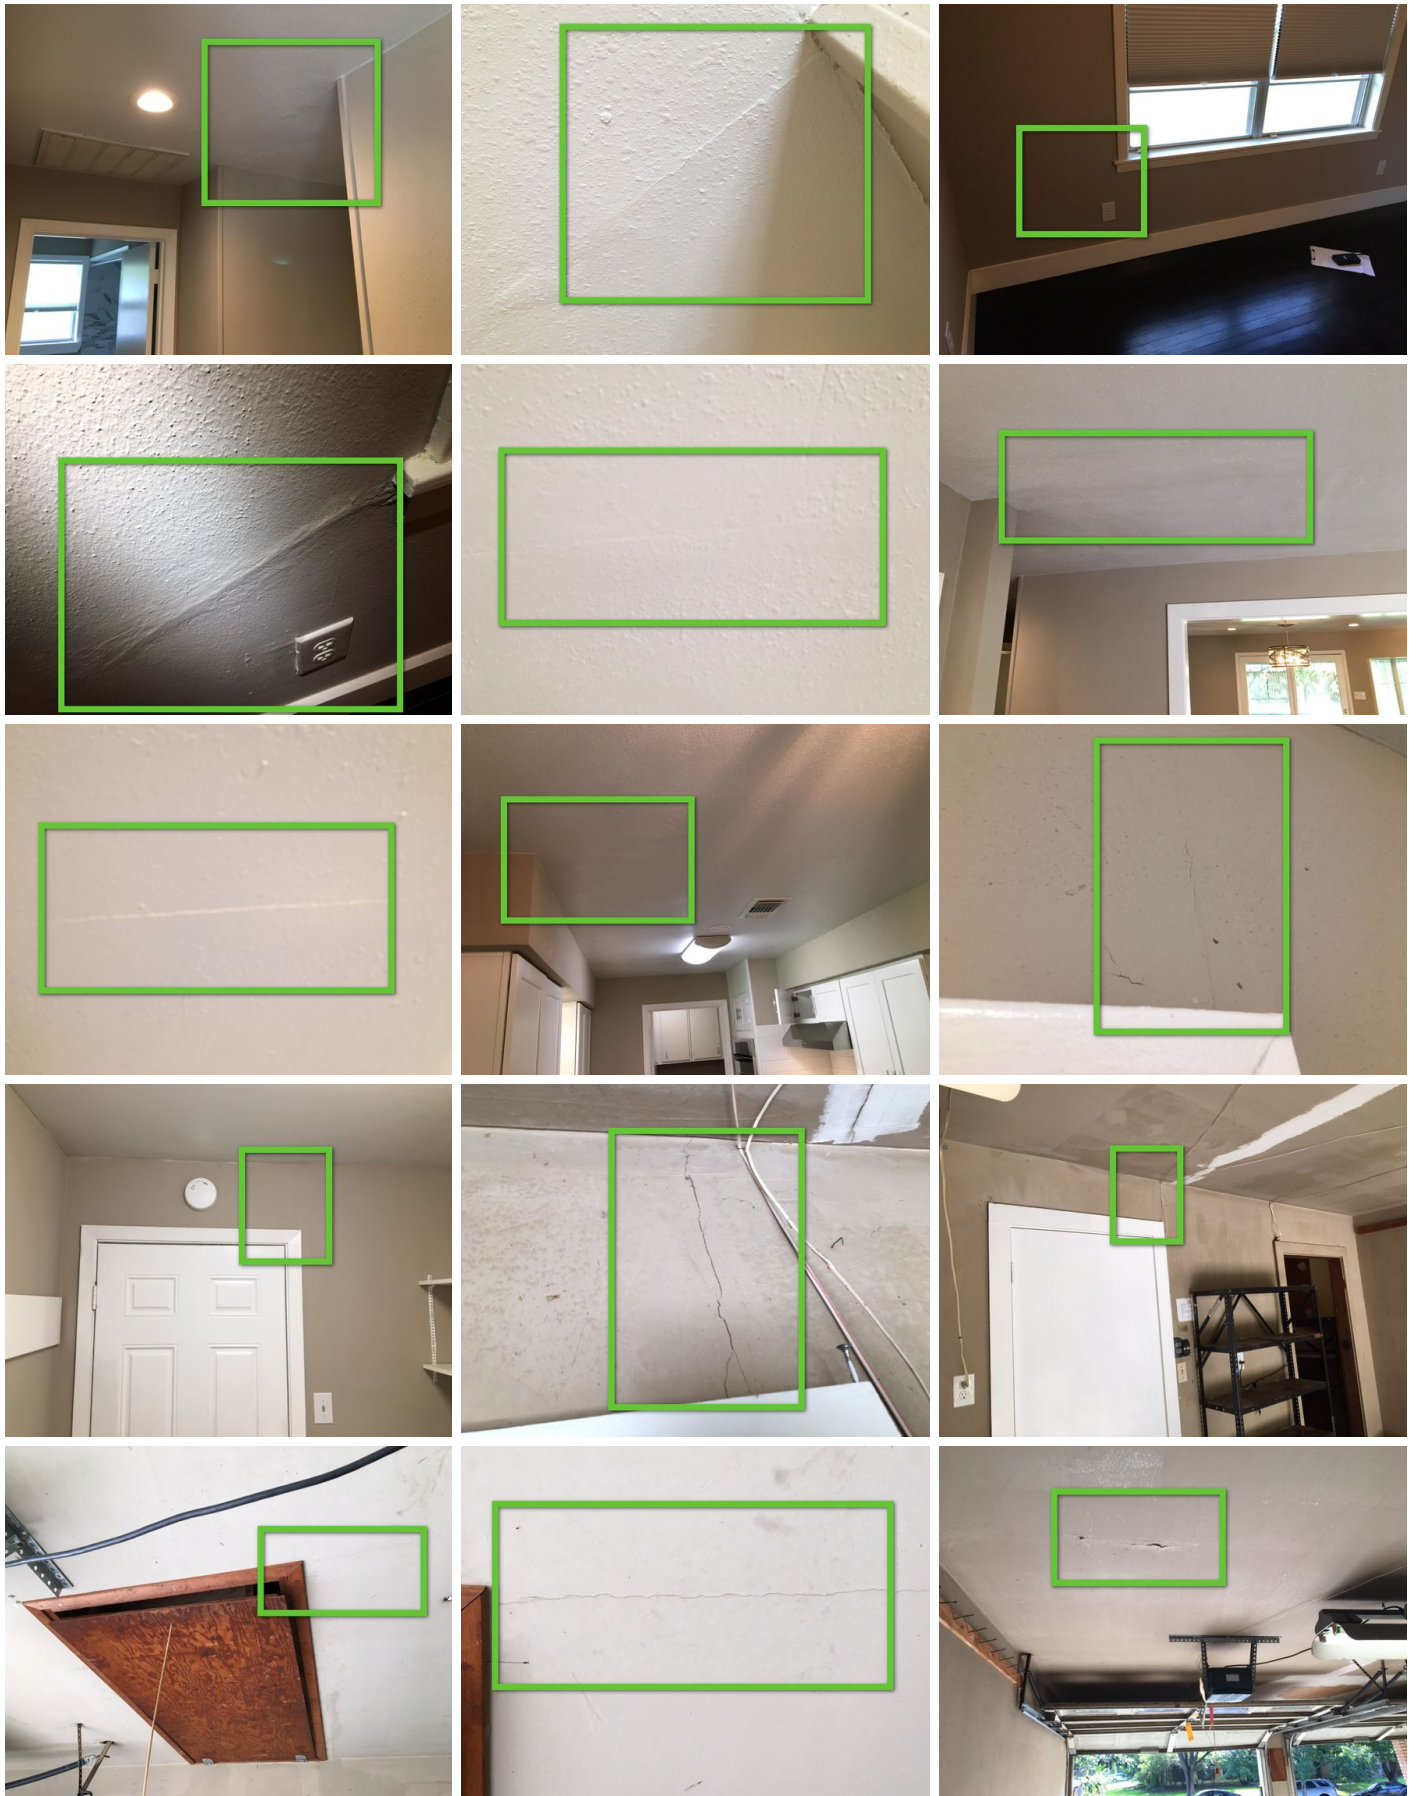
Sheetrock Cracks/Patches/Compression ridges

Garage, utility room, kitchen, breakfast area, foyer, hallway, and the master bedroom.

Sheetrock cracks, patches, and/or compression ridges were observed in the house during the inspection, including at the specified locations. It is recommended to repair the cracks.

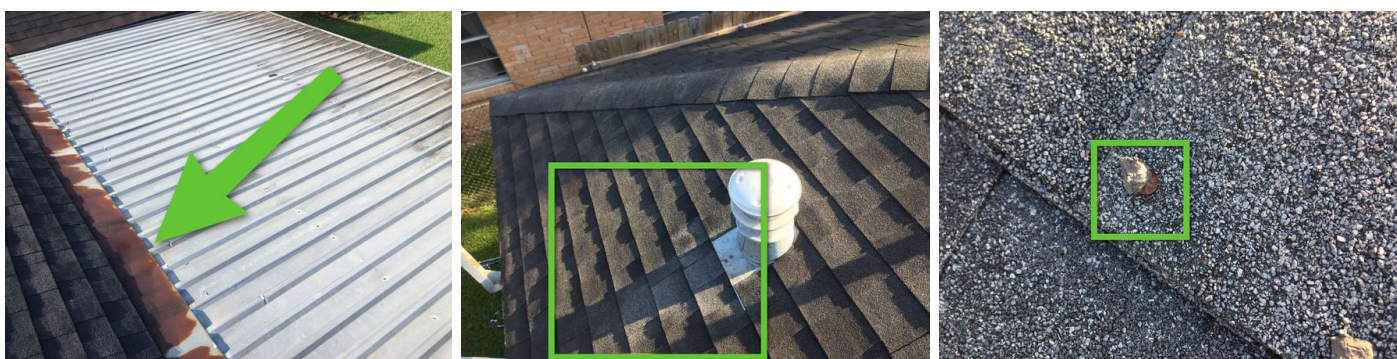
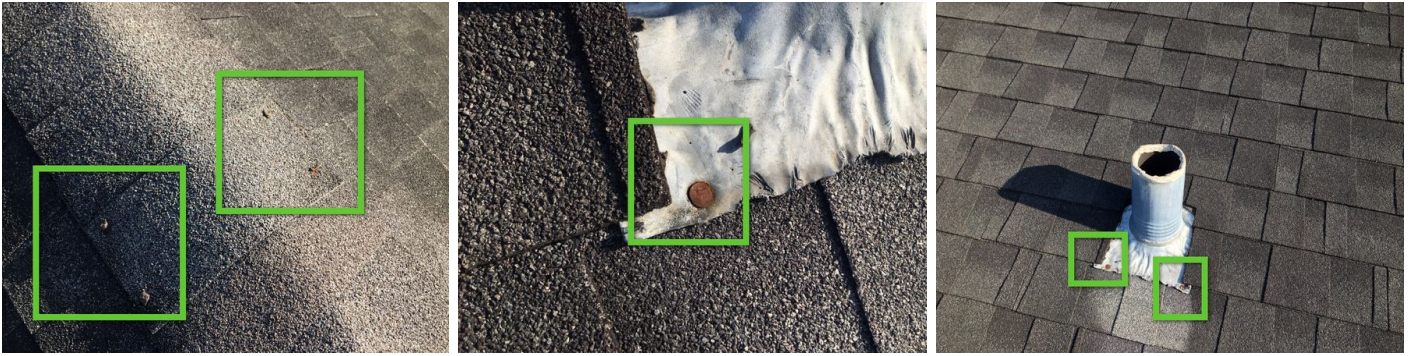
Discolored, Nail Heads not Sealed, Aggregate Missing, Rusted metal flashing

The composition roof surface was showing evidences of some deterioration of the roof surface as described above and shown below.

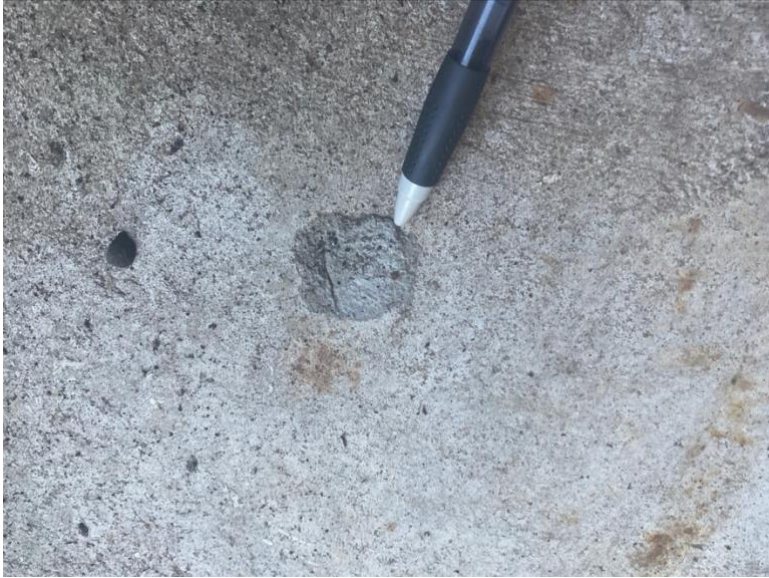
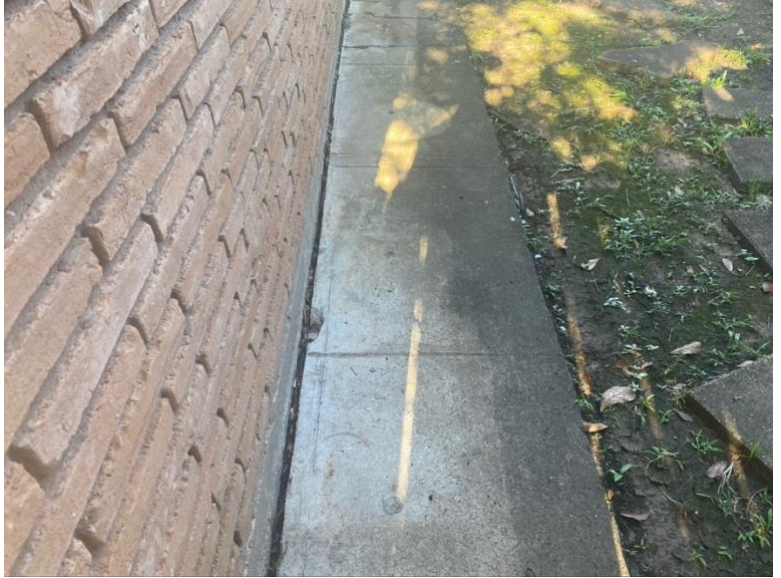
Drill Holes observed around the structure.

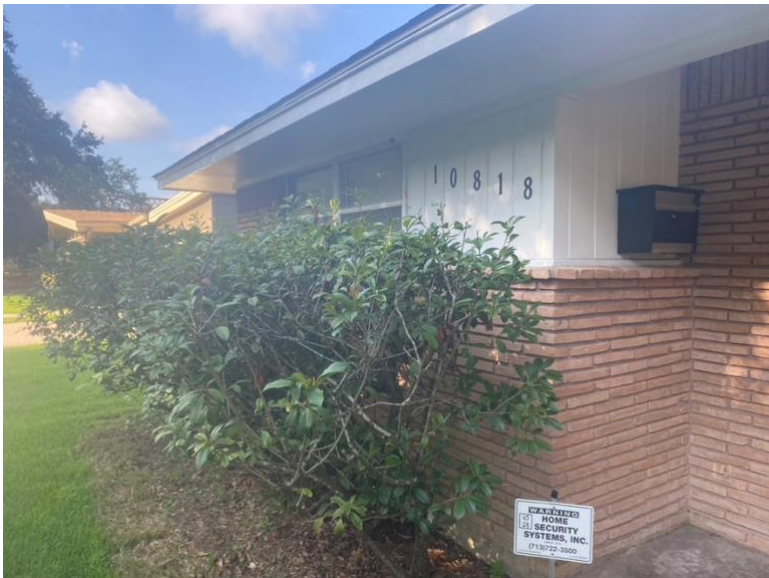
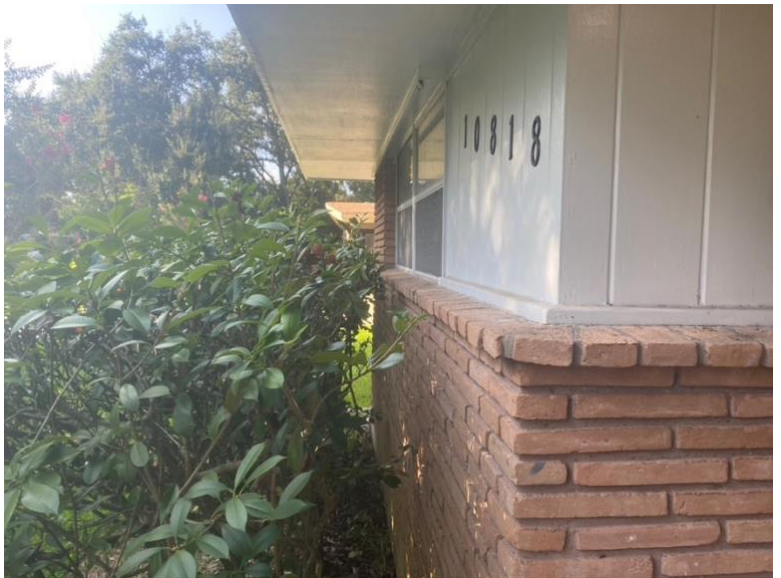
Foliage needs to be trimmed back from the structure.

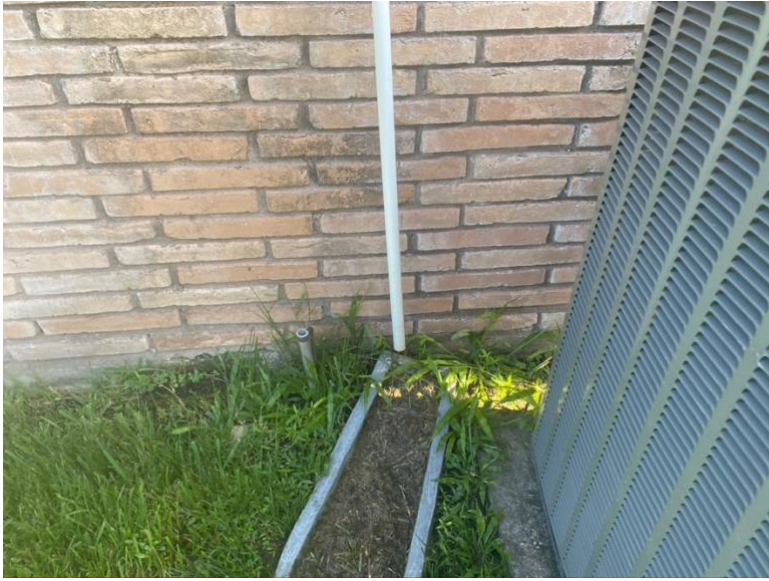
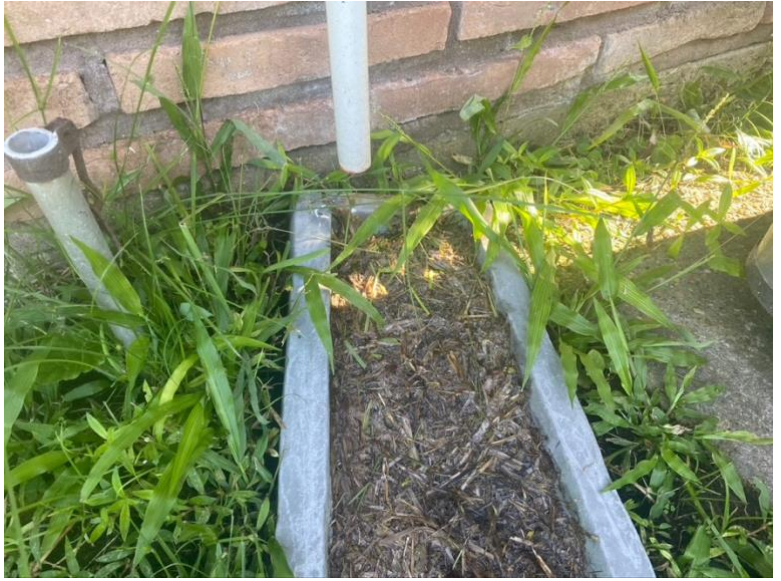
Moisture was observed due to the A/C primary drain line. Condition needs to be corrected.
