HEDDERMAN SERVICES

STRUCTURAL INSPECTION

10726 Tupper Lake Dr
Houston TX 77042

JULY 2, 2021

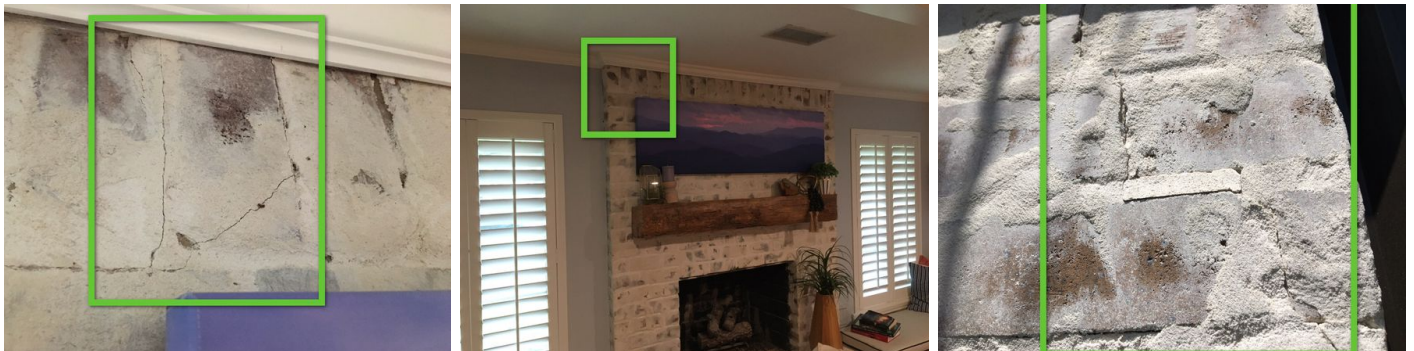
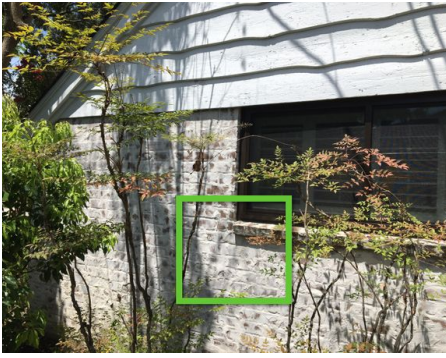
Differential Movement: Veneer Cracks - Minimal

We observed that cracks in the exterior veneer were minimal in number and degree at the time of the inspection.

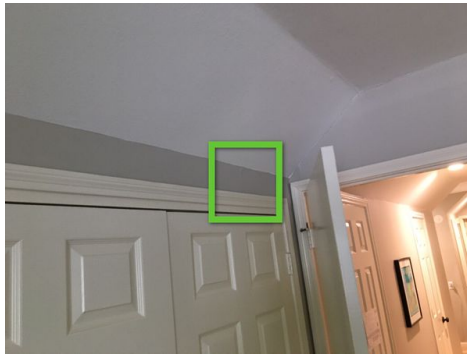
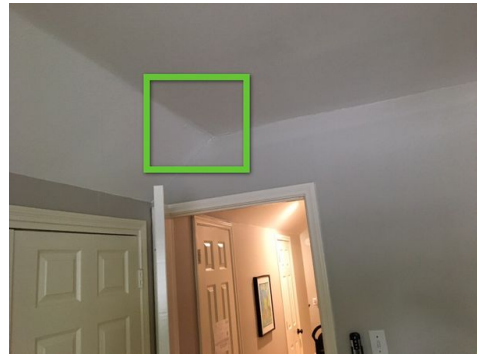
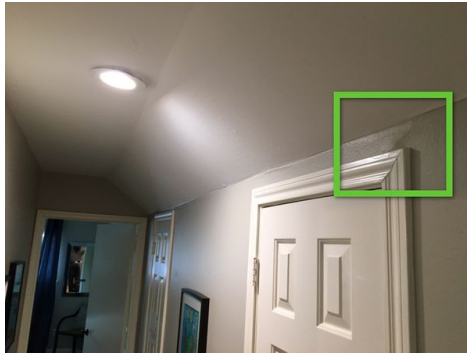
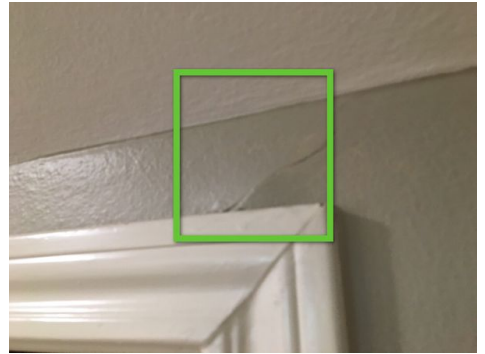
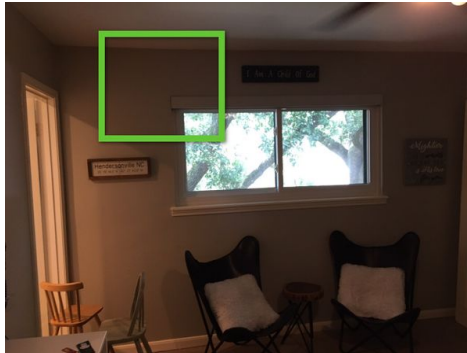
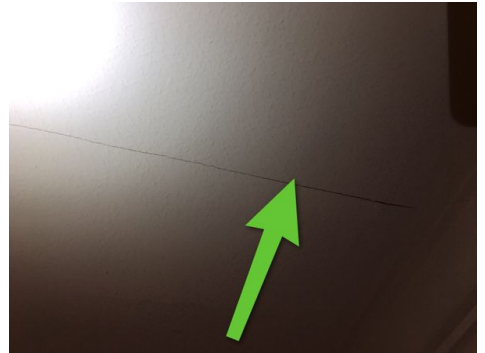
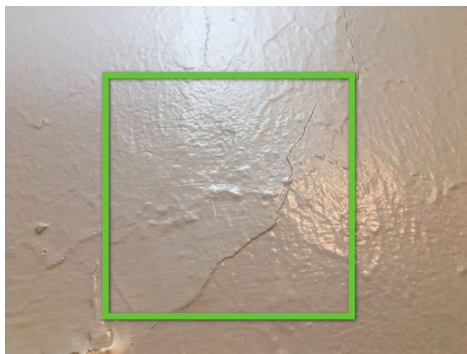
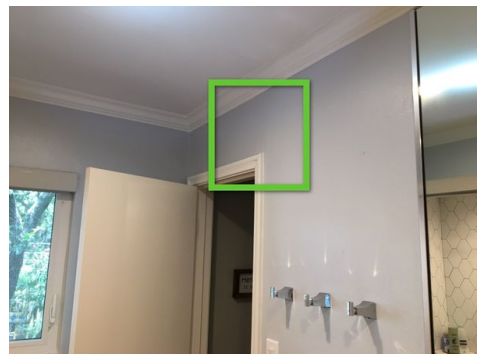
West bedroom, stairs, second-floor hallway, second-floor bathroom, north bedroom, and the east bedroom.

Differential Movement: Sheetrock Cracks/Patches/Compression ridges

Sheetrock cracks, patches, and/or compression ridges were observed in the house during the inspection, including at the specified locations.

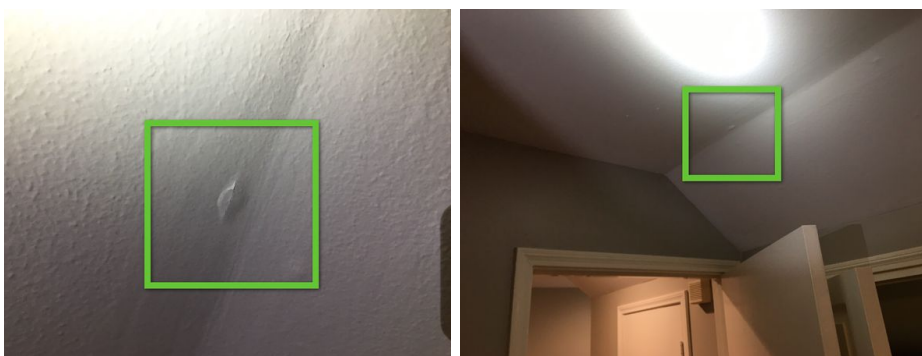
West bedroom

Differential Movement: Sheetrock - Nail pops

Nail pops were observed in the surface of the sheetrock at the time of the inspection including at the above locations.

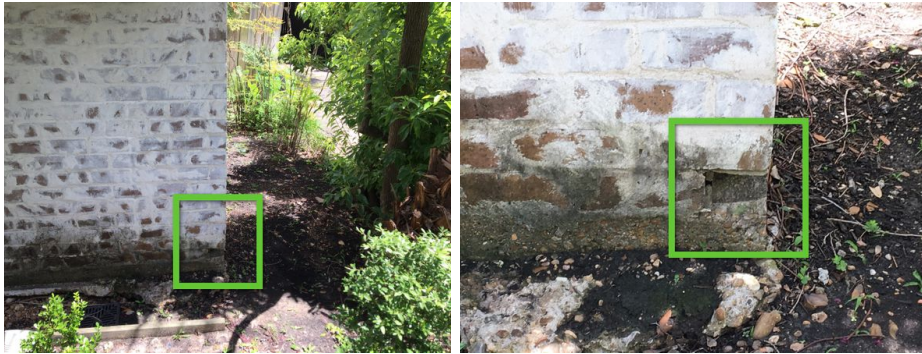
South east corner of the house

The corner of the foundation was observed to be chipped at the above locations. This condition is typically caused by differences in thermal expansion between the brick veneer and the concrete foundation. Also, this condition can be caused by a lack of reinforcement in the corner of the foundation during original construction. In our opinion, this condition does not affect the overall structural integrity of the foundation, nor is it an indication of foundation movement.

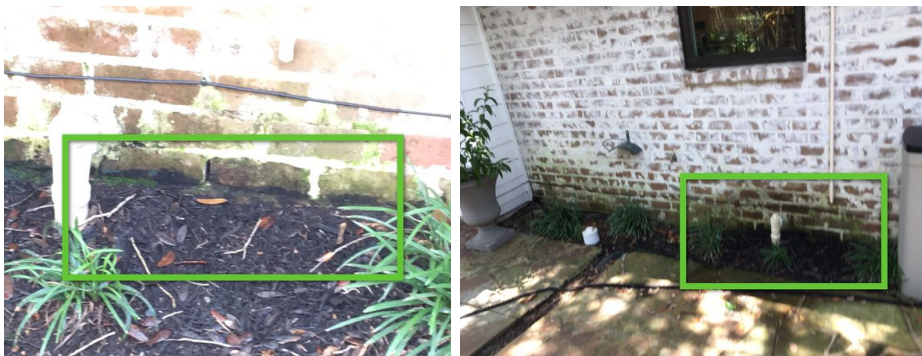
Differential Movement: Slab Not visible - High Soil

It is pointed out that a portion of the foundation concrete could not be viewed due to soil that was graded near or above the top of the foundation and/or heavy foliage growing against the house. The soil and/or foliage should be removed, and 3-4 inches of foundation concrete exposed.

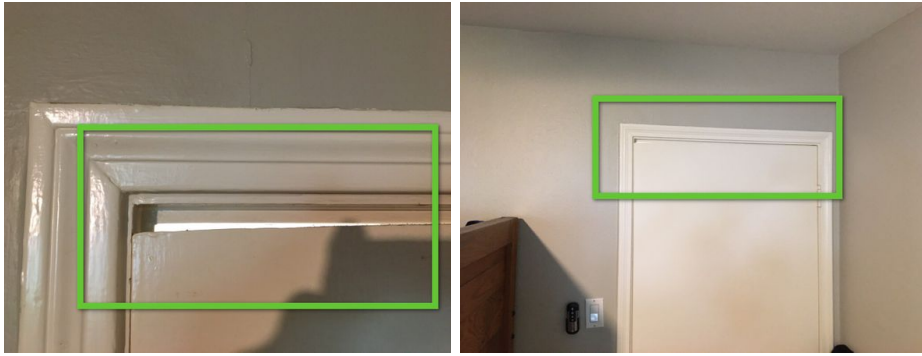
Second floor north bedroom

Door frames that were out of square, leaving a triangular separation between the door and the door frame at the top of the door were observed where a separation was visible at the top of the door.

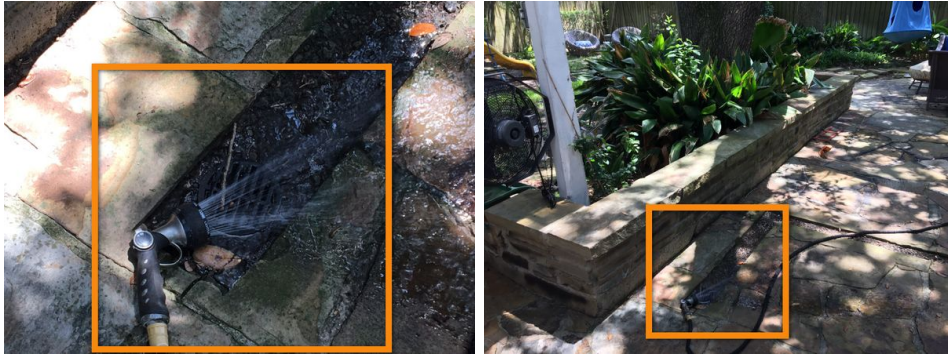
4.7.2 Perimeter Grading/Drainage

UNDERGROUND DRAIN, UNKNOWN EXIT POINT

The underground drainage system at the rear of the house was checked by running water into the drain, and the system was observed to be draining properly. However, we could not determine the exit point of the drainage system, and further investigation is recommended.

Contact a qualified landscaping contractor

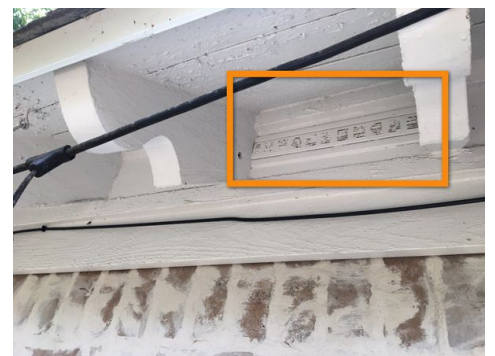
The eave vent screens were clogged with paint/debris and need to be cleaned or replaced.

Contact a qualified professional.

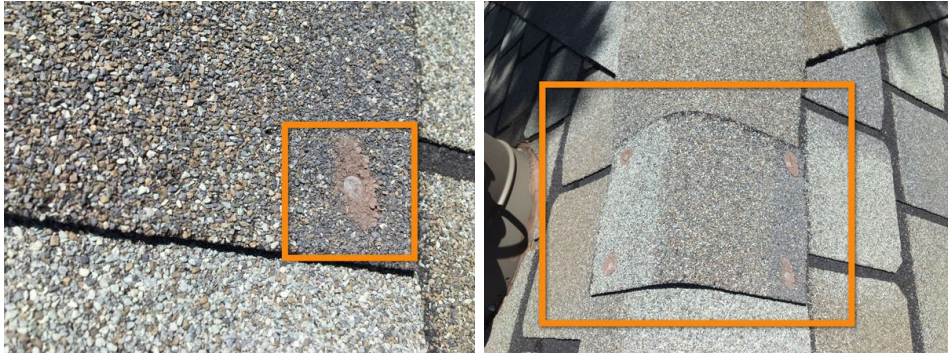
DETERIORATED SEALANTS

We observed sealants that were cracked/separated/missing and repair is needed.

Contact a qualified professional.

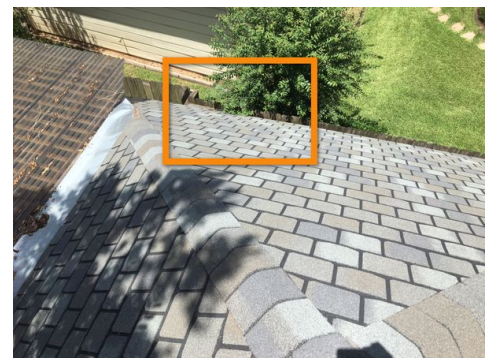
5.5.2 Roof Details

ROOF: MISCELLANEOUS

We observed some miscellaneous items related to the surface of the roof, including the items listed above. Have a roofing contractor provide a cost estimate to make any needed repairs.

Contact a qualified professional.

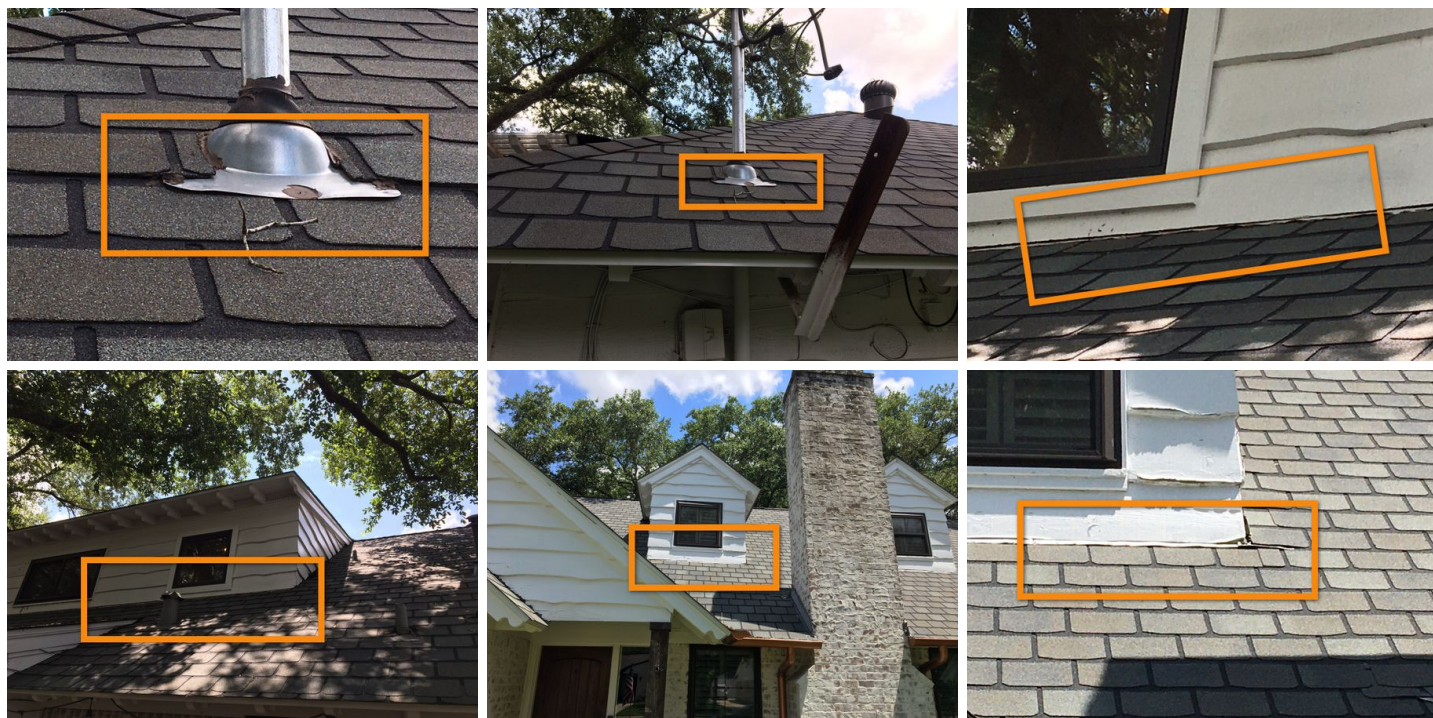
5.5.3 Roof Details

FLASHING/COUNTER FLASHING

We observed one or more conditions with the roof flashing as pointed out above. Have a roofing contractor provide a cost estimate to make all needed repairs

Contact a qualified professional.

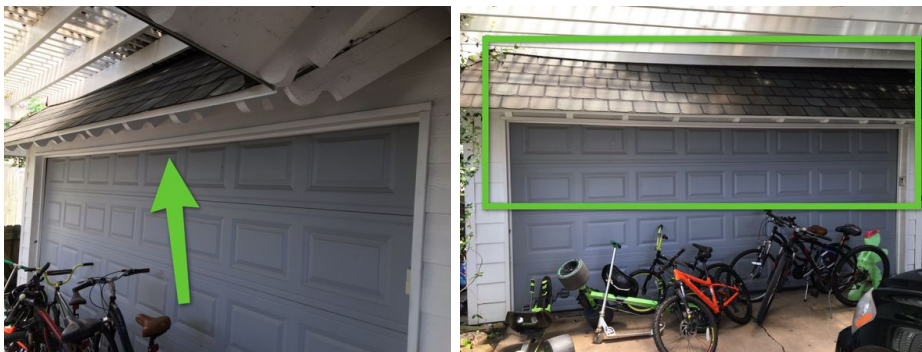
Deflected Framing: Garage header - Deflected slightly

The header over the garage door was deflected slightly (less than one inch deflection in a 30-foot horizontal distance ($L/\Delta = 360$ per the building code)). The degree of the deflection was not such that the header was not performing its intended function and, therefore, no repairs are recommended at this time. It is recommended that the condition of the header be monitored in the future for any additional deflection.

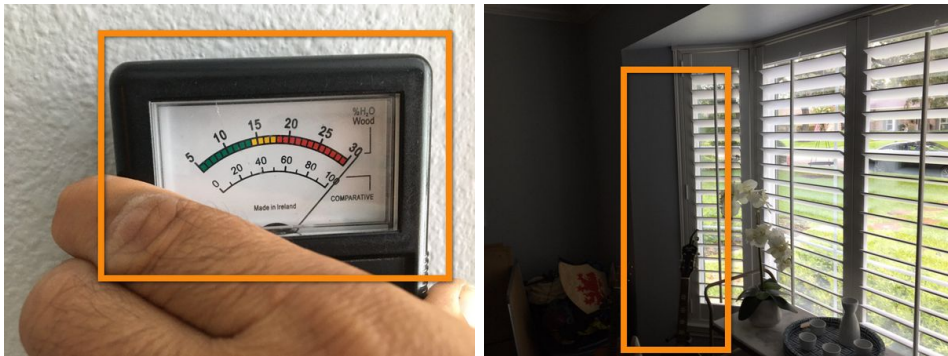
MOISTURE METER - HIGH READING

Our moisture meter showed a higher than normal reading at the east side of the window.

Contact a qualified professional.

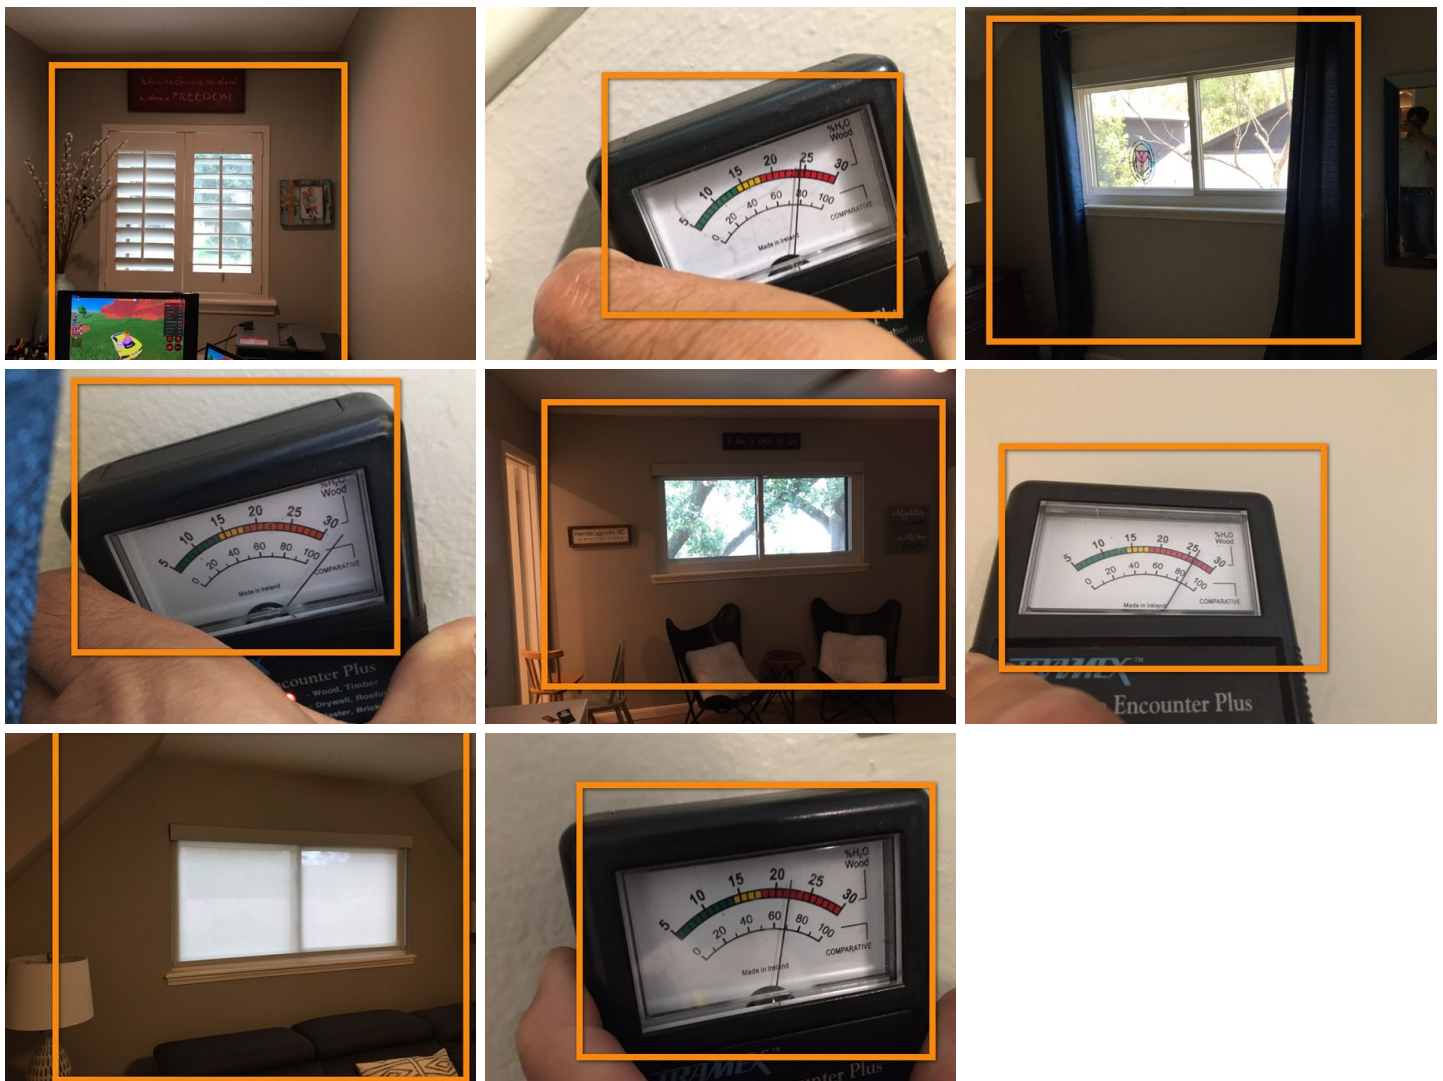
7.1.2 Water Penetration

MOISTURE METER - HIGH READING

Our moisture meter showed a higher than normal reading at the exterior walls. It is pointed out that the high moisture on these locations was at the entire walls rather than just around or near the windows. The source of the moisture was not determined with certainty. However, it appears to be related to the high humidity in the lower attics. While the lower attics have some ventilation in the soffits the ventilation was minimal due to clogged soffit vents and no ventilation in the upper sections of the lower attics. It is recommended to provide cross ventilation in the lower attics.

Contact a qualified professional.

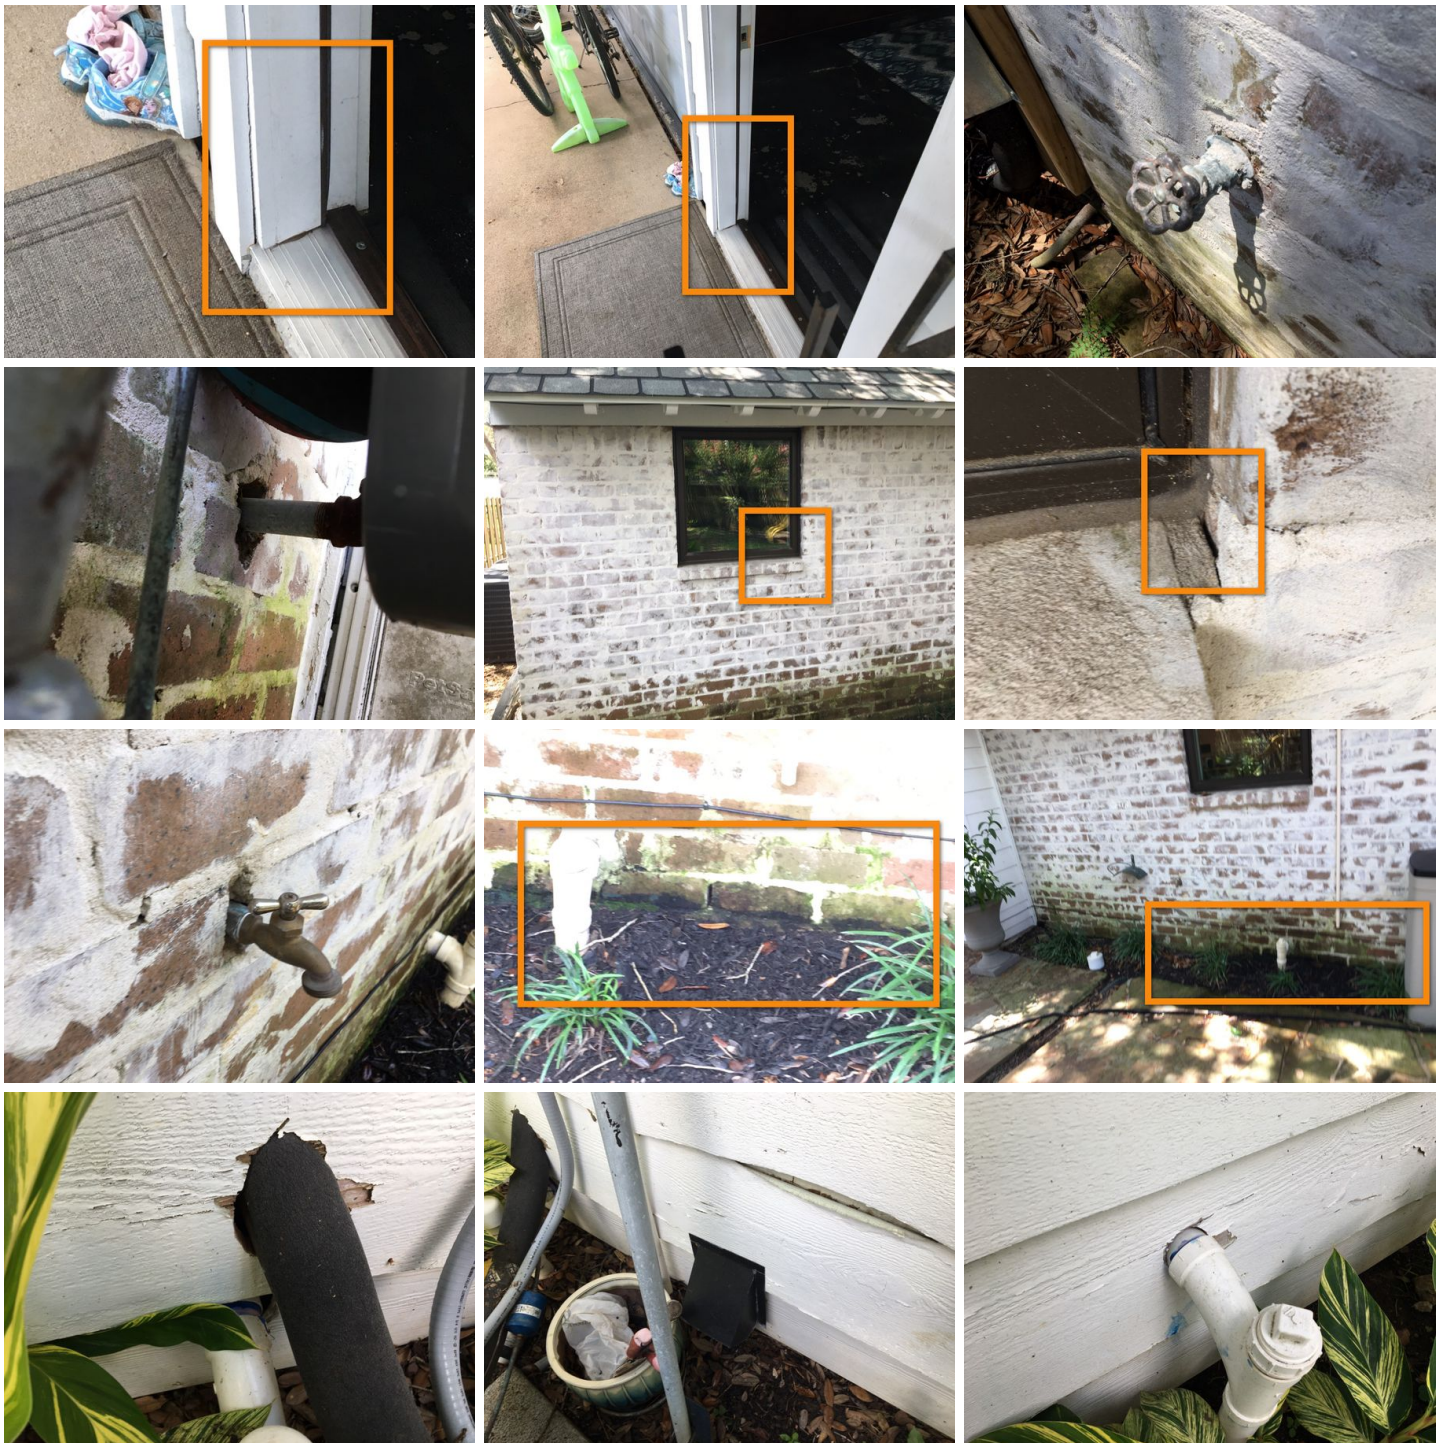
7.1.3 Water Penetration

VULNERABILITY TO WATER PENETRATION

Sealants deteriorated/missing, Window sealants, Light Fixtures, Hose Bibb, Vent Caps, Piping, Conduit, High Soil, Door Threshold

A substantial vulnerability to water penetration was observed at penetrations/openings through the exterior building envelope, and it is recommended that all penetrations/openings be sealed against water penetration. Typical examples on a structure may include light fixtures, air conditioning refrigerant lines, water piping, gas piping, vent caps, windows, doors, expansion joints, etc. Below is a representative sample of locations and/or photographs showing some, but not necessarily all, locations where there is a vulnerability to water penetration. Have a contractor provide a cost estimate to seal all vulnerable areas on the exterior building envelope against water penetration and/or open up any clogged weepholes in the veneer.

Contact a qualified professional.

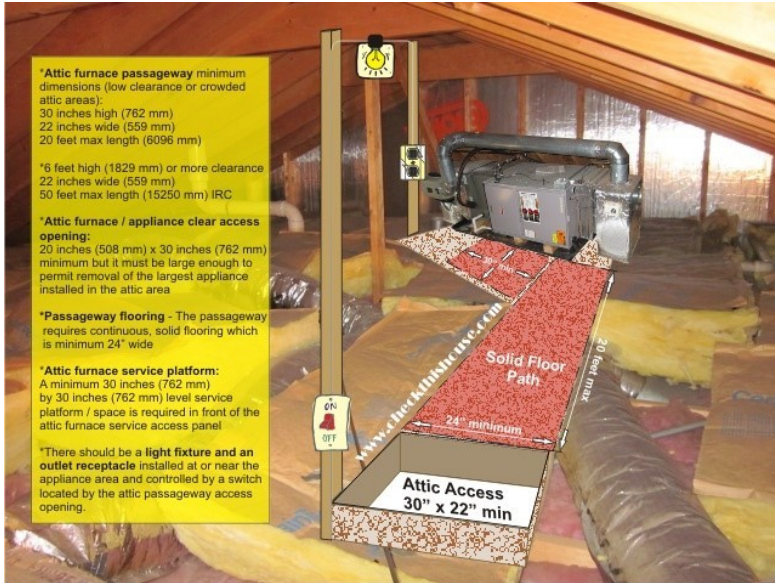
INADEQUATE WALKWAY DECKING

The attic did not have adequate service decking to all the equipment in the attic. The service decking should be a continuous deck that is a minimum of 24 inches wide, that extends from the attic access opening to all equipment in the attic. In addition, the decking should be free from any obstructions, such as gas lines, electrical wiring, ductwork, framing members, etc.

Recommendation
Contact a qualified professional.

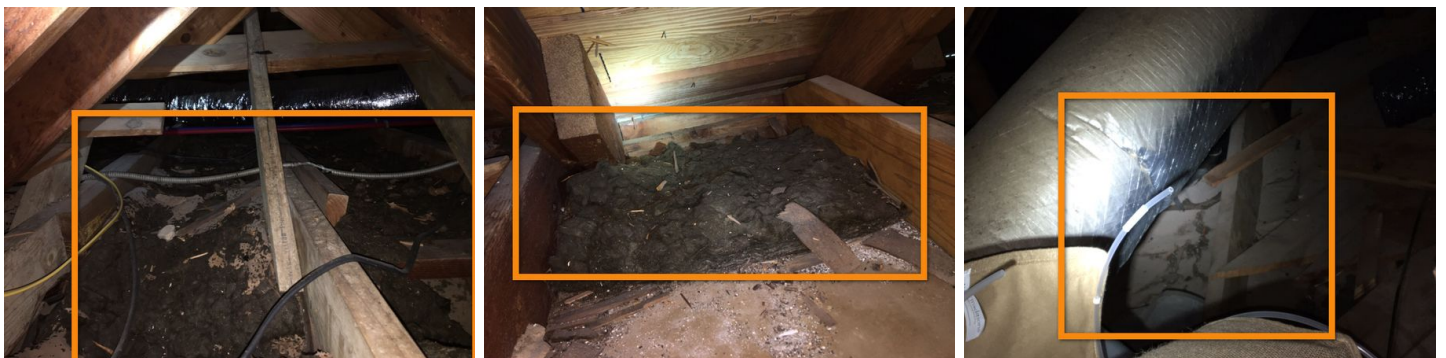
9.4.1 Insulation

The insulation in the attic was very thin by today's standards. This attic appeared to have approximately 1-3 inches of insulation in the ceiling. It is recommended that consideration be given to installing additional insulation. Current construction standards for new homes have insulation that is a minimum of an R-38 rating.

Recommendation
Contact a qualified professional.

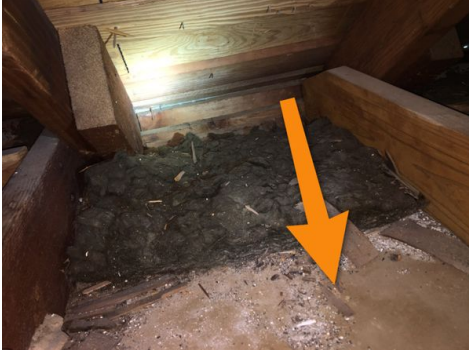
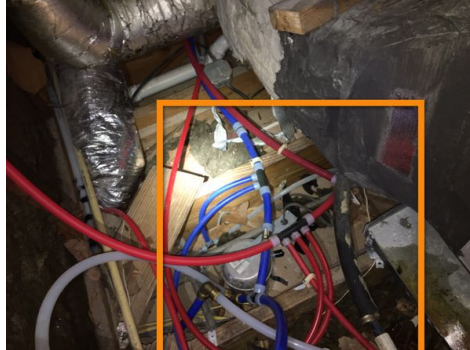
9.4.2 Insulation

INSULATION MISSING - BETWEEN JOISTS

The insulation in the attic was missing from between some of the joists. Have a service company provide a cost estimate for repairs.

Contact a qualified professional.

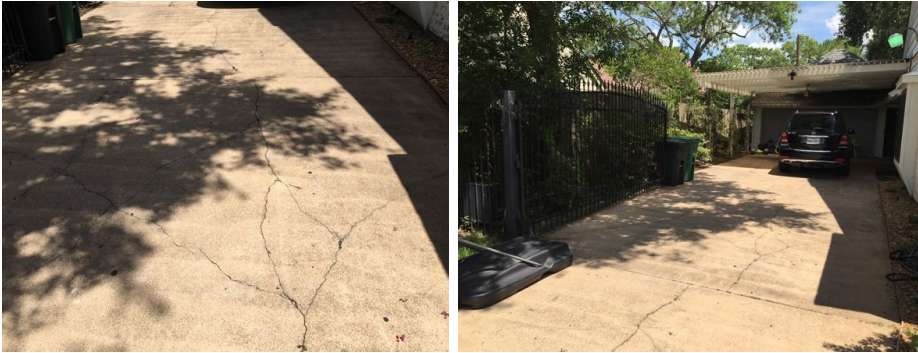
Flatwork Concrete/Patios/Walkways: Cracks Driveway

Cracks and some separations were observed in the driveway concrete. In our opinion, the driveway is still in serviceable condition at this time.

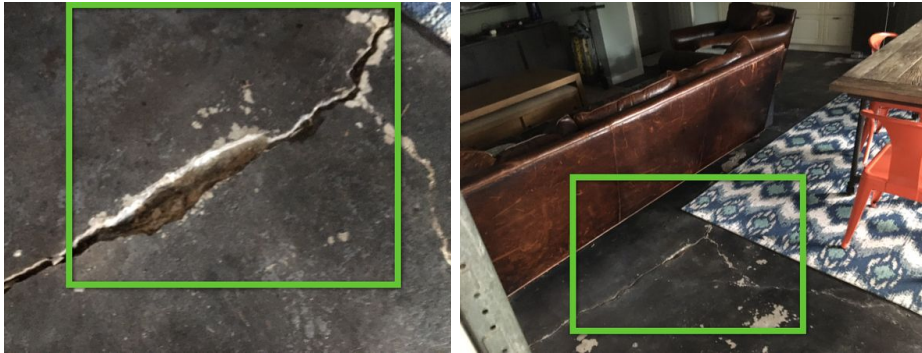
Converted Garage: Foundation Cracked-Monitor

The concrete floor of the garage was observed to have one or more cracks, but was still functional at the time of the inspection. The exterior perimeter of the garage has experienced some settlement, but the degree is not such at this time to recommend foundation releveling. The garage foundation should be monitored in the future for additional movement as it can be expected that additional movement can take place.

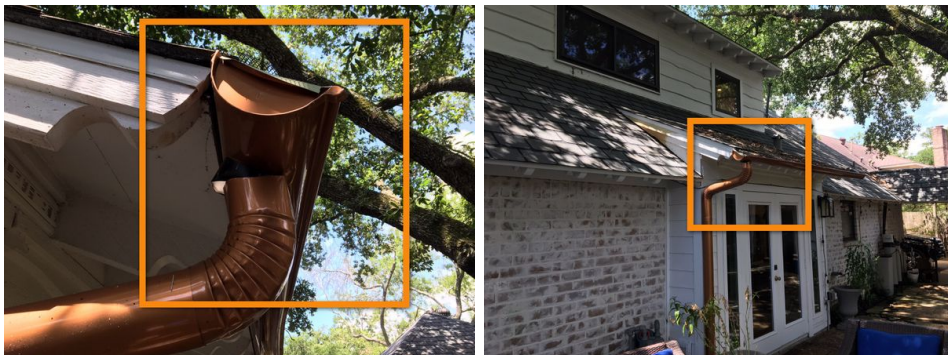
10.2.1 Gutters and Downspouts

GUTTER DAMAGED

The gutter was damaged and needs to be repaired.

Contact a qualified professional.

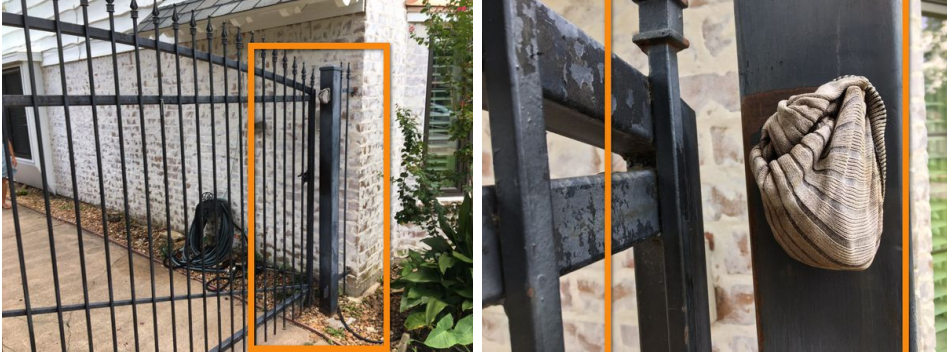
10.3.1 Gates and Fences

ELECTRIC GATE STICKING

The electric gate was operational but sticking and not fully closing at the time of the inspection. Have a service company find the source of the problem, and make any necessary repairs.

Contact a qualified professional.

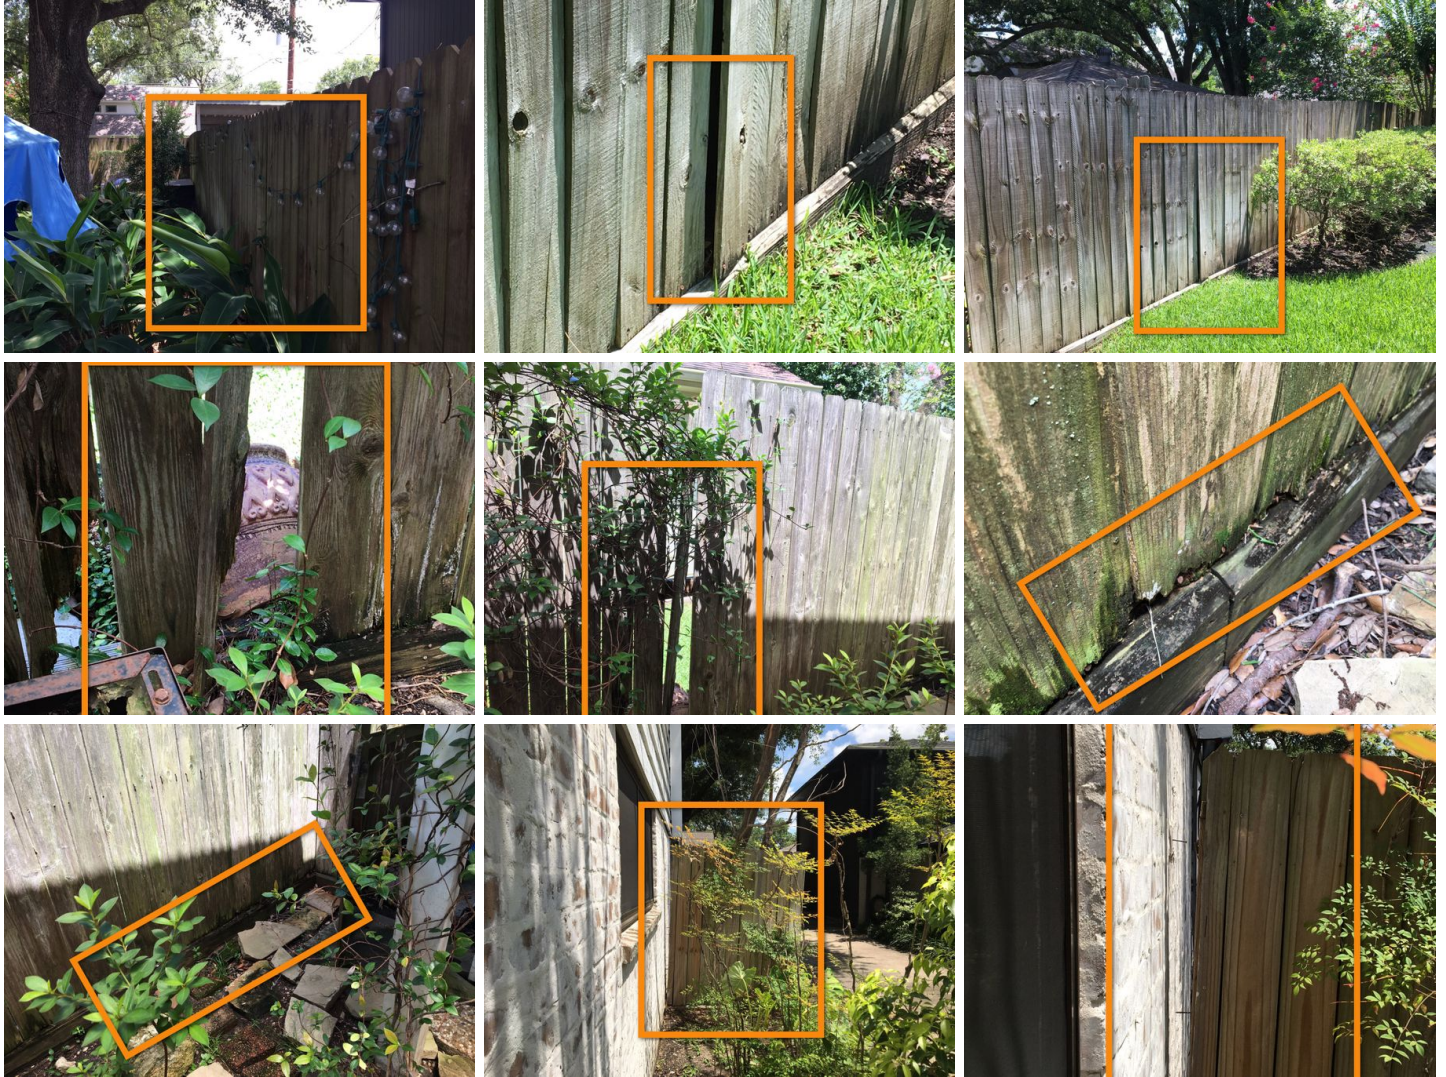
10.3.2 Gates and Fences

WOOD FENCE

Leaning, Starting to rot, Loose boards

The wood fence was in need of some repairs.

Contact a qualified professional.

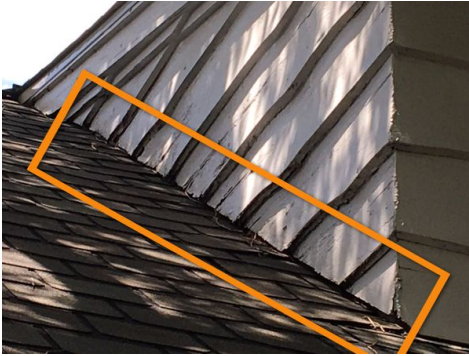
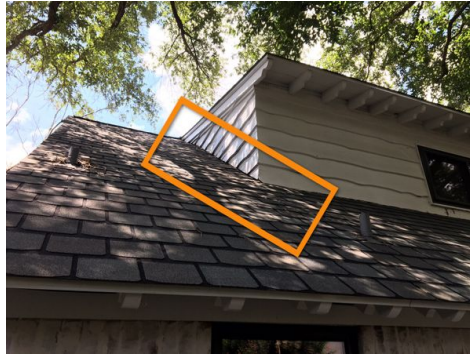
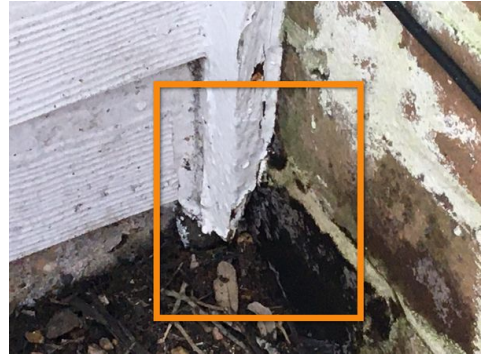
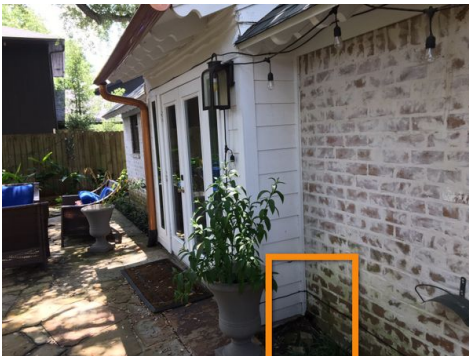
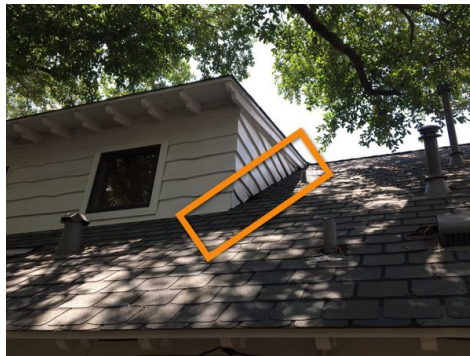
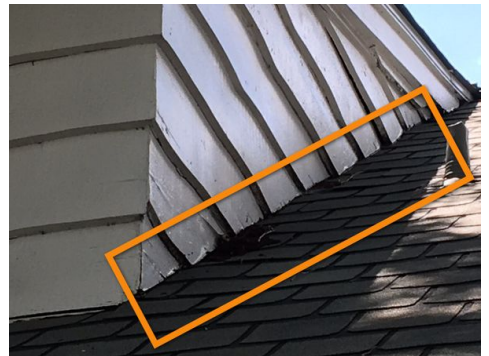
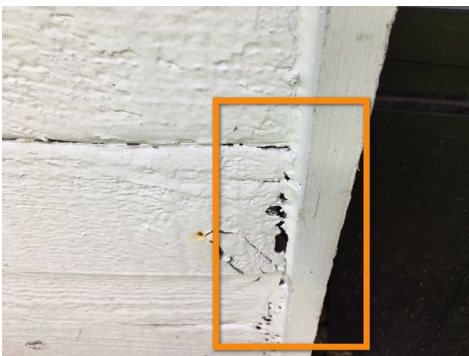
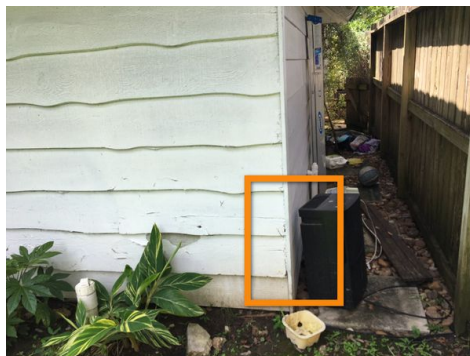
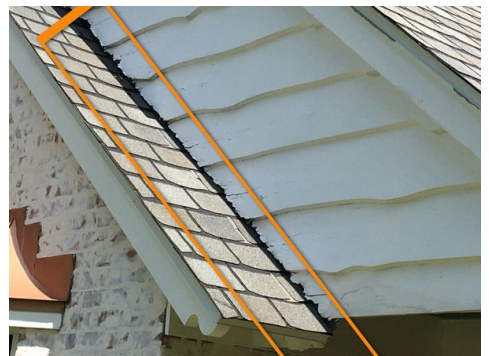
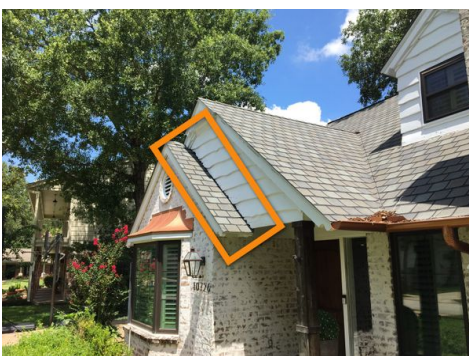
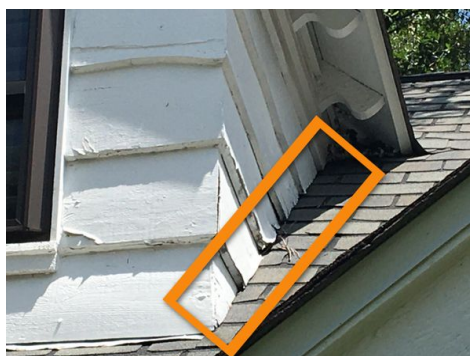
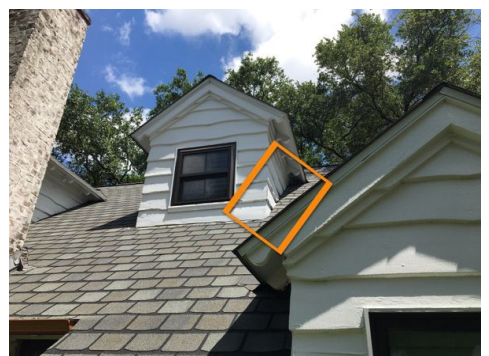
10.4.1 Wood Rot

WOOD ROT

Wood rot was observed and needs to be replaced. Have a contractor provide a cost estimate to determine the entire scope of the wood rot, and provide a cost estimate to replace all rotted wood in the house.

Contact a qualified professional.

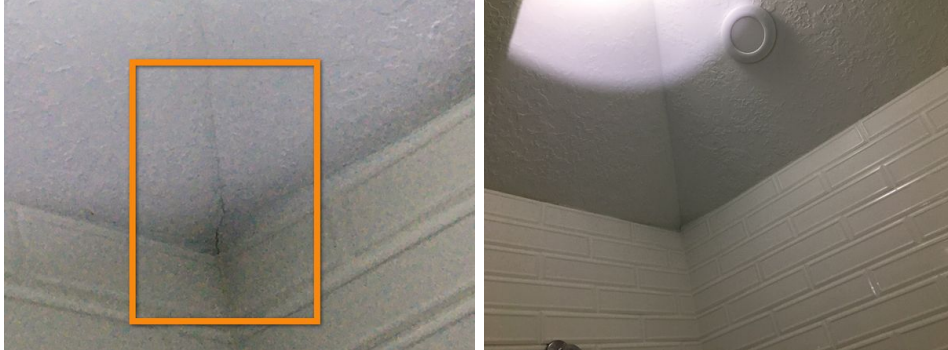
10.6.1 Converted Garage

SHEETROCK DAMAGE

The sheet rock was cracked and in needs to be repaired.

Contact a qualified professional.

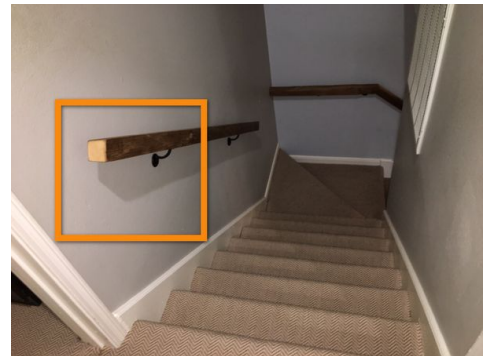
The handrails for the stairway were not constructed according to the current building code standards, which is expected given the age of the house. Therefore, the ends of the handrails do not terminate into the wall, which could allow loose clothing or a purse or bag to catch on the open end, causing tripping and/or falling down the stairs.

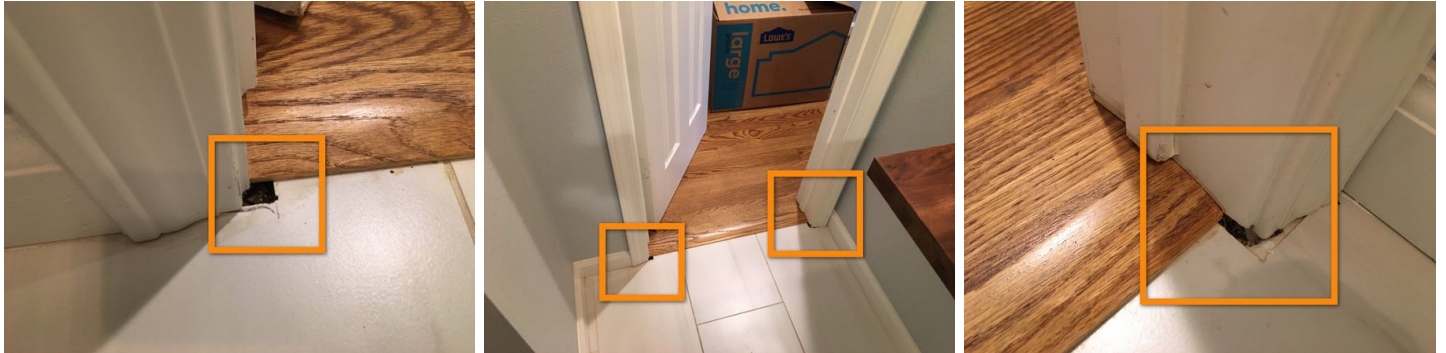
11.9.1 Miscellaneous interiors

SEAL SEPARATIONS

Contact a qualified professional.

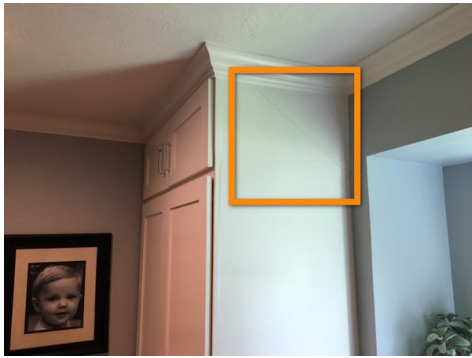
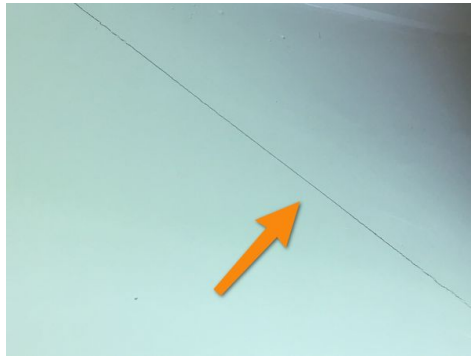
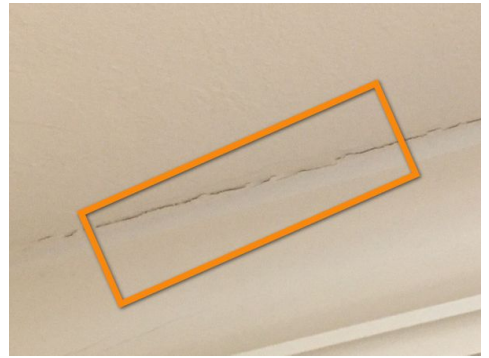
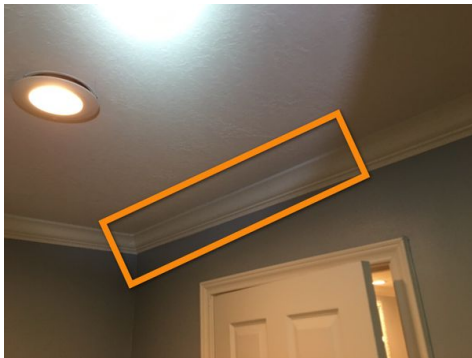
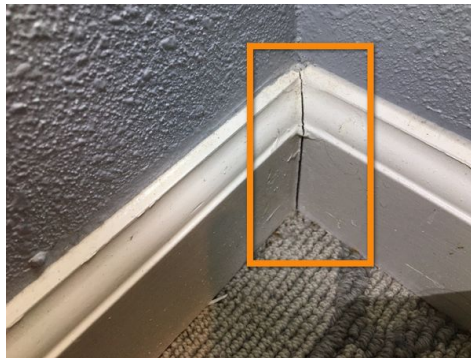
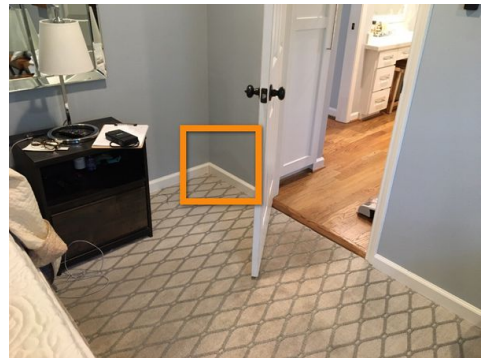
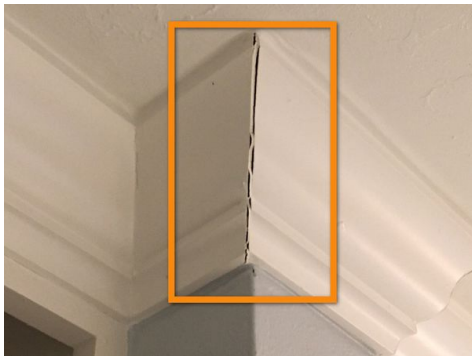
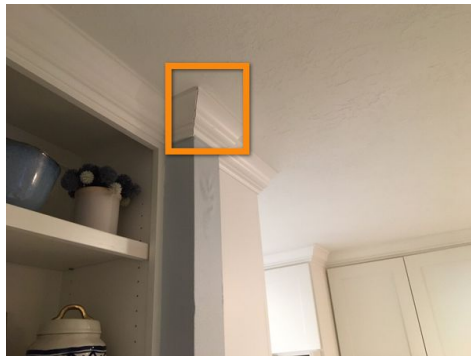
11.9.2 Miscellaneous interiors

CAULKING SEPARATIONS - THROUGHOUT/DRYING

Contact a qualified professional.
