## MECHANICAL INSPECTION

10726 Tupper Lake Dr  
Houston TX 77042

# PROPERTY INSPECTION REPORT

**Concerning:** 10726 Tupper Lake Dr, Houston TX 77042  
(Address or Other Identification of Inspected Property)

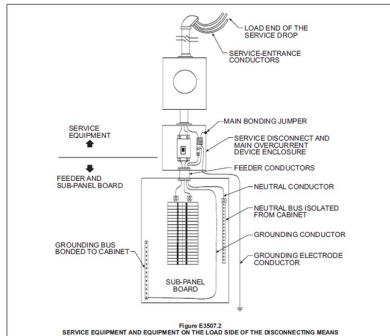
The grounded conductors (white wires) and the equipment grounding conductors (bare copper wires) were improperly connected inside the sub panel. The two sets of wires should be connected to separate

buses, which are then connected with separate wires to the main grounding bus in the main panel.

**Obtain Cost Estimate**

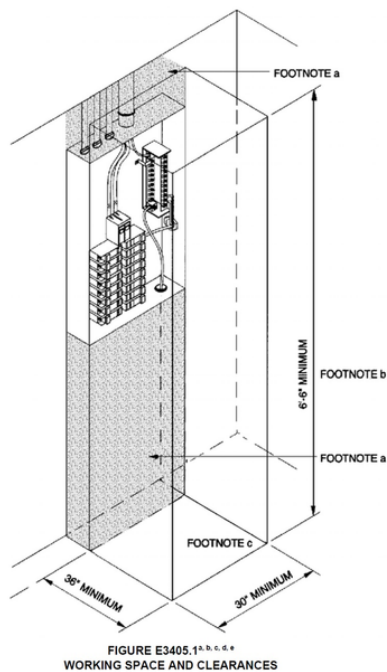
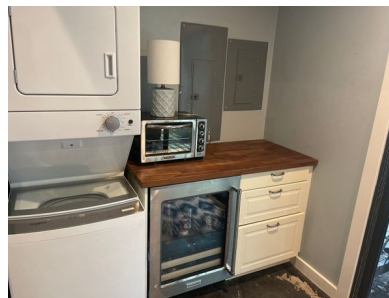
**6: Breaker Panel - Inadequate Clearance**

The breaker panel did not have the required three foot clearance at the front and it is recommended that the minimum required clearance be made or that the panel be relocated.

**Obtain Cost Estimate**

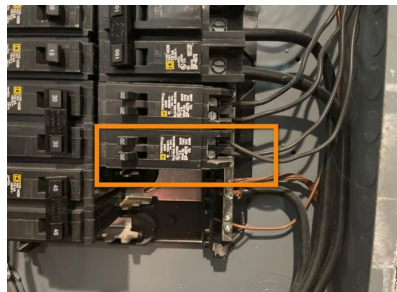
A circuit breaker was observed that was rated higher than the wire that it was protecting. This condition can be a fire hazard, and the oversized breaker should be replaced with a breaker that is sized in accordance with the allowable ampacity of the wire.

**Obtain Cost Estimate**

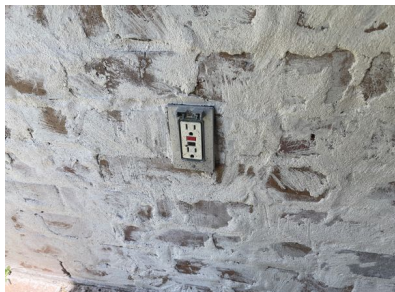
**4: Outlet - Exterior cover plate damaged**

The cover plate for the exterior outlet was damaged, and needs to be replaced with a weather-tight cover plate.

**Obtain Cost Estimate**

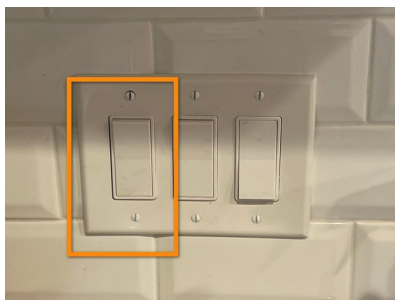
A switch whose function we could not determine was observed. Further investigation with the homeowner and/or a service company is recommended.

**Obtain Cost Estimate**

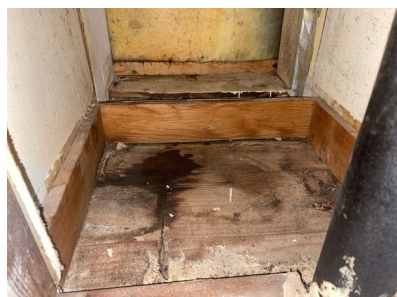
**5: Coil - Missing overflow pan**

An overflow pan was not installed under the coil. The overflow pan is intended to catch leaking water from the coil should a problem occur. It is recommended that an overflow pan with a drain line to the outside be installed under the coil in an approved manner. Water and damage were observed under the unit in the return air area due to the lack of an overflow pan. Have a service company make any necessary repairs due to the water damage.

**Obtain Cost Estimate**

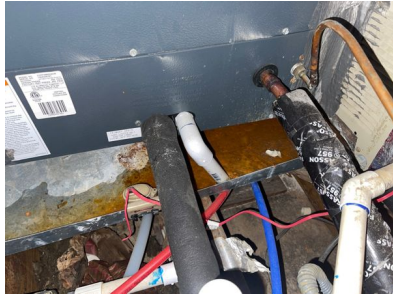
**6: Overflow Pan - Standing water**

Standing water was observed in the overflow pan under the coil. This can indicate a clogged primary drain line, or some other problem with the coil. Have a service company find the source of the water in the pan, and make any necessary repairs.

**Obtain Cost Estimate**

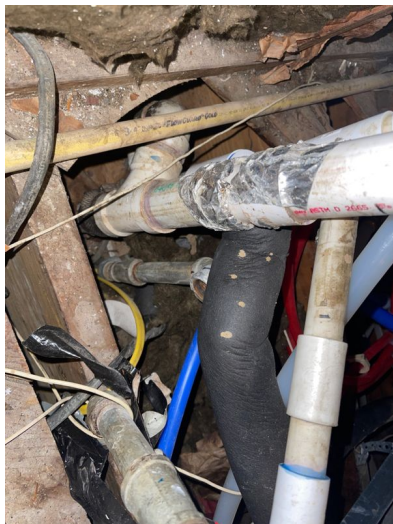
**7: Primary Drain Line - Terminated in plumbing trap in attic**

The primary condensate drain line terminates into an plumbing trap in the attic. This condition can allow sewer gases to back up into the house and HVAC system. The drain line should be rerouted to an approved location.

**Obtain Cost Estimate**

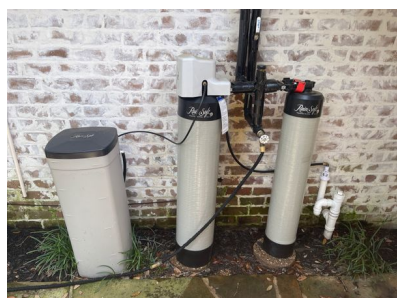
**4: Water Treatment System - Not inspected**

The water treatment system was not checked at the time of the inspection and is omitted from the scope of this inspection. If it is desirable to you to determine if the unit is operational and is softening the water, then it is recommended that water samples be taken and analyzed by a testing laboratory.

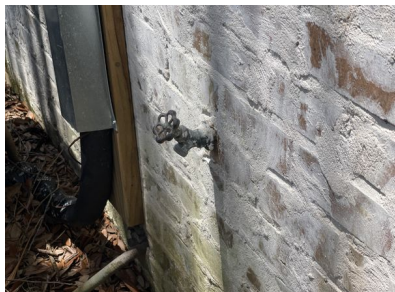
A hose bibb was observed to be nonfunctional at the time of the inspection.

**Obtain cost estimate**

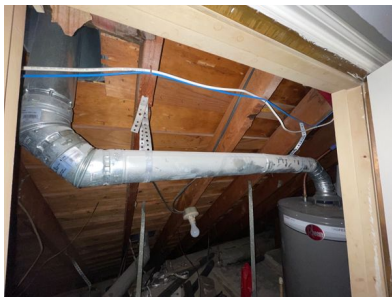
The vent pipe had a long horizontal run, and very little vertical rise. The vent pipe is not installed properly and can allow hazardous combustion gases to vent into the attic. Have a service company provide a cost estimate to make the needed repairs.

**Obtain Cost Estimate**

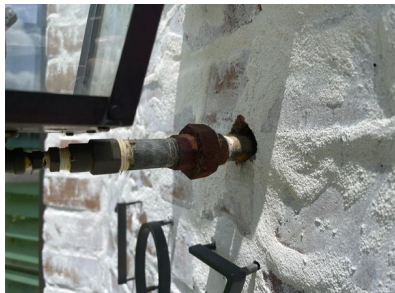
Contact a plumber to determine the entire extent of the rusted pipe and provide a cost estimate for the needed repairs.

**Obtain cost estimate**

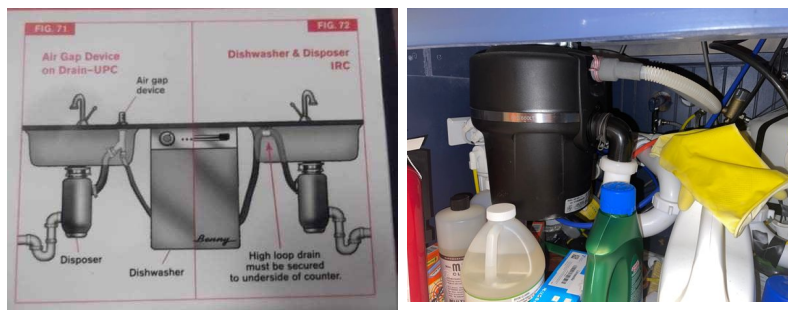
The drain line under the sink was not equipped with an anti-siphon device, nor was it looped up so that the top of the loop is at least six inches above the entrance of the drain line into the disposal. It is recommended at least that the drain line be looped to prevent the water from the garbage disposal from siphoning back into the dishwasher, or an anti-siphon device installed.

**Obtain Cost Estimate**
