SIGNATURE INSPECTIONS

Stacy Hollowell

1118 Haye Friendswood TX. 77546

Inspector: Randy Irwin TREC#5957

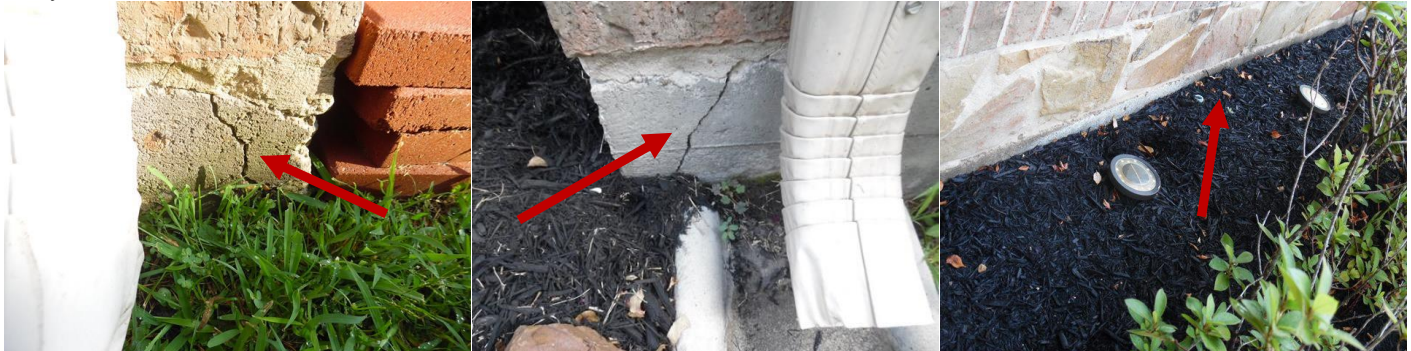
Corner pop was observed on the front, and rear foundation corners. These do not normally present a structural support problem but can be location(s) of undetected insect entry. Be sure to advise your pest control professional of the presence and location(s) of large corner spald(s).

A high soil area was observed in the front flower bed. High soil areas are a conducive condition for undetected insect entry, 4" minimum foundation visual is desired.

Corner pop

high soil

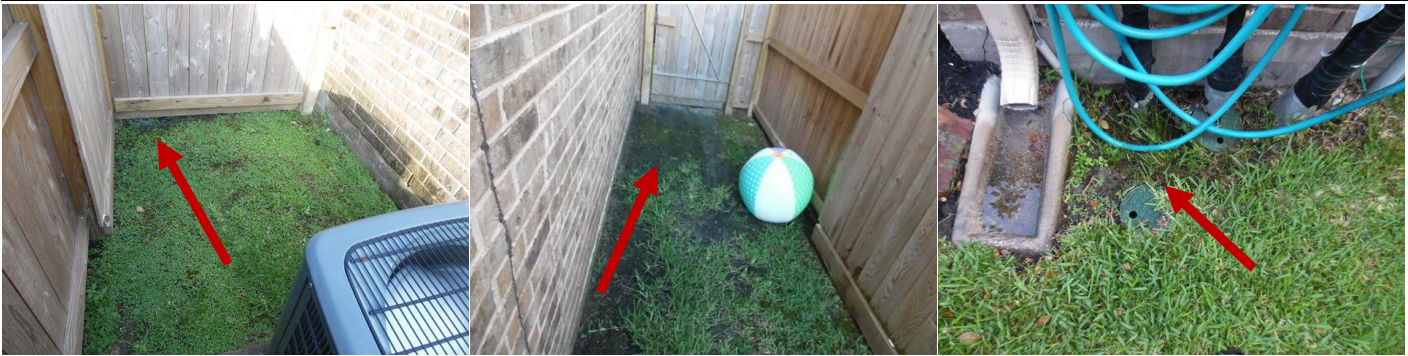
Evidence of previous water ponding on both sides of the structure by the fence and gate were observed monitoring the areas to determine if repairs are needed is recommended.

Standing water was standing at the front right corner of the house at the irrigation system air break the source of the water is unknown and should be identified and repaired if needed.

Possible ponding areas

standing water

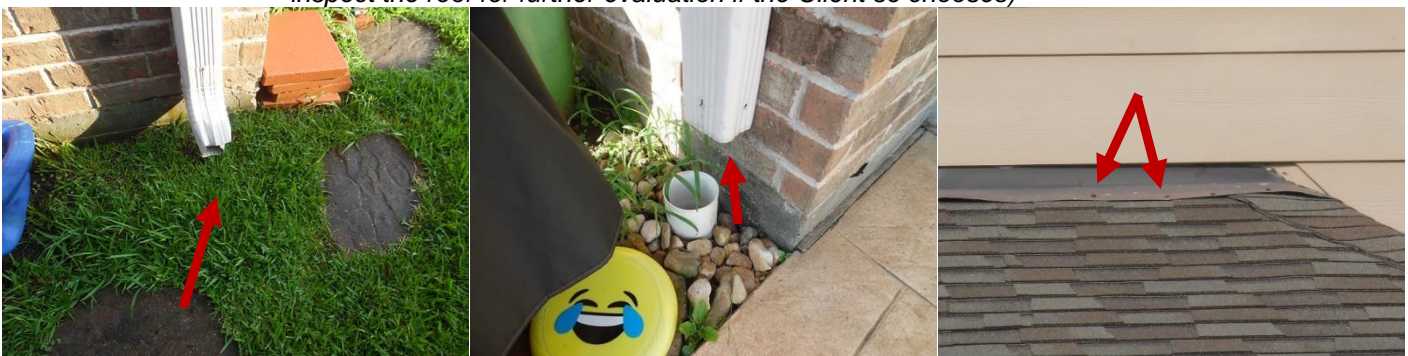
A splash block is missing on the right rear corner of the house, the splash blocks help prevent soil erosion next to the foundation.

A down spout is too short and does not fit into the subterrain drain.

Exposed nail heads were observed on the rear patio roof line flashing, sealing the nail heads to prevent roof leaks is recommended.

Splash block missing

down spout too short

exposed nail heads

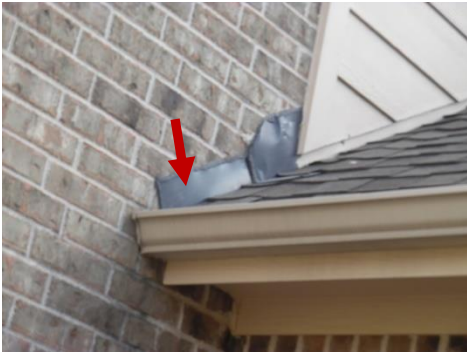
Kickout flashing is missing at the rain gutter to divert water away from the wall on the front of the structure, (typical observation for a structure this age)

Kick out flashing missing

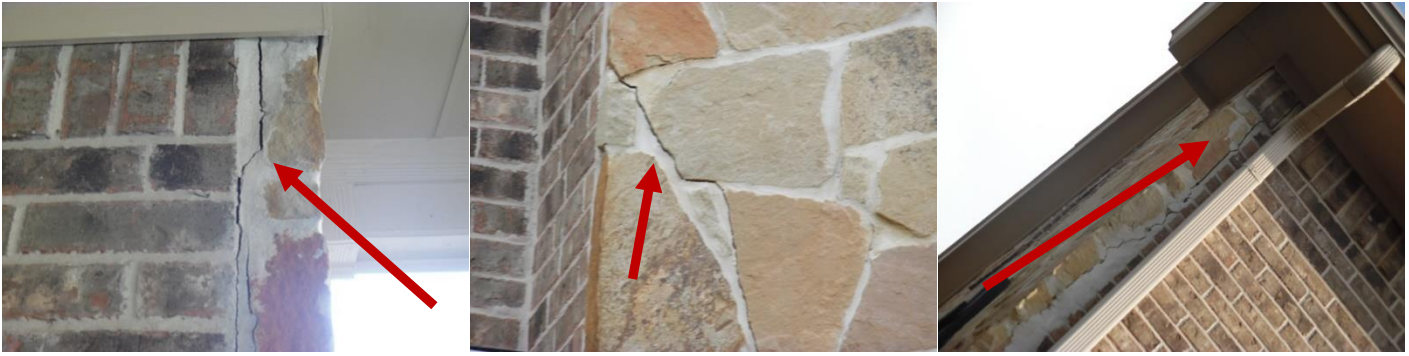
Brick mortar separation, settling was observed on the stone sheathing on the front of the structure.

This is an indication of structural movement (settling) at some point in time.

Settling gaps

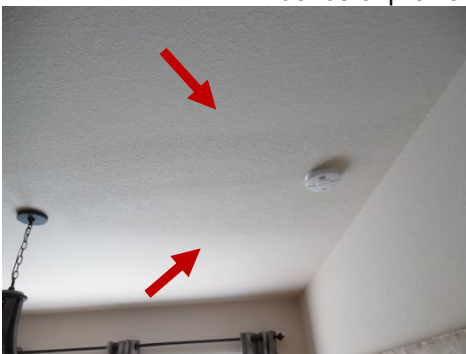
Evidence of previous ceiling repairs were observed in the dinette area.

Previous repair

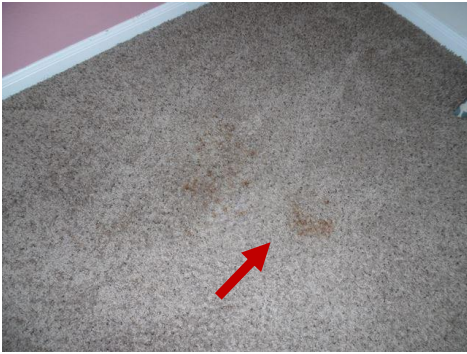
Front bedroom carpet stains

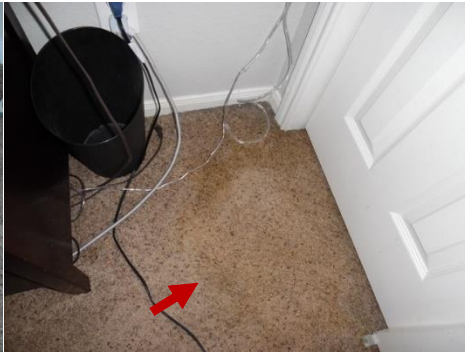
rear bedroom carpet stains

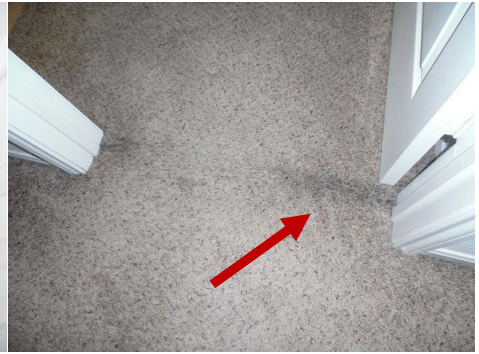
carpet stains under bedroom doors

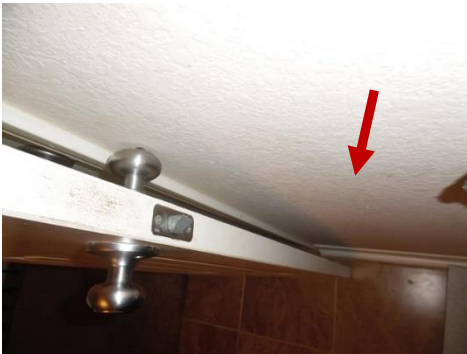
Doorstops are missing on the upstairs bathroom door. Door stops help prevent wall damage from doorknobs.

Doorstop missing

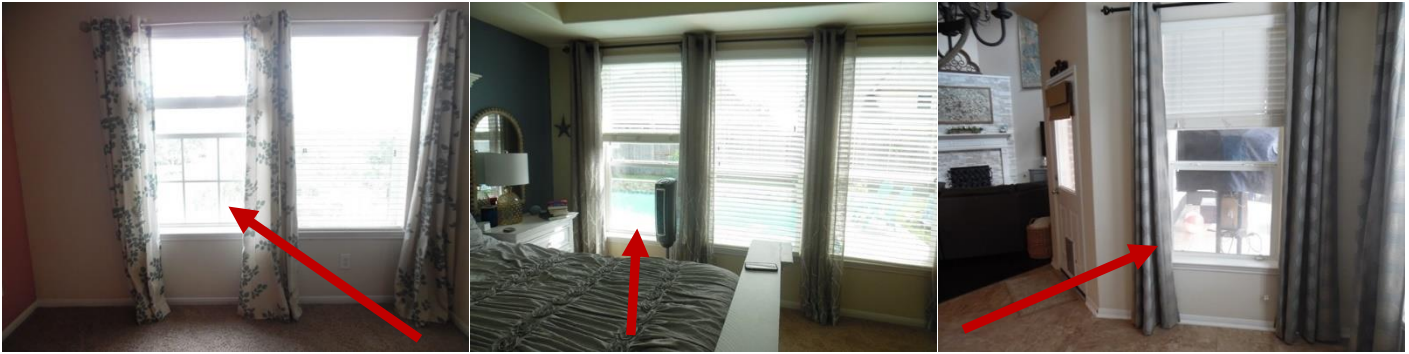
Windows were stuck and would not open with normal force in the upstairs front right bedroom, and master bedroom, and various locations thru out the structure.

Windows were stuck and would not open

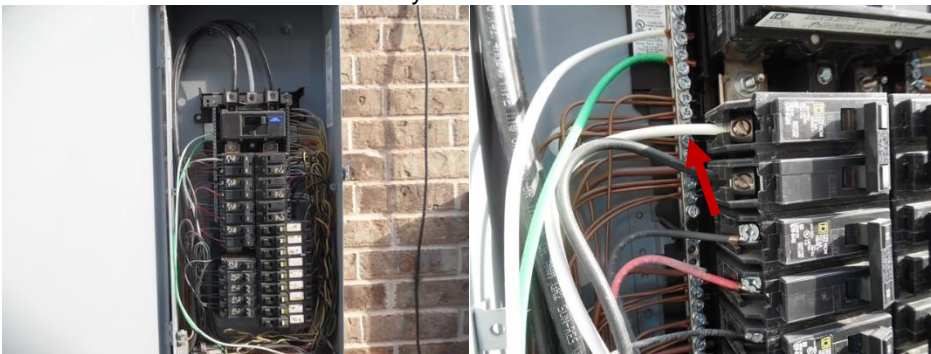
White wires are known to be identified as neutrals. If a white wire is on a breaker for a 220 volt circuit it should be color coded as a hot wire with black or red tape.

Put black tape on white wire

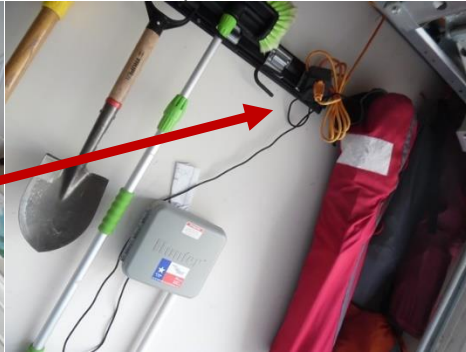
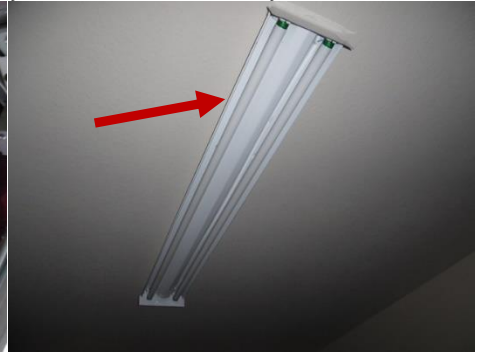
The lens cover is missing on the fluorescent light fixture in the master closet.

lens cover missing

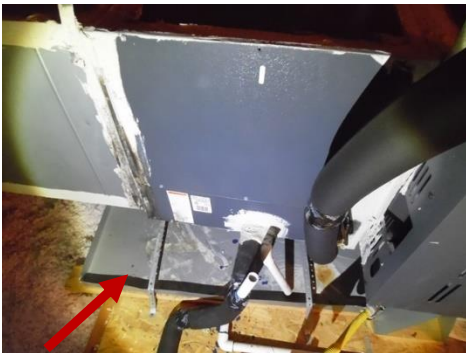
No float switch in pan

This inspector recommends a float switch in the overflow pan in case the pan fills up with water the float switch will cut the unit off to prevent an overflow onto the ceiling.

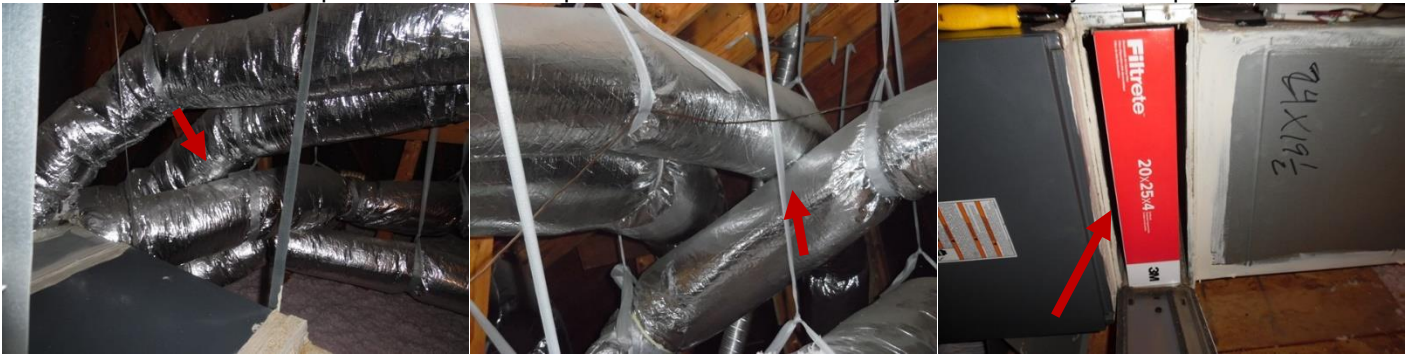
Several areas of the duct work are touching each other. This may cause a condensation issue. Separating the duct work or insulating the duct work from each other is recommended.

Ducts touching

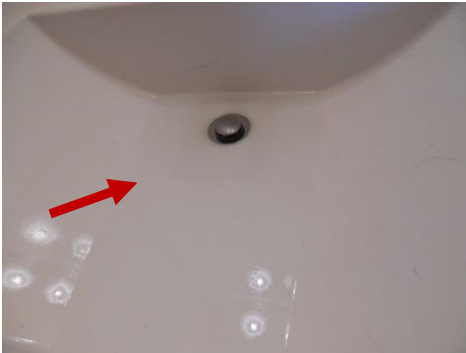
Bath Sinks: A slow drain was noted in the right sink in the upstairs Hollywood bathroom.
 Bathtubs: No problem observed at the time of inspection.
 Shower: No problem observed at the time of inspection.
 Commodes: No problem observed at the time of inspection.

Slow drain

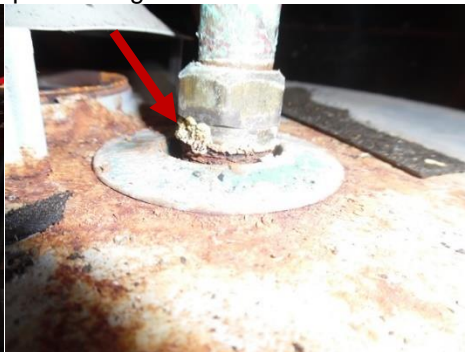
The water line connector is corroded on the right water heater.

rust / corrosion on right unit

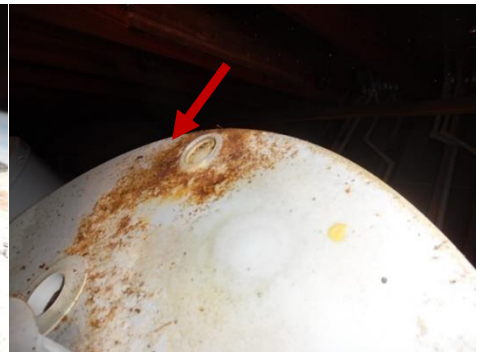
Rust is present on the top of both water heaters.

rust on top of the left unit

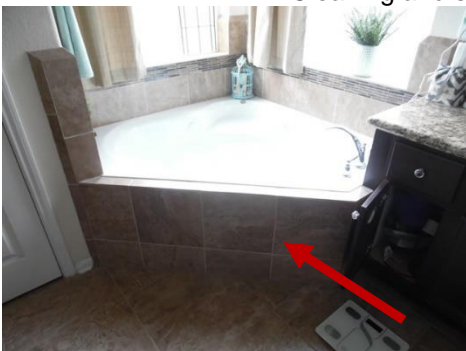
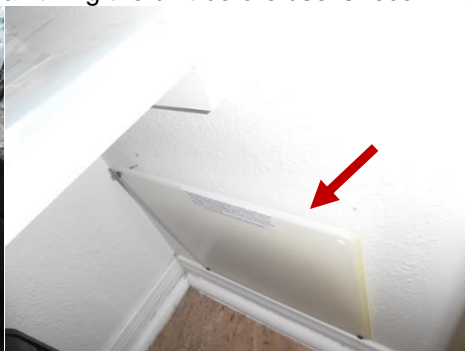
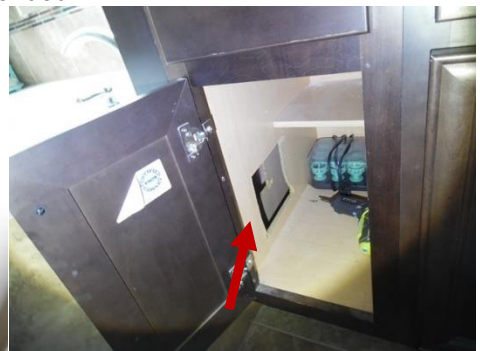
No readily accessible access underneath the tub as required for the pump, motor and plumbing was observed

No access to pump under tub

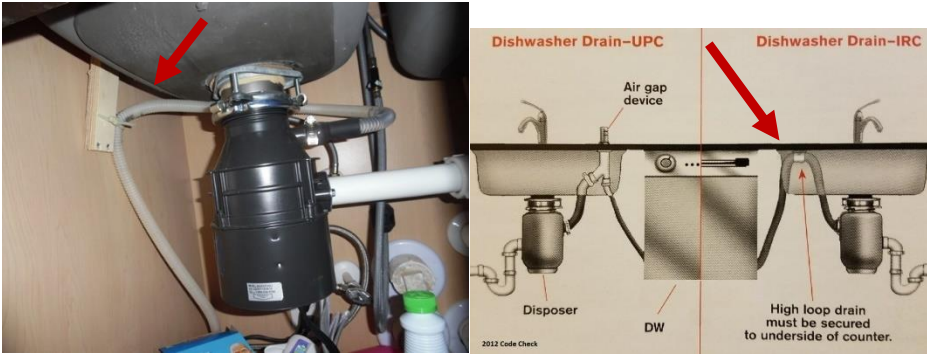
No proper air gap on the unit was observed. The drain line should be raised above the bottom of the sink to the bottom of the counter top with a loop or sharp bend of the hose before terminating in the disposal tail piece the hose appears to need raising, or a counter top air break may be needed. This helps prevent the water in the sink from draining back into the dishwasher.

Air gap not high enough
