STRUCTURAL REPORT

1234 Lehman St
Houston, TX 77018

APRIL 26, 2024

REF: CONDITION OF PROPERTY SURVEY

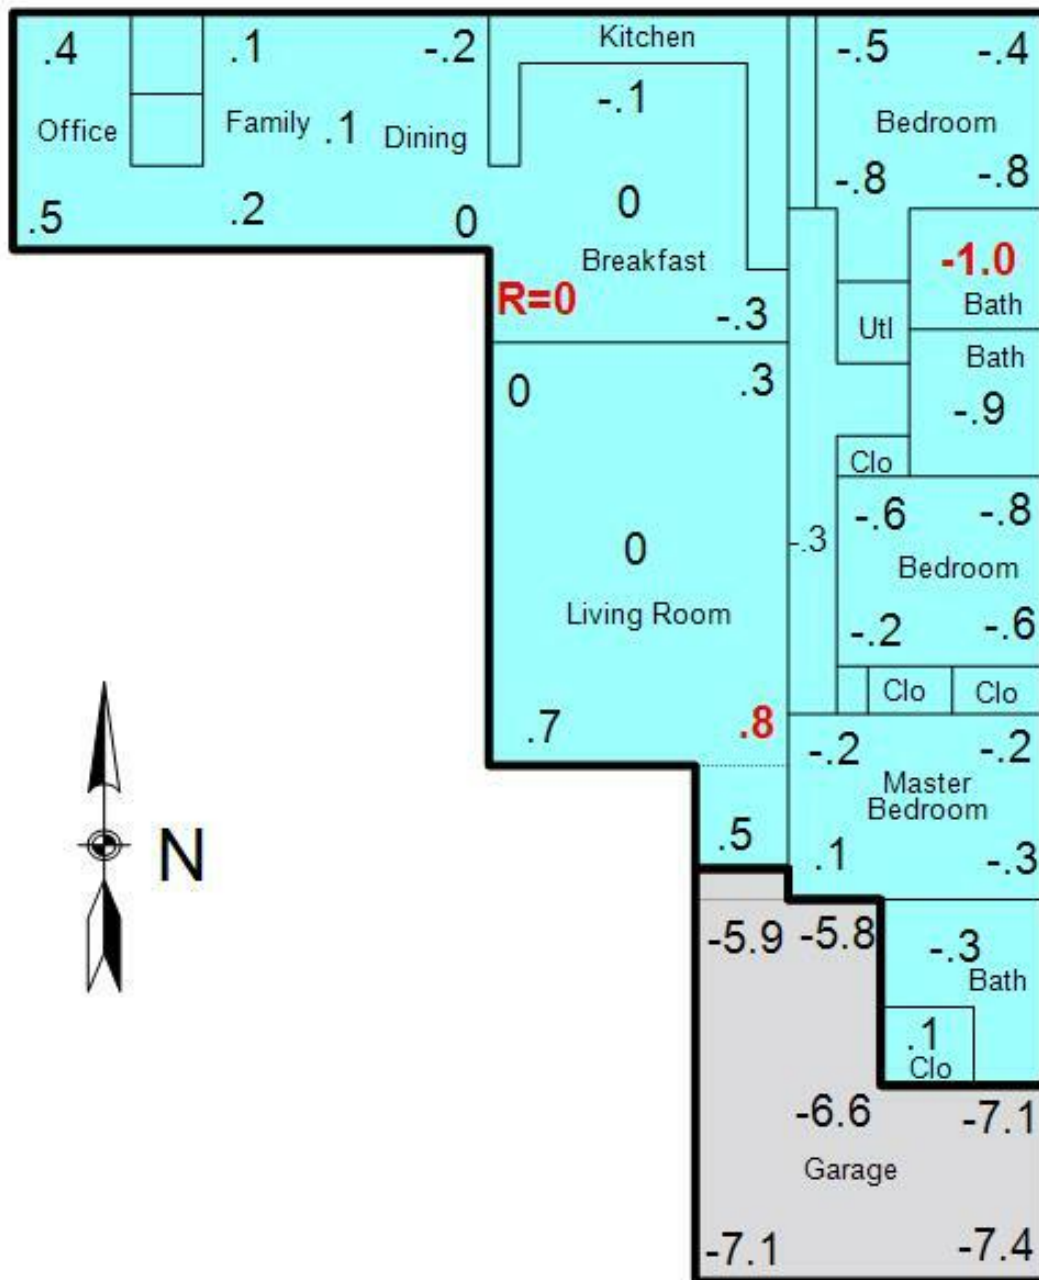
Elevation Readings 1234 Lehman St.

The floors were checked with an electronic level, and were observed to be sloping towards the east side of the house. The difference in elevation between the high point and low point was 1.8 inches. The high point was located at living room, and the low point was located at the rear bathroom. The unlevelness takes place over a horizontal distance of approximately 20-30 feet.

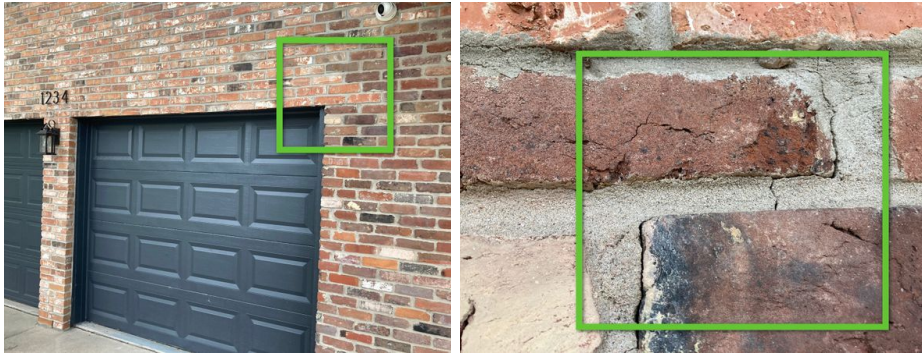
Differential Movement: Veneer Cracks - Minimal

We observed that cracks in the exterior veneer were minimal in number and degree at the time of the inspection.

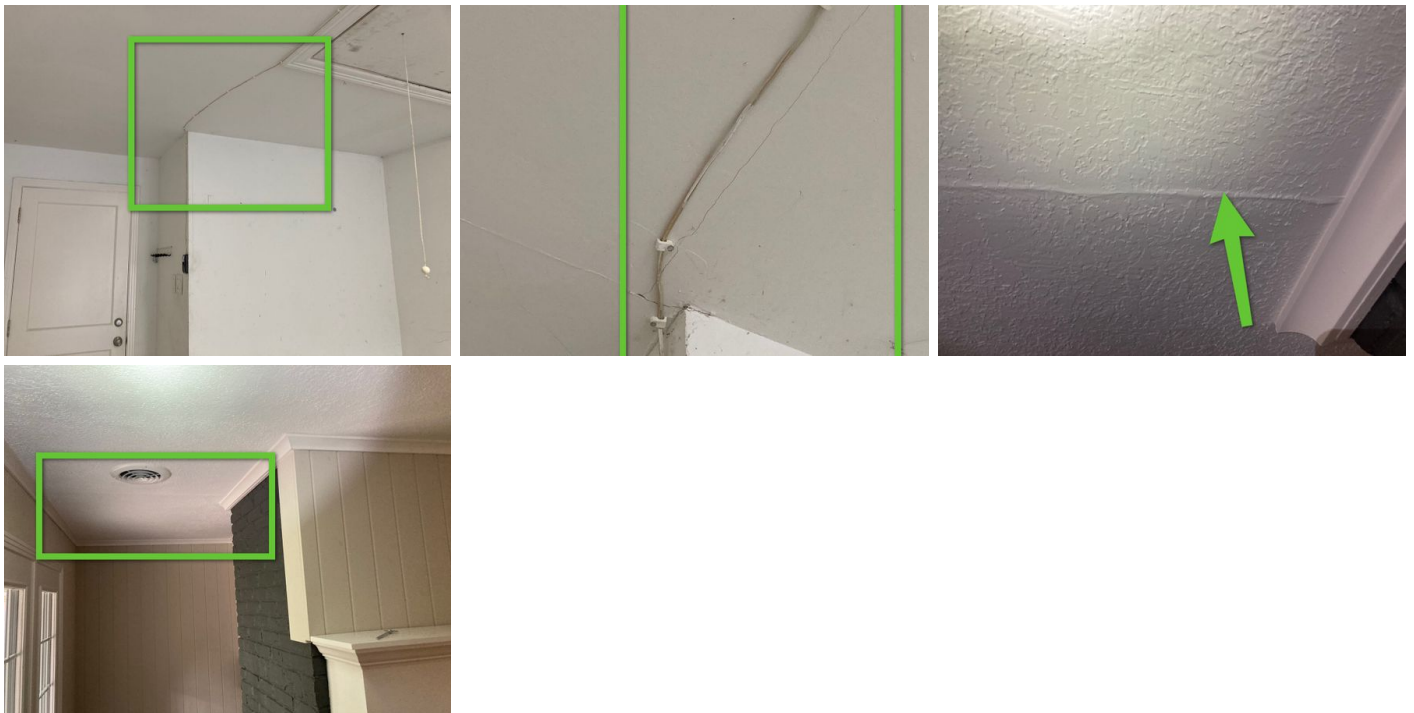
Garage, and the office.

Differential Movement: Sheetrock Cracks - Minimal

We observed that sheetrock cracks were minimal in number and degree at the time of the inspection.

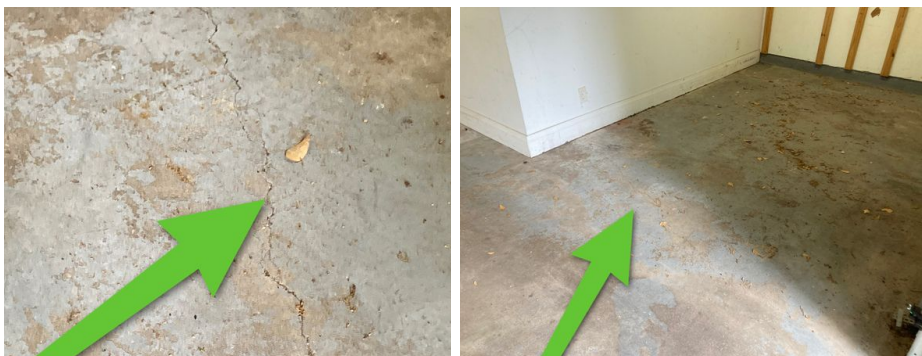
Differential Movement: Concrete Cracks - Garage

Cracking of the foundation concrete exists in virtually all foundations. It is pointed out that cracking is a normal property of concrete and other brittle materials, and Hedderman Engineering, Inc. assumes no responsibility should cracks be found that are not mentioned in this report. Some cracking was observed in this concrete foundation, including at the garage floor.

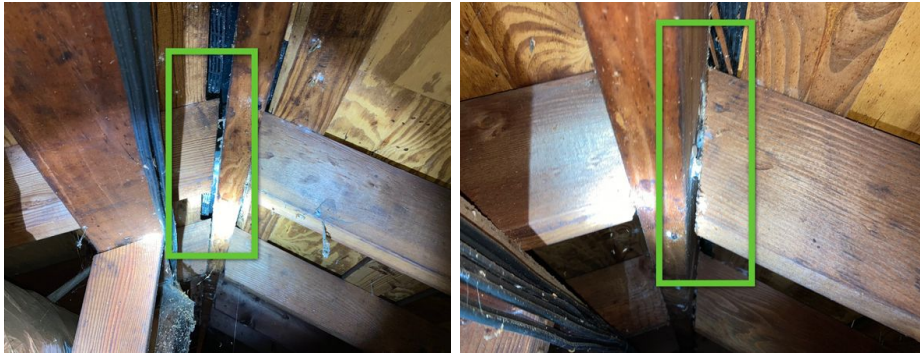
Separation of Materials: "Ghost" doors

Master closet

"Ghost" doors, where the door swings open and/or shut by itself due to unlevelness were observed.

Separation of Materials: Rafter separation

One or more rafters were observed to be separated from the ridge beam in the attic, which can be an evidence of movement.

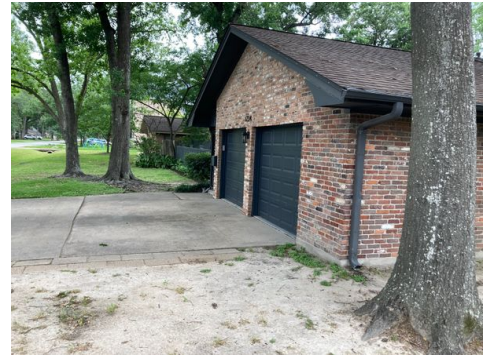
TREES AND/OR FOLIAGE

Trees and/or foliage were observed in the vicinity of the house which can contribute significantly to differential movement of the house foundation. Care should be taken to prevent the trees and foliage from removing an excessive amount of water from near the foundation of the house.

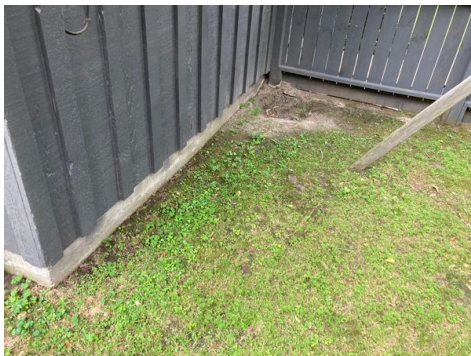
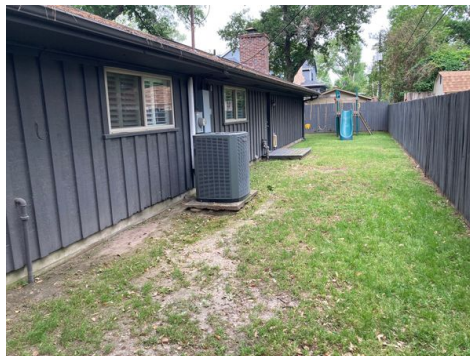
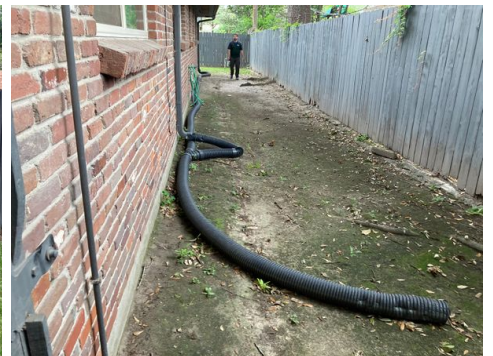
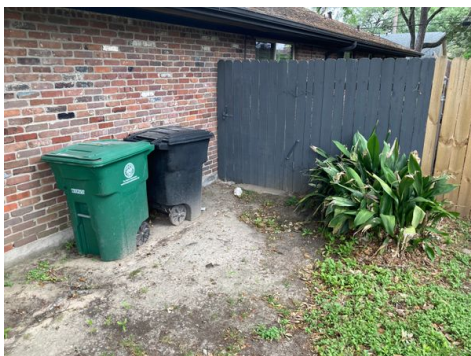
The drainage was observed to be poor at some low areas where it appears that water will pond. It is recommended that a company specializing in drainage solutions be contacted to provide a recommended solution, along with a cost estimate to provide proper drainage.

Obtain Cost Estimate

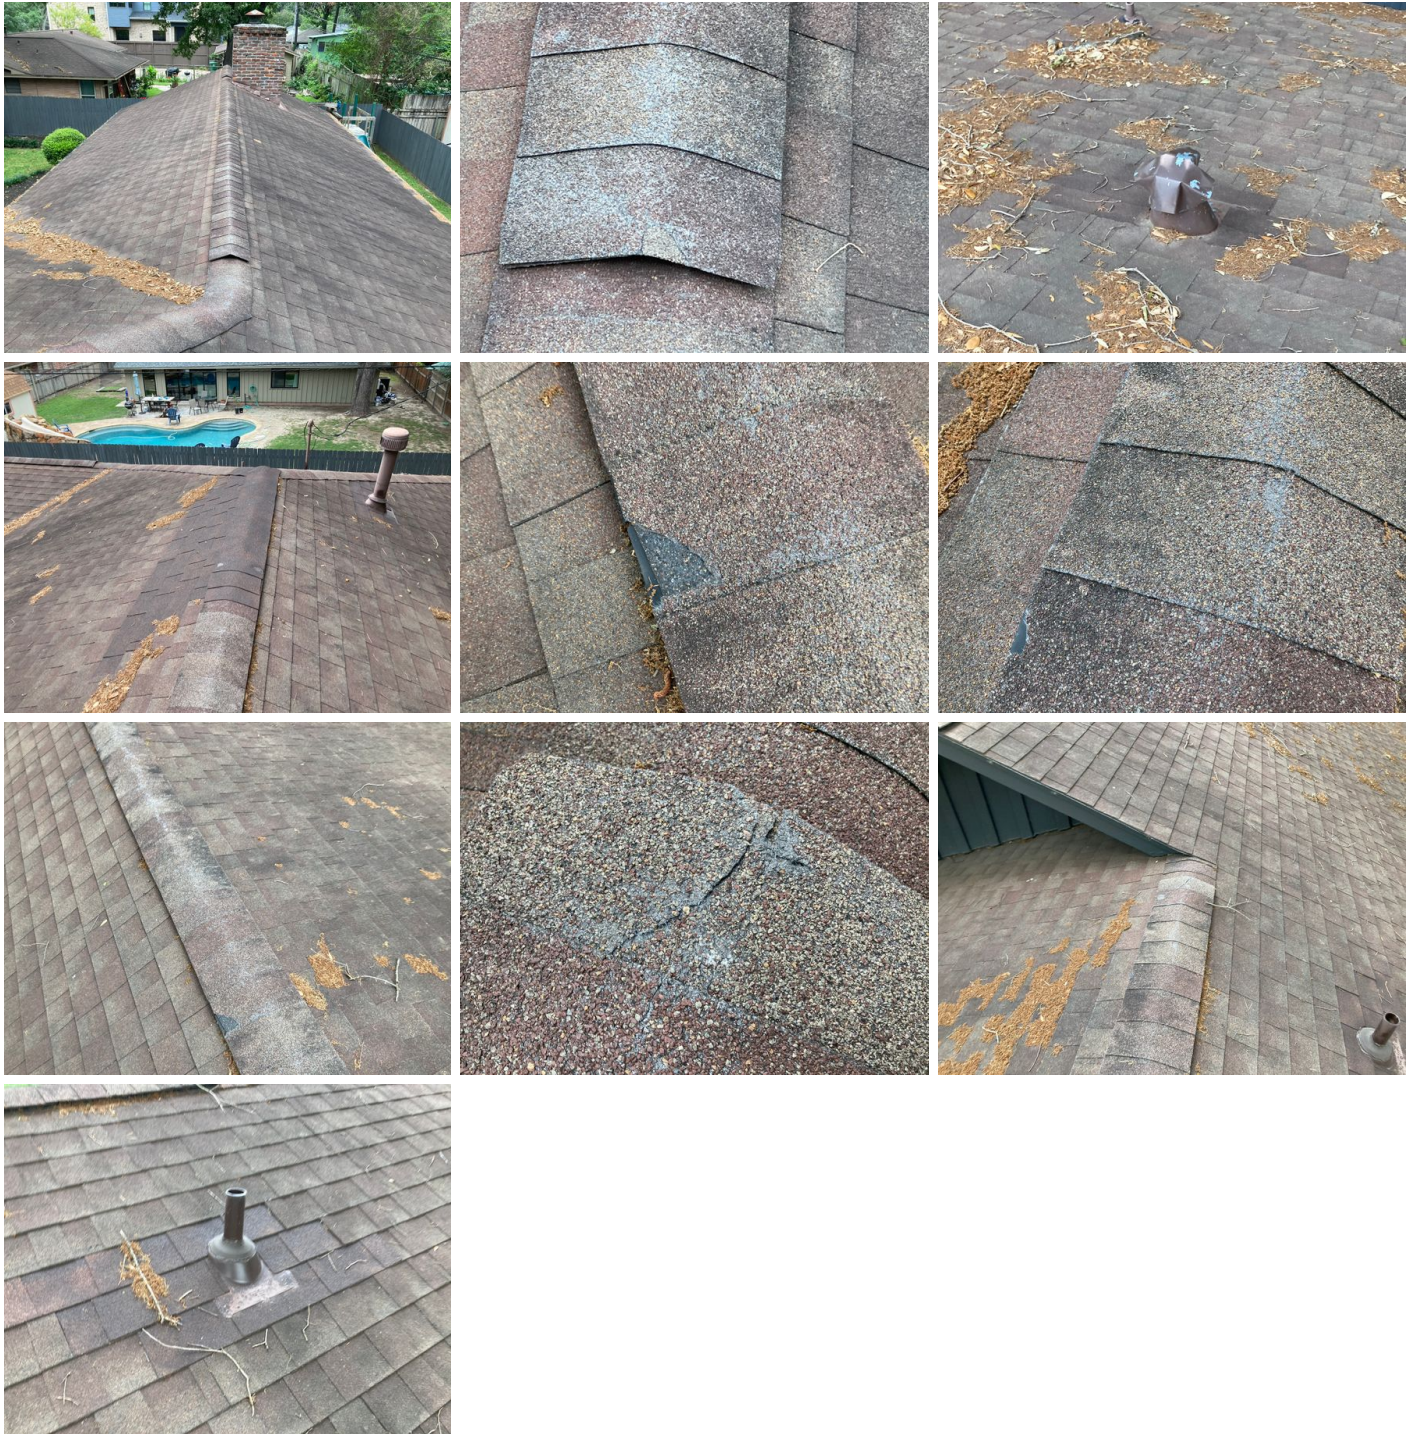
Wear and Deterioration: Composition - Some

Discolored, Damaged Shingles, Patched

The composition roof surface was showing evidences of some deterioration of the roof surface as described above and shown below.

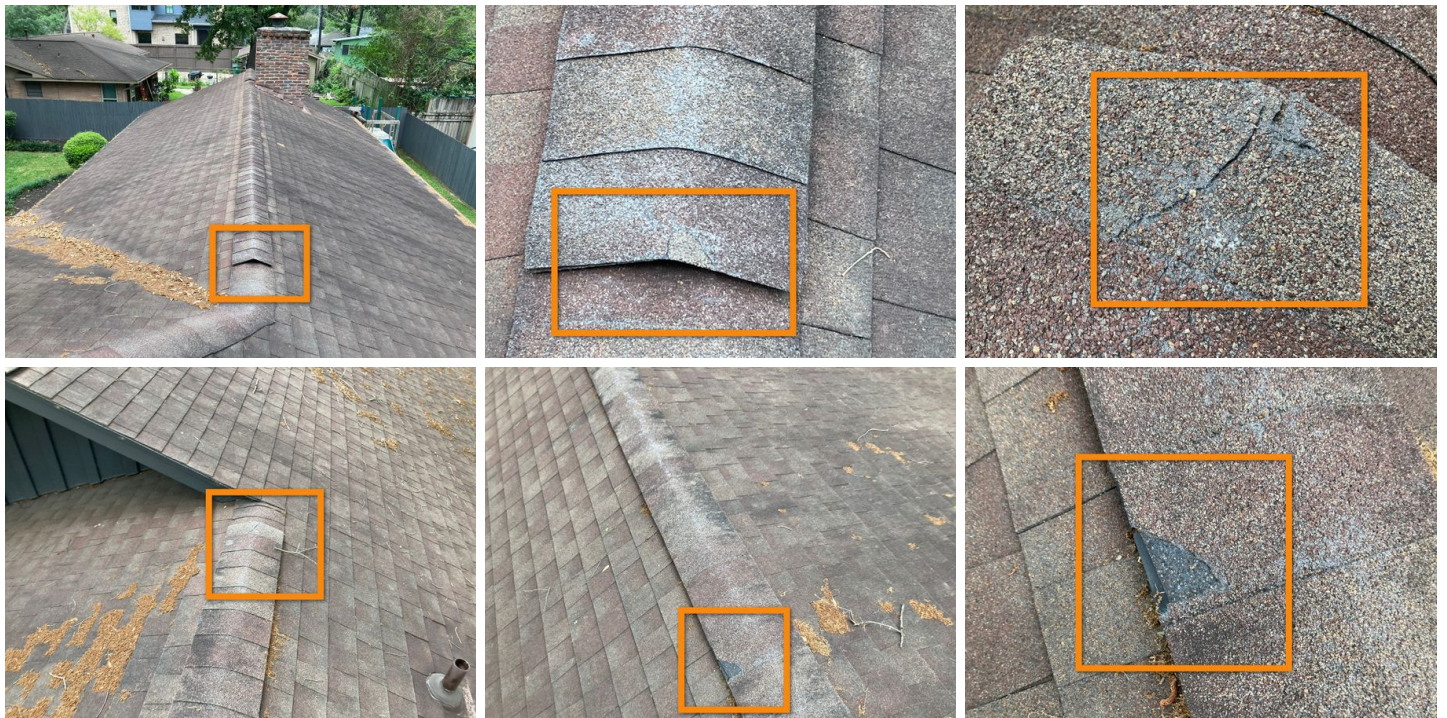
SHINGLES DAMAGED

Shingles were observed to be damaged and the roof is in need of repair. Contact a roofing contractor to obtain a cost estimate for repairs.

Obtain Cost Estimate

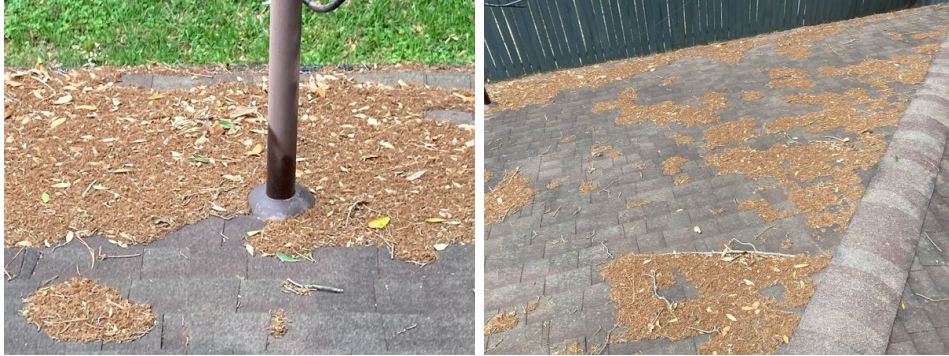
5.8.2 Roof Details

ROOF: MISCELLANEOUS

We observed some miscellaneous items related to the surface of the roof, including the items listed above. Have a roofing contractor provide a cost estimate to make any needed repairs.

Obtain Cost Estimate

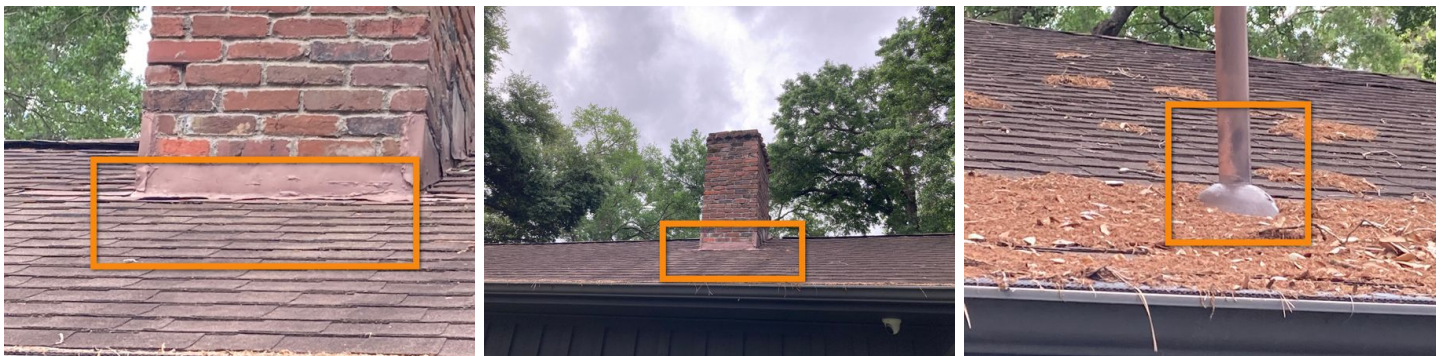
5.8.3 Roof Details

FLASHING/COUNTER FLASHING

Flashing not secure at the chimney, Rubber boot at electrical service mast is missing

We observed one or more conditions with the roof flashing as pointed out above. Have a roofing contractor provide a cost estimate to make all needed repairs.

Obtain Cost Estimate

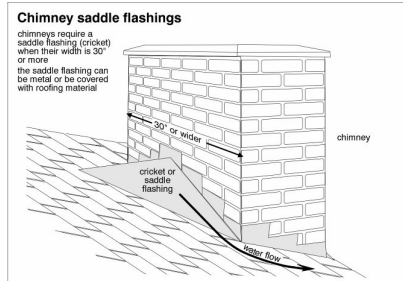
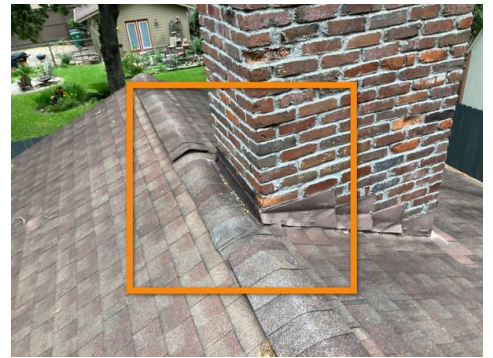
5.8.4 Roof Details

NO CRICKET

No cricket has been installed behind the chimney to divert the roof runoff around the chimney. Since the chimney is more than 30 inches wide, it is recommended that a cricket be installed.

Obtain Cost Estimate

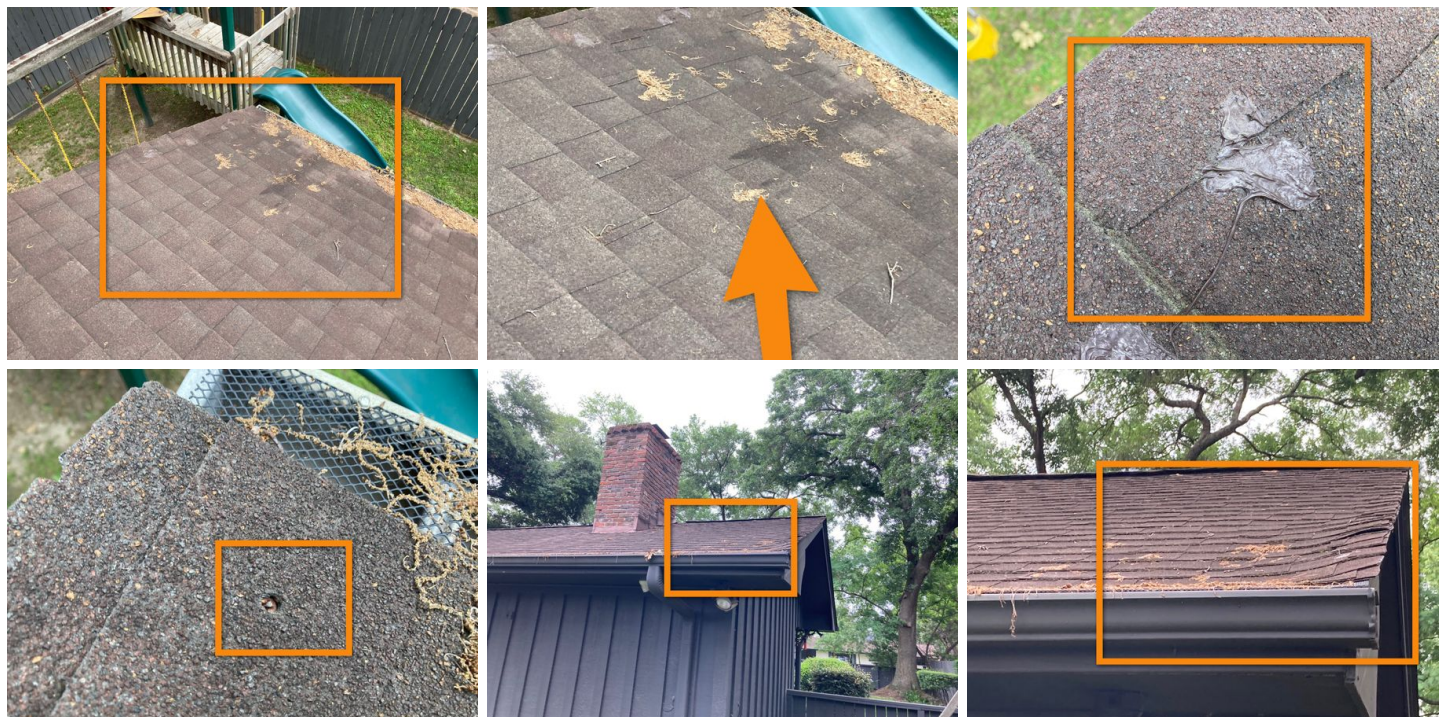
5.8.5 Roof Details

DIP

The is a dip at the roof decking near the northwest corner of the house. The area appeared to be previously repaired. Further investigation with a roofer is recommended regarding the cause of this condition and the extent of any repairs which may be needed.

Obtain Cost Estimate

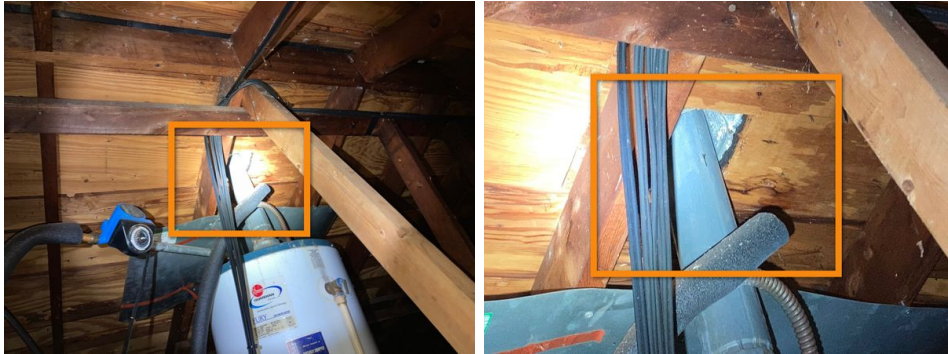
5.9.1 Roof Leaks

ATTIC ROOF DECKING AND/OR FRAMING MEMBERS

After observing the interior of the structure, evidences of roof leaks were visible in the attic, where the roof decking and/or roof framing members were water stained. It is recommended that a roofing contractor be contacted to find the source of the leaks, and to make any needed repairs.

Obtain Cost Estimate

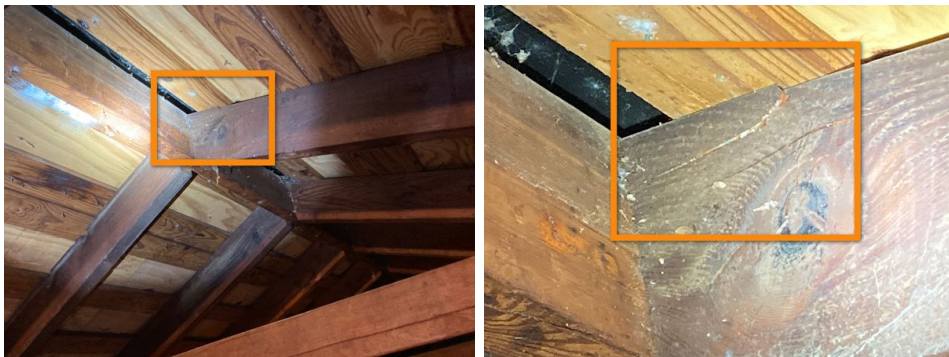
One or more rafters in the attic were observed to be split, and need to be repaired.

Obtain Cost Estimate

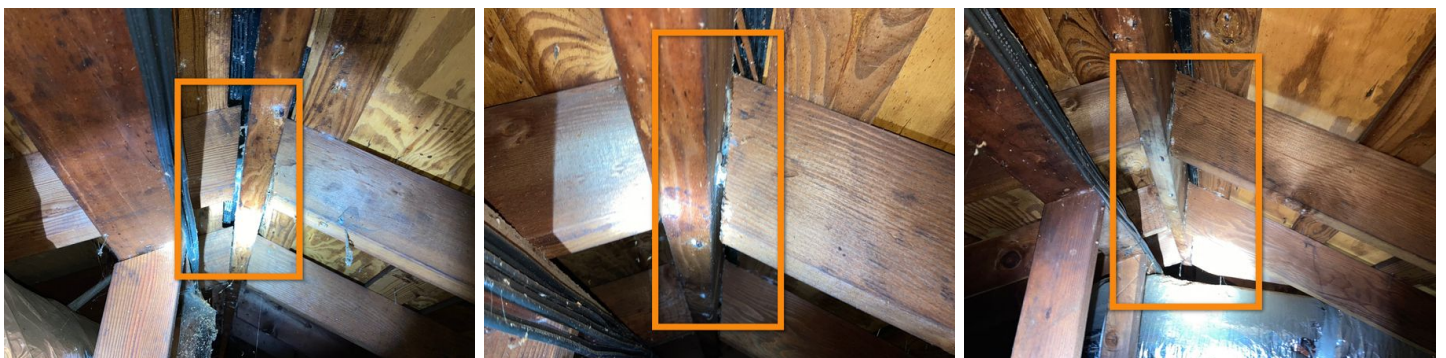
6.9.2 Rafters

RAFTER NOT FLUSH ON RIDGE BEAM

We observed rafters that were separated at the top of the rafter, where the rafter meets the top ridge beam. Rafters should be flush against the ridge beam, and it is recommended that 3 foot make-up pieces be "sistered" onto the rafters, so that the make-up pieces are flush against the ridge. This will allow the rafters to bear against the ridge beam for the entire length of the miter cut on the rafter.

Obtain Cost Estimate

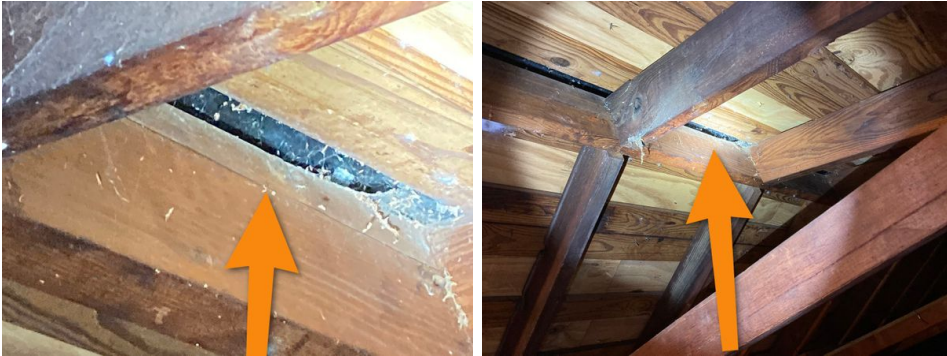
6.13.1 Ridge Beam

REPAIRS - CRACKED

The ridge beam was cracked, and needs to be repaired.

Obtain Cost Estimate

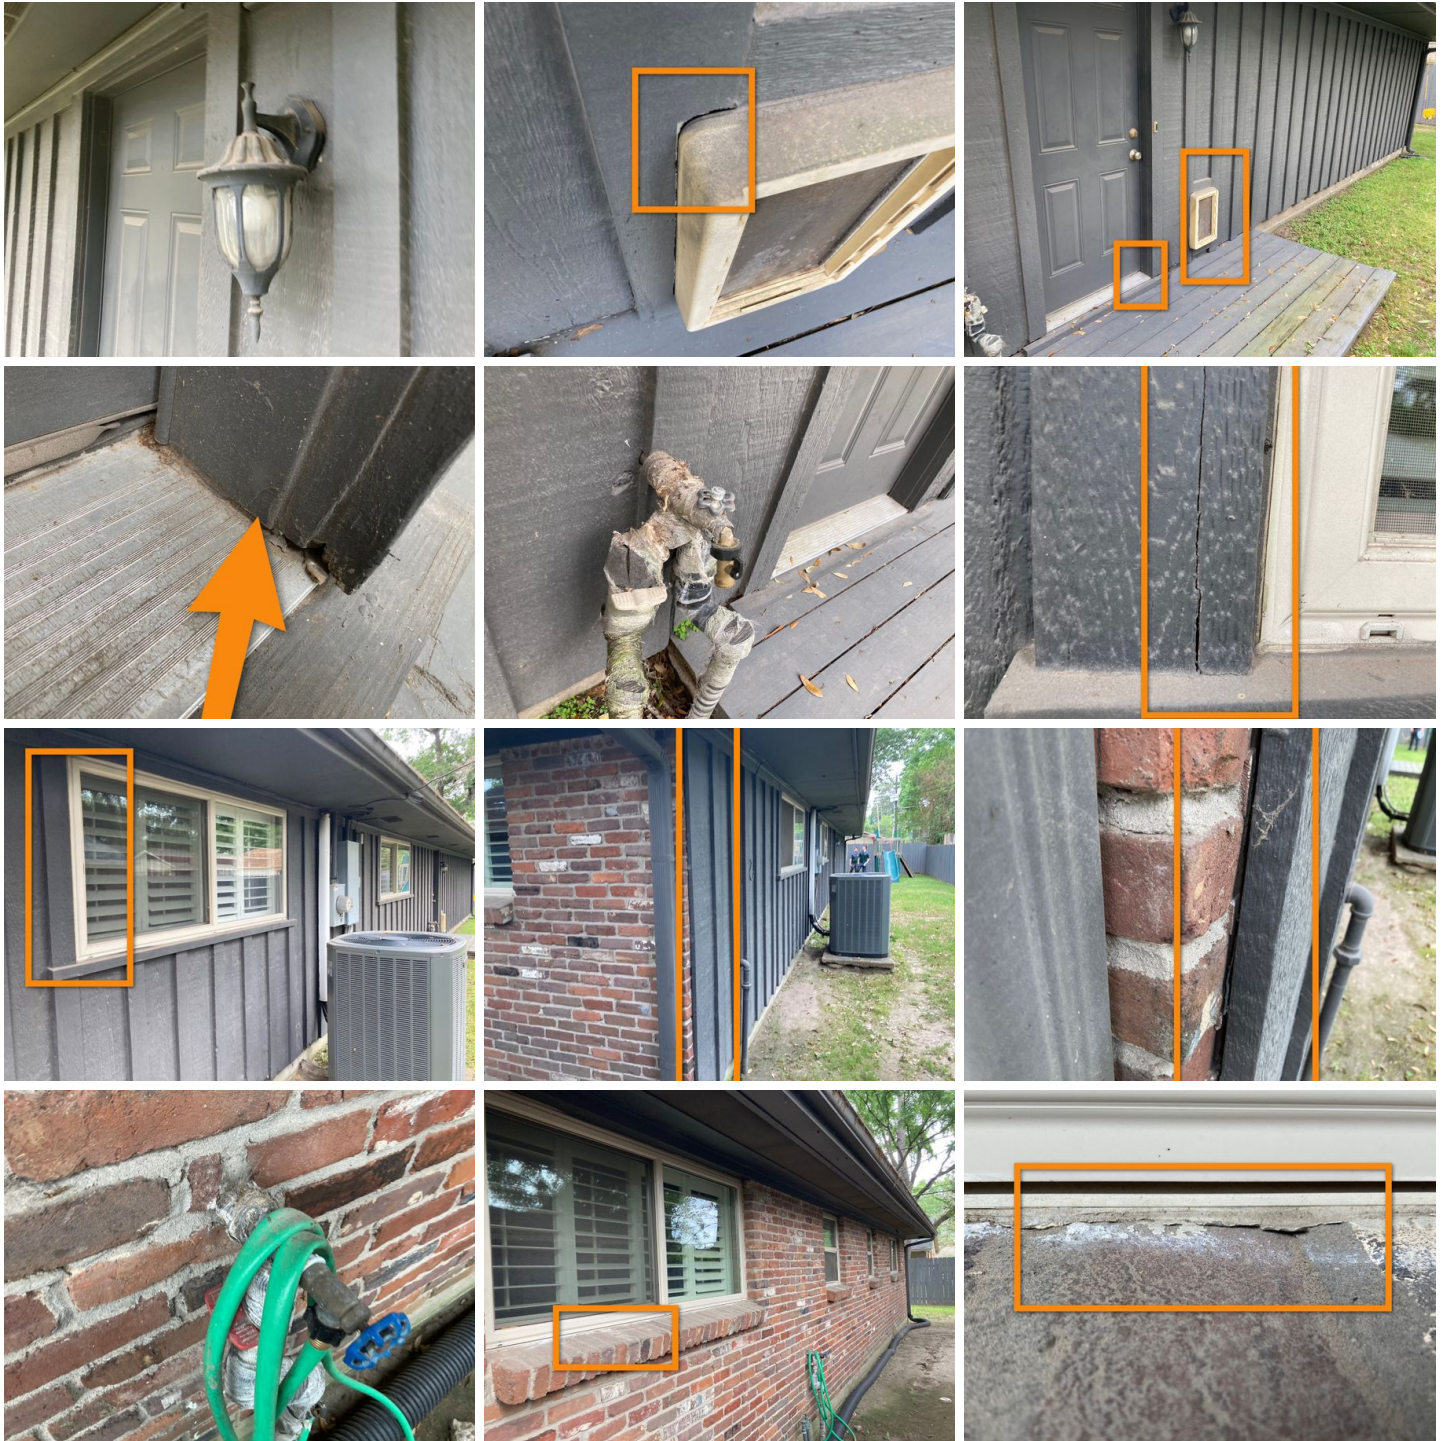
Sealants deteriorated/missing, Window sealants, Light Fixtures, Hose Bibb, Piping, Door Threshold, Vertical joint between materials

A substantial vulnerability to water penetration was observed at penetrations/openings through the exterior building envelope, and it is recommended that all penetrations/openings be sealed against water penetration. Typical examples on a structure may include light fixtures, air conditioning refrigerant lines, water piping, gas piping, vent caps, windows, doors, expansion joints, etc. Below is a representative sample of locations and/or photographs showing some, but not necessarily all, locations where there is a vulnerability to water penetration. Have a contractor provide a cost estimate to seal all vulnerable areas on the exterior building envelope against water penetration.

Obtain Cost Estimate

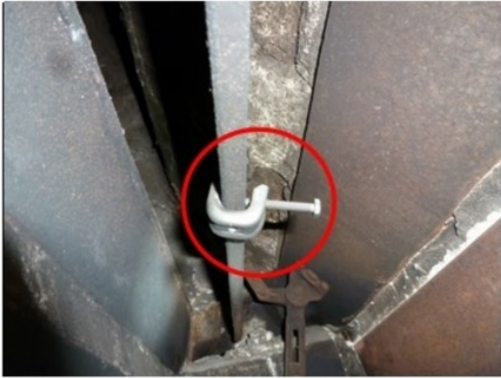
DAMPER - C CLAMP MISSING

The damper was not equipped with a C-Clamp device to prevent closing the damper completely to allow the hazardous combustion gases a path to escape up the chimney.

Obtain Cost Estimate

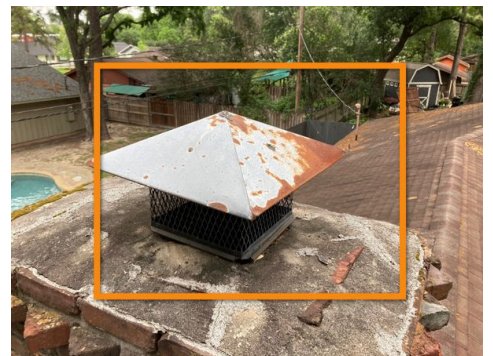
8.3.2 Masonry fireplace

WEATHER CAP - RUSTED

The top of the chimney flue had a metal spark arrester/weather cap installed in the flue to prevent water penetration down the chimney. The cap was rusted and needs to be cleaned and sealed to prevent further deterioration.

Obtain Cost Estimate

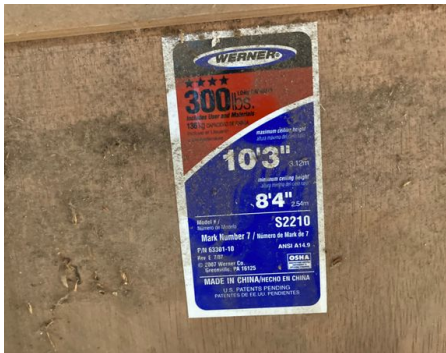
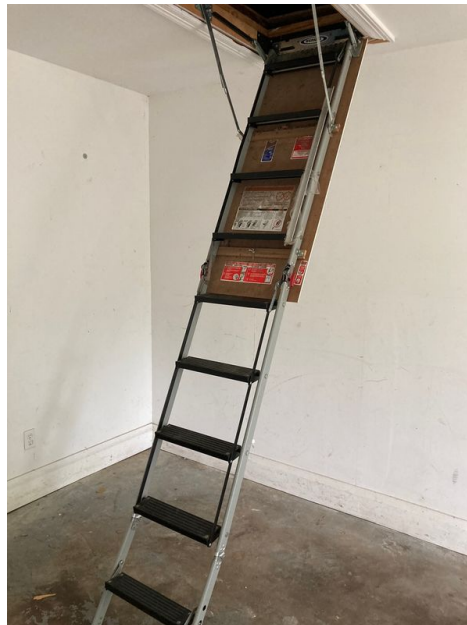
Ladder: Ladder - 300 Lb. rating

The rated capacity of the access ladder into the attic is 300 pounds. The ladder does not meet current code requirements for ladders into attics. Consideration should be given to replacing the ladder with a ladder that meets current code requirements.

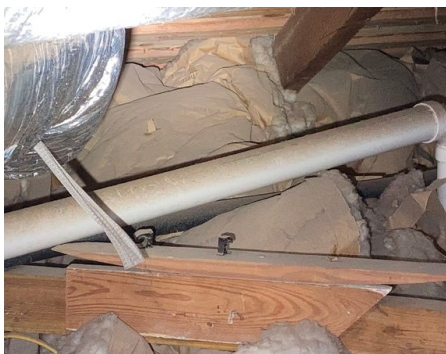
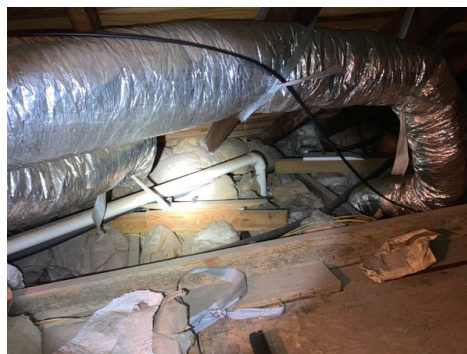
Fromt bedroom

This attic had approximately 9-10 inches of fiberglass batt insulation in the ceiling, which is equivalent to an R30. It is pointed out that the insulation requirements according to the latest standard for new houses in this area is an R38 energy rating.

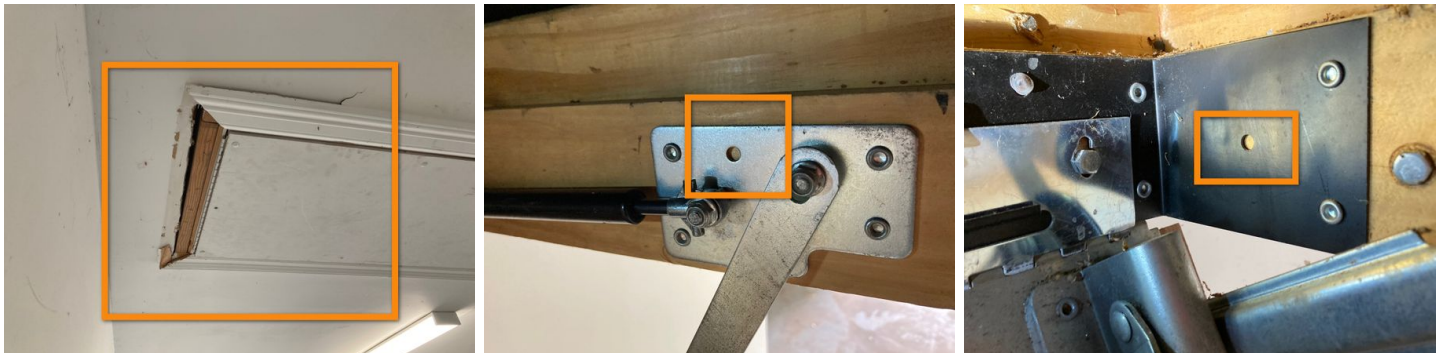
LADDER ATTACHMENT IMPROPER

Nail(s) missing in spring arm pivot(s), Nail(s) missing in corner bracket(s), Loose/missing trim

The stair assembly was not properly installed or secured to the framing members, and repair is needed for safety purposes. The condition(s) can be a safety hazard, and repair is needed, as an improperly installed stair assembly can possibly collapse.

Obtain Cost Estimate

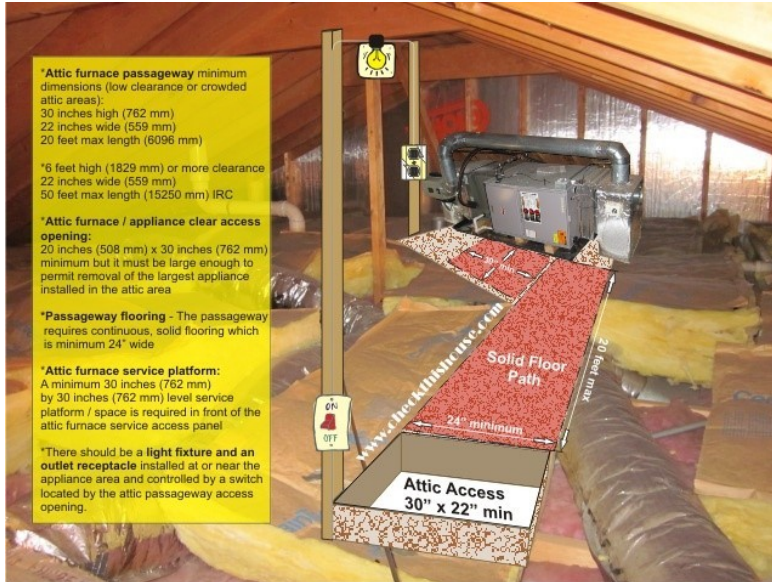
INADEQUATE WALKWAY DECKING

The attic did not have adequate service decking to all the equipment in the attic. The service decking should be a continuous deck that is a minimum of 24 inches wide, that extends from the attic access opening to all equipment in the attic. In addition, the decking should be free from any obstructions, such as gas lines, electrical wiring, ductwork, framing members, etc.

M1305.1.3**Obtain Cost Estimate**

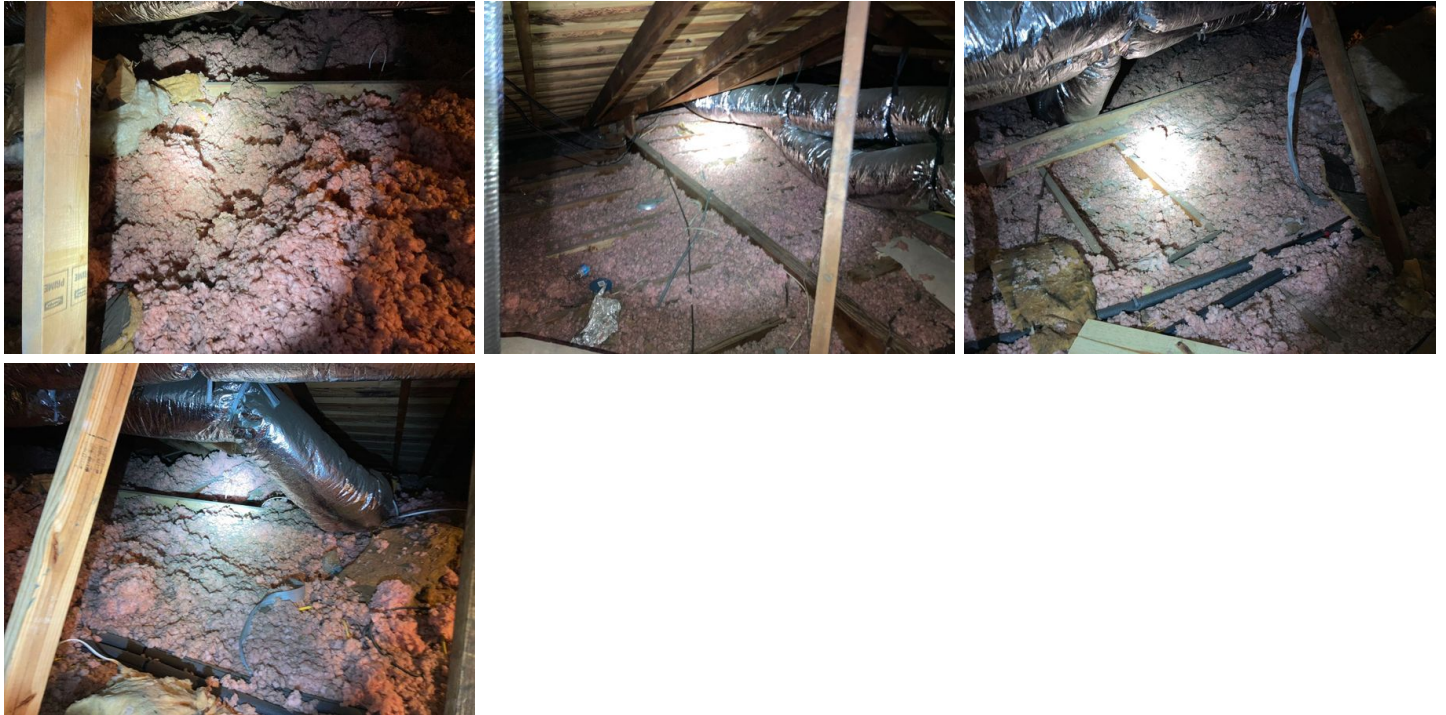
9.6.1 Insulation

THIN 3-10 INCHES

This attic appeared to have approximately 3-10 inches of insulation in the ceiling. It is recommended that consideration be given to installing additional insulation. Current construction standards for new homes have insulation that is a minimum of an R-38 rating, approximately 14 inches of insulation.

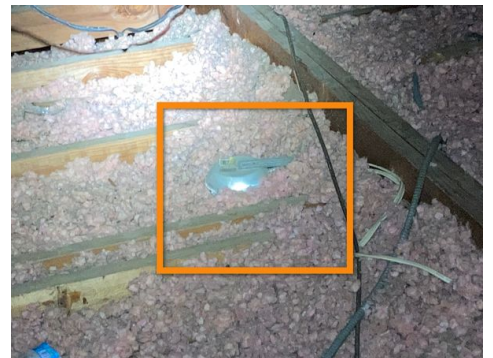
9.6.2 Insulation

CONTACT WITH RECESSED LIGHTS - LABELED AS NON-IC

The insulation was in contact with the recessed lights, which can be a fire hazard and shorten the life of the light bulbs. The recessed cans were specifically labeled as "Non-IC", which indicates that the recessed can cannot be in contact with the insulation. It is recommended that the insulation be pulled back to provide a three inch air space around the recess lights.

Obtain Cost Estimate

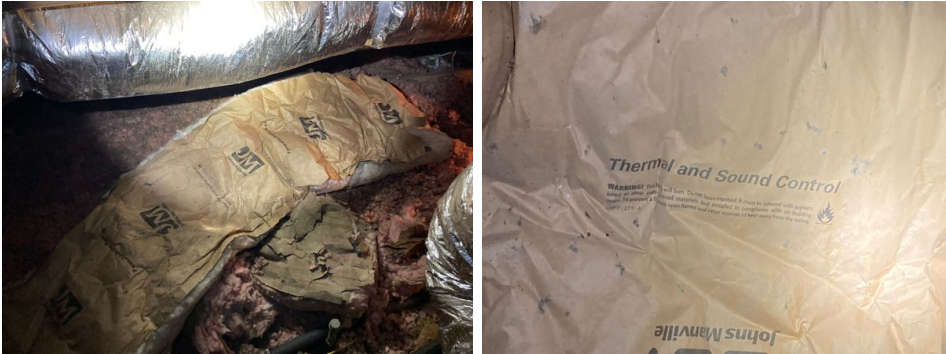
9.6.3 Insulation

INSULATION INSTALLED WITH VAPOR BARRIER TO ATTIC

The batt insulation in the front bedroom attic was installed with the vapor barrier up to the attic, rather than down against the sheetrock. This is a fire hazard and it is recommended to flip the insulation with the vapor barrier towards the Sheetrock.

Obtain Cost Estimate

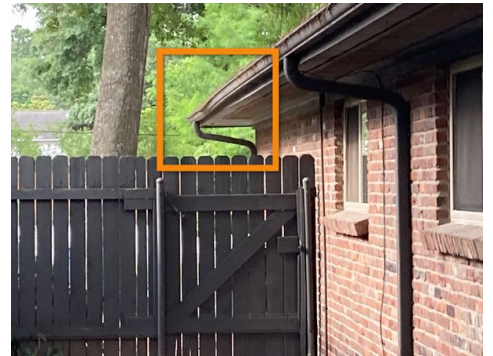
GUTTER DAMAGED

The gutter was damaged and needs to be repaired.

Obtain Cost Estimate

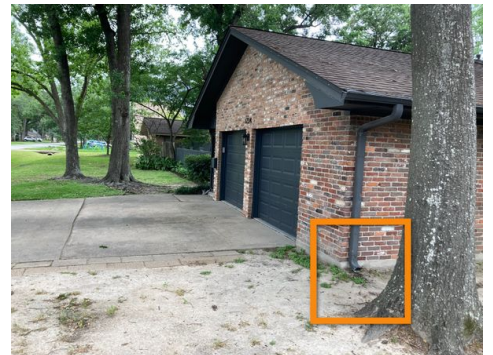
11.3.2 Gutters and Downspouts

DS SPLASH BLOCK

The downspout was missing a splash block.

Obtain Cost Estimate

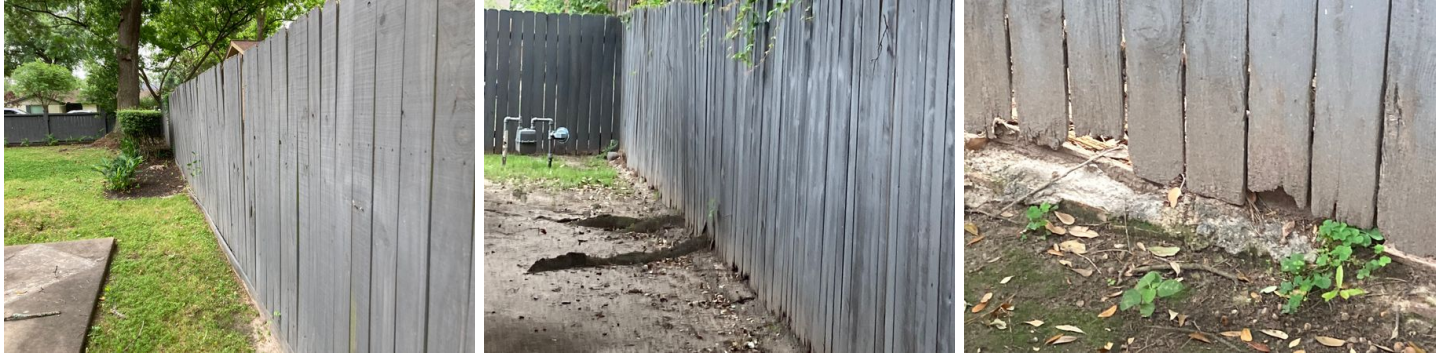
The wood fence was in need of some repairs.

Obtain Cost Estimate

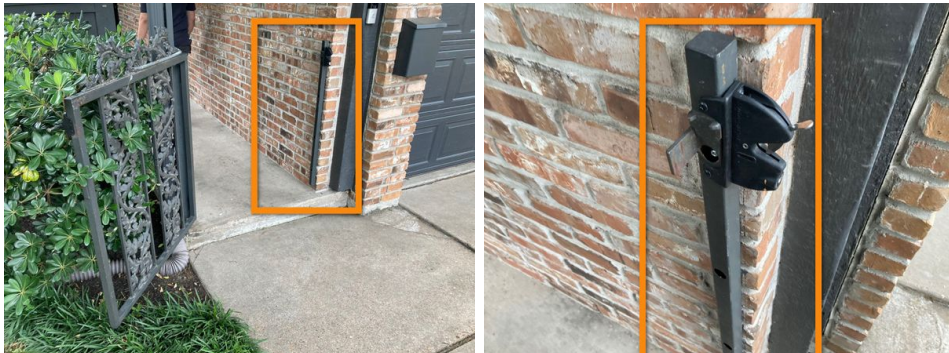
11.4.3 Gates and Fences

WROUGHT IRON GATE

Loose post

The wrought iron gate was in need of some repairs.

Obtain Cost Estimate

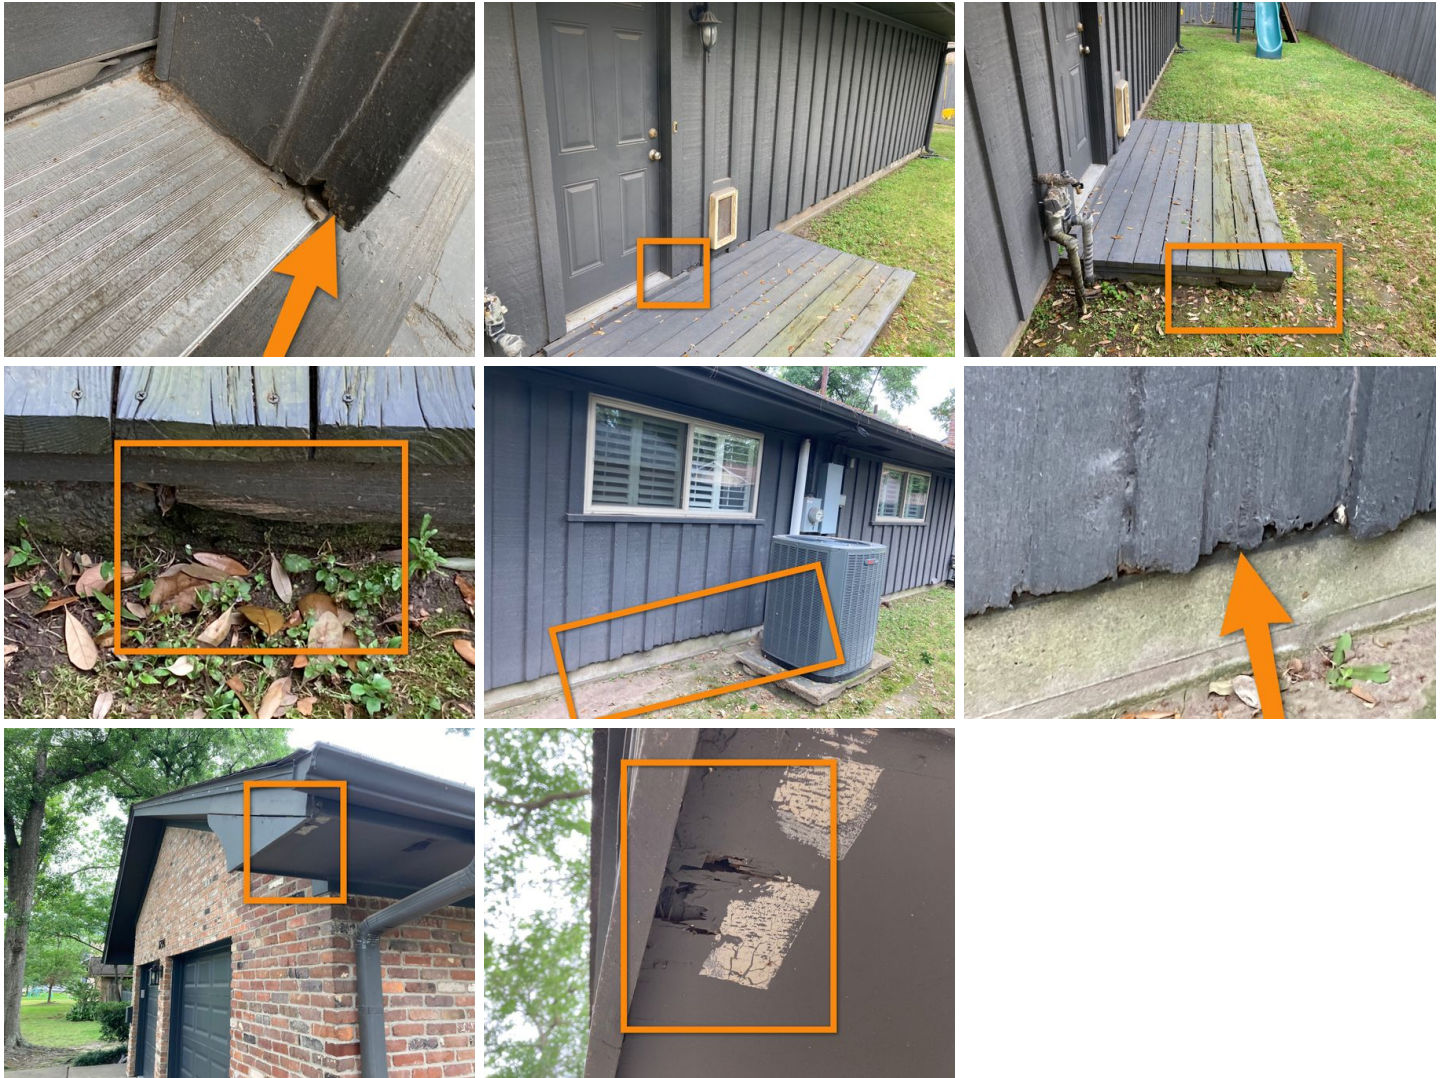
11.5.1 Wood Rot

WOOD ROT

We observed evidences of wood rot and it is recommended that all rotted wood be replaced. Have a contractor provide a cost estimate to determine the entire scope of the wood rot, and provide a cost estimate to replace all rotted wood in the house.

Obtain Cost Estimate

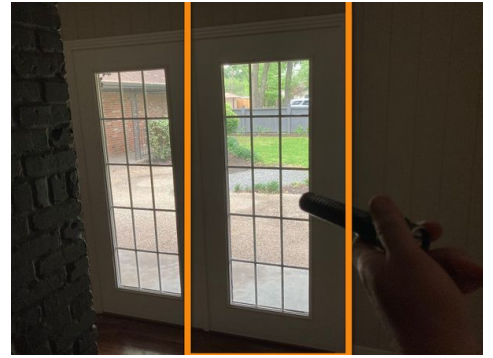
One double pane window was observed where the seal has been compromised and allowed moisture between the two panes. It is pointed out that we were not able to view every window under differing lighting conditions at different times of the day, and we may not be able to see discoloration that may become visible under different lighting and/or weather conditions, other than at the locations listed below. Further investigation with a window specialist is recommended concerning the windows to determine the extent of the condition throughout the house, and to make all needed repairs.

Obtain Cost Estimate

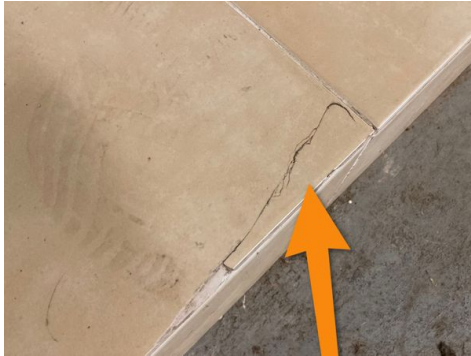
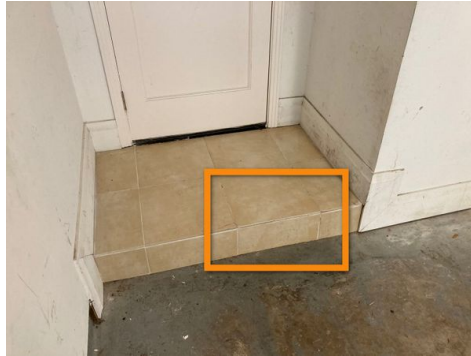
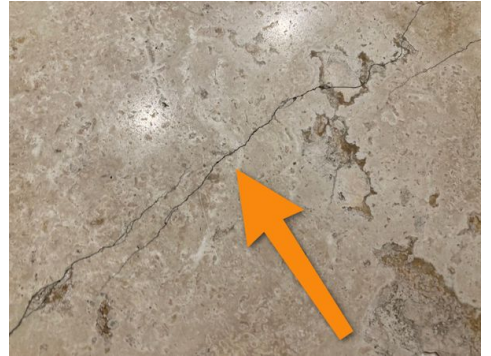
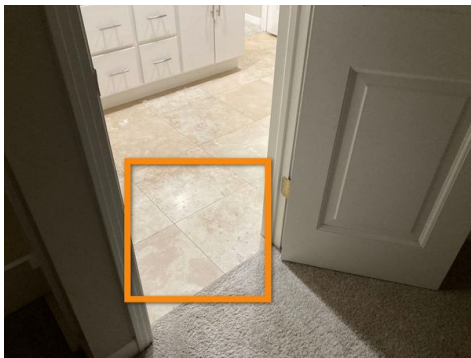
Floor tiles were cracked and it is recommended they be replaced.

Obtain Cost Estimate
