STRUCTURAL REPORT

1234 Lehman St
Houston, TX 77018

APRIL 26, 2024

REF: CONDITION OF PROPERTY SURVEY

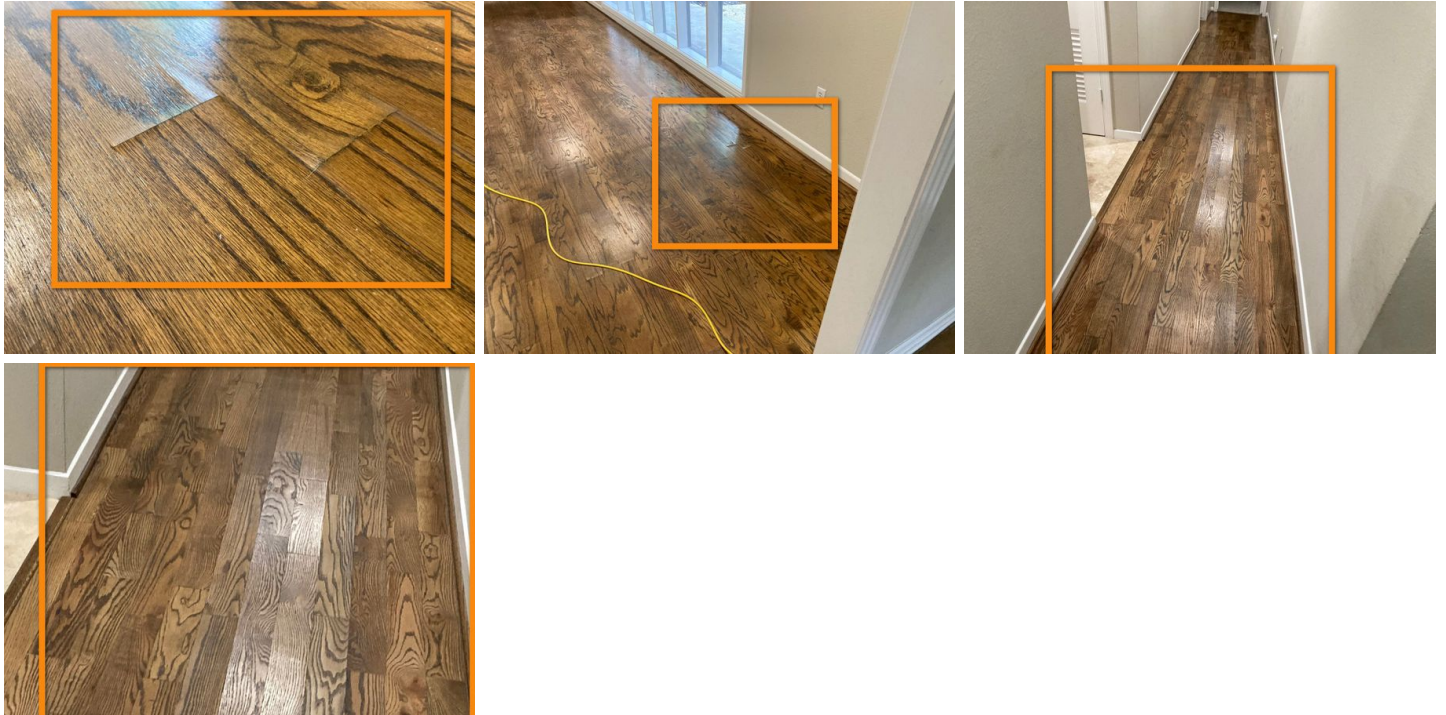
12.4.2 Floor coverings

WOOD FLOOR WASHBOARD

The wood floor boards were observed to be cupped, with the edges of the boards curling upwards into a “washboard” effect. This condition is typically caused by moisture entering the wood and causing the boards to swell in size, causing peaking of the edges as they are pressed together. Further investigation with a wood floor specialist and/or a service company is recommended to determine the source of the moisture, and to make any needed repairs.

Obtain Cost Estimate

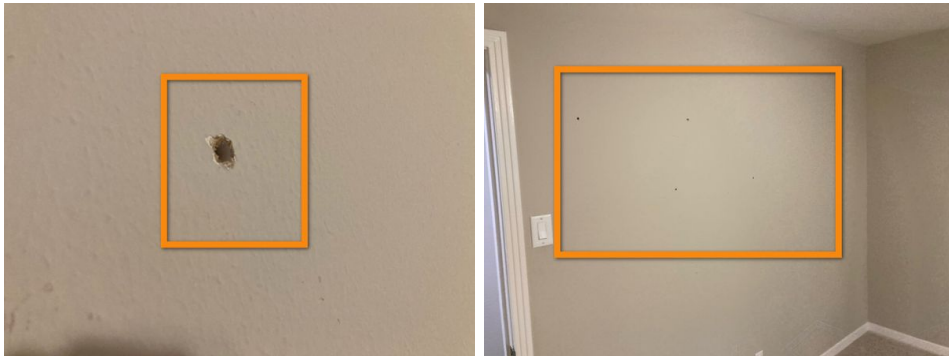
The sheetrock was damaged and needs to be repaired.

Obtain Cost Estimate

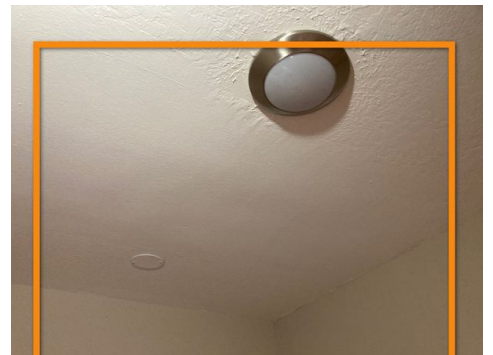
12.7.2 Sheetrock

PATCHES, FURTHER INVESTIGATION

UTILITY

Patches in the sheetrock were seen. The cause of the patching could not be determined at the time of the inspection, and further investigation into the cause of the patch with the homeowner is recommended.

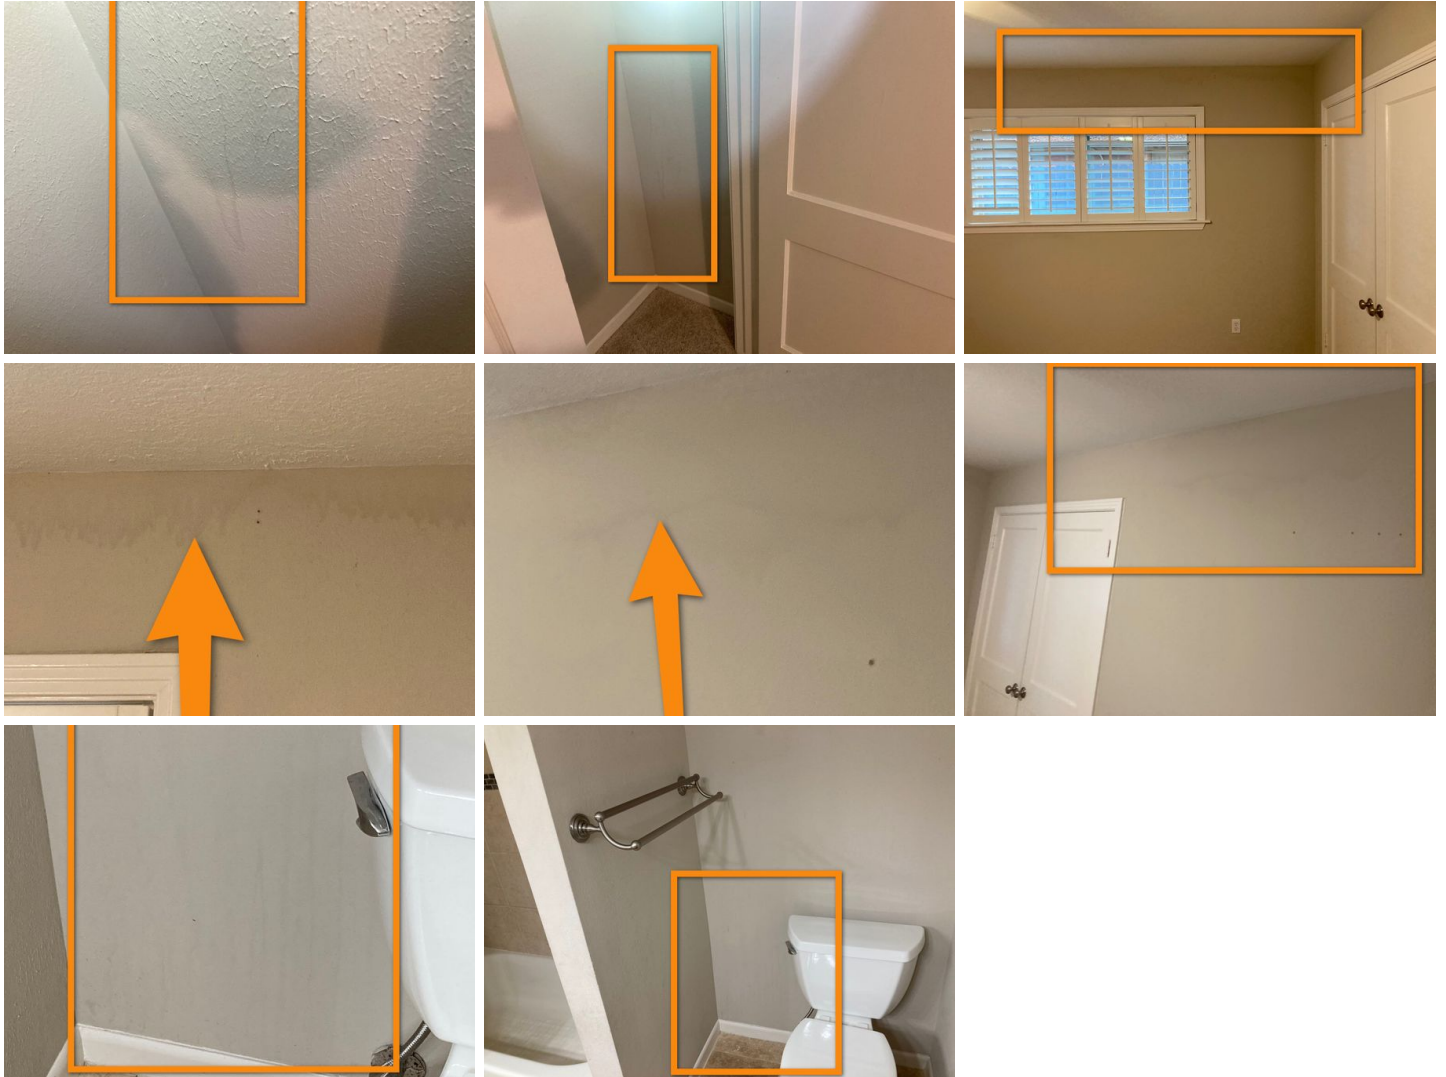
12.7.3 Sheetrock

WATER STAINS - SOURCE UNKNOWN-DRY

Obtain Cost Estimate

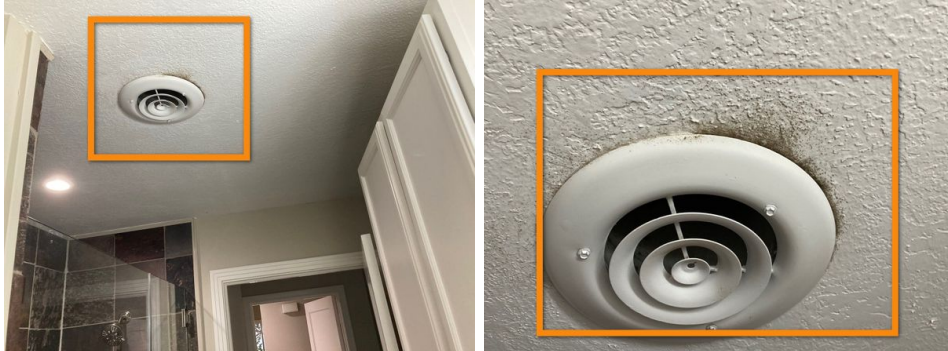
12.9.1 Other Interior Observations

MICROBIAL GROWTH

Obtain Cost Estimate
