HEDDERMAN ENGINEERING, INC.

MECHANICAL REPORT

1234 Lehman St
Houston, TX 77018

Frank Knott & Bonnie Reay <i>Name of Client</i>	04/26/2024 9:00 am <i>Date of Inspection</i>
1234 Lehman St, Houston, TX 77018 <i>Address of Inspected Property</i>	
Luis Mireles <i>Name of Inspector</i>	TREC#22797 <i>TREC License #</i>
<i>Name of Sponsor (if applicable)</i>	<i>TREC License #</i>

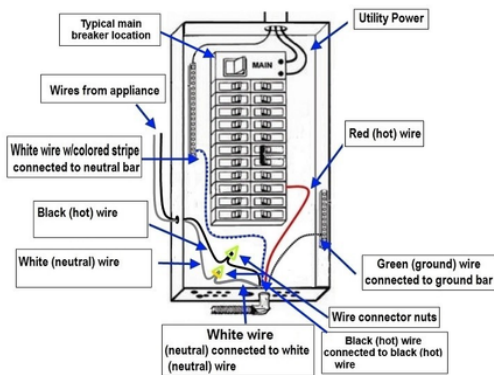
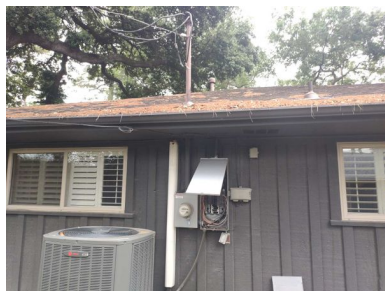
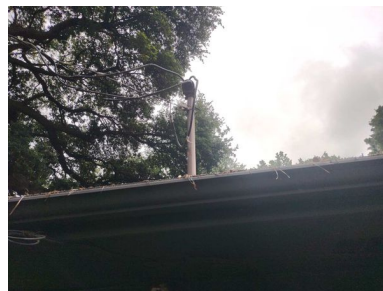
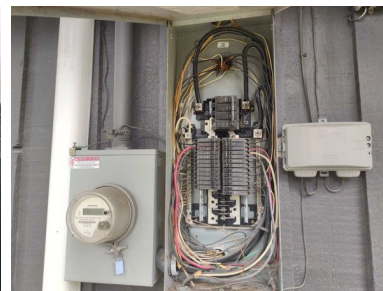
Circuit Breaker Wiring Diagram

We observed one or more white wires that were used as a power wires, and were connected to a circuit breaker. Typically, the white wires are the grounded/neutral conductors, and if they are used as a power conductor, they must be permanently marked or wrapped with black or red tape to identify them as a “hot” ungrounded conductor.

All of the breakers were not labeled to identify the circuits they were protecting. It is recommended that an electrician be contacted to specifically identify each circuit.

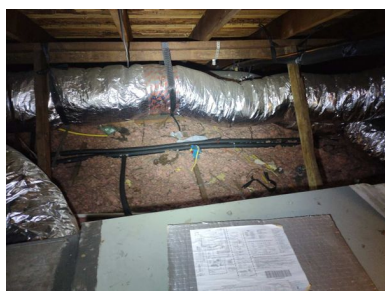
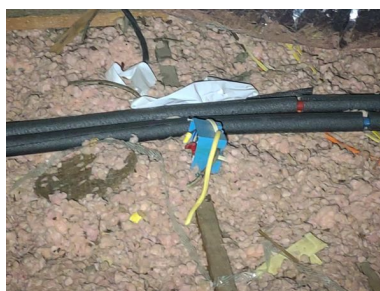
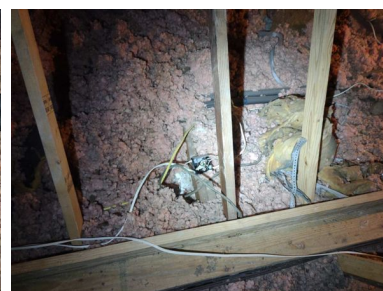
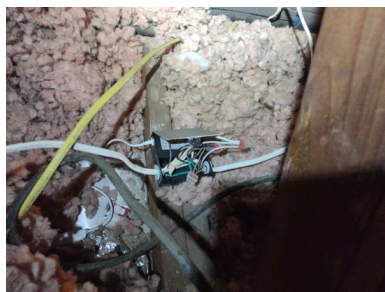
An open junction box that was missing a cover was observed.

Obtain Cost Estimate

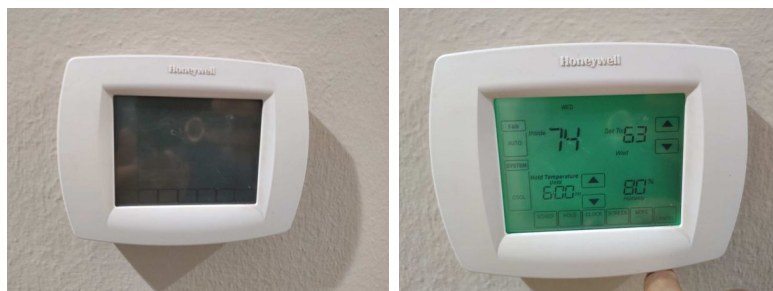
2: Thermostat - replace batteries

The thermostat batteries need to be replaced.

Inspector used new batteries for inspection only

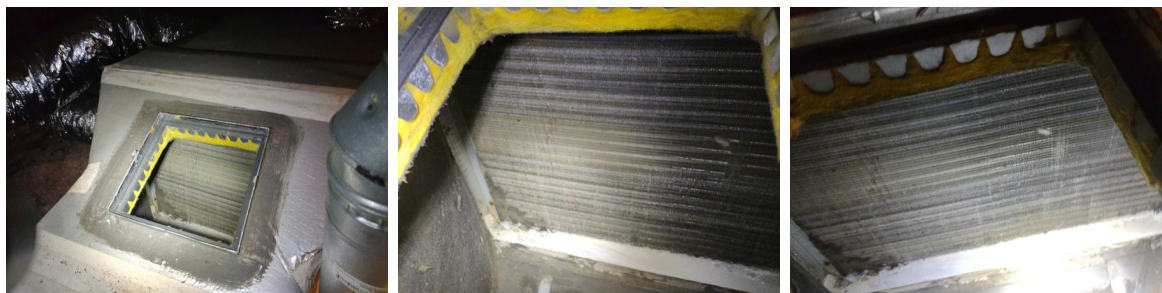
The coil was dirty and needs to be cleaned and serviced at this time. Have a service company clean the coils to allow for proper operation.

Obtain Cost Estimate

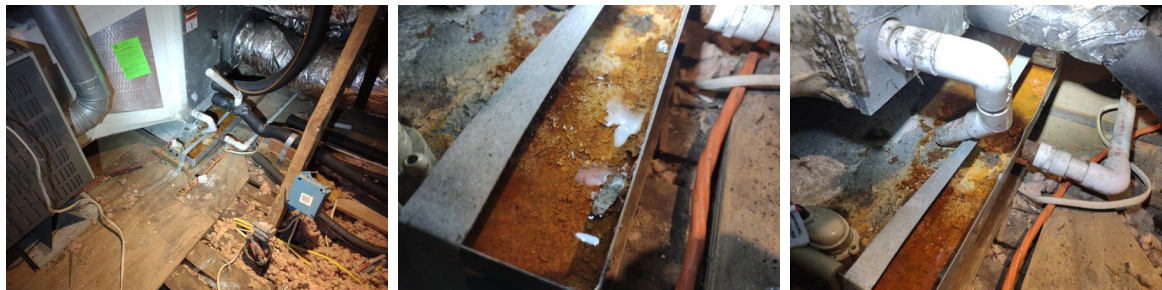
2: Overflow Pan - Standing water

Standing water was observed in the overflow pan under the coil. This can indicate a clogged primary drain line, or some other problem with the coil. Have a service company find the source of the water in the pan, and make any necessary repairs.

Obtain Cost Estimate

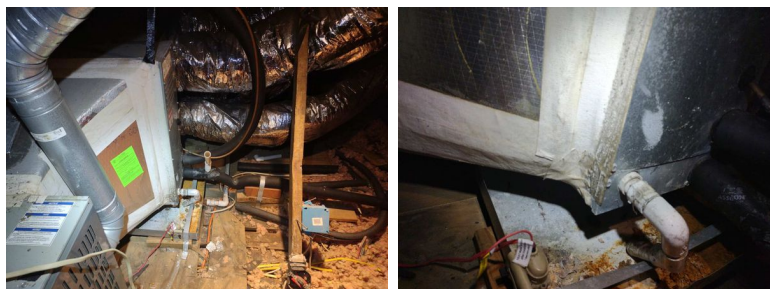
Microbial growth was observed on the outside of the air handler and/or evaporator coil casing. This condition can be indicative of a moisture/condensation problem, possibly due to air leaks at the equipment and/or a lack of adequate attic ventilation, or possibly some other problem. Further investigation is recommended with a service company to determine the cause of the microbial growth and to determine if the growth is present inside the equipment and/or air ducts. It is recommended that you obtain a cost estimate for any needed repairs.

Recommendation: Contact a qualified professional.

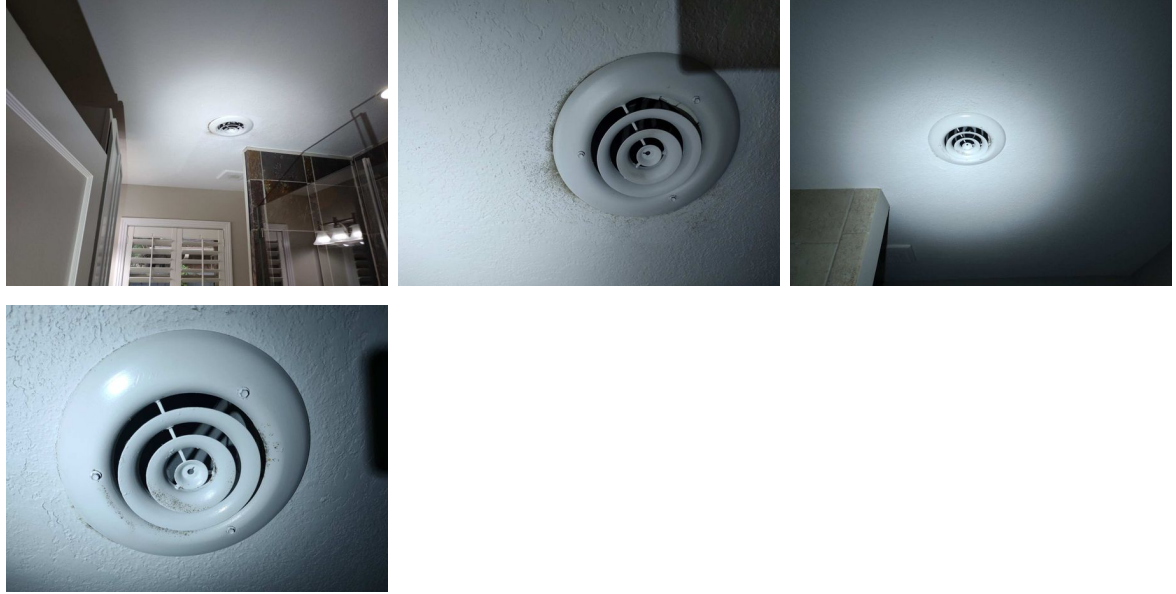
1: Registers - Microbial growth observed

Some of the registers were covered with mildew/debris. It is recommended that a service company be contacted to check the inside a of the duct work to determine if there is a build-up of debris/mold/mildew inside, and make any needed repairs. Further investigation is recommended.

Obtain Cost Estimate

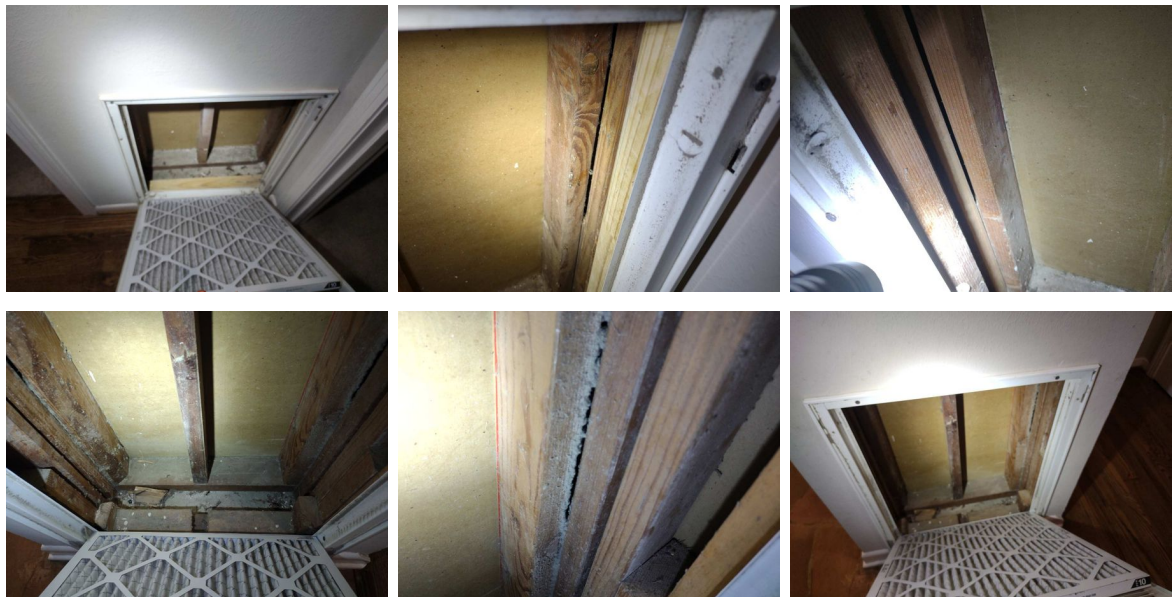
2: Return Air - Not sealed

The chase was not sealed properly and was drawing unconditioned air from the floor and/or wall cavities into the system. Have the chase sealed against air leaks.

Obtain Cost Estimate

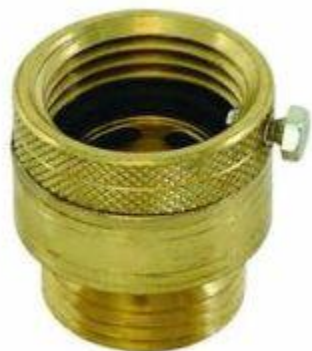
1: Vacuum Breaker - Missing

The atmospheric vacuum breaker devices were missing at one or more of the hose bibbs, and it is recommended that they be installed to prevent cross connections, which can allow contaminated water to enter the potable water supply.

Obtain Cost Estimate

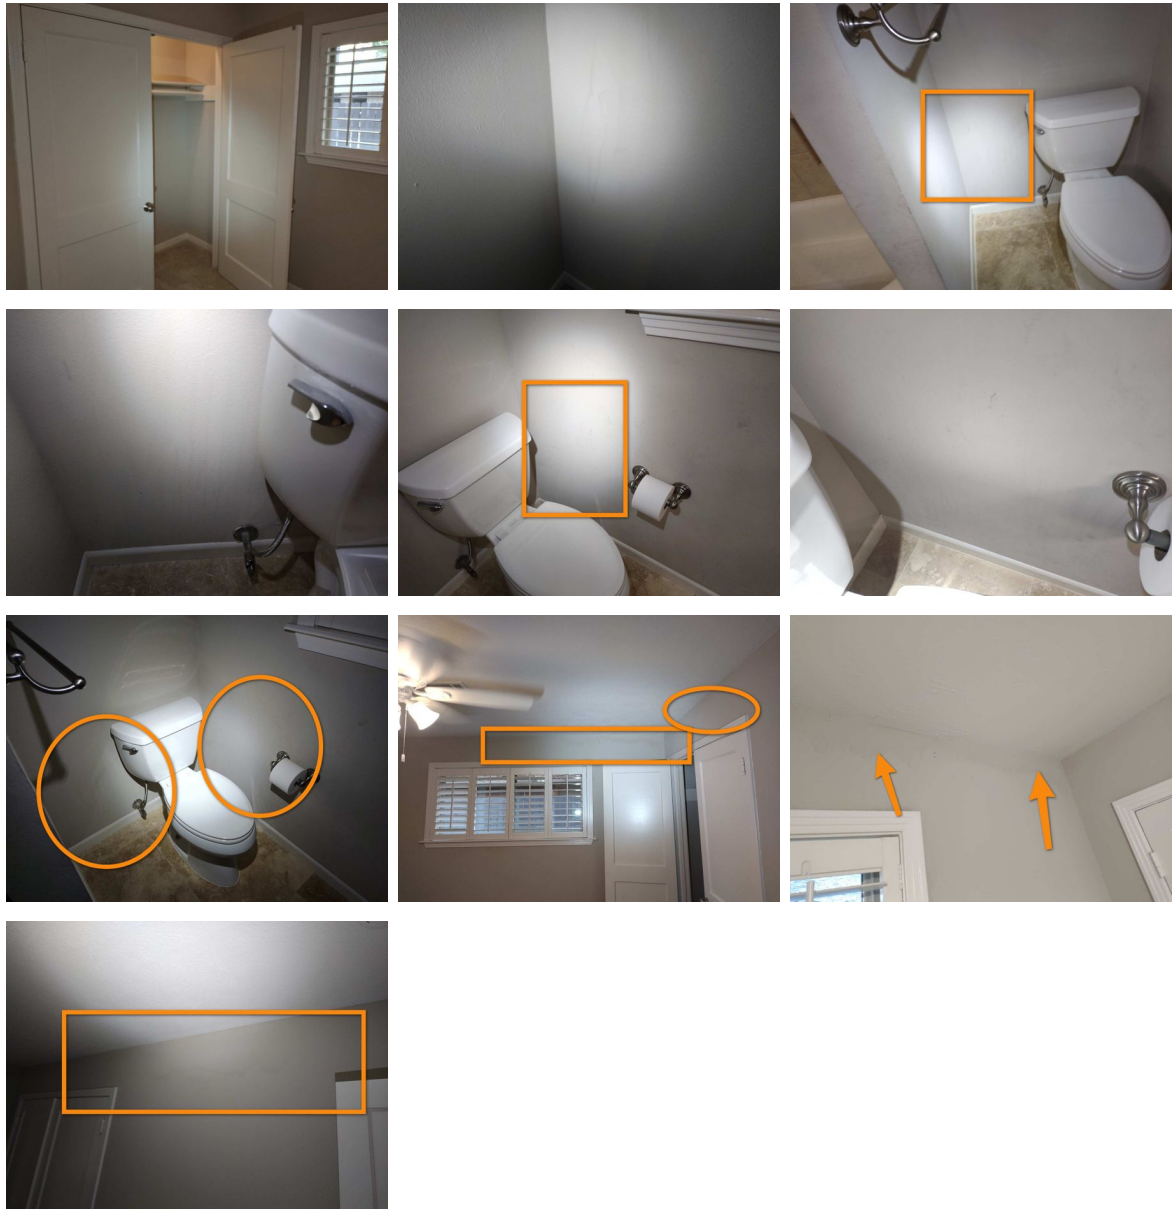
2: Water Stains/Damage Observed

East Bedroom, northeast bedroom closet, East Bathroom,

Recommendation: Contact a qualified professional.

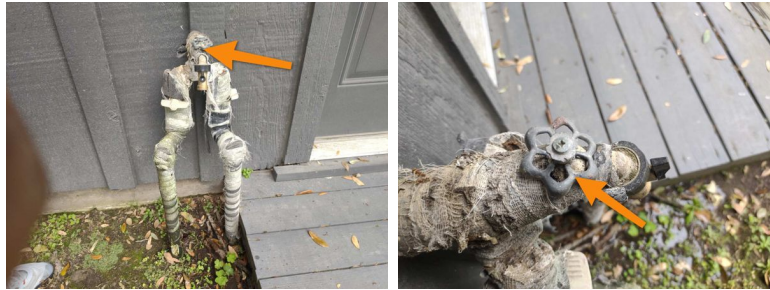
3: Hose Bibb - Handle missing/damaged

North

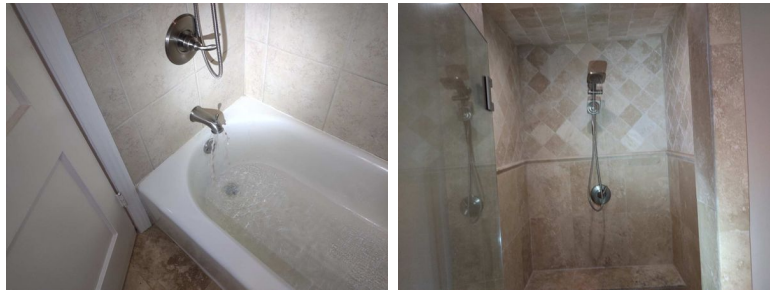
4: Shower/tub assembly loose

East Bathroom, southeast bathroom,

A shower/tub assembly was loose and needs to be repaired/secured.

Obtain Cost Estimate

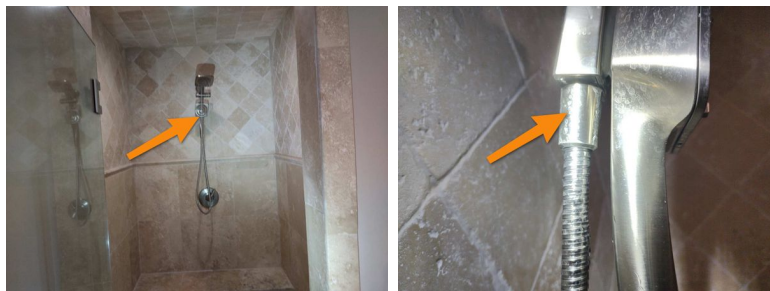
5: Sprayer - Leak

Southeast bathroom,

The sprayer was leaking and needs to be repaired and/or replaced.

Obtain Cost Estimate

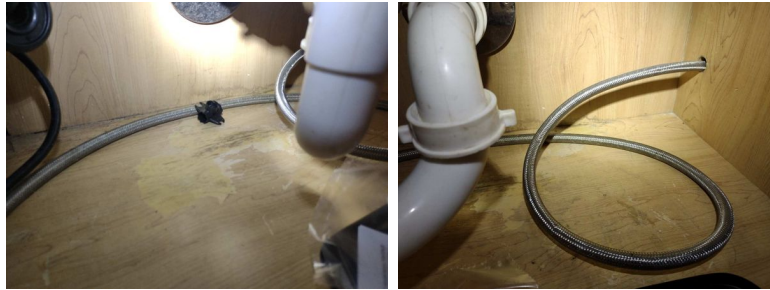
6: Water Stains/Damage Under Sink

Kitchen

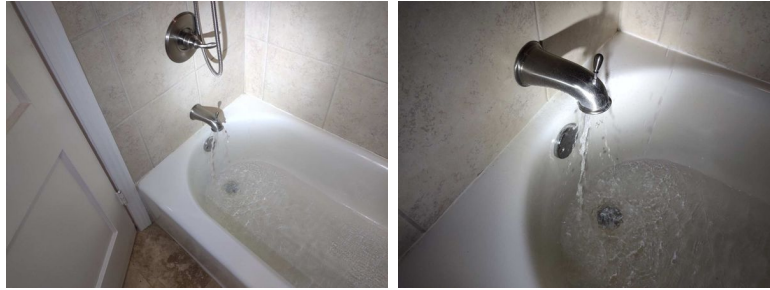
The diverter valve was leaking water past the valve when the valve was turned to the shower.

Obtain Cost Estimate

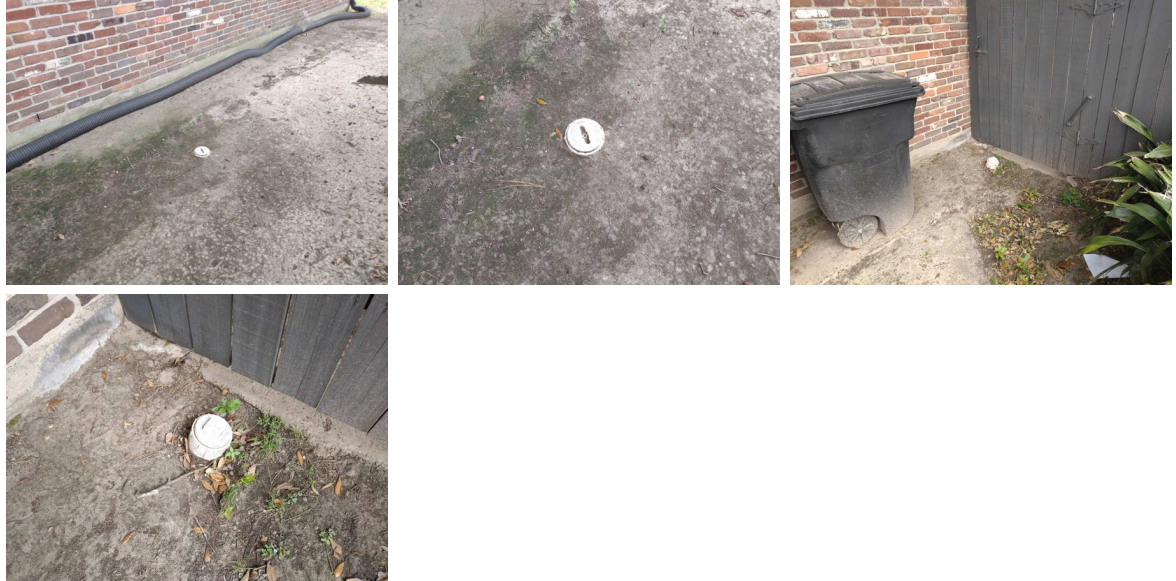
Sewer Piping - Evidence of repairs observed: PVC clean out present -

Evidences of sewer line repairs and/or replacement were observed. It is noted that we could not determine the extent of the repairs to the sewer system or if any of the original cast iron piping is still active. Further

investigation is recommended with the owner and/or a service company to determine the extent of the repairs and to determine if any further repairs are needed. A sewer inspection with a plumber to verify the extent of the repairs and the condition of the sewer piping and the repairs is recommended. The plumber should also determine if the washing machine drain riser is adequately sized to accommodate a modern washing machine.

Further investigation is recommended

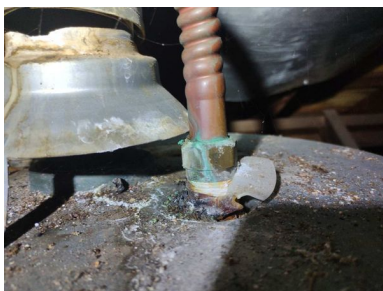
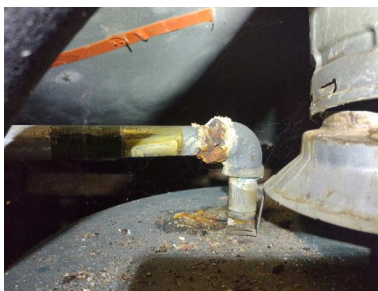
2: Fittings - Corroded

The piping at the top of the water heater was severely corroded at the fittings and is in need of repair.

Obtain Cost Estimate

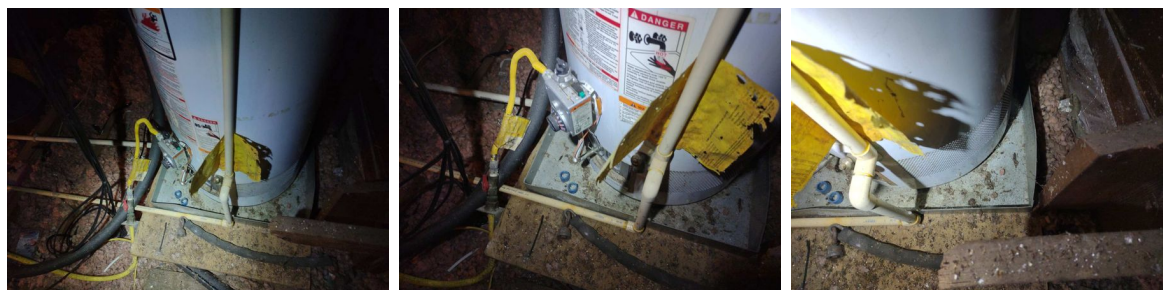
Insulation and/or debris was observed in the overflow pan and needs to be removed.

Obtain Cost Estimate

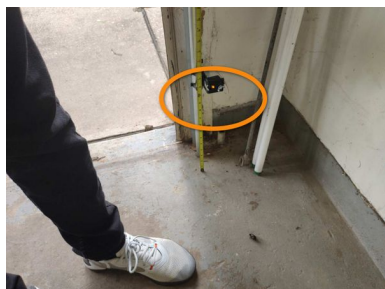
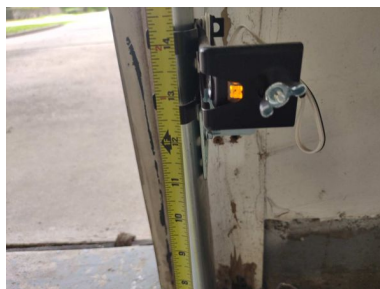
The infrared device was located too high on the garage door, and should be located no more than six inches above the floor. It is recommended that the device be lowered.

Obtain Cost Estimate
