February 21, 2024

RE: Foundation Inspection  
Job #21669

# 17115 Canyon Ridge Drive

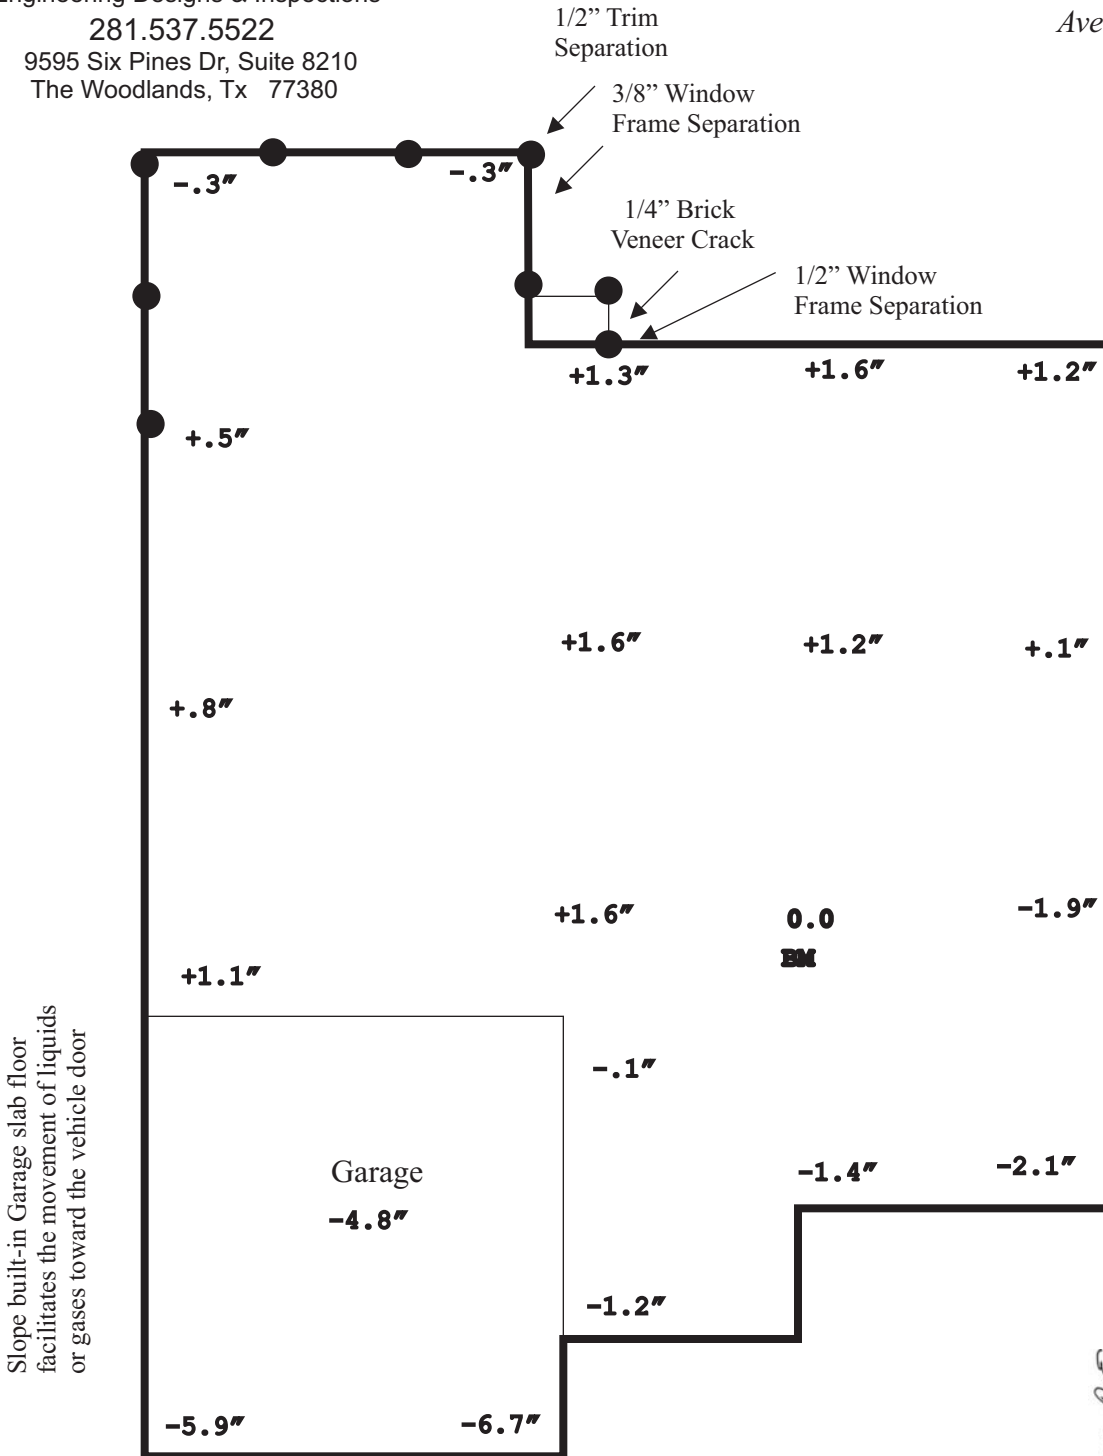
Moderate foundation movement has occurred, per the floor elevations, trim separations, window frame separations, master bedroom door at the rear left rubs the frame, bubble levels, and brick veneer cracks, Movement whether it be settlement or heaving is documented with the elevations on the floor-plan attached. Spreadsheet calculations were performed utilizing the FPA (Foundation Performance Association's SC-13-1 Calculation Spreadsheet) resulting in a deflection ratio of  $L/240$ , which is excessive and will require foundation repair with piers. The tilt ratio 0.17% is within the 1% allowable tolerance. This spreadsheet and report were reviewed and this engineer has taken into consideration the recommendations and guidelines of the ASCE (American Society of Civil Engineers), ACI (American Concrete Institute), and TRCC (Texas Residential Construction Commission).

Elevation Differential 3.7"

*Average Lift = Approximately 1"*

**Approximately 9 exterior piers will need to be installed along the *Rear Left Section* of the house, as depicted on the attached diagram the reasonable placement is based on the opinions and engineering judgment of this engineer. The piers should be of either *driven piles* or a *bell bottom design* and described as follows:**

- set on approximately 5-7-foot centers – Average Lift 1”
- drilled to load-bearing soils between 16 and 22 feet
- shaft diameters 8 to 10 inches, using 3 #3 steel rebar tied in a triangle
- bell diameter 20 to 24 inches, 8” shaft diameter minimum
- pier top reinforced with 6 #3 rebar, minimum dimensions are 20” x 24” and 12” deep
- minimum 5 sx mix or at least 3000 psi compressive strength
- shim with 3000 psi compressive strength precast blocks and steel.
