AM SOLUTIONS, LLC

PROPERTY INSPECTION REPORT FORM

Jose Flores <i>Name of Client</i>	09/29/2023 <i>Date of Inspection</i>
6610 Deckard St, Houston, TX 77061 <i>Address of Inspected Property</i>	
Arturo Marquez <i>Name of Inspector</i>	TREC 2685 <i>TREC License #</i>
 <i>Name of Sponsor (if applicable)</i>	 <i>TREC License #</i>

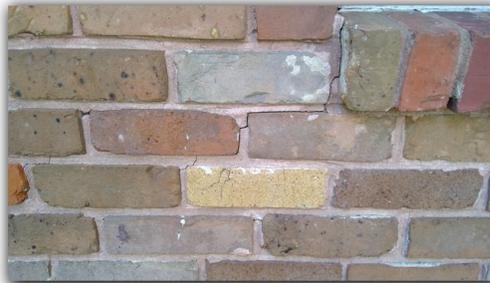
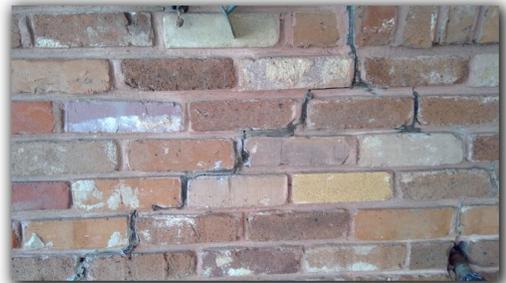
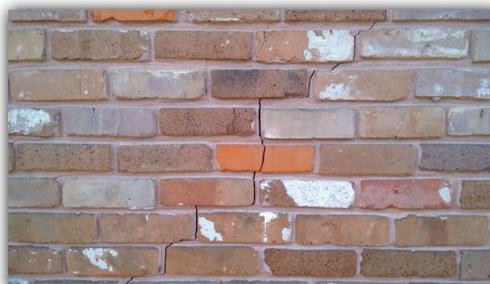
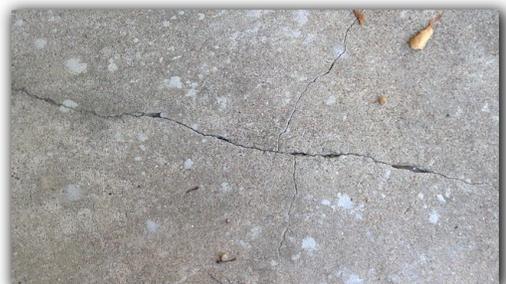
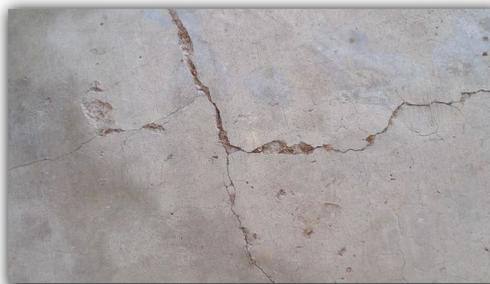
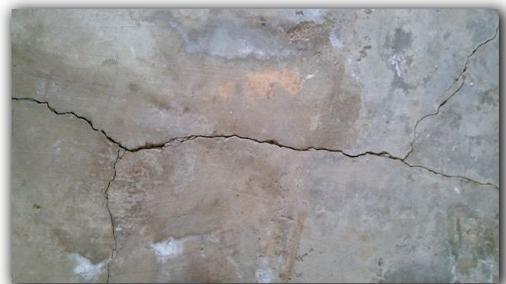
Comments: Numerous cracks and/or crack repairs were observed including but not limited to: the front, right, and rear brick veneers, the front porch slab, the carport slab, the garage slab, and on multiple interior wall or ceilings spots, see sample pictures. The rear left corner brick frieze boards were observed pushed outwards, see sample picture. The concrete patches on exterior flatwork, see sample pictures, indicates previous foundation repairs may have already been performed on this home.

However, differential movement in excess of marginal was detected using a four ft. digital level; marginal being described as within the generally accepted criteria for foundation performance and repair of L/360 (1 inch bend/differential movement, in 30 feet). Several door frames were observed out-of-square. The laundry/kitchen door, and the hallway front closet door stick on jambs and would not close

It is this inspector's opinion additional piers and/or adjustment on existing piers may be required. Need to contact homeowner regarding extent of any previous foundation repairs and warranty. Need to also contact contractor that performed any previous work and/or a qualified engineer for further evaluation regarding any necessary corrections.

It is also recommended that a monitoring and maintenance program be initiated in an effort to minimize possible future differential movement.

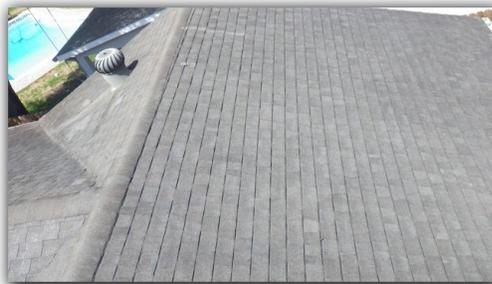
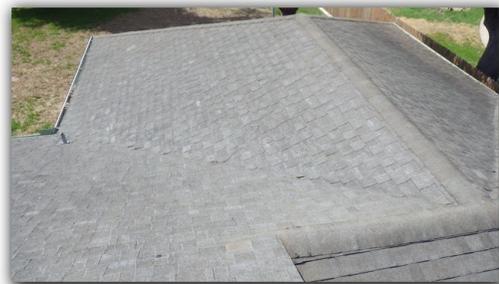
Comments: **However**, multiple damaged shingles were observed, see sample picture.

Several nails were observed pushing out through the shingles, see sample picture.

*It is this inspector's opinion this roof has lived its' expected useful lifespan. **Need to contact a qualified roofer for further evaluation regarding any necessary corrections.***

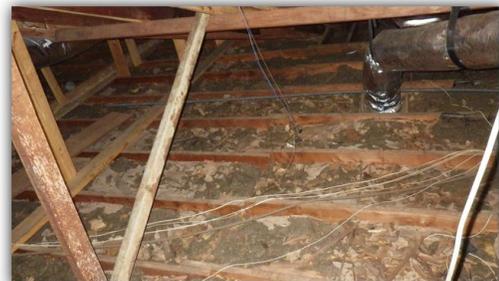
Need blocking for gaps observed on some rafter/ridge junctions, see sample picture.

Attic drop ladder did not close adequately, see sample picture, creating a point for air-loss/air-infiltration; and, need to insulate attic drop ladder panel.

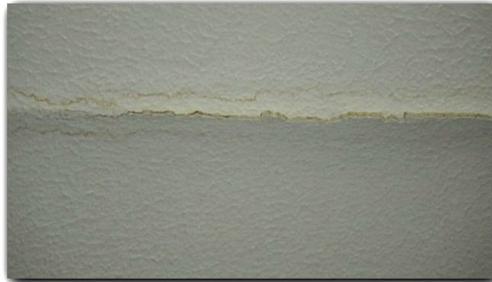
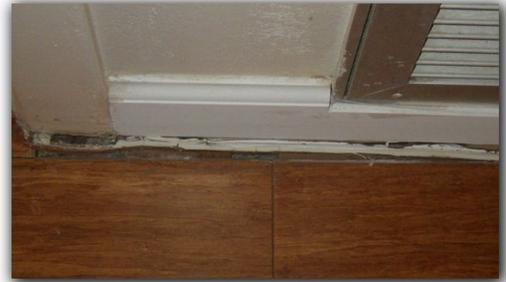
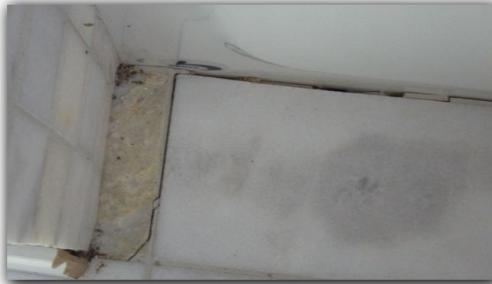
However, a crack and moisture stain were observed on formal living room ceiling, see sample picture; this indicates a possible roof leak.

A gap/missing trim was observed on floor/wall junction next to air-return grill, see sample picture.

Deteriorated grout was observed at spare bathtub/floor junction, see sample picture.

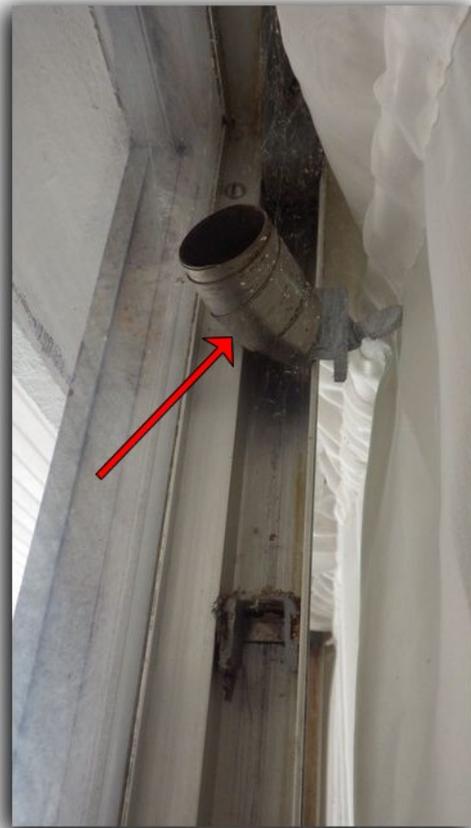
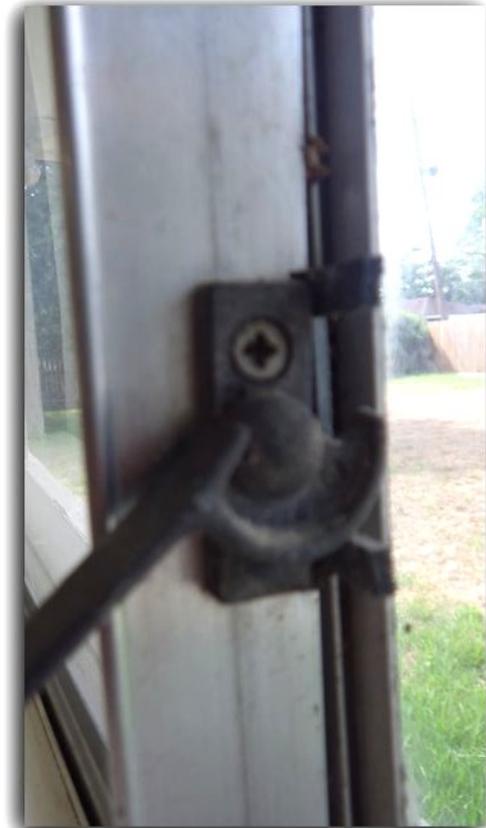
Detached tension strip was observed on one window, see sample picture.

Broken and/or missing lock components were observed on master bedroom right rear window, and on both windows in left middle bedroom, see sample picture.

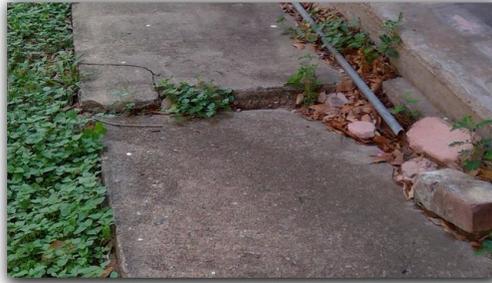
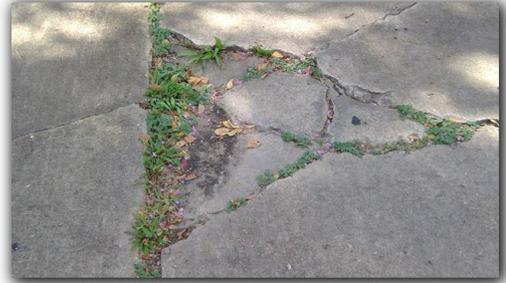
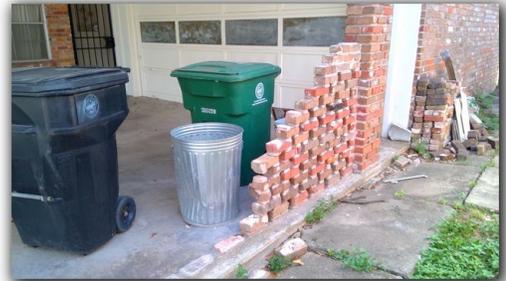
However, broken and/or uneven sidewalk and driveway slabs were observed creating potential tripping hazards, see sample pictures.

Need to service gutter system to facilitate proper drainage; sections were observed full of debris, see sample picture.

The carport privacy brick wall was observed partially/mostly removed, see sample picture.

Evidence of rodent activity/droppings were observed behind spare tub, see sample picture.

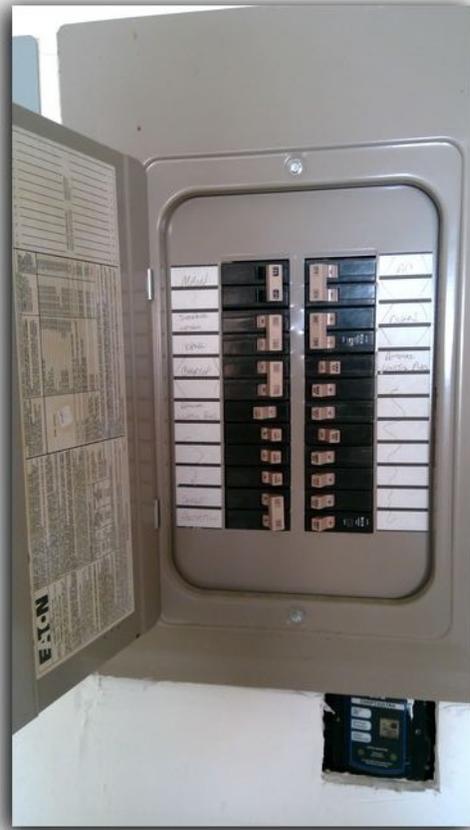
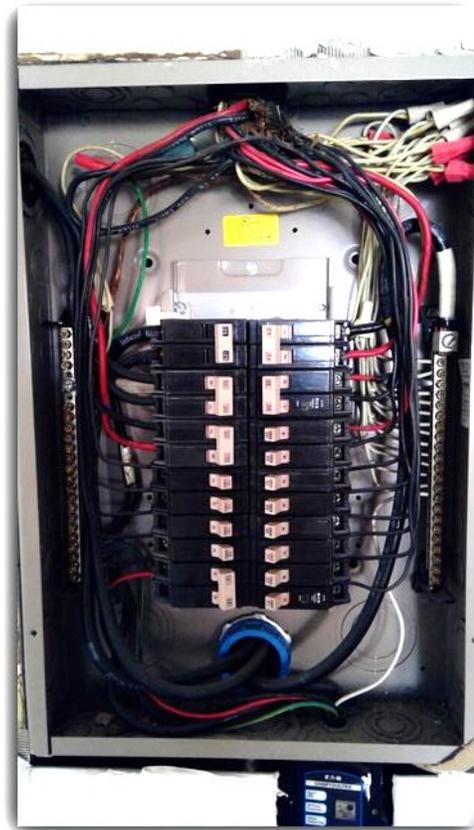
Comments: Load calculations were not performed. The main panel is an Eaton with a 125 amp main breaker, and the sub-panel is a GE; both panels were observed currently operable, see sample pictures.

Cloth electrical wire also called rage wire is considered older wire, therefore, considered a fire hazard in an electrical panel by most insurance companies, was observed in the main panel and in attic, see sample picture. This type of wire should be replaced with non-metallic wire, also known as romex.
