RESIDENTIAL INSPECTION REPORT

11506 Shady Canyon Dr Houston, TX 77095

PROPERTY INSPECTION REPORT FORM

Michael Lin	04/02/2024 2:00 pm
Name of Client	Date of Inspection
11506 Shady Canyon Dr, Houston, TX 77095	
Address of Inspected Property	
Daniel Clark	TREC #23081
Name of Inspector	TREC License #
Greg Bryan TREC#	3608
Name of Sponsor (if applicable)	TREC License #

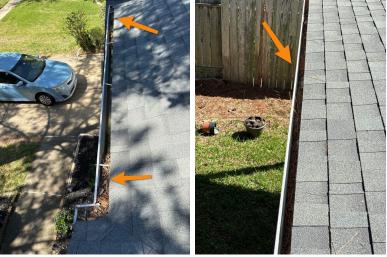
1: Gutters & Downspouts: Defects Present

Gutters and/or downspouts had one or more defects at the time of the inspection. Examples include, but are not limited to:

Front (clogged)

Evaluation and remediation is recommended.

Recommendation: Contact a qualified professional.

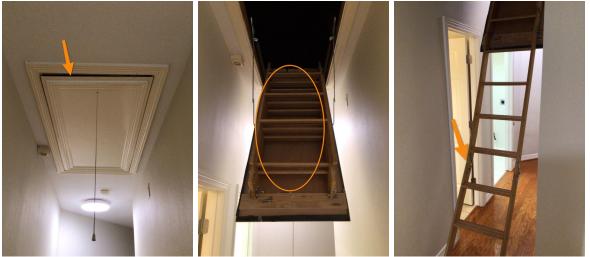
1: Pull-down Stairs/Ladder: Defects Present

The pull-down ladder/stairs had one or more defects at the time of the inspection. Examples include, but are not limited to:

Does not seal

Not insulated

Improperly sloped

Evaluation and remediation is recommended.

Recommendation: Contact a qualified professional.

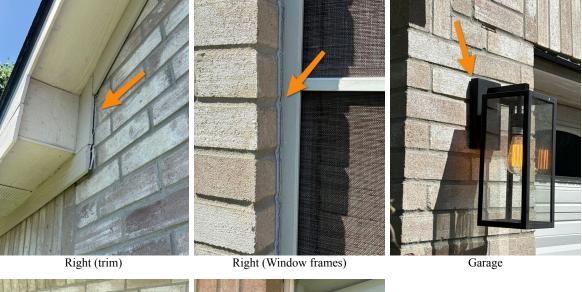
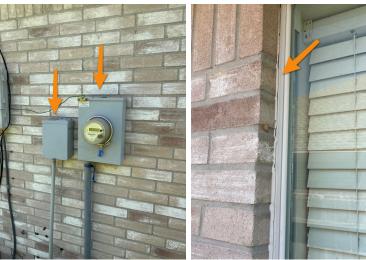
One or more areas were not properly sealed/caulked. Most exterior sealants have a lifespan of 5 to 8 years and should be regularly maintained with that lifespan in mind. Evaluation and remediation is recommended.

Electric

Left (window frames)

Recommendation: Contact a qualified professional.

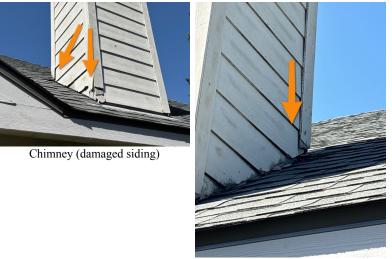
3: Exterior Walls: Surface Defects

The exterior wall coverings, such as siding, trim fascia, soffit or eave had defects. Examples include, but are not limited to:

Chimney (damaged siding)

Evaluation and remediation is recommended.

Recommendation: Contact a qualified professional.

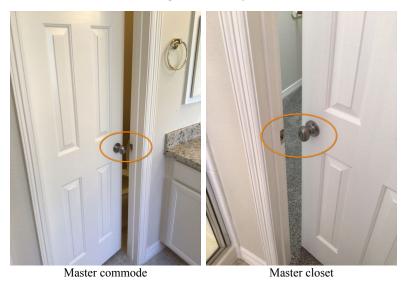
Doors did not latch properly. Evaluation and remediation is recommended.

Recommendation: Contact a qualified handyman.

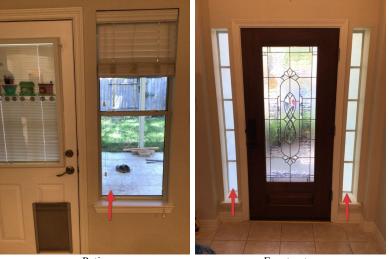
Safety glass with a tempered stamp should be installed in all hazardous locations, such as:

Patio

Front entry

Recommendation: Contact a qualified window repair/installation contractor.

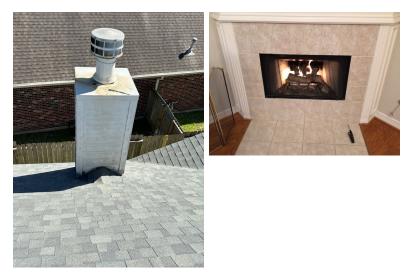
Limited Access/Visibility: There was limited access and visibility to safely inspect chimney flue.

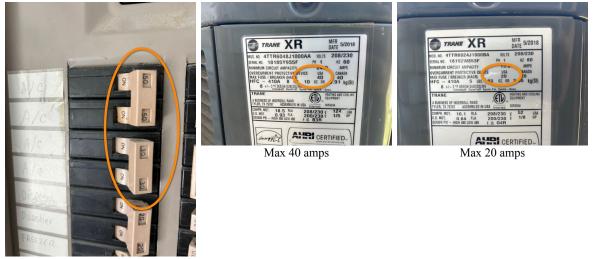
5: A/C Breaker Sizes Improper

The listed A/C circuit protection was not sized properly per the data label on exterior condensing unit. Evaluation and/or remediation by a licensed electrician is recommended.

50 & 30 amp breakers

Recommendation: Contact a qualified electrical contractor.

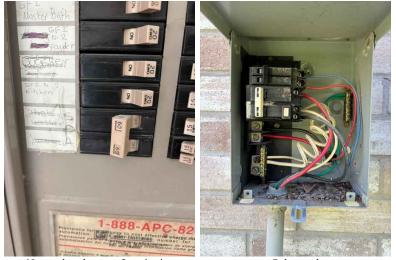
8: Breaker Not Functioning Recommendation

60 amp breaker for sub-panel would not reset. This carries power to the sub-panel. All breakers in sub-panel were in the off position.

60 amp breaker not functioning

Sub panel

Recommendation: Contact a qualified professional.

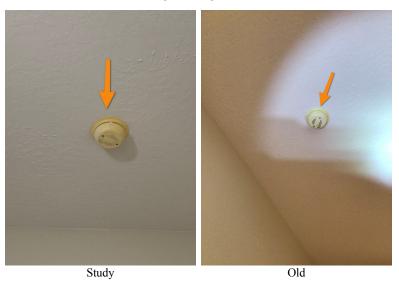
1: Smoke/Carbon Monoxide Detectors Defective ©Recommendation

As gas appliance(s) were installed in the living portion of the home, installation of carbon monoxide detectors is recommended for safety. Evaluation and remediation is recommended.

Recommendation: Contact a qualified professional.

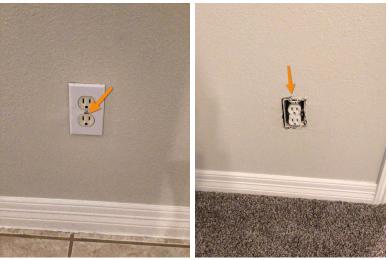
4: Receptacle/Switch Covers: Missing, Loose or Damaged Recommendation

One or more receptacle/switch cover plates were missing, loose or damaged. Replacement of cover plates is recommended for safety. Evaluation and remediation by a qualified electrical contractor is recommended.

Kitchen (cracked)

Master bedroom (missing)

Recommendation: Contact a qualified electrical contractor.

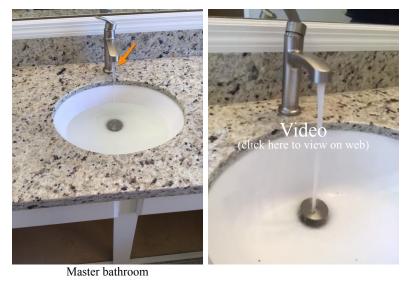
Fixtures had poor flow/water pressure at the hot supply side. This occurs when more than one fixture is operated. Cause was not determined. Further evaluation by a qualified plumbing professional is recommended.

Recommendation: Contact a qualified plumbing contractor.

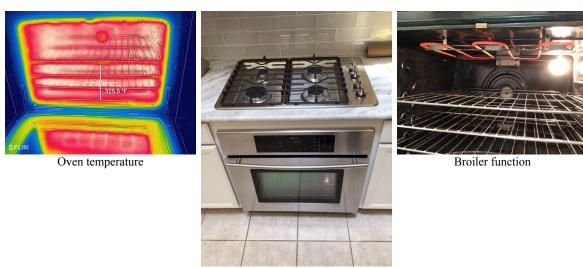
1: Oven Not Secured Asafety Hazard

The oven was not properly secured under the countertop. Evaluation and remediation is recommended.
