RESIDENTIAL INSPECTION REPORT

4326 Hazelton St
Houston, TX 77035

PROPERTY INSPECTION REPORT FORM

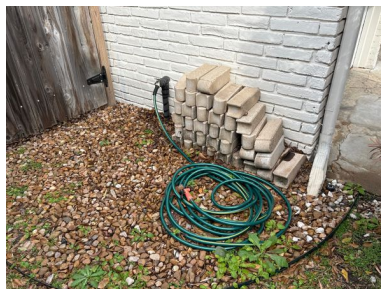
Left side

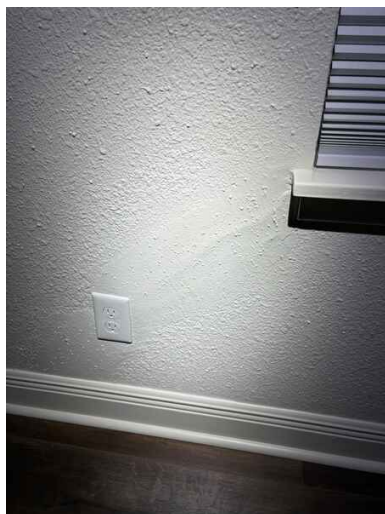
1: Evidence of Foundation Settlement Present

Noticeable floor slope, Drywall cracks, Brick Cracks, Slab Cracks -

Front bedroom

Due to evidence of foundation settlement, further evaluation by a licensed structural engineer and/or qualified foundation contractor is recommended.

Recommendation: Contact a qualified structural engineer.

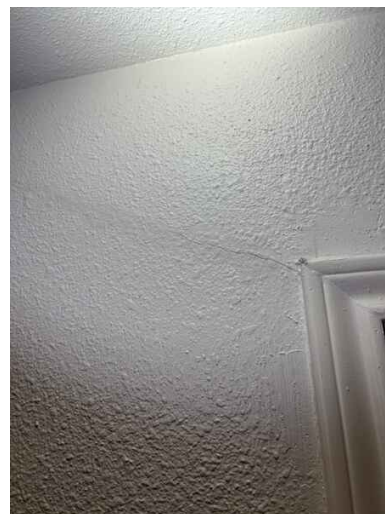
Master bedroom

Living room (floor slope)

Living room (slope measurement)

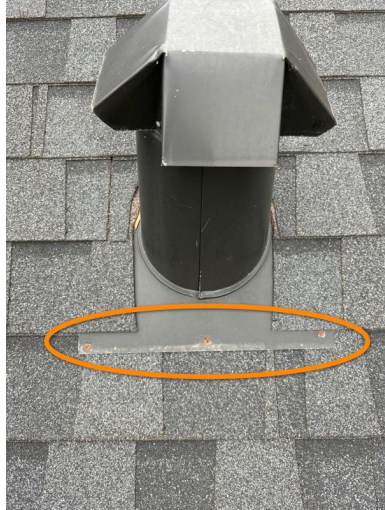
Master bathroom exhaust vent

3: Sheathing: Wavy or Sagging

Areas of the roof were wavy or sagging, indicating sheathing or framing deficiencies. Evaluation and repair by a qualified roofing professional is recommended.

Recommendation: Contact a qualified roofing professional.

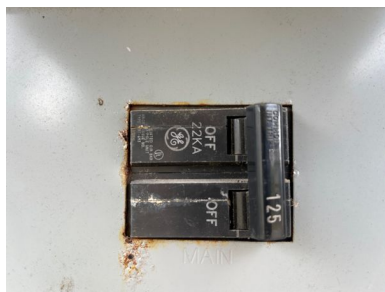
1: AFCI (Arc-Fault Circuit Interrupt) protection was lacking or not present.

Note: AFCI protection was required by the National Electrical Code for all homes built after 2008. The Texas Real Estate Commission recognizes that the building codes have not always required AFCI's, however, the agency believes that it is important for consumers to be made aware of these safety devices when they are not present or fail to function properly in a home as a consumer protection issue and requires inspectors to report the lack of proper AFCI protection in the distribution panel as deficient, regardless of the homes age.

Recommendation: Contact a qualified electrical contractor.

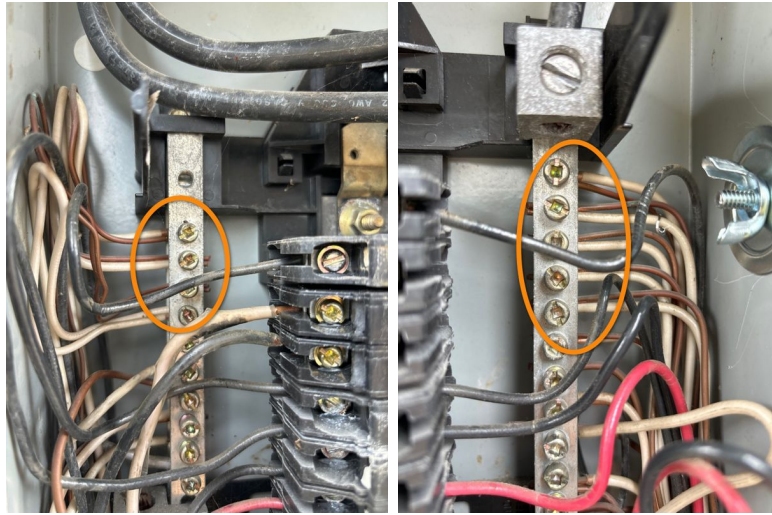
2: Double Lugged Neutral Wires

Double lugged neutral wires were on the neutral bus bar inside the distribution panel. One neutral wire per lug is recommended. Evaluation and remediation is recommended.

Recommendation: Contact a qualified electrical contractor.

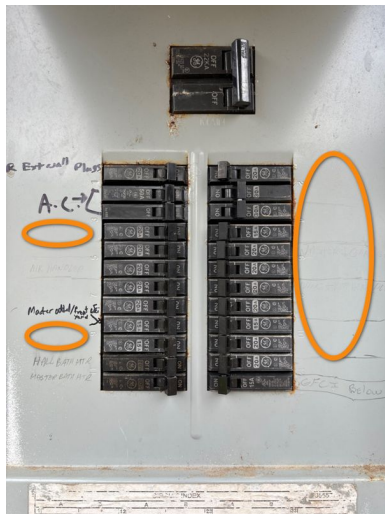
3: Circuits Not Labeled

Circuits in the distribution panel were not properly labeled. Evaluation and remediation is recommended.

Recommendation: Contact a qualified electrical contractor.

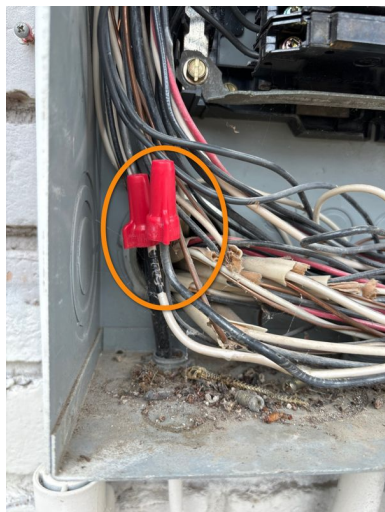
4: Abandoned Wire in Panel

Evaluation and remediation by a licensed electrician is recommended.

Recommendation: Contact a qualified professional.

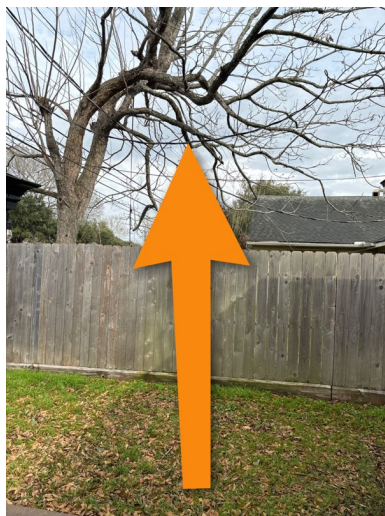
5: Service Entrance Wires: Insufficient Clearance

Service drop overhead wires are too low, not giving enough clearance. Contacting your local electric utility company or licensed electrician to see if they can remedy is recommended.

Approximately 9-10 feet from ground.

Recommendation: Contact a qualified electrical contractor.

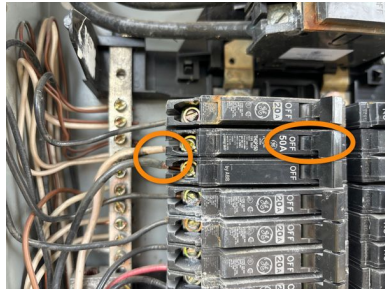
6: Undersized Conductors

One or more conductors appear to be undersized for the breakers that they are attached to. Further evaluation by a licensed electrician is recommended.

50 amp breaker

Recommendation: Contact a qualified electrical contractor.

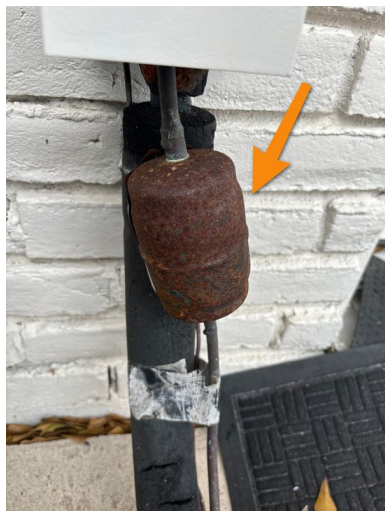
1: Condenser: Rusted Filter Drier

The filter drier was rusted. Evaluation and remediation by a licensed HVAC contractor is recommended.

Recommendation: Contact a qualified HVAC professional.

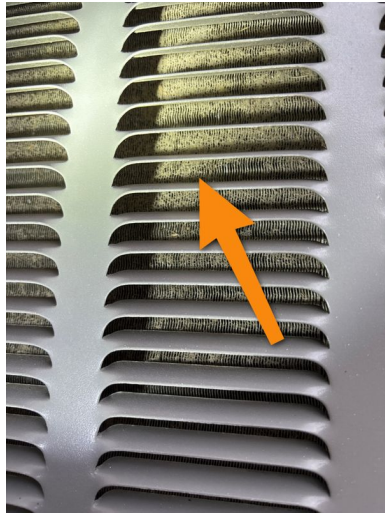
2: Condenser: Dirty

The condensing unit was dirty. Servicing by a licensed HVAC contractor is recommended.

Dirty condenser fins

Recommendation: Contact a qualified HVAC professional.

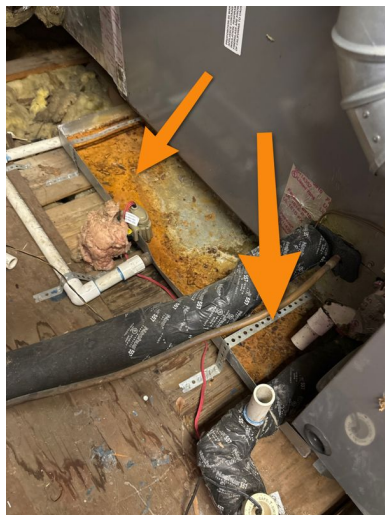
3: Condensate system: Rusted Emergency pan

The emergency overflow pan is rusted. Further evaluation by an HVAC professional is recommended.

Recommendation: Contact a qualified HVAC professional.

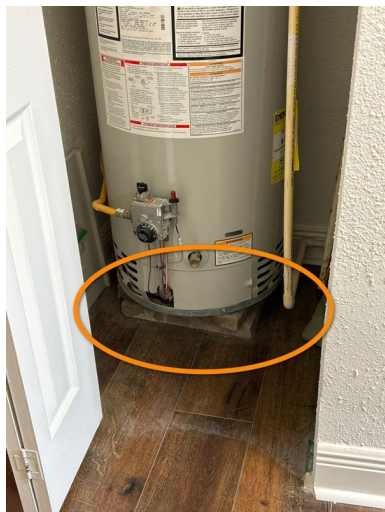
2: Tank: Missing Drain Pan

Missing drain pan and drain line to exterior. Evaluate and remedy as needed.

Recommendation: Contact a qualified professional.

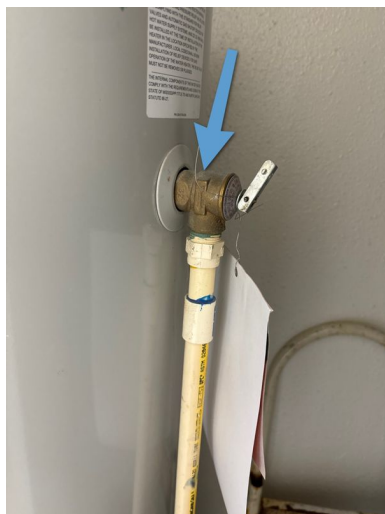
3: TPR Valve Note: Replacement may be needed

The manufacturer recommends replacement of the pressure relief valve every three years to ensure proper emergency function. The inspector does not test TPR valves due to safety hazard or possible damage to unit.

Recommendation: Contact a qualified professional.

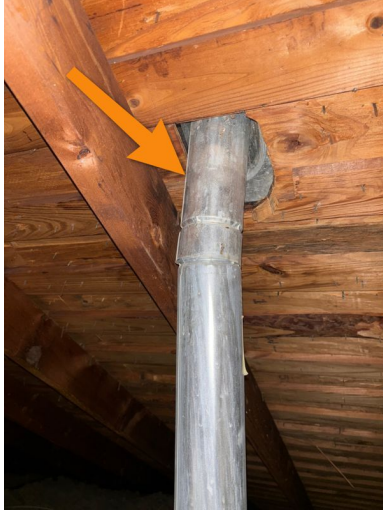
4: Venting system: Missing vent pipe strap

The water heater combustion vent pipe was not properly supported/secured with strapping. Evaluation and remediation is recommended.

Recommendation: Contact a qualified professional.

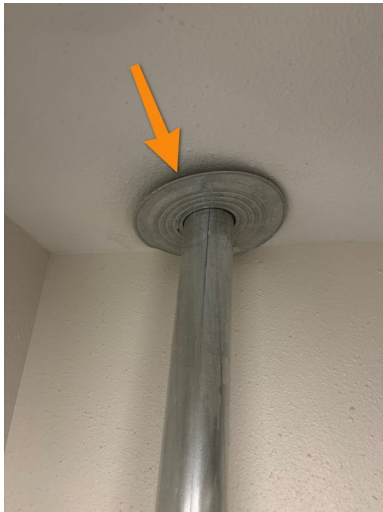
5: Venting system: Missing/loose ceiling collar

The collar was missing/loose where the flue passes through the ceiling. Evaluation and remediation is recommended.

Loose collar

Recommendation: Contact a qualified professional.

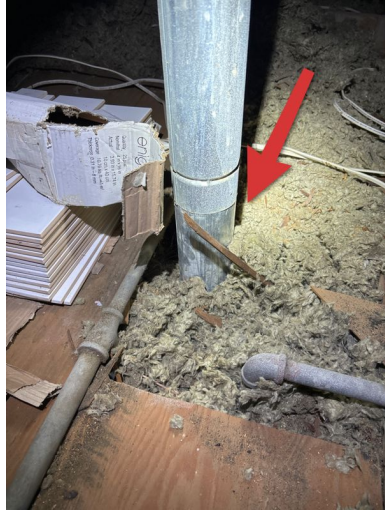
6: Venting System: Inadequate Combustible Clearance

Double-walled B type vents require at least one inch clearance from combustible materials. Evaluate and remedy as needed.

Insulation around vent

Recommendation: Contact a qualified professional.
