Lone Star Stucco, LLC

Moisture Assessment Report

2638 Westgate Street

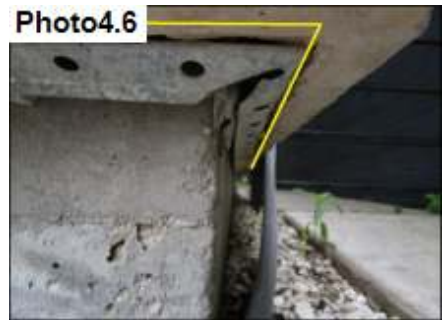
Photo4.6

Proper Grade Termination with Weep Screed / Positive Detail

Grid Location	Item Description	Moisture Readings	Substrate Condition	Observations
Yellow Lines	Grade Termination			Stucco/manufactured stone veneer appears to be typically detailed at grade for the time of this construction. The inspector suggests that this is a positive detail and recommends no modification at this time but to always keep soil away from the structure. Please refer to photos #4.2, #4.3, #4.4, #4.5 and #4.6 for more detail.

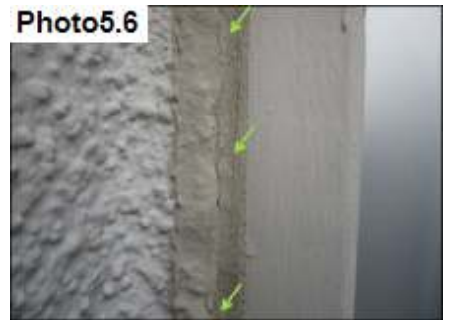
Photo5.6

Garage Door Trim Sealant / Seal

Grid Location	Item Description	Moisture Readings	Substrate Condition	Observations
Green Arrows	Garage Door			The garage door trim sealants are aged at this location. The inspector suggests to have a qualified waterproofing contractor seal this area with a low modulus sealant in an effort to prevent moisture intrusion. These types of sealants are of high quality and compatible with stucco and other termination points. Please refer to photos #5.2, #5.3, #5.4, #5.5 and #5.6 for more detail.

- The garage door trim sealants are aged at this location. The inspector suggests to have a qualified waterproofing contractor seal this area with a low modulus sealant in an effort to prevent moisture intrusion. These types of sealants are of high quality and compatible with stucco and other termination points. Please refer to photos #5.2, #5.3, #5.4, #5.5 and #5.6 for more detail. [The garage door trim has been sealed.](#)

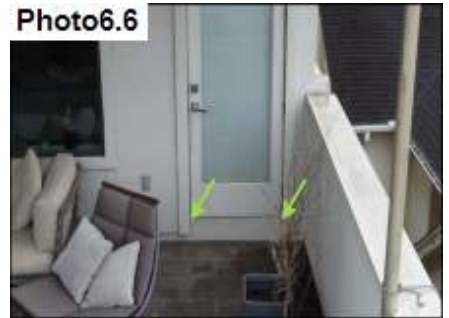
Photo6.6

Door Trim and Miter Sealant / Seal

Grid Location	Item Description	Moisture Readings	Substrate Condition	Observations
Green Arrows	Doors			The door trim and miter sealants are aged at this location. The inspector suggests to have a qualified waterproofing contractor seal this area with a low modulus sealant in an effort to prevent moisture intrusion. These types of sealants are of high quality and compatible with stucco and other termination points. Please refer to photos #6.2, #6.3, #6.4, #6.5 and #6.6 for more detail.

- The door trim and miter sealants are aged at this location. The inspector suggests to have a qualified waterproofing contractor seal this area with a low modulus sealant in an effort to prevent moisture intrusion. These types of sealants are of high quality and compatible with stucco and other termination points. Please refer to photos #6.2, #6.3, #6.4, #6.5 and #6.6 for more detail. [Door trim and miters have been sealed.](#)

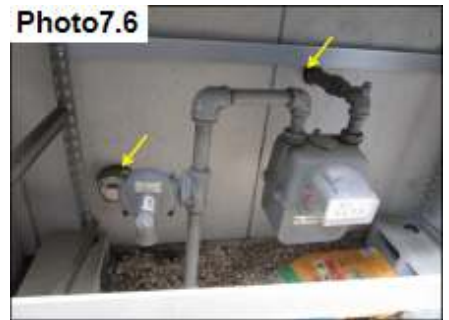
Photo7.6

Penetration Sealants / Seal

Grid Location	Item Description	Moisture Readings	Substrate Condition	Observations
Yellow Arrows	Penetrations			The penetration sealants are aged in this location. The inspector suggests to have a qualified waterproofing contractor seal this area with a low modulus sealant in an effort to prevent moisture intrusion. These types of sealants are of high quality and compatible with stucco and other termination points. Please refer to photos #7.2, #7.3, #7.4, #7.5 and #7.6 for more detail.

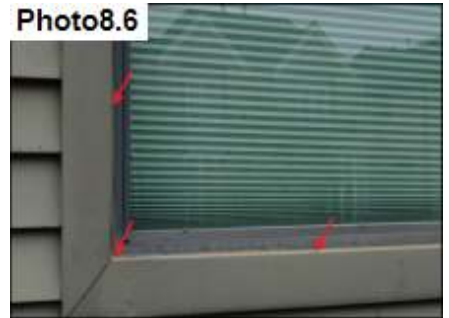
Photo8.6

Window Sealants / Seal

Grid Location	Item Description	Moisture Readings	Substrate Condition	Observations
Red Arrows	Windows			The window sealants are aged. The inspector suggests to have a qualified waterproofing contractor further assess and seal this area with a low modulus sealant in an effort to prevent moisture intrusion. These types of sealants are of high quality and compatible with stucco and other termination points. Please refer to photos #8.2, #8.3, #8.4, #8.5, #8.6, #9.1, #9.2 and #9.3 for more detail.

- The window sealants are aged. The inspector suggests to have a qualified waterproofing contractor further assess and seal this area with a low modulus sealant in an effort to prevent moisture intrusion. These types of sealants are of high quality and compatible with stucco and other termination points. Please refer to photos #8.2, #8.3, #8.4, #8.5, #8.6, #9.1, #9.2 and #9.3 for more detail. [All windows have been sealed.](#)

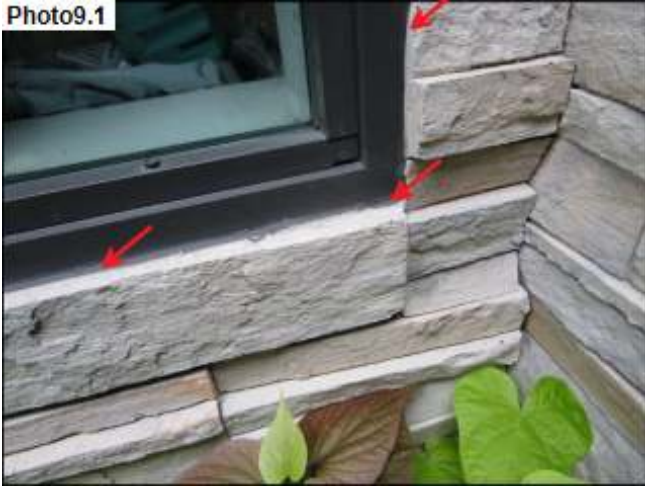
Photo9.1

Window Sealants / Seal

Windows have been sealed.

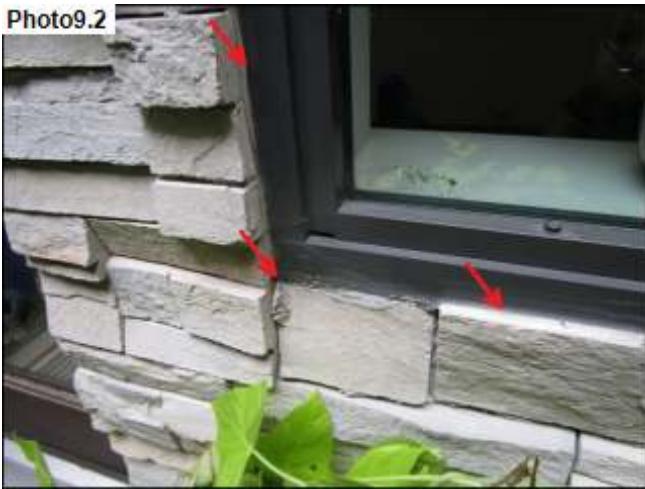
Photo9.2

Window Sealants / Seal

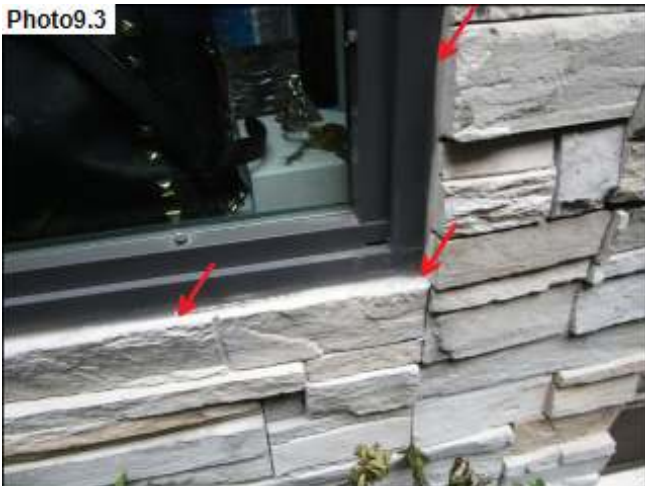
Photo9.3

Window Sealants / Seal

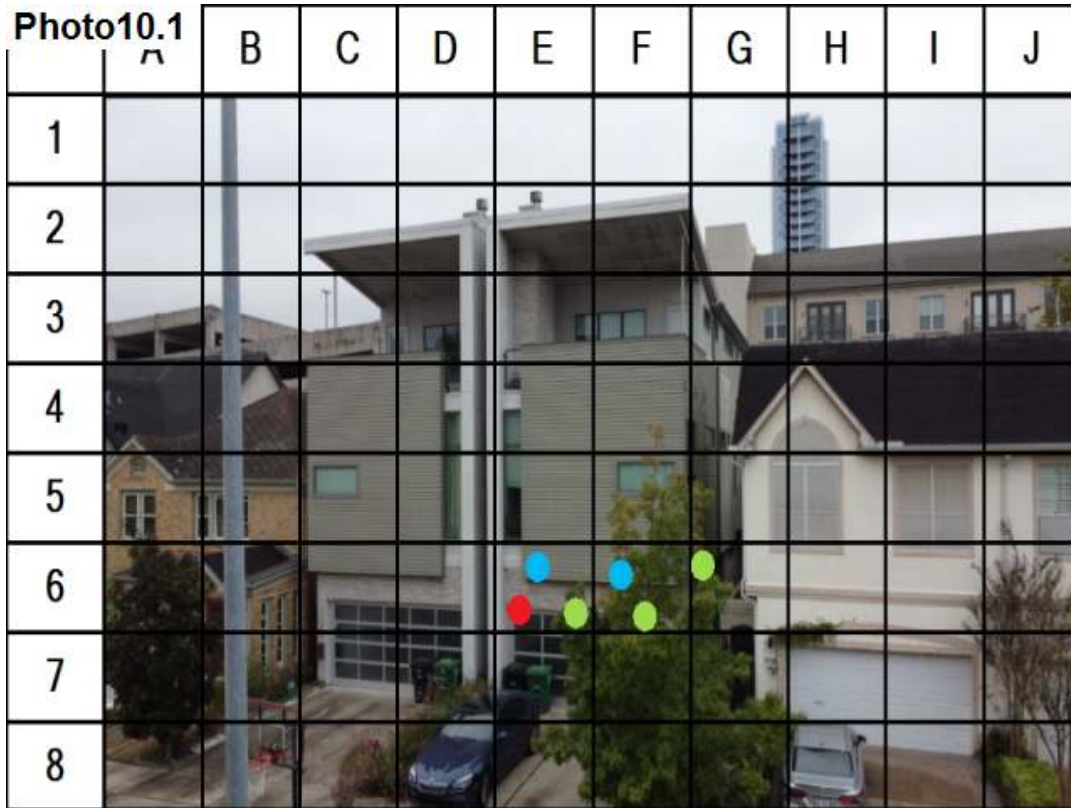
Grid Location	Item Description	Moisture Readings	Substrate Condition	Observations
E6 (red)	Garage Header	20%	Firm	A moisture probe was taken at the garage header. An elevated moisture reading was noted with a firm substrate.
E6 (green)	Garage Header	16%	Firm	A moisture probe was taken at garage header. The substrate was firm with no damage noted at this time.
F6 (green)	Garage Header	15%	Firm	A moisture probe was taken at garage header. The substrate was firm with no damage noted at this time.
E6 (blue)	Bottom Wall	17%	Firm	A moisture probe was taken at bottom wall. The substrate was firm with no damage noted at this time.
F6 (blue)	Bottom Wall	18%	Firm	A moisture probe was taken at bottom wall. The substrate was firm with no damage noted at this time.
G6	Bottom Wall	16%	Firm	A moisture probe was taken at bottom wall. The substrate was firm with no damage noted at this time.

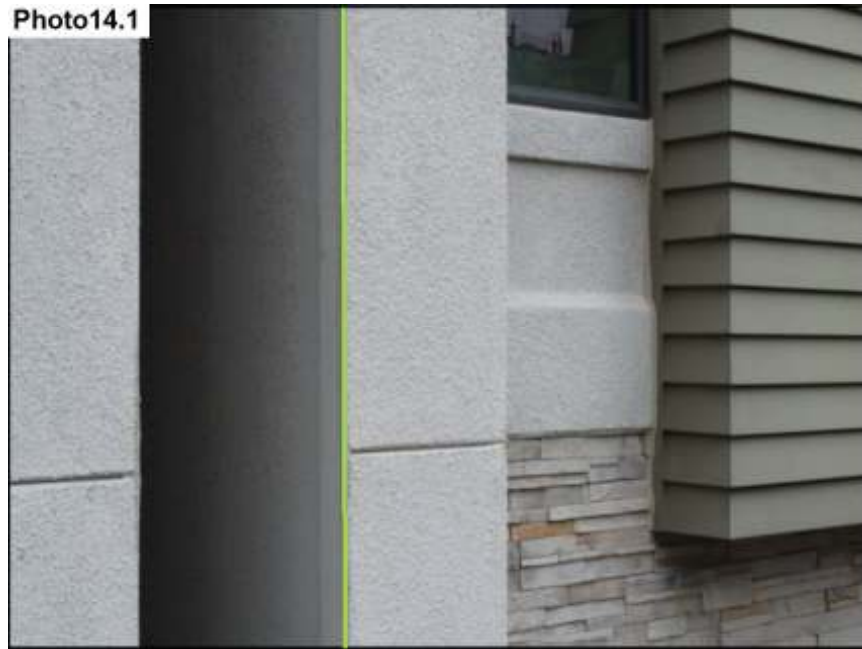
Siding & Stucco Termination / Seal

Siding & Stucco terminations have been sealed.

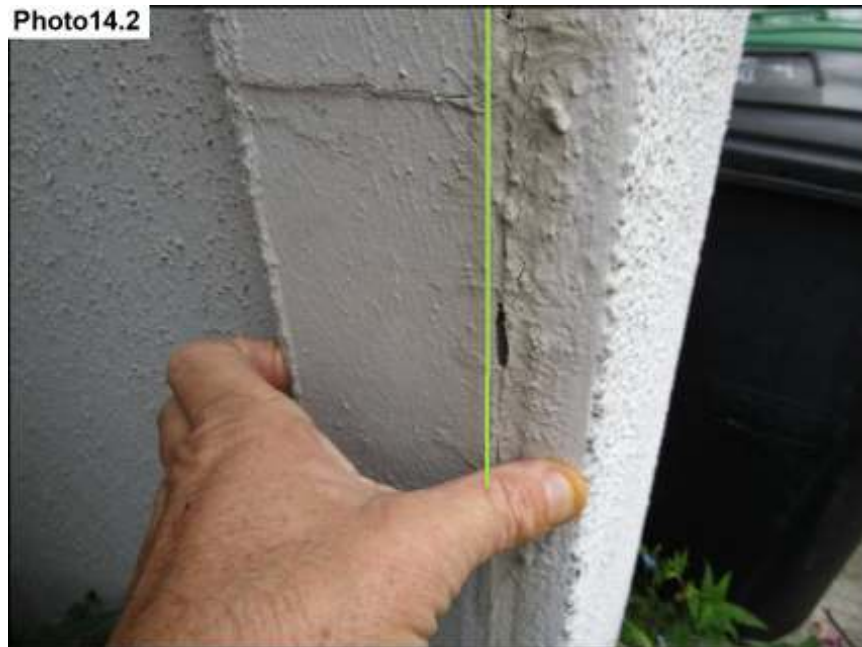
Siding & Stucco Termination / Seal

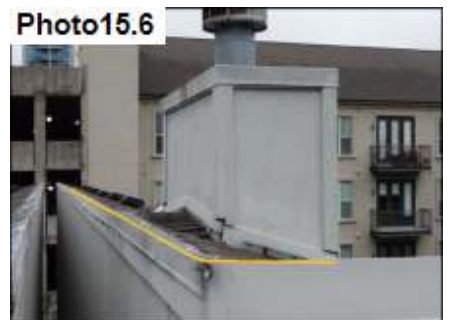
Photo15.6

Metal Cap Termination / Seal

Grid Location	Item Description	Moisture Readings	Substrate Condition	Observations
Orange Line	Metal Cap			The metal cap sealants are separated at this location. The inspector suggests to have a qualified waterproofing contractor further assess and seal this area with a low modulus sealant in an effort to prevent moisture intrusion. These types of sealants are of high quality and compatible with stucco and other termination points. Please refer to photos #15.2, #15.3, #15.4, #15.5 and #15.6 for more detail.

- The metal cap sealants are separated at this location. The inspector suggests to have a qualified waterproofing contractor further assess and seal this area with a low modulus sealant in an effort to prevent moisture intrusion. These types of sealants are of high quality and compatible with stucco and other termination points. Please refer to photos #15.2, #15.3, #15.4, #15.5 and #15.6 for more detail. [Metal caps have been sealed.](#)

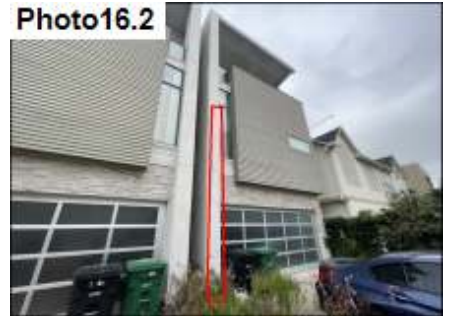
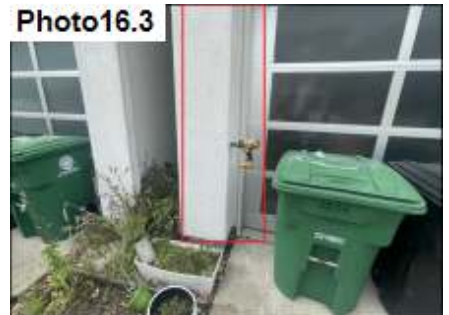
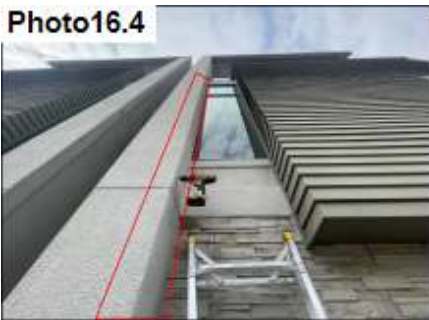
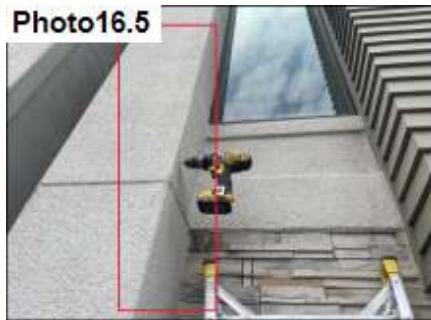
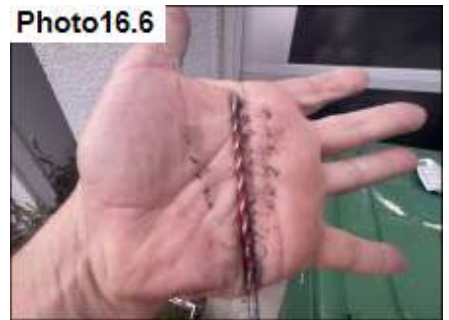
Substrate Damage / Assess, Core Sample & Repair as Needed

Grid Location	Item Description	Moisture Readings	Substrate Condition	Observations
Red Box	Damage			Substrate and potential frame damage is noted on the outside corner wall below the roof diverter flashing. The inspector suggests consulting with a qualified waterproofing contractor to further assess the extent of damage, core sample the probe locations, then repair if needed. Please refer to photos #16.2, #16.3, #16.4, #16.5 and #16.6 for more detail.
E7	Corner Wall		None	A moisture probe was made at corner wall. No substrate was noted at this time, modify as needed.
E6 (red)	Corner Wall		None	A moisture probe was made at corner wall. No substrate was noted at this time, modify as needed.
E6 (orange)	Corner Wall	27%	Semi-Firm	A moisture probe was made at corner wall. An elevated moisture reading was noted with a semi-firm substrate.
E5	Corner Wall	29%	Semi-Firm	A moisture probe was made at corner wall. An elevated moisture reading was noted with a semi-firm substrate.

- Substrate and potential frame damage is noted on the outside corner wall below the roof diverter flashing. The inspector suggests consulting with a qualified waterproofing contractor to further assess the extent of damage, core sample the probe locations, then repair if needed. Please refer to photos #16.2, #16.3, #16.4, #16.5 and #16.6 for more detail. [Damaged frame was removed/replaced.](#)

Damaged area has been repaired/replaced.

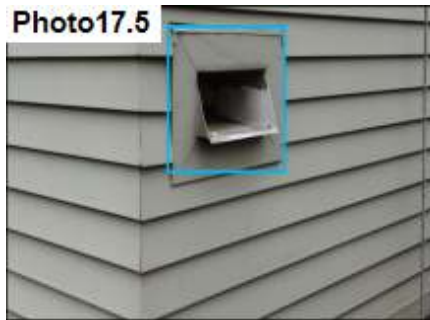
Photo17.5

Scuppers / Seal

Grid Location	Item Description	Moisture Readings	Substrate Condition	Observations
Blue Box	Scuppers			The scupper sealants are aged in this location. The inspector suggests to have a qualified waterproofing contractor seal this area in an effort to prevent moisture intrusion. Please refer to photos #17.2, #17.3, #17.4 and #17.5 for more detail.

Scuppers have been sealed.

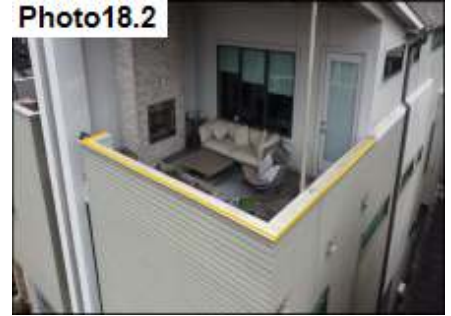
Photo18.2

Metal Cap / Seal

Metal cap has been sealed.

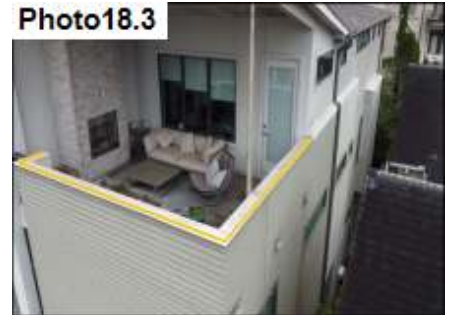
Photo18.3

Metal Cap / Seal

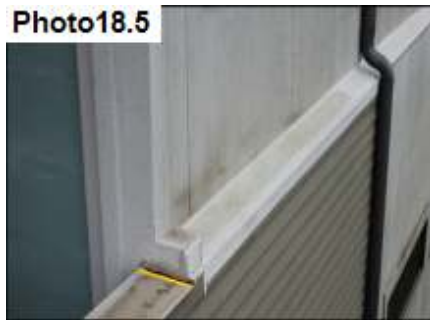
Photo18.5

Metal Cap / Seal

Grid Location	Item Description	Moisture Readings	Substrate Condition	Observations
Orange Line	Metal Cap			The metal cap sealants are aged at this location. The inspector suggests to have a qualified waterproofing contractor further assess and seal this area in an effort to prevent moisture intrusion. Please refer to photos #18.2, #18.3, #18.4 and #18.5 for more detail.

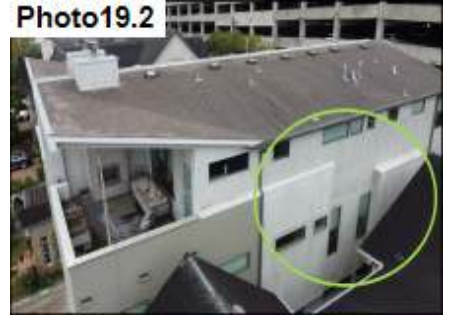
Photo19.2

Mildew Stains / Clean (Aesthetic Concern)

Homes exterior has been power washer/cleaned.

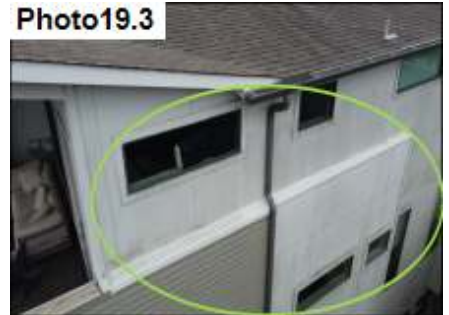
Photo19.3

Mildew Stains / Clean (Aesthetic Concern)

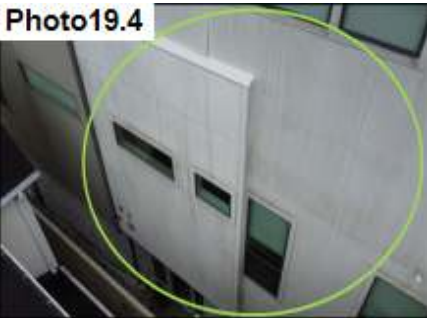
Photo19.4

Mildew Stains / Clean (Aesthetic Concern)

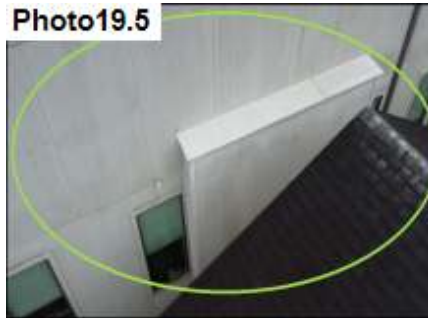
Photo19.5

Mildew Stains / Clean (Aesthetic Concern)

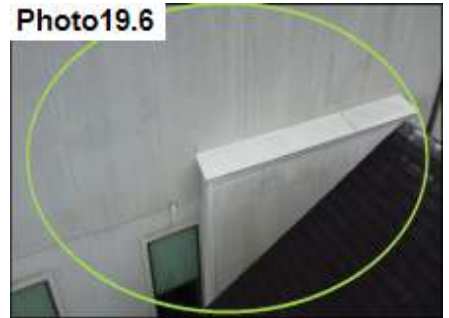
Photo19.6

Mildew Stains / Clean (Aesthetic Concern)

Grid Location	Item Description	Moisture Readings	Substrate Condition	Observations
Green Circle	Stains			Mildew stains have been noted in this area. The inspector suggests to clean the areas as needed from an aesthetic concern only. Please refer to photos #19.2, #19.3, #19.4, #19.5 and #19.6 for more detail.

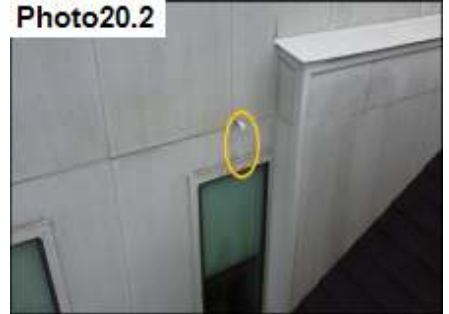
Photo20.2

Rust Stains / Clean and Paint as Needed

Rust stains have been removed. A new AC pan was installed.

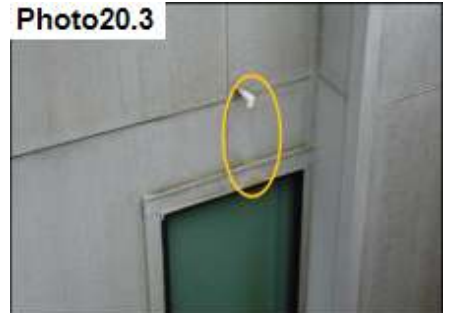
Photo20.3

Rust Stains / Clean and Paint as Needed

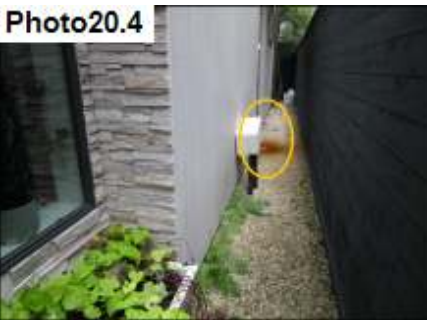
Photo20.4

Rust Stains / Clean and Paint as Needed

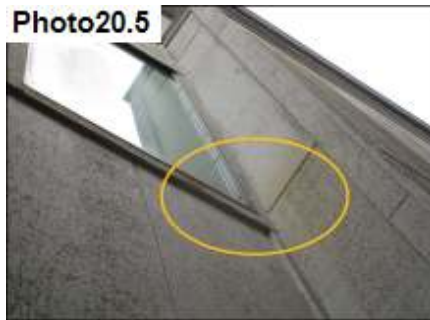
Photo20.5

Rust Stains / Clean and Paint as Needed

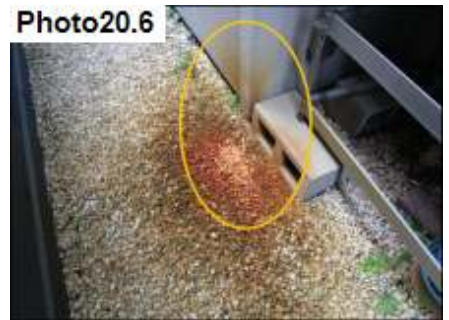
Photo20.6

Rust Stains / Clean and Paint as Needed

Grid Location	Item Description	Moisture Readings	Substrate Condition	Observations
Orange Circles	Stains			Rust stains from the HVAC overflow are noted in this area. This inspector suggests to clean this area with a wire brush and paint, as needed, from an aesthetic concern, but to also have a qualified HVAC contractor further assess the unit and drain pan causing the stain. Please refer to photos #20.2, #20.3, #20.4, #20.5 and #20.6 for more detail.

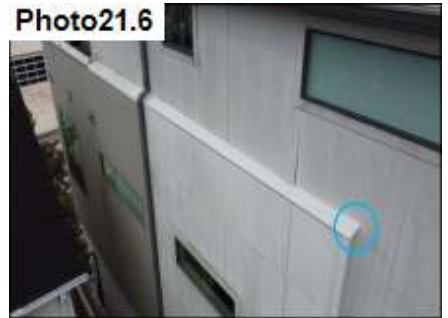
Photo21.6

Roof Diverter Flashing and Metal Cap / Seal

Grid Location	Item Description	Moisture Readings	Substrate Condition	Observations
Blue Circle	Flashing			The roof diverter flashing/metal cap sealants are aged at this location. The inspector suggests to have a qualified waterproofing contractor further assess and seal this area in an effort to prevent moisture intrusion. Please refer to photos #21.2, #21.3, #21.4, #21.5 and #21.6 for more detail.

Roof diverter flashing and metal cap has been sealed.

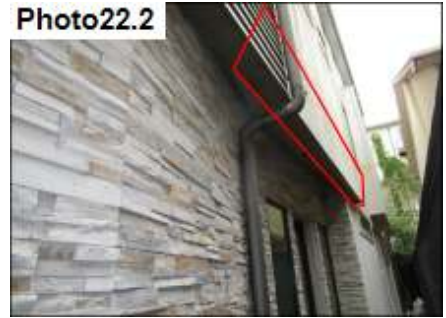
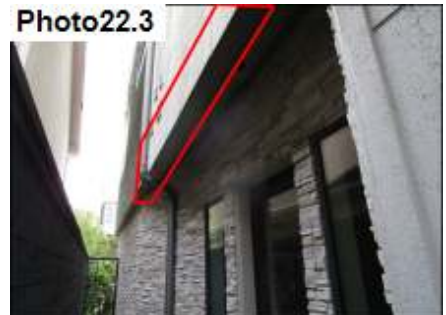
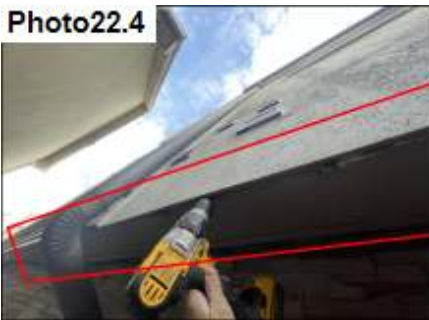
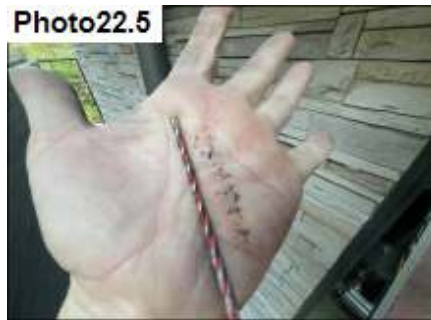
Substrate Damage / Assess, Repair & Modify as Needed

Grid Location	Item Description	Moisture Readings	Substrate Condition	Observations
Red Box	Damage			Confirmed substrate and potential frame damage is noted at the bottom beam below improper kickout flashing. The inspector suggests to have a qualified waterproofing contractor further assess the extent of damage, repair and modify this area as needed in an effort to prevent moisture intrusion. Please refer to photos #22.2, #22.3, #22.4 and #22.5 for more detail.
G6 (red)	Bottom Wall		None	A moisture probe was made at bottom wall. No substrate was noted at this time, modify as needed.
G6 (orange)	Bottom Wall		None	A moisture probe was made at bottom wall. No substrate was noted at this time, modify as needed.
G5	Above Probe G6 (red)	18%	Firm	A moisture probe was taken above Probe G6 (red). The substrate was firm with no damage noted at this time.

- Confirmed substrate and potential frame damage is noted at the bottom beam below improper kickout flashing. The inspector suggests to have a qualified waterproofing contractor further assess the extent of damage, repair and modify this area as needed in an effort to prevent moisture intrusion. Please refer to photos #22.2, #22.3, #22.4 and #22.5 for more detail.
[Damaged frame pieces and concrete board were replaced.](#)

Damage substrate and framing was removed/replaced.

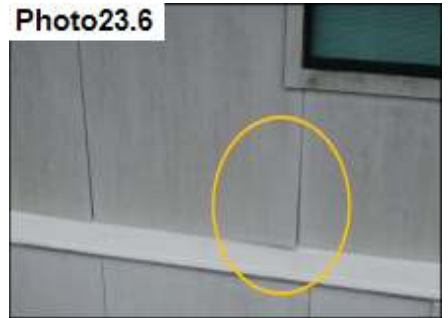
Photo23.6

Cementitious Fiber Panel / Re-Fasten

Grid Location	Item Description	Moisture Readings	Substrate Condition	Observations
Orange Circle	Siding			The cementitious fiber panels are separated at this location. The inspector suggests having a qualified waterproofing contractor further assess this area and re-fasten all panels to prevent moisture intrusion. Please refer to photos #23.2, #23.3, #23.4, #23.5 and #23.6 for more detail.

Cement panels were re-fastened/secured.

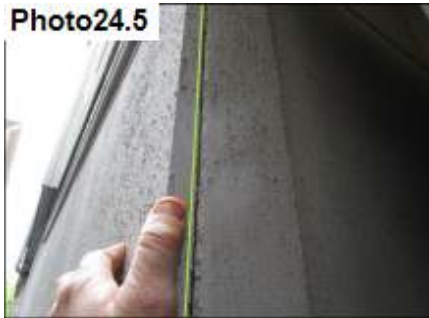
Photo24.5

Trim Termination / Seal

Grid Location	Item Description	Moisture Readings	Substrate Condition	Observations
Green Line	Trim Termination			Trim termination sealants are separated at this location. The inspector suggests to have a qualified waterproofing contractor further assess and seal this area in an effort to prevent moisture intrusion. Please refer to photos #24.2, #24.3, #24.4 and #24.5 for more detail.

- Trim termination sealants are separated at this location. The inspector suggests to have a qualified waterproofing contractor further assess and seal this area in an effort to prevent moisture intrusion. Please refer to photos #24.2, #24.3, #24.4 and #24.5 for more detail.
[Trim terminations have been sealed.](#)

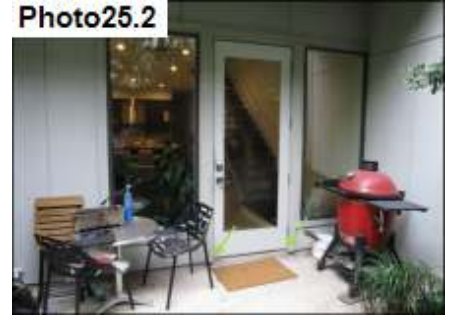
Photo25.2

Door Trim and Miter Sealant / Seal

Door trim and Miter has been sealed.

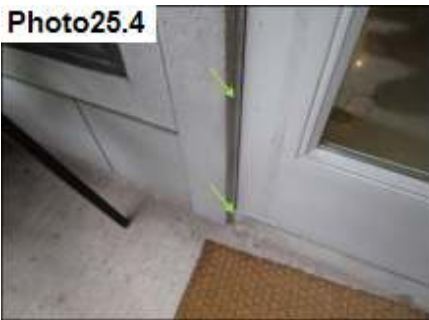
Photo25.4

Door Trim and Miter Sealant / Seal

Grid Location	Item Description	Moisture Readings	Substrate Condition	Observations
Green Arrow	Doors			The door trim and miter sealants are aged at this location. The inspector suggests to have a qualified waterproofing contractor seal this area in an effort to prevent moisture intrusion. Please refer to photos #25.2, #25.3 and #25.4 for more detail.

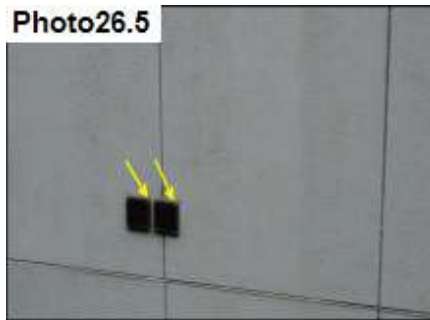
Photo26.5

Penetration Sealants / Seal

Grid Location	Item Description	Moisture Readings	Substrate Condition	Observations
Yellow Arrows	Penetrations			The penetration sealants are aged in this location. The inspector suggests to have a qualified waterproofing contractor seal this area in an effort to prevent moisture intrusion. Please refer to photos #26.2, #26.3, #26.4 and #26.5 for more detail.

Penetrations have been sealed.

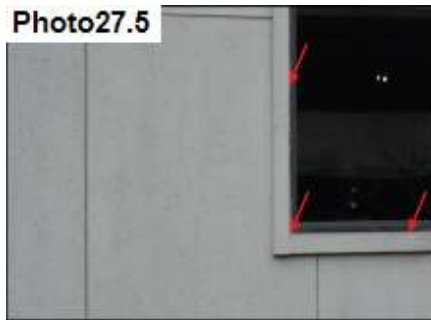
Photo27.5

Window Sealants / Seal

Grid Location	Item Description	Moisture Readings	Substrate Condition	Observations
Red Arrows	Windows			The window sealants are aged. The inspector suggests to have a qualified waterproofing contractor further assess and seal this area with a low modulus sealant in an effort to prevent moisture intrusion. These types of sealants are of high quality and compatible with stucco and other termination points. Please refer to photos #27.2, #27.3, #27.4 and #27.5 for more detail.

Windows have been sealed.

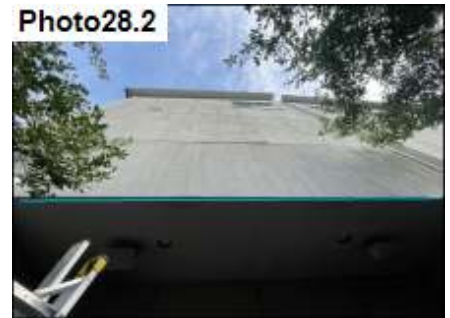
No Relief / No Modification

Grid Location	Item Description	Moisture Readings	Substrate Condition	Observations
Blue Lines	Relief			Although the bottom of the wall noted does not have a proper relief, this was a proper detail at the time of construction. Upon invasive testing at this location, the substrate was firm with low moisture readings. The inspector recommends no modification at this point in time but recommends to maintain all sealants above this location to prevent potential moisture intrusion. Please refer to photos #28.2 and #28.3 for more detail.
D7	Bottom Wall	14%	Firm	A moisture probe was made at bottom wall. The substrate was firm with no damage noted at this time.
E7	Bottom Wall	16%	Firm	A moisture probe was made at bottom wall. The substrate was firm with no damage noted at this time.
F7	Bottom Wall	18%	Firm	A moisture probe was made at bottom wall. The substrate was firm with no damage noted at this time.

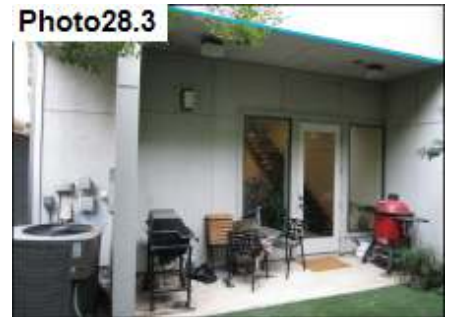
No Relief / No Modification

F6	Bottom Wall	17%	Firm	A moisture probe was made at bottom wall. The substrate was firm with no damage noted at this time.

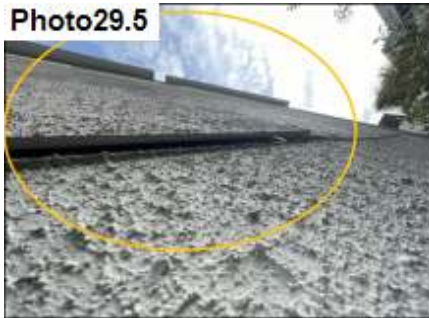
Photo29.5

Cementitious Fiber Panel / Re-Fasten

Grid Location	Item Description	Moisture Readings	Substrate Condition	Observations
Orange Circle	Siding			The cementitious fiber panels are separated at this location. The inspector suggests having a qualified waterproofing contractor further assess this area and re-fasten all panels to prevent moisture intrusion. Please refer to photos #29.2, #29.3, #29.4 and #29.5 for more detail.

- The cementitious fiber panels are separated at this location. The inspector suggests having a qualified waterproofing contractor further assess this area and re-fasten all panels to prevent moisture intrusion. Please refer to photos #29.2, #29.3, #29.4 and #29.5 for more detail.
[Cement panels have been re-fastened.](#)
