PROPERTY INSPECTION REPORT FORM

Corbin Beall <i>Name of Client</i>	04/24/2024 <i>Date of Inspection</i>
19002 Village Creek Park Drive , Cypress, TX 77433 <i>Address of Inspected Property</i>	
Jason Micallef <i>Name of Inspector</i>	TREC # 25743 <i>TREC License #</i>
<i>Name of Sponsor (if applicable)</i>	<i>TREC License #</i>

Home Inspection Report

Inspection No. 521560-390

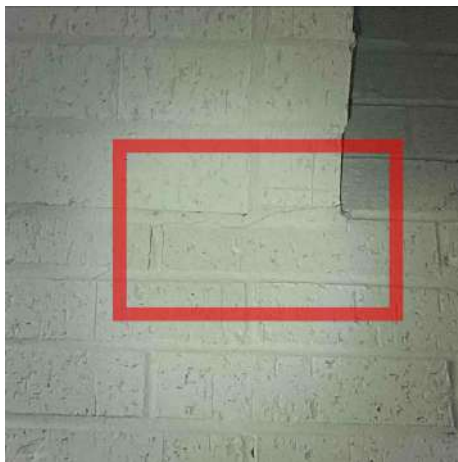
- Minor cracking has been observed in the mortar, which is typically from settlement. It is recommended to reseal the mortar. **(Exterior Front)**

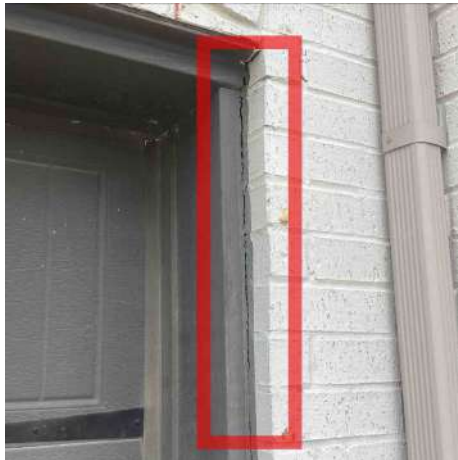
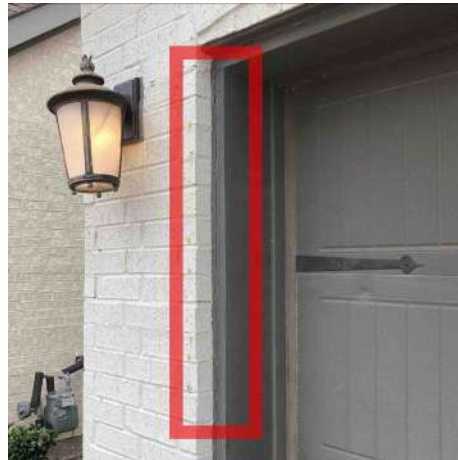
- Caulking around the garage door frame is cracked. It is recommended to remove all old caulking and replace to prevent moisture or p pest intrusion. **(Exterior Front)**

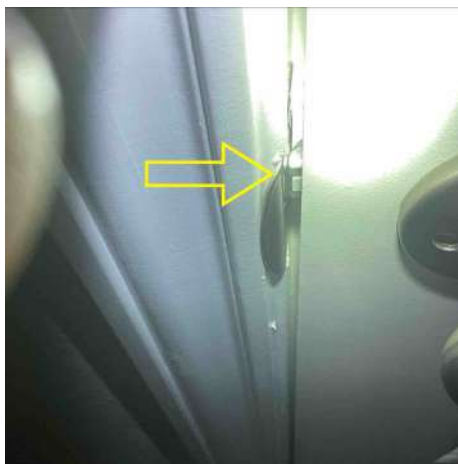
- Door does not latch when operated. It is recommended to consult with a qualified contractor to adjust the striker, to restore proper function. **(Upper Front Bedroom)**

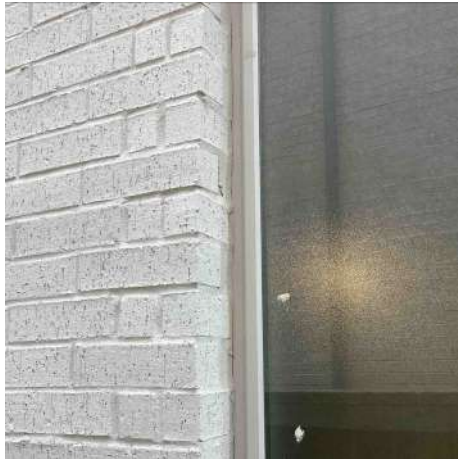
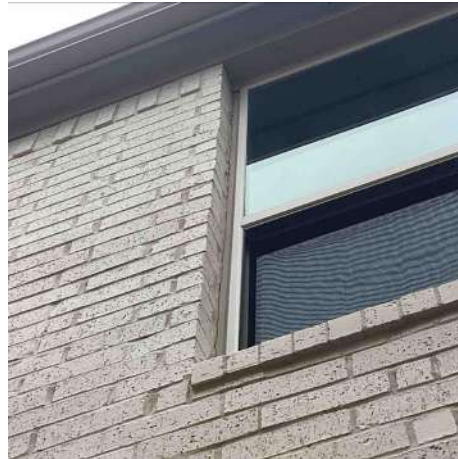
- The window caulking is cracked. It is recommended to remove old caulking and re-apply to prevent moisture or pest intrusion.

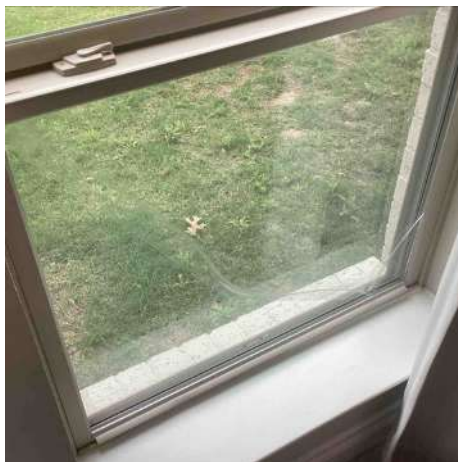
- The window is cracked within the lower window sash. It is recommended to consult with a qualified window company to replace the window, to restore proper function. **(Primary Bedroom)**

• The window is cracked within the lower window sash. It is recommended to consult with a qualified window company to replace the window, to restore proper function. (Primary Bedroom)

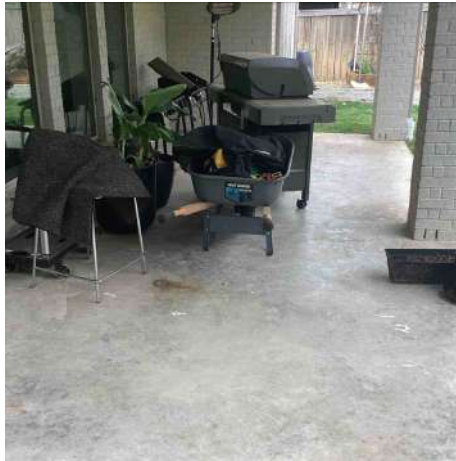
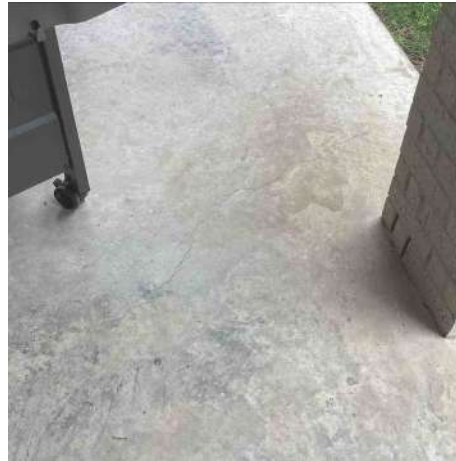
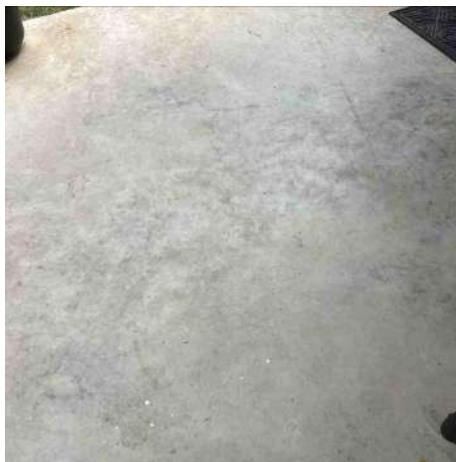
Minor settlement and curing cracks were observed on the back patio. These do not appear to be a structural concern, and it is recommended to monitor the cracks for future spreading. **(Exterior Back)**

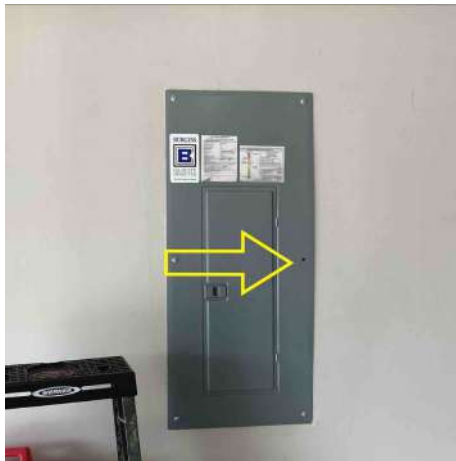
Dead front cover cover screw is missing. It is recommended to install the remaining hardware. **(Garage)**

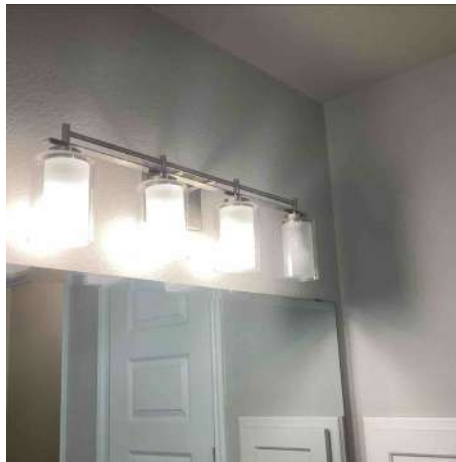
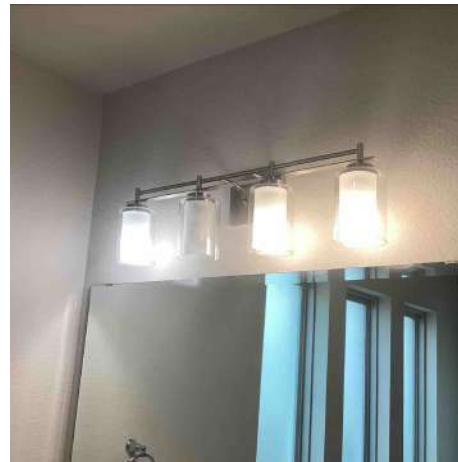
- Burned out lightbulbs have been observed above each vanity. It is recommended to replace a lightbulbs and test for function. **(Primary Bathroom)**

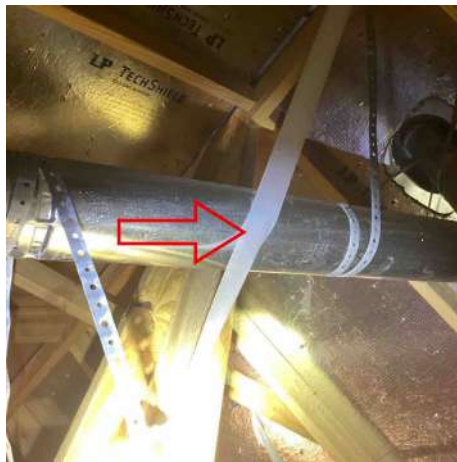
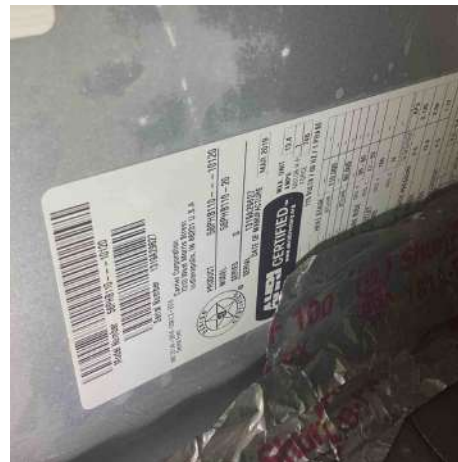
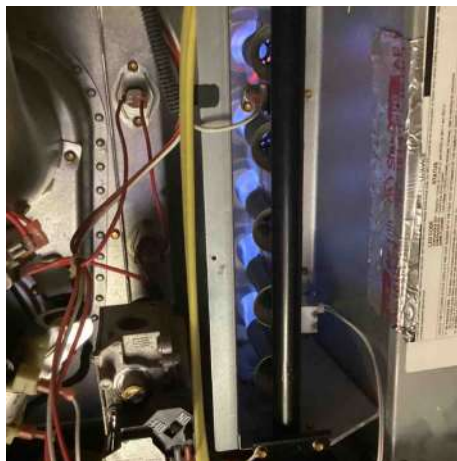
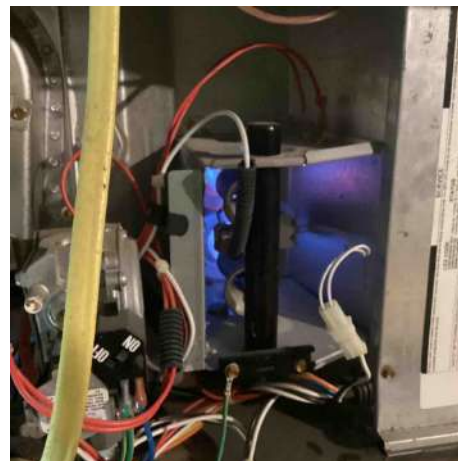
The ductwork support strap is in direct contact with the exhaust vent for the main floor unit. Exhaust vents require a minimum of 1" from any combustible material.

It is recommended to consult with a licensed HVAC company to adjust the strap, to achieve the required clearance.

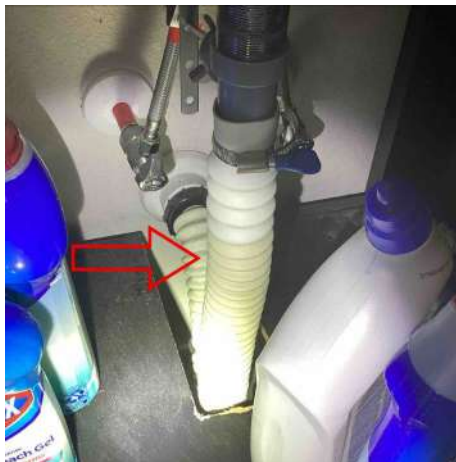
- Improper piping techniques have been observed under the powder room vanity. Piping should be rigid with a union P-trap for cleaning purposes. It is recommended to consult with a licensed plumber to evaluate and install the appropriate piping to meet proper plumbing practices. **(Powder Room)**

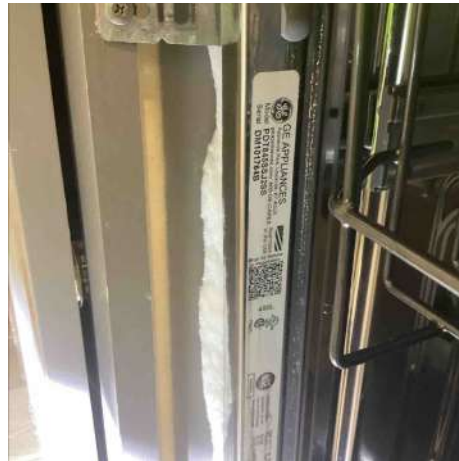
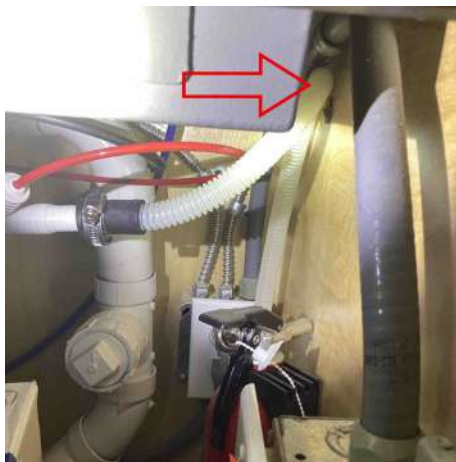
There was no anti siphon loop or mechanical air gap in the drain pipe. An air gap or anti siphon loop is used to prevent back flow of contaminated water or bacteria from the disposer or plumbing drain back into the dishwasher. Many models come with back flow valves, but the anti siphon loop or mechanical air gap is still required. An anti siphon loop is created by forming an upside down "U" in the drain hose. The top of the "U" must be in contact with the bottom of the counter. The hose is then tied in place, usually to the underside of the sink or to the faucets.

It is recommended to consult with a licensed plumber or qualified appliance company to extend the high loop to make contact with the bottom of the countertop. **(Kitchen)**
